# Contract No.: CV/2015/07 Handling of Surplus Public Fill (2016-2018)

TSEUNG KWAN O AREA 137 FILL BANK

MONTHLY EM&A REPORT NO.25

(MAY 2019)

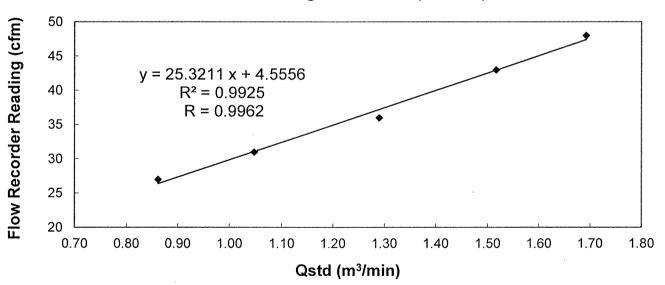
# Sampler 9795 Calibration Curve Site: Tseung Kwan O 137 (TKO-A1)

Acceptance Criteria : Correlation coefficient (r) of the calibration curve greater than 0.990 after a 5-point calibration

The high volume sampler complies\* / does not comply\* with the specified requirements and is deemed acceptable\*/ unacceptable\* for use.

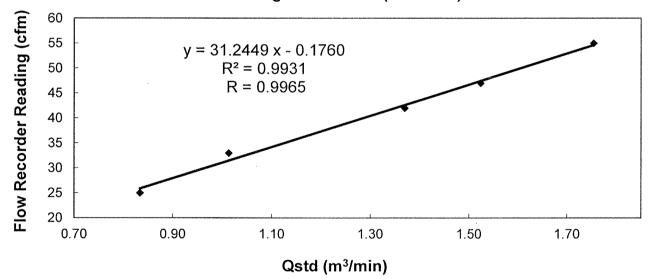
Sampler 1176 Calibration Curve Site: Tseung Kwan O 137 (TKO-A2a)

Acceptance Criteria : Correlation coefficient (r) of the calibration curve greater than 0.990 after a 5-point calibration

The high volume sampler complies\* / does not comply\* with the specified requirements and is deemed acceptable\* / unacceptable \* for use.

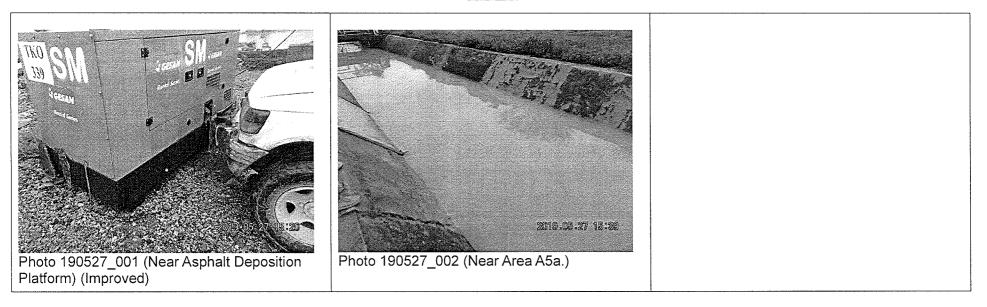
### <u>Photo</u>

Table 7.1	Key Findings of Week	y ET Site Audits in this re	eporting period	
Date	Key Findings	Action(s) Taken recommended by ET	Action(s) Taken by the Contractor during the ET weekly site audit	Rectification Status by ET
08 May 2019	No defective work or	observation was recorded du	ring the weekly ET site inspec	tion
15 May 2019	No defective work or	observation was recorded du	ring the weekly ET site inspec	tion
22 May 2019	Oil stains were observed beside the generator near asphalt deposition platform.(New Item)	To clean the oil stain properly.		Follow-up
27 May 2019	Oil stains were observed beside the generator near asphalt deposition platform.(Previous Item)	To clean the oil stain properly.	Oil stains near asphalt deposition platform were cleaned	Closed
	Silting screen was found performance degradation near Area A5a. (New Item)	Replace the silting screen properly.		Follow-up
