## ***China Harbour – Zhen Hua Joint Venture***

**Contract No.: CV/2015/07  
Handling of Surplus Public Fill  
(2016-2018)**

**TSEUNG KWAN O AREA 137 FILL BANK**

**MONTHLY EM&A REPORT NO.39**

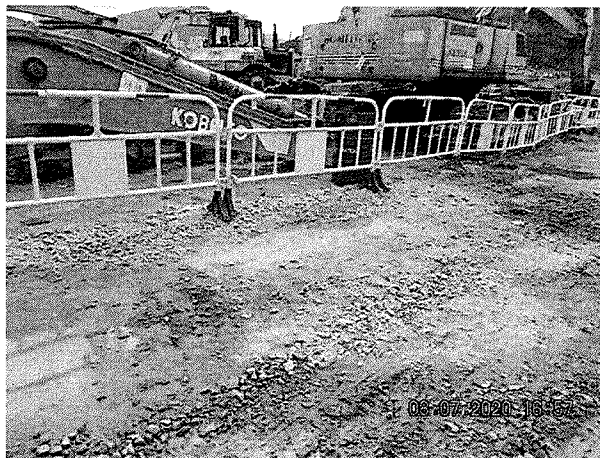
Photo 200708\_001 (Near Workshop)  
(Improved)

Date	Key Findings	Action(s) Taken recommended by ET	Action(s) Taken by the Contractor during the ET weekly site audit	Rectification Status by ET
08 July 2020	Oil stains were observed near workshop (Previous item)	To clean the oil stain properly	Oil stains were cleaned.	Closed
	Stagnant water were observed near generator on soil platform (New item)	To clean the stagnant water properly	---	Follow-up
15 July 2020	Stagnant water were observed near generator on soil platform (Previous item)	To clean the stagnant water properly	Stagnant water was cleaned	Closed
22 July 2020	Dust emissions were observed near soil platform (New item)	Provide the water spray to control the dust emission	---	Follow-up
29 July 2020	Dust emissions were observed near soil platform (Previous item)	Provide the water spray to control the dust emission	Water spray were provided	Closed

The Contractor should provide sufficient preventive measures during equipment maintenance works so as to avoid oil leakage on the ground. In the event of any oil leakage, the Contractor should clean up the polluted soil and handle all the materials used for this cleaning works as chemical waste.
