## Sheung Shui to Lok Ma Chau Spur Line

Monthly EM&A Report for Kwu Tung Station

(March 2023)

## **Contract 1633 –Alteration and Addition Works at Kwu Tung for East Rail Line Protection Works**

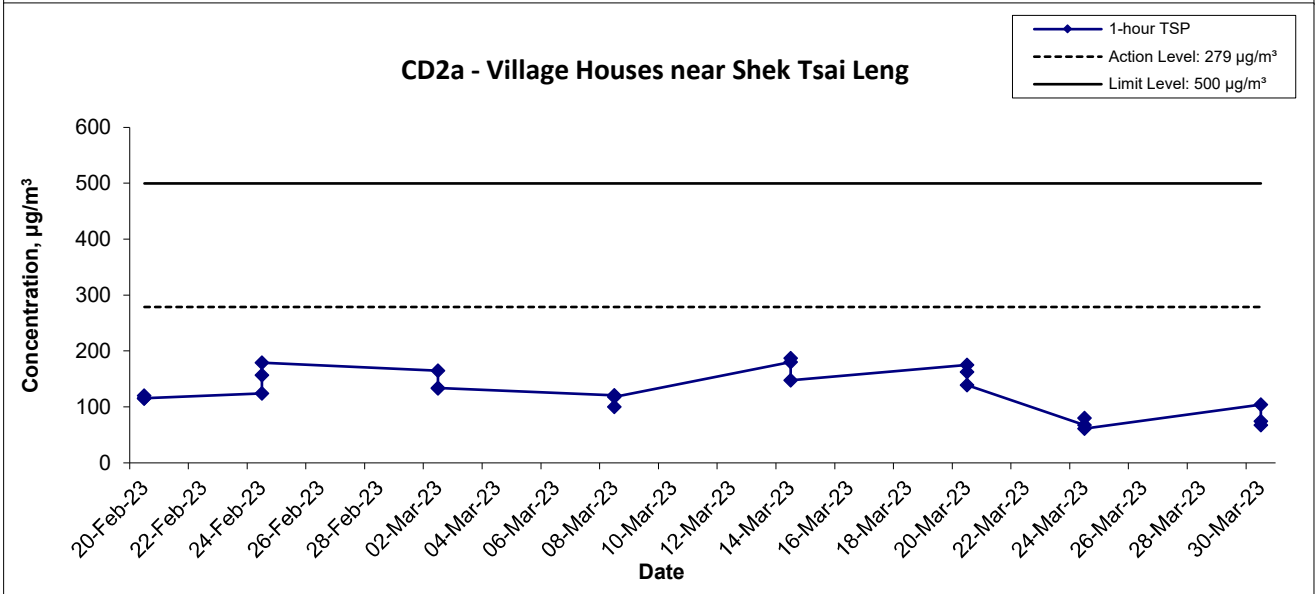
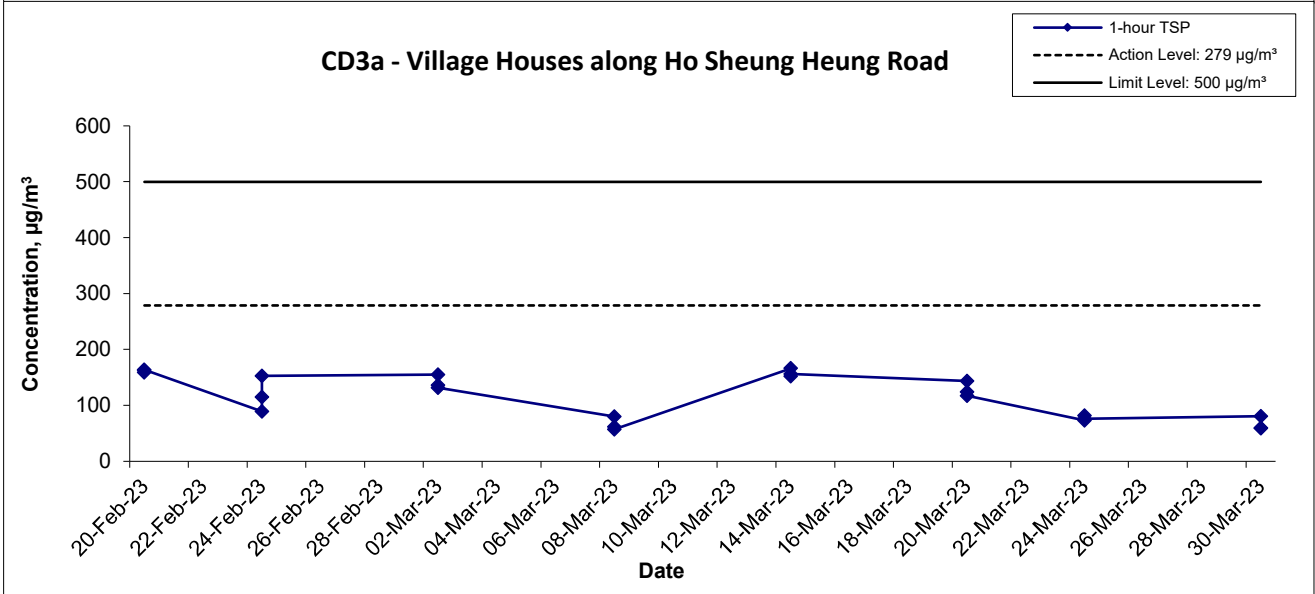
### 1-hr TSP Concentration Levels

Title Contract 1633 –  
Alteration and Addition Works at Kwu Tung for  
East Rail Line Protection Works  
Graphical Presentation of 1-hour TSP Monitoring Results

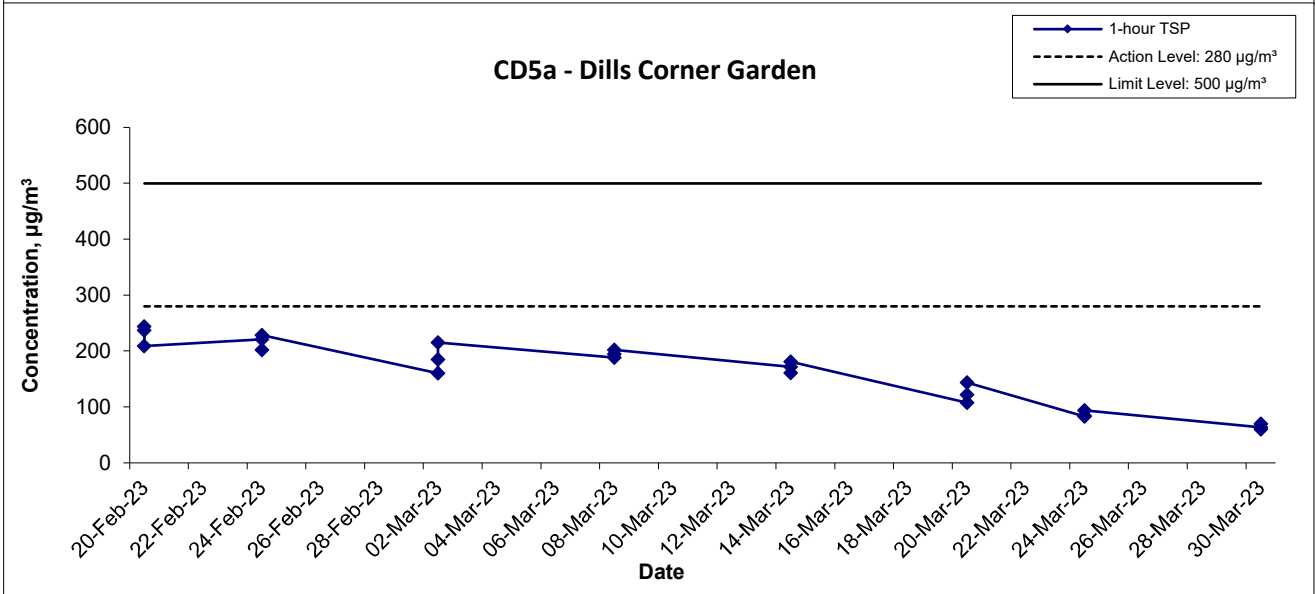
### 1-hr TSP Concentration Levels

Title Contract 1633 –  
Alteration and Addition Works at Kwu Tung for  
East Rail Line Protection Works  
Graphical Presentation of 1-hour TSP Monitoring Results

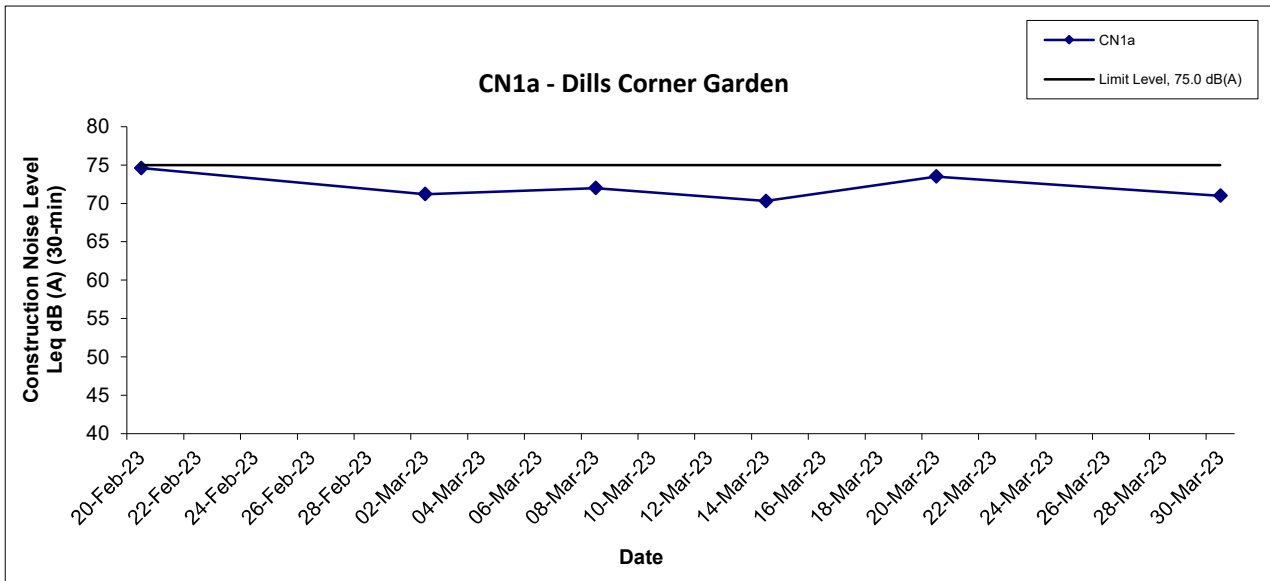
## Noise Levels

Title Contract 1633 – Alteration and Addition Works at Kwu Tung for East Rail Line Protection Works  Graphical Presentation of Construction Noise Monitoring Results	Scale N.T.S	Project No. WMA22014	匯力 consulting . testing . research
	Date Mar 23	Appendix F

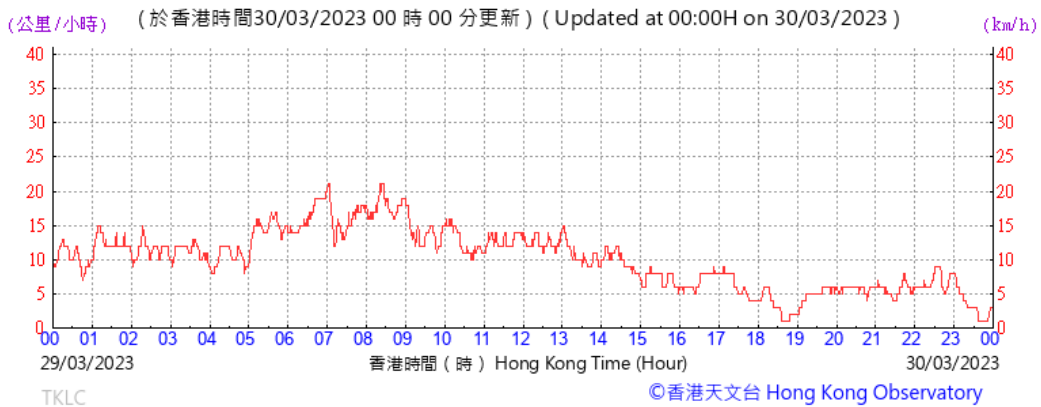
## Wind Speed:

Title Contract 1633 - Alteration and Addition Works at Kwu Tung for East Rail Line Protection Works  Meteorological Data at Ta Kwu Ling Weather Station	Scale N.T.S	Project No. WMA22104	
	Date Mar 23	Appendix G
