Sheung Shui to Lok Ma Chau Spur Line

Monthly EM&A Report for Kwu Tung Station

(May 2023)

Contract 1633 –Alteration and Addition Works at Kwu Tung for East Rail Line Protection Works

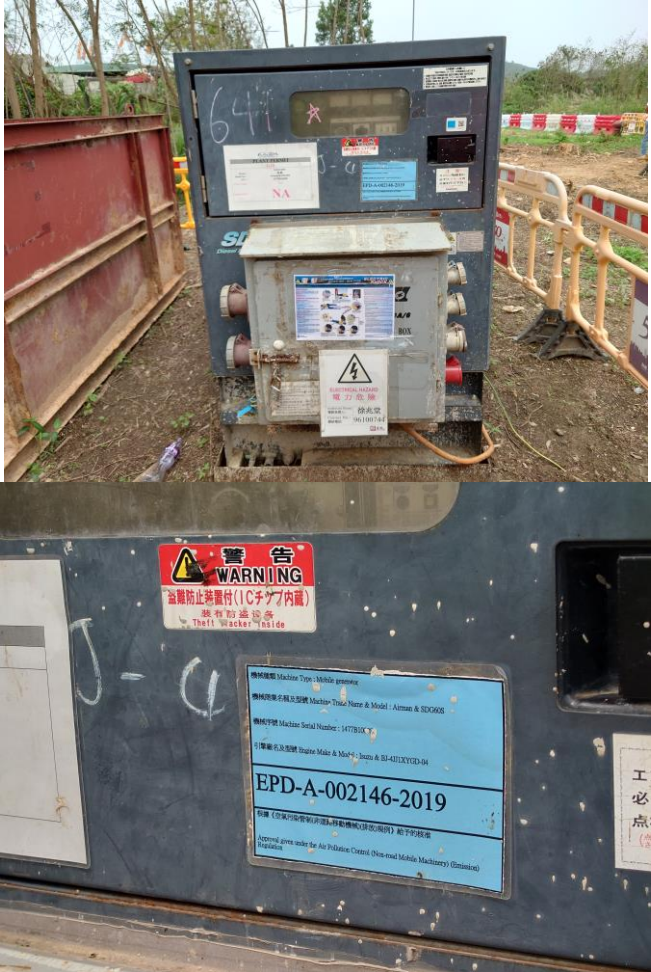
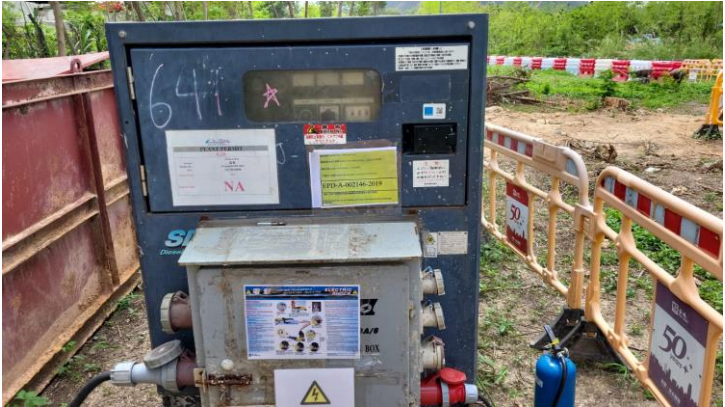
<p>Ref no.: 230424-R01</p> <p>Impact: Air Quality (B 26)</p> <p>Detail: Faded NRMM label should be replaced.</p>	<p>Follow-up: NRMM label was replaced.</p>

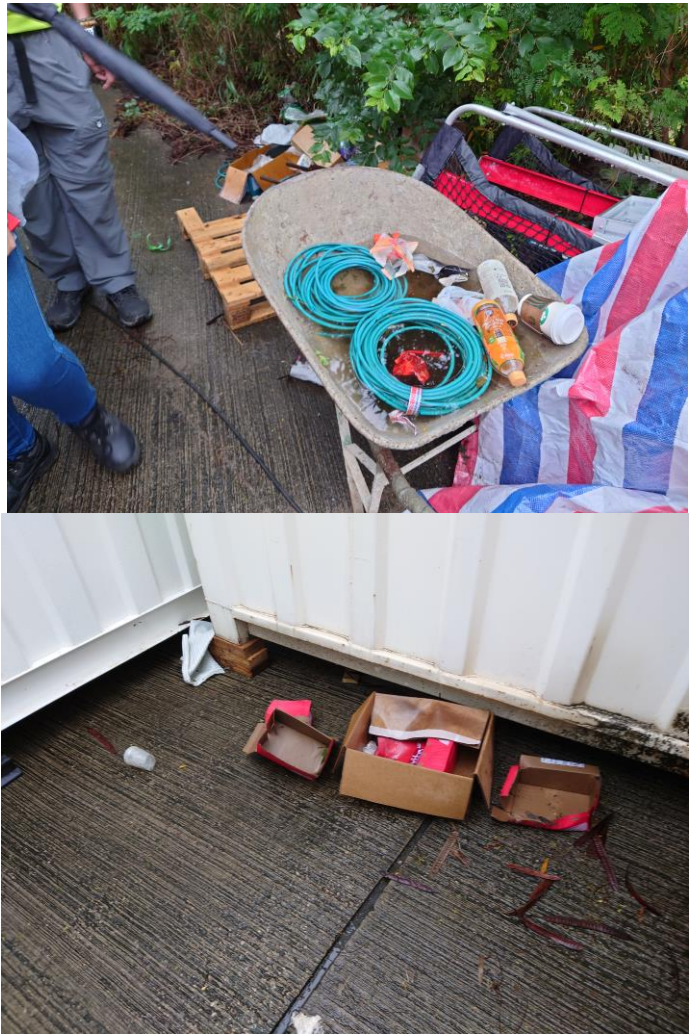
<p>Ref no.: 230508-R01</p> <p>Impact: <i>Waste/Chemical Management (E 12)</i></p> <p>Detail: The site should be generally clean and tidy.</p>
