Sheung Shui to Lok Ma Chau Spur Line

Monthly EM&A Report for Kwu Tung Station

(June 2023)

Contract 1633 –Alteration and Addition Works at Kwu Tung for East Rail Line Protection Works

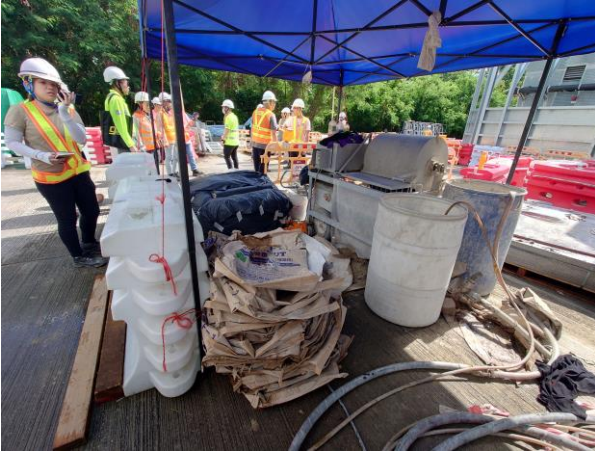
<p>Ref no.: 230605-001</p> <p>Impact: <i>Air Quality</i> (B 14)</p> <p>Details: Stock of more than 20 bags of cement or dry PFA should be covered or sheltered on top and 3 sides.</p>

<p>Ref no.: 230605-001</p> <p>Impact: <i>Air Quality</i> (B 14)</p> <p>Details: Stock of more than 20 bags of cement or dry PFA should be covered or sheltered on top and 3 sides.</p>	<p>Follow-up: Stock of cement or dry PFA was sheltered on top and 3 sides.</p>

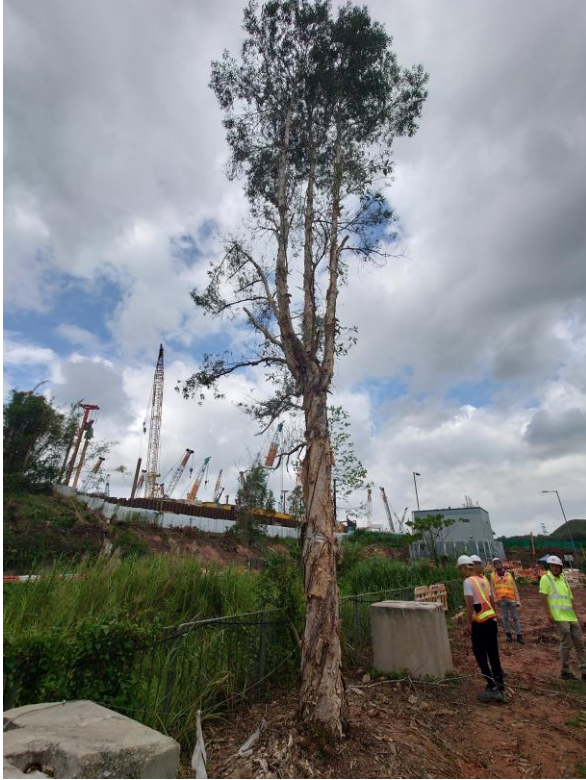
<p>Ref no.: 230605-002</p> <p>Impact: <i>Landscape & Visual</i> (G 2)</p> <p>Details: The tree to be transplant should be maintained properly and securely.</p>

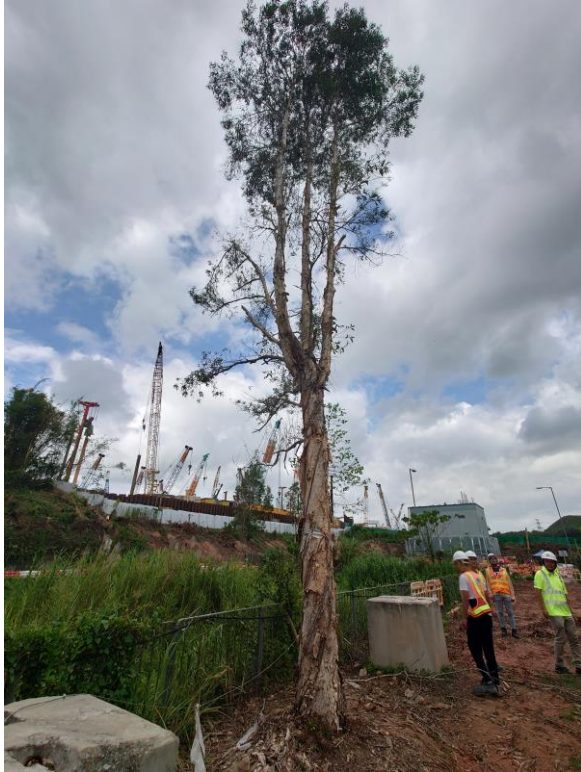
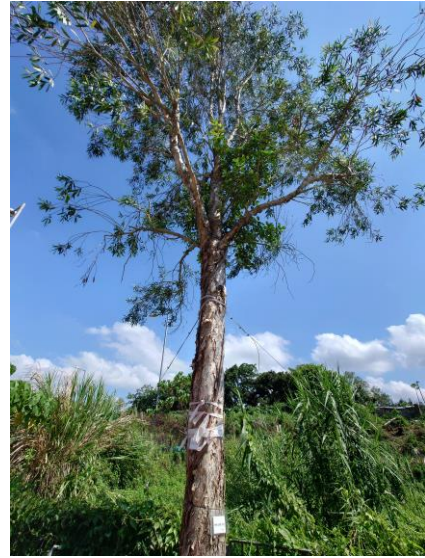
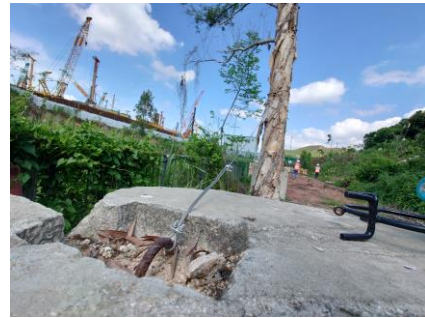
Ref no.: 230605-002

Impact: *Landscape & Visual (G 2)*

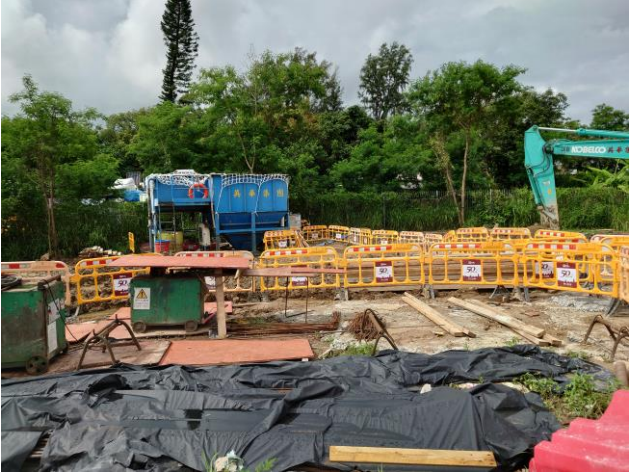
<p>Ref no.: 230619-R01</p> <p>Impact: <i>Air Quality</i> (B 2)</p> <p>Details: Stockpile of dusty material should be covered by tarpaulin sheets properly.</p>	<p>Follow-up:</p> <p>The dusty stockpile was removed and cleared.</p>
