Sheung Shui to Lok Ma Chau Spur Line

Monthly EM&A Report for Kwu Tung Station

(August 2023)

Contract 1633 –Alteration and Addition Works at Kwu Tung for East Rail Line Protection Works

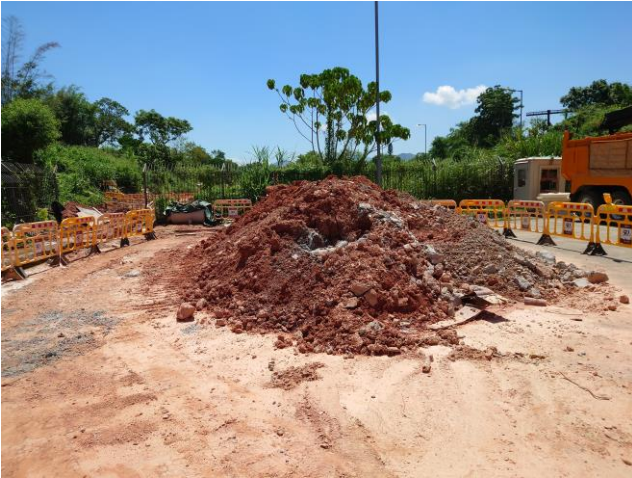
Photo	Details

<p>Ref no.: 2300803-R01 Impact: <i>Air Quality</i> (B 2) Details: Stockpile of dusty materials should be covered entirely by impervious sheeting.</p>

Date	Parameters	Observation(s) / Recommendation(s)	Follow Up Action
03/08/2023	<i>Air Quality</i>	Stockpile of dusty materials should be covered entirely by impervious sheeting.	Improvement/Rectification was observed during follow-up audit session on 14 August 2023.
07/08/2023			
14/08/2023	--	No major environmental deficiency was identified during the site inspection.	--
21/08/2023	--	No major environmental deficiency was identified during the site inspection.	--
28/08/2023	--	No major environmental deficiency was identified during the site inspection.	--

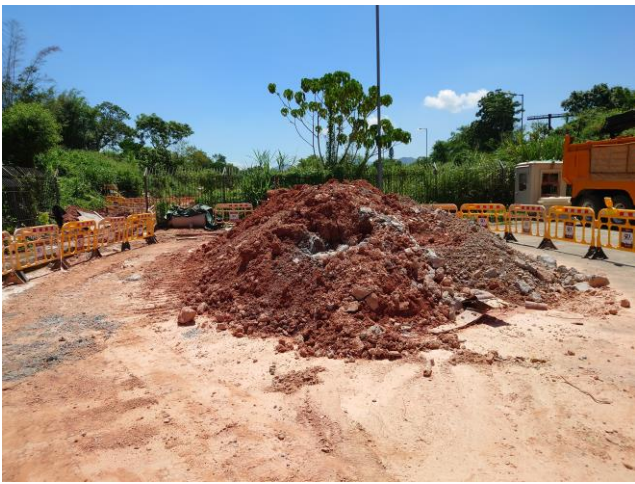
Photo Record	Rectified Photo

<p>N/A</p>
<p>Ref no.: 230803-R01 Impact: <i>Air Quality</i> (B 2) Details: Stockpile of dusty materials should be covered entirely by impervious sheeting.</p>	<p>Follow-up: Item was remarked as 230807-R01. Follow-up action is needed to be reviewed.</p>

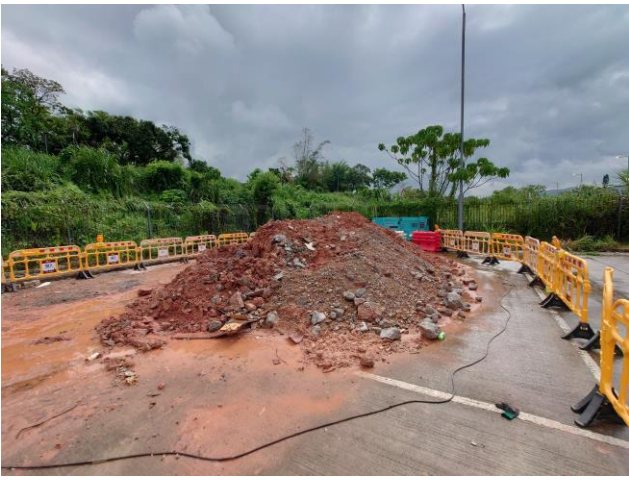
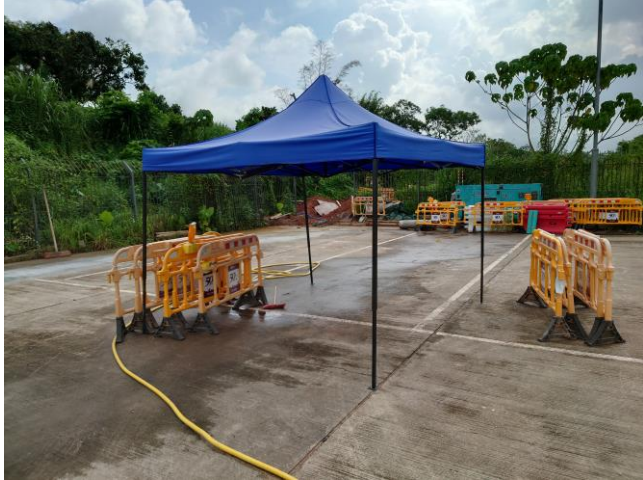
Photo Record	Rectified Photo

<p>Ref no.: 230807-R01 Impact: <i>Air Quality</i> (B 2) Details: Stockpile of dusty materials should be covered entirely by impervious sheeting.</p>	<p>Follow-up: The stockpile of dusty materials was cleared. The hard pave ground was washed completely.</p>
