Sheung Shui to Lok Ma Chau Spur Line

Monthly EM&A Report for Kwu Tung Station

(November 2023)

Kwu Tung Station on East Rail Line

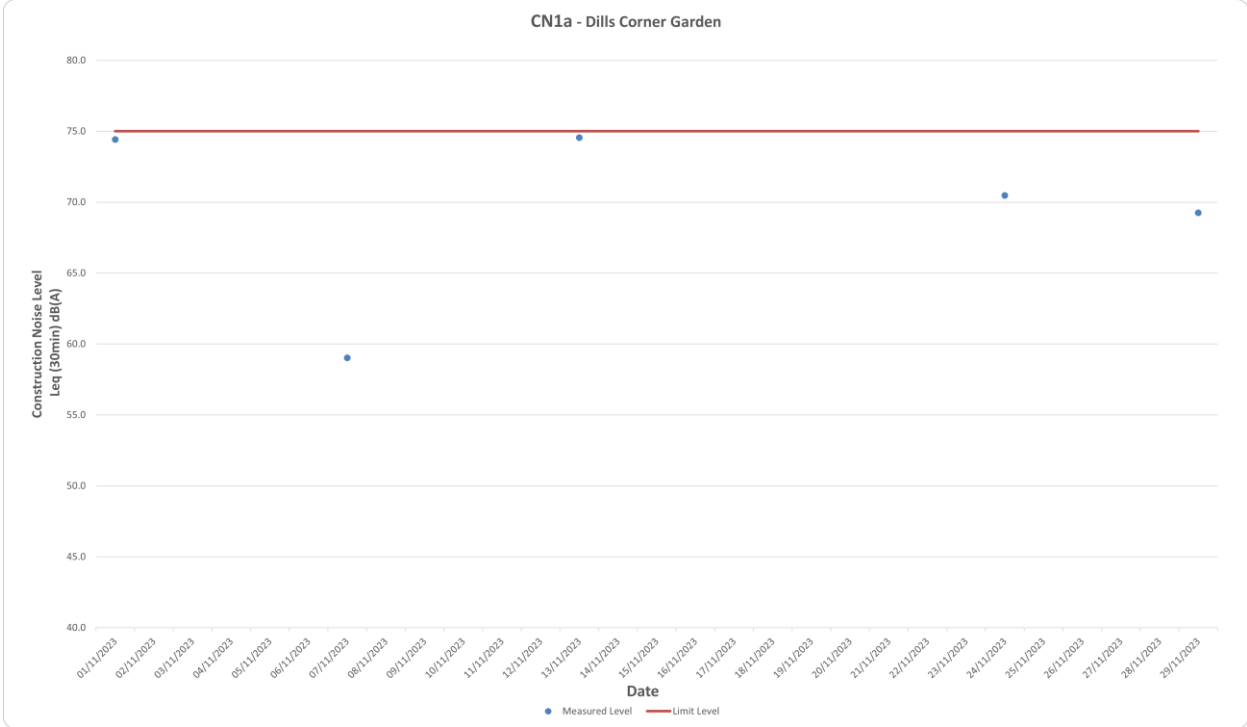
Noise Monitoring Results

3.7.4 At CN1a, major noise sources included excavation, dump truck, and road traffic observed in the construction sites nearby CN1a during noise monitoring.

Location CN1a - Dills Corner Garden						
Date	Weather	Time	Measure Level			Average L _{eq}
			Unit: dB (A) (5-mins)			
			L _{eq}	L ₁₀	L ₉₀	
2023-11-01	Sunny	16:49	73.9	77.5	67.0	74.4
