Sheung Shui to Lok Ma Chau Spur Line

Monthly EM&A Report for Kwu Tung Station

(December 2023)

Kwu Tung Station on East Rail Line

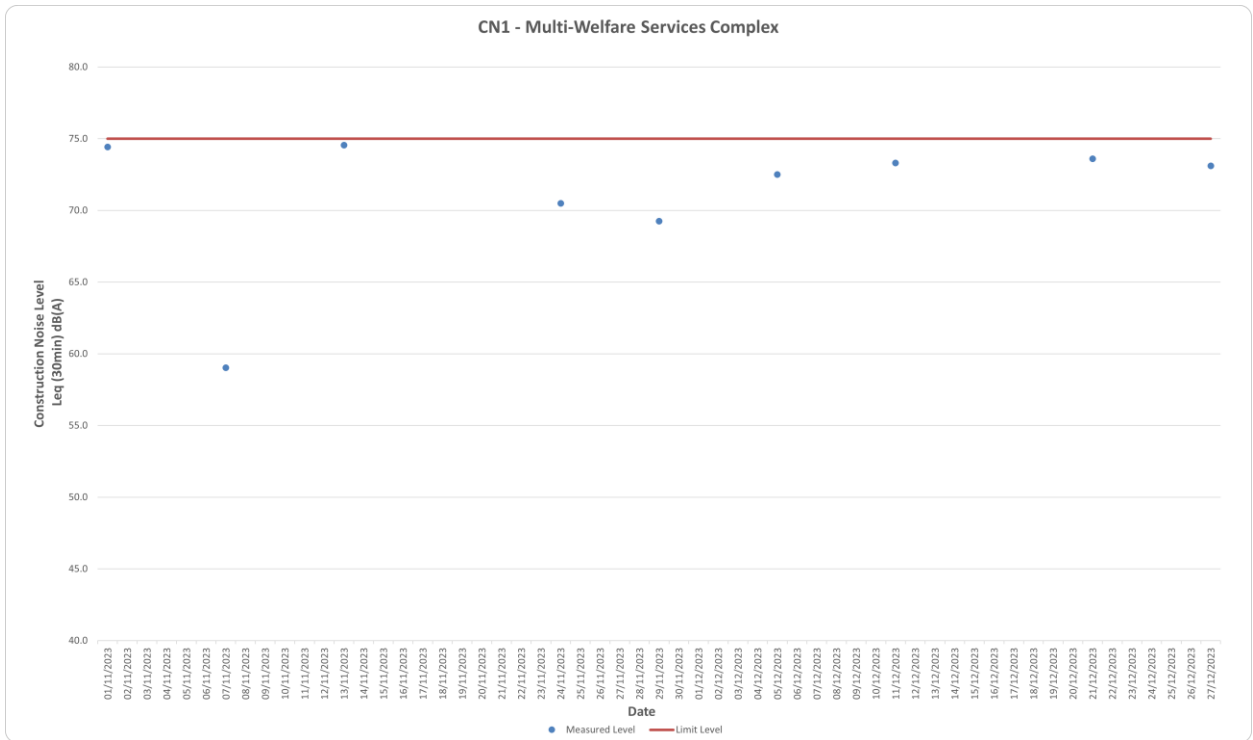
Noise Monitoring Results

Location CN1 - Multi-Welfare Services Complex						
Date	Weather	Time	Measure Level			Average Leq
			Unit: dB (A) (5-mins)			
			Leq	L10	L90	
2023-12-05	Sunny	14:17	71.4	73.0	69.2	72.5
		14:22	72.1	73.4	70.0	
		14:27	71.8	73.4	69.6	
		14:32	73.0	64.6	70.9	
		14:37	72.4	74.2	70.2	
		14:42	73.7	75.6	70.8	
2023-12-11	Sunny	13:52	72.7	75.0	68.8	73.3
		13:57	72.8	75.7	68.4	
		14:02	73.5	75.4	70.1	
		14:07	74.3	76.7	70.2	
		14:12	72.6	76.0	68.8	
		14:17	73.4	75.6	70.1	
2023-12-21	Sunny	14:23	73.8	76.3	68.9	73.6
		14:28	74.6	76.7	70.2	
		14:33	74.1	76.3	69.5	
		14:38	73.3	76.0	69.1	
		14:43	72.5	74.4	68.3	
		14:48	73.1	75.0	70.0	
2023-12-27	Sunny	8:53	71.1	73.1	67.8	73.1
		8:58	73.2	75.6	69.6	
		9:03	72.9	74.7	70.5	
		9:08	73.5	75.6	69.5	
		9:13	72.7	74.7	70.0	
		9:18	74.6	77.0	70.7
