Sheung Shui to Lok Ma Chau Spur Line

Monthly EM&A Report for Kwu Tung Station

(January 2024)

Kwu Tung Station on East Rail Line

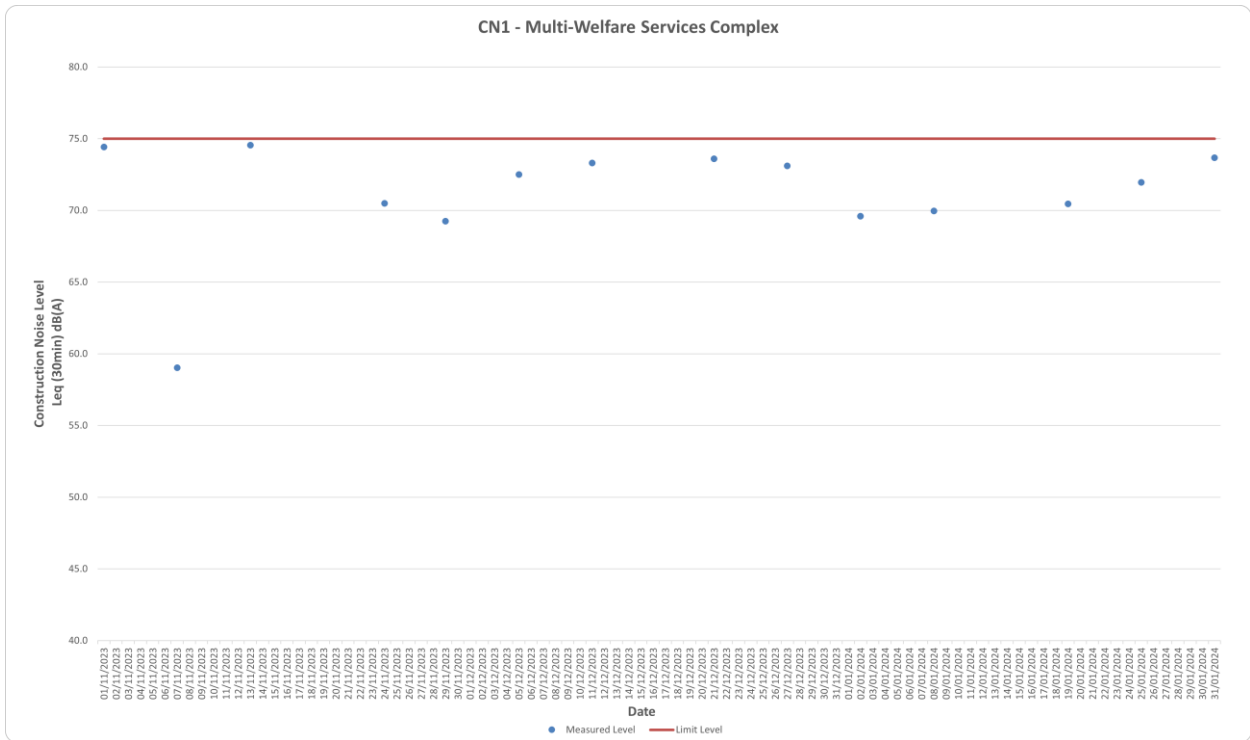
Noise Monitoring Results

9:26	73.4	75.9	70.0		
		9:31	73.6	75.7	70.2		
		9:36	74.4	75.2	70.8		
		9:41	73.3	75.4	69.3		
		9:46	74.1	76.7	69.2

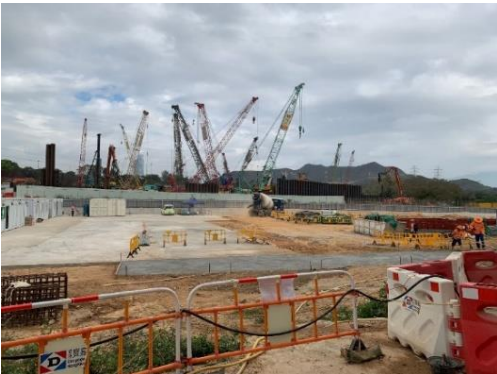
Date	Environmental Observation(s) / Recommendation(s)	Rectification Photos	Close-out Date / Status
2024 - 1 - 17	<p>Obsevation 1:</p>

<p>1. Haul Road should be sprayed water to enhance dust mitigation measure. (Upper platform)</p>	<p>Action Taken:</p>

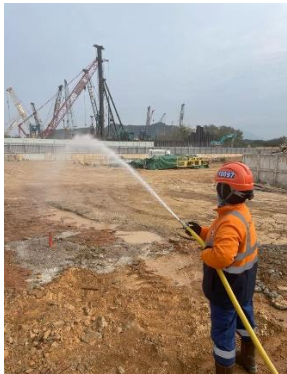
<p>1. Haul road was sprayed water to control dust. (Upper platform)</p>	Rectified on 17 January 2024.
	<p>Obsevation 2:</p>

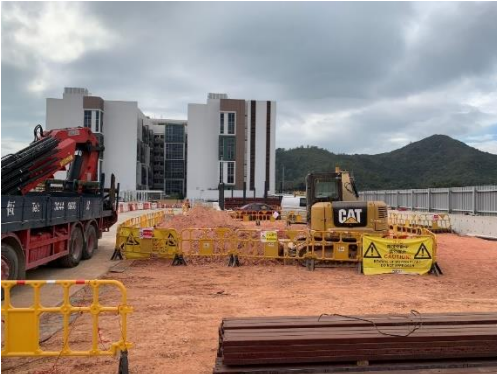
<p>2. Stockpile should be covered by tarpaulin sheet. (Upper platform)</p>	<p>Action Taken:</p>

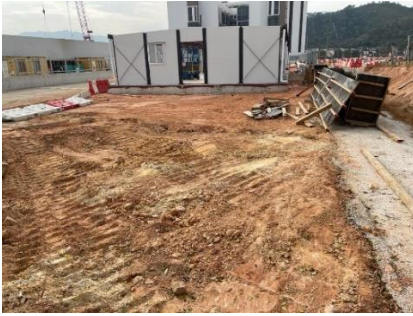
<p>2. Stockpile was removed. (Upper platform)</p>	Rectified on 17 January 2024.
