Sheung Shui to Lok Ma Chau Spur Line

Monthly EM&A Report for Kwu Tung Station

(February 2024)

Kwu Tung Station on East Rail Line

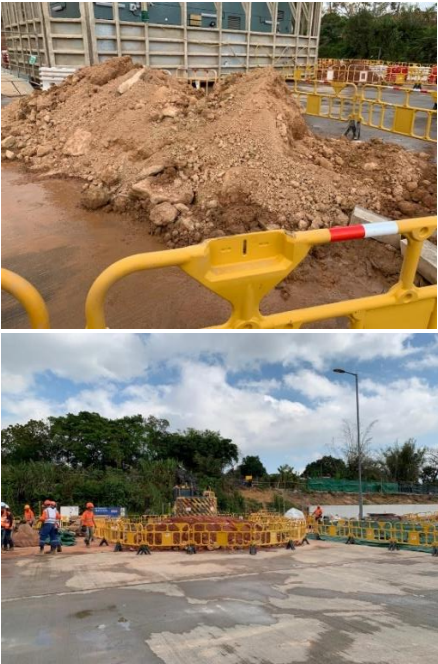
Date	Environmental Observation(s) / Recommendation(s)	Rectification Photos	Close-out Date / Status
2024 - 2 - 21	<p>Obsevation 1:</p>

<p>1. Stockpile should be covered by tarpaulin sheet near EAP 4. (Lower platform)</p>	<p>Action Taken:</p>
