Figure 4: Indicative Details of Temporary Staging, Gabion Barrier and Habitat Creation at Slope No. 15NW-C/C3

## Environmental Permit No.: EP-149/2002/A

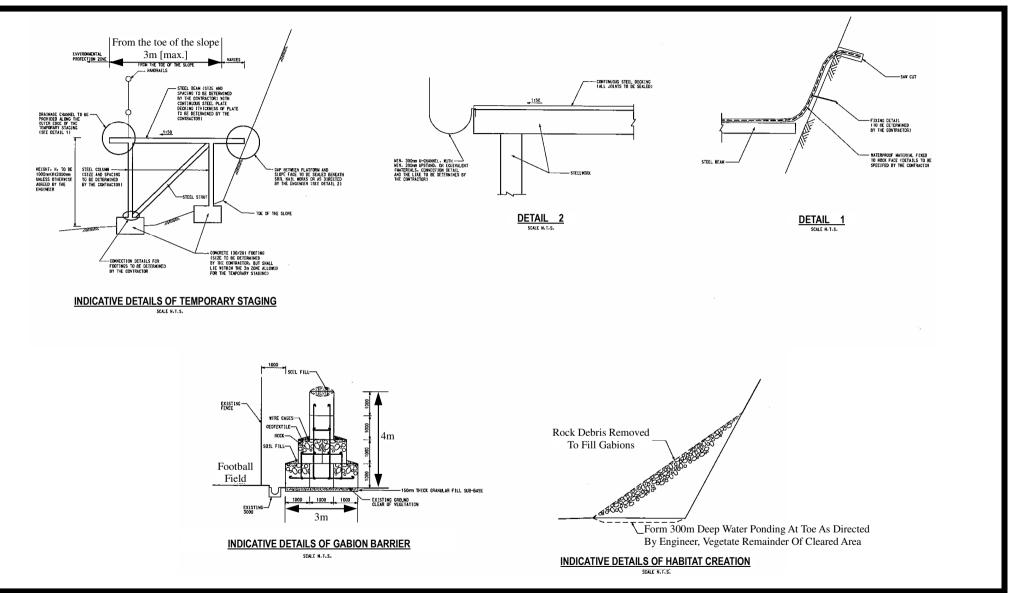
圖 4: 斜坡號碼 15NW-C/C3 的臨時工作台、石籠圍牆及生境創造的指示資科
