AGREEMENT NO. CE 52/2007(HY)
 TUEN MUN - CHEK LAP KOK LINK - INVESTIGATION

GEOLOGICAL SECTION

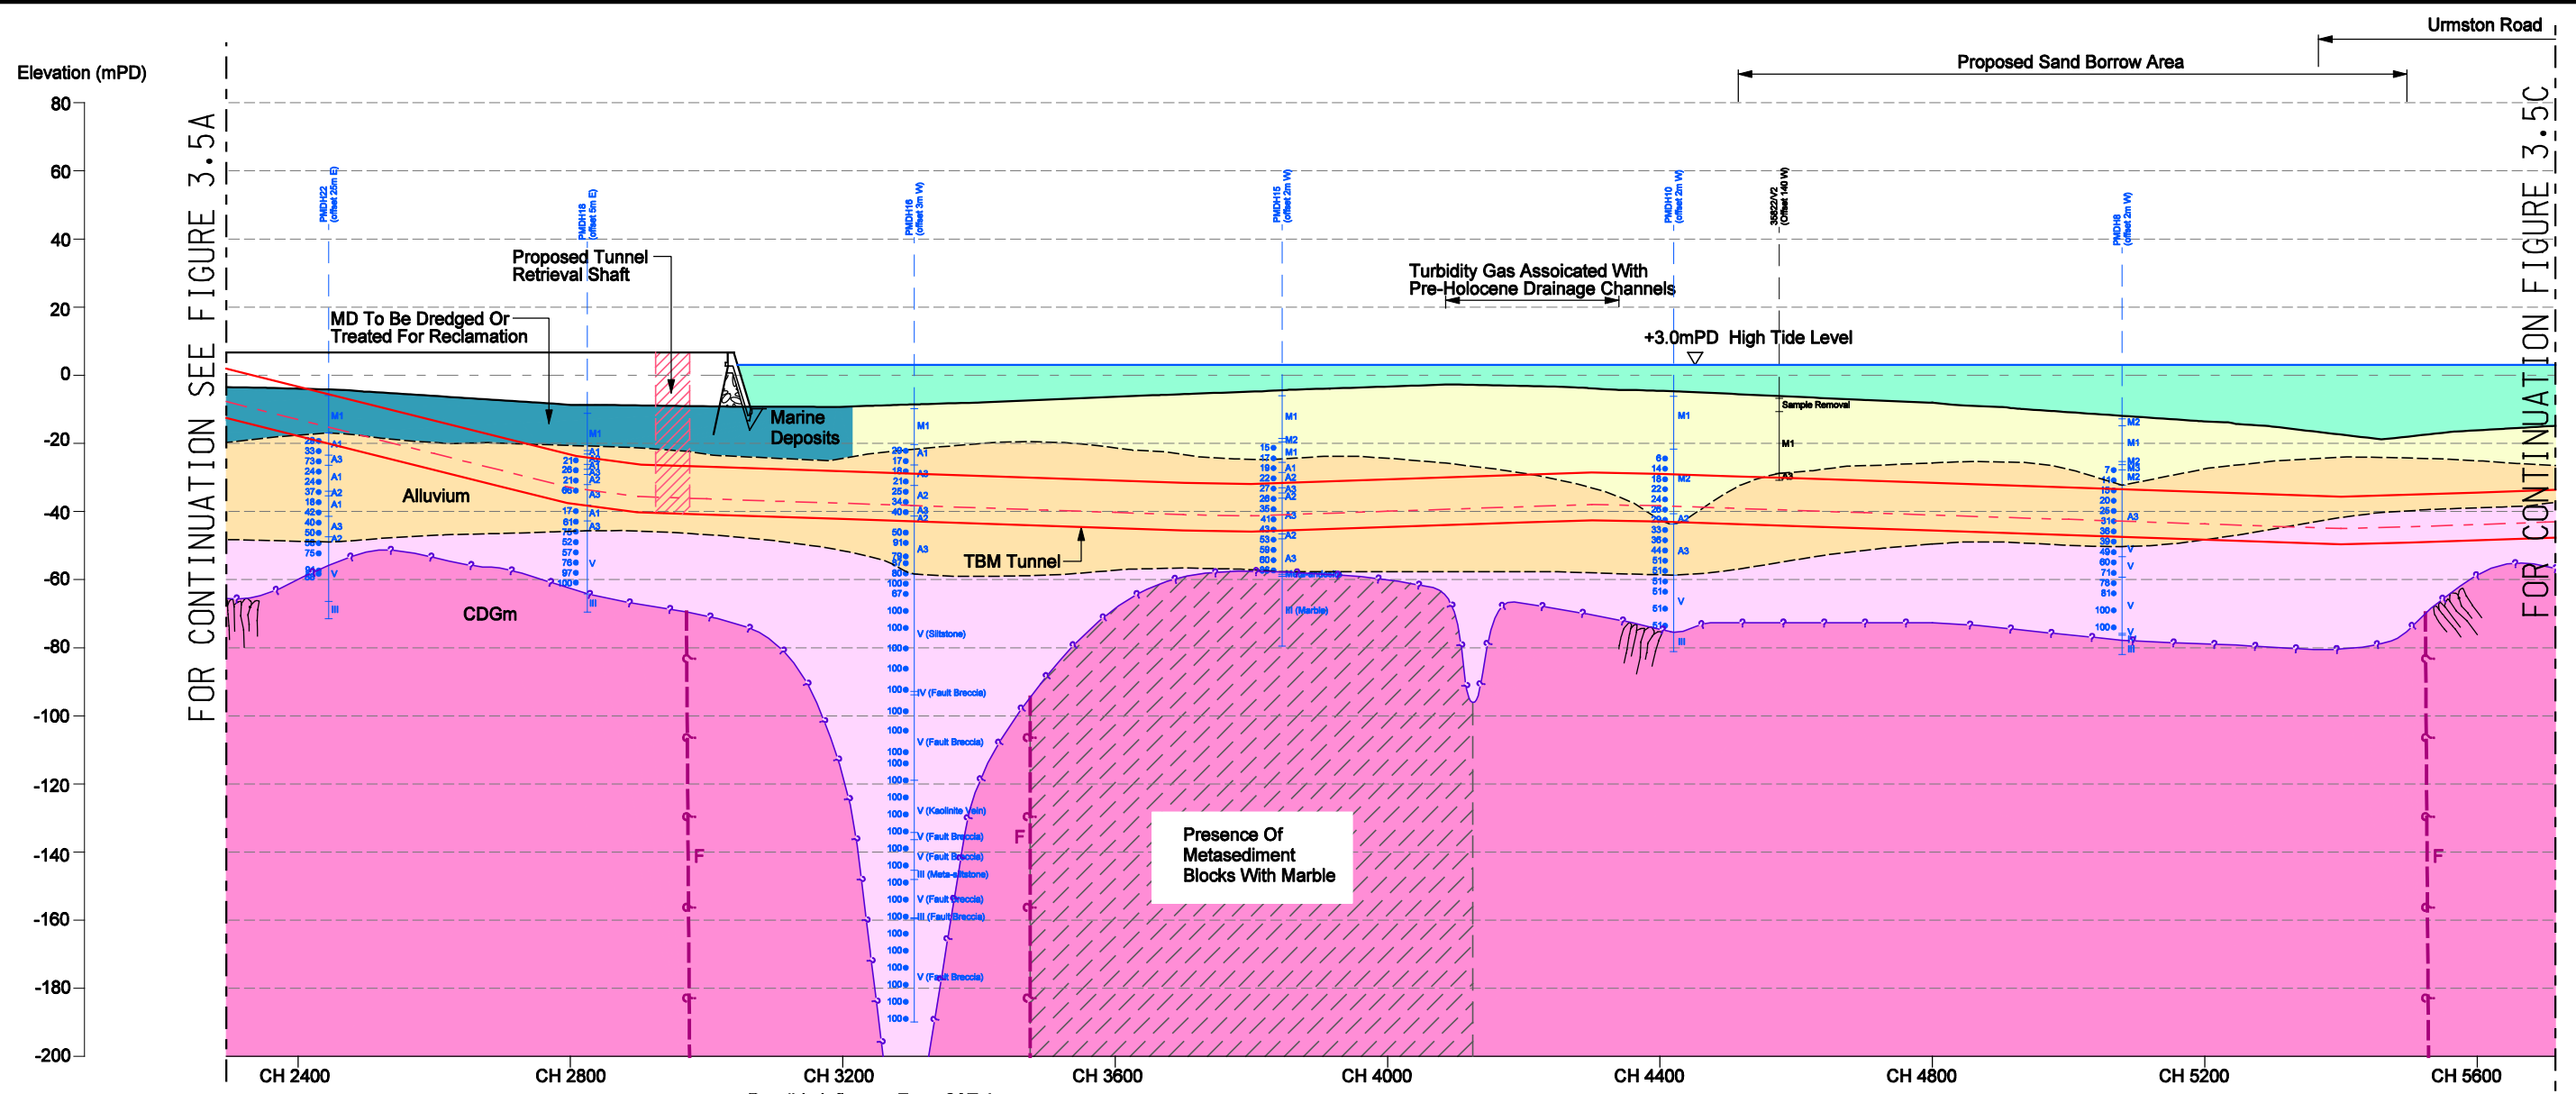
SCALE	AS SHOWN	DATE	APR. 2009
CHECK	---	DRAWN	CL
JOB No.	60044963	DRAWING No.	FIGURE 3.5B
		REV	---

CHAINAGE	2975	3800	4212	4404	4430	4551	5199	5400
GROUND CONDITION AT TUNNEL LEVEL	ALL	ALL	MD	MD	MD	MD	ALL	ALL
PROPOSED ROAD LEVEL (mPD)	-36.1	-41.26	-38.5	-38.3	-38.5	-39.3	-43.6	-44.98
TUNNEL AXIS (mPD)	-33.75	-38.71	-36.15	-35.95	-36.15	-36.95	-41.25	-42.63
BOTTOM LEVEL OF TUNNEL (mPD)	-40.75	-45.91	-43.15	-42.95	-43.15	-43.95	-48.25	-49.63
INSPECTION PRESSURE (BAR)	3.78	4.29	4.02	4.00	4.02	4.10	4.53	4.66
MAX. PRESSURE (BAR)	4.38	4.89	4.62	4.60	4.62	4.70	5.13	5.26

Note:
 Rockhead Level & Material Profiles Are Referred From Adjacent Drillholes & Geophysical Survey Results
