Improvement Dredging for Lamma Power Station Navigation Channel Environmental Impact Assessment

Appendix 1.1 Extracts of Past Bathymetry Surveys and Dredging Extents

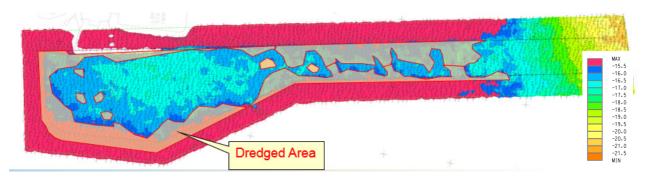
2009 (High Spot Dredging Only)

(Note: bathymetry survey taken in 2008)
