ACE Paper 25/2017
For discussion on 4 December 2017

Improving the Water Quality in Hong Kong

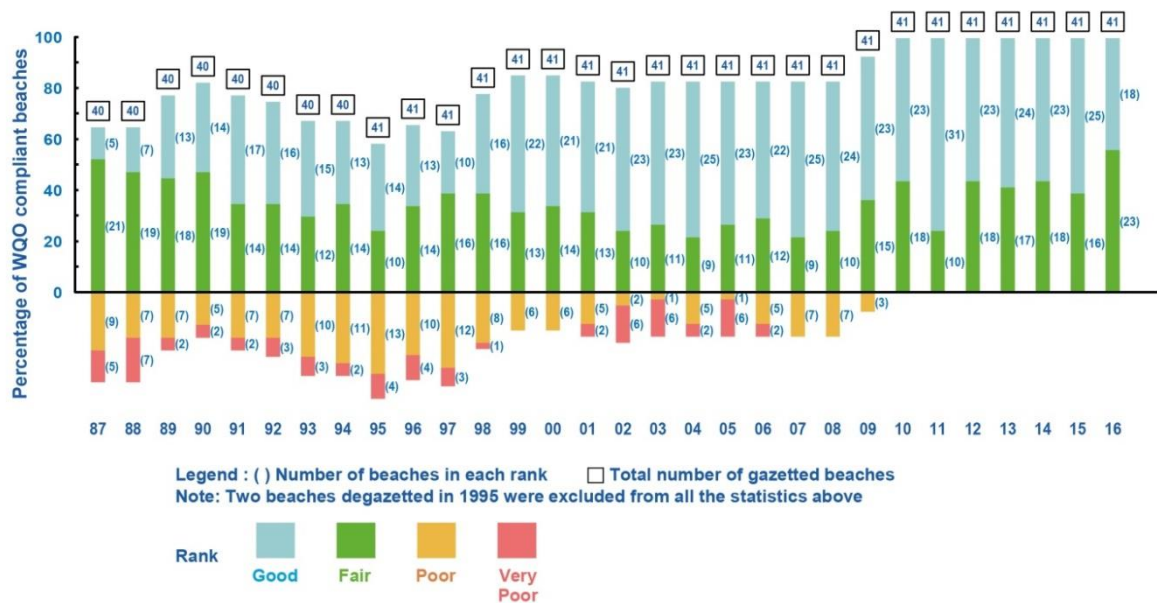
Figure 3 Beach Water Quality (1987 – 2016)

relatively high overall Water Quality Objectives (WQOs) compliance rate¹ of 86% recorded in 2016 (see **Figure 2**). Since the commissioning of the advance disinfection facilities (ADF) of HATS in 2010, all 41 gazetted beaches in Hong Kong have achieved the bacteriological WQO (see **Figure 3**) and remain suitable for swimming. In 2016, 18 beaches were rated “Good, Grade 1” while the remaining 23 beaches were graded “Fair, Grade 2” in the annual ranking. The cross-harbour swimming race, resumed since 2011, has been moved to the legendary route in Central Harbour in October this year as a result of further water quality improvement achieved by the HATS Stage 2A. Detailed information of the marine, river and beach water quality are available in their respective annual reports available on EPD’s website².

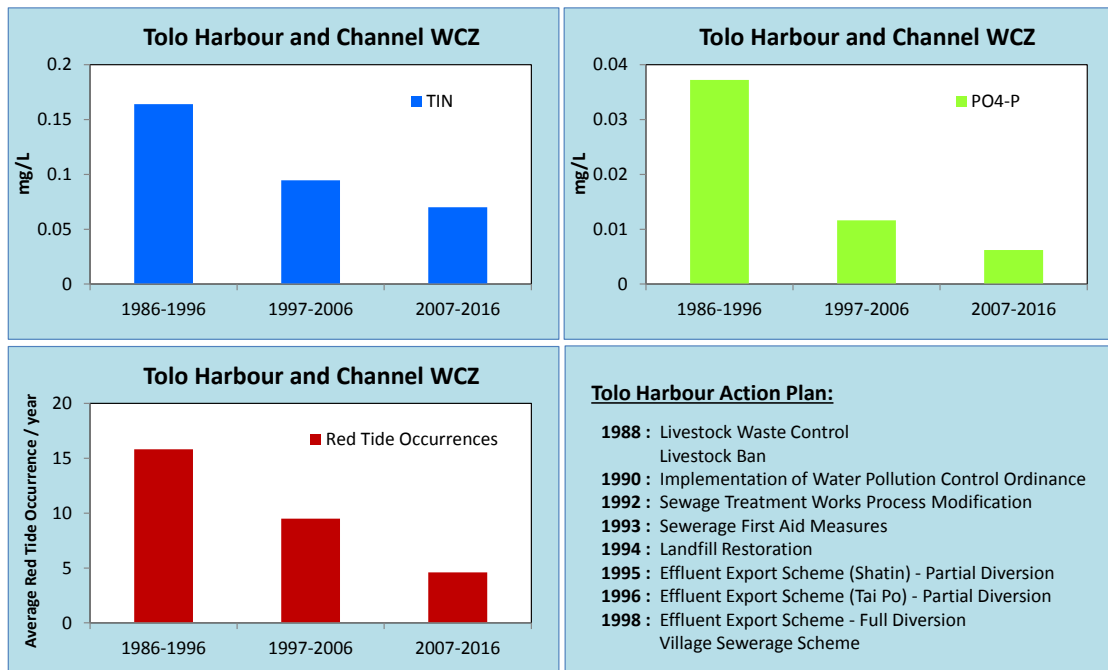
Figure 4 Reductions in total inorganic nitrogen (TIN), orthophosphate phosphorus (PO₄-P) levels and red tide occurrence in Tolo Harbour since the implementation of the Tolo Harbour Action Plan

4. Tolo Harbour is another coastal waterbody that has shown significant improvement in water quality. Due to its specific topographic nature, Tolo Harbour is an enclosed water body which had been suffering from serious pollution in the 1970s. To tackle the water pollution problems, the Government implemented the Tolo Harbour Action Plan (THAP) in 1980s, including the implementation of the WPCO and the Livestock Waste Control Scheme (LWCS), the provision of sewerage facilities, upgrading of the Sha Tin and Tai Po Sewage Treatment Works (STWs), and the export of the treated effluent from these two STWs to the Victoria Harbour for better dispersive discharge. Since then, the water quality of Tolo Harbour has significantly improved. The nutrients (i.e. nitrogen and phosphorus) levels have greatly reduced and the number of red tides has substantially decreased from the record high of 43 in 1988 to 4 in 2016 (**Figure 4**).

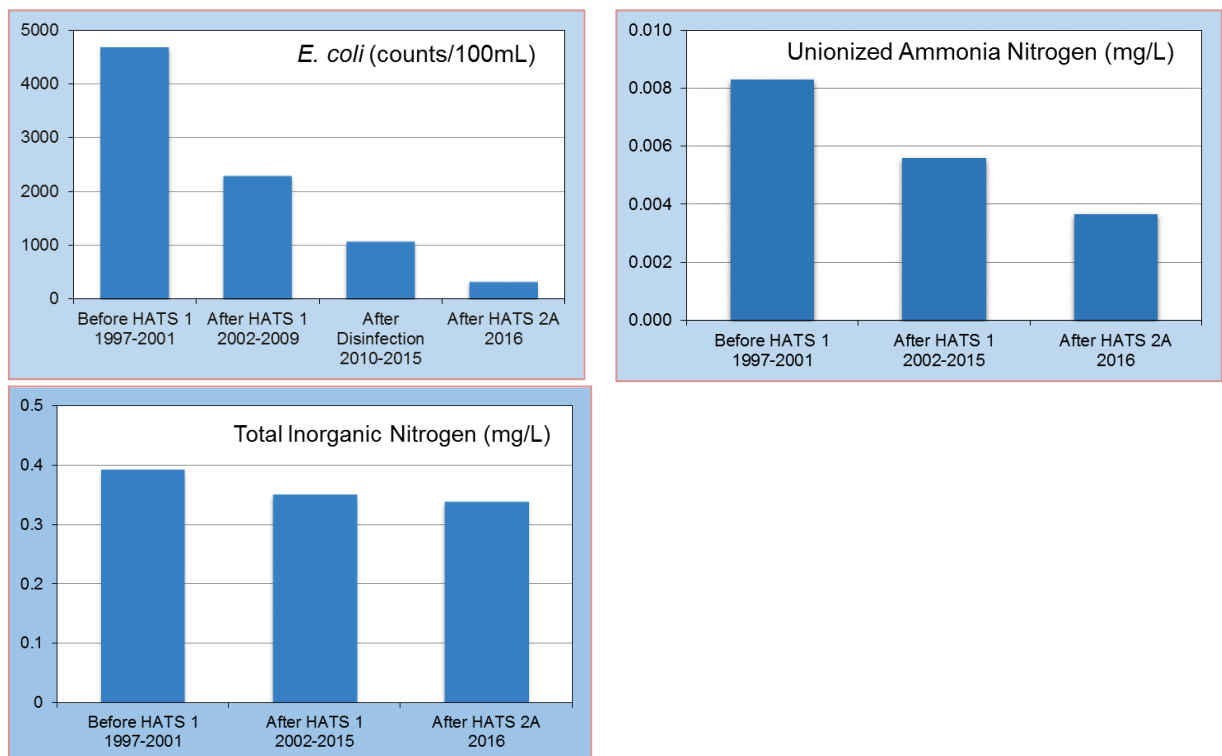
Figure 8 Reductions of *E. coli*, unionized ammonia nitrogen and total inorganic nitrogen levels in the Victoria Harbour as brought by the progressive implementation of HATS

9. When comparing the situation in 2016 to that before HATS (1997-2001), the commissioning of HATS has resulted in marked water quality improvements in the Victoria Harbour, with an overall 14% increase in dissolved oxygen (DO). There has also been a substantial reduction of pollutants, including a 93% decrease in *E. coli*, 56% decrease in unionized ammonia nitrogen (UIA) and 14% decrease in total inorganic nitrogen (TIN), as shown in **Figure 8**. In 2016, the overall WQOs

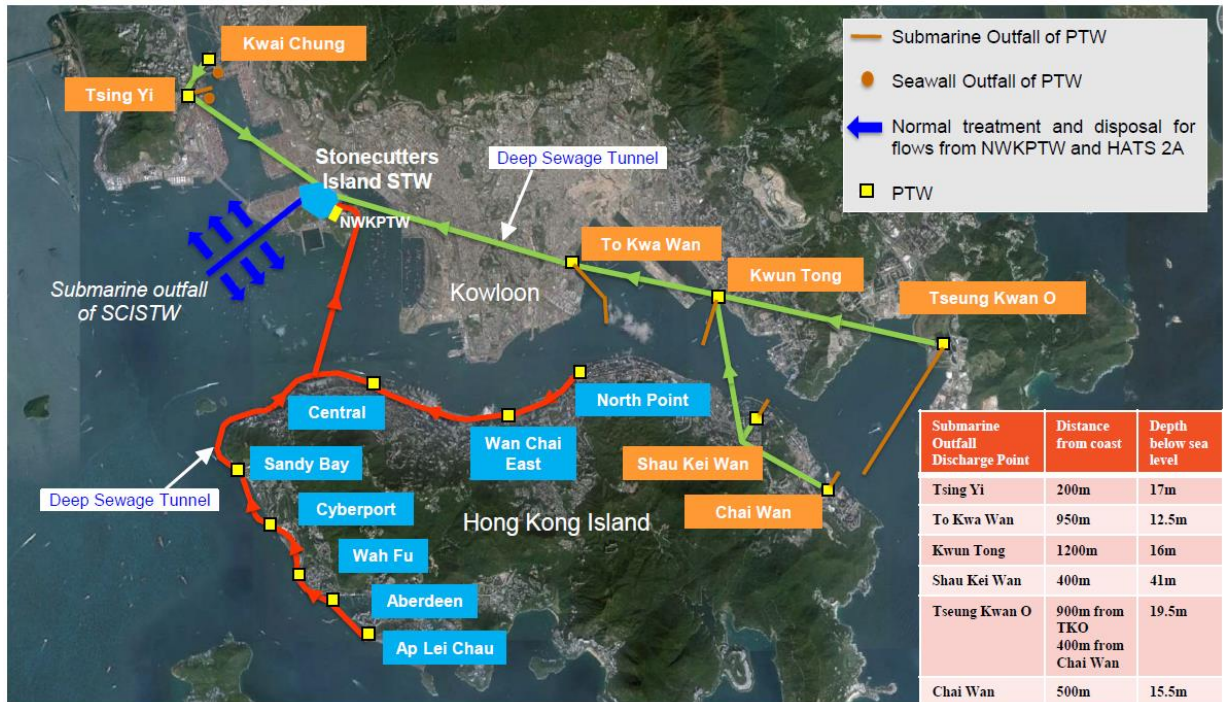
Figure A Proposed Two-week Sewage Bypass at Seven PTWs of HATS Stage 1

Main Pumping Station No.1 (MPS1), including the two penstocks to be replaced, has been in use since 2001. The wet well of MPS1 is a very large structure with an internal dimension of 50 metres (m) in diameter and 45 m in height. The penstocks are situated 34 m below ground level, and of considerable size – one of 4.4 m(H) x 2.6 m(W); and the other of 4.2 m(H) x 1.4 m(W). They are located at the points where sewage enters MPS1, one on the side of the deep tunnel from the To Kwa Wan, Kwun Tong, Tseung Kwan O, Shau Kei Wan, Chai Wan Preliminary Treatment Works (PTWs), and the other on the side of the deep tunnel from Tsing Yi and Kwai Chung PTWs (see **Figure A**).

4. The penstock replacement works are scheduled to take place in dry seasons. On works safety grounds and taking into account equipment manufacturing time, the works will comprise a number of steps, during which screened sewage bypass at the aforementioned seven upstream PTWs will be required in five occasions, each lasting up to two weeks. Detailed works sequencing of the penstocks replacement works is tabulated below. The discharge locations are shown in the **Figure A**.

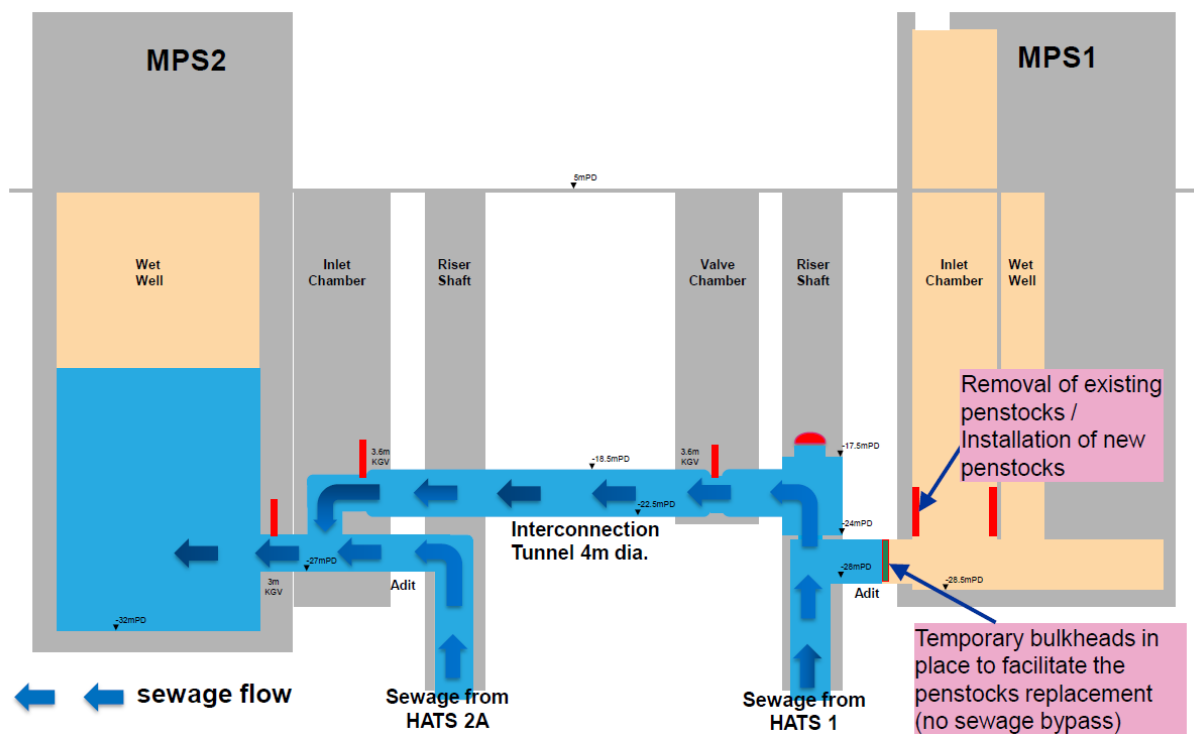
Figure E Removal / Installation of Penstocks in MPS1 (without Sewage Bypass)

Step	Start time	Activity and Purpose	Sewage flows from the 7 HATS Stage 1 PTWs ^[1]		Reference Figures
1	February 2018	<ul style="list-style-type: none"> • Install temporary support to the existing penstocks • Conduct detailed survey for temporary bulkhead production 	Bypass (2 weeks)		Figure C
2A	Early November 2018	<ul style="list-style-type: none"> • Install temporary bulkheads to seal off MPS1 	Bypass (2 weeks)		Figure D
2B	Mid November 2018	<ul style="list-style-type: none"> • Remove existing penstocks 		Handled by MPS2 ^[2] (12 weeks)	Figure E
2C	Mid February 2019	<ul style="list-style-type: none"> • Remove temporary bulkheads • MPS1 resume normal functioning 	Bypass (2 weeks)		Figure D
3A	Early November 2019	<ul style="list-style-type: none"> • Install temporary bulkheads to seal off MPS1 	Bypass (2 weeks)		Figure D
3B	Mid November 2019	<ul style="list-style-type: none"> • Install new penstocks 		Handled by MPS2 ^[2] (12 weeks)	Figure E
