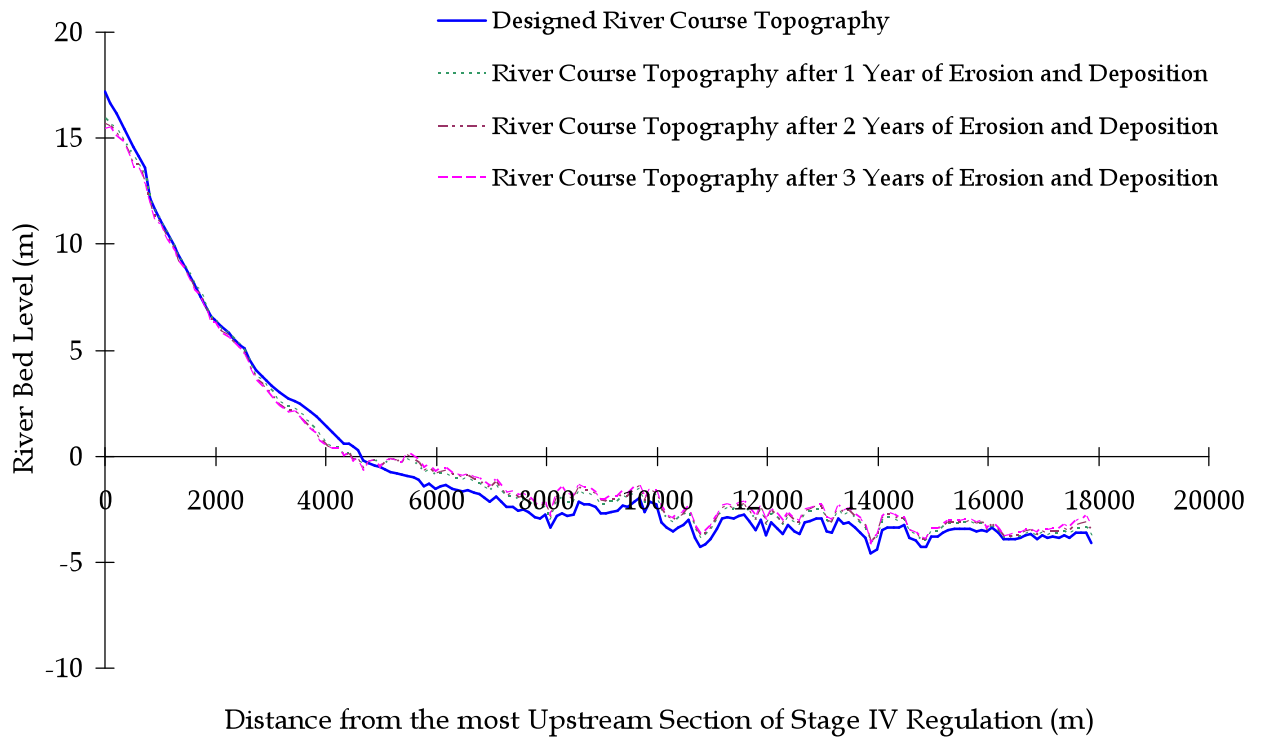
Figure C-13: River Course Topography after one, two and three years of implementation of the Project (Working Condition 2, 3 and 4).

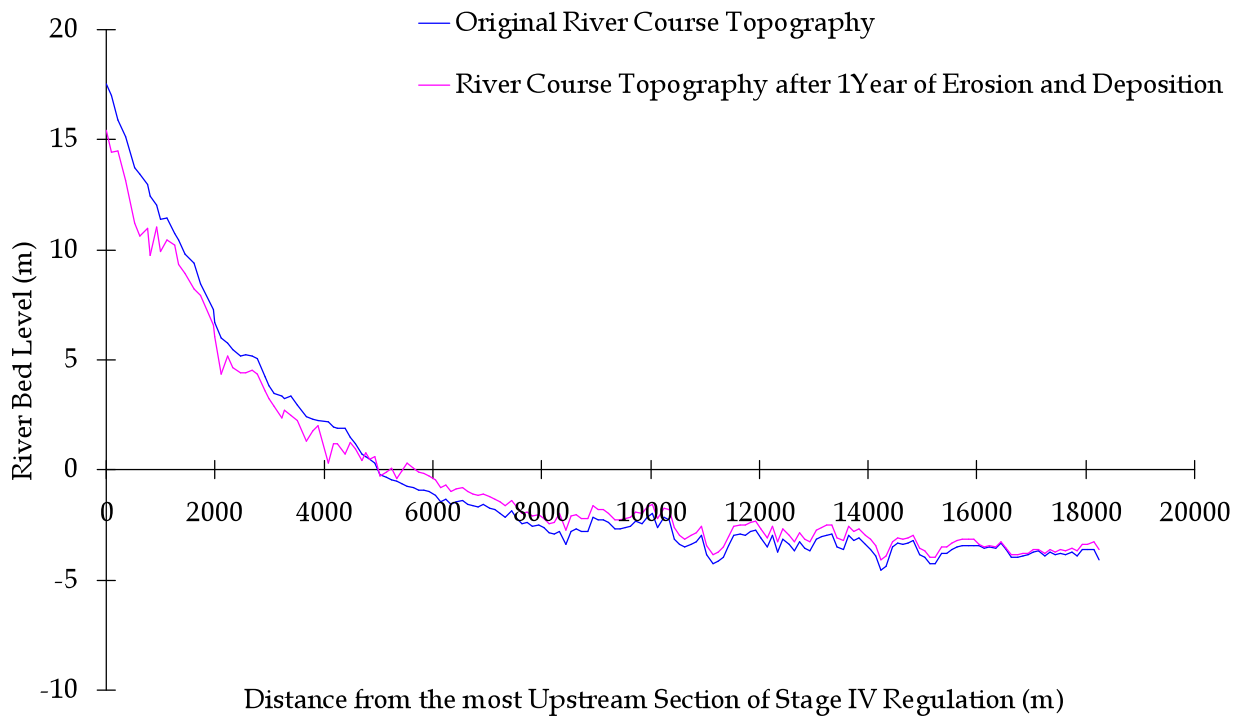
Figure C-14: River Course Topography after one year's flow and sediment before construction of the Project (Working Condition 1).
