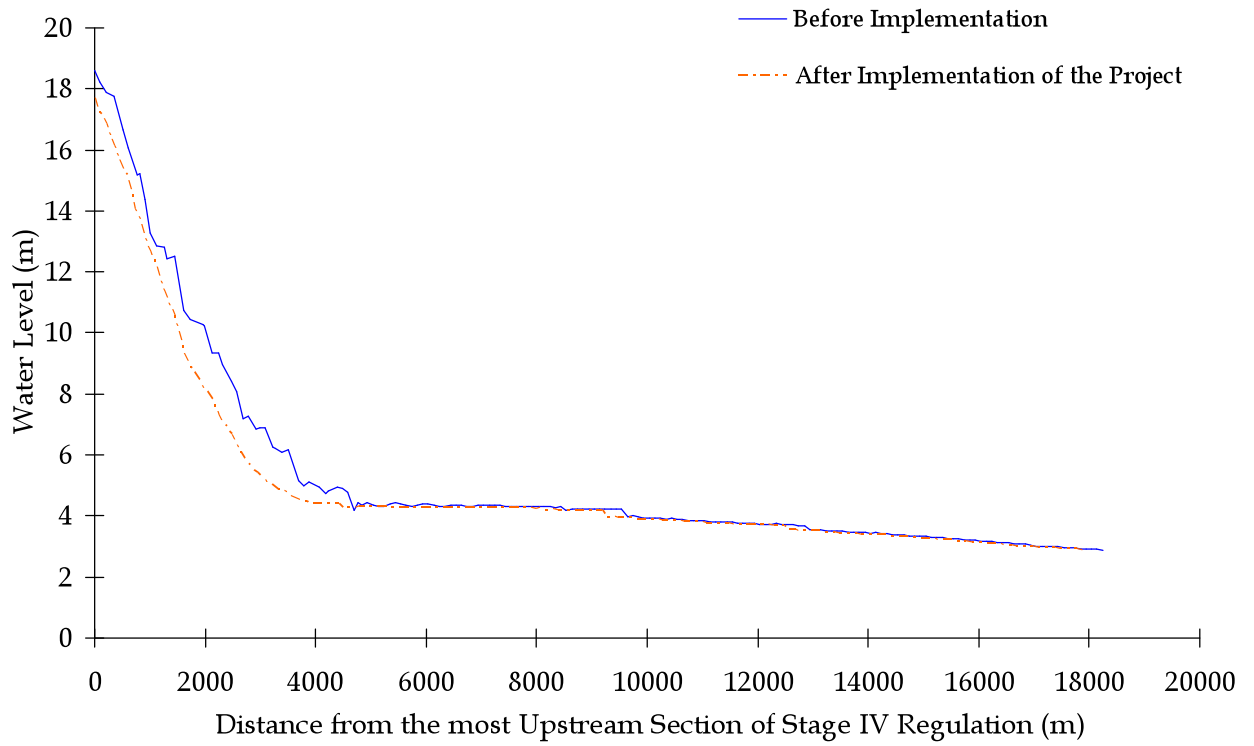
Figure C-5: Water surface profile before and after implementation of Project when 1 in 50 years flood encounters 1 in 50 years tidal level (Working Condition 1).

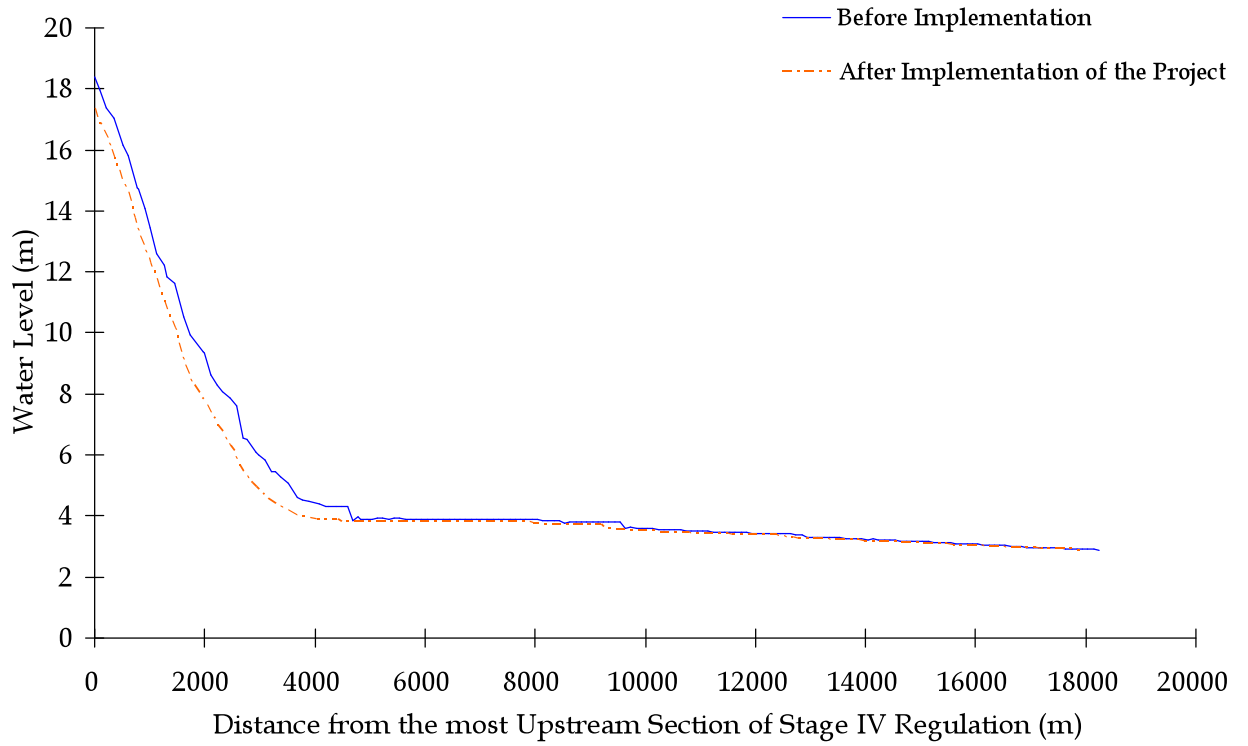
Figure C-7: Water surface profile before and after implementation of Project when 1 in 10 years flood encounters 1 in 50 years tidal level (Working Condition 3).

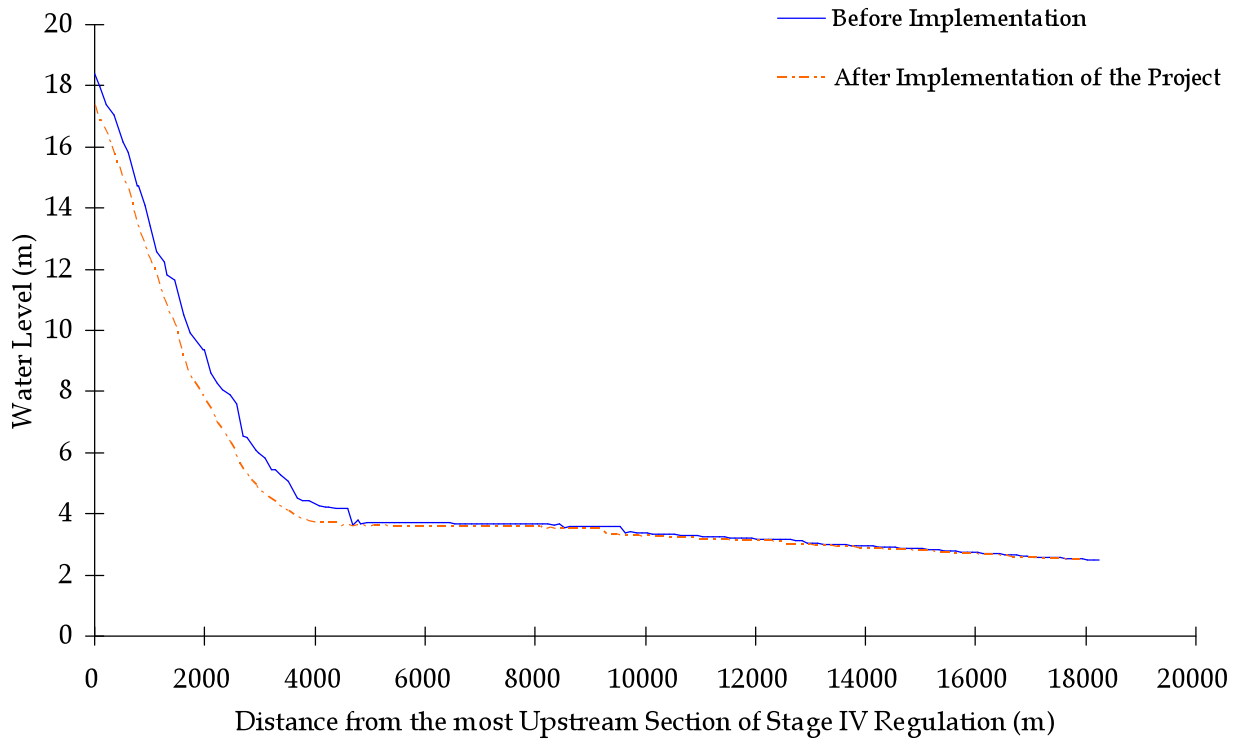
Figure C-8: Water surface profile before and after implementation of Project when 1 in 10 years flood encounters 1 in 10 years tidal level (Working Condition 4).

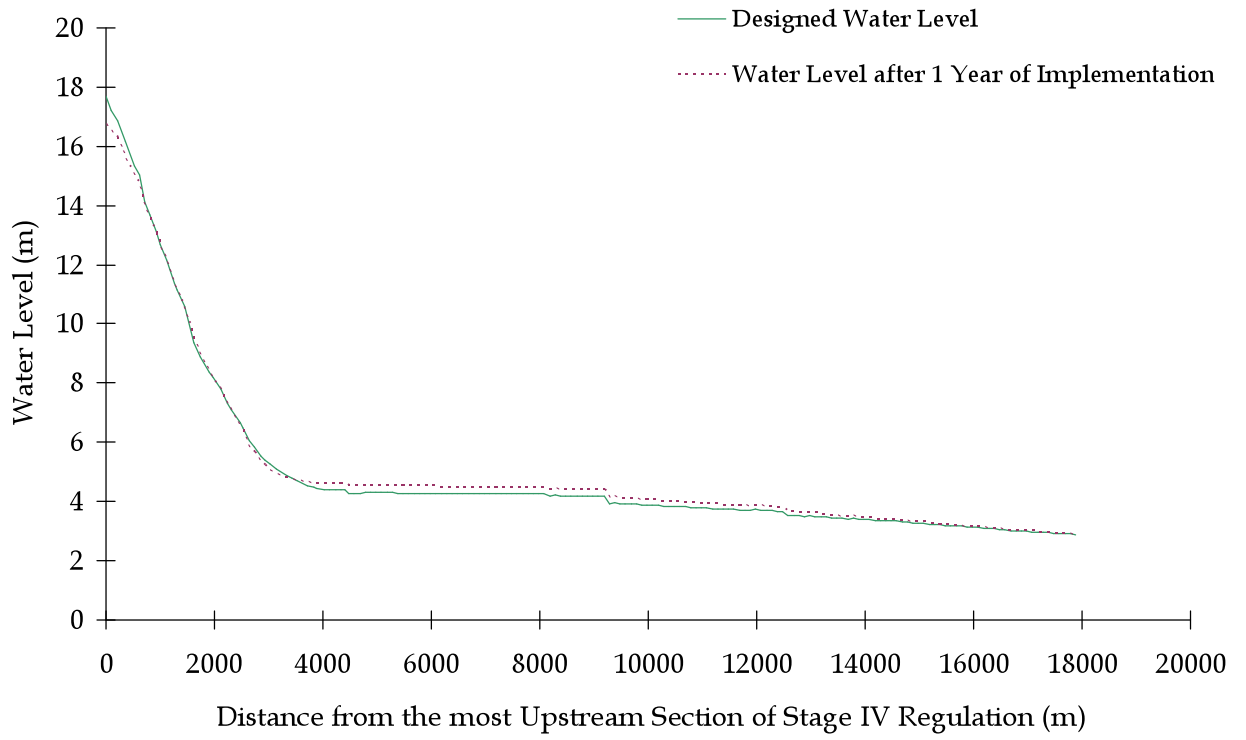
Figure C-9: Water surface profile one year after implementation of the Project when 1 in 50 years flood encounters 1 in 50 years tidal level (Working Condition 5).

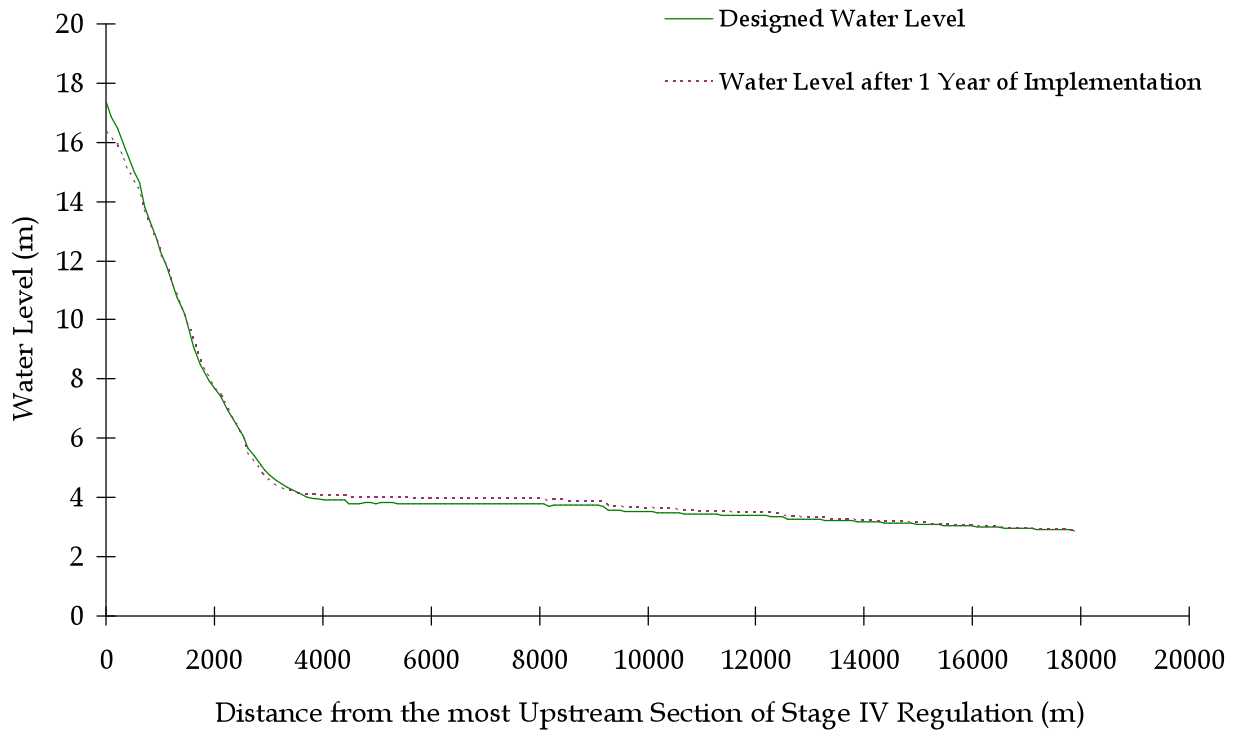
Figure C-11: Water surface profile one year after implementation of the Project when 1 in 10 years flood encounters 1 in 50 years tidal level (Working Condition 7).
