EcoPark Operation Quarterly EM&A Compliance Report

November 2011 to January 2012

Project/Deliverable Number:	J494A D01/06
Project Name:	EcoPark Operation EM&A
Report Name:	Quarterly EM&A Compliance Report – November 2011 to January 2012
Report Date:	February 2012
Report for:	Serco Guardian JV

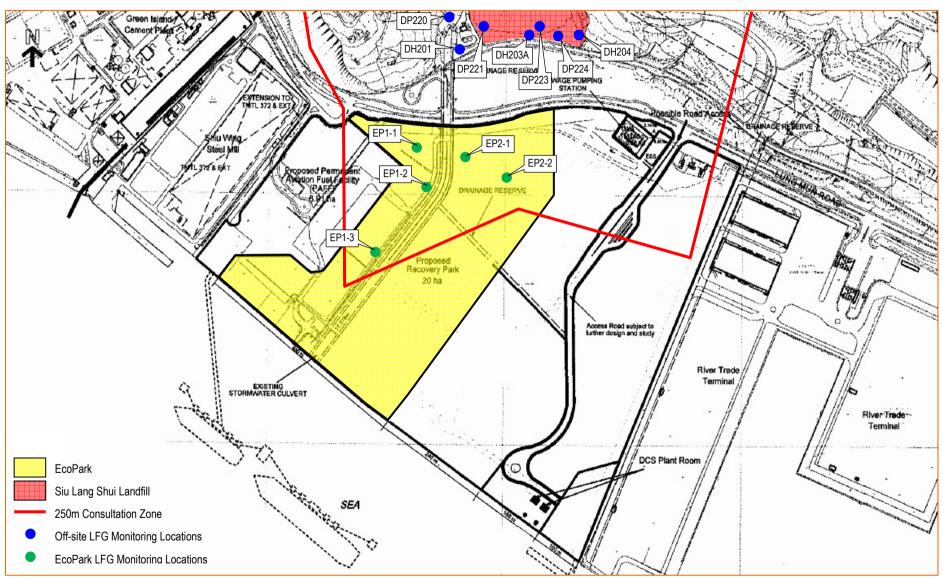
Figure 2-2 Replacement Figure for EM&A Manual Figure 6.1

- 2.1.4 Figure 2-2 is a replacement page for the EM&A Manual, in accordance with footnote to Figure 6.1 in the approved EM&A Manual, and shall be deemed to be included in the EM&A Manual.
- 2.1.5 Routine LFG monitoring has been carried out on a quarterly basis. Should EPD alert the Operator that high LFG levels have been detected during monthly monitoring under the Siu Lang Shui Landfill restoration contract, the Operator may be required to increase LFG monitoring to monthly until such time as EPD inform the Operator that quarterly monitoring can be resumed. To-date, EPD have not alerted the Operator.
