CONTRACT NO. EP/SP/186/21

WEST NEW TERRITORIES LANDFILL EXTENSION

**MONTHLY ENVIRONMENTAL MONITORING AND AUDIT
REPORT – DECEMBER 2025**

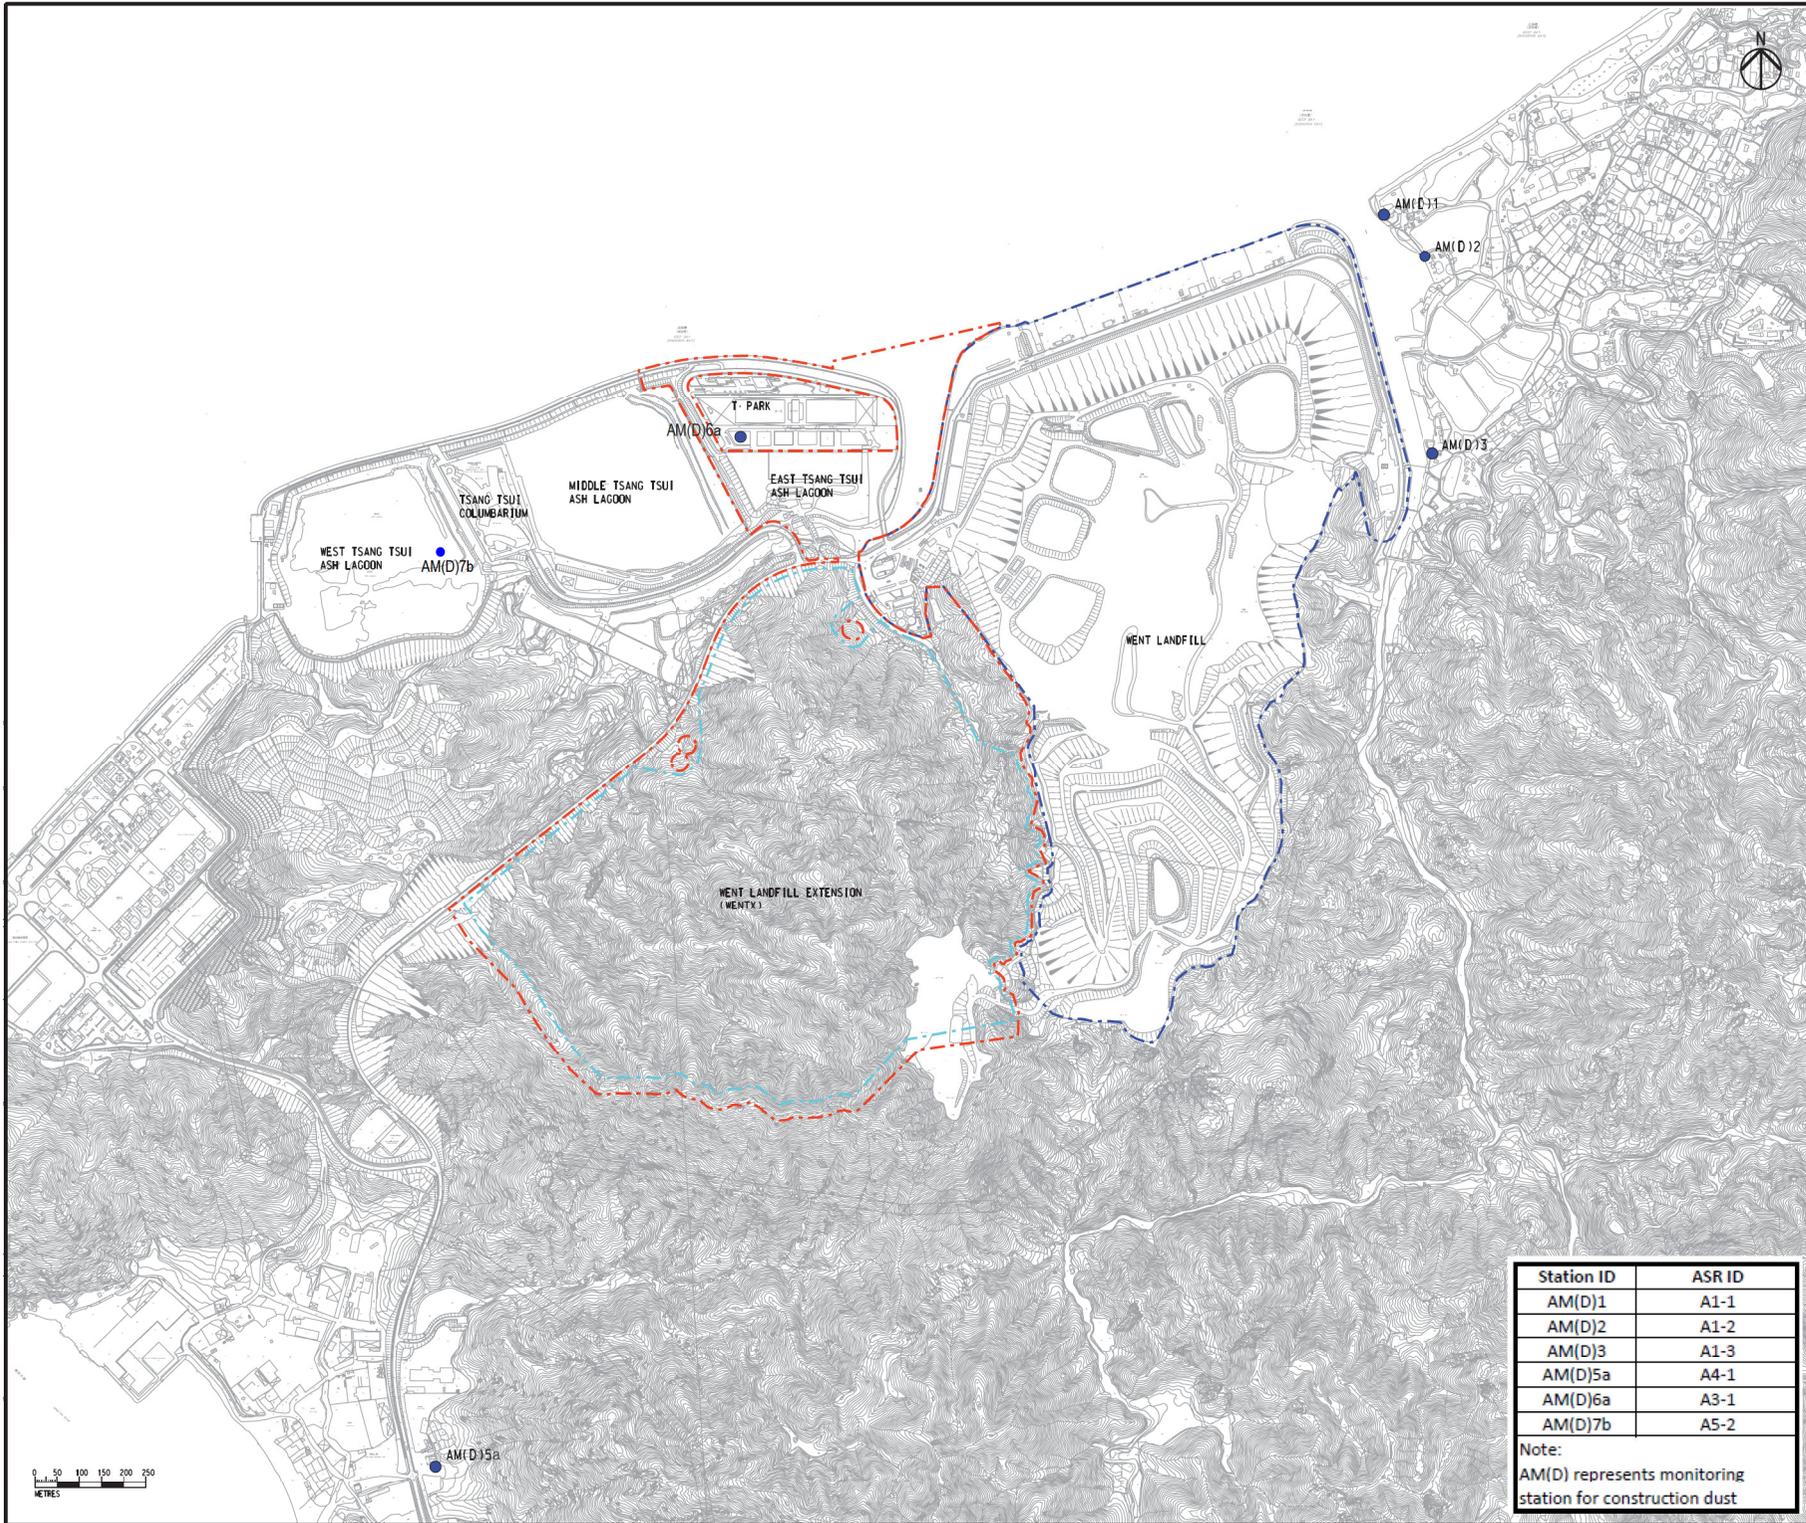
Drawing title
LOCATIONS OF AIR QUALITY MONITORING STATIONS

- 3.3.1 Five dust monitoring locations have been recommended in the approved Final EM&A Manual and two additional monitoring stations (AM(D)6 and AM(D)7) were suggested in VEP supporting document. Joint site visits by the Contractor and ET have been conducted at the recommended locations to verify their status and obtain agreement to install dust monitoring equipment for before the implementation of EM&A Programme.
- 3.3.2 When alternative monitoring locations are proposed, the following criteria, as far as practicable, should be followed:
- At the site boundary or such locations close to the major dust emission source;
 - Close to the sensitive receptors; and
 - Account for the prevailing meteorological conditions

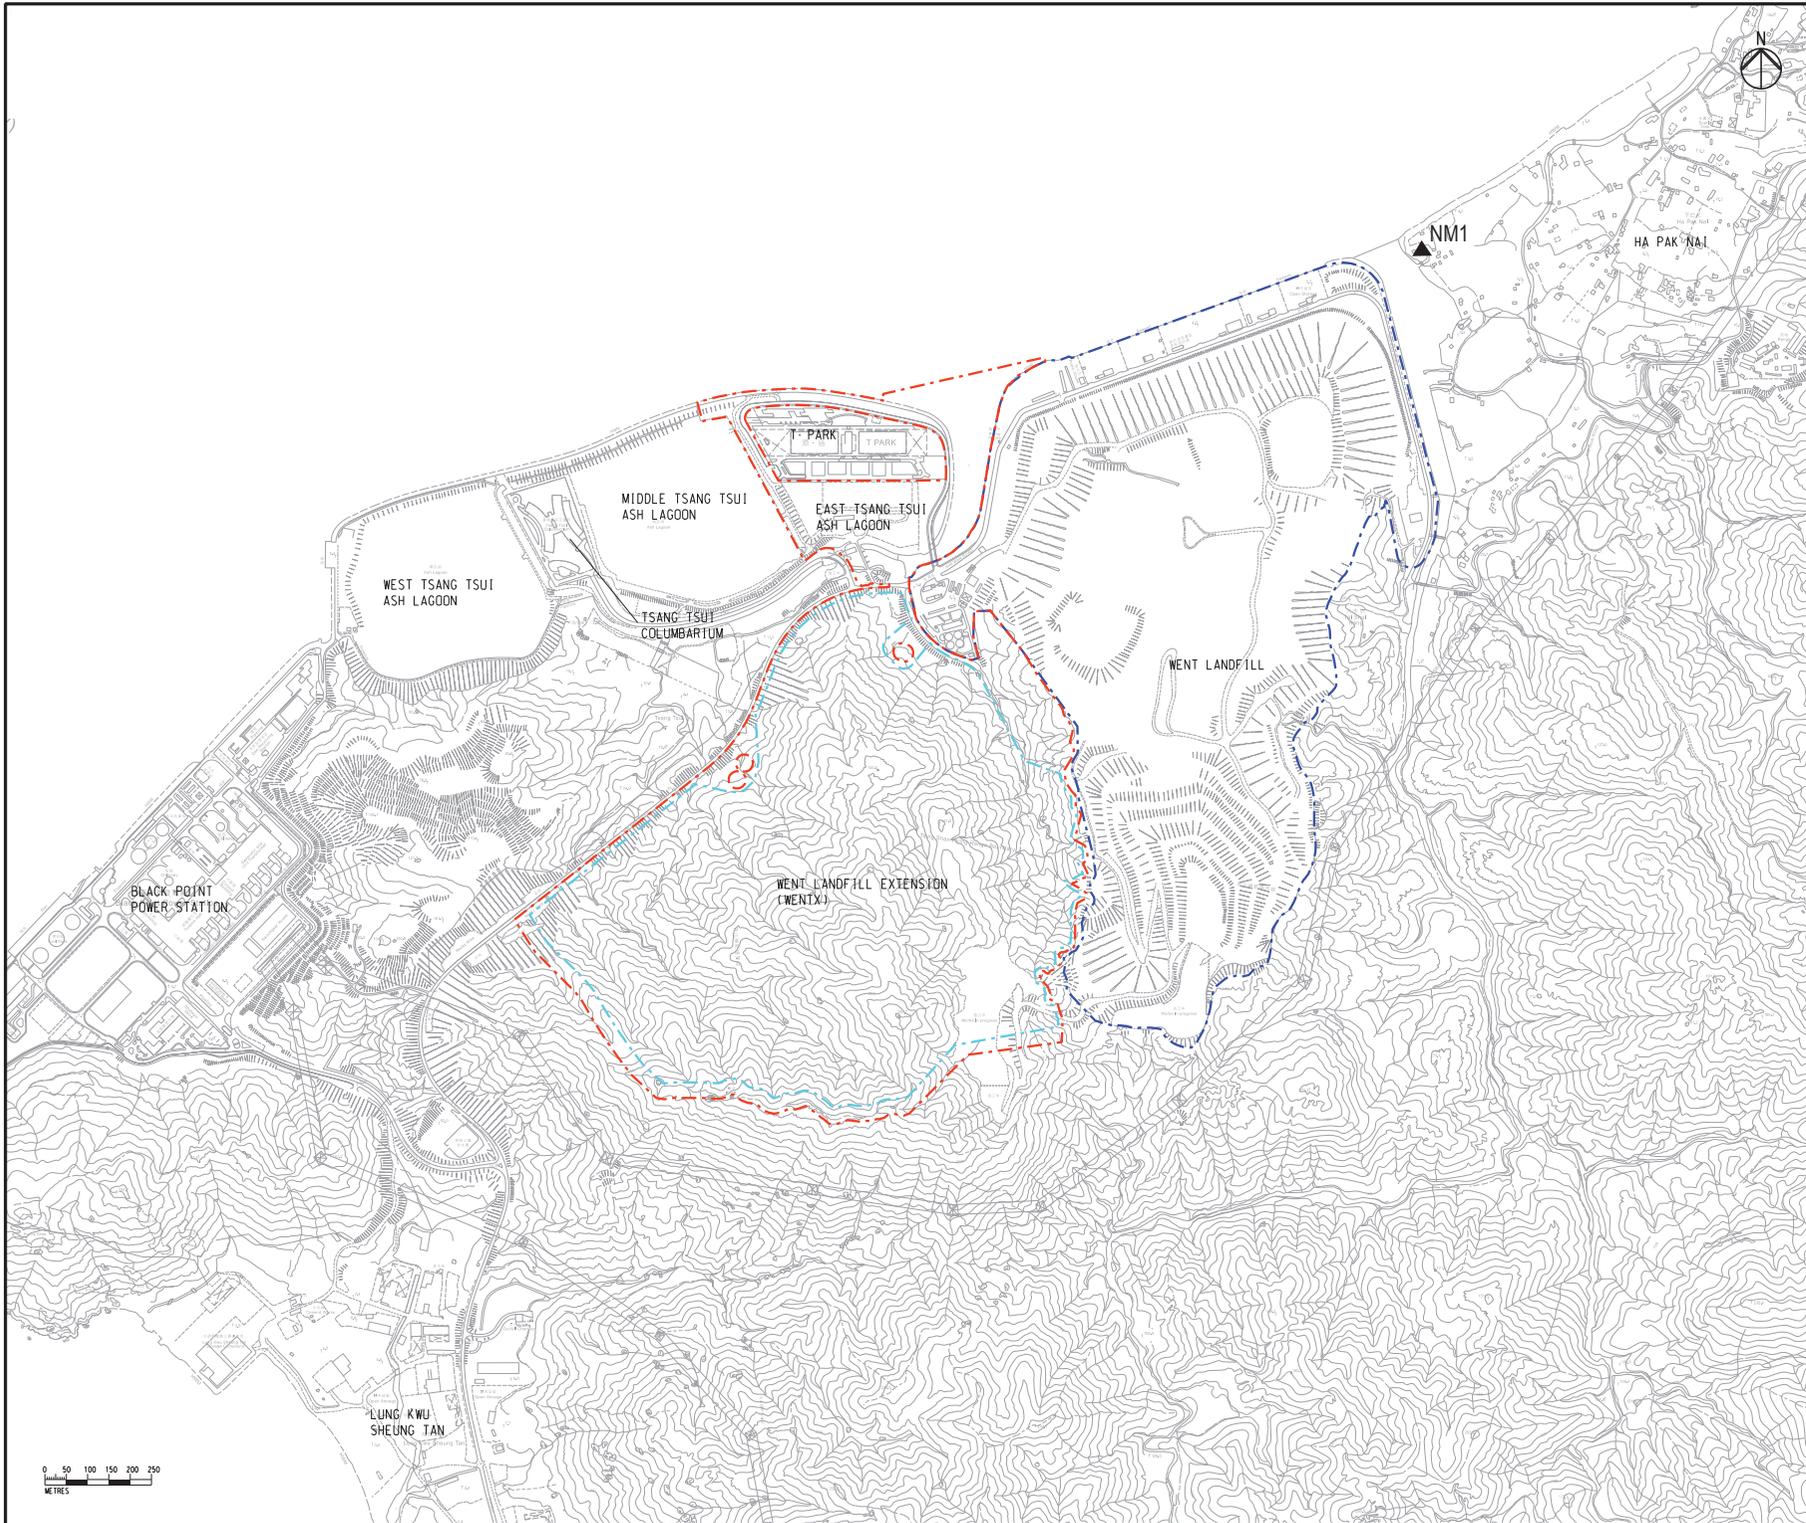
NOISE MONITORING LOCATION

4.5.1 The microphone of the sound level meter was set at a height of about 1.5m subject to site condition and oriented pointed to the site, with the microphone facing perpendicular to the line of sight. Moreover, the microphone was positioned away from any reflective surface, and a correction of +3 dB(A) has been made for the free field measurements.

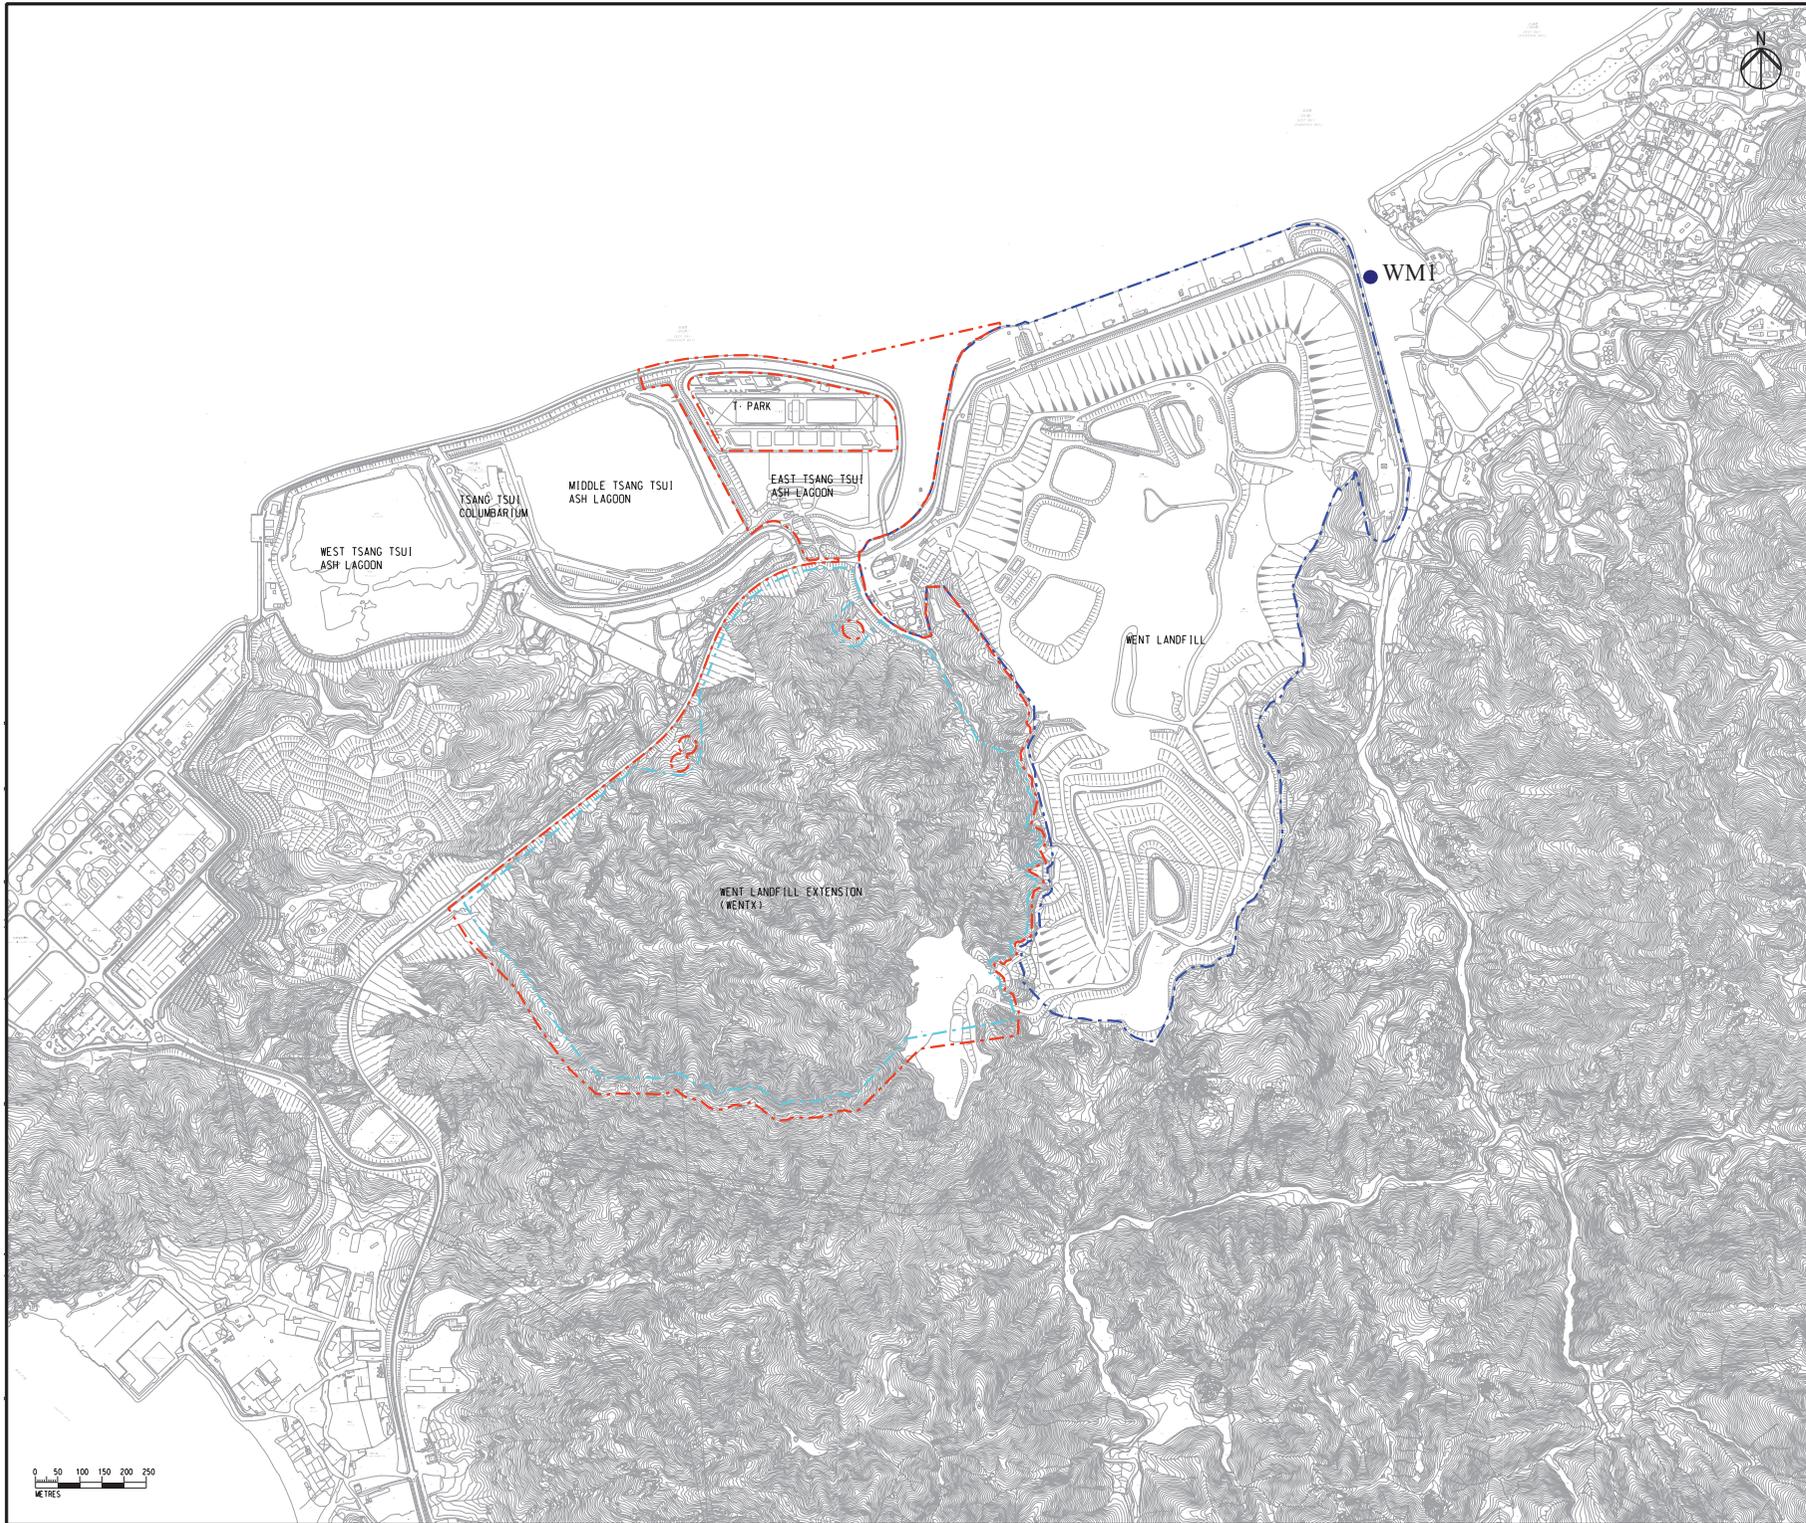
- 5.7.1 Prior to conducting in-situ measurement and water sampling, general information such as the sampling date, time, weather conditions and the personnel responsible for the monitoring would be recorded on the field data sheet. The location of water quality monitoring station was confirmed using GPS prior to in-situ monitoring and sampling. Moreover, the water depth at the monitoring station will be measured using a portable digital global positioning system.

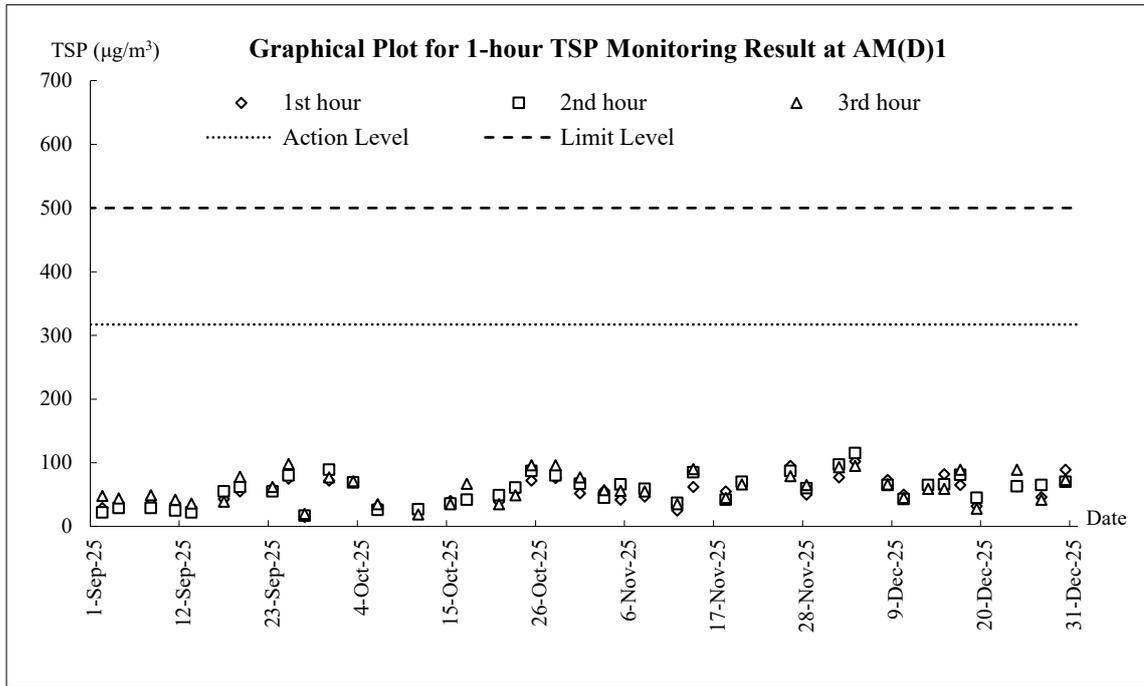
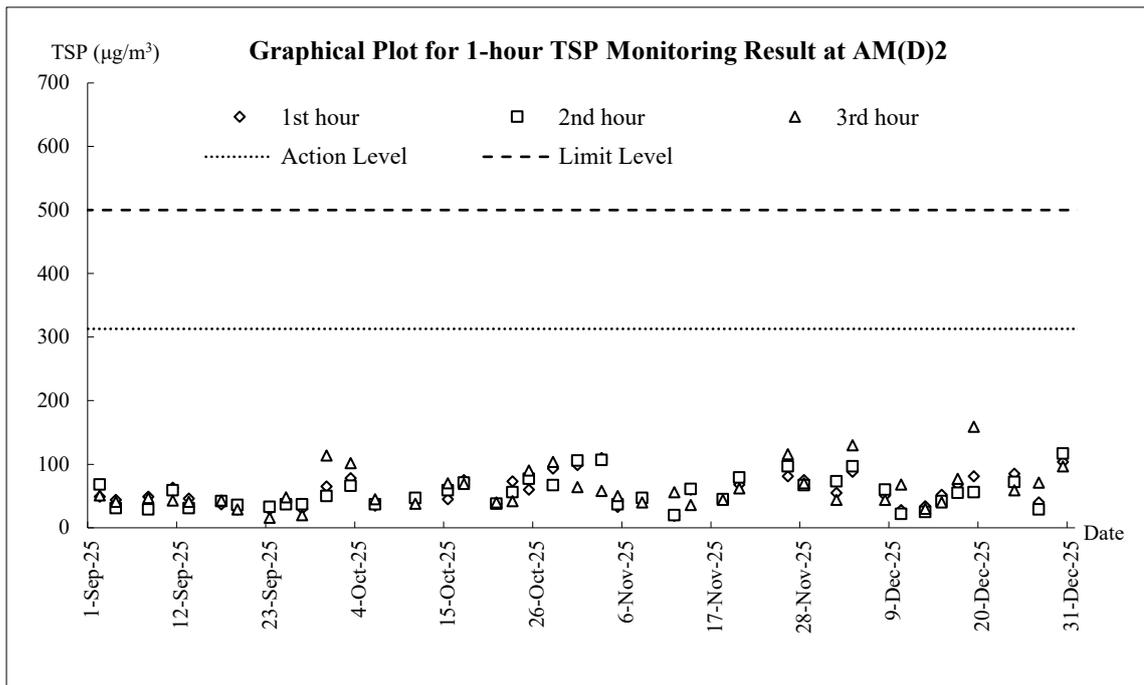
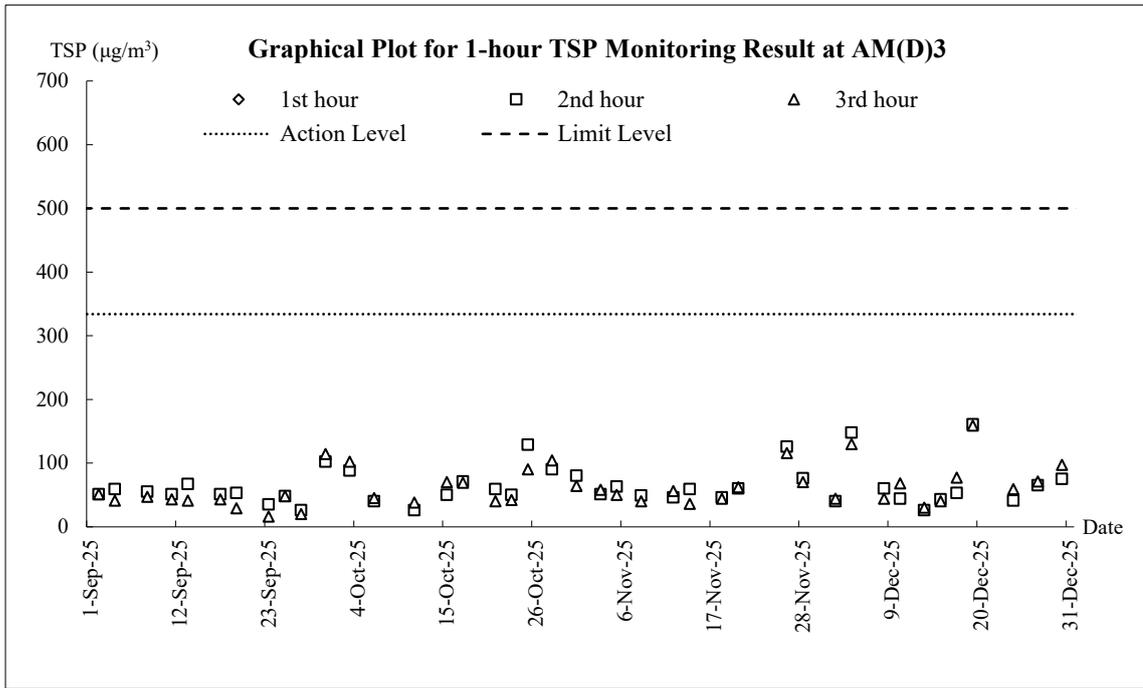
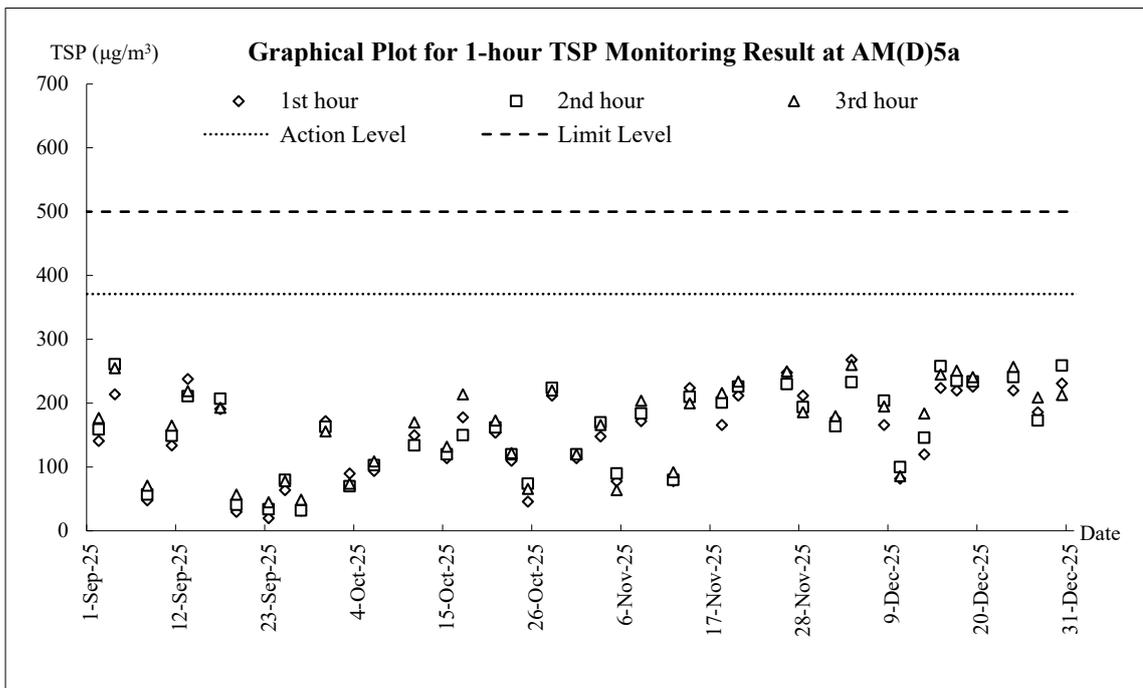
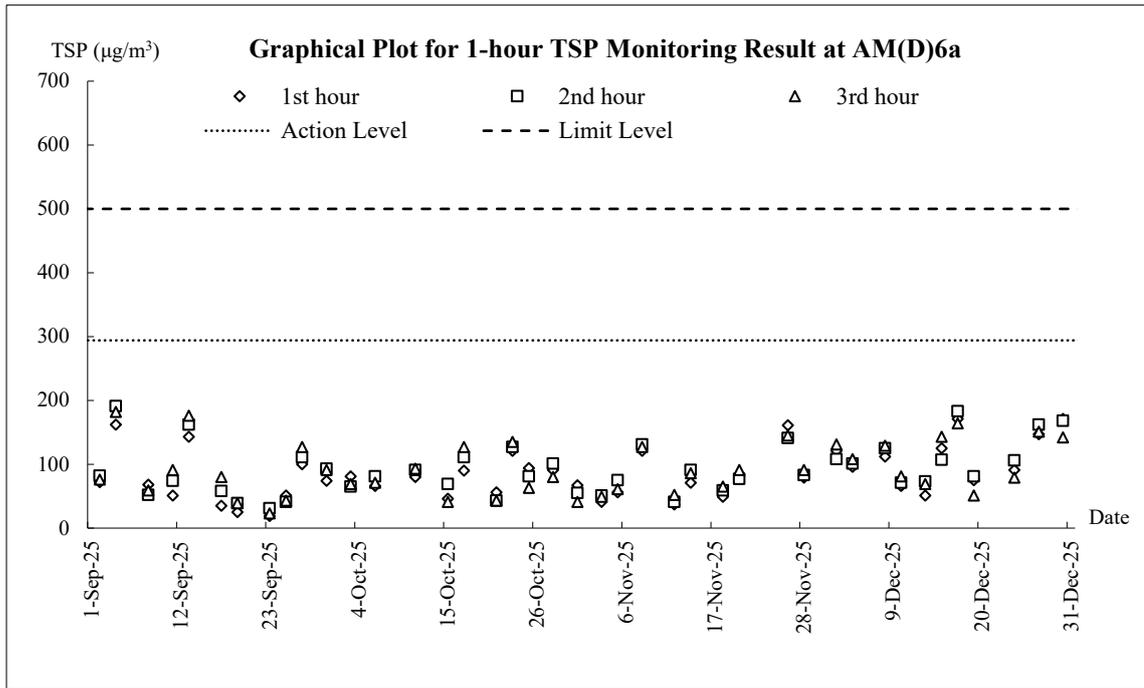
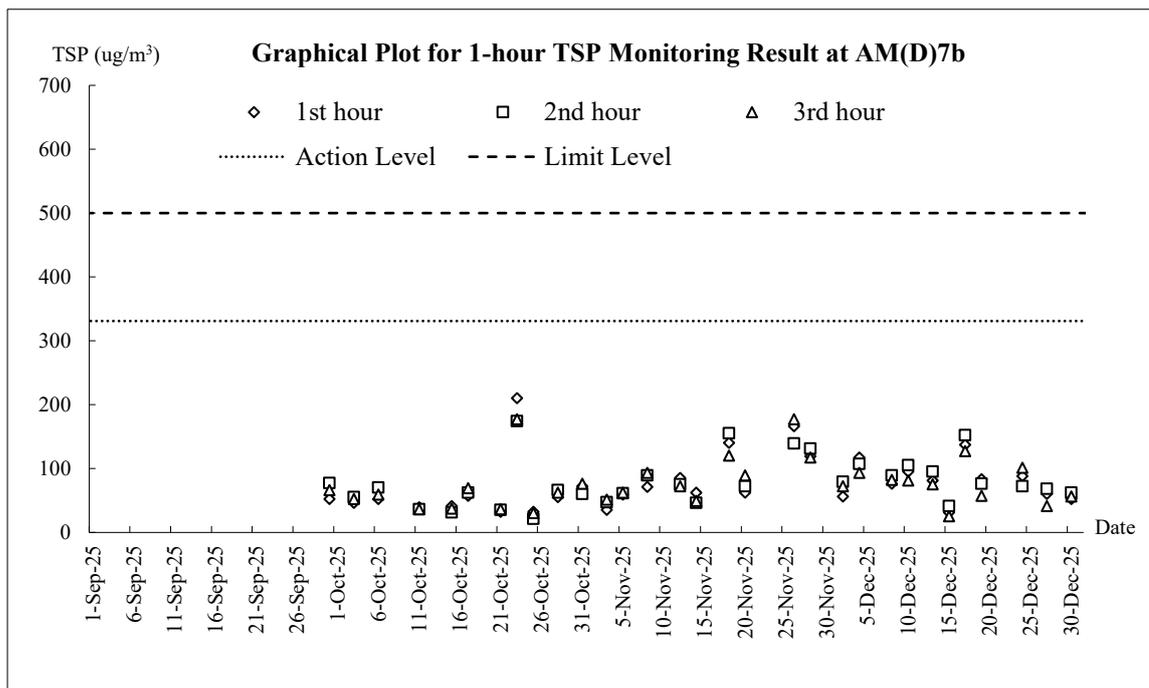
Air Quality – 1-hour TSP

- 3.1.1 Monitoring of the Total Suspended Particulate (TSP) levels shall be carried out by the ET to ensure that any deteriorating air quality could be readily detected and timely action be taken to rectify the situation. 1-hour and 24-hour TSP levels should be measured to indicate the impacts of construction dust on air quality. The TSP levels shall be measured by following the standard high volume sampling method as set out in the Title 40 of the Code of Federal Regulations, USA, Chapter 1 (Part 50), Appendix B. Upon approval by the IEC, 1-hour TSP levels can be measured by direct reading methods which are capable of producing comparable results as that by the high volume sampling method, to indicate short event impacts.

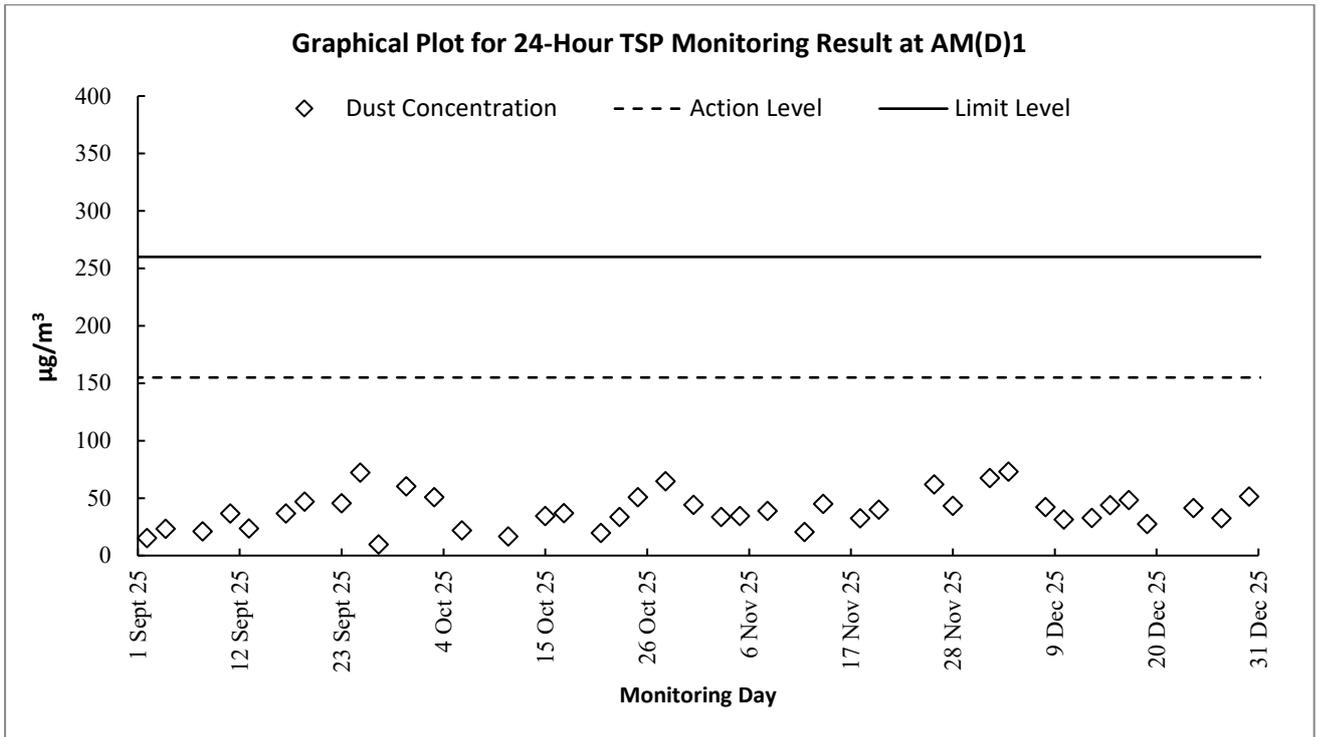
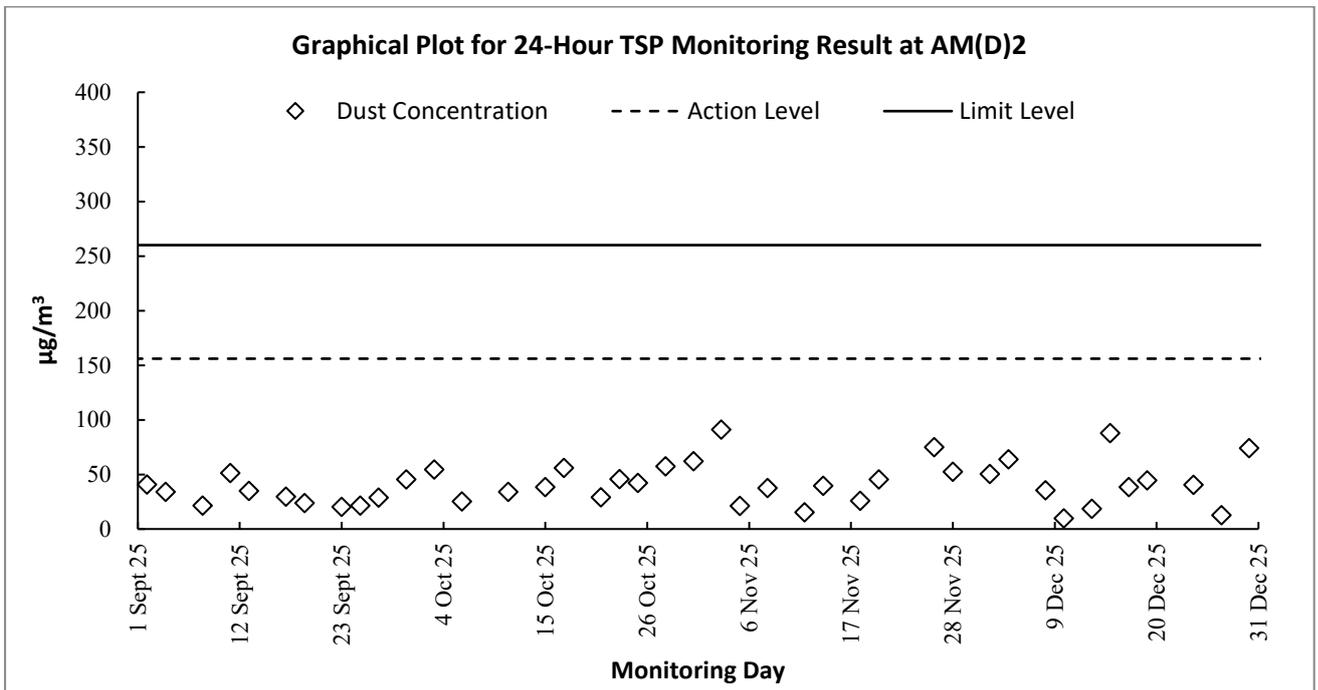
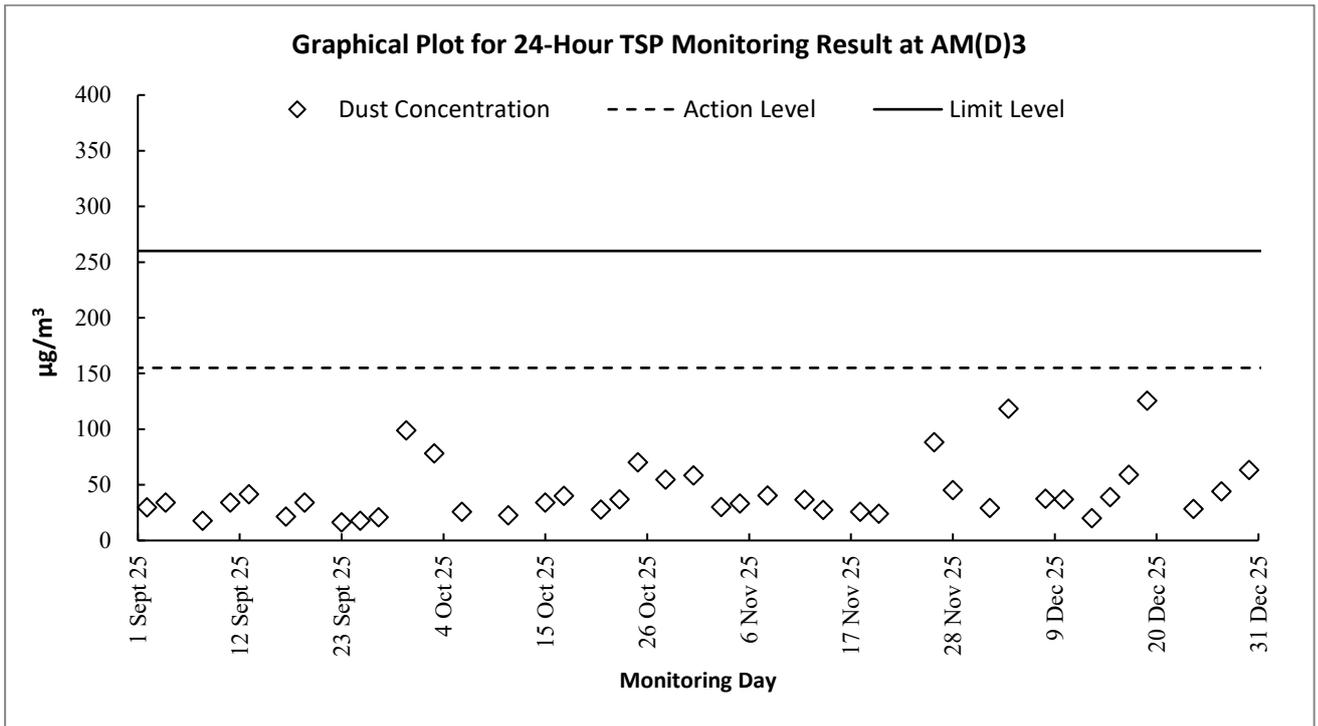
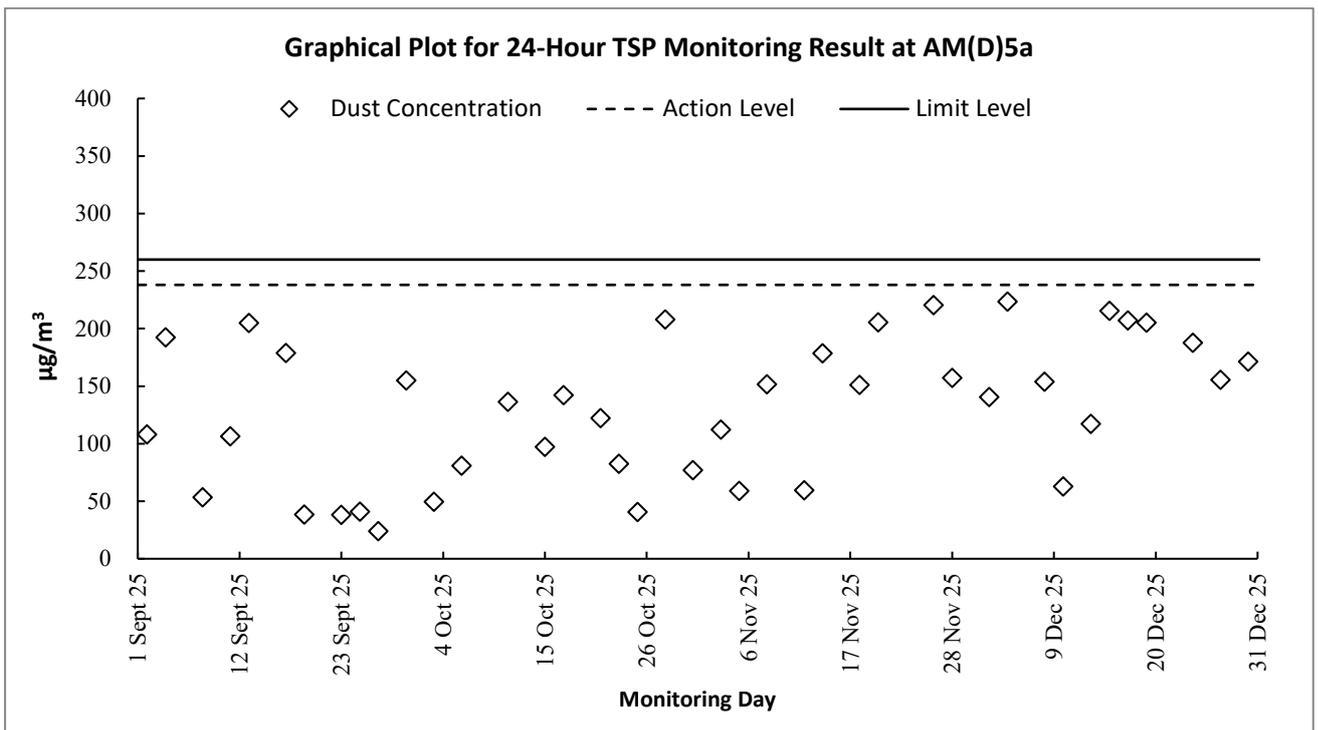
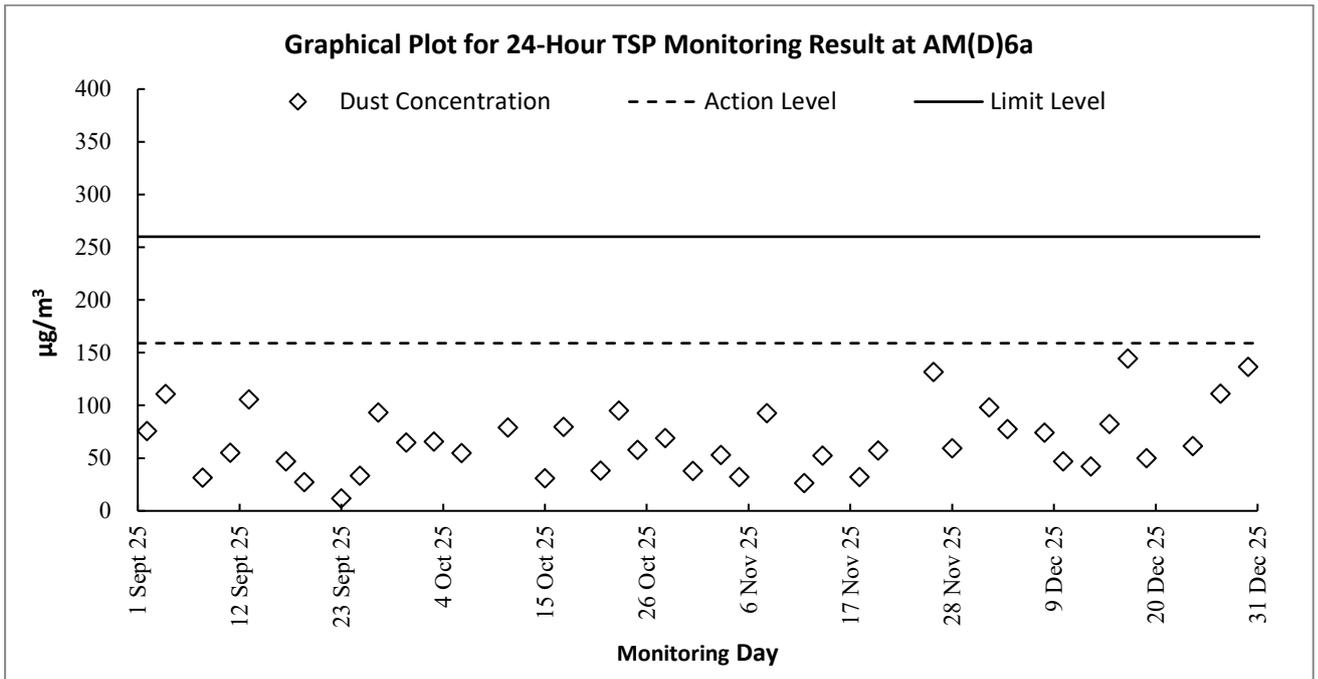
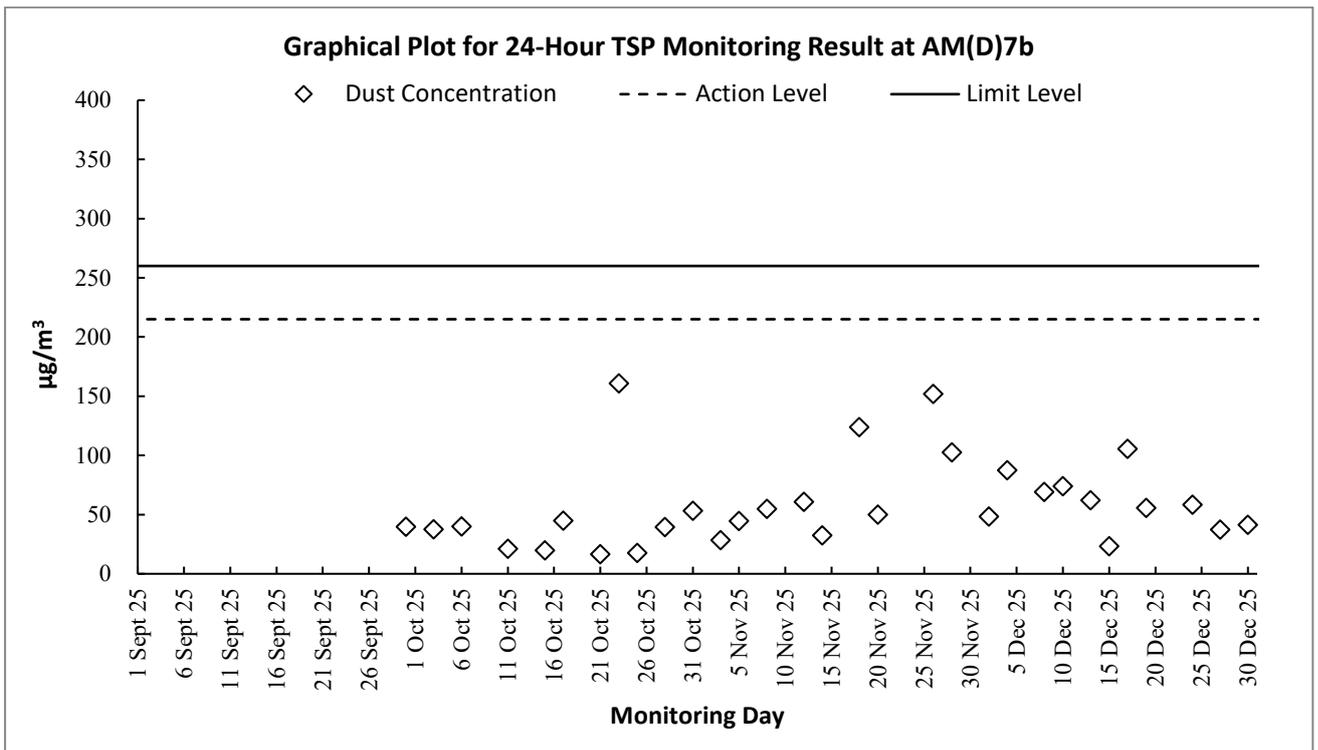
Air Quality – 24-hour TSP

- 3.2.1 In accordance with the EP requirement, for regular impact monitoring, the sampling frequency of at least twice in every six-days, shall be strictly observed at all the monitoring stations for 24-hr TSP monitoring. For 1-hr TSP monitoring, the sampling frequency of at least six times in every six-days should be undertaken when the highest dust impact occurs. The specific time to start and stop the 24-hr TSP monitoring shall be clearly defined for each location and be strictly followed by the Contractor.

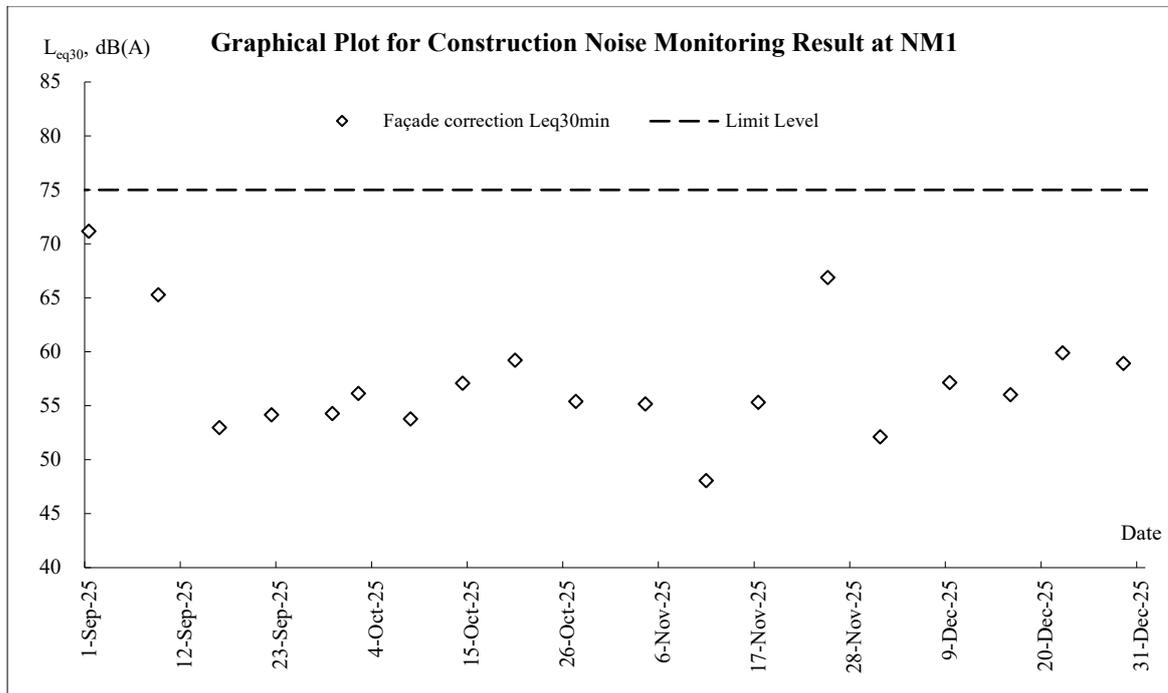
4.7.3 As shown in **Table 4-4**, no construction noise measurement results triggered the Limit Level (75 dB(A)) in the Reporting Month. Due to the construction programme, construction works during restricted hour was commenced from 15 November 2024. According to site inspection and auditing on Contractor’s record have shown that the conditions stipulated in the Construction Noise Permit (CNP) issued by the Noise Control Authority for construction works during restricted hours were followed. Thus, the stipulated requirement on noise impact control during restricted hour was achieved.
