CONTRACT NO. EP/SP/186/21

WEST NEW TERRITORIES LANDFILL EXTENSION

**MONTHLY ENVIRONMENTAL MONITORING AND AUDIT
REPORT – JANUARY 2026**

Date	Reference No.	Prepared By	Certified By
13 February 2026	TCS01325/23/600/R0188v1

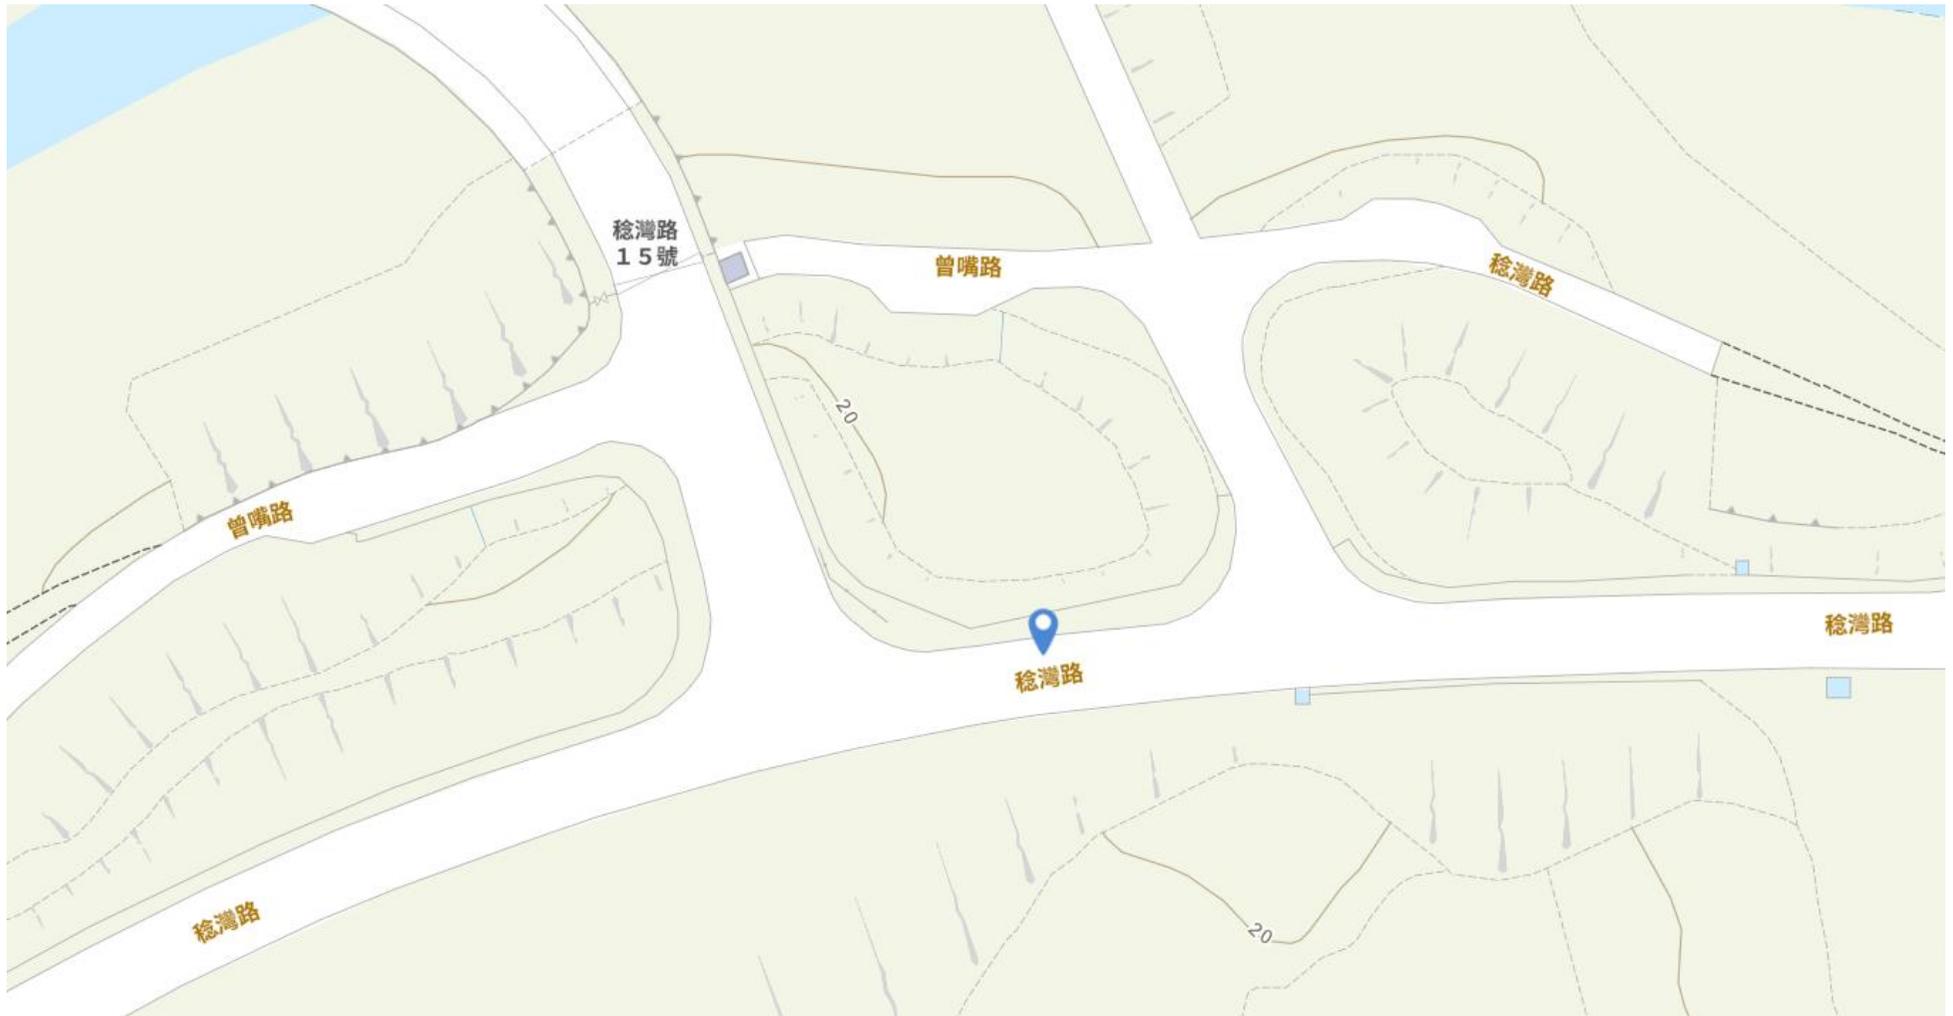
Figure 1 Construction Dust Complaint Location

<p>5. In our investigation, HKRRP implemented dust mitigation measures at to reduce potential dust impact to nearby environment, and no dust monitoring exceedances were recorded on 28 and 30 January 2026. Nevertheless, HKRRP was reminded to implement the recommended Environmental Mitigation Implementation Schedule, and to implement the mitigation measures as far as practicable, as recommended in the EM&A Program.</p>
--	--
