CONTRACT NO. EP/SP/186/21

WEST NEW TERRITORIES LANDFILL EXTENSION

**QUARTERLY ENVIRONMENTAL MONITORING AND AUDIT
SUMMARY REPORT – JANUARY TO MARCH 2026**

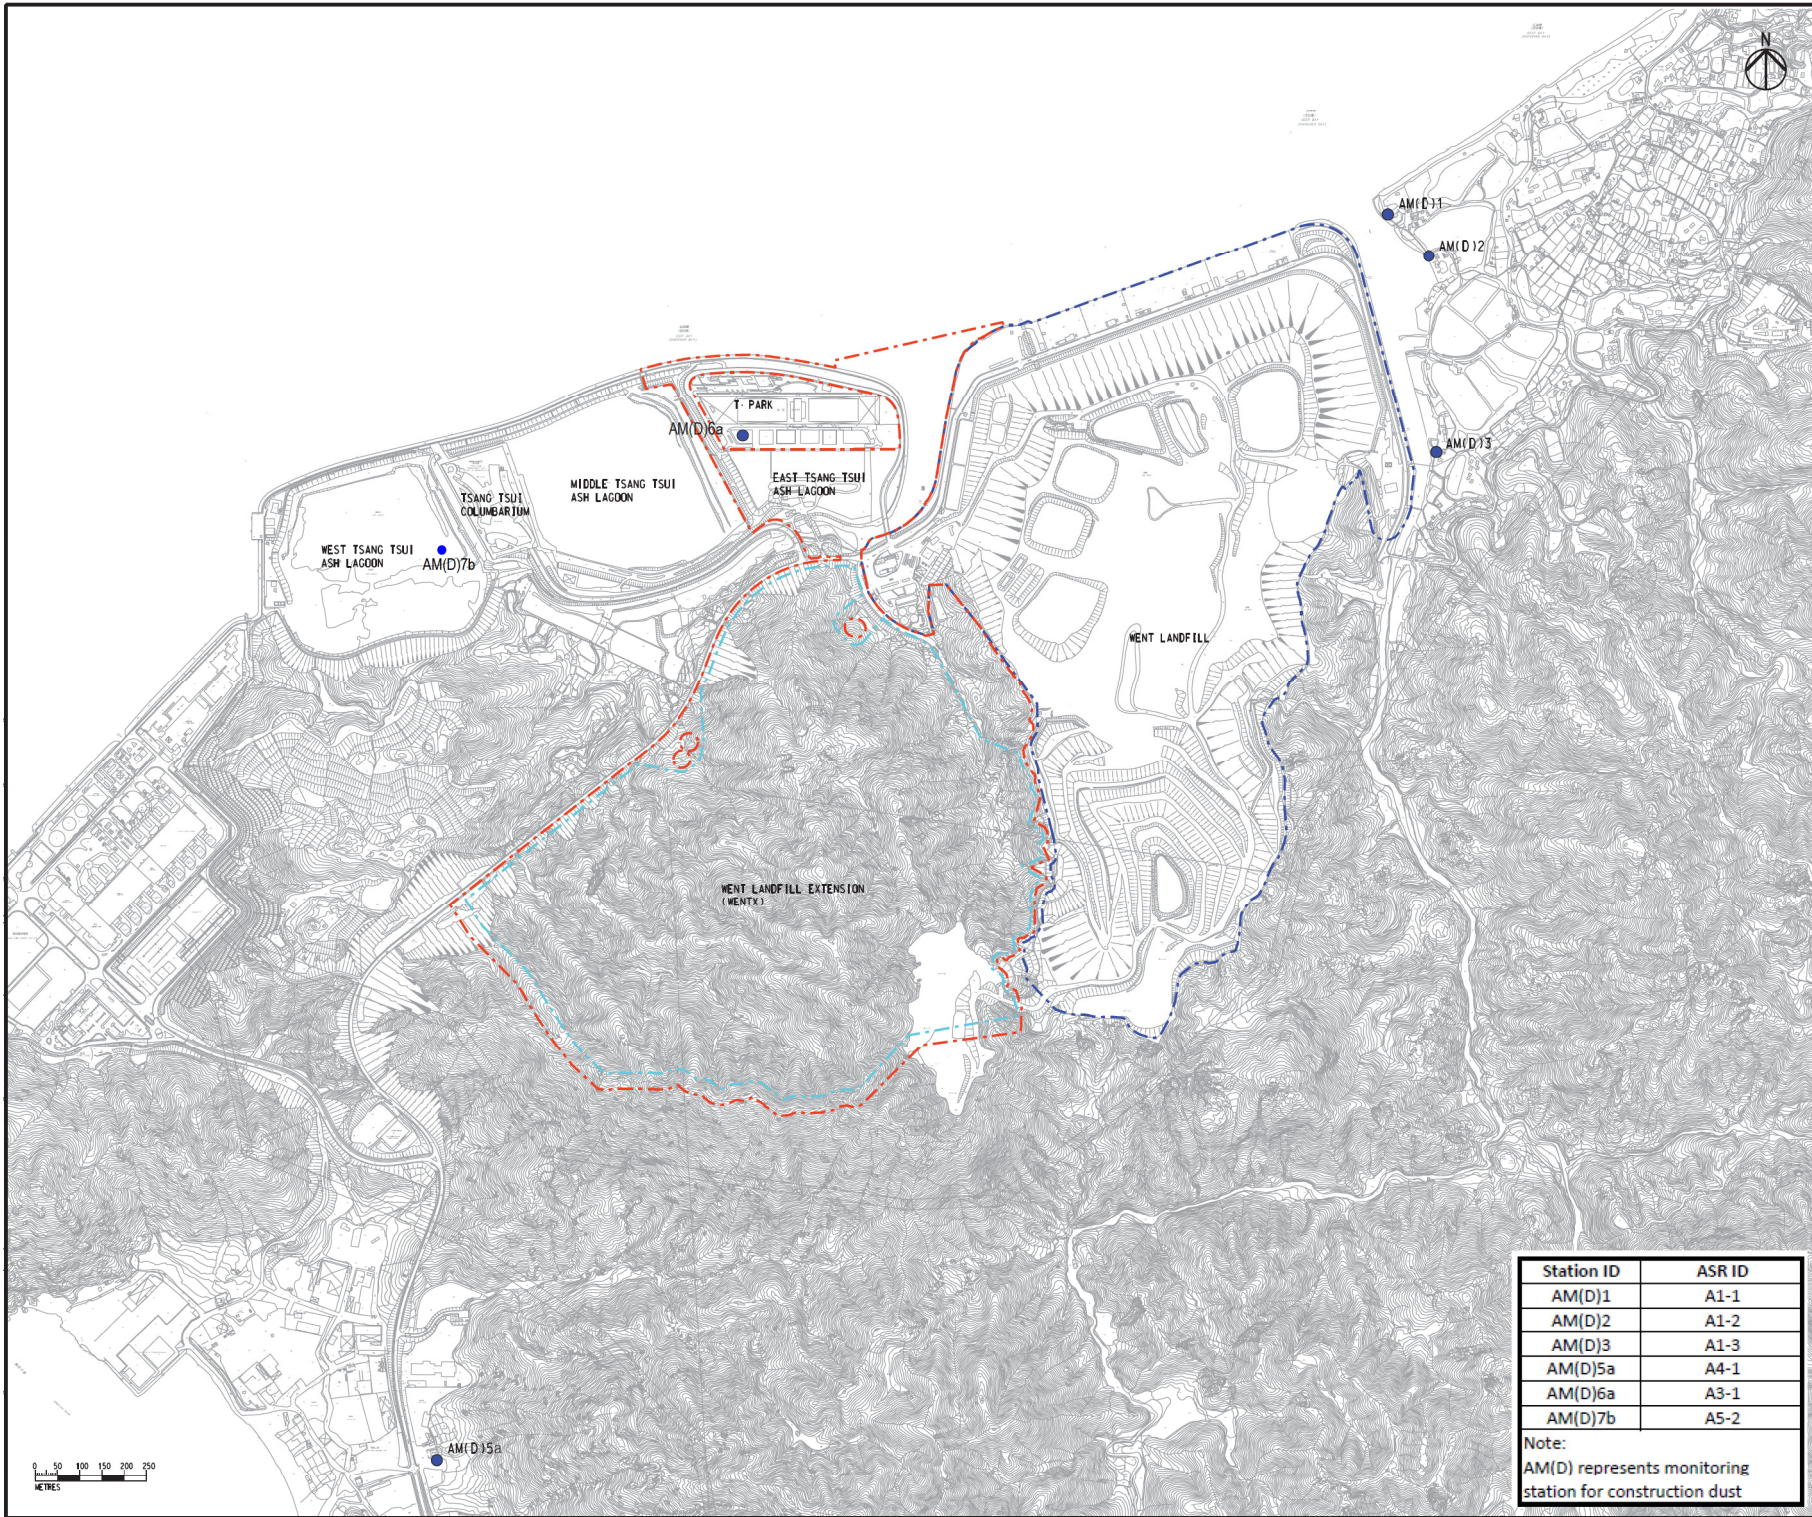
Drawing title
LOCATIONS OF AIR QUALITY MONITORING STATIONS

- LEGEND**
- WENT LANDFILL EXTENSION (WENTX) BOUNDARY
 - WENTX WASTE BOUNDARY
 - WENT LANDFILL BOUNDARY
 - AIR QUALITY MONITORING LOCATIONS

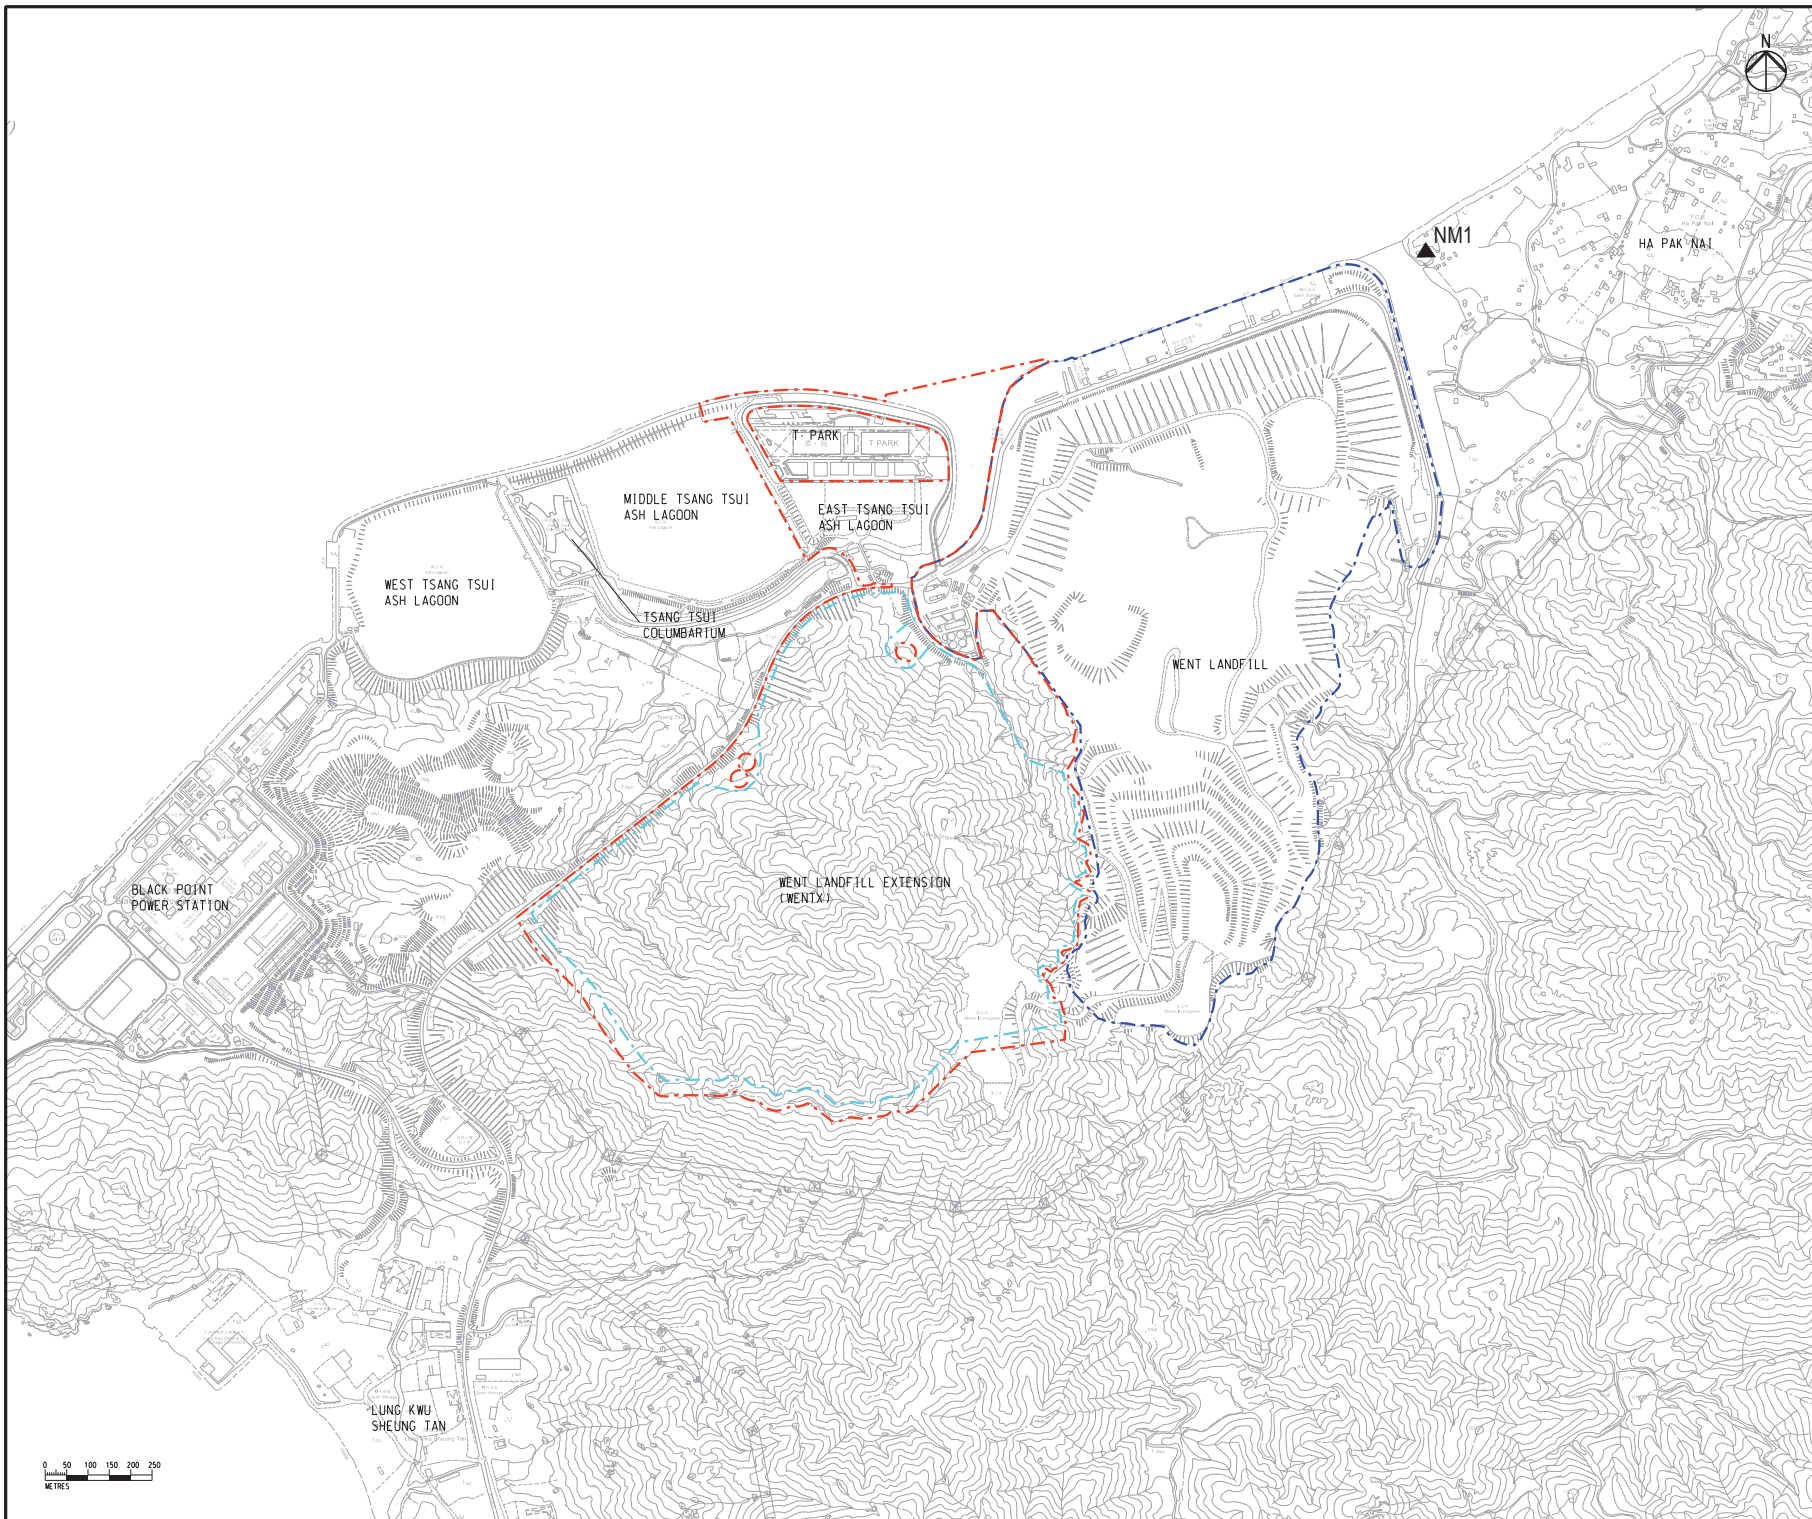
- LEGEND**
- WENT LANDFILL EXTENSION (WENTX) BOUNDARY
 - WENTX WASTE BOUNDARY
 - WENT LANDFILL BOUNDARY
 - NOISE MONITORING LOCATION

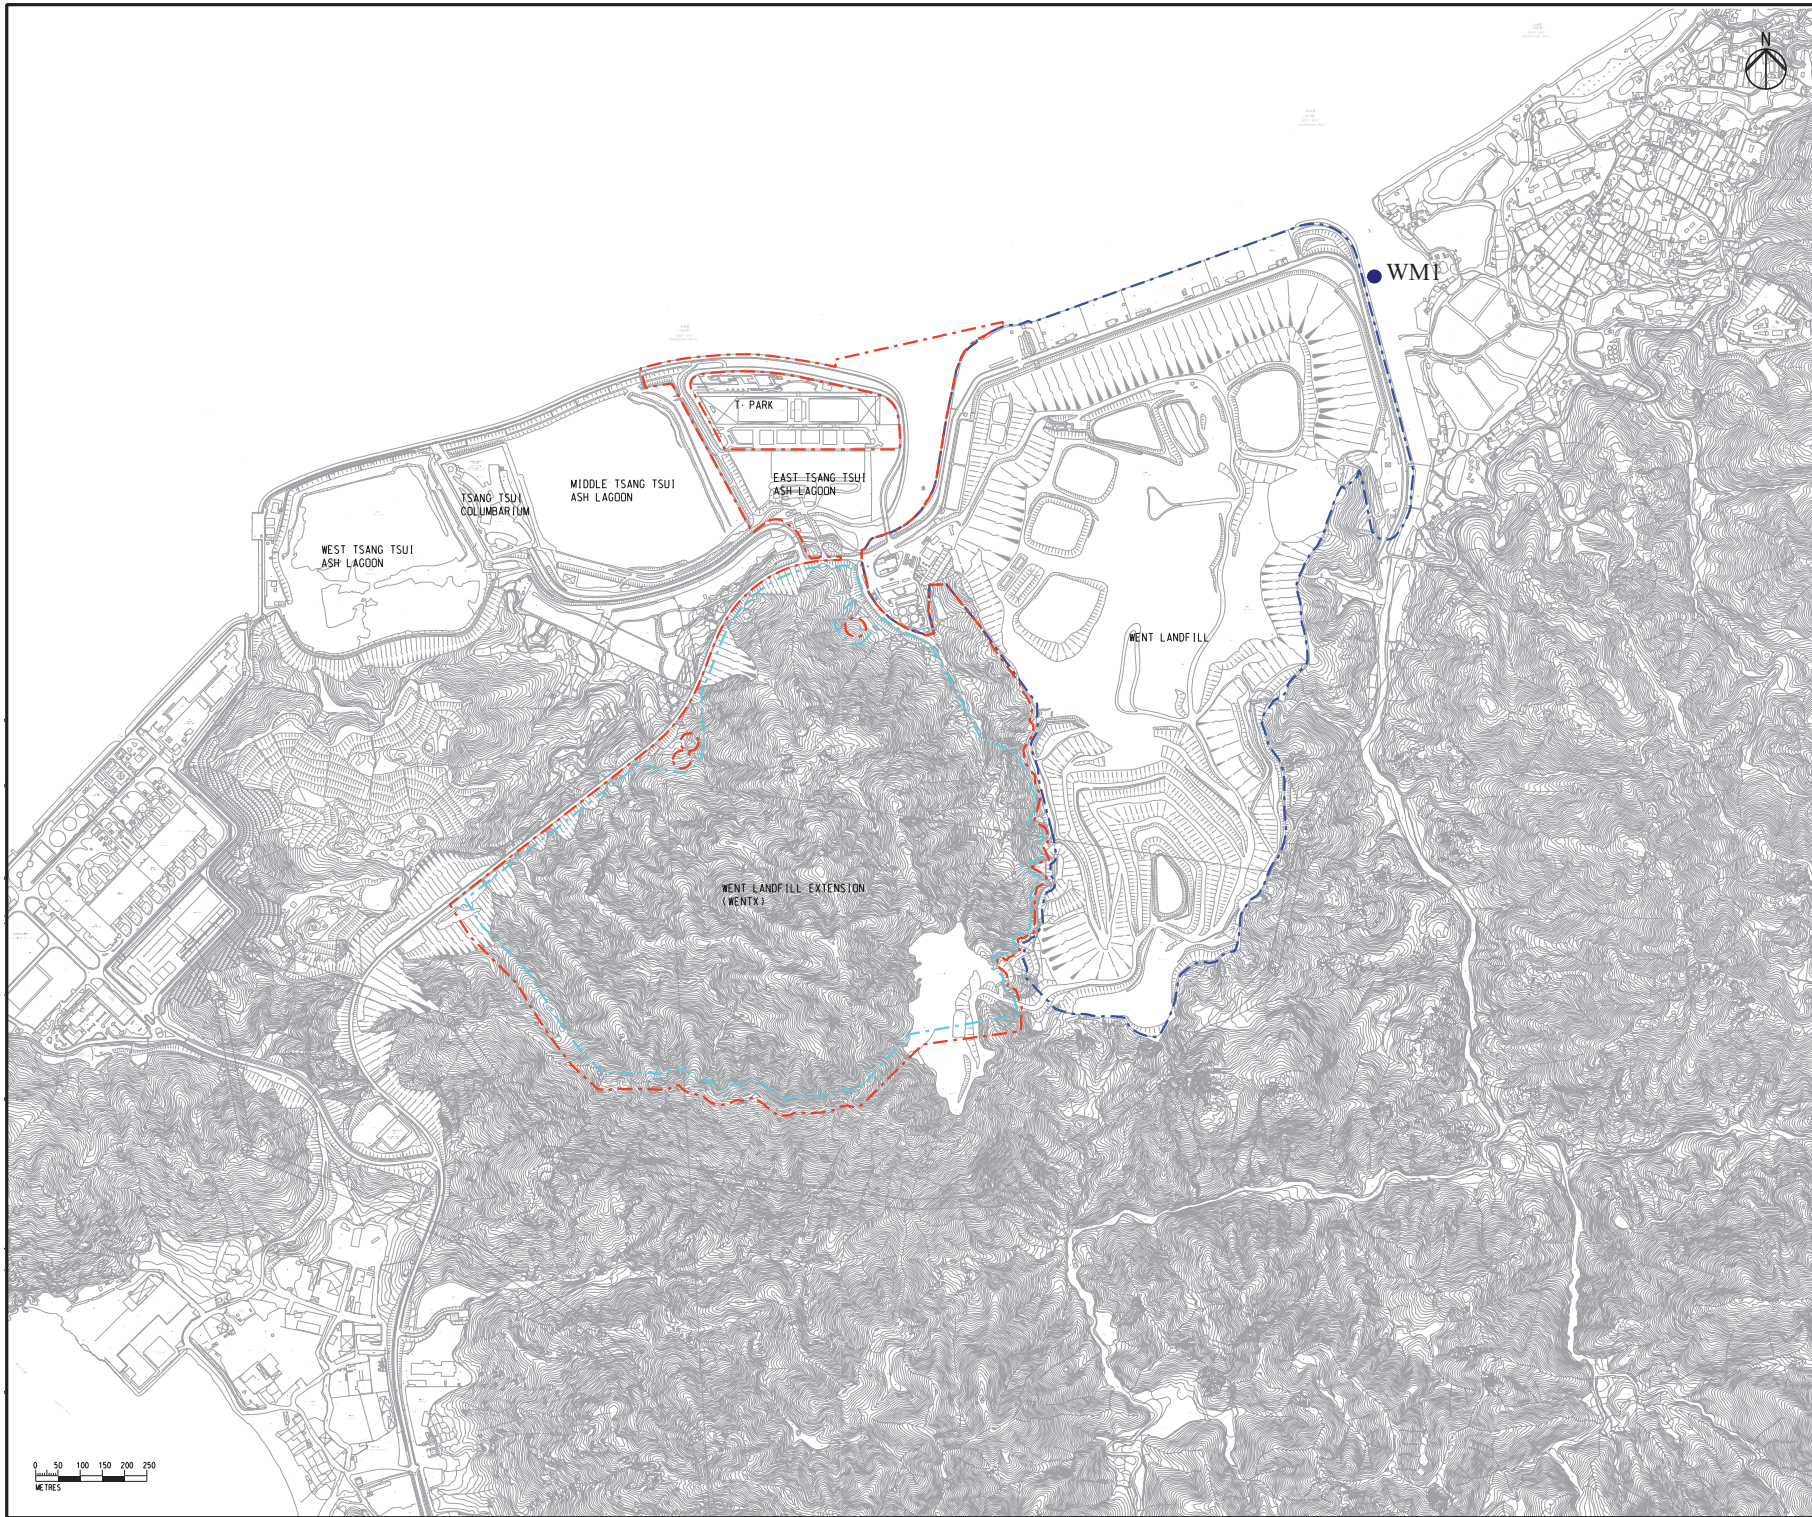
- LEGEND**
- - - WENT LANDFILL EXTENSION (WENTX) BOUNDARY
 - - - WENTX WASTE BOUNDARY
 - - - WENT LANDFILL BOUNDARY
 - SURFACE WATER MONITORING STATION

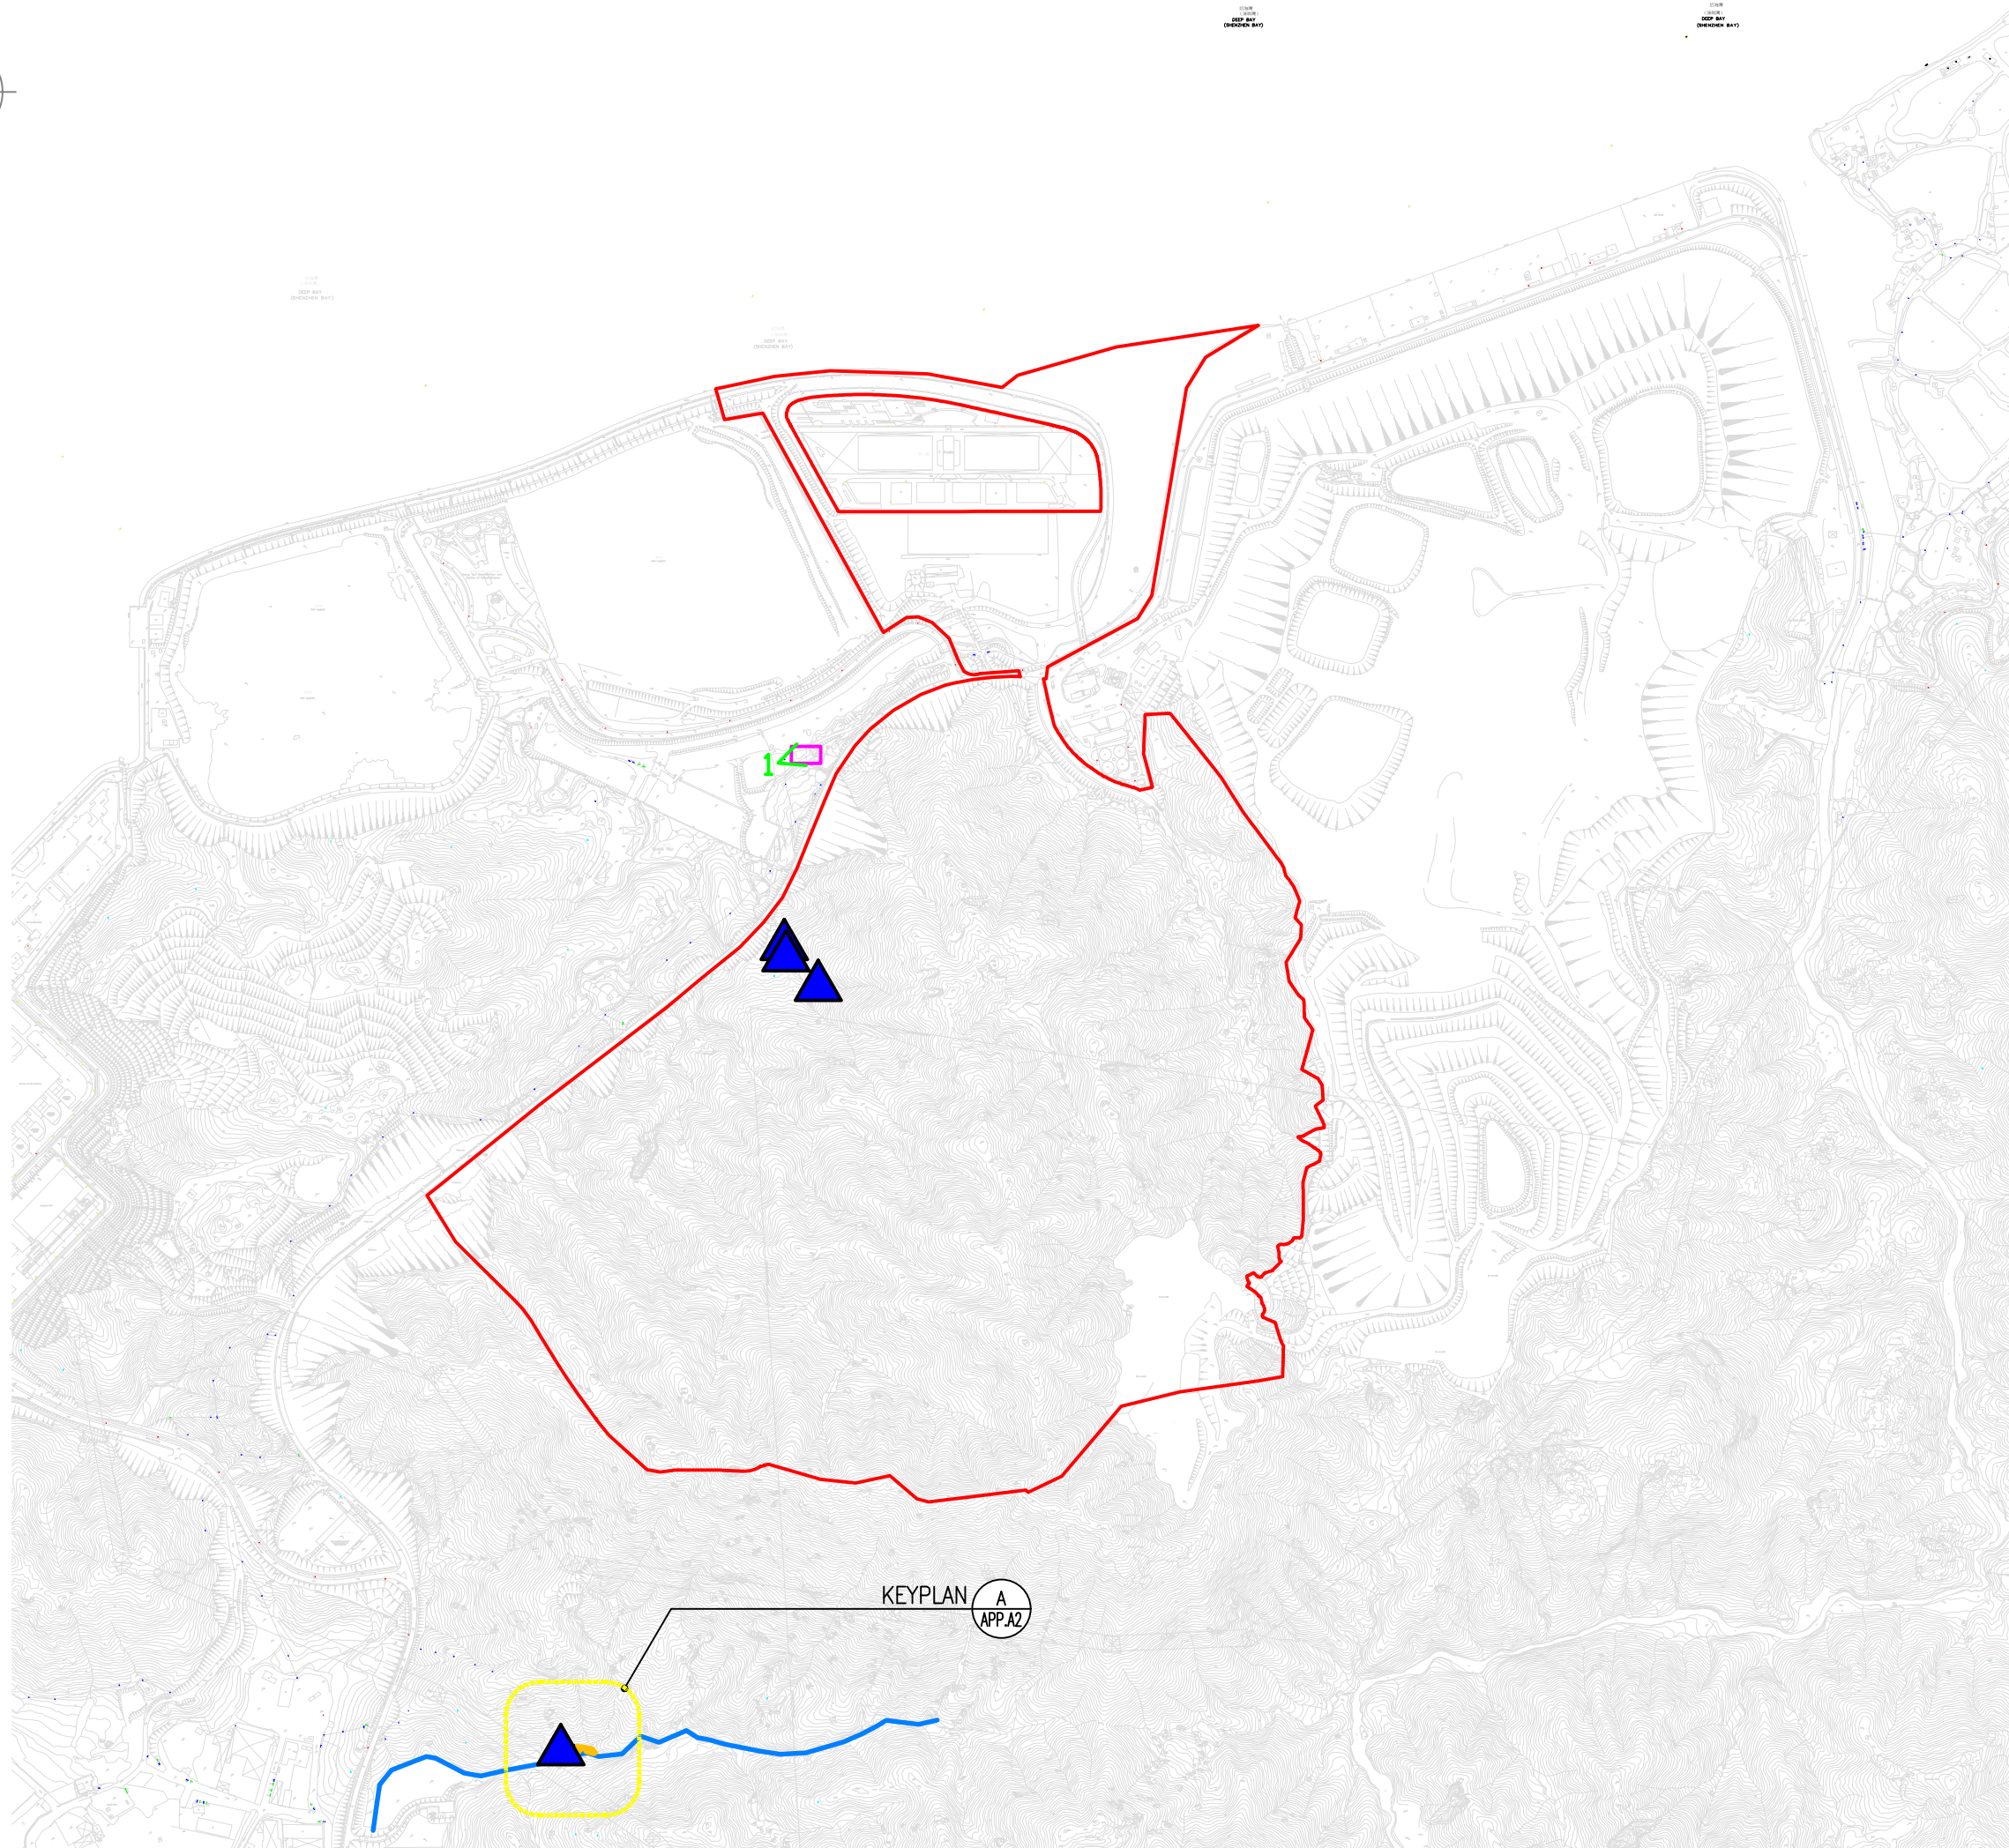
- FEP/EP WENTX PROJECT BOUNDARY
- ▲ PITCHER PLANT
- STREAM B
- RECEPTOR SITE FOR PITCHER PLANT (~254sqm)
- ON-SITE TRANSIT NURSERY
- > PHOTO TAKING ANGLE (REFER TO APPENDIX A2)

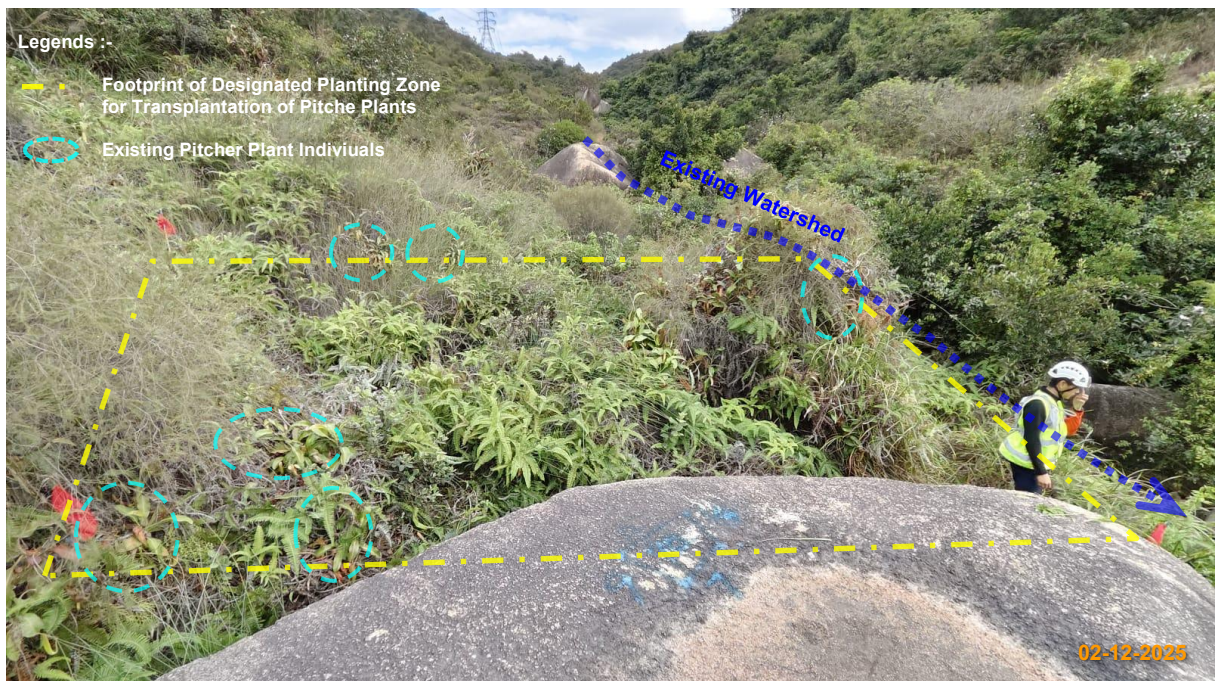
The findings presented in Section 4 indicate that the qualified ecologist has not advised the implementation of additional conservation measures and arrangements, given the absence of additional species of conservation importance distribute within the affected habitats. It is highlighted that certain existing Pitcher Plants were mainly observed in close proximity to the boundary edge of the designated planting zone at the final receptor site. This observation demonstrates that the selected habitat condition can provide right suitability and available quality, which closely resemble those of the original donor site. In particular, the receptor site exhibits comparable characteristics with the original donor site in terms of watershed, natural woodland and grassland types, as well as similar characteristics related to sun exposure, landform, altitude, and vicinity to all-season water bodies, as illustrated in the Figure 2.

Figure 2. Pitcher Plant Condition found at the Designated Planting Zone of the Receptor Site
