## South East New Territories (SENT) Landfill Extension

**Monthly Environmental Monitoring & Audit Report No.57  
for September 2023**

## Monthly Environmental Monitoring & Audit Report for September 2023

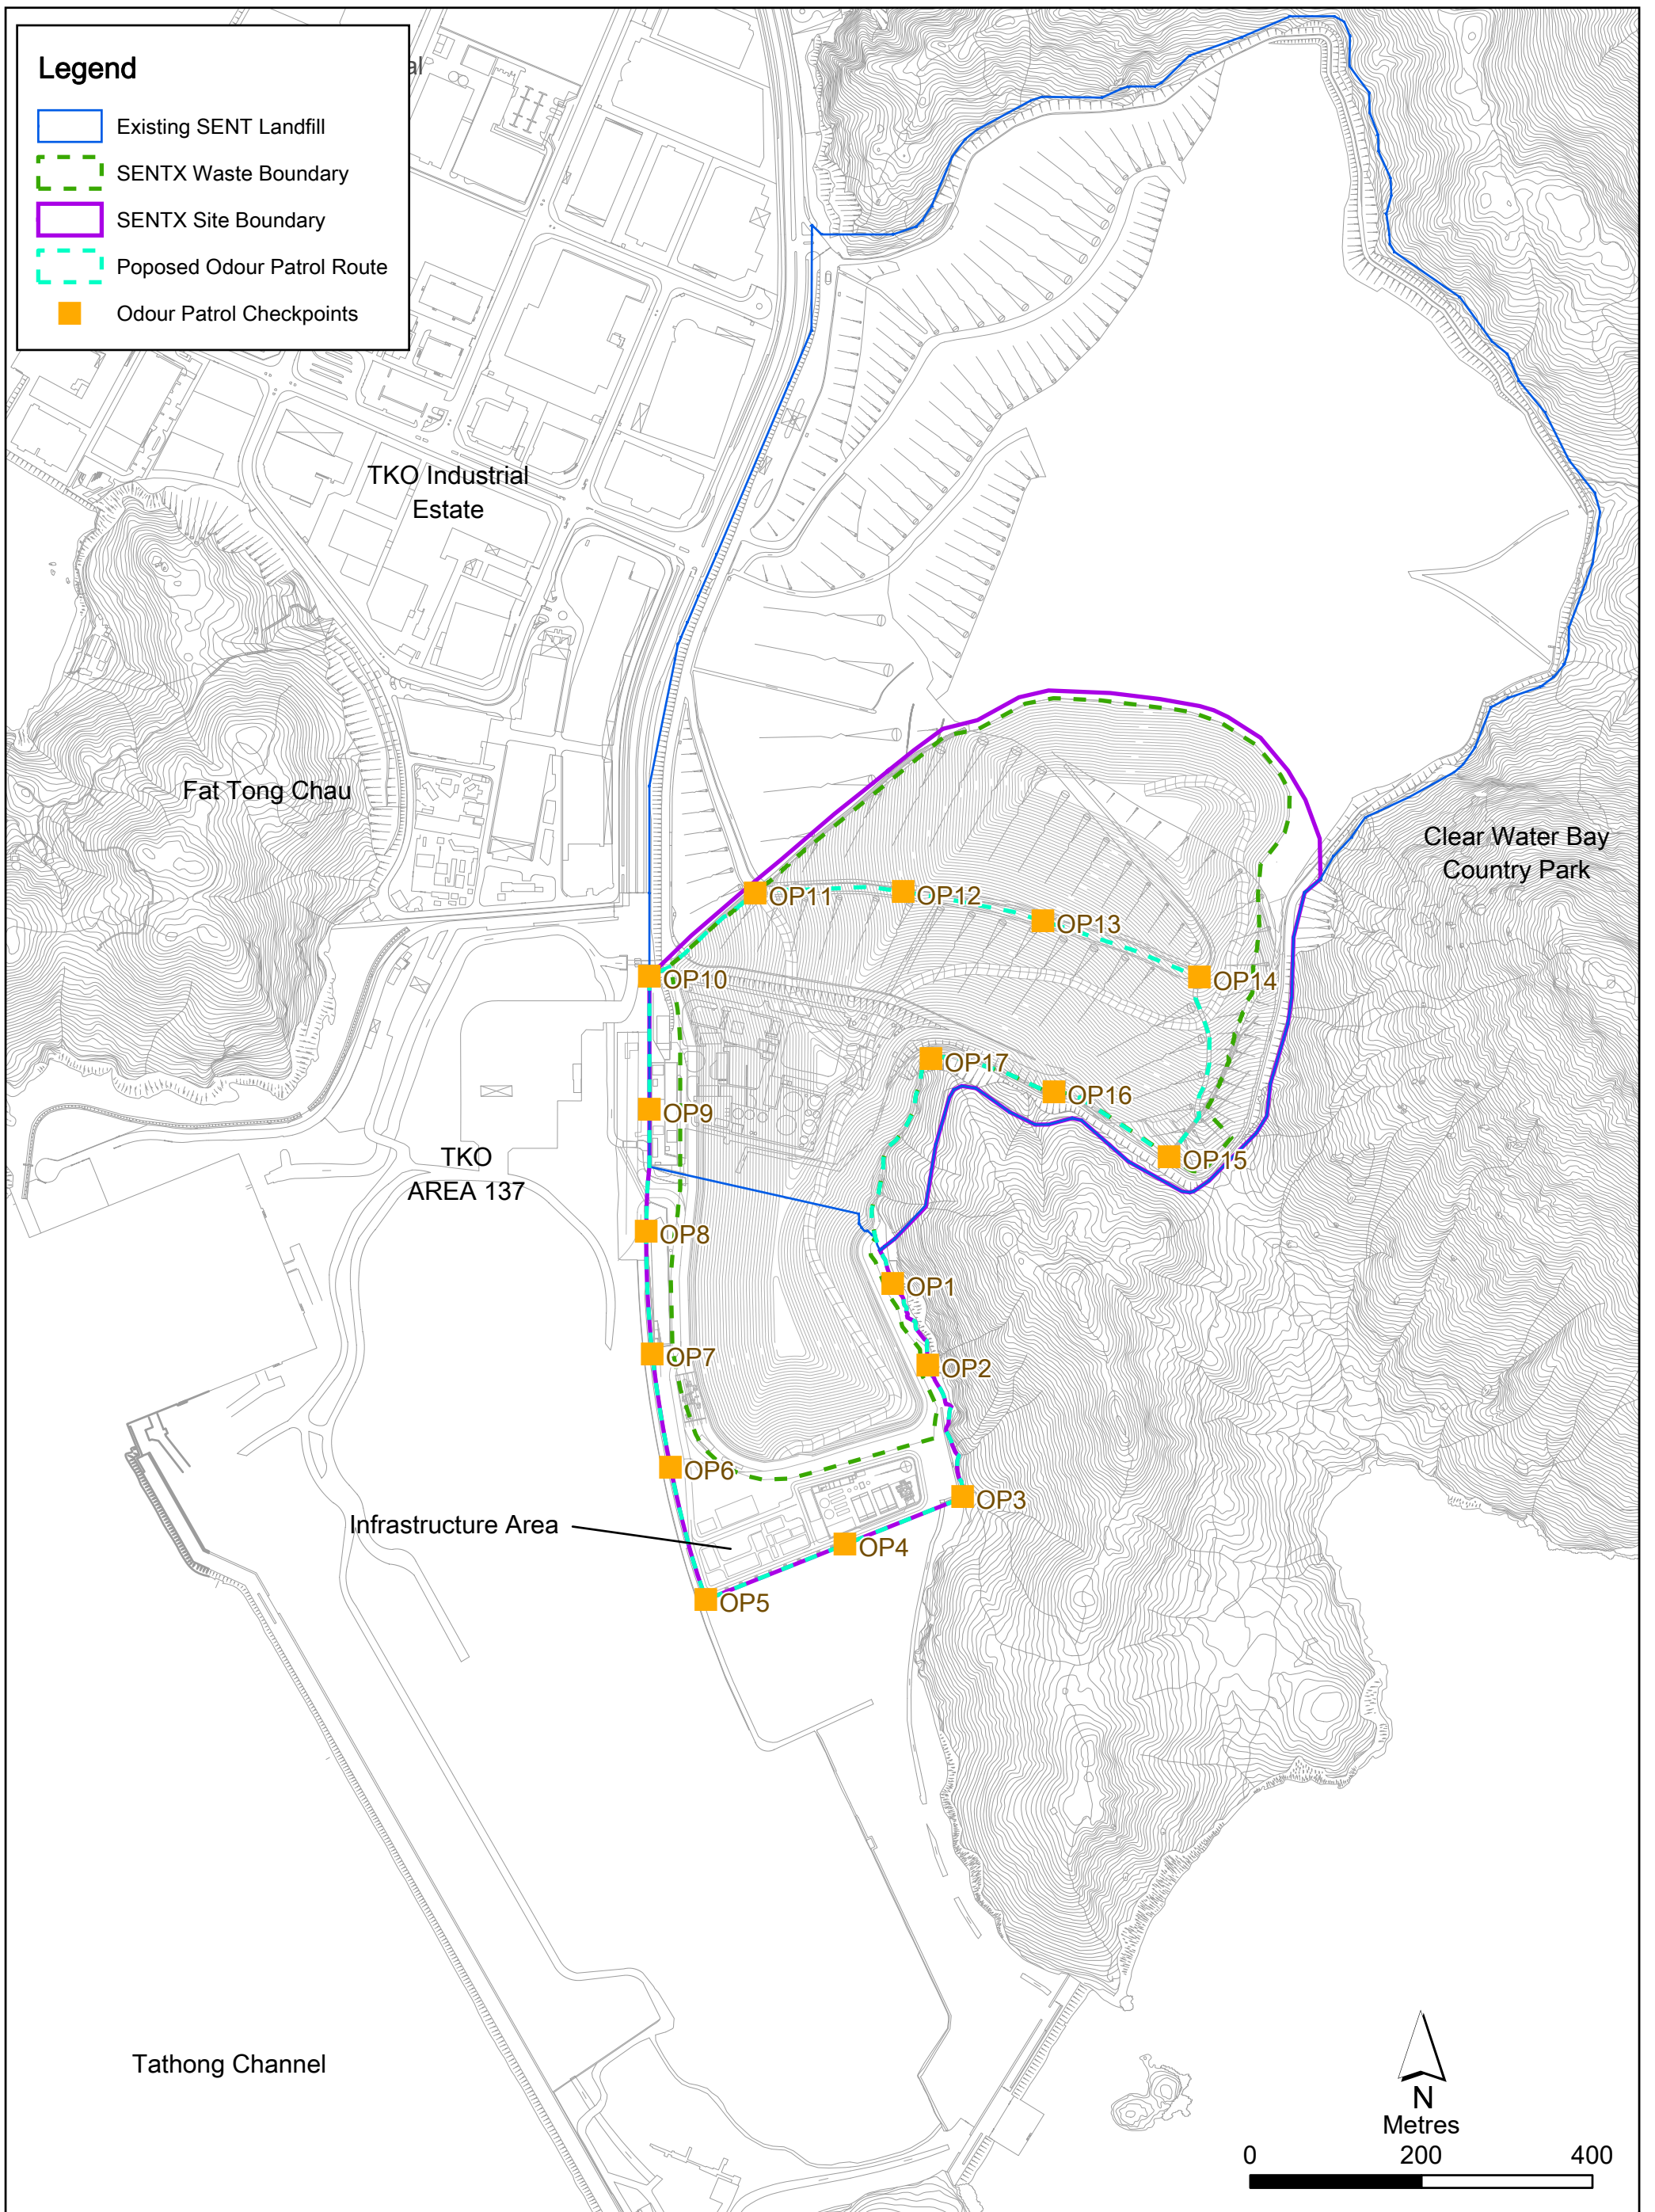
Figure 2.2

## Odour Patrol Route for Operation/ Restoration Phase Odour Monitoring

The odour monitoring programme and patrol route are summarised in *Table 2.5* and illustrated in *Figure 2.2* respectively. Copies of the certificates of the qualified odour panelist are presented in *Annex D5*.

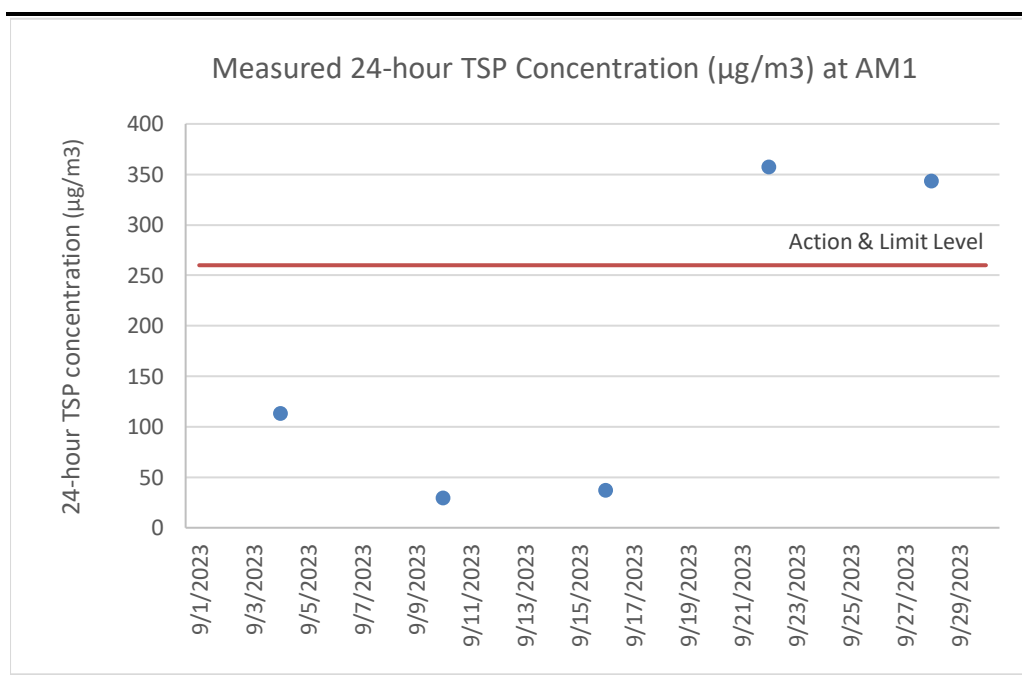
Start Date	Start Time	Finish Date	Finish Time	Weather	24-hour TSP ( $\mu\text{g}/\text{m}^3$ )
4 Sep 23	8:00	5 Sep 23	8:00	Sunny	113
10 Sep 23	8:00	11 Sep 23	8:00	Cloudy	29
16 Sep 23	8:00	17 Sep 23	8:00	Cloudy	37
22 Sep 23	8:00	23 Sep 23	8:00	Sunny	357
28 Sep 23	8:00	29 Sep 23	8:00	Sunny	343
<b>Average</b>					176
<b>Min</b>					29
<b>Max</b>					357

**Figure D2.1 Graphical Presentation for 24-hr TSP Monitoring at AM1**

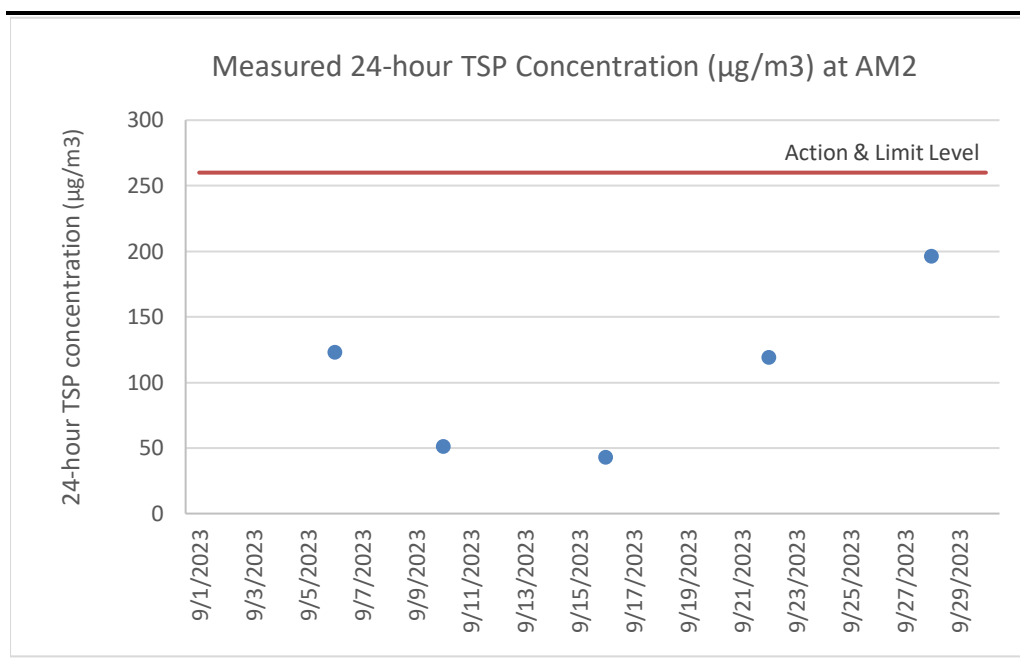
Start Date	Start Time	Finish Date	Finish Time	Weather	24-hour TSP ( $\mu\text{g}/\text{m}^3$ )
6 Sep 23	8:00	7 Sep 23	8:00	Cloudy	123
10 Sep 23	8:00	11 Sep 23	8:00	Cloudy	51
16 Sep 23	8:00	17 Sep 23	8:00	Cloudy	43
22 Sep 23	8:00	23 Sep 23	8:00	Sunny	119
28 Sep 23	8:00	29 Sep 23	8:00	Sunny	196
Average					106
Min					43
Max					196

**Figure D2.2 Graphical Presentation for 24-hr TSP Monitoring at AM2**

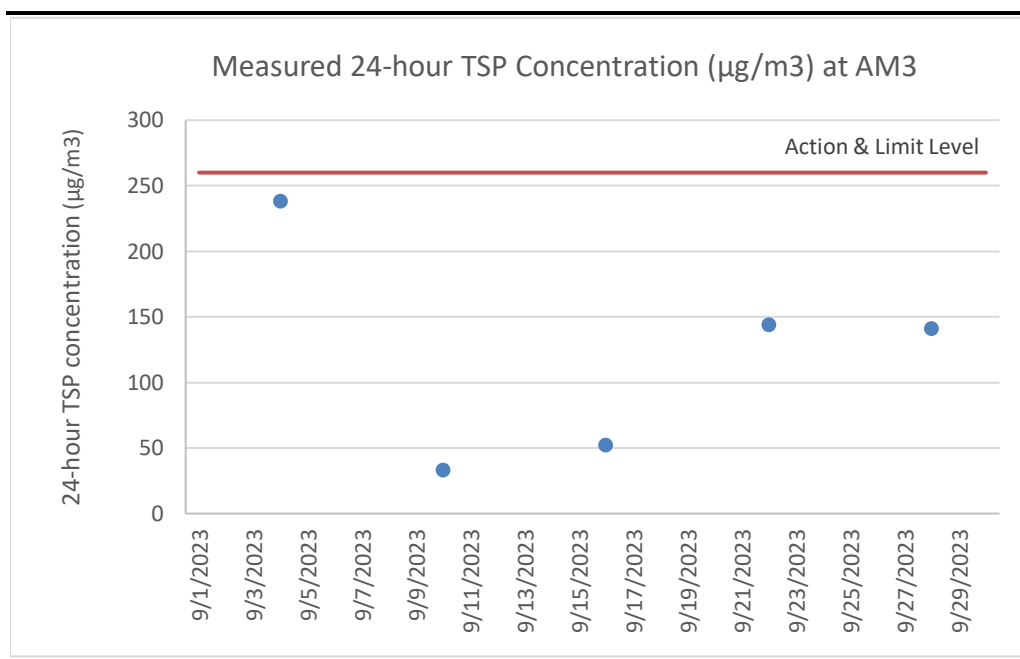
Start Date	Start Time	Finish Date	Finish Time	Weather	24-hour TSP ( $\mu\text{g}/\text{m}^3$ )
4 Sep 23	8:00	5 Sep 23	8:00	Sunny	238
10 Sep 23	8:00	11 Sep 23	8:00	Cloudy	33
16 Sep 23	8:00	17 Sep 23	8:00	Cloudy	52
22 Sep 23	8:00	23 Sep 23	8:00	Sunny	144
28 Sep 23	8:00	29 Sep 23	8:00	Sunny	141
Average					122
Min					33
Max					238

**Figure D2.3 Graphical Presentation for 24-hr TSP Monitoring at AM3**

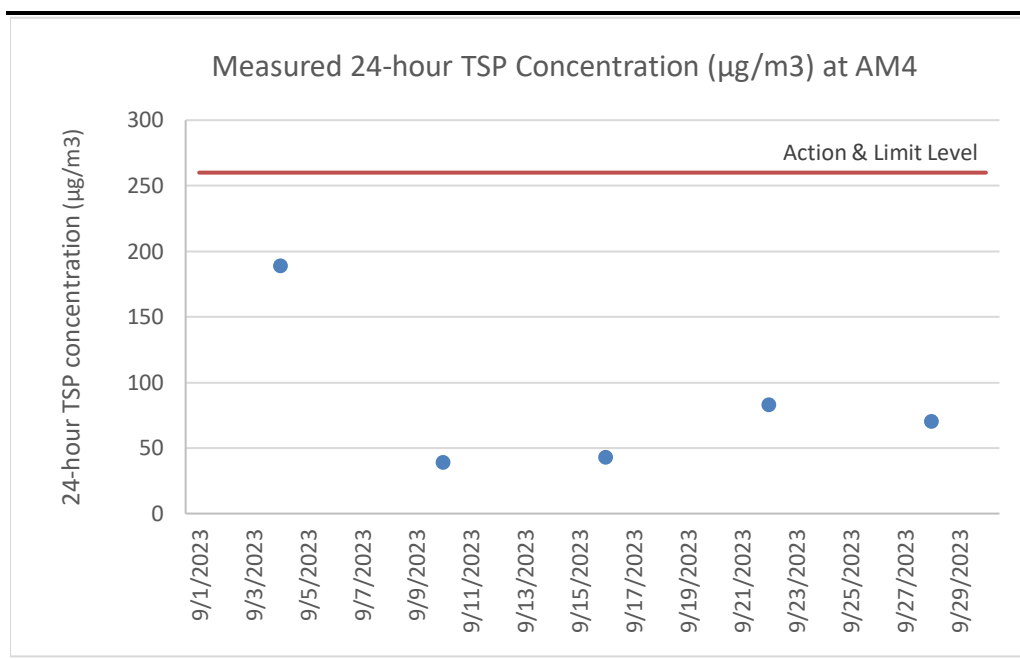
Start Date	Start Time	Finish Date	Finish Time	Weather	24-hour TSP ( $\mu\text{g}/\text{m}^3$ )
4 Sep 23	8:00	5 Sep 23	8:00	Sunny	189
10 Sep 23	8:00	11 Sep 23	8:00	Cloudy	39
16 Sep 23	8:00	17 Sep 23	8:00	Cloudy	43
22 Sep 23	8:00	23 Sep 23	8:00	Sunny	83
28 Sep 23	8:00	29 Sep 23	8:00	Sunny	70
Average					85
Min					39
Max					189

**Figure D2.4 Graphical Presentation for 24-hr TSP Monitoring at AM4**

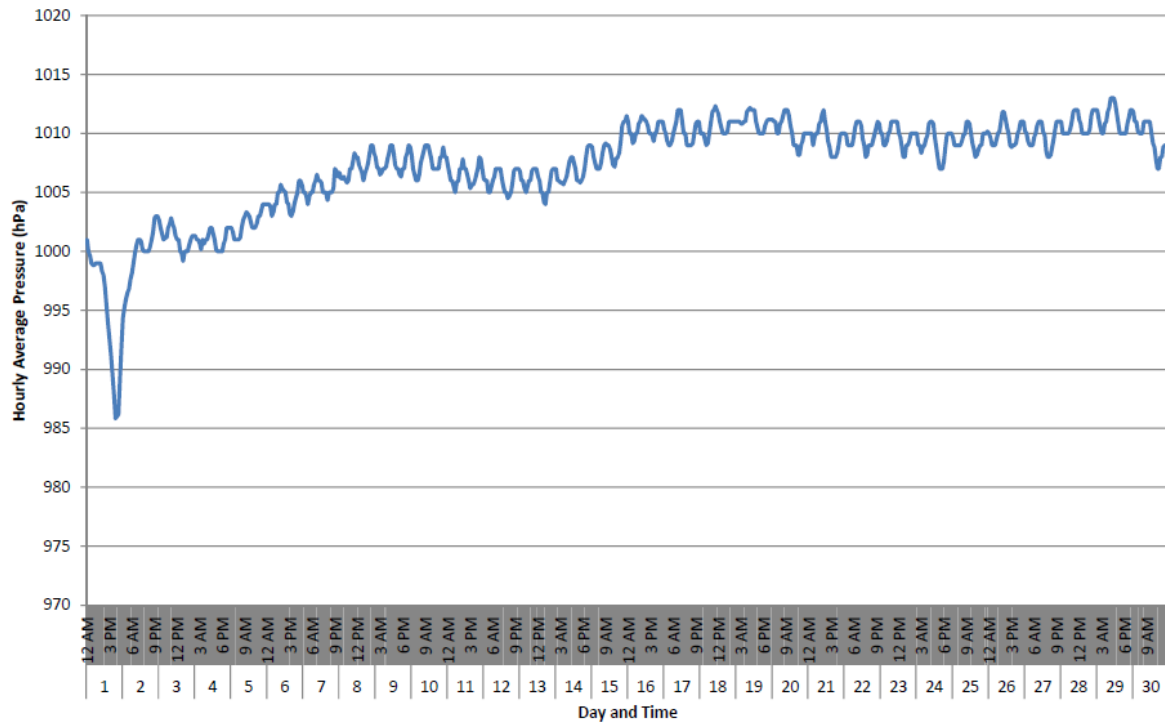
### Hourly Average Pressure (hPa) for September 2023

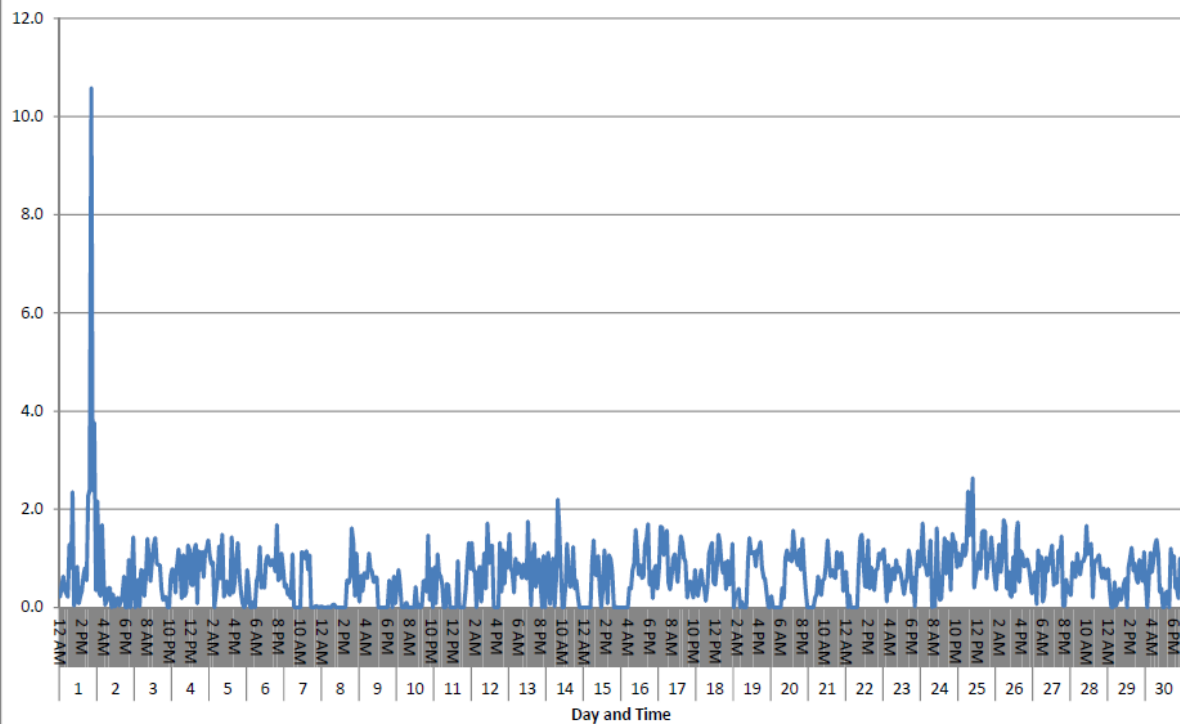
### Hourly Average Wind Speed (m/s) for September 2023

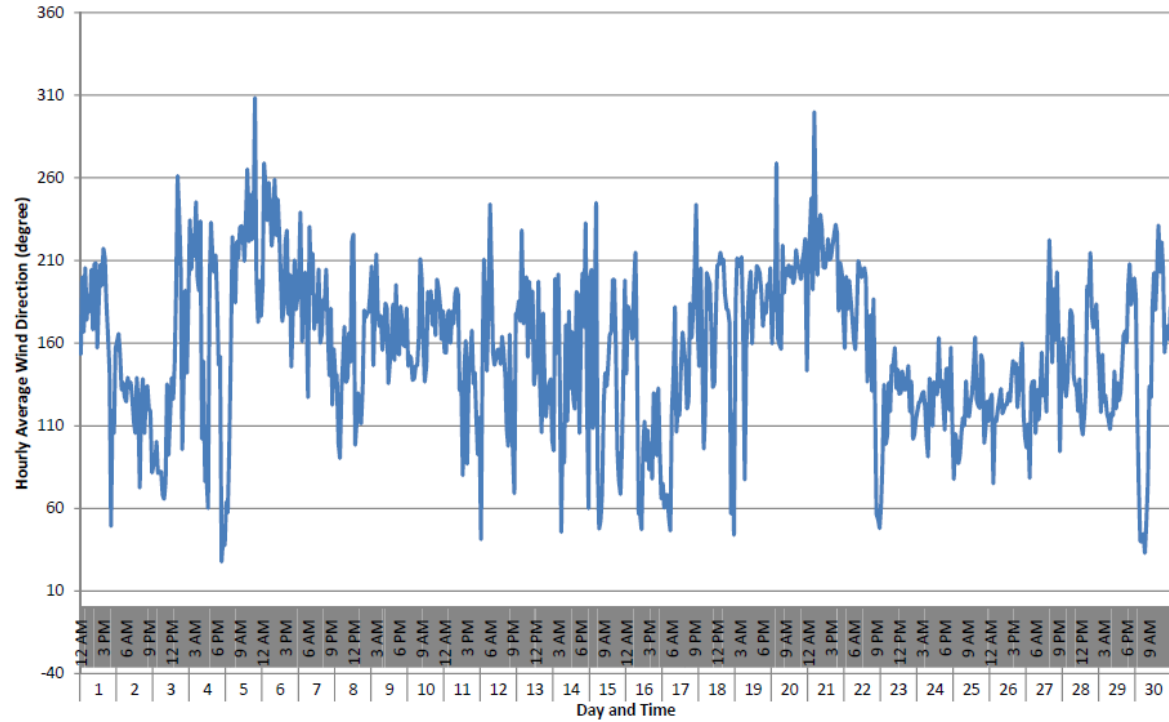
### Hourly Average Wind Direction (degree) for September 2023

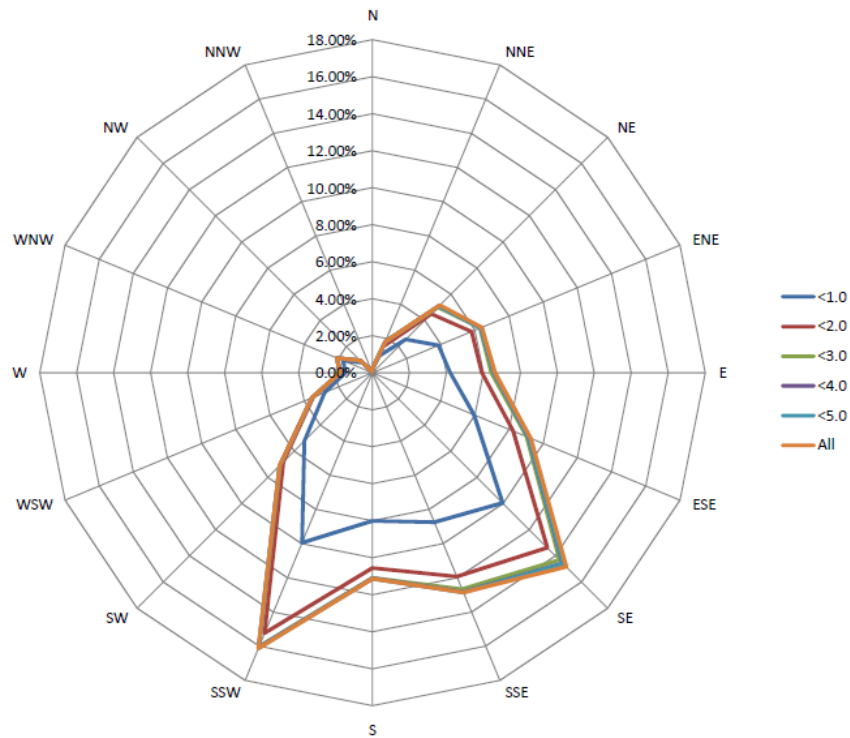
### Wind Rose for September 2023

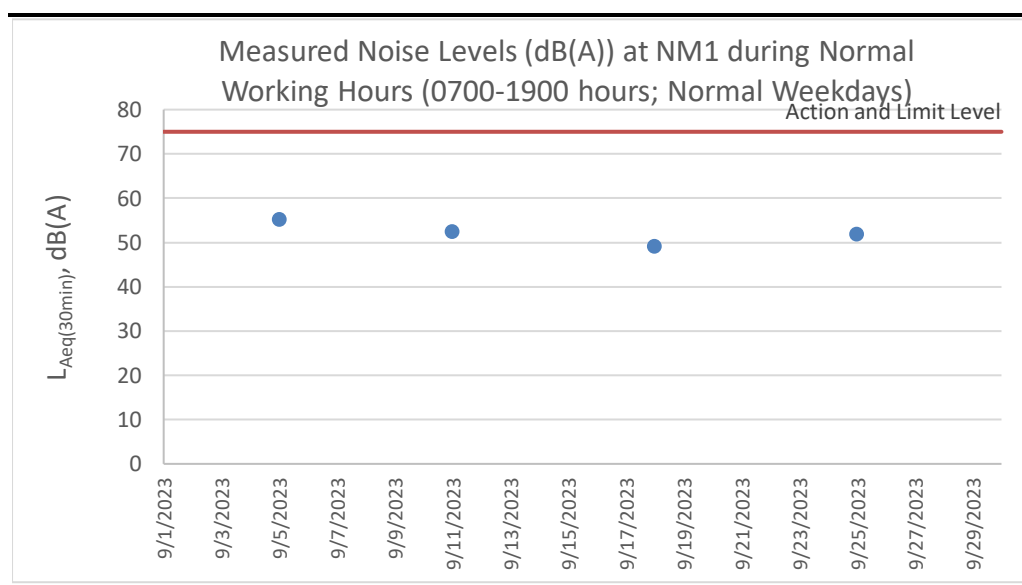
Date	Start Time	Finish Time	Weather	L <sub>10</sub> (30min)	L <sub>90</sub> (30min)	L <sub>eq</sub> (30min)
5 Sep 23	14:27	14:57	Cloudy	56.5	53.4	55.2
11 Sep 23	10:40	11:10	Cloudy	54.0	49.3	52.5
18 Sep 23	10:11	10:41	Sunny	50.9	46.4	49.1
25 Sep 23	10:41	11:11	Sunny	53.6	48.0	51.9
<b>Average</b>						52.2
<b>Min</b>						49.1
<b>Max</b>						55.2

**Figure E2.1**      **Graphical Presentation for Noise Monitoring at NM1**
