# Ocean Park Master Redevelopment Project

Monthly Environmental Monitoring & Audit  
Report – March 2010

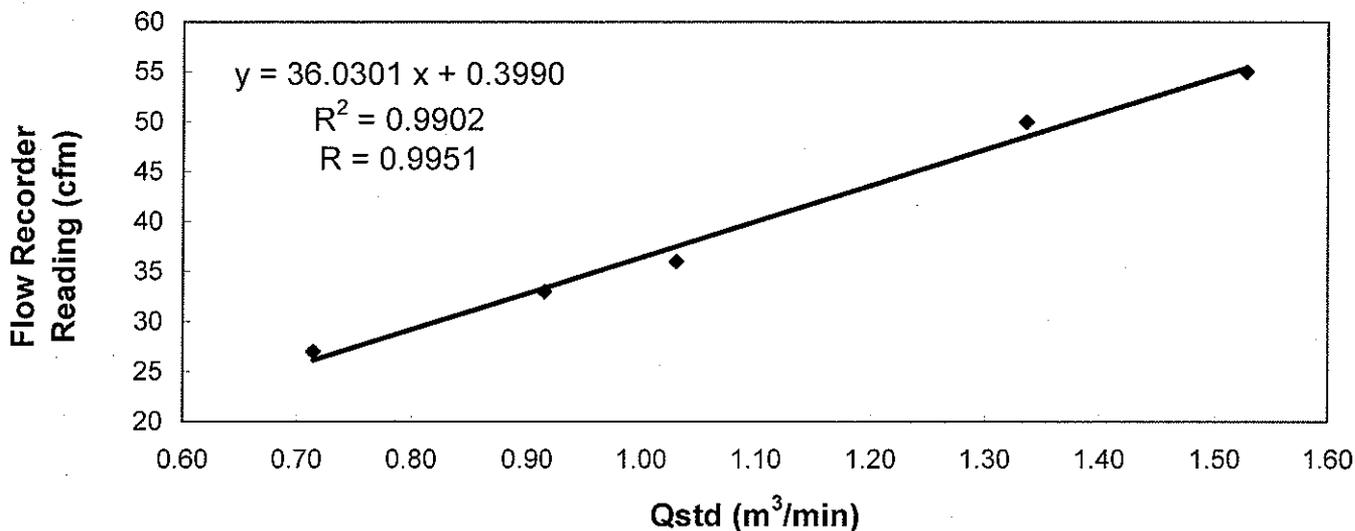
**Sampler 1174 Calibration Curve  
Site: Ocean Park (AM-1)**

Flow recorder reading (cfm)	55	50	36	33	27
Qstd (Actual flow rate, m <sup>3</sup> /min)	1.53	1.34	1.03	0.91	0.71
Pressure :	758.31 mm Hg		Temp. :	298 K

Acceptance Criteria : Correlation coefficient (r) of the calibration curve greater than 0.990 after a 5-point calibration.

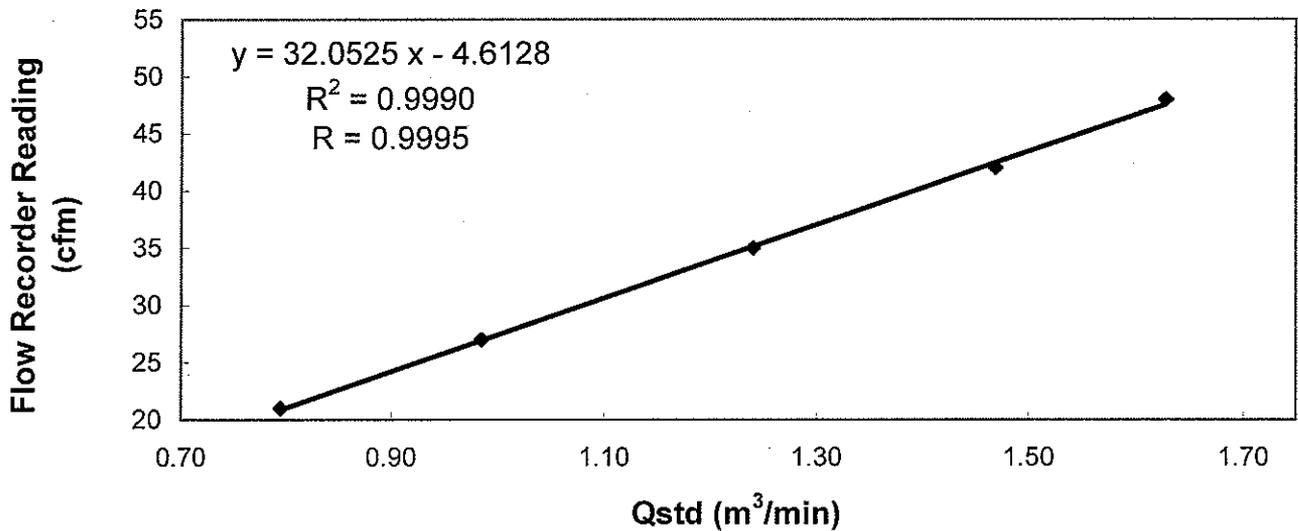
**Sampler 1177 Calibration Curve**  
**Site: Ocean Park (AM-2)**

Flow recorder reading (cfm)	48	42	35	27	21
Qstd (Actual flow rate, m <sup>3</sup> /min)	1.63	1.47	1.24	0.98	0.80
Pressure : 759.06 mm Hg	Temp. : 288		K

Acceptance Criteria : Correlation coefficient (r) of the calibration curve greater than 0.990 after a 5-point calibration.

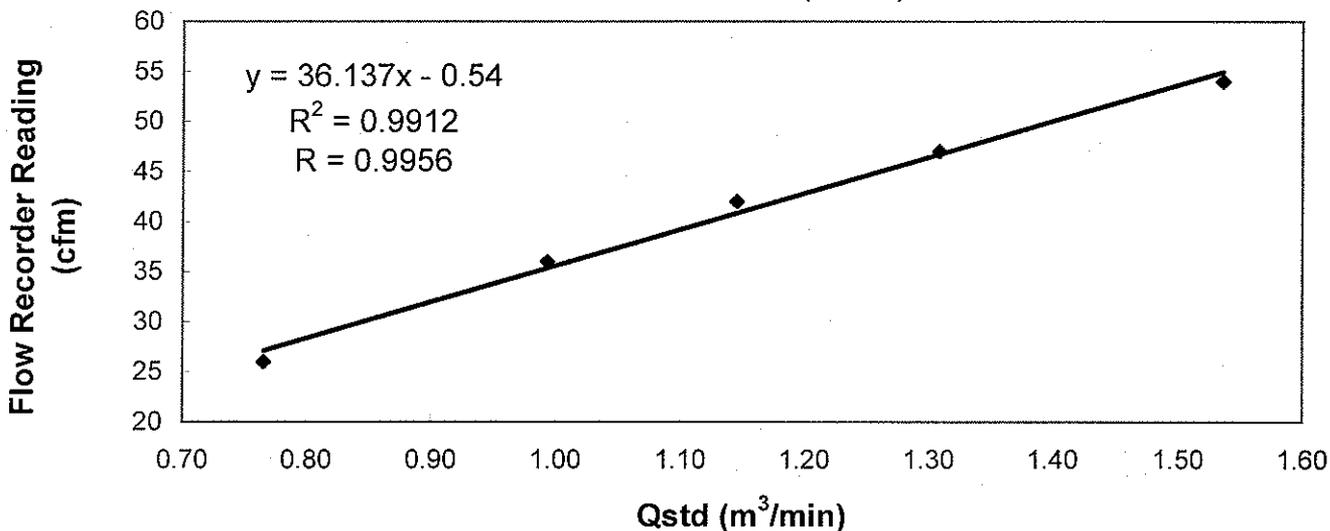
**Sampler 1177 Calibration Curve**  
**Site: Ocean Park (AM-2)**

Flow recorder reading (cfm)	54	47	42	36	26
Qstd (Actual flow rate, m <sup>3</sup> /min)	1.54	1.31	1.15	0.99	0.77
Pressure :	758.31 mm Hg			Temp. :	298 K

Acceptance Criteria : Correlation coefficient (r) of the calibration curve greater than 0.990 after a 5-point calibration.

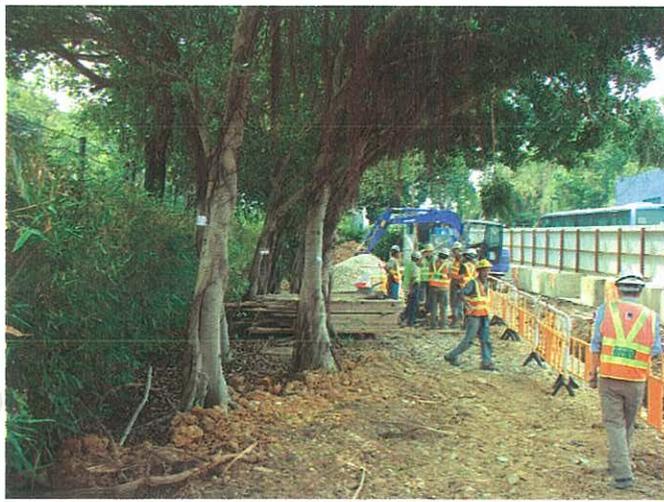
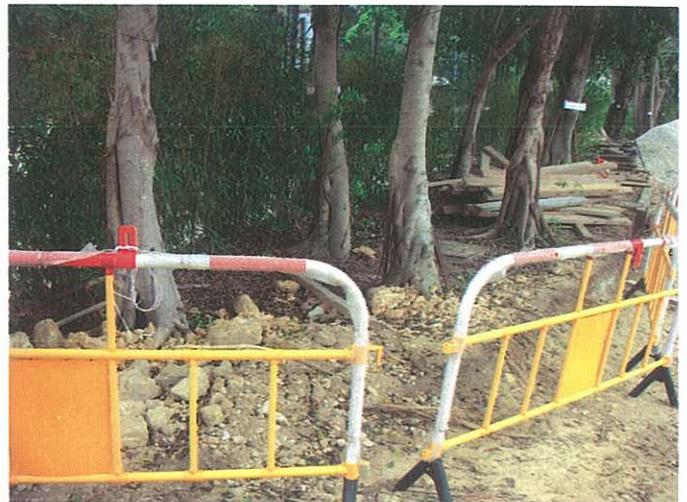
**Inspection / Follow up Report No 066.**

1. No fencing was provided around the trees to be retained at Area B.

1. The contractor was reminded to provide fencing to protect the retained trees.

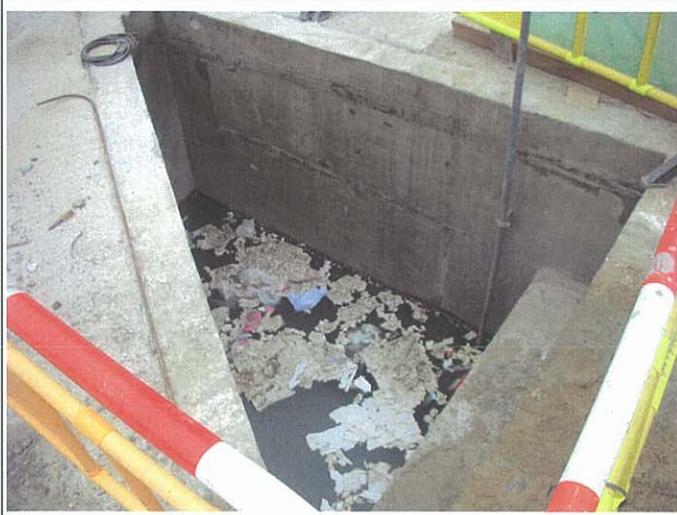
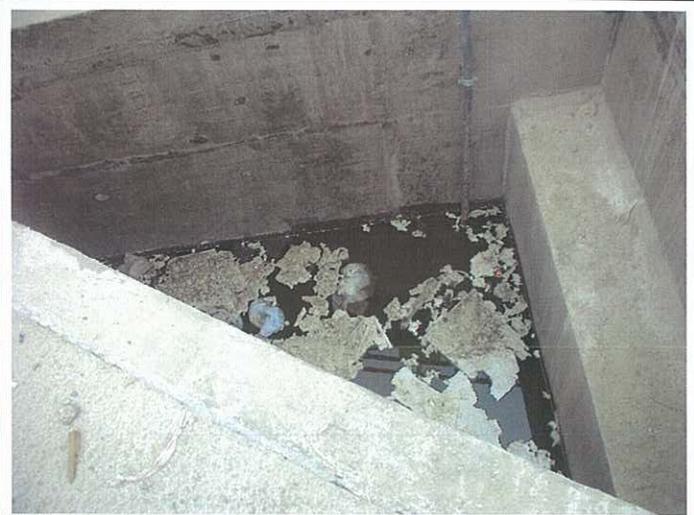
**Inspection / Follow up Report No 067.**

1. Stagnant water has been observed at the podium deck of Entry Plaza.

1. The contractor was reminded to remove the stagnant water or to spray larvicide preventing mosquito breeding.

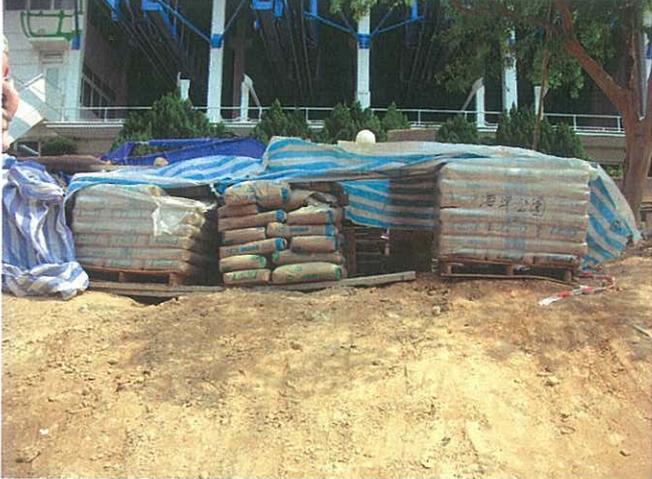
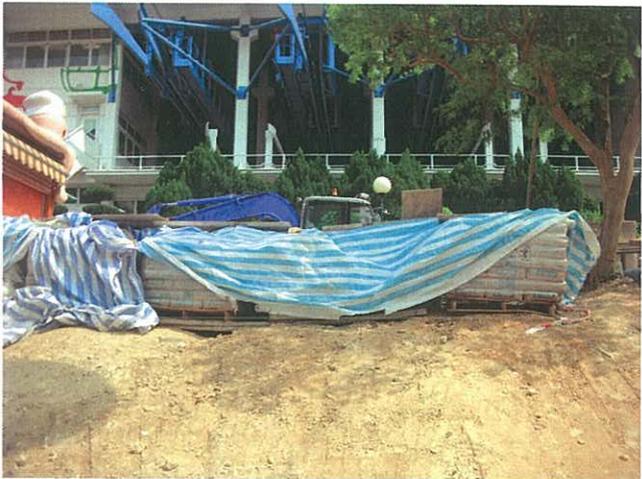
**Inspection / Follow up Report No 068.**

<p>1. Cement bag was open but was not fully covered with impervious sheeting at Carousel Plaza just below the cable track.</p>	<p>1. The contractor was reminded to fully cover the cement with tarpaulin.</p>

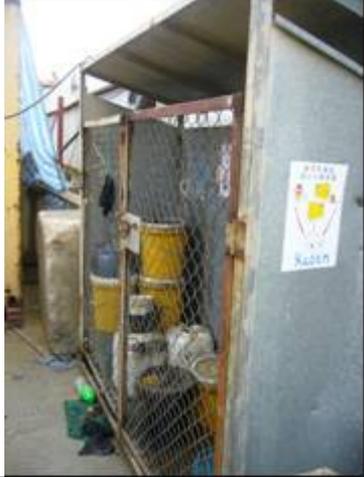
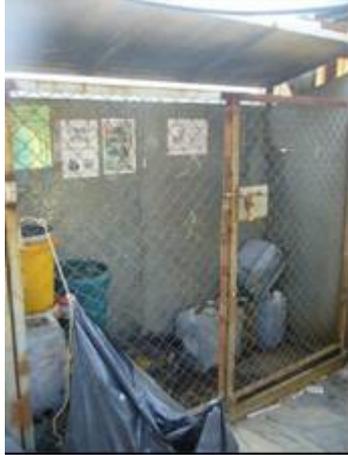
<p>P1080540: Chemical waste storage area was accumulated with water due to rainy weather. The Contractor should ensure the chemical waste storage area is maintained properly.</p>		<p>Closed - P1080809: Water accumulated in the chemical waste storage area was removed.</p>

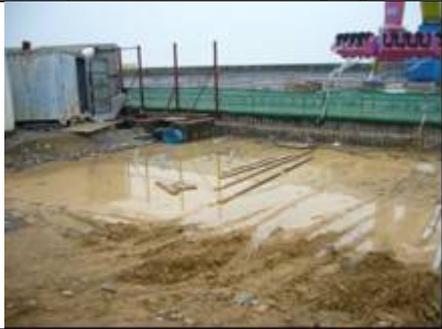
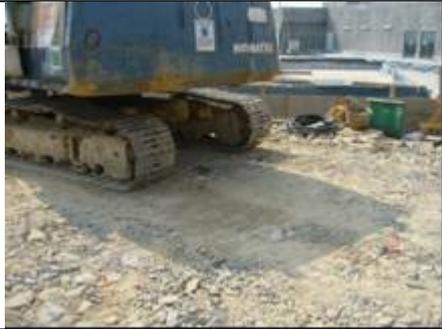
<p>P1080534: Stagnant water was accumulated on-site. The Contractor should remove them as soon as possible.</p>		<p>Closed - P1080807: Stagnant water accumulated on-site was removed.</p>	
<b>Observations in March 2010</b>
