MTR Corporation Limited

West Island Line Project

Environmental Monitoring and Audit Report No.63

(November 2014)

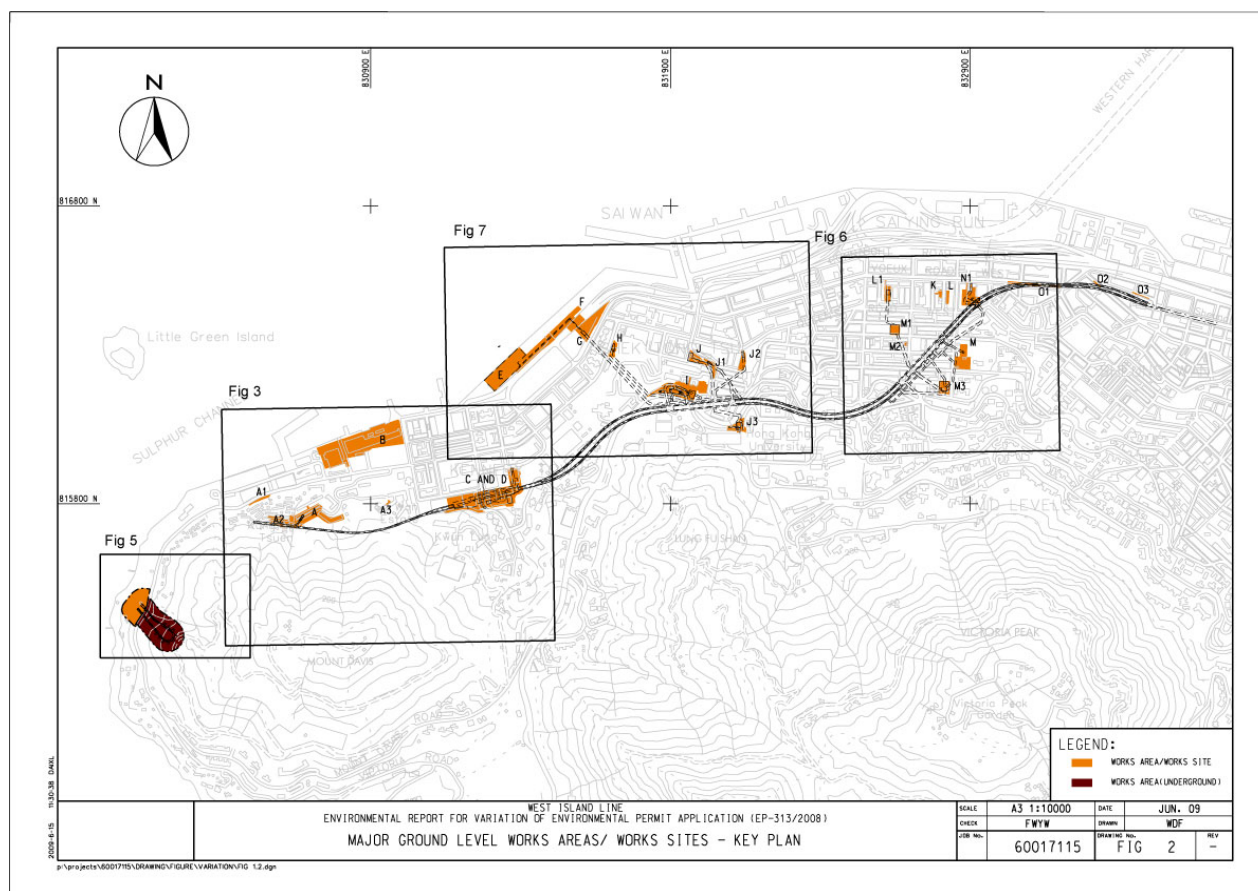
The WIL Project works areas and the locations of environmental monitoring stations are shown in Figures 2 and 3 to 7 respectively. Table 2 shows the details of the active monitoring stations as reported in Sections 3.1 and 3.2 below.
