MTR Corporation Limited

West Island Line Project

Environmental Monitoring and Audit Report No.66

(February 2015)

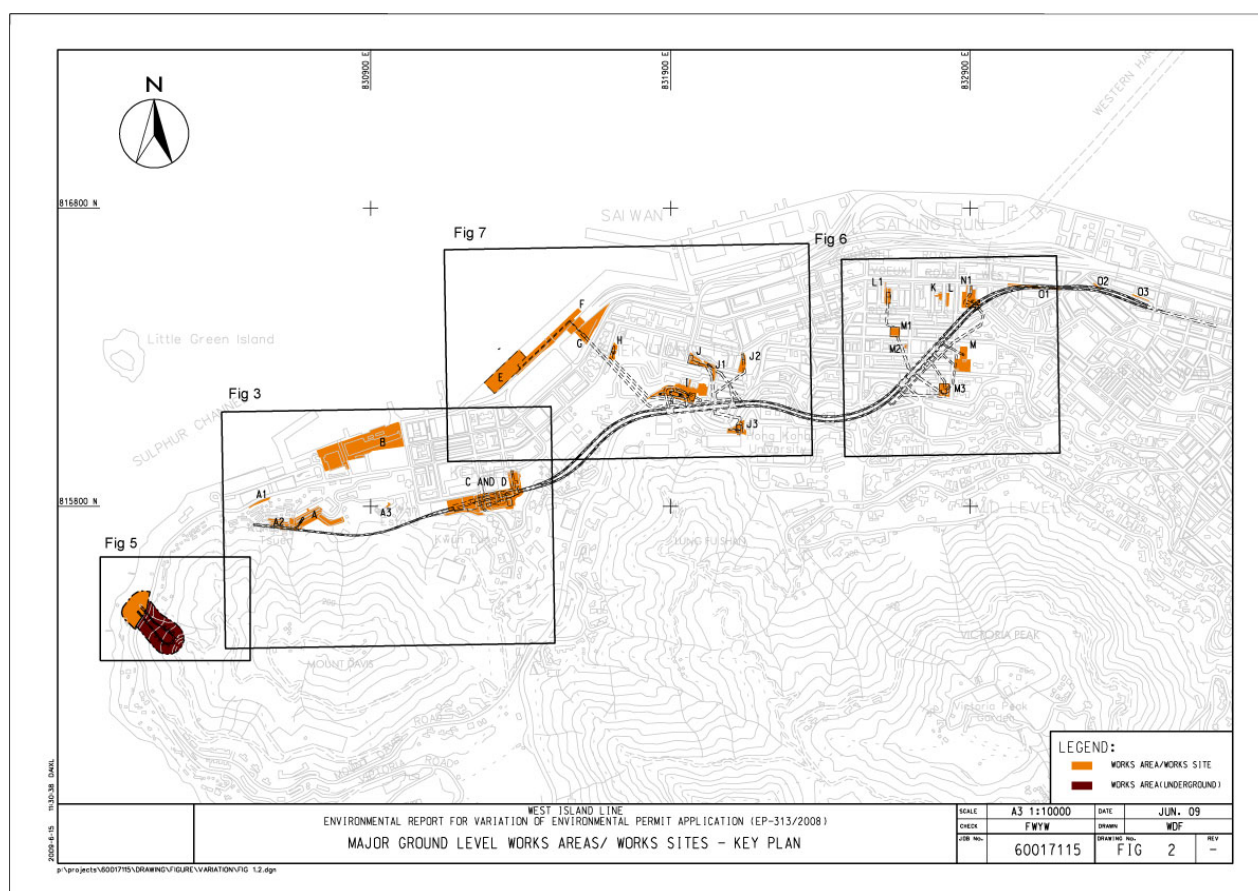
The WIL Project works areas and the locations of environmental monitoring stations are shown in Figures 2 and 3 to 7 respectively. Table 2 shows the details of the active monitoring stations as reported in Sections 3.1 and 3.2 below.

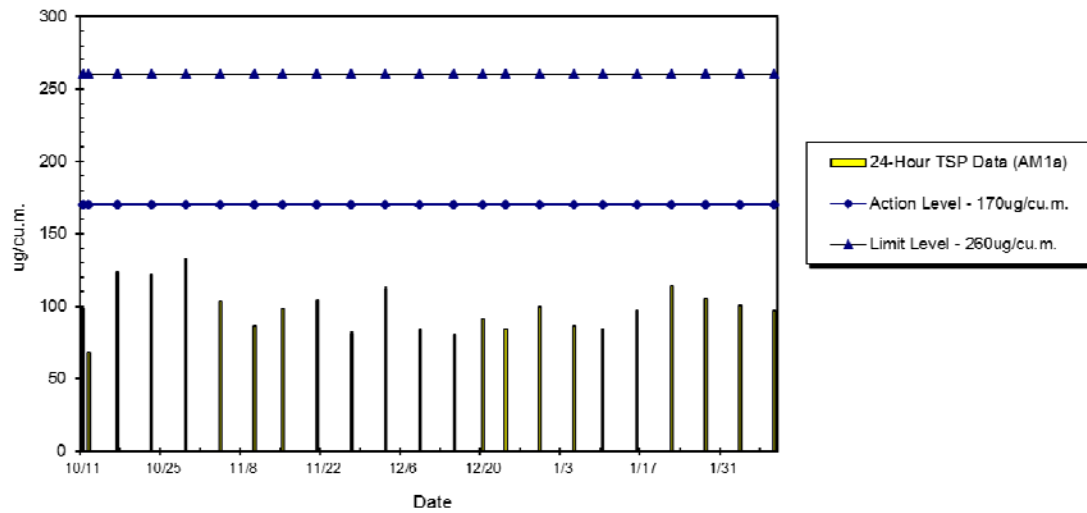
**WIL-AM1a 24hr TSP Level at Kwun Lung Lau Block 1 (Oct 2014 - Feb 2015)**

To examine the construction dust levels, 24-hour TSP monitoring was undertaken according to the EM&A Manual. The dust monitoring locations are shown in the Section 2.2 above. Monitoring results are presented in the following table (see Appendix D for graphical plot). The 24-hour TSP levels when there were construction activities during the monitoring period were within the Action Level. No exceedance was found. This indicates that the construction activities did not have a noticeable adverse effect on the general air quality for the works areas.

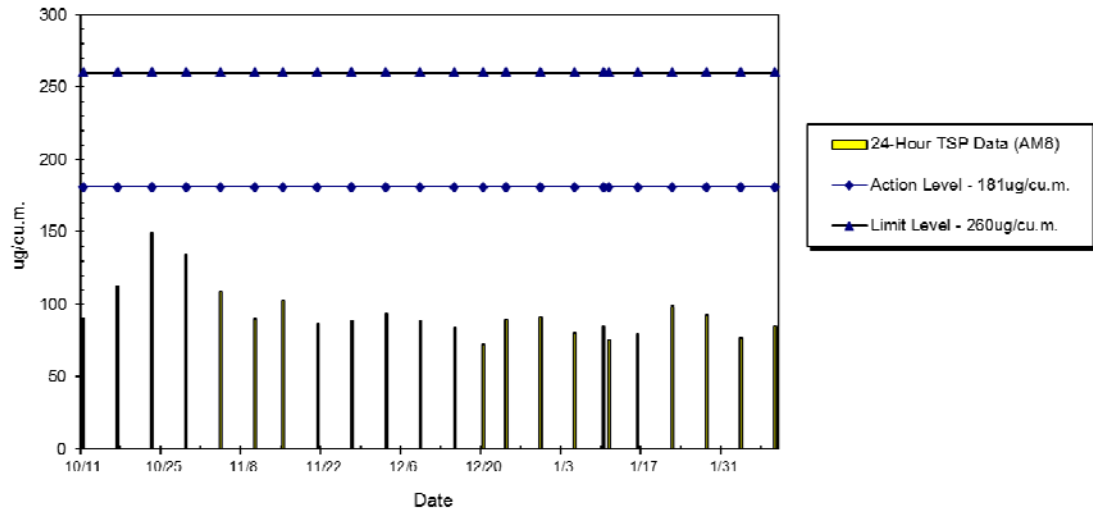
**WIL-AM8 24hr TSP Level at Bon-Point (Oct 2014 - Feb 2015)**

In addition, air baseline checks for monitoring stations AM8 and AM10 were conducted on Sunday when no construction work was carried out in the vicinity. It is observed that there is no significant deviation of the air baseline level obtained from the previous air baseline check.

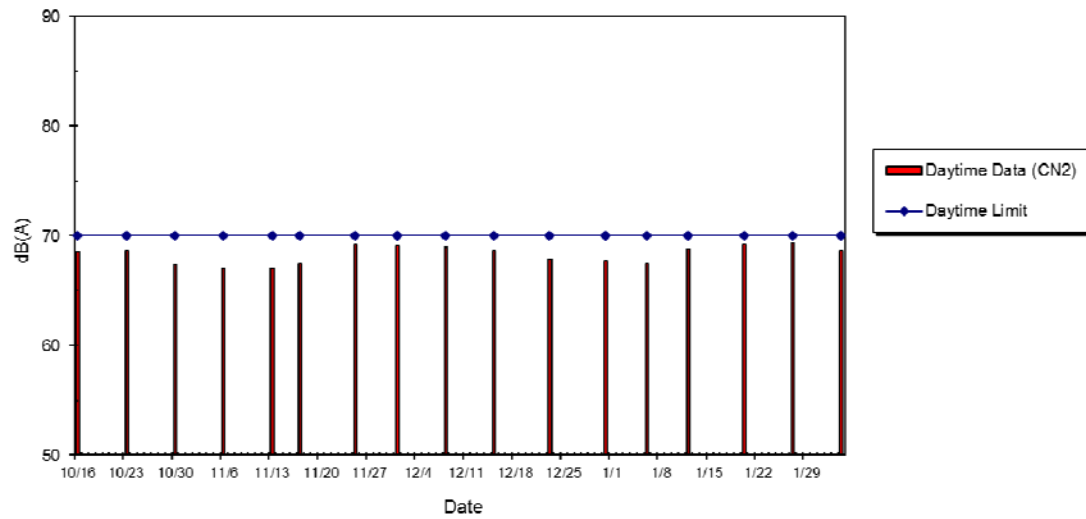
**WIL-CN2 Noise Level at HK IVE (Tsing Yi) Kennedy Town Centre, Oct 2014 - Feb 2015**

Monitoring results are presented in the following table (see Appendix D for graphical plot). No exceedance was found. Monitoring schedules are shown in Appendix F.

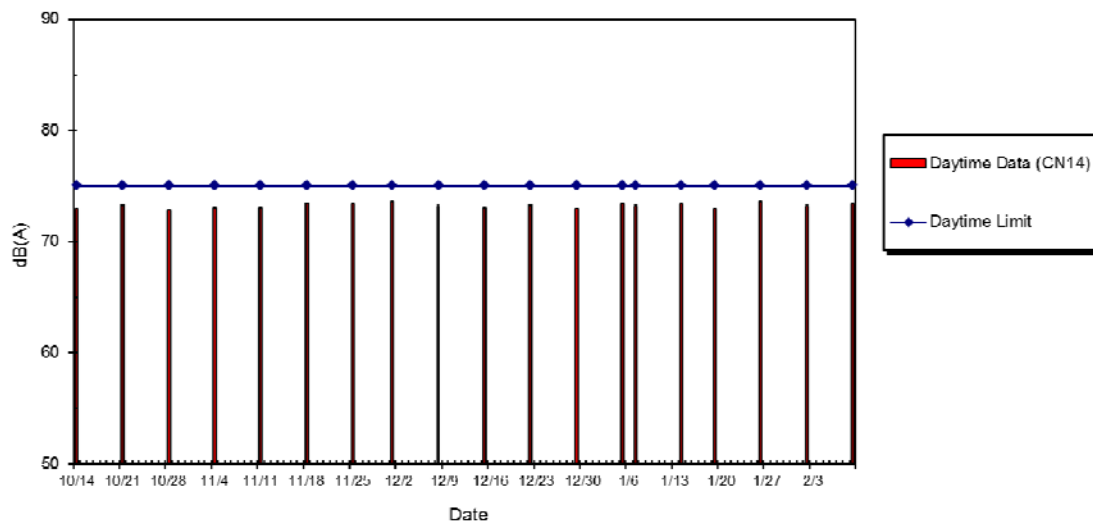
**WIL-CN14 Noise Level at Bon-Point, Oct 2014 - Feb 2015**

In addition, noise baseline checks for monitoring stations CN14, CN15 and CN16 were conducted during noon time when no construction work was carried out in the vicinity. It is observed that there is no significant deviation from the noise baseline level obtained from the previous noise baseline check.
