**PROVISION OF CREMATORS AT  
WO HOP SHEK CREMATORIUM**

**ENVIRONMENTAL MONITORING &  
AUDIT REPORT (NOVEMBER 2009)**

**ALLIED ENVIRONMENTAL CONSULTANTS LTD.**

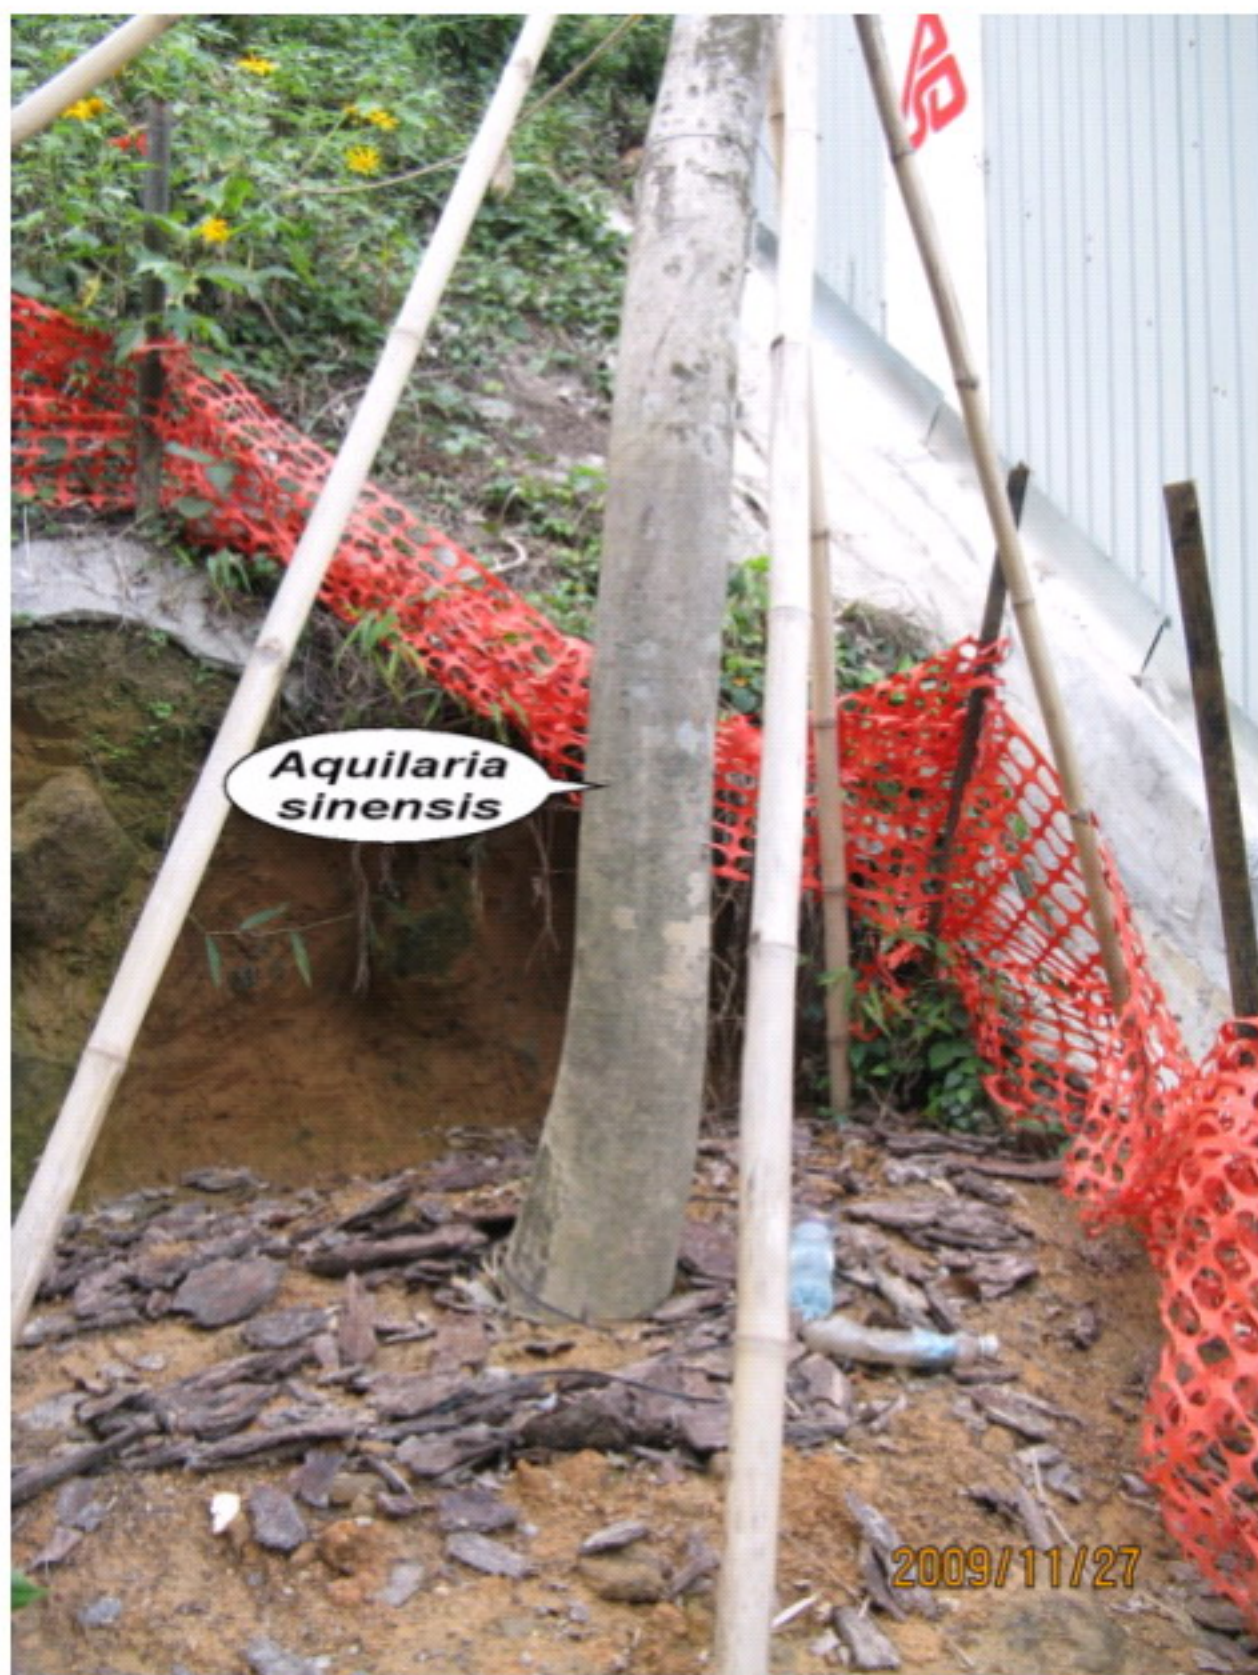
*Aquilaria sinensis*

| Species | Height<br>(m) | Diameter<br>(m) | Spread<br>(m) | Remark | | |
|---|---|---|---|---|---|---|
| <i>Aquilaria sinensis</i> | 8 | 0.2 | 4 | Fair condition | Fair condition | Fair condition |

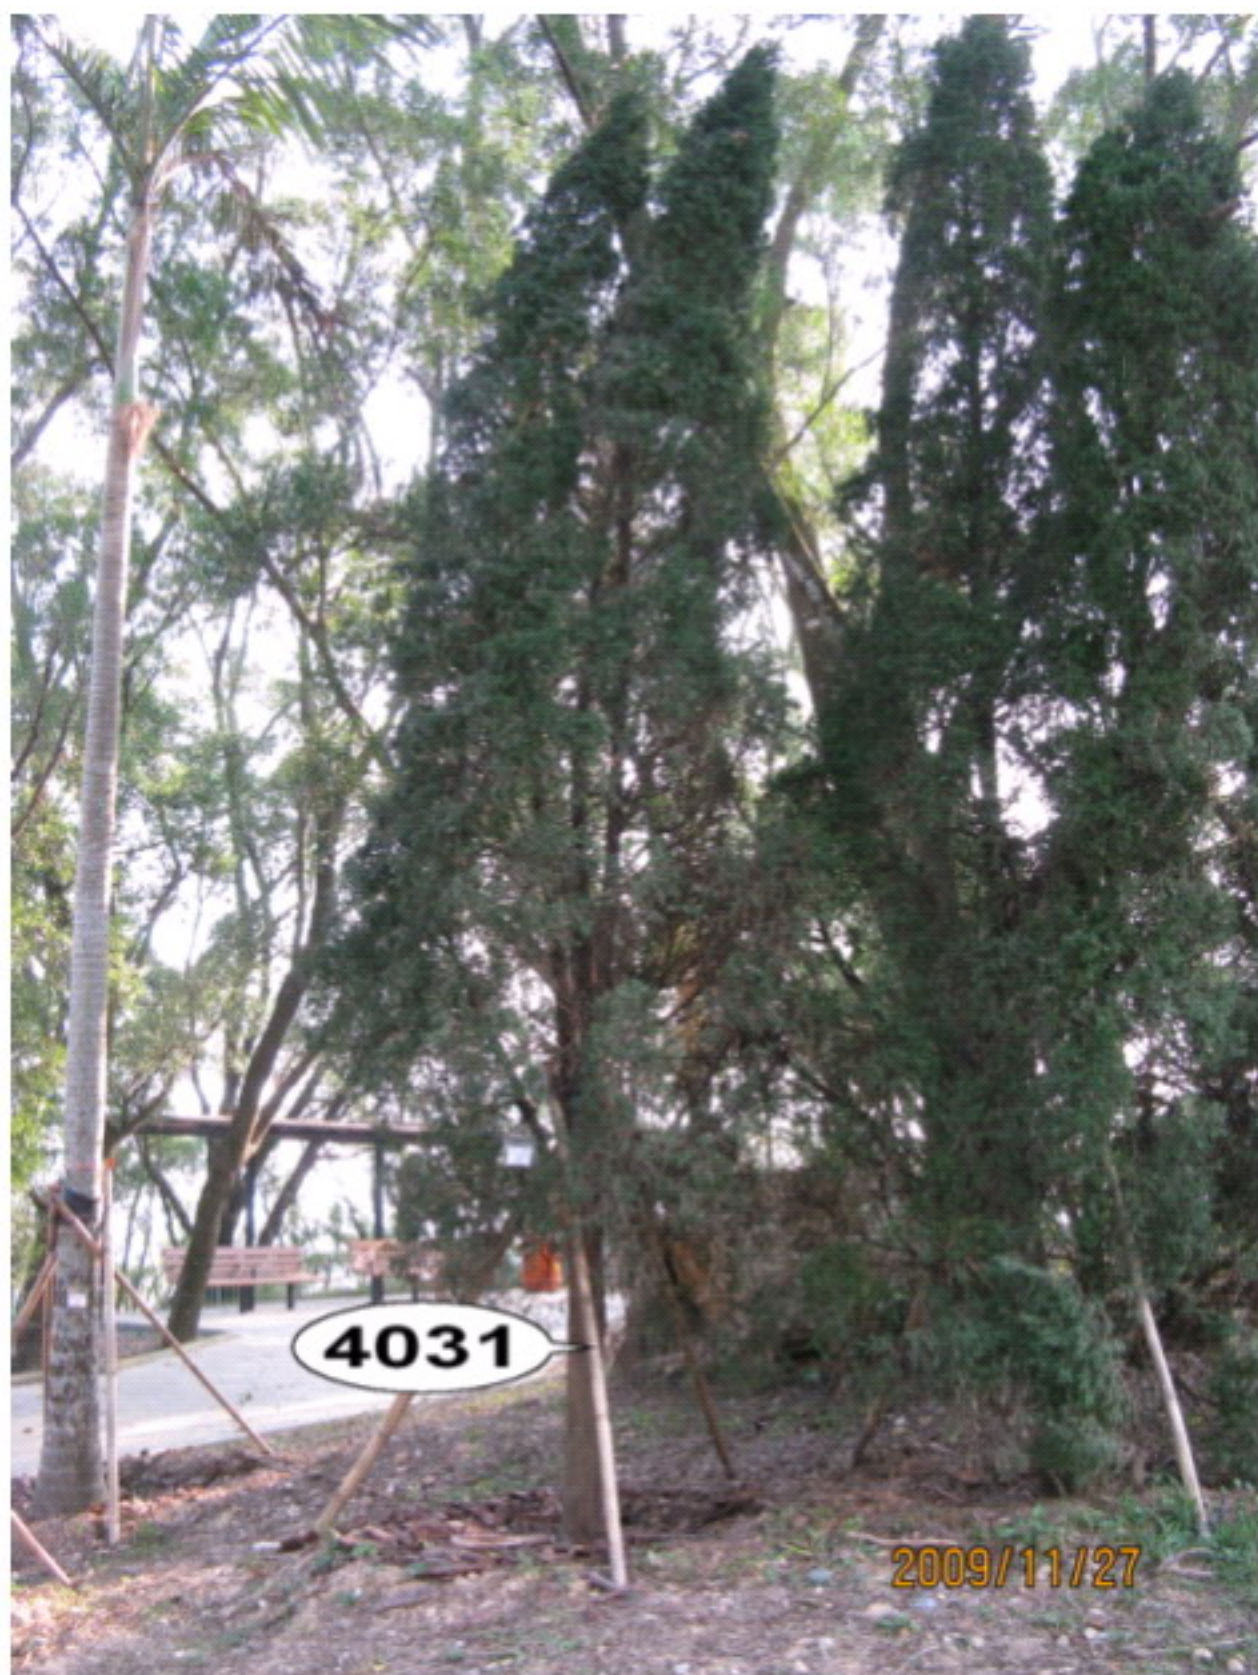
Tree No: 4031

| Tree Number | Species | Chinese name | Height (m) | Diameter (m) | Spread (m) | Remark | | |
|---|---|---|---|---|---|---|---|---|
| 4031 | <i>Juniperus chinensis var.kaizuca</i> | 龍柏 | 5 | 0.12 | 2 | Fair condition | Fair condition | Fair condition |

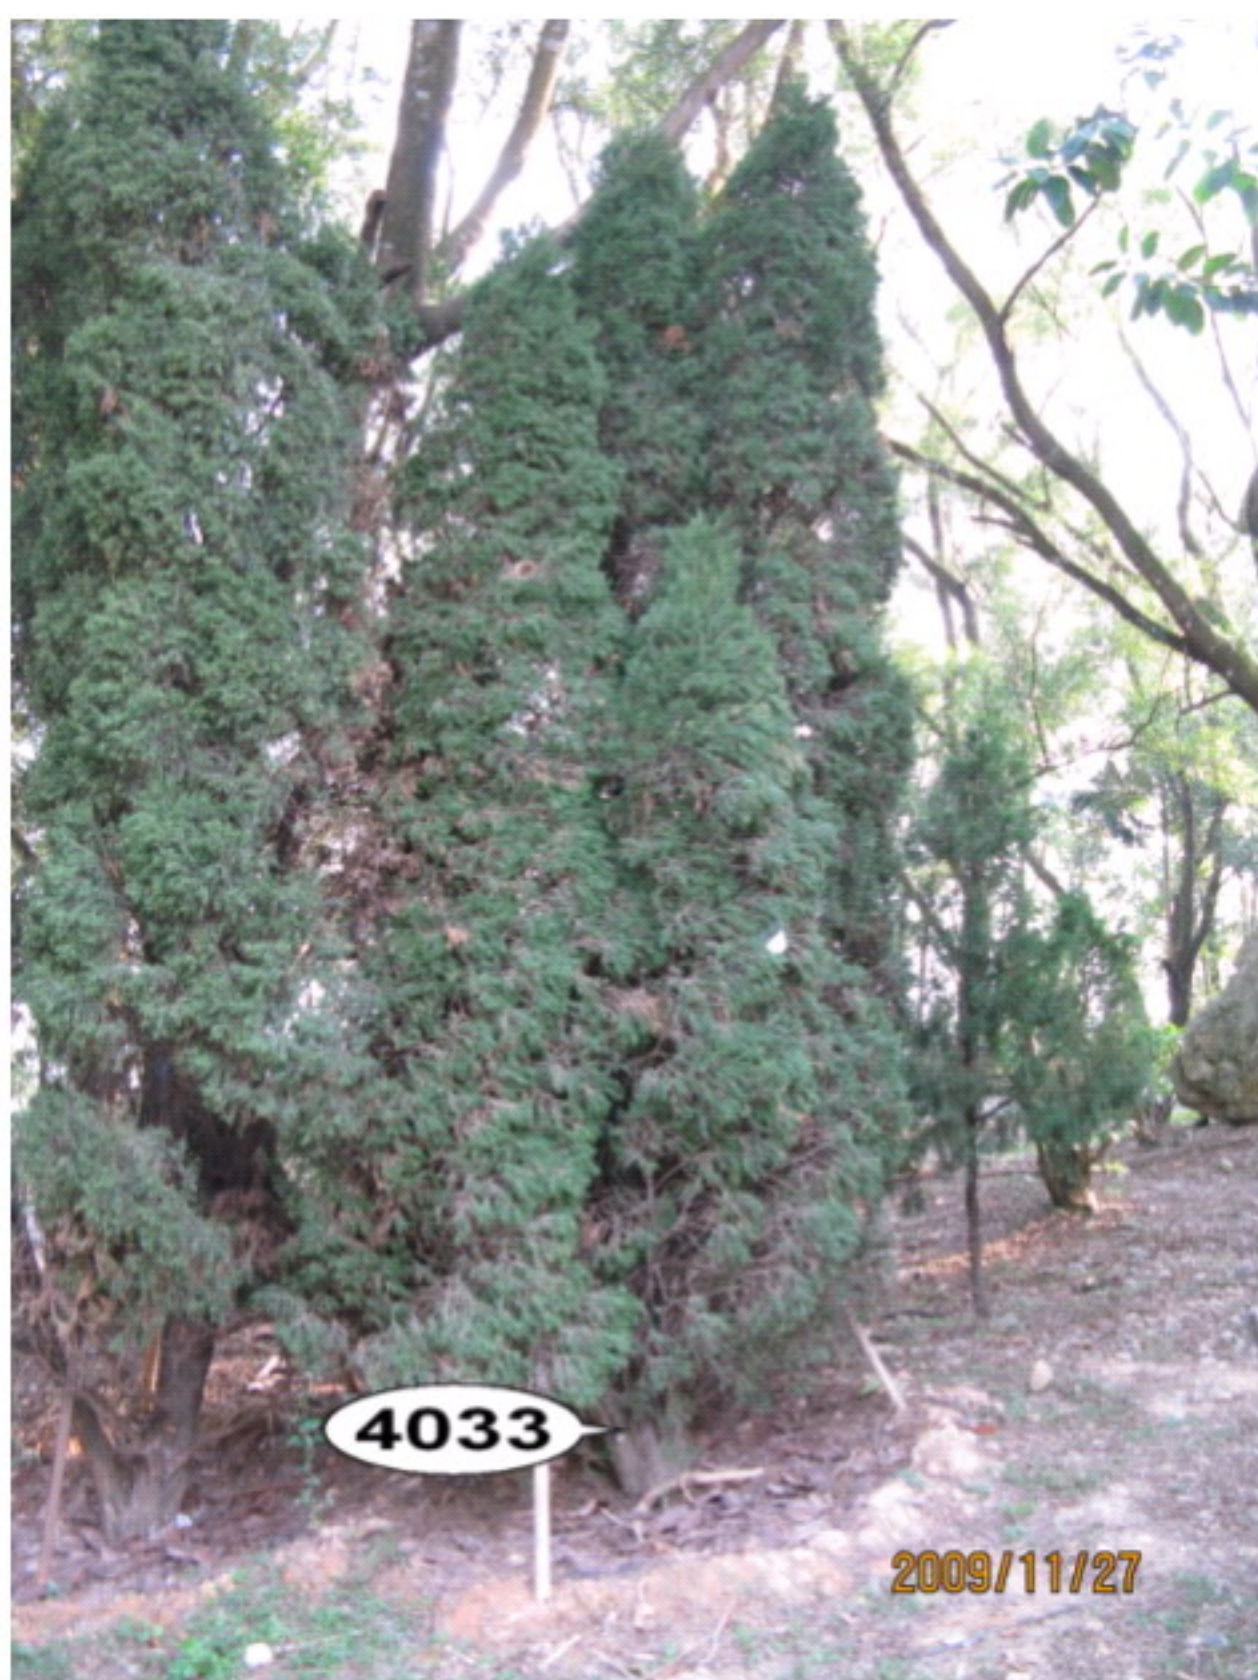
Tree No: 4033

| Tree Number | Species | Chinese name | Height (m) | Diameter (m) | Spread (m) | Remark | | |
|---|---|---|---|---|---|---|---|---|
| 4033 | <i>Juniperus chinensis var.kaizuca</i> | 龍柏 | 4 | 0.13 | 2 | Fair condition | Fair condition | Fair condition |

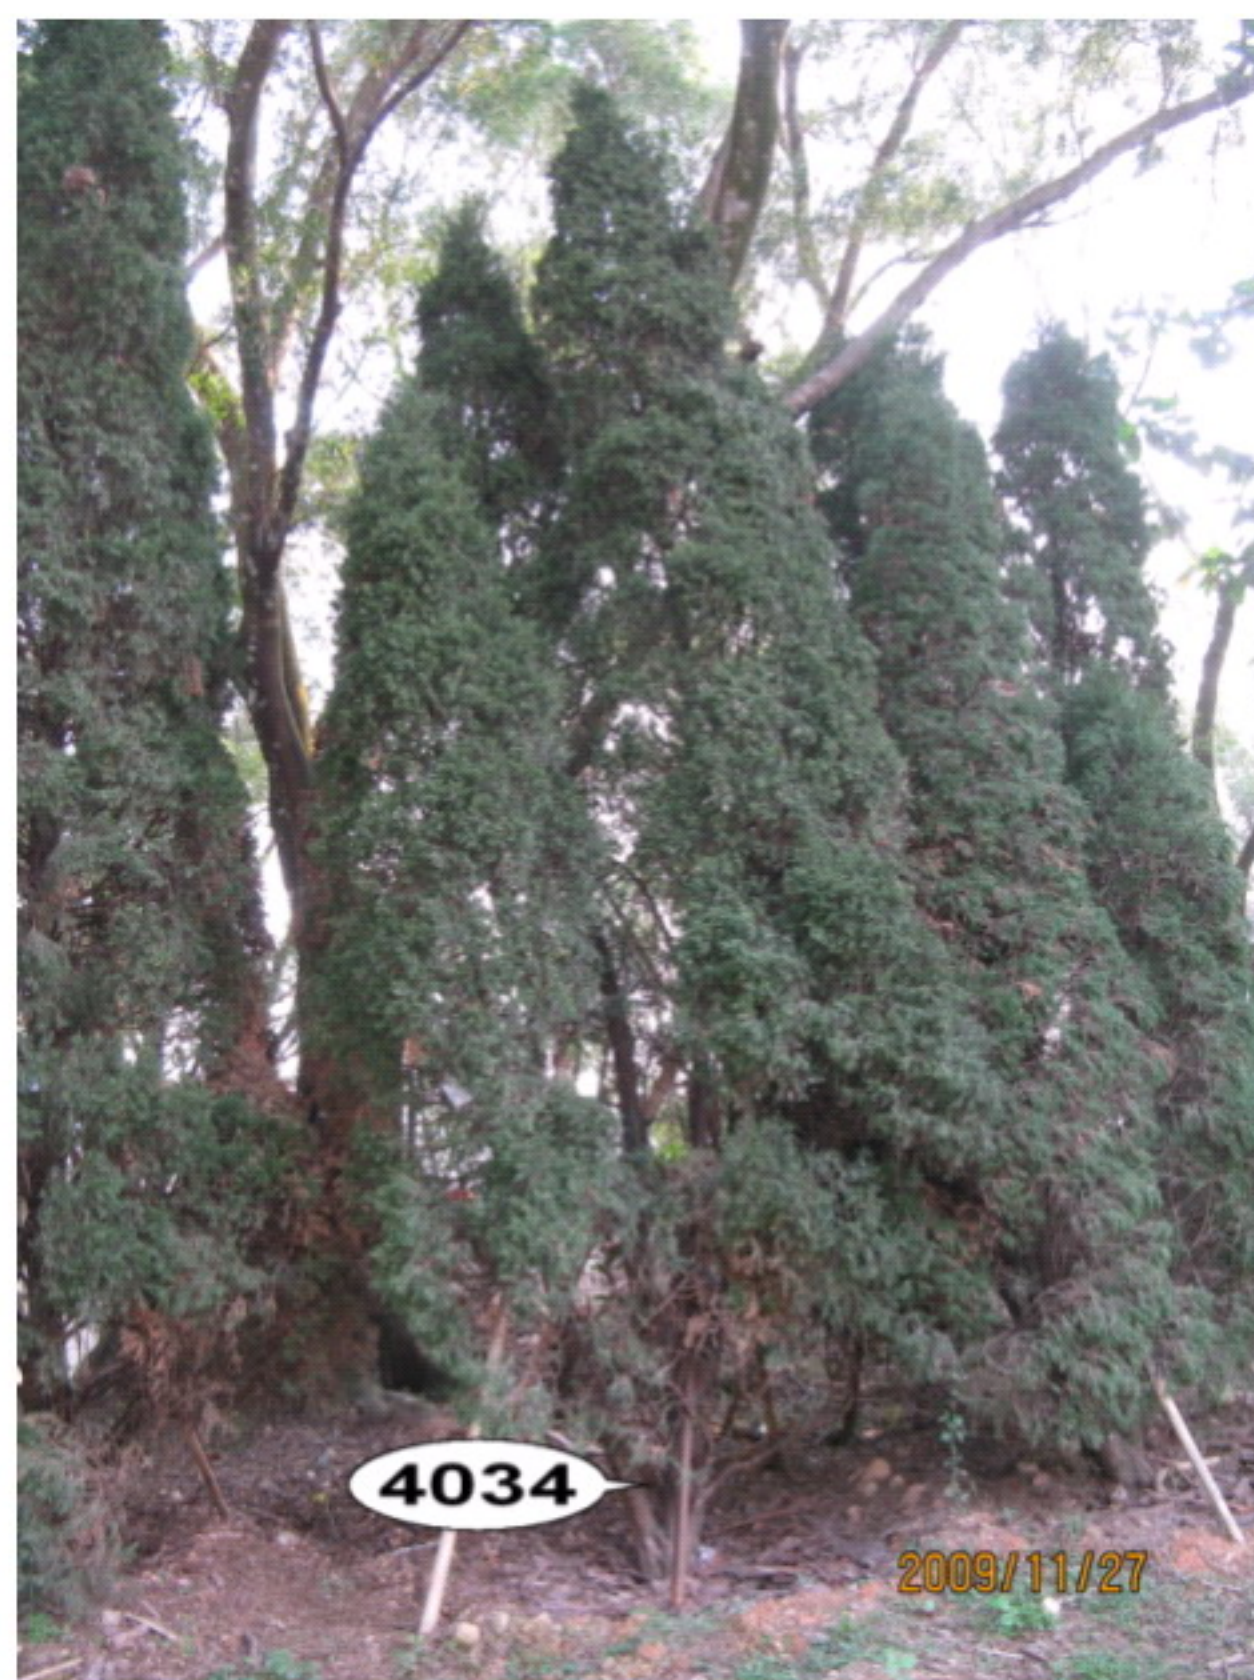
Tree No: 4034

| Tree Number | Species | Chinese name | Height (m) | Diameter (m) | Spread (m) | Remark | | |
|---|---|---|---|---|---|---|---|---|
| 4034 | <i>Juniperus chinensis var.kaizuca</i> | 龍柏 | 4 | 0.13 | 2 | Fair condition | Fair condition | Fair condition |

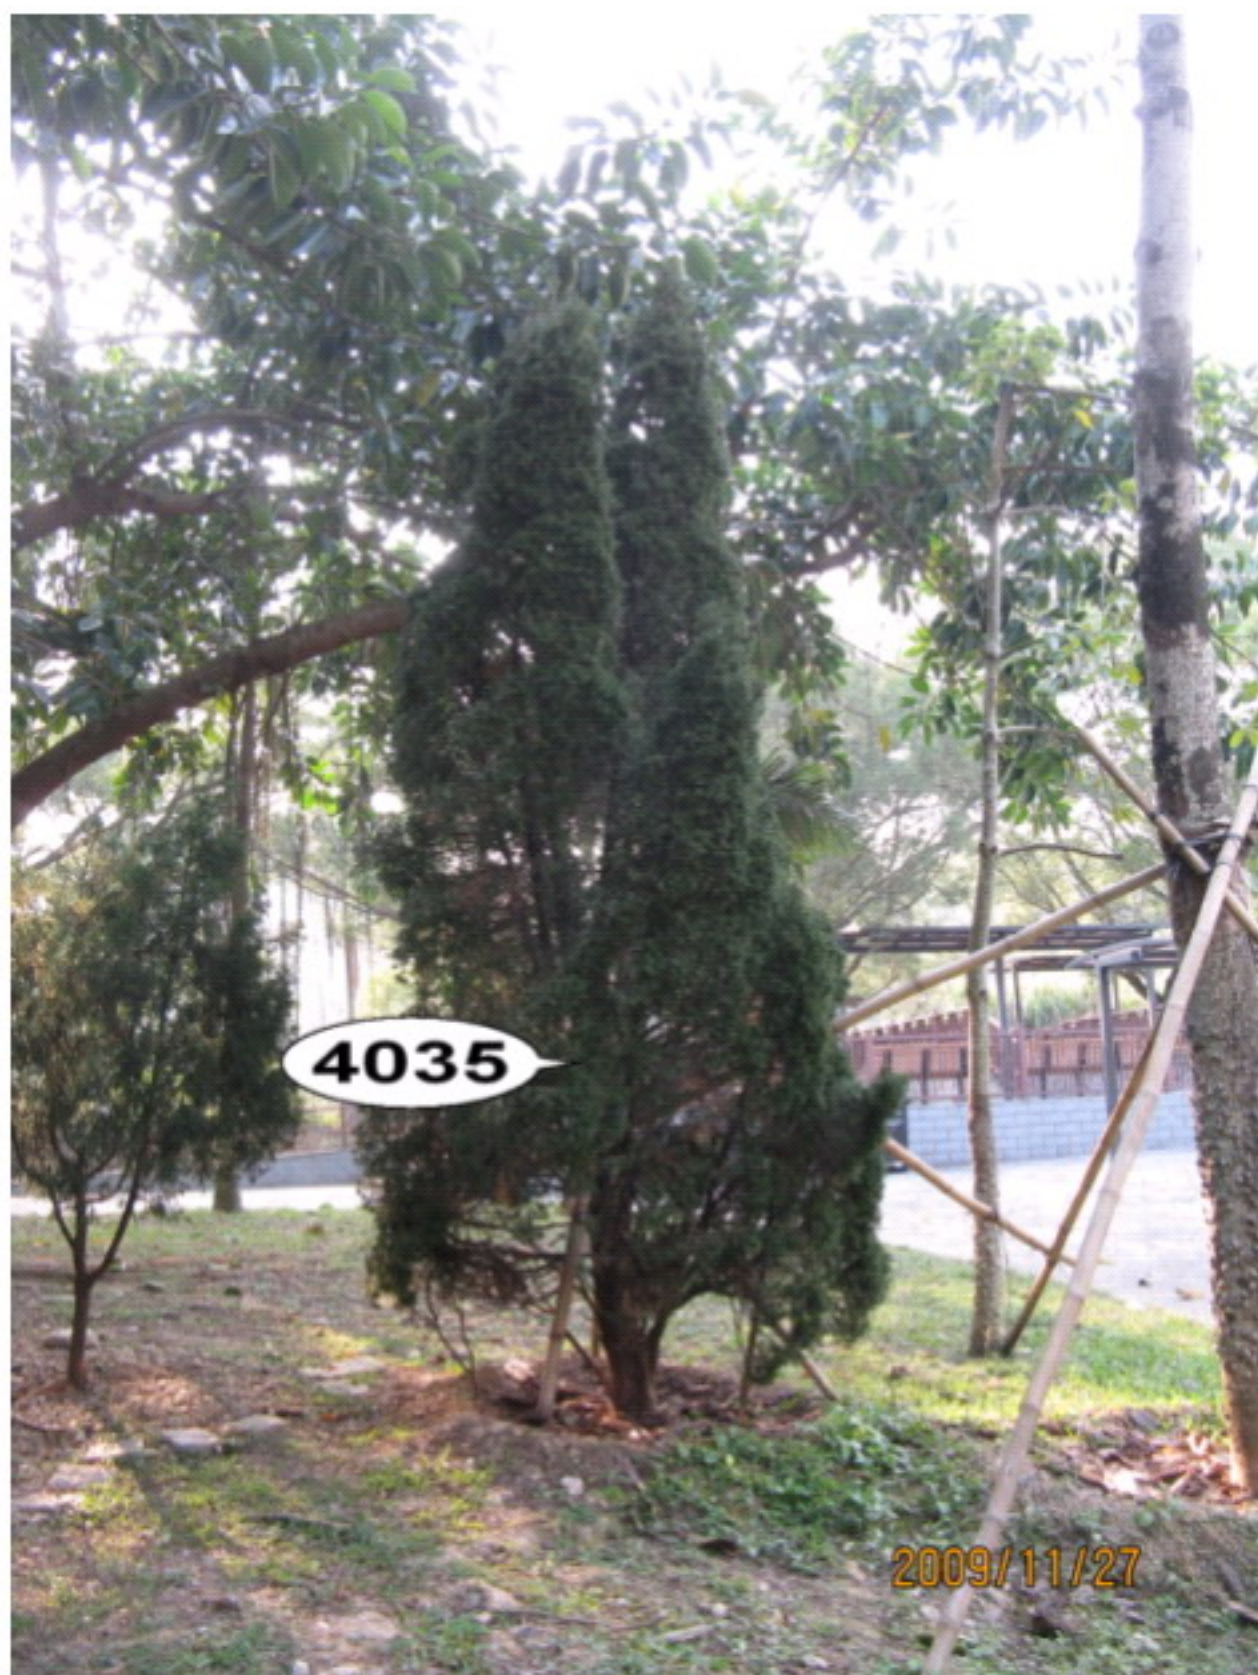
Tree No: 4035

| Tree Number | Species | Chinese name | Height (m) | Diameter (m) | Spread (m) | Remark | | |
|---|---|---|---|---|---|---|---|---|
| 4035 | <i>Juniperus chinensis var.kaizuca</i> | 龍柏 | 4 | 0.16 | 2 | Fair condition | Fair condition | Fair condition |

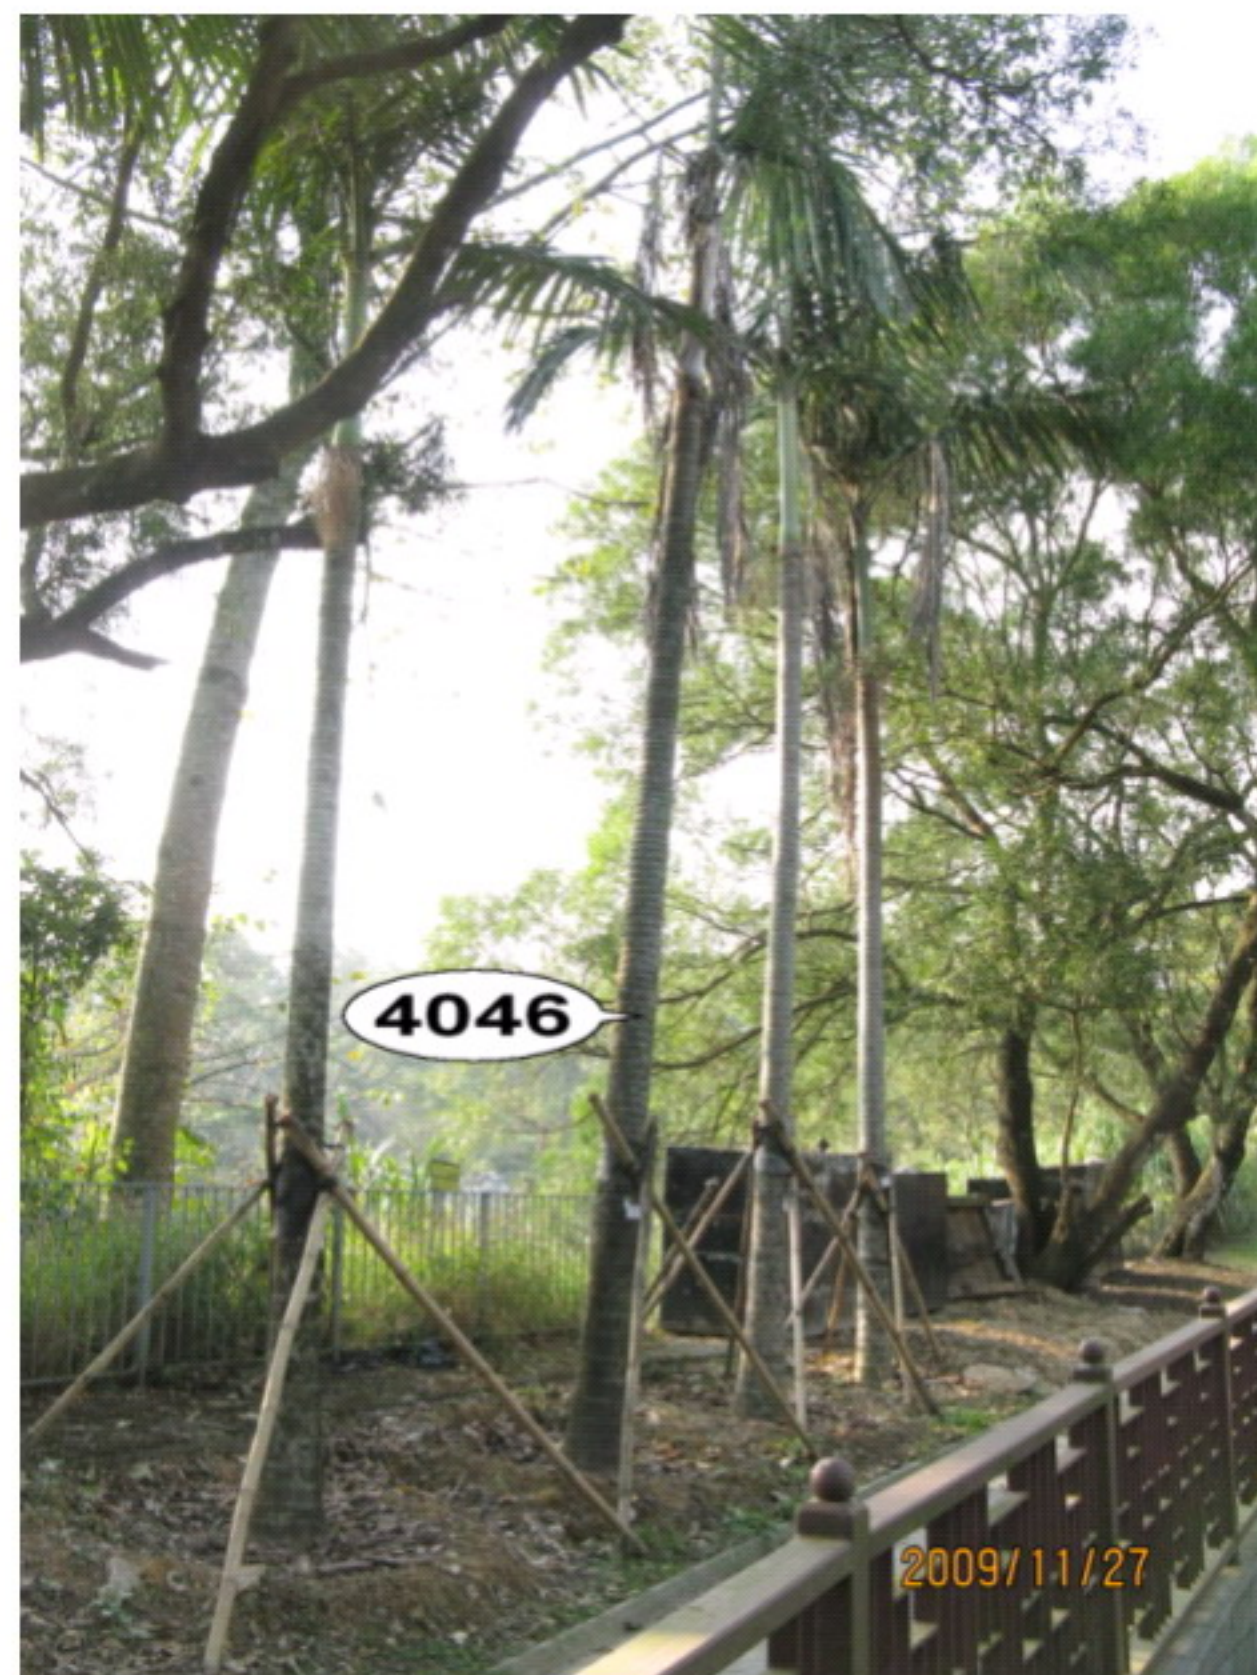
Tree No: 4046

| Tree Number | Species | Chinese name | Height (m) | Diameter (m) | Spread (m) | Remark | | |
|---|---|---|---|---|---|---|---|---|
| 4046 | <i>Archontophoenix alexandrae</i> | 假檳榔 | 5 | 0.19 | 4 | Fair condition, Yellow leave | Fair condition, Yellow leave | Fair condition, Yellow leave |

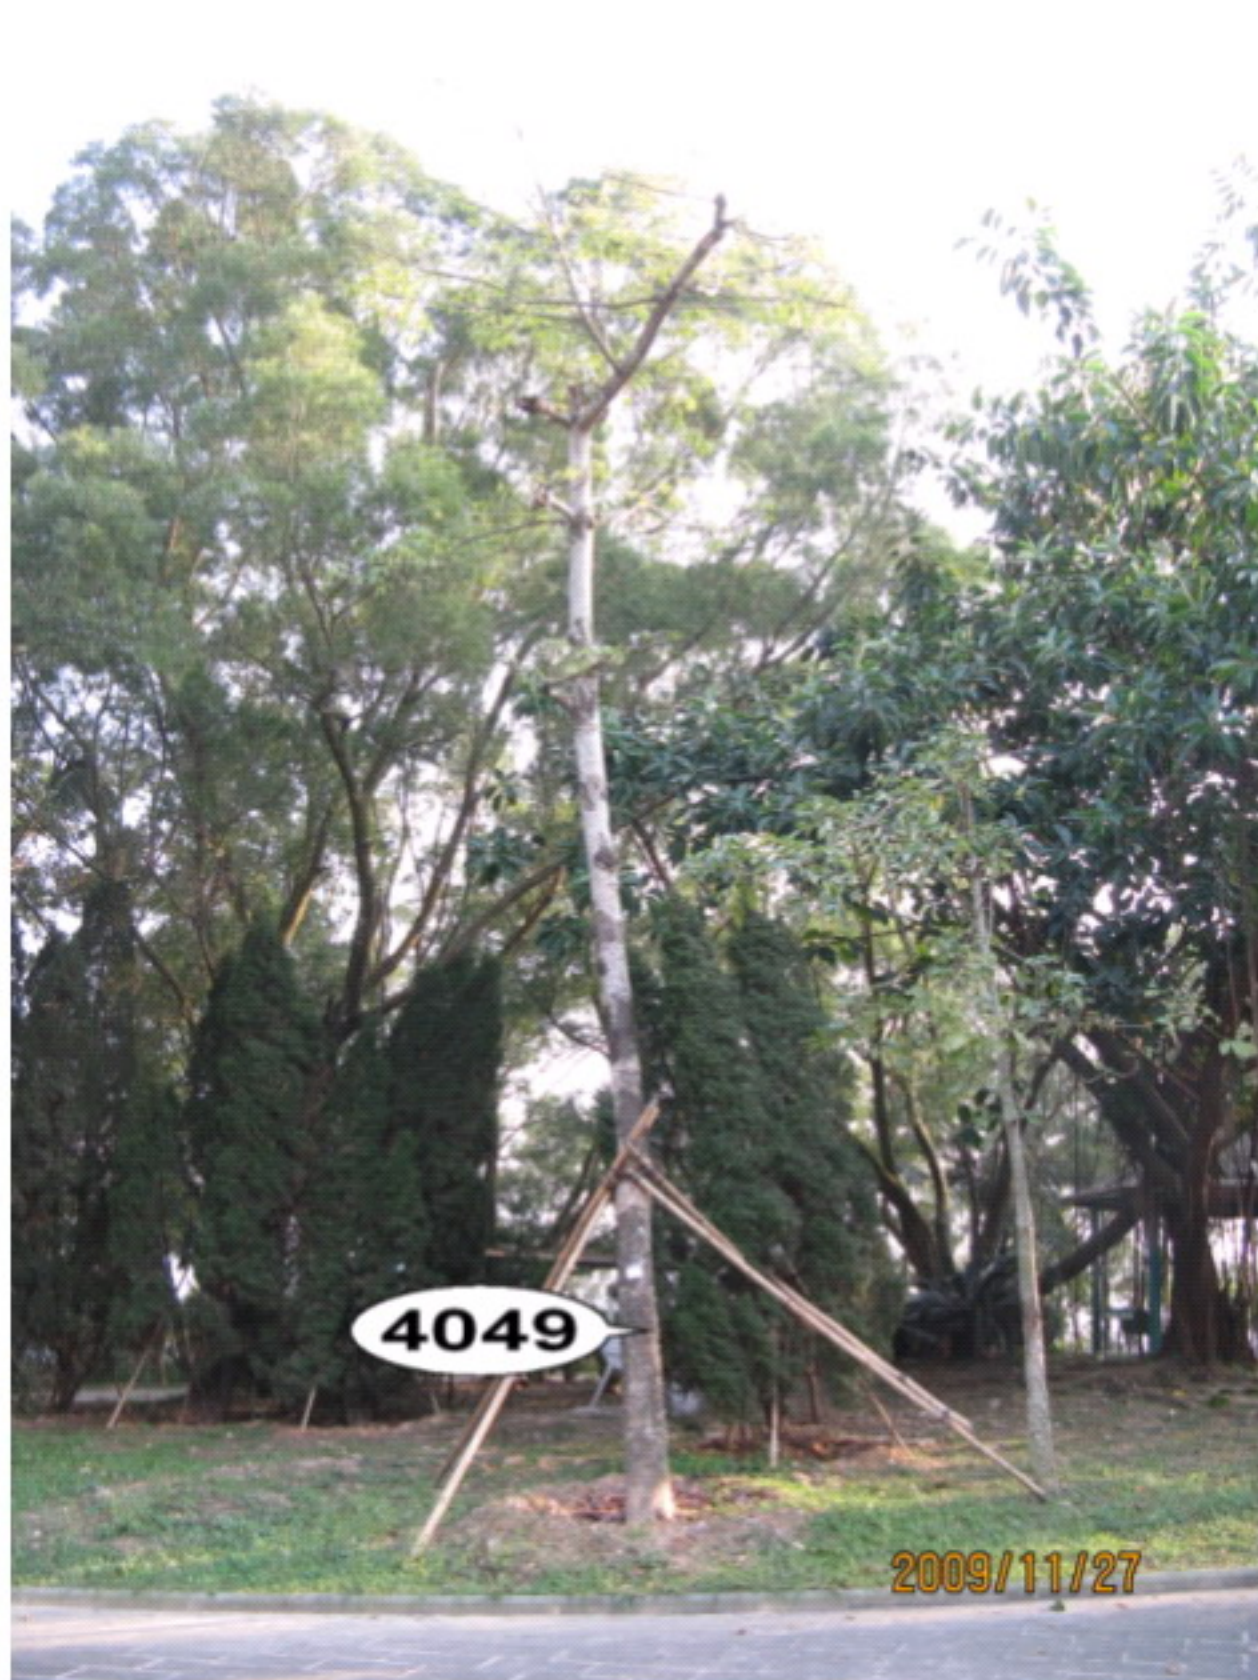
Tree No: 4049

| Tree Number | Species | Chinese name | Height (m) | Diameter (m) | Spread (m) | Remark | | |
|---|---|---|---|---|---|---|---|---|
| 4049 | <i>Ficus hispida</i> | 對葉榕 | 6 | 0.16 | 5 | Poor condition, Fork | Missing from monitoring site | Missing from monitoring site |

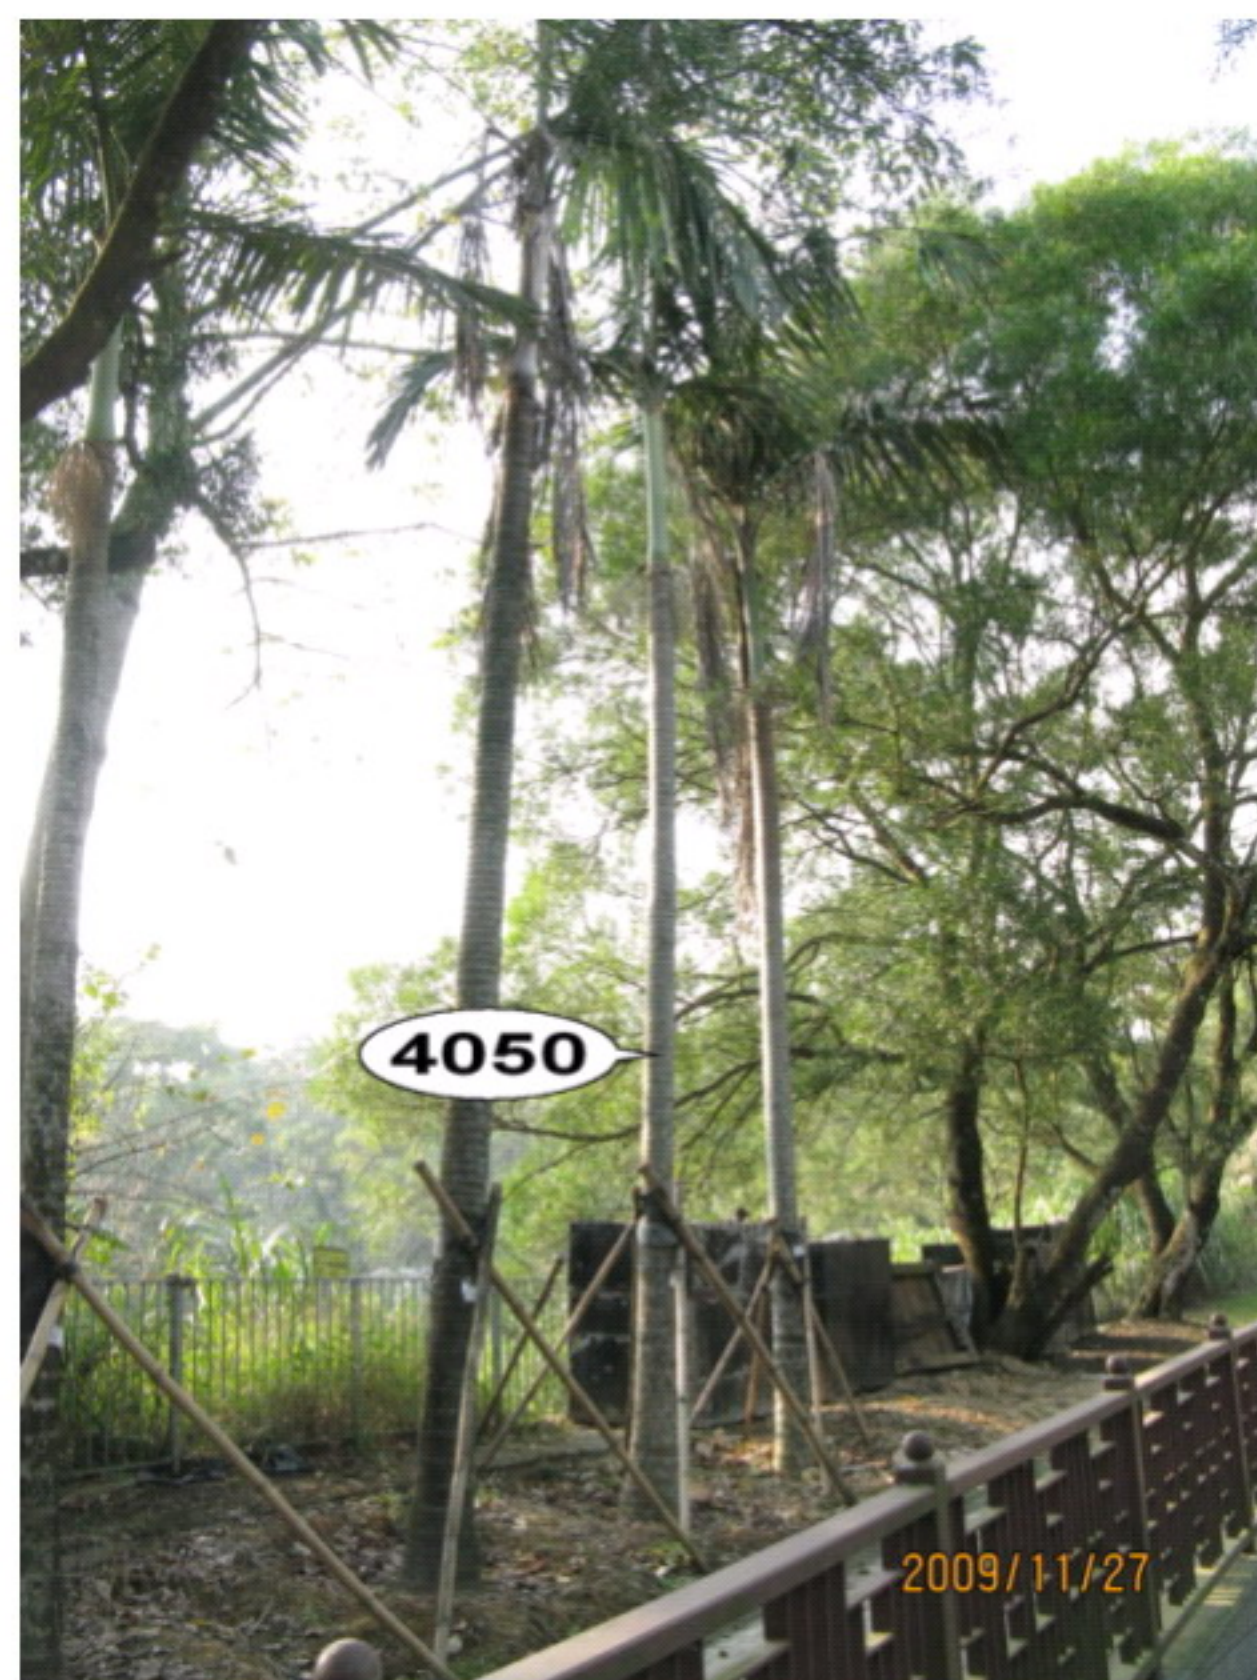
Tree No: 4050

| Tree Number | Species | Chinese name | Height (m) | Diameter (m) | Spread (m) | Remark | | |
|---|---|---|---|---|---|---|---|---|
| 4050 | <i>Archontophoenix alexandrae</i> | 假檳榔 | 5 | 0.16 | 4 | Fair condition, Yellow leave | Fair condition, Yellow leave | Fair condition, Yellow leave |

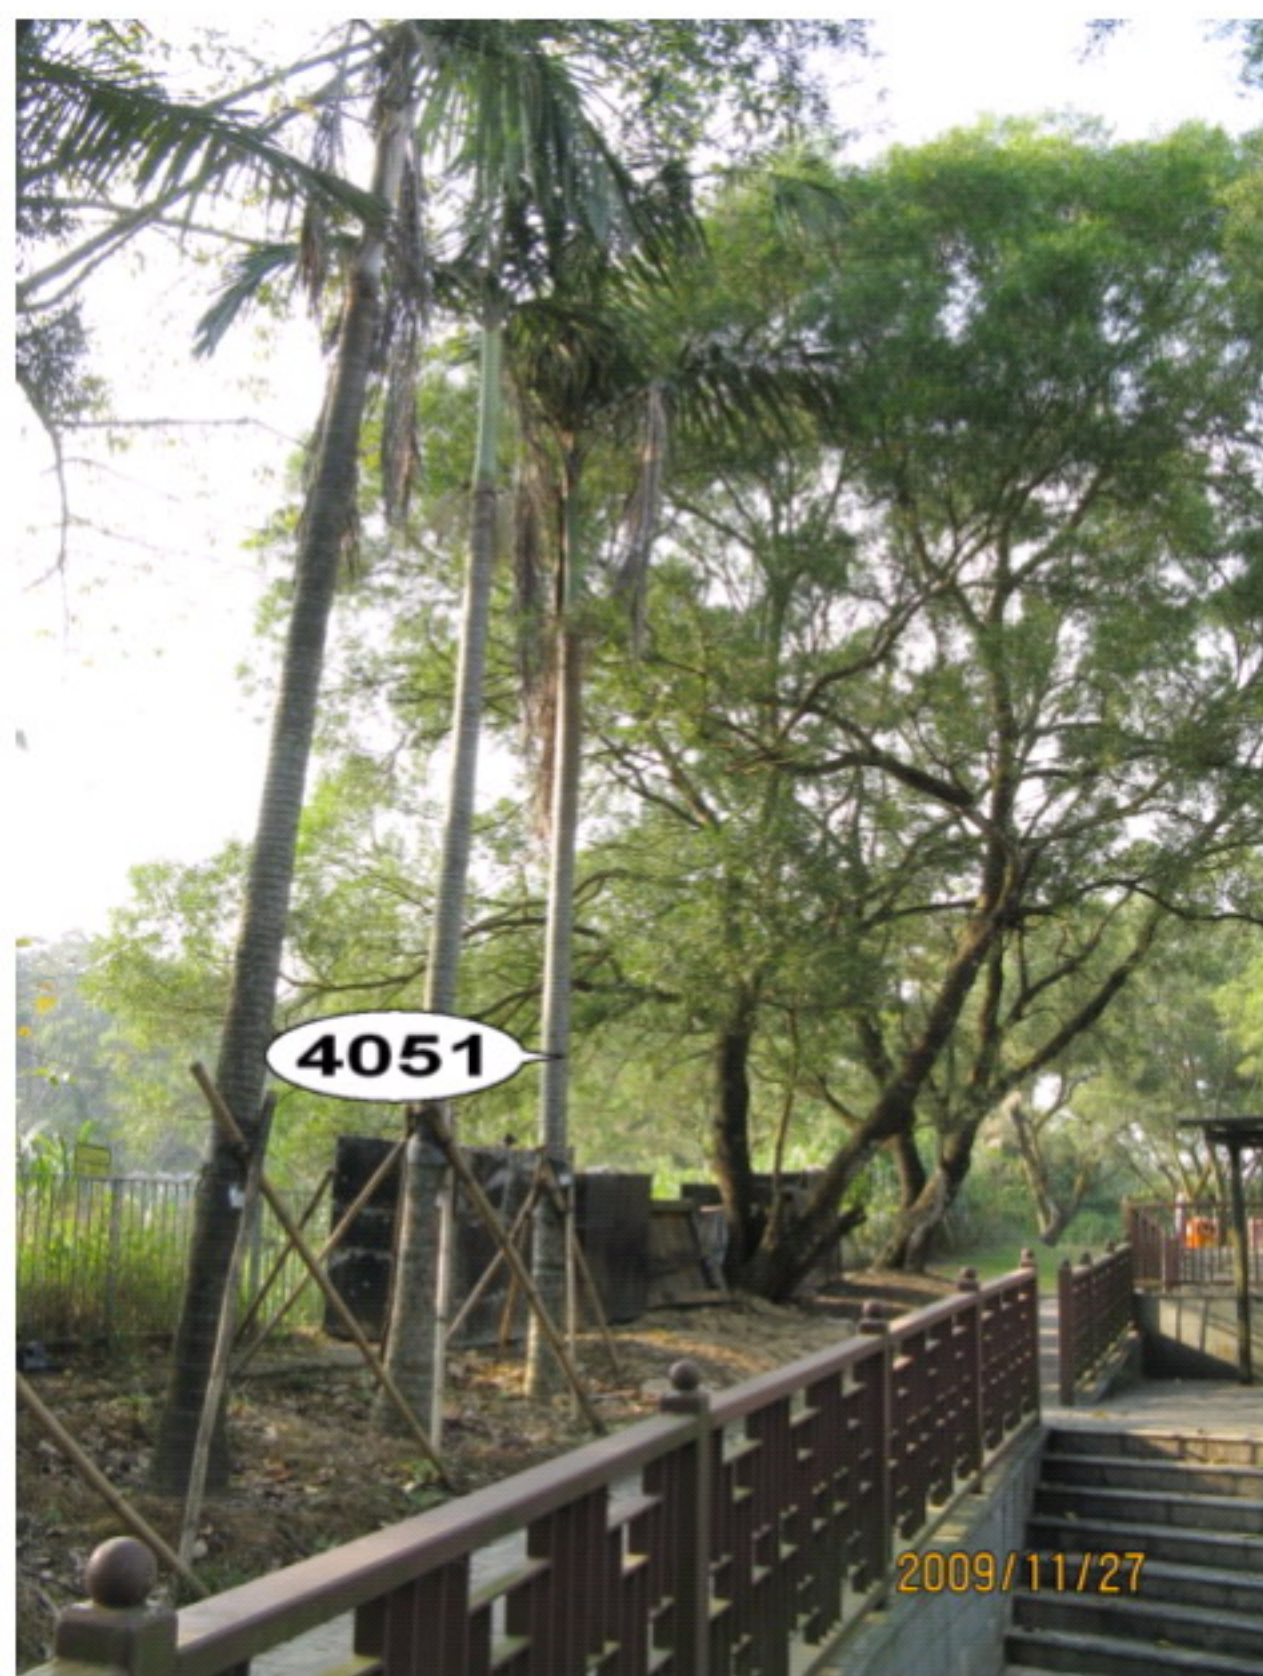
Tree No: 4051

| Tree Number | Species | Chinese name | Height (m) | Diameter (m) | Spread (m) | Remark | | |
|---|---|---|---|---|---|---|---|---|
| 4051 | <i>Archontophoenix alexandrae</i> | 假檳榔 | 5 | 0.18 | 3 | Fair condition, Yellow leave | Fair condition, Yellow leave | Fair condition, Yellow leave |

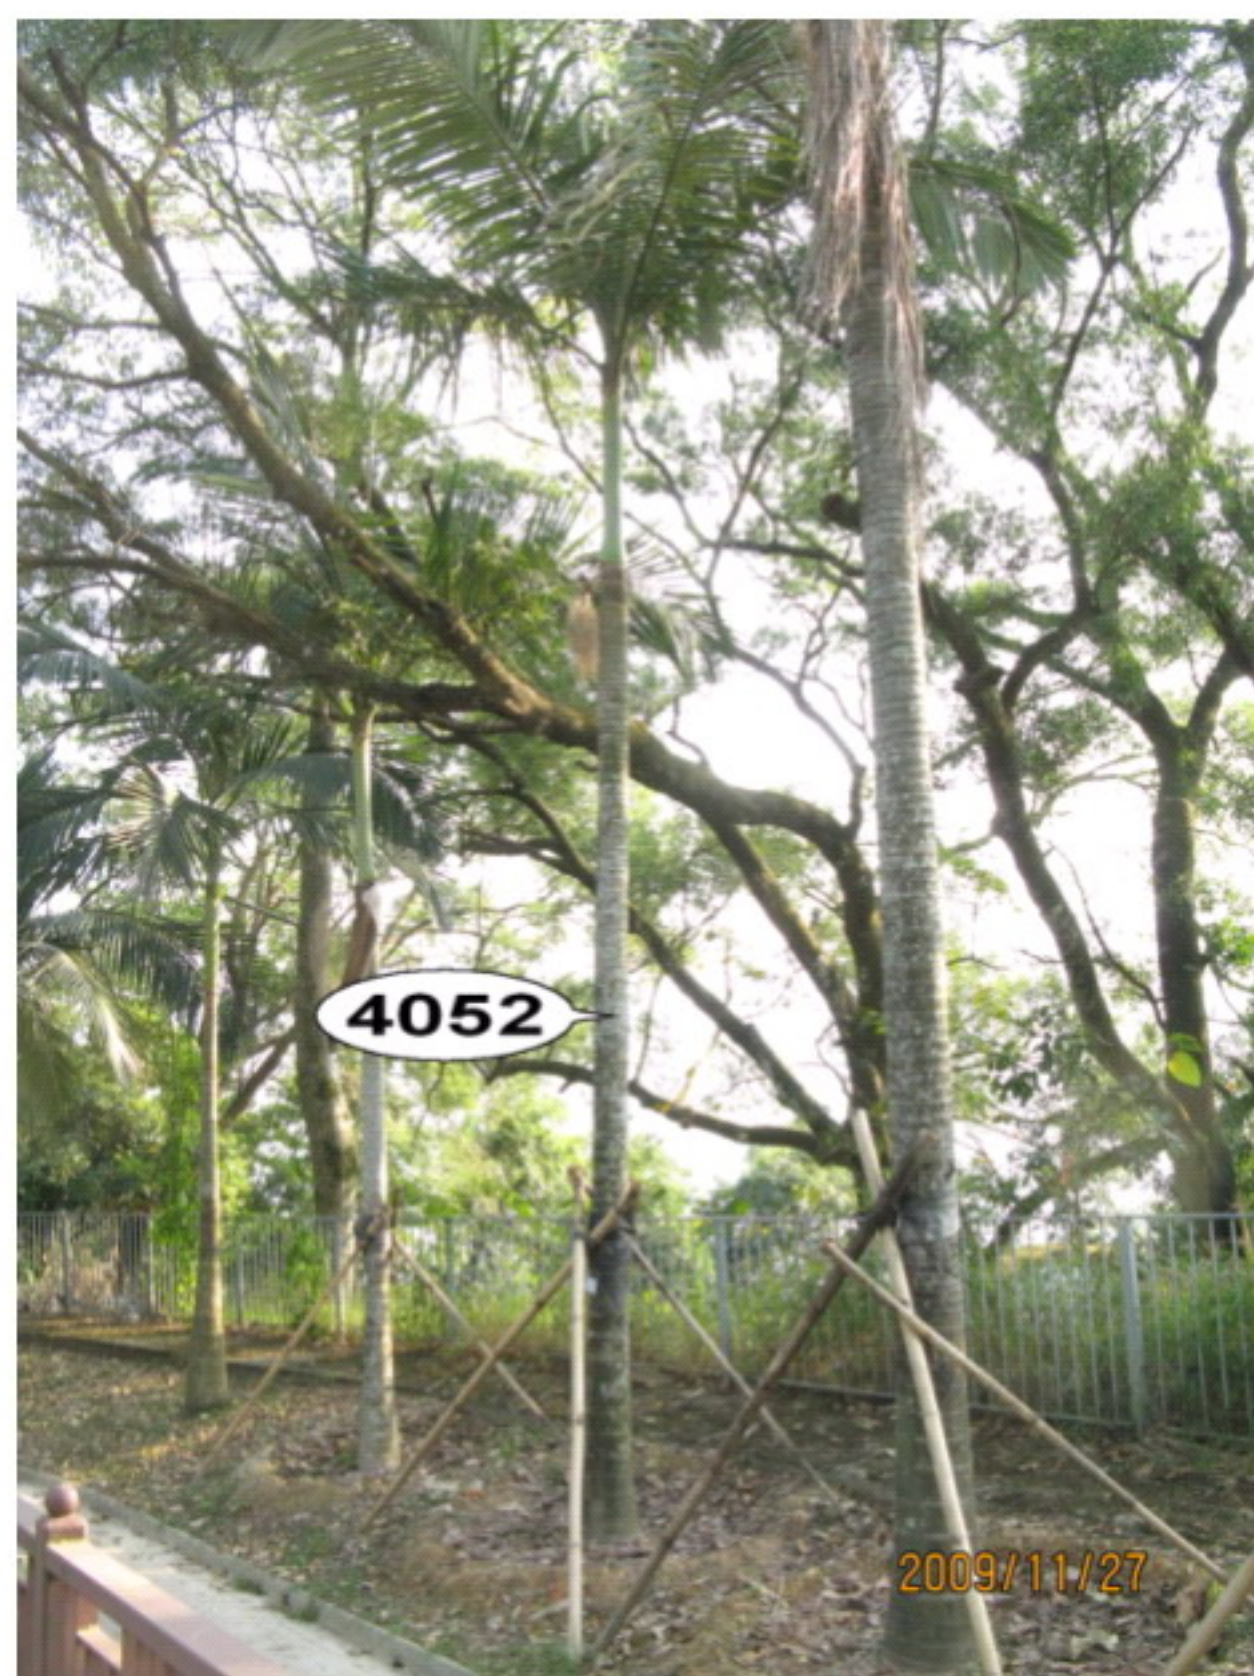
Tree No: 4052

| Tree Number | Species | Chinese name | Height (m) | Diameter (m) | Spread (m) | Remark | | |
|---|---|---|---|---|---|---|---|---|
| 4052 | <i>Archontophoenix alexandrae</i> | 假檳榔 | 5 | 0.17 | 3 | Fair condition, Yellow leave | Fair condition, Yellow leave | Fair condition, Yellow leave |
