**PROVISION OF CREMATORS AT  
WO HOP SHEK CREMATORIUM**

**ENVIRONMENTAL MONITORING &  
AUDIT REPORT (NOVEMBER 2009)**

**ALLIED ENVIRONMENTAL CONSULTANTS LTD.**

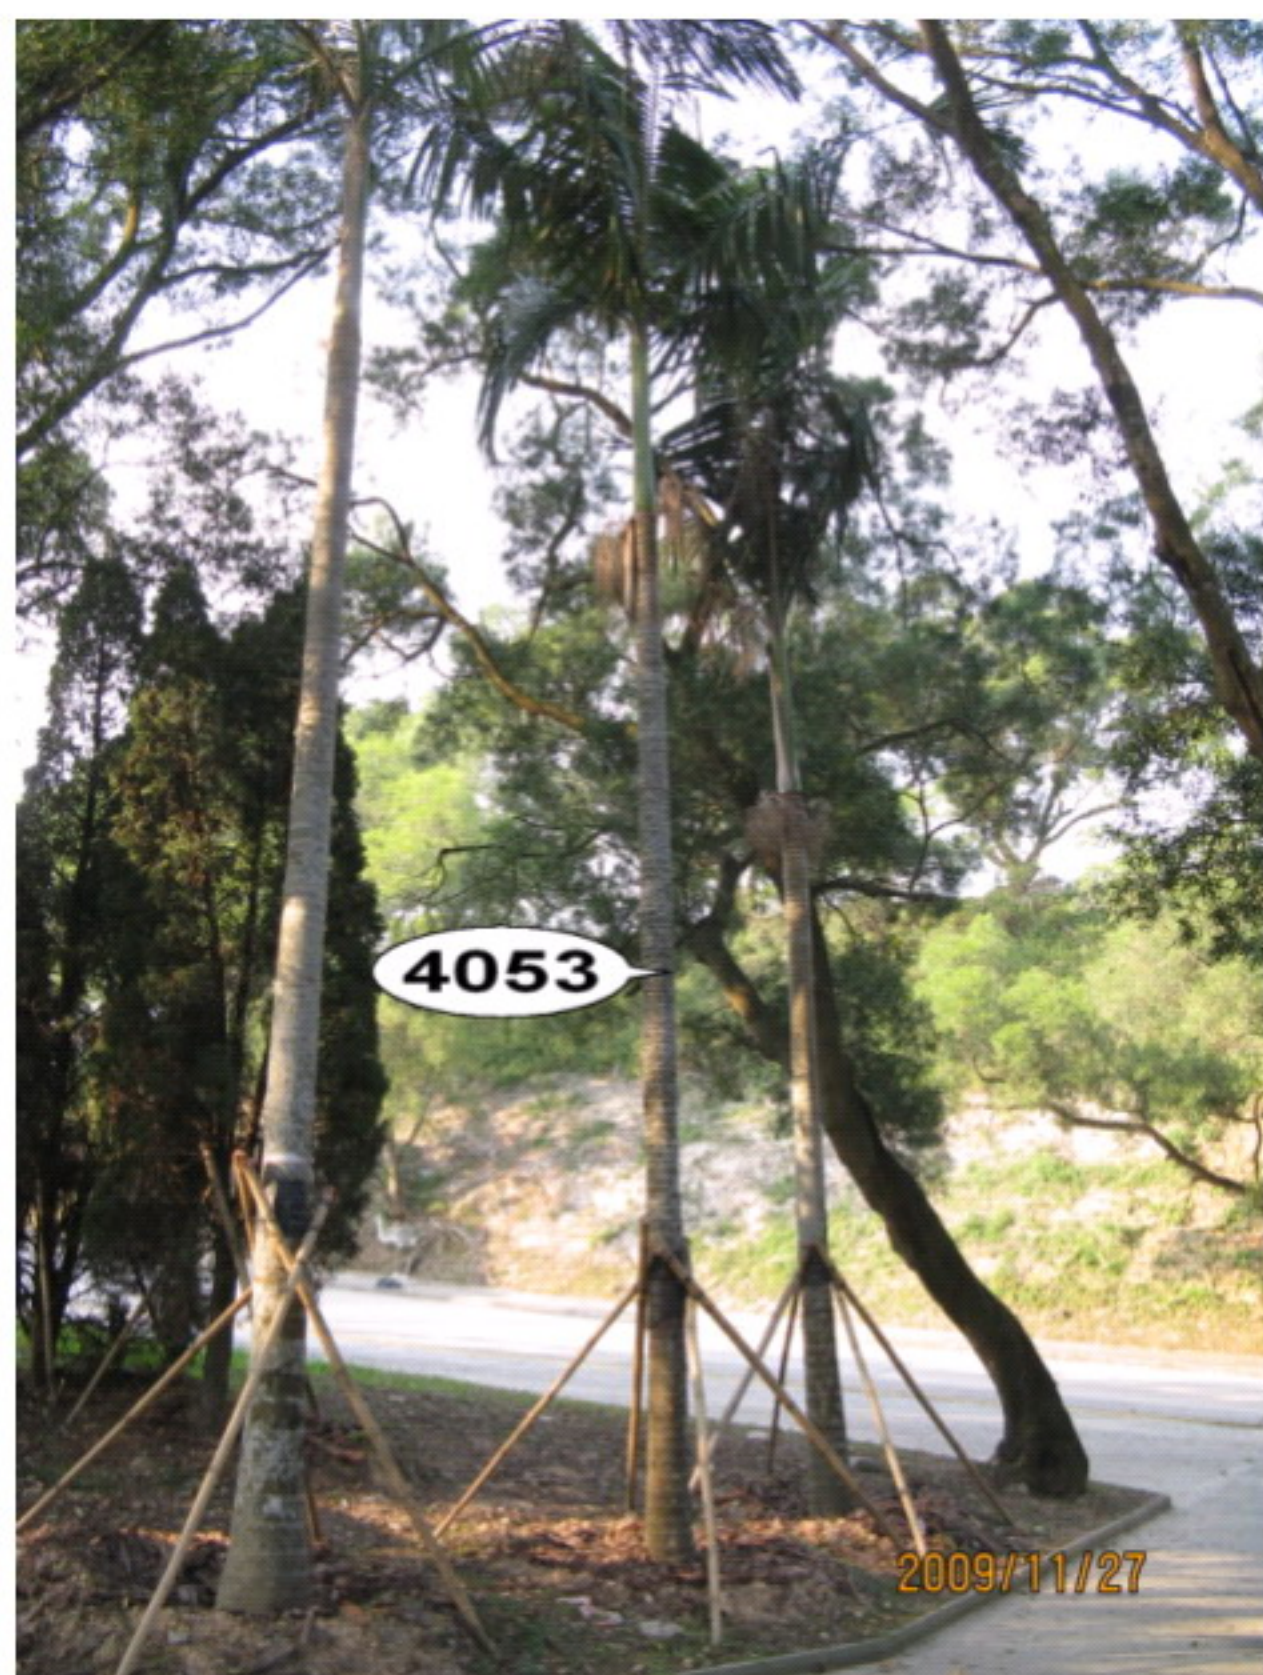
Tree No: 4053

| Tree Number | Species | Chinese name | Height (m) | Diameter (m) | Spread (m) | Remark | | |
|---|---|---|---|---|---|---|---|---|
| 4053 | <i>Archontophoenix alexandrae</i> | 假檳榔 | 4 | 0.2 | 3 | Fair condition, Yellow leave | Fair condition, Yellow leave | Fair condition, Yellow leave |

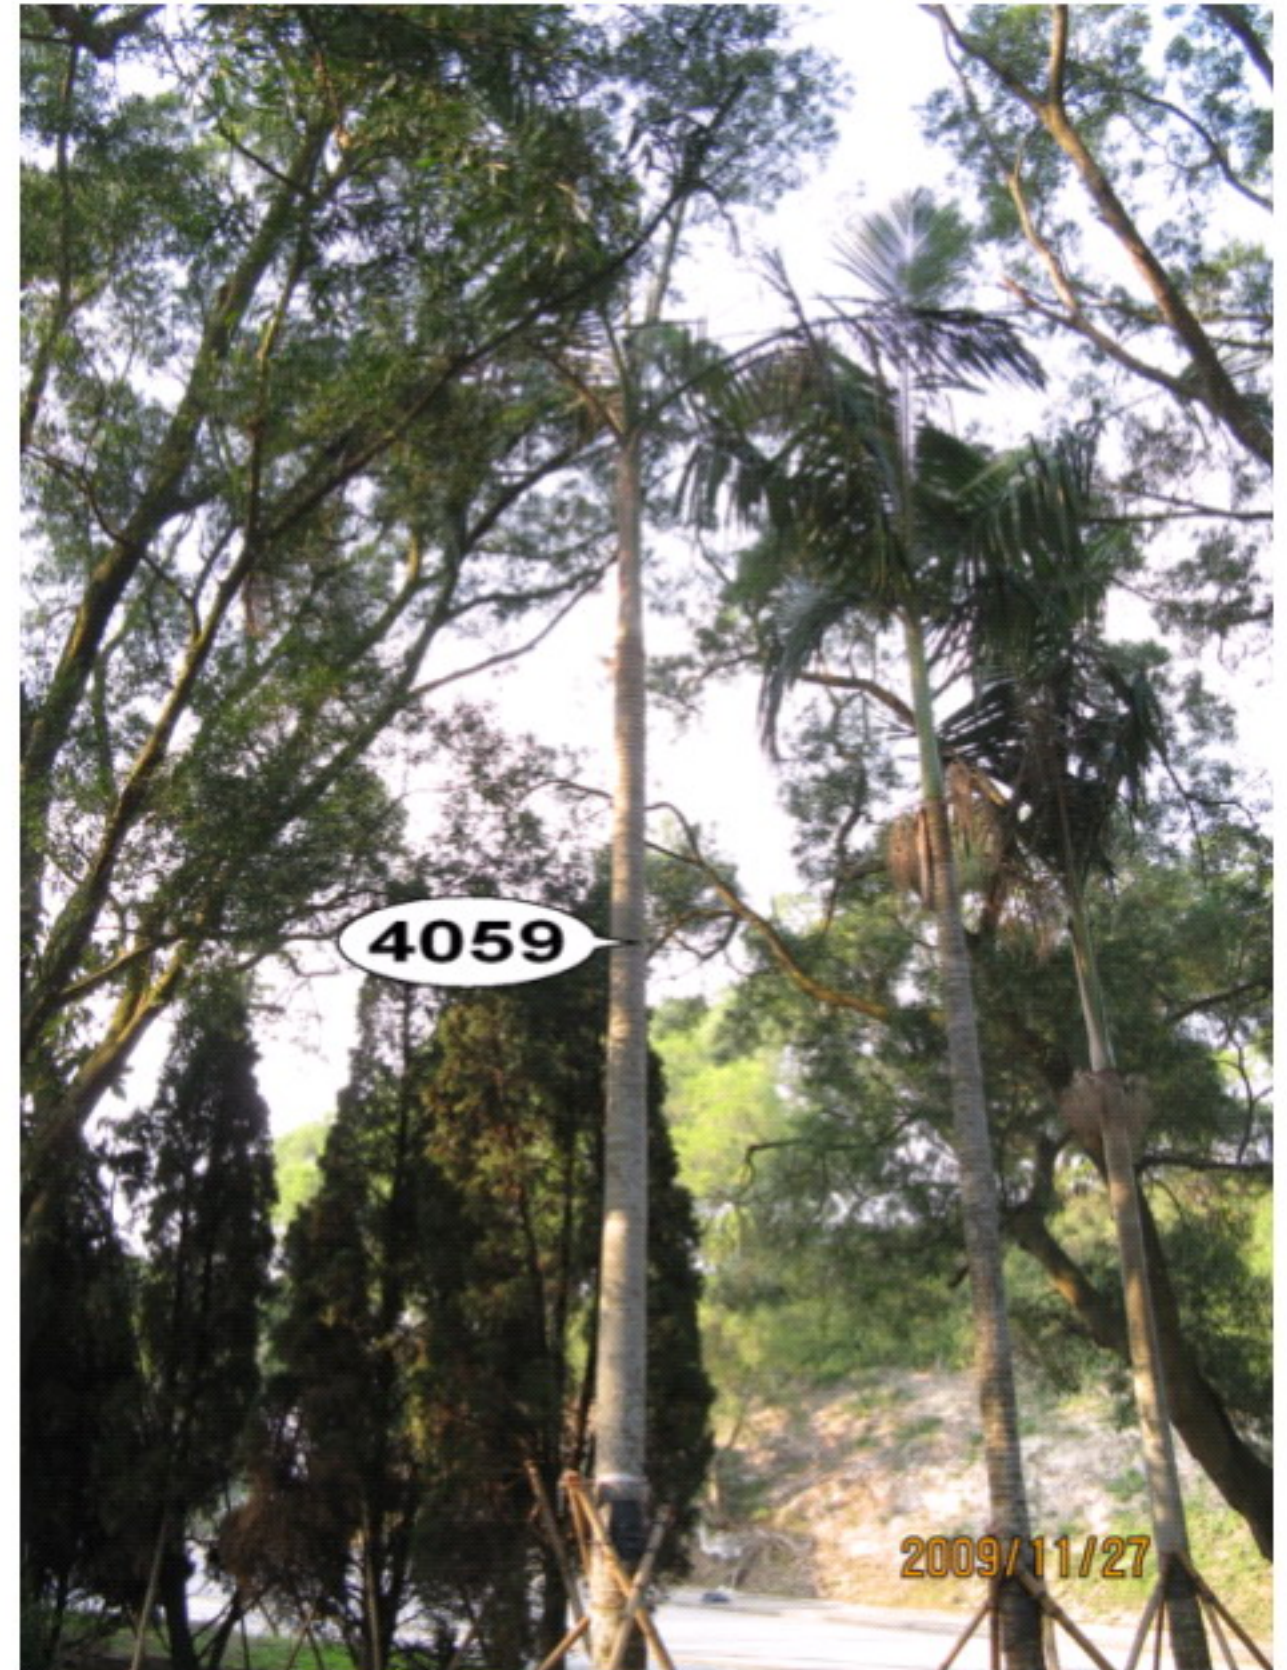
Tree No: 4059

| Tree Number | Species | Chinese name | Height (m) | Diameter (m) | Spread (m) | Remark | | |
|---|---|---|---|---|---|---|---|---|
| 4059 | <i>Archontophoenix alexandrae</i> | 假檳榔 | 6 | 0.23 | 4 | Fair condition, Yellow leave | Fair condition, Yellow leave | Fair condition, Yellow leave |

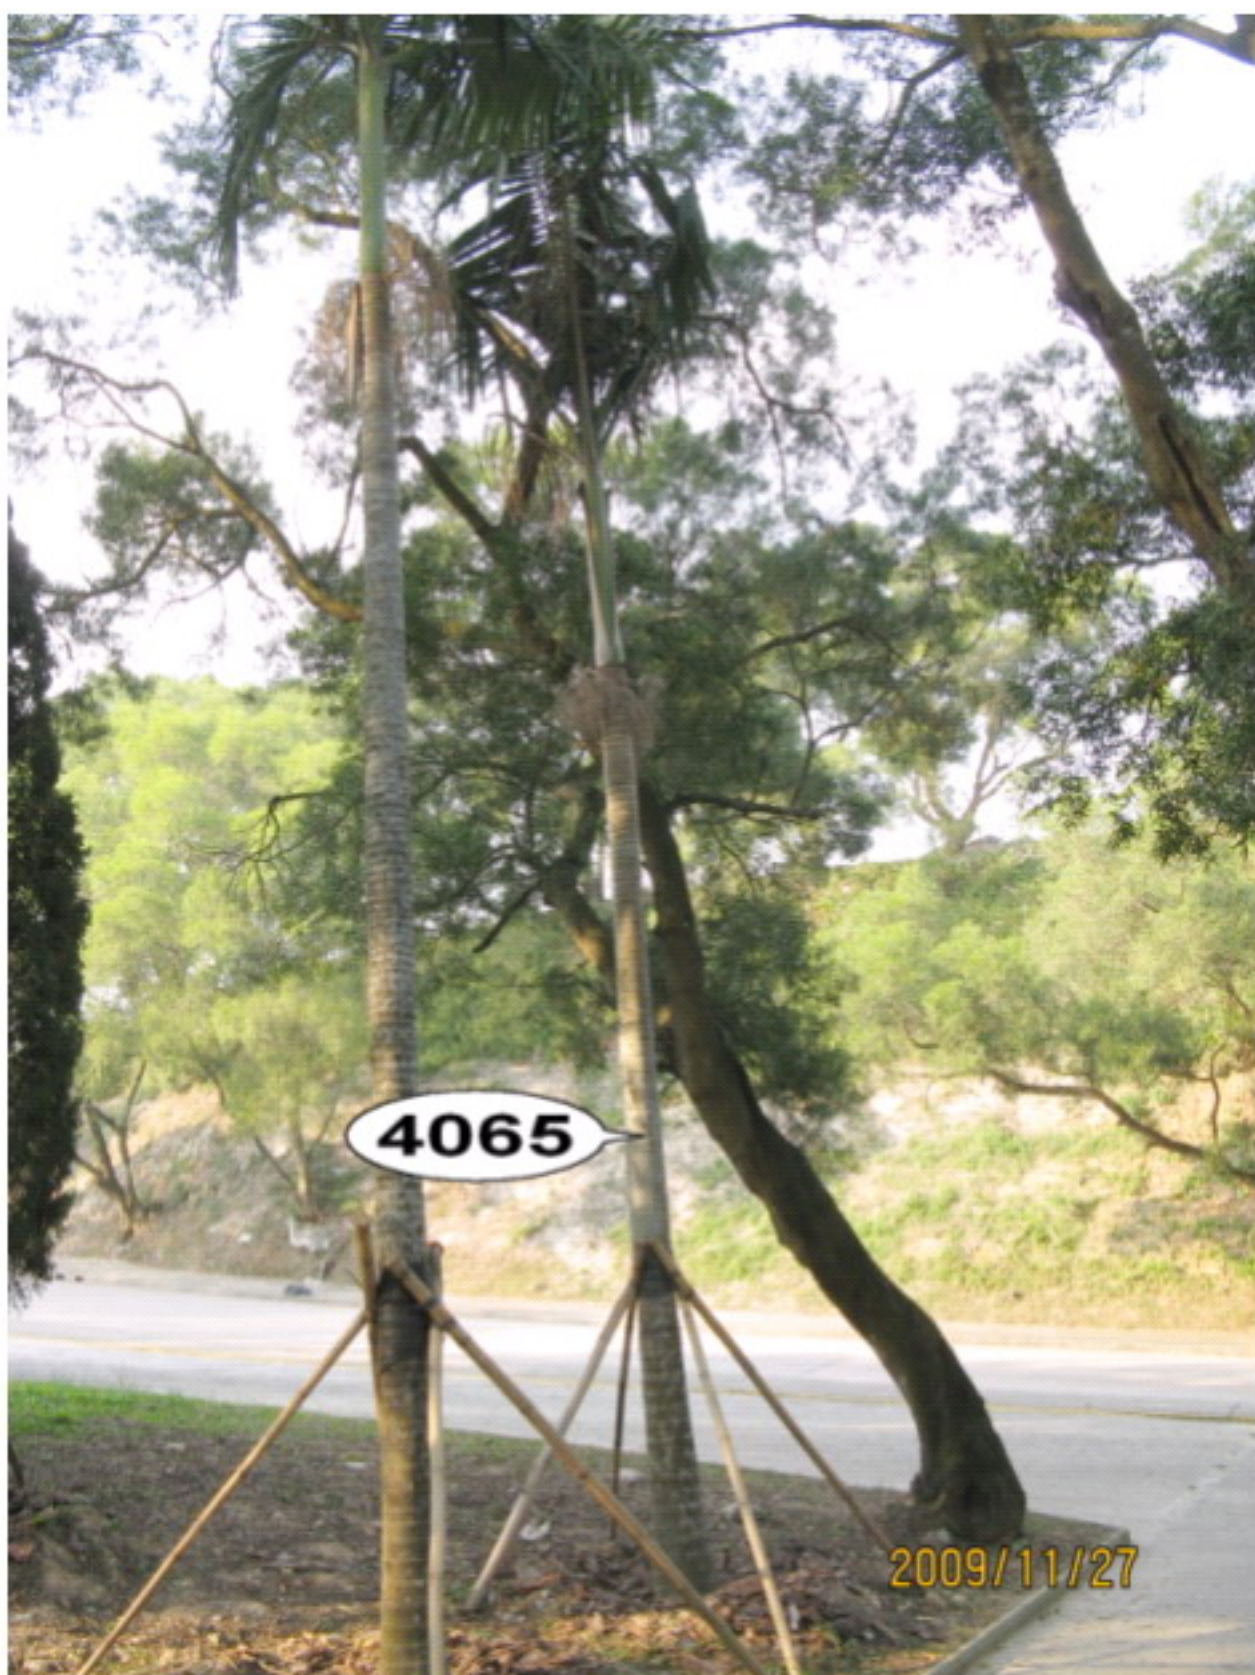
Tree No: 4065

| Tree Number | Species | Chinese name | Height (m) | Diameter (m) | Spread (m) | Remark | | |
|---|---|---|---|---|---|---|---|---|
| 4065 | <i>Archontophoenix alexandrae</i> | 假檳榔 | 7 | 0.21 | 4 | Fair condition, Yellow leave | Fair condition, Yellow leave | Fair condition, Yellow leave |

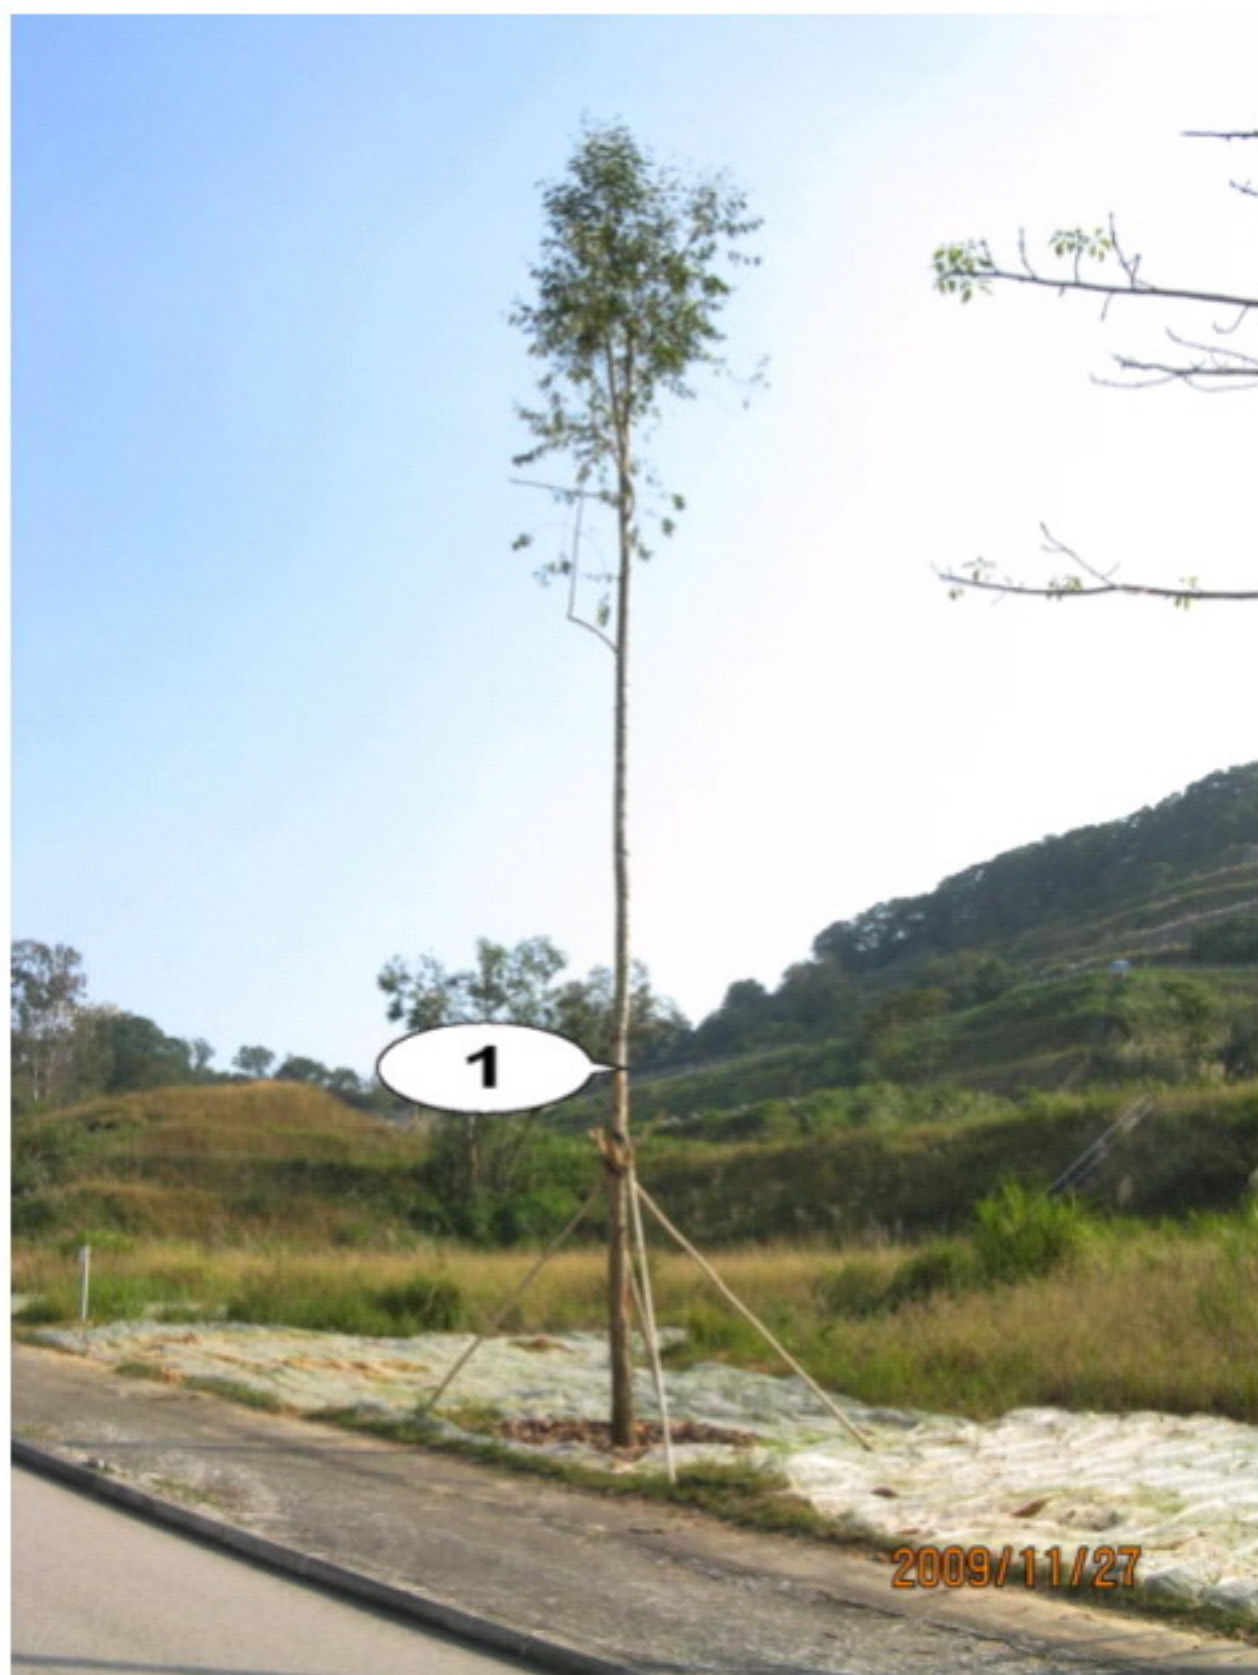
Tree No: 0001

| Tree Number | Species | Chinese name | Height (m) | Diameter (m) | Spread (m) | Remark | | |
|---|---|---|---|---|---|---|---|---|
| 1 | <i>Eucalyptus citriodora</i> | 檸檬桉 | 6 | 0.2 | 1.5 | Not found on site | Fair condition | Fair condition |

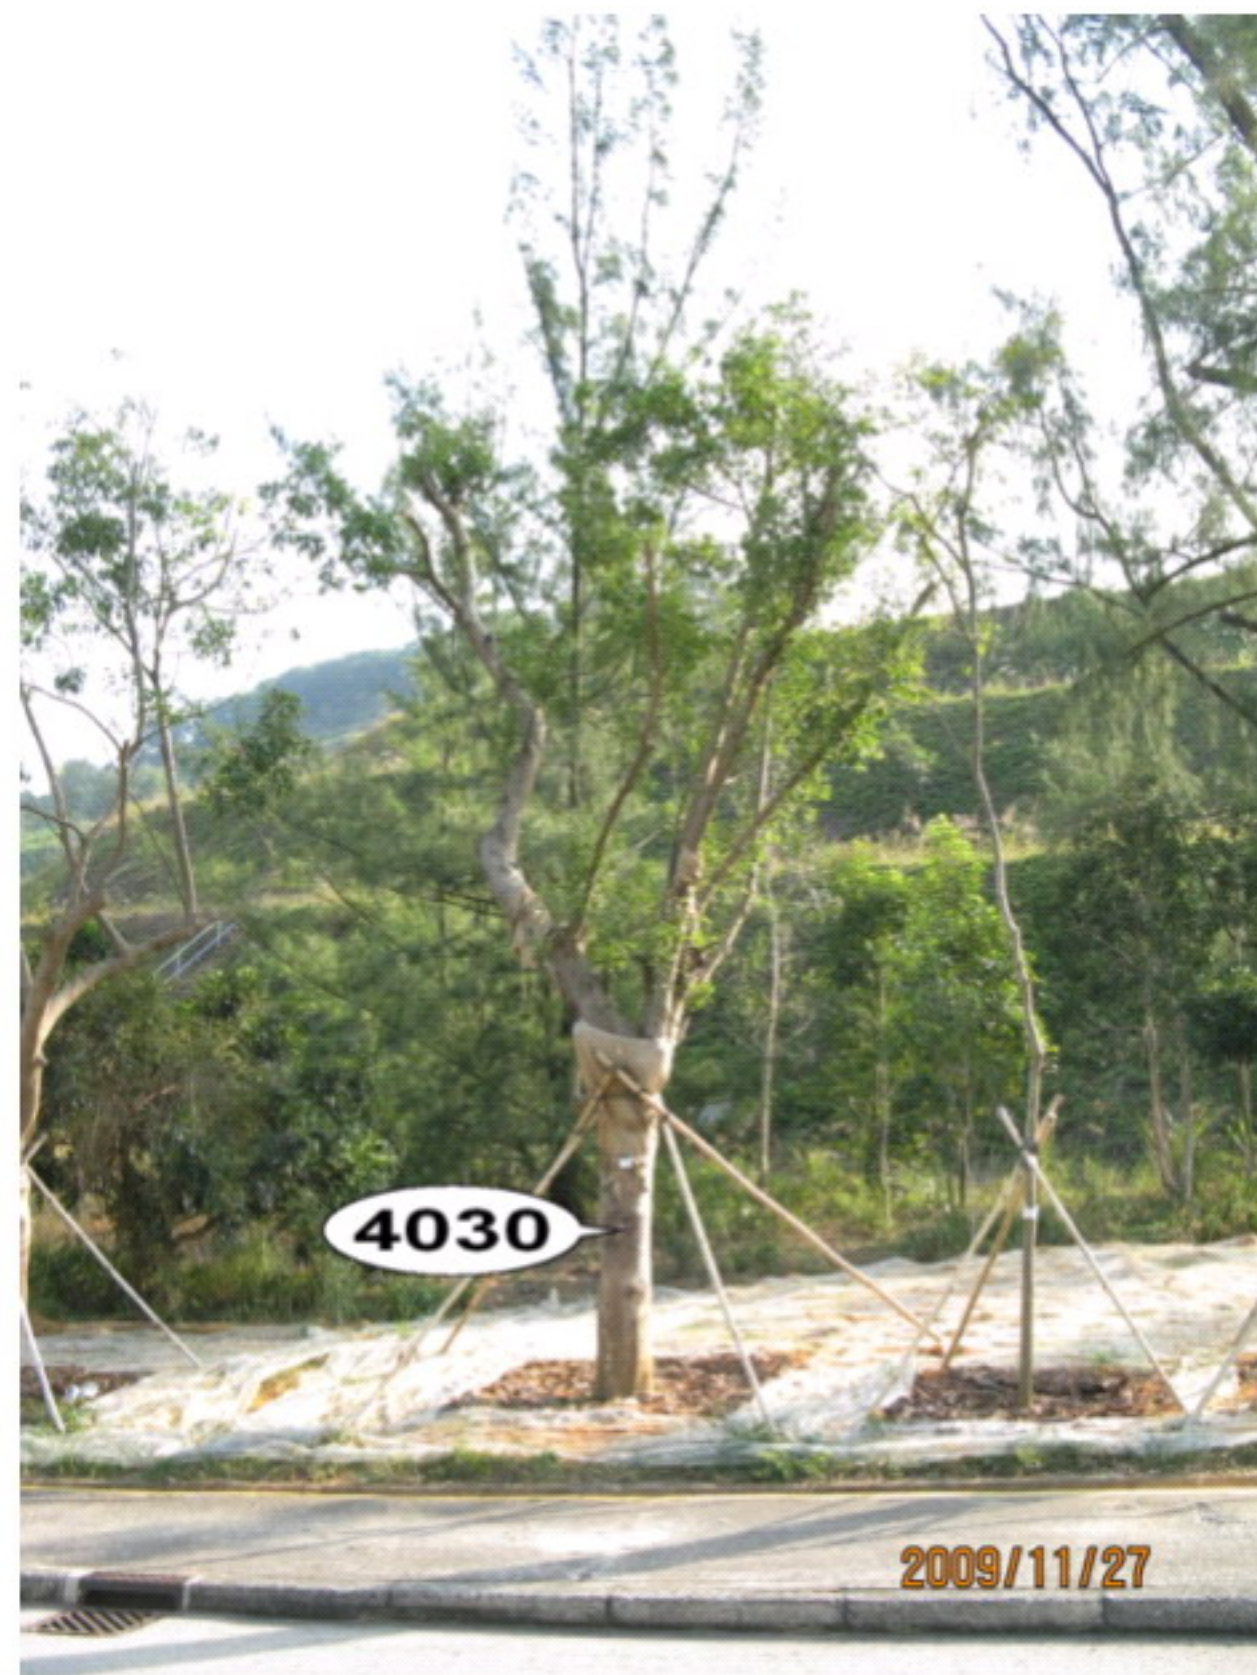
Tree No: 4030

| Tree Number | Species | Chinese name | Height (m) | Diameter (m) | Spread (m) | Remark | | |
|---|---|---|---|---|---|---|---|---|
| 4030 | <i>Cinnamomum burmannii</i> | 陰香 | 5.5 | 0.16 | 4 | Poor condition, Fork, Pruned | Poor condition, Fork, Pruned | Poor condition, Fork, Pruned, Decay |

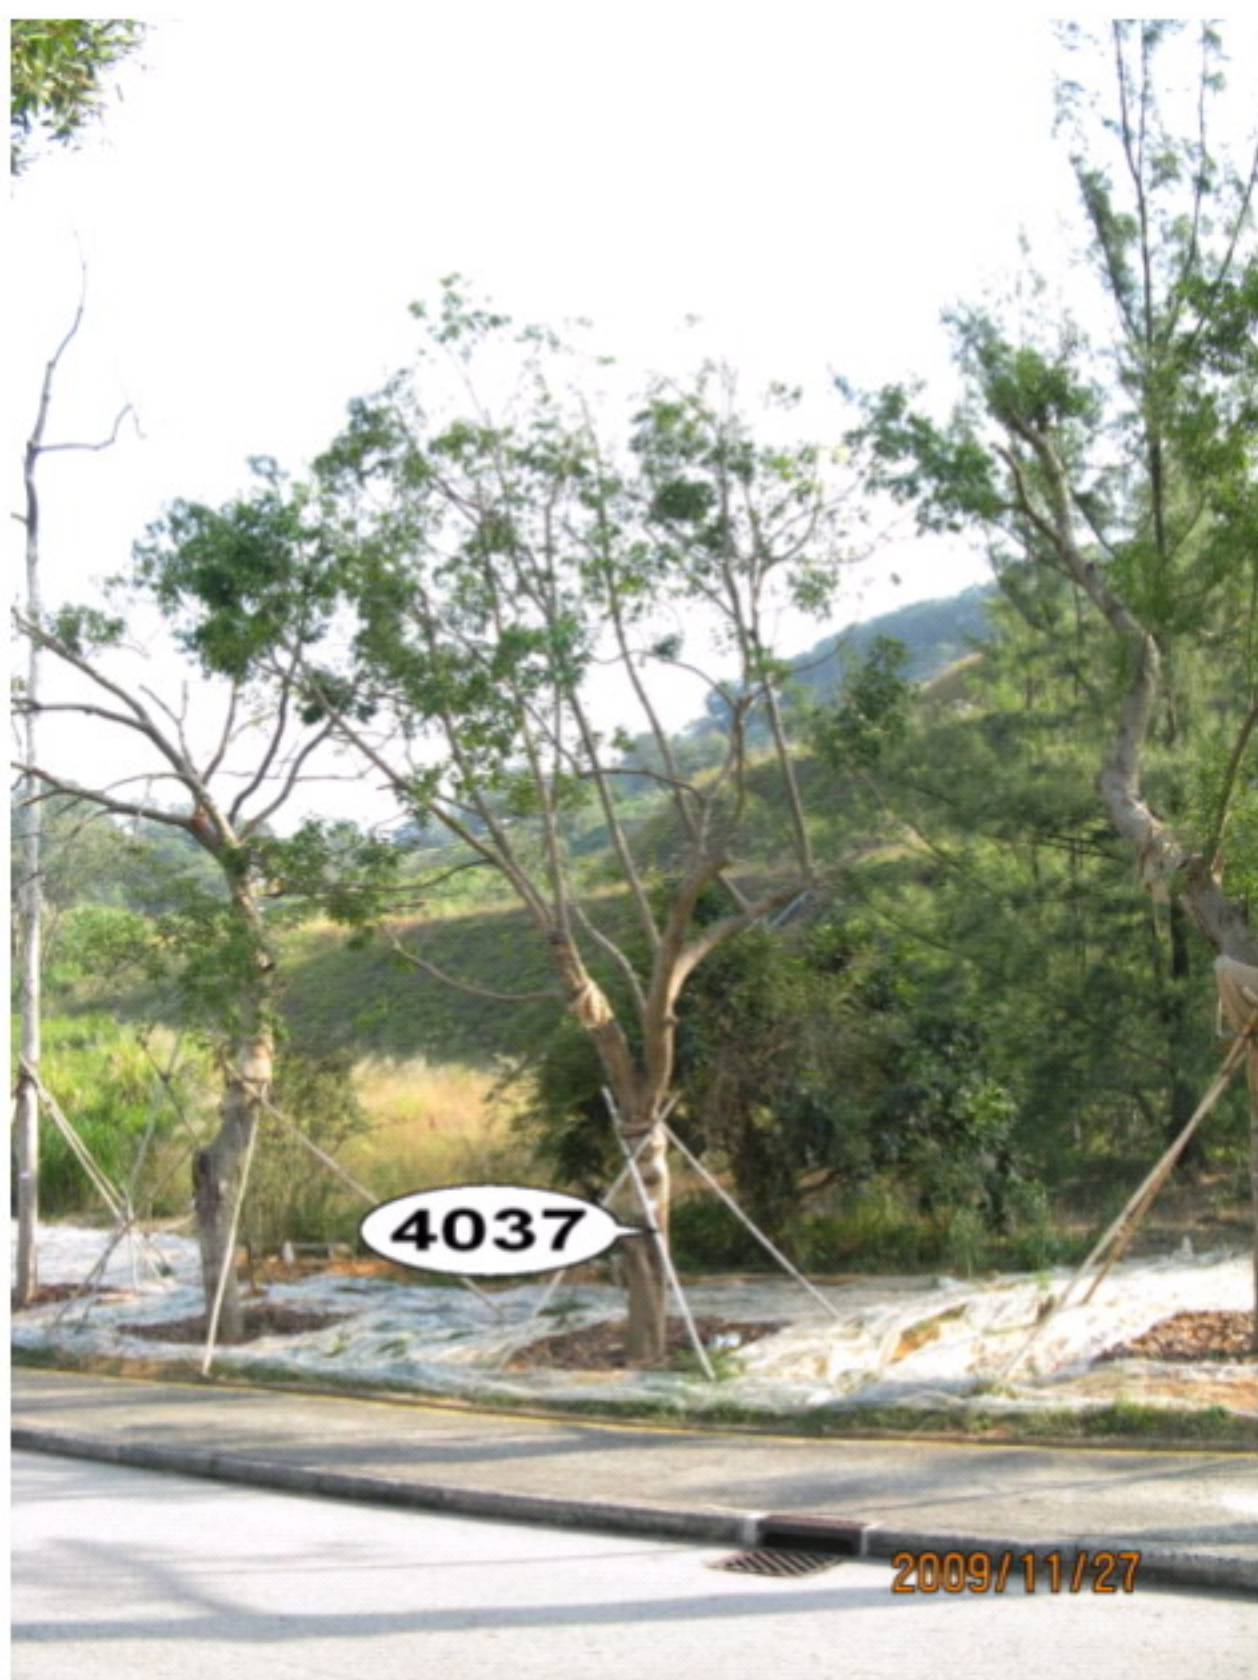
Tree No: 4037

| Tree Number | Species | Chinese name | Height (m) | Diameter (m) | Spread (m) | Remark | | |
|---|---|---|---|---|---|---|---|---|
| 4037 | <i>Cinnamomum burmannii</i> | 陰香 | 6 | 0.25 | 4 | Fair condition, Fork, Pruned | Fair condition, Fork, Pruned | Fair condition, Fork, Pruned |

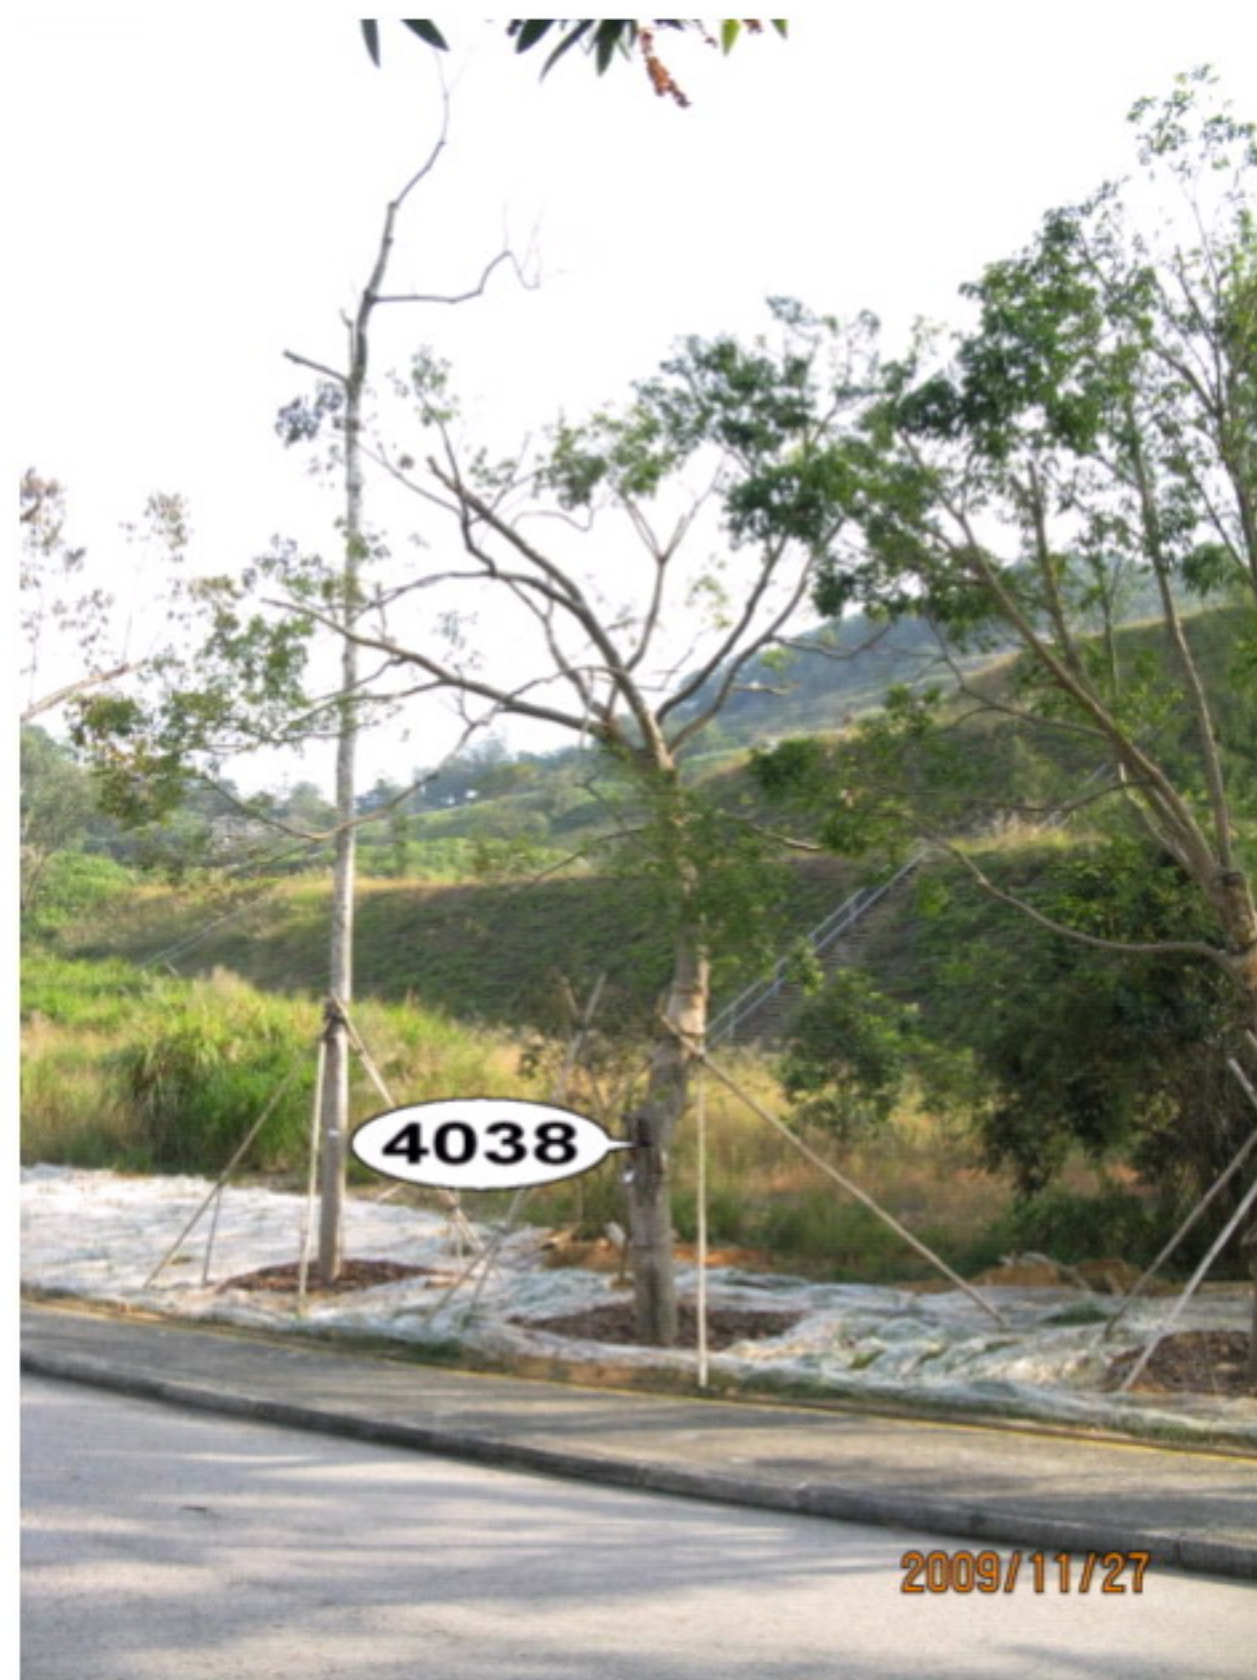
Tree No: 4038

| Tree Number | Species | Chinese name | Height (m) | Diameter (m) | Spread (m) | Remark | | |
|---|---|---|---|---|---|---|---|---|
| 4038 | <i>Cinnamomum burmannii</i> | 陰香 | 6 | 0.25 | 4 | Poor condition, Bark damage | Poor condition, Bark damage, leave generating | Poor condition, Bark damage, leave generating |

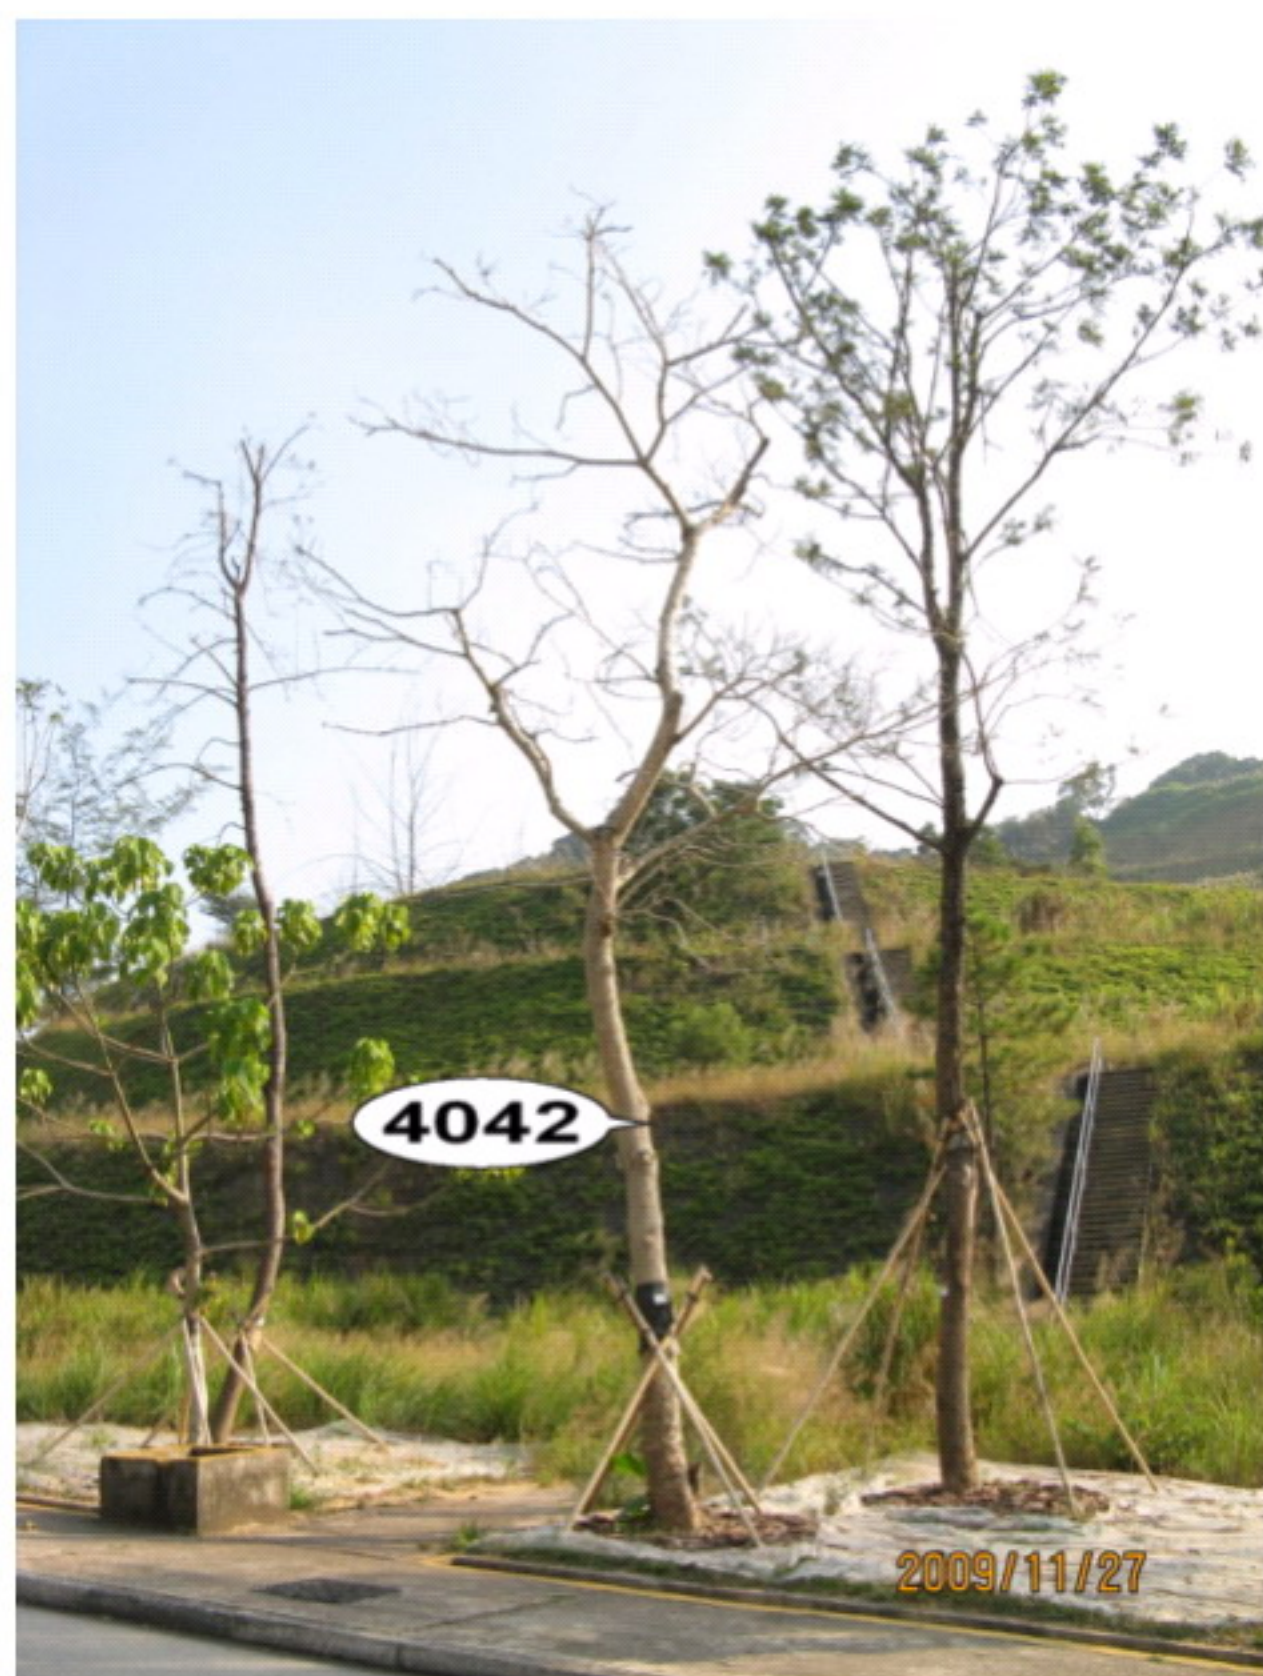
Tree No: 4042

| Tree Number | Species | Chinese name | Height (m) | Diameter (m) | Spread (m) | Remark | | |
|---|---|---|---|---|---|---|---|---|
| 4042 | <i>Albizia lebbeck</i> | 大葉合歡 | 8 | 0.16 | 4 | Poor condition, No leave | Poor condition, No leave | Poor condition, No leave |

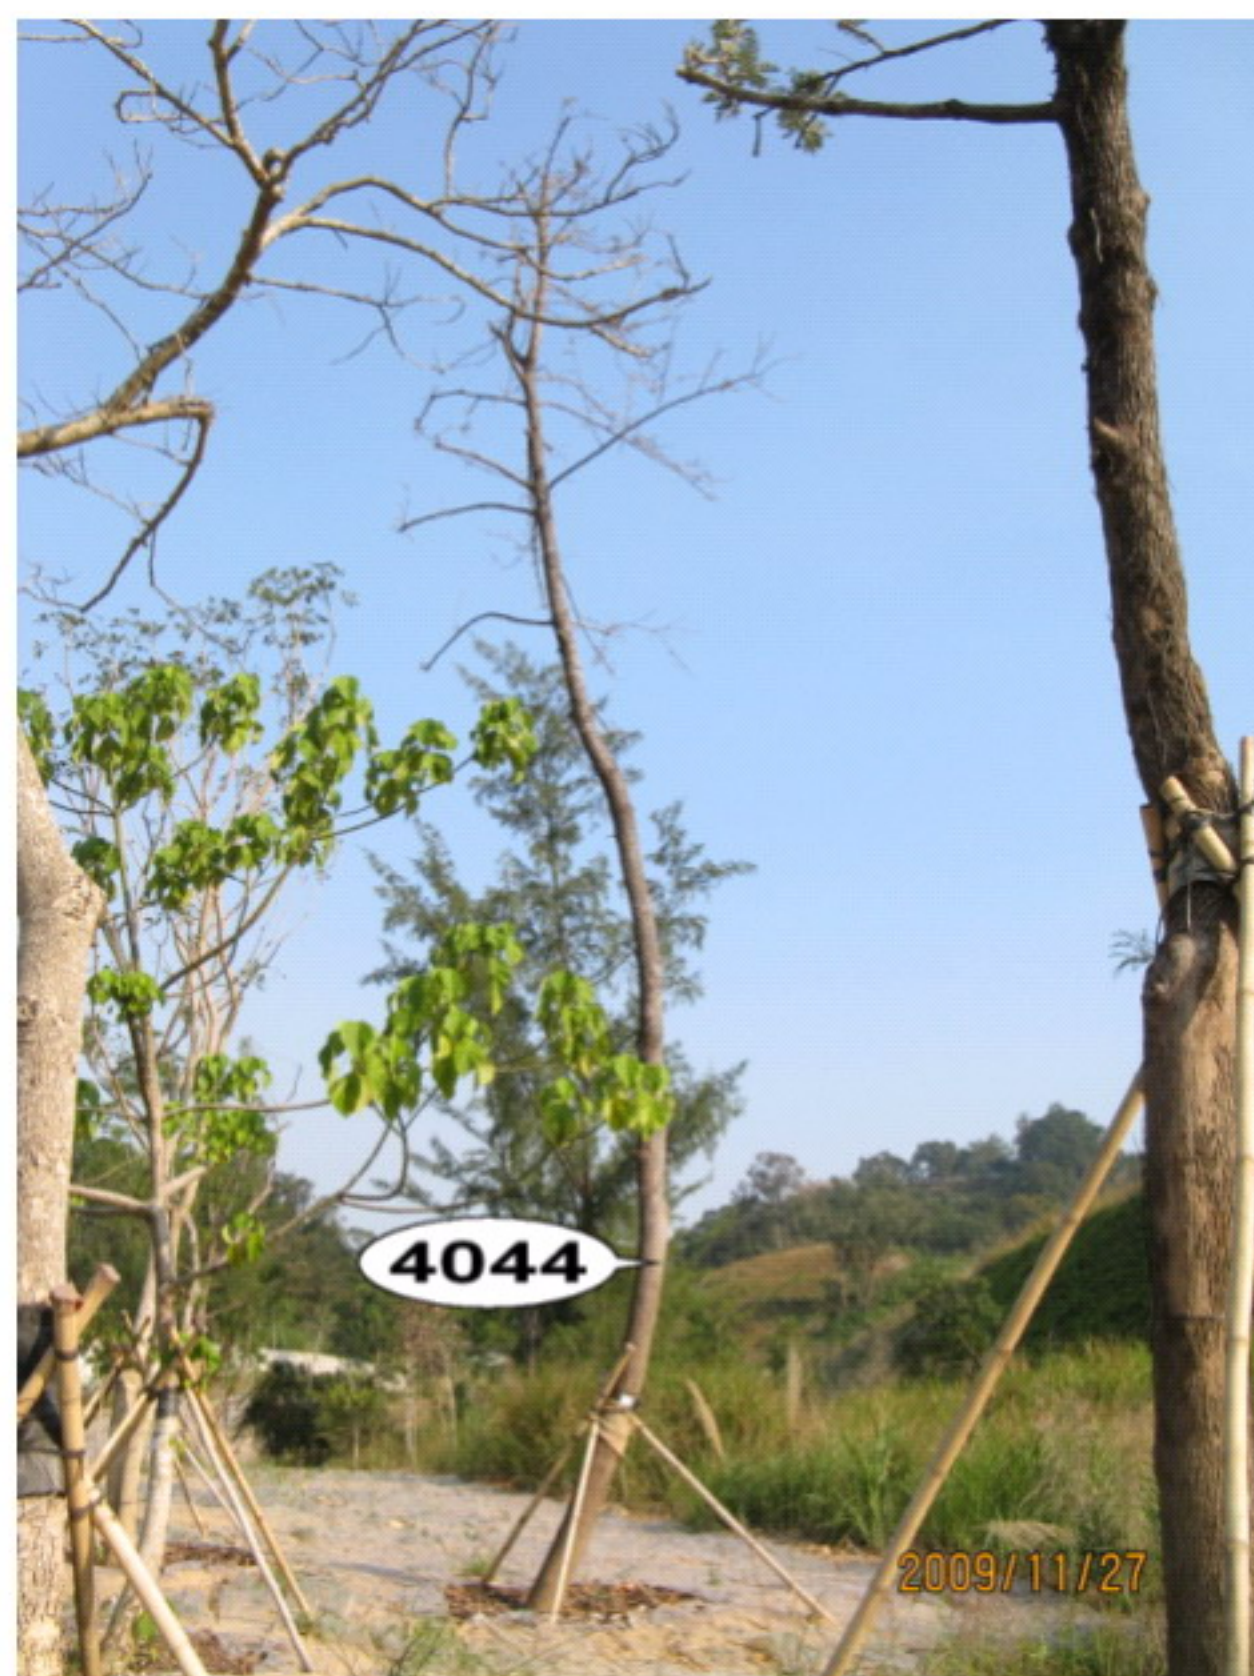
Tree No: 4044

| Tree Number | Species | Chinese name | Height (m) | Diameter (m) | Spread (m) | Remark | | |
|---|---|---|---|---|---|---|---|---|
| 4044 | <i>Grevillea robusta</i> | 銀樺 | 9 | 0.16 | 3 | Fair condition | Fair condition, Sparse crown | Fair condition, Heavy sparse crown |

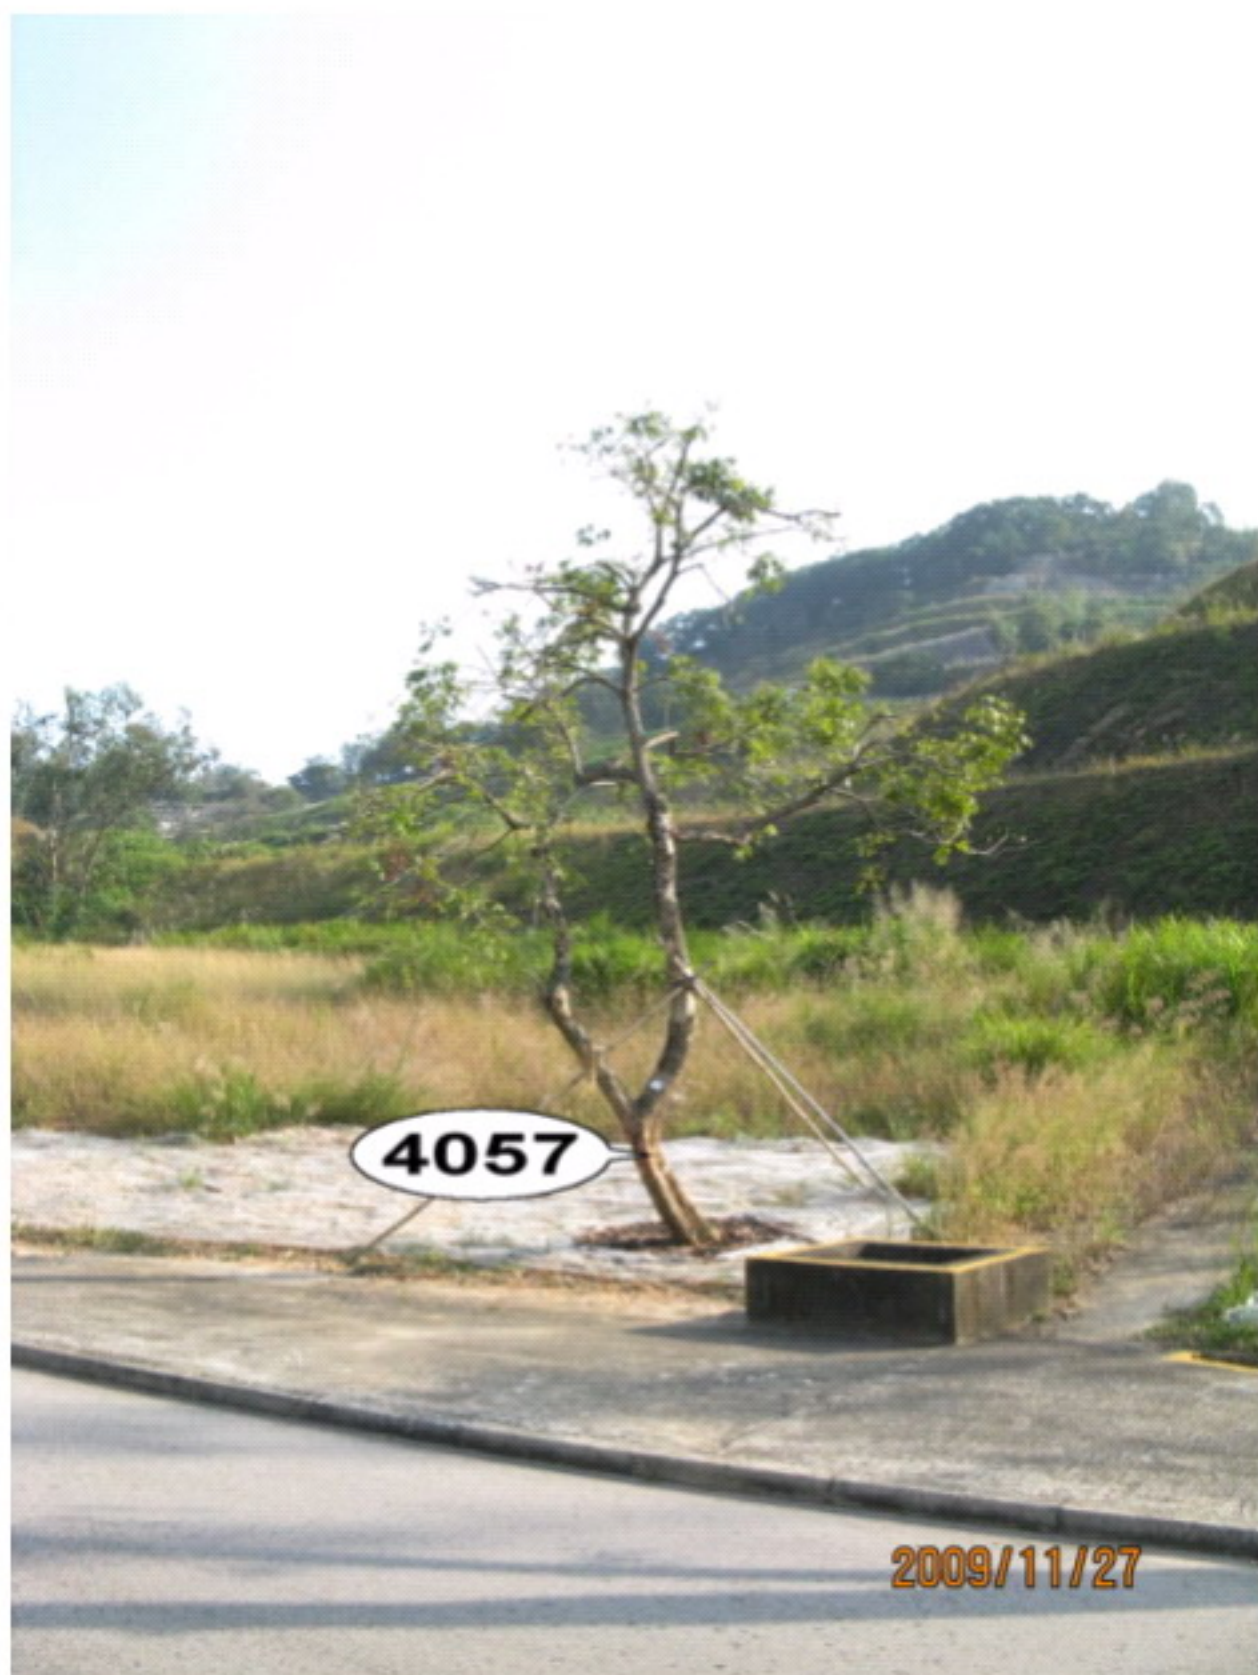
Tree No: 4057

| Tree Number | Species | Chinese name | Height (m) | Diameter (m) | Spread (m) | Remark | | |
|---|---|---|---|---|---|---|---|---|
| 4057 | <i>Dimocarpus longan</i> | 龍眼 | 6 | 0.16 | 4 | Poor condition, Bark damage, Fork | Leave infected by insect. | Leave infected by insect. |
