**PROVISION OF CREMATORS AT  
WO HOP SHEK CREMATORIUM**

**ENVIRONMENTAL MONITORING &  
AUDIT REPORT (NOVEMBER 2009)**

**ALLIED ENVIRONMENTAL CONSULTANTS LTD.**

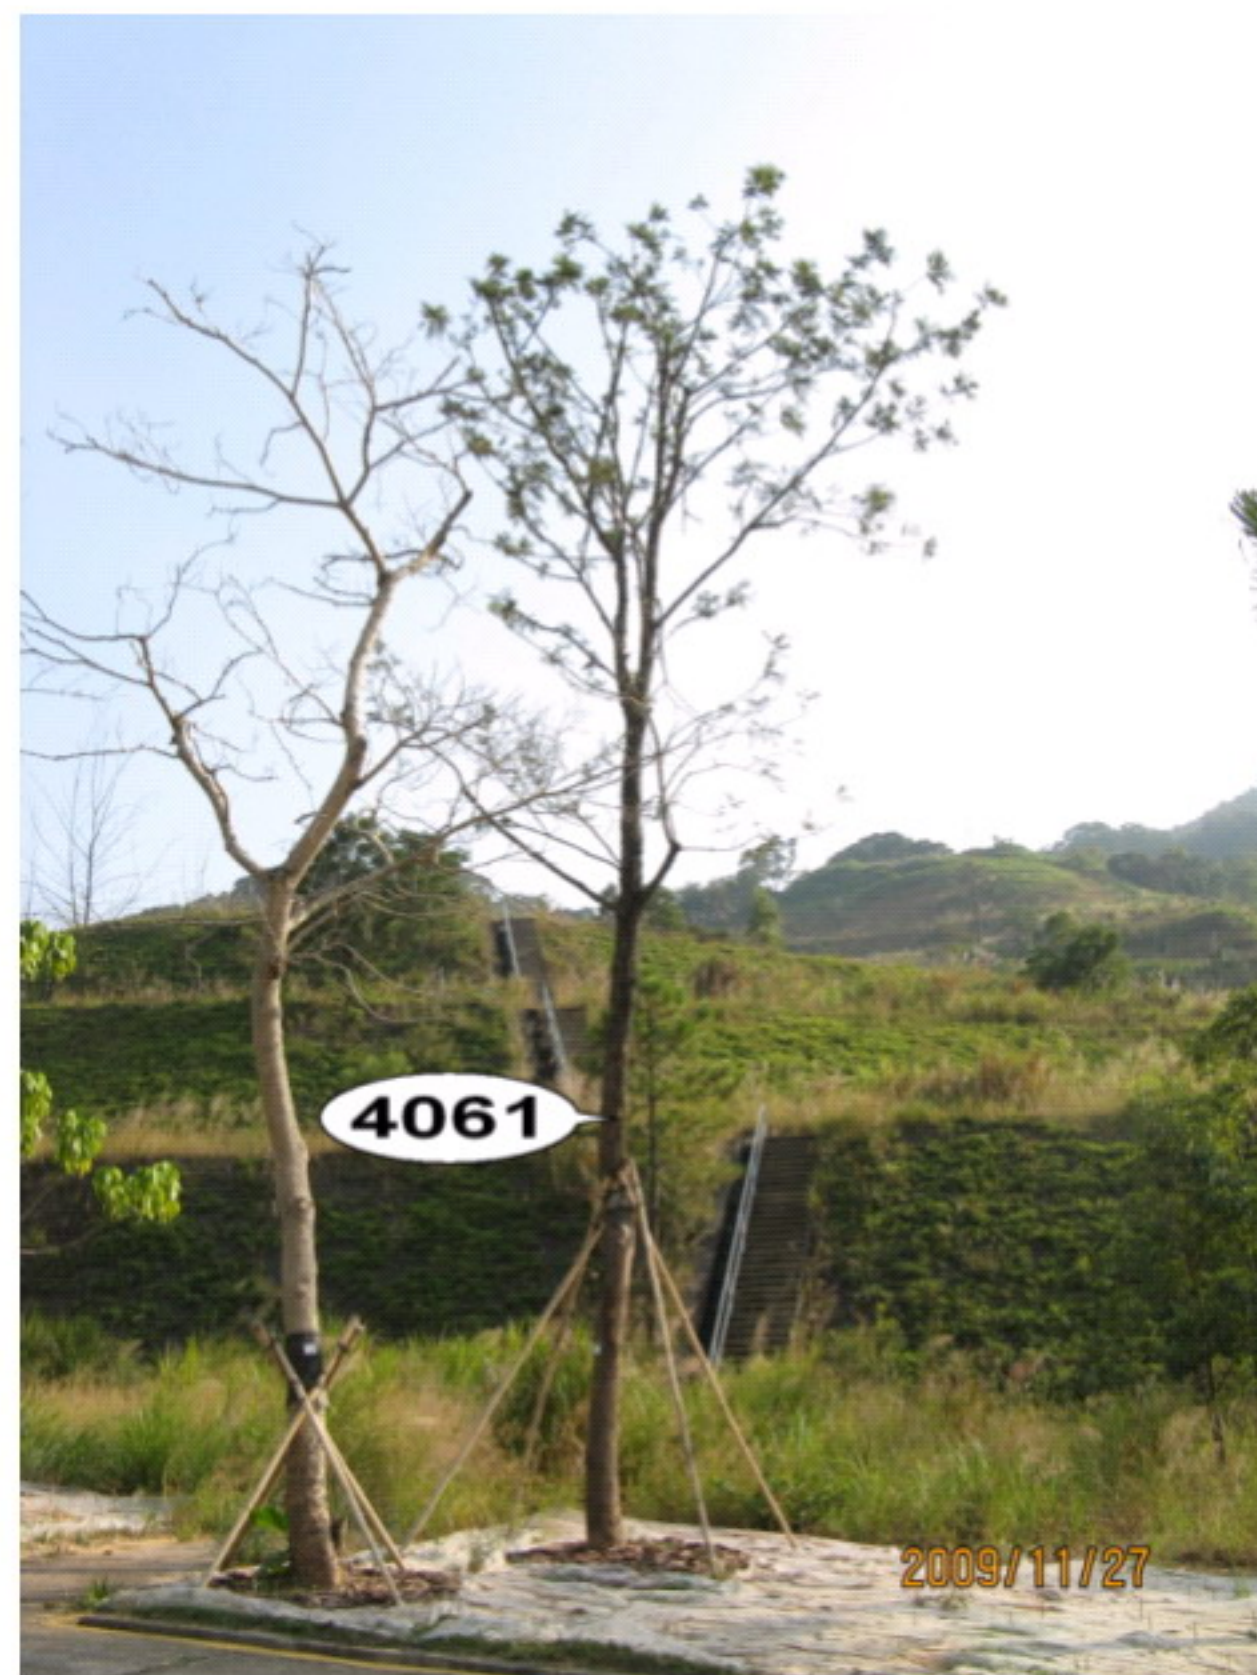
Tree No: 4061

| Tree Number | Species | Chinese name | Height (m) | Diameter (m) | Spread (m) | Remark | | |
|---|---|---|---|---|---|---|---|---|
| 4061 | <i>Grevillea robusta</i> | 銀樺 | 7 | 0.13 | 4 | Fair condition | Fair condition | Fair condition |

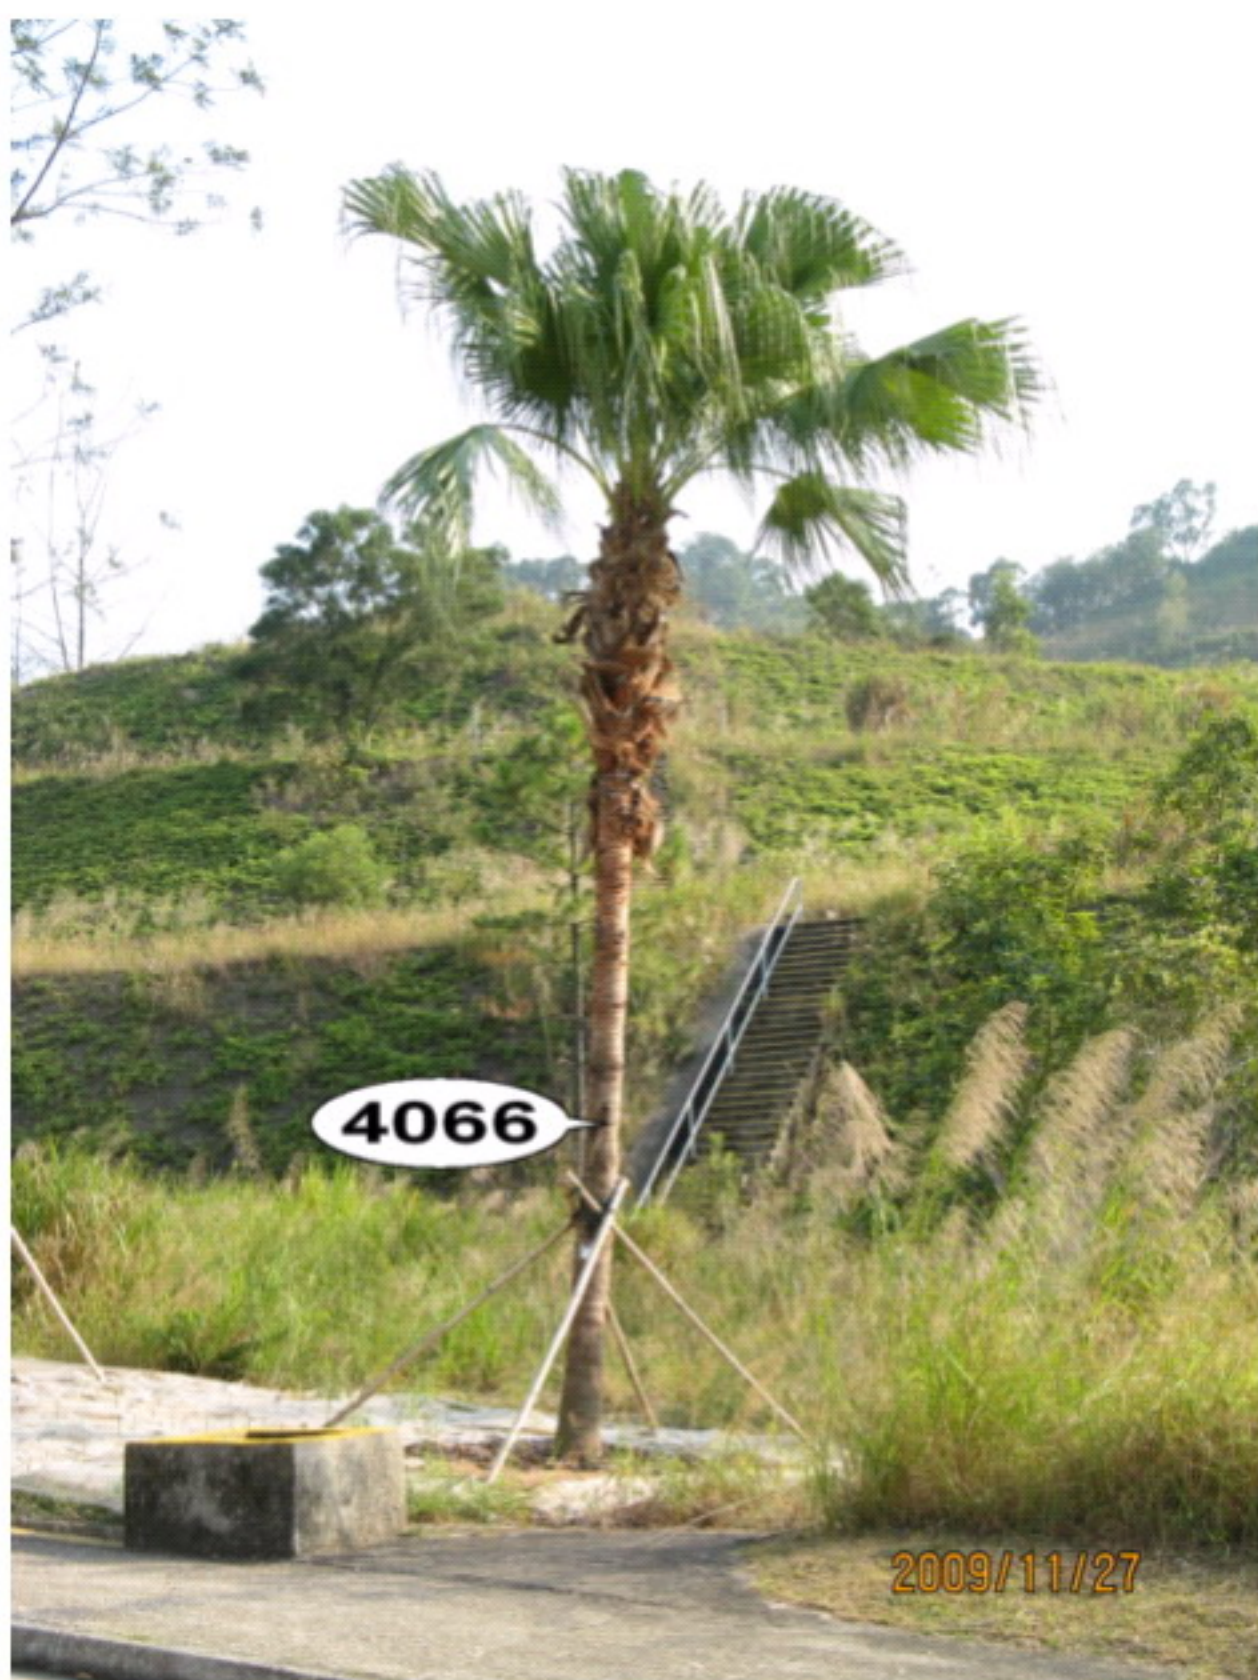
Tree No: 4066

| Tree Number | Species | Chinese name | Height (m) | Diameter (m) | Spread (m) | Remark | | |
|---|---|---|---|---|---|---|---|---|
| 4066 | <i>Livistona chinensis</i> | 蒲葵 | 6 | 0.21 | 2 | Fair condition | Fair condition | Fair condition |

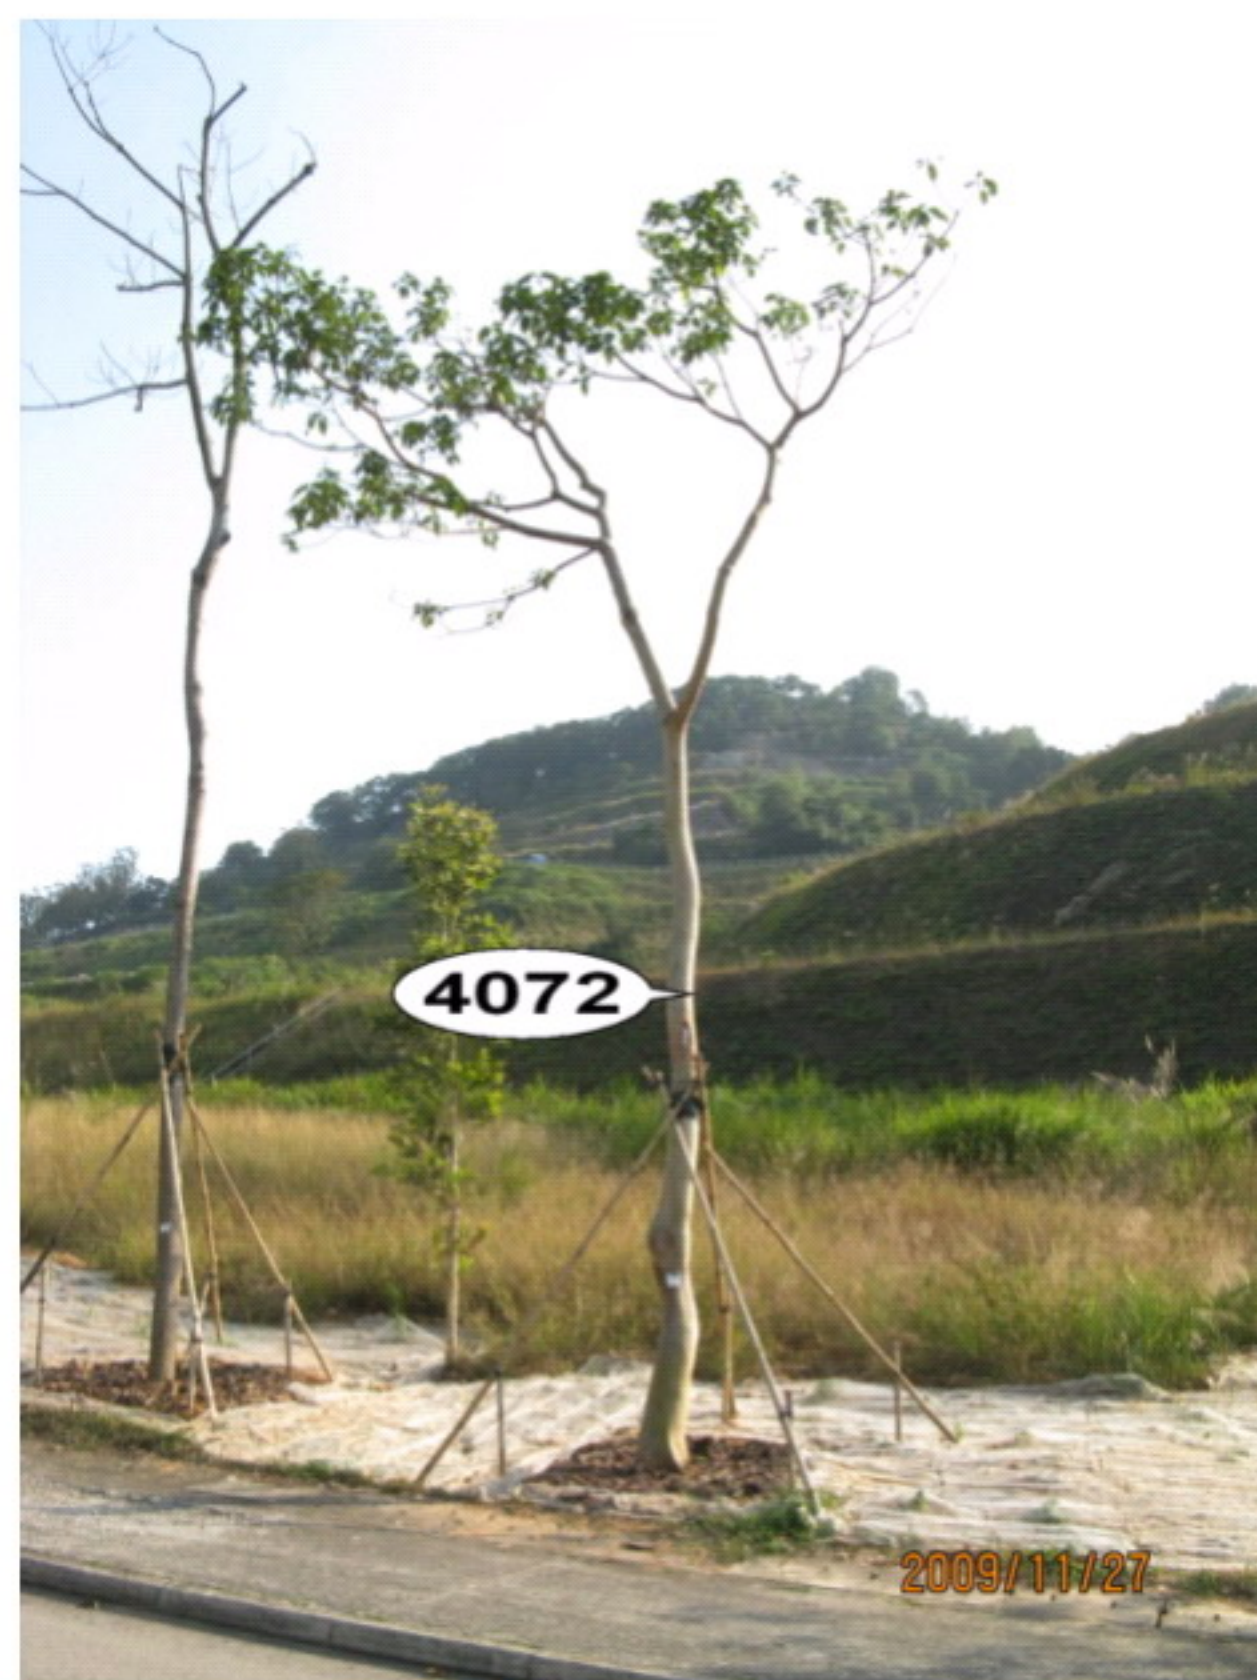
Tree No: 4072

| Tree Number | Species | Chinese name | Height (m) | Diameter (m) | Spread (m) | Remark | | |
|---|---|---|---|---|---|---|---|---|
| 4072 | <i>Ficus variegata</i> | 青果榕 | 6 | 0.13 | 3 | Poor condition, Leave generating, Fork | Poor condition, Sparse crown, loose bark, bark damage | Poor condition, Sparse crown, loose bark, bark damage |

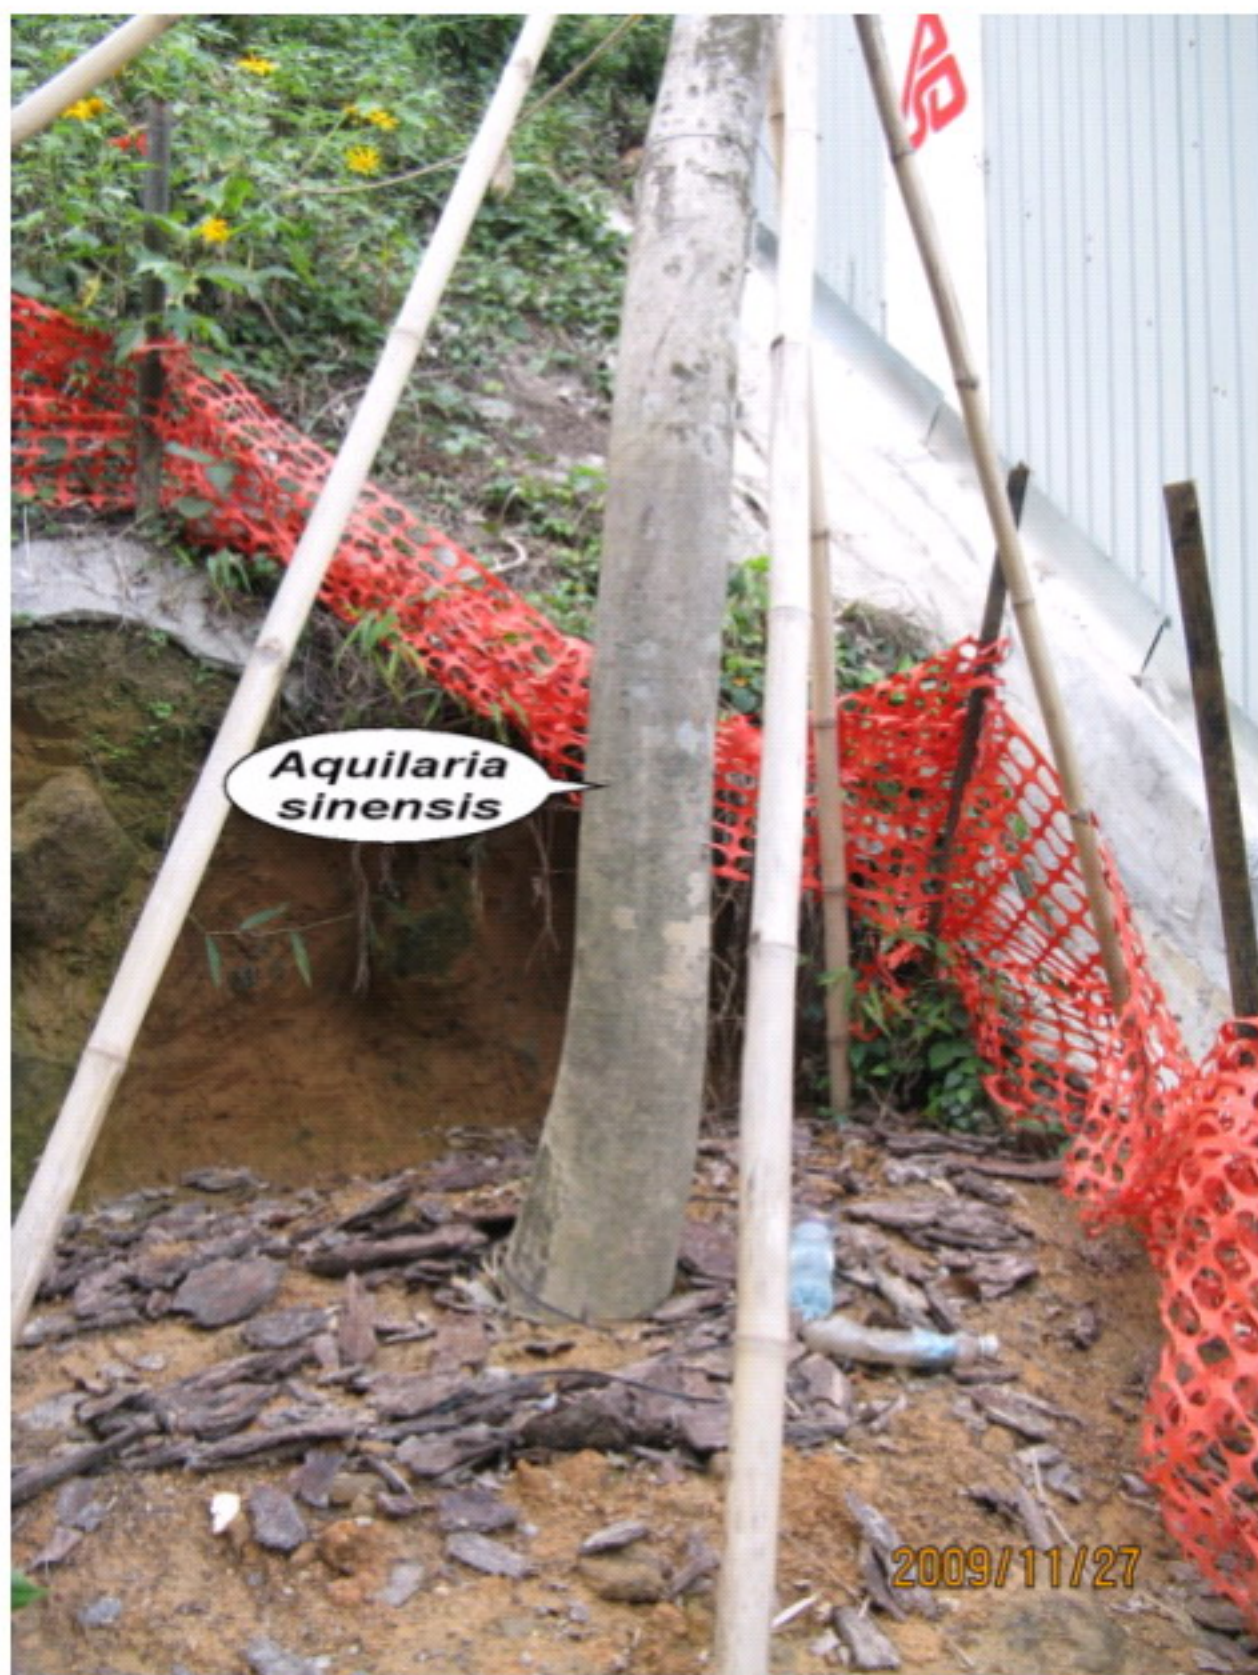
*Aquilaria sinensis*

| Species | Height<br>(m) | Diameter<br>(m) | Spread<br>(m) | Remark | | |
|---|---|---|---|---|---|---|
| <i>Aquilaria sinensis</i> | 8 | 0.2 | 4 | Fair condition | Fair condition | Fair condition |

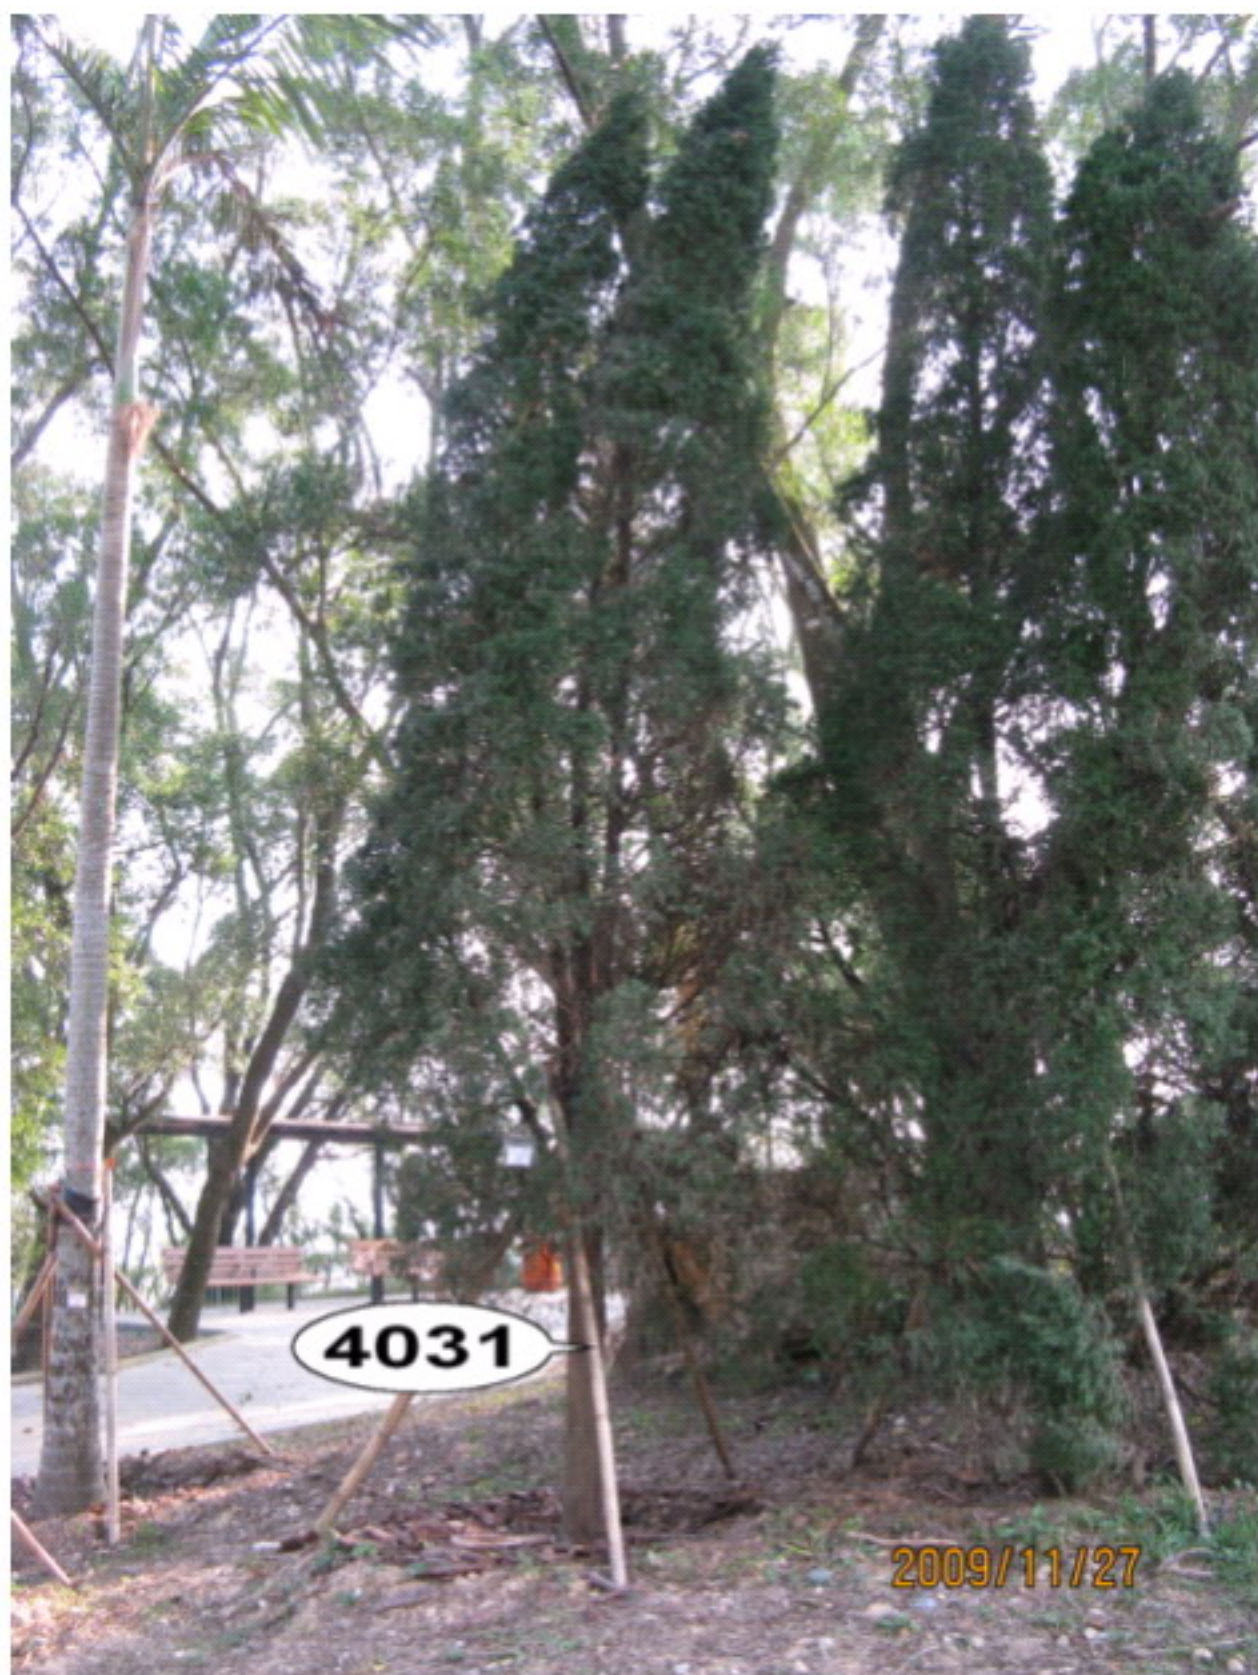
Tree No: 4031

| Tree Number | Species | Chinese name | Height (m) | Diameter (m) | Spread (m) | Remark | | |
|---|---|---|---|---|---|---|---|---|
| 4031 | <i>Juniperus chinensis var.kaizuca</i> | 龍柏 | 5 | 0.12 | 2 | Fair condition | Fair condition | Fair condition |

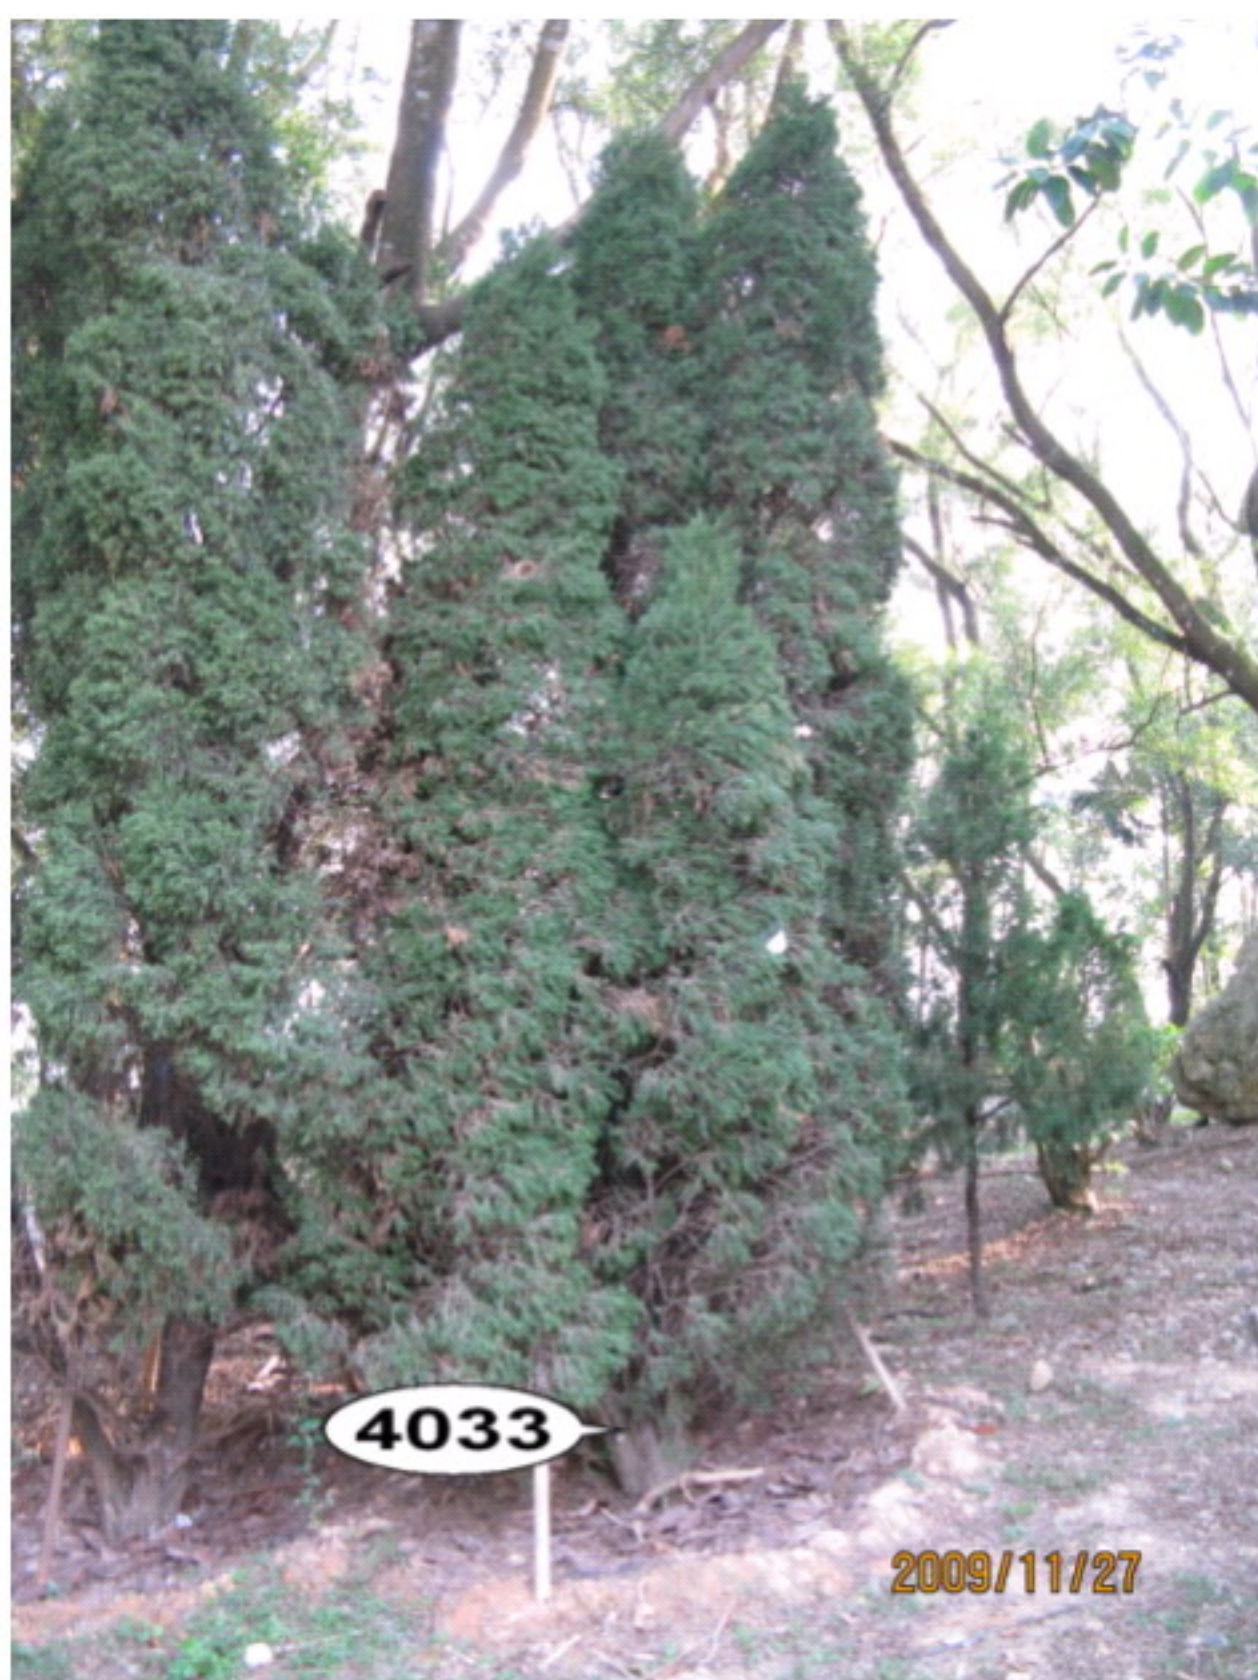
Tree No: 4033

| Tree Number | Species | Chinese name | Height (m) | Diameter (m) | Spread (m) | Remark | | |
|---|---|---|---|---|---|---|---|---|
| 4033 | <i>Juniperus chinensis var.kaizuca</i> | 龍柏 | 4 | 0.13 | 2 | Fair condition | Fair condition | Fair condition |

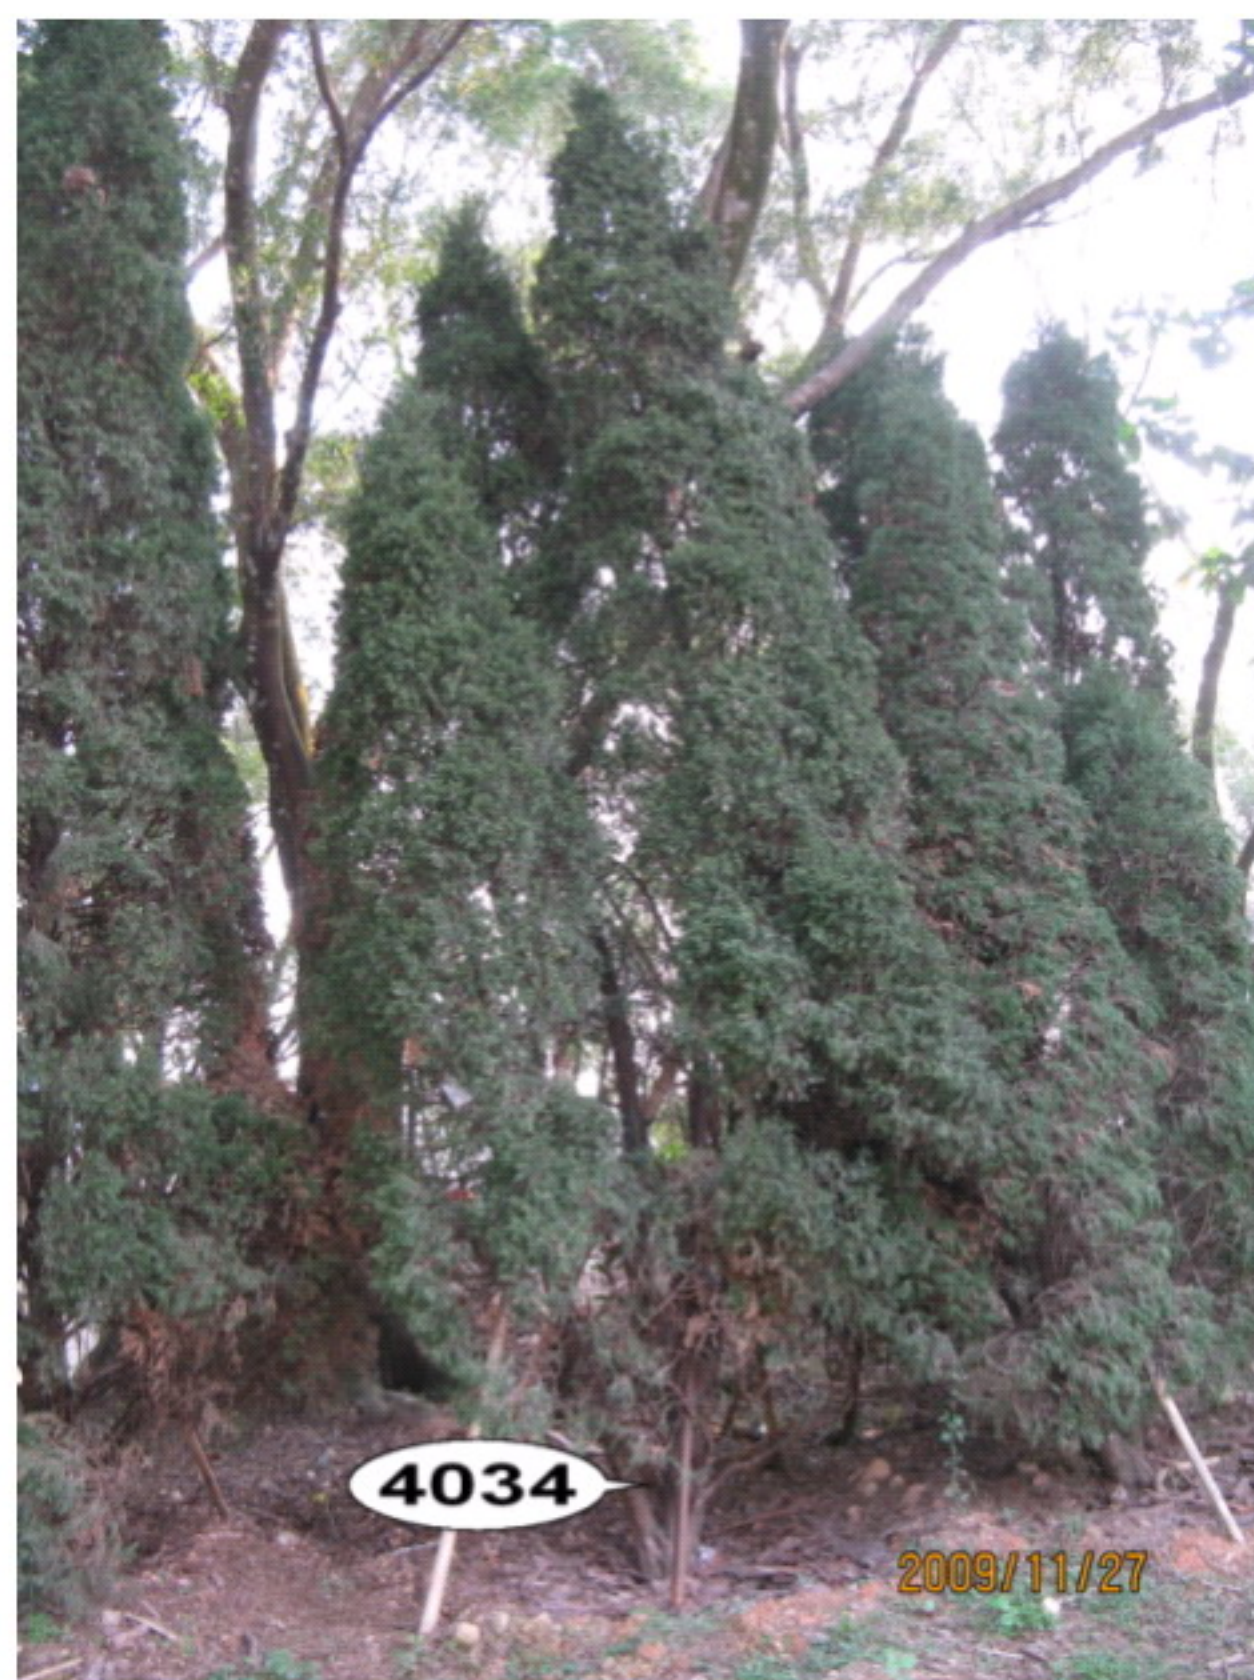
Tree No: 4034

| Tree Number | Species | Chinese name | Height (m) | Diameter (m) | Spread (m) | Remark | | |
|---|---|---|---|---|---|---|---|---|
| 4034 | <i>Juniperus chinensis var.kaizuca</i> | 龍柏 | 4 | 0.13 | 2 | Fair condition | Fair condition | Fair condition |

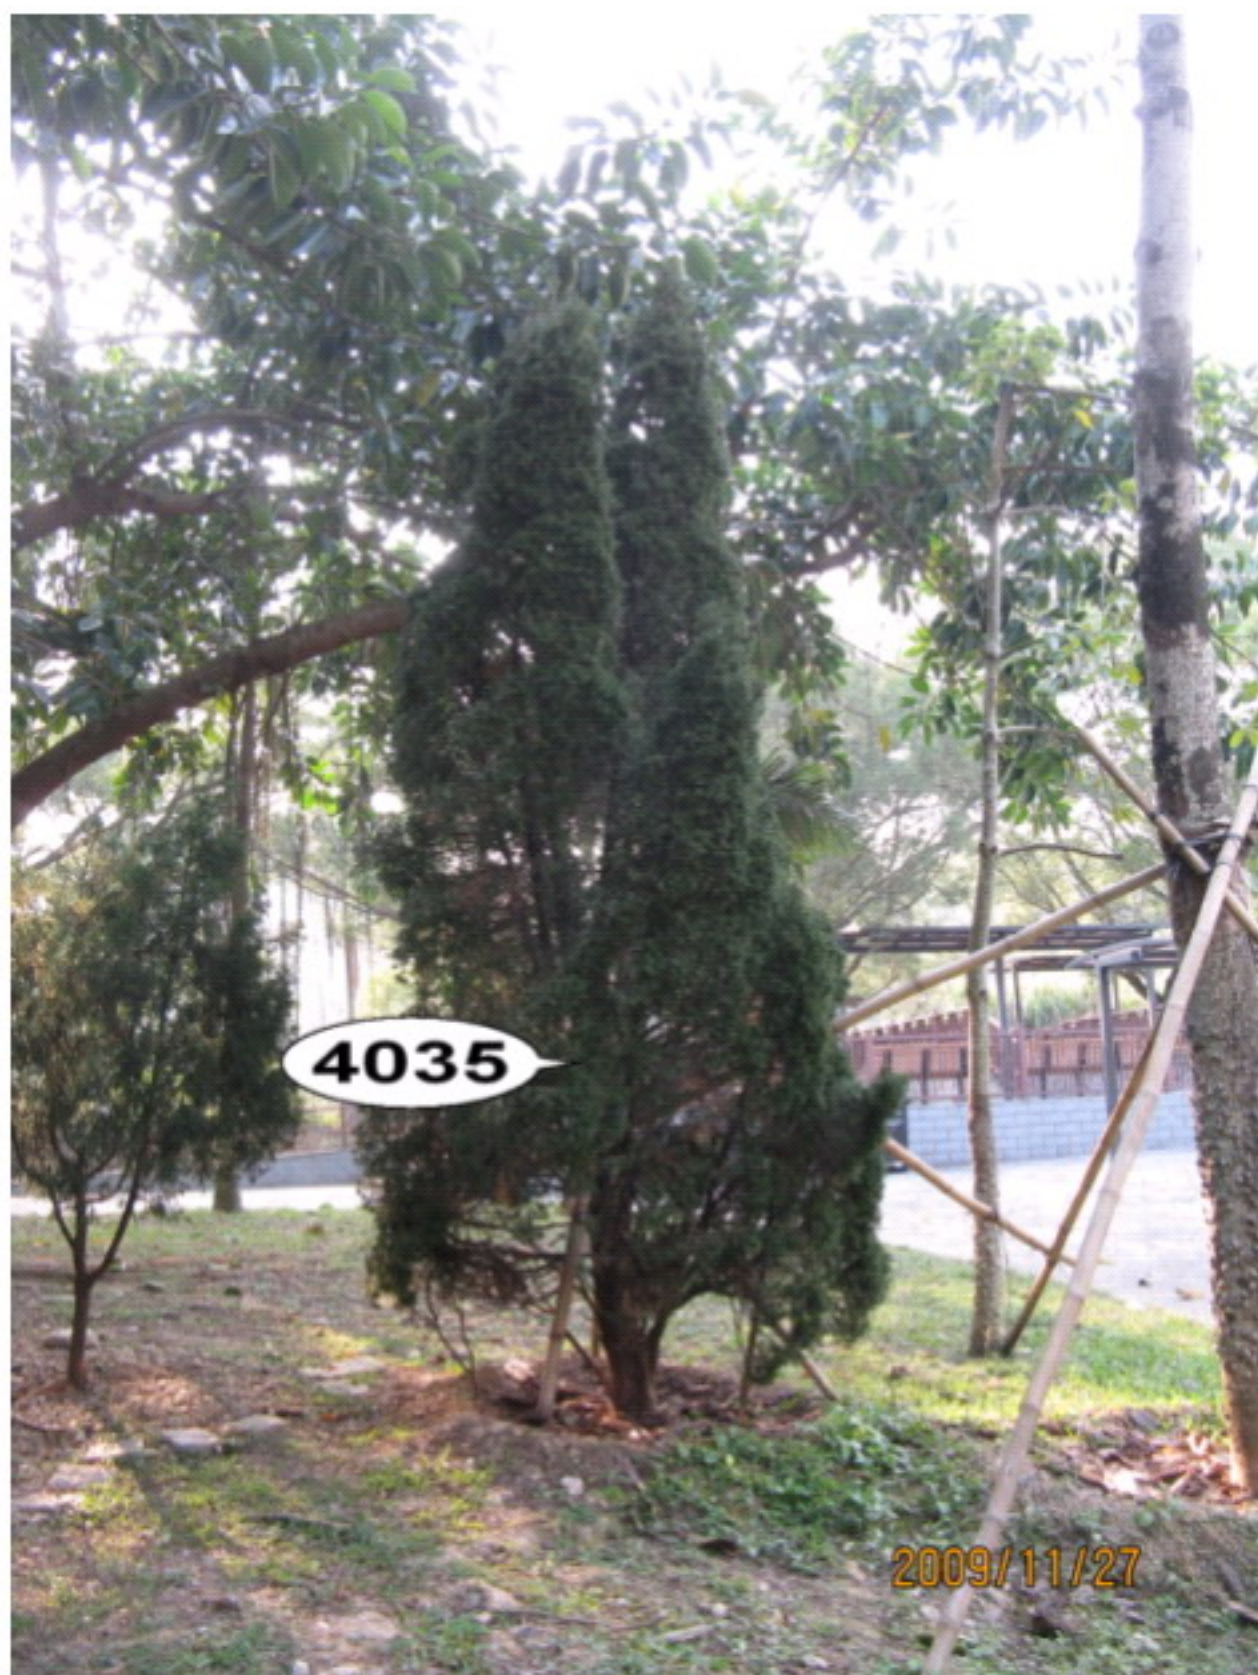
Tree No: 4035

| Tree Number | Species | Chinese name | Height (m) | Diameter (m) | Spread (m) | Remark | | |
|---|---|---|---|---|---|---|---|---|
| 4035 | <i>Juniperus chinensis var.kaizuca</i> | 龍柏 | 4 | 0.16 | 2 | Fair condition | Fair condition | Fair condition |

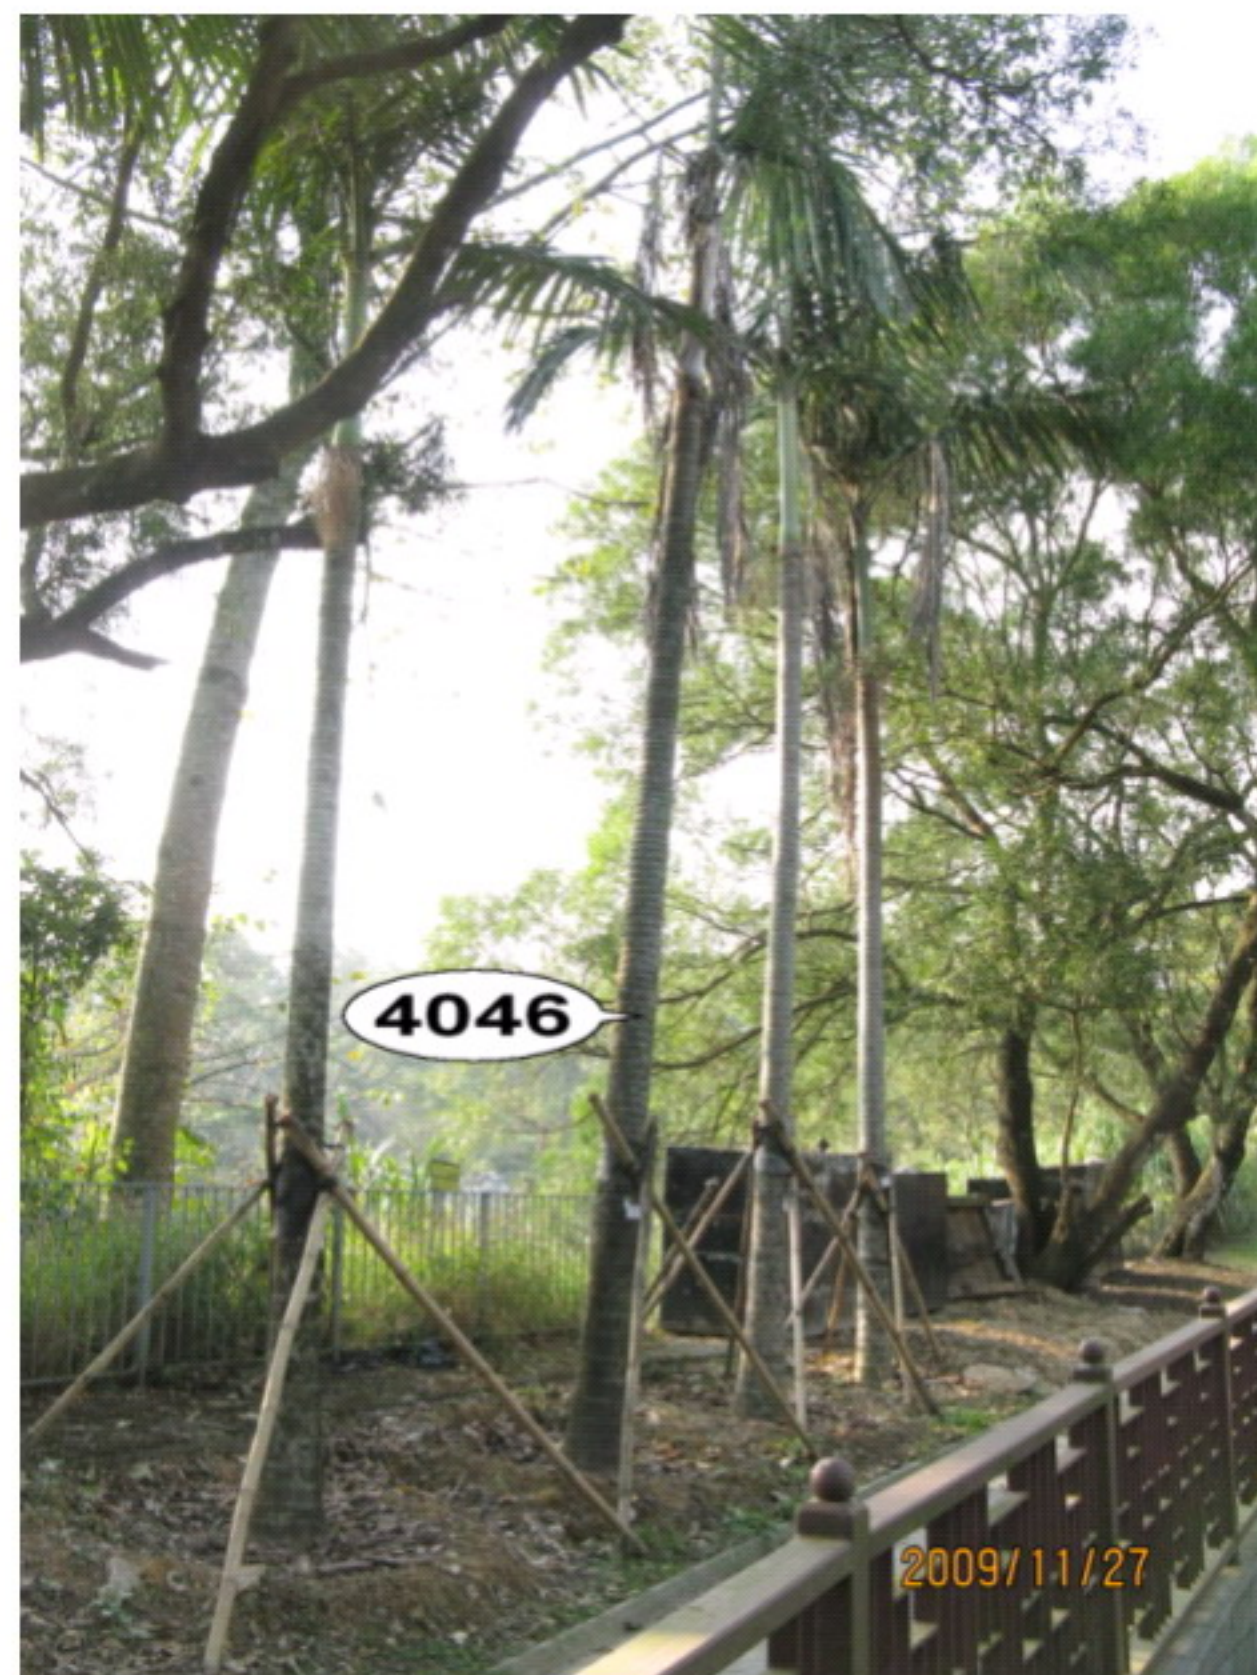
Tree No: 4046

| Tree Number | Species | Chinese name | Height (m) | Diameter (m) | Spread (m) | Remark | | |
|---|---|---|---|---|---|---|---|---|
| 4046 | <i>Archontophoenix alexandrae</i> | 假檳榔 | 5 | 0.19 | 4 | Fair condition, Yellow leave | Fair condition, Yellow leave | Fair condition, Yellow leave |

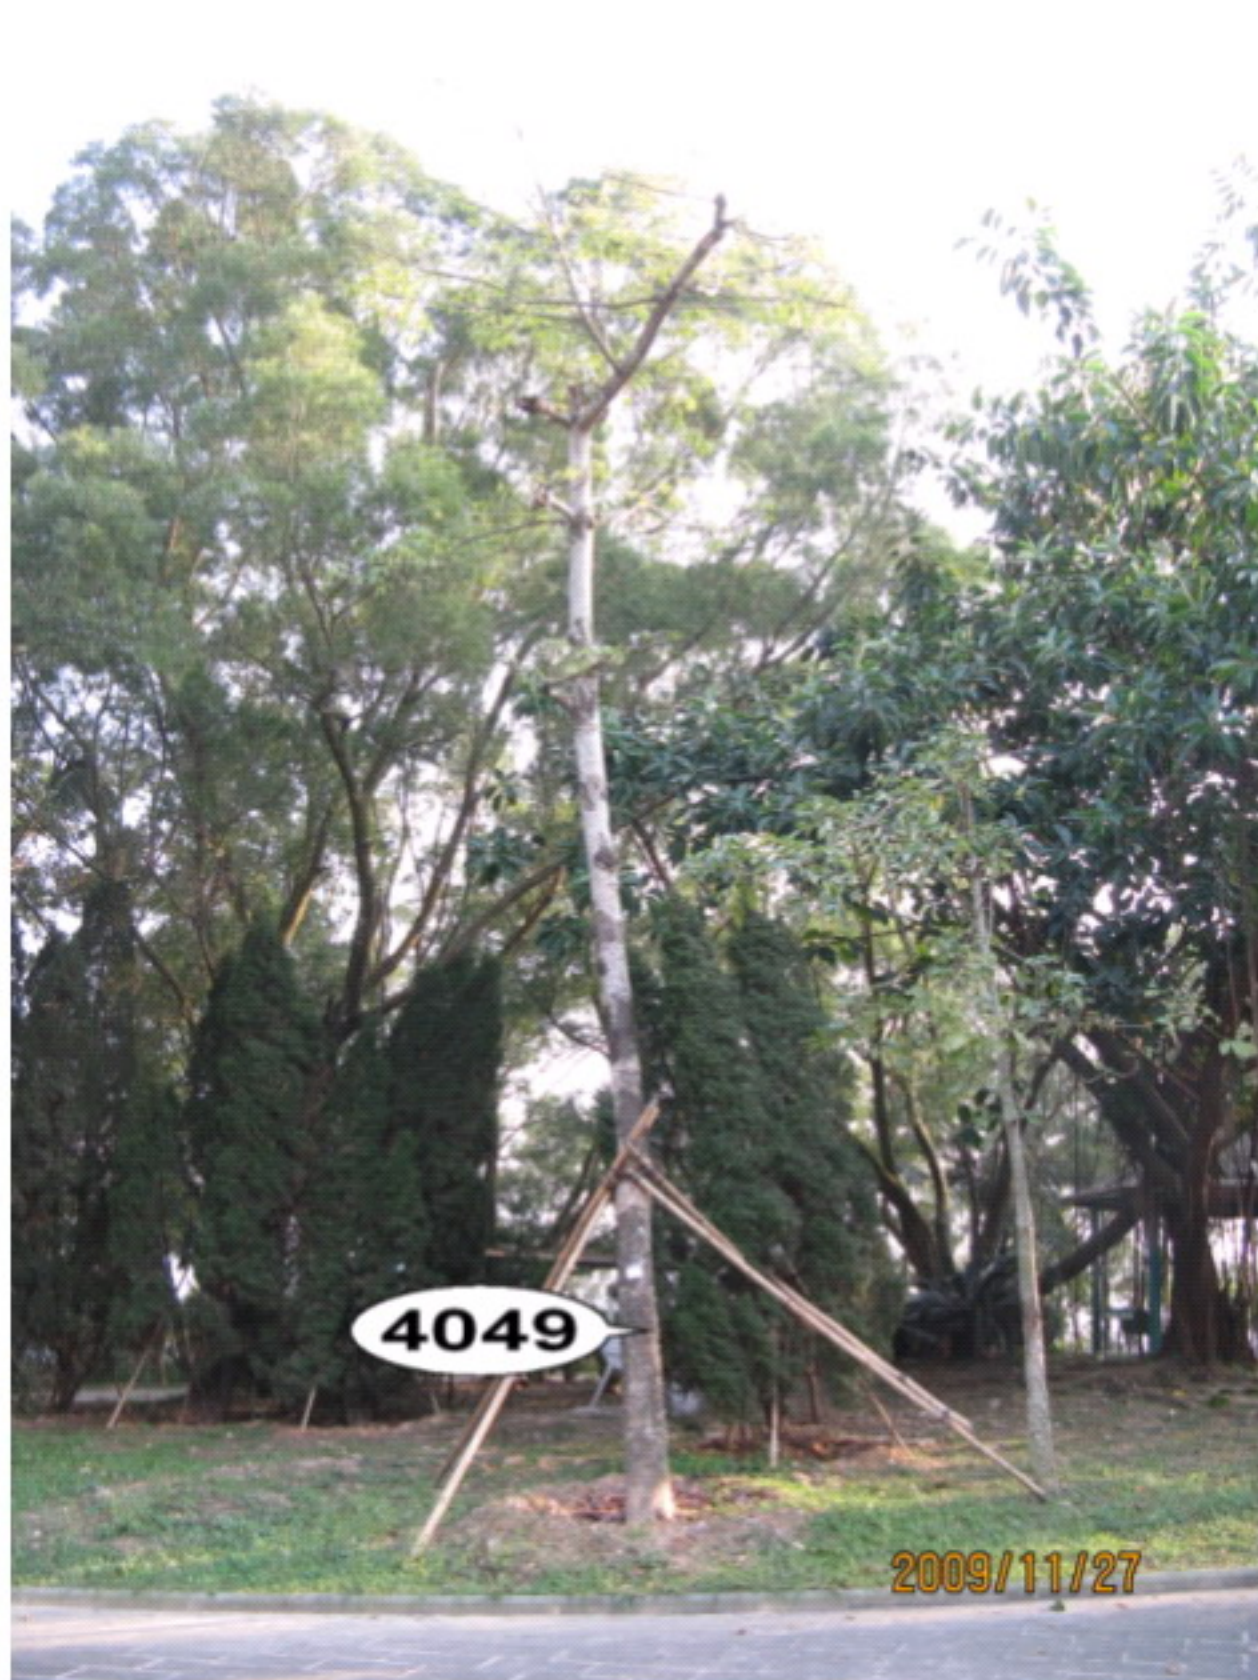
Tree No: 4049

| Tree Number | Species | Chinese name | Height (m) | Diameter (m) | Spread (m) | Remark | | |
|---|---|---|---|---|---|---|---|---|
| 4049 | <i>Ficus hispida</i> | 對葉榕 | 6 | 0.16 | 5 | Poor condition, Fork | Missing from monitoring site | Missing from monitoring site |
