**PROVISION OF CREMATORS AT  
WO HOP SHEK CREMATORIUM**

**ENVIRONMENTAL MONITORING &  
AUDIT REPORT (NOVEMBER 2009)**

**ALLIED ENVIRONMENTAL CONSULTANTS LTD.**

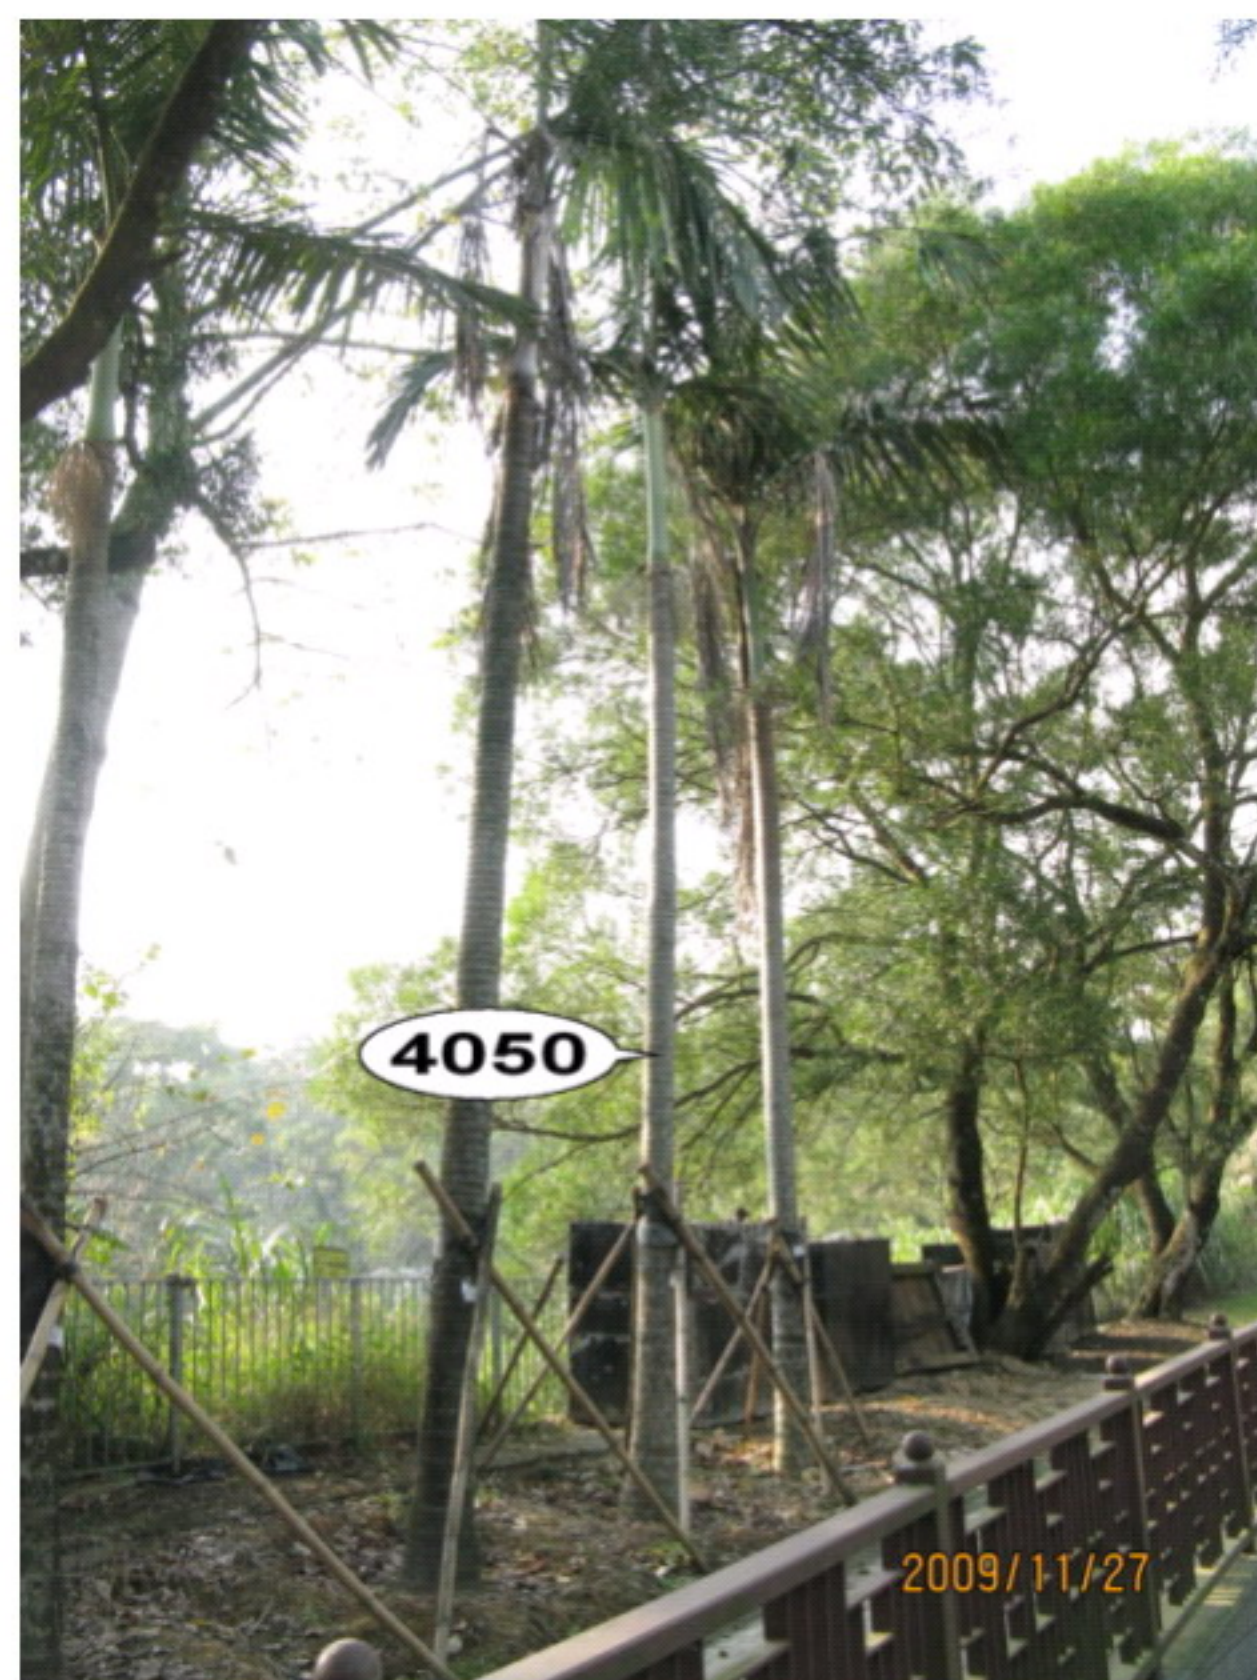
Tree No: 4050

| Tree Number | Species | Chinese name | Height (m) | Diameter (m) | Spread (m) | Remark | | |
|---|---|---|---|---|---|---|---|---|
| 4050 | <i>Archontophoenix alexandrae</i> | 假檳榔 | 5 | 0.16 | 4 | Fair condition, Yellow leave | Fair condition, Yellow leave | Fair condition, Yellow leave |

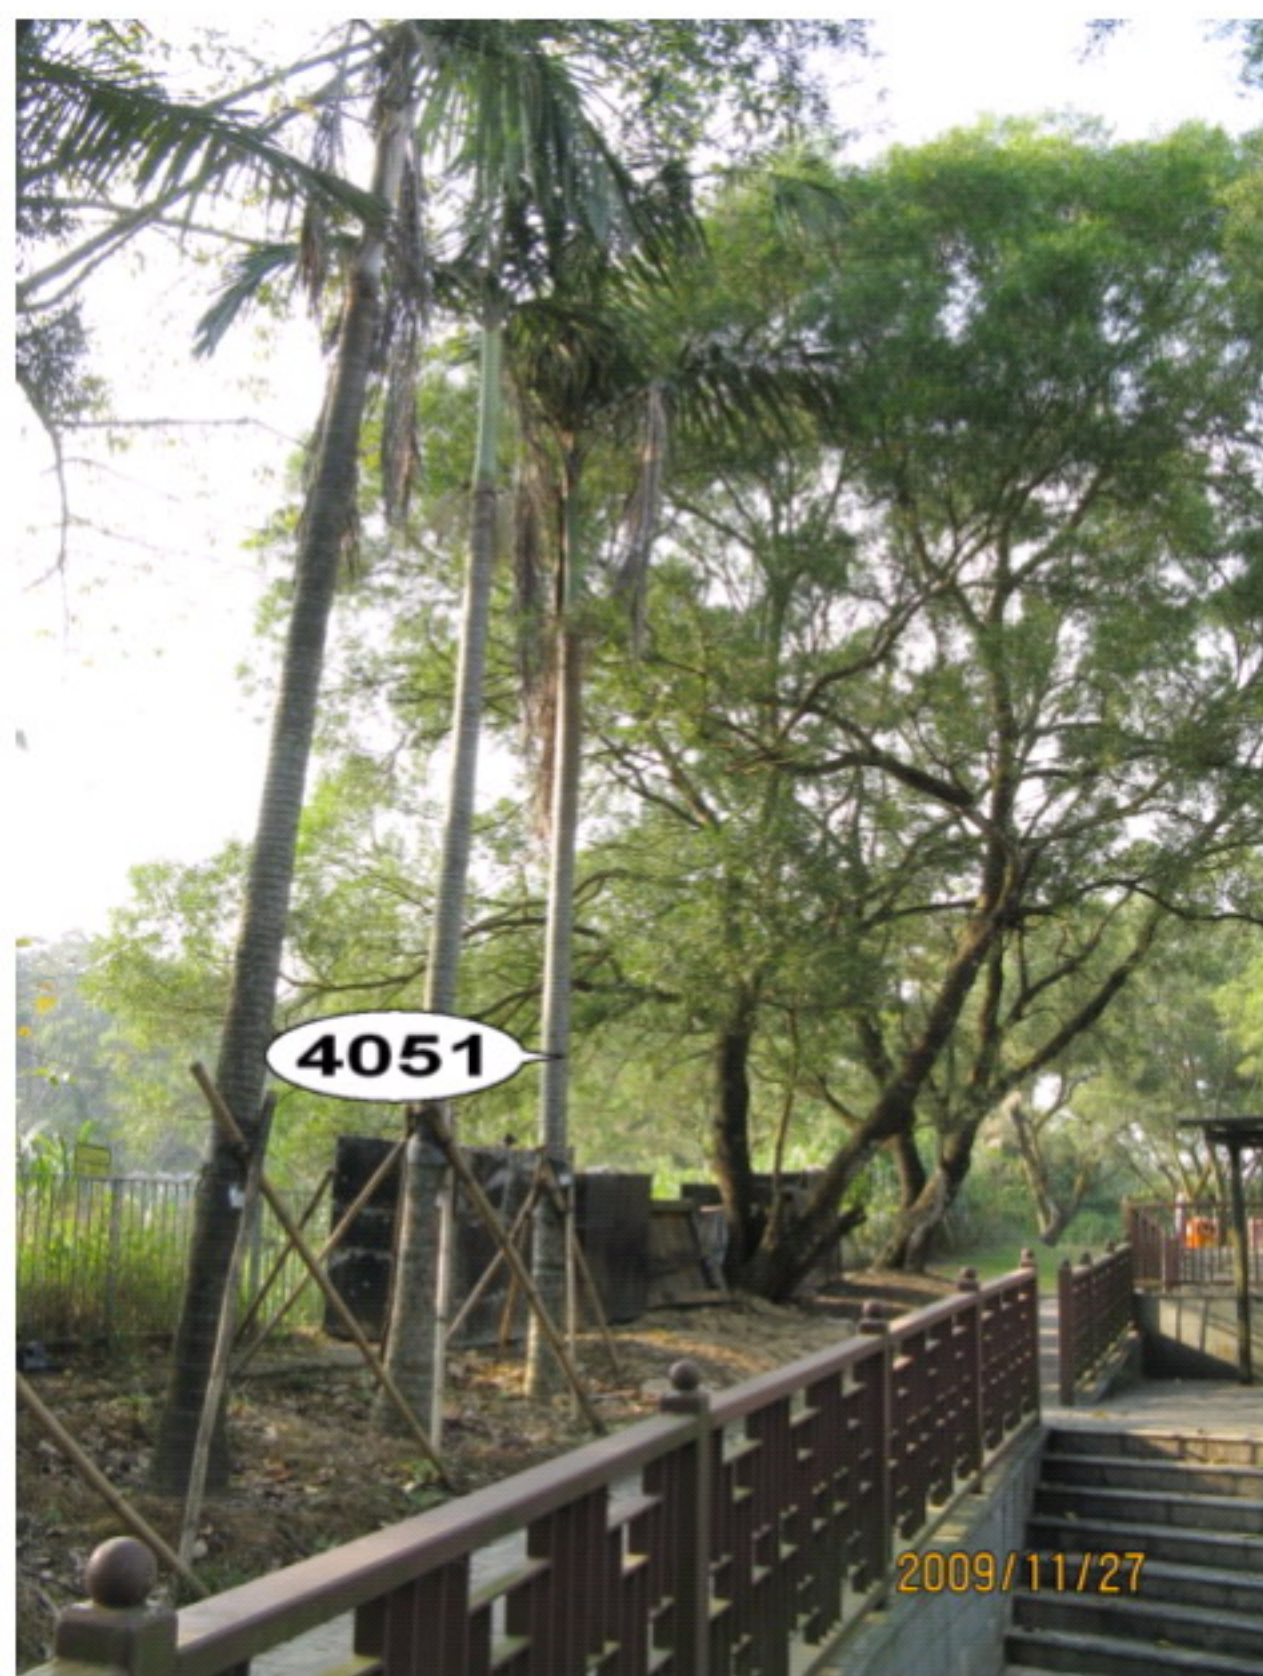
Tree No: 4051

| Tree Number | Species | Chinese name | Height (m) | Diameter (m) | Spread (m) | Remark | | |
|---|---|---|---|---|---|---|---|---|
| 4051 | <i>Archontophoenix alexandrae</i> | 假檳榔 | 5 | 0.18 | 3 | Fair condition, Yellow leave | Fair condition, Yellow leave | Fair condition, Yellow leave |

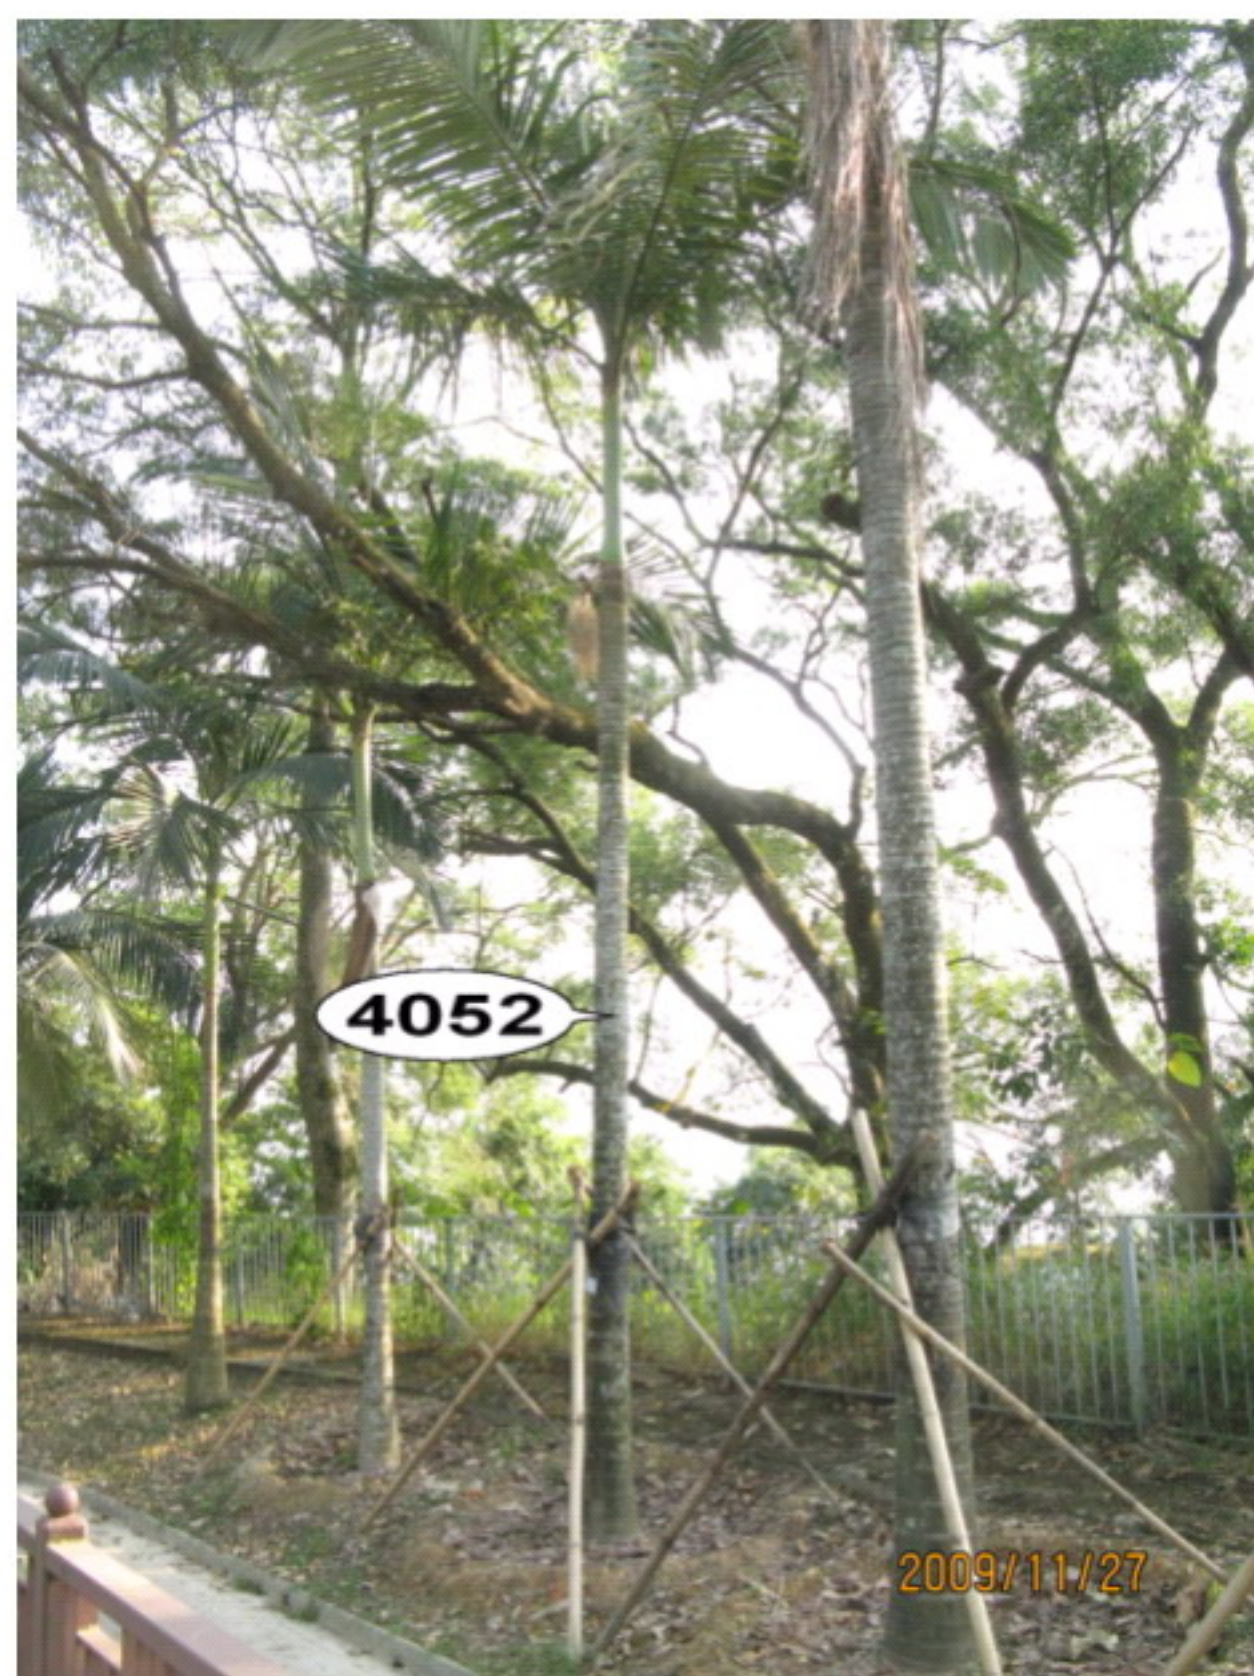
Tree No: 4052

| Tree Number | Species | Chinese name | Height (m) | Diameter (m) | Spread (m) | Remark | | |
|---|---|---|---|---|---|---|---|---|
| 4052 | <i>Archontophoenix alexandrae</i> | 假檳榔 | 5 | 0.17 | 3 | Fair condition, Yellow leave | Fair condition, Yellow leave | Fair condition, Yellow leave |

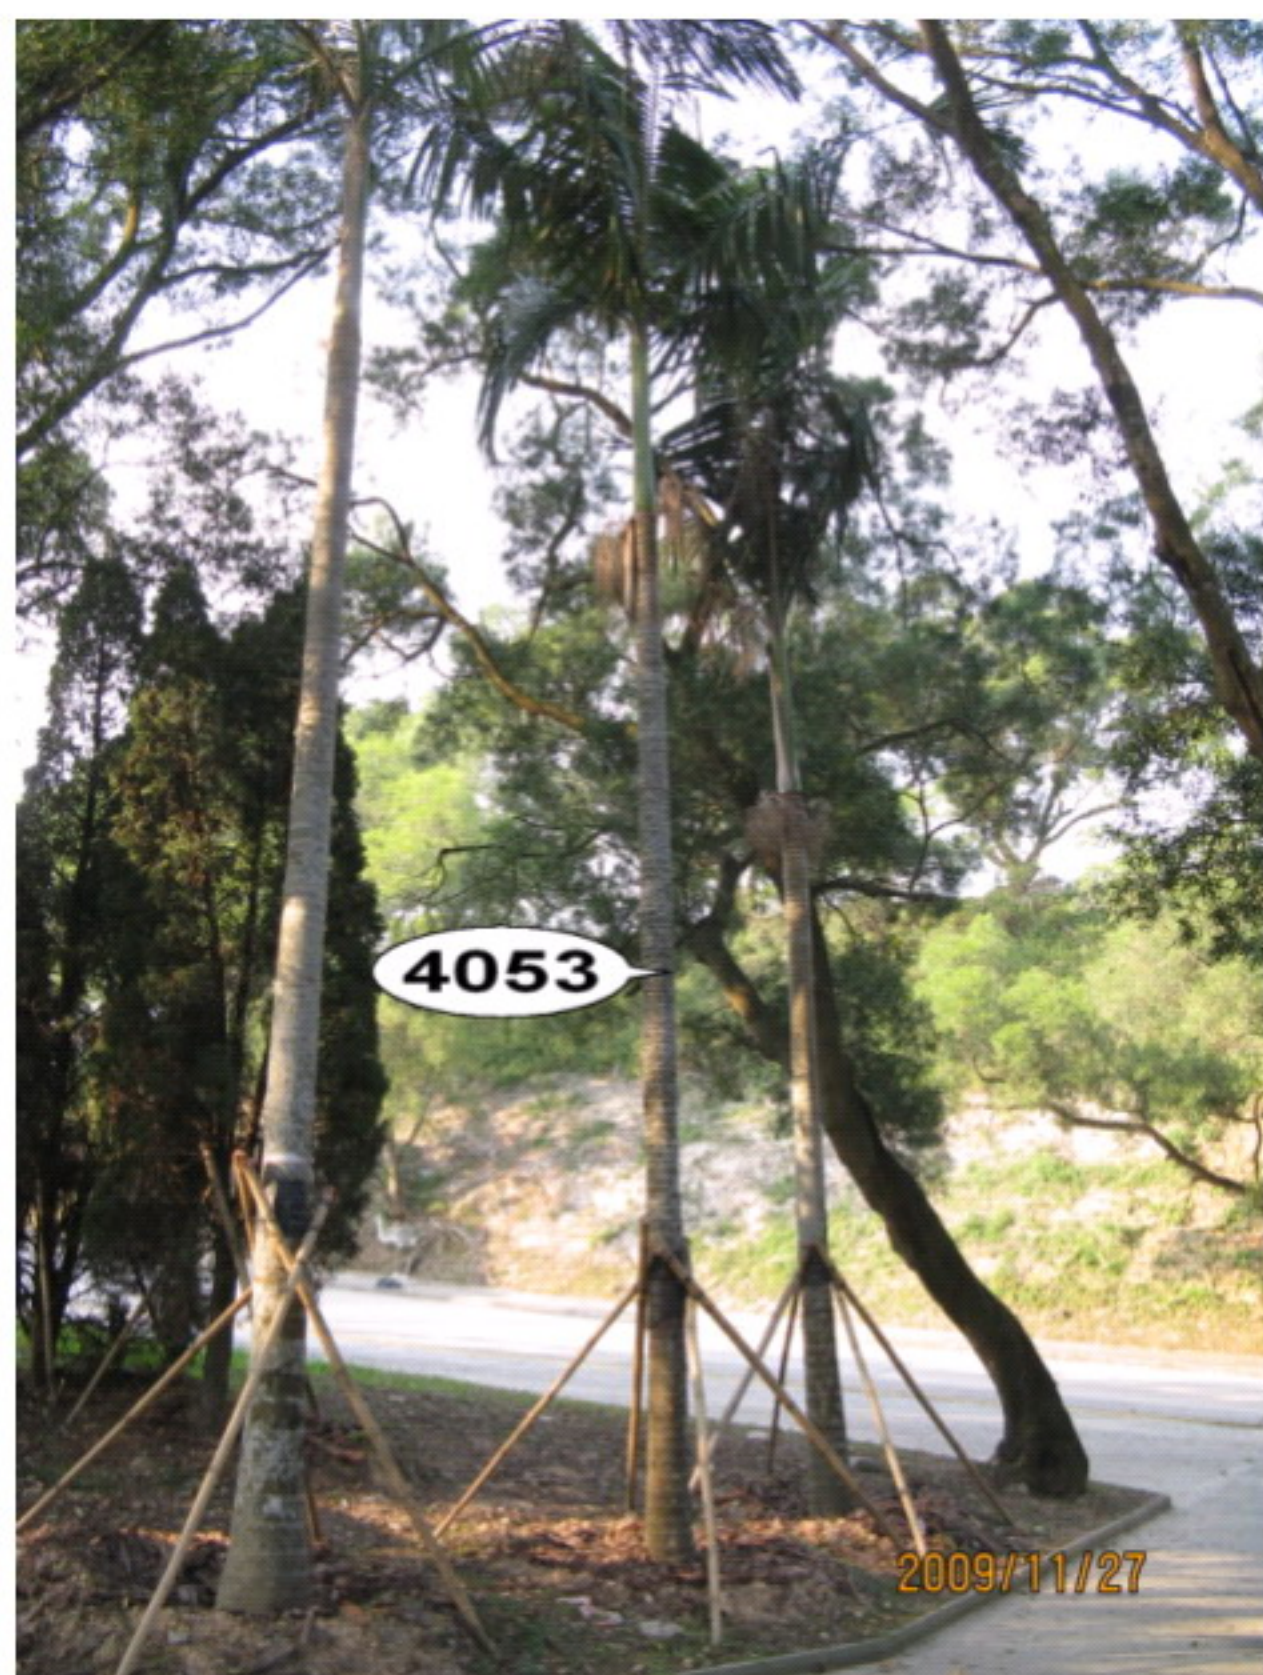
Tree No: 4053

| Tree Number | Species | Chinese name | Height (m) | Diameter (m) | Spread (m) | Remark | | |
|---|---|---|---|---|---|---|---|---|
| 4053 | <i>Archontophoenix alexandrae</i> | 假檳榔 | 4 | 0.2 | 3 | Fair condition, Yellow leave | Fair condition, Yellow leave | Fair condition, Yellow leave |

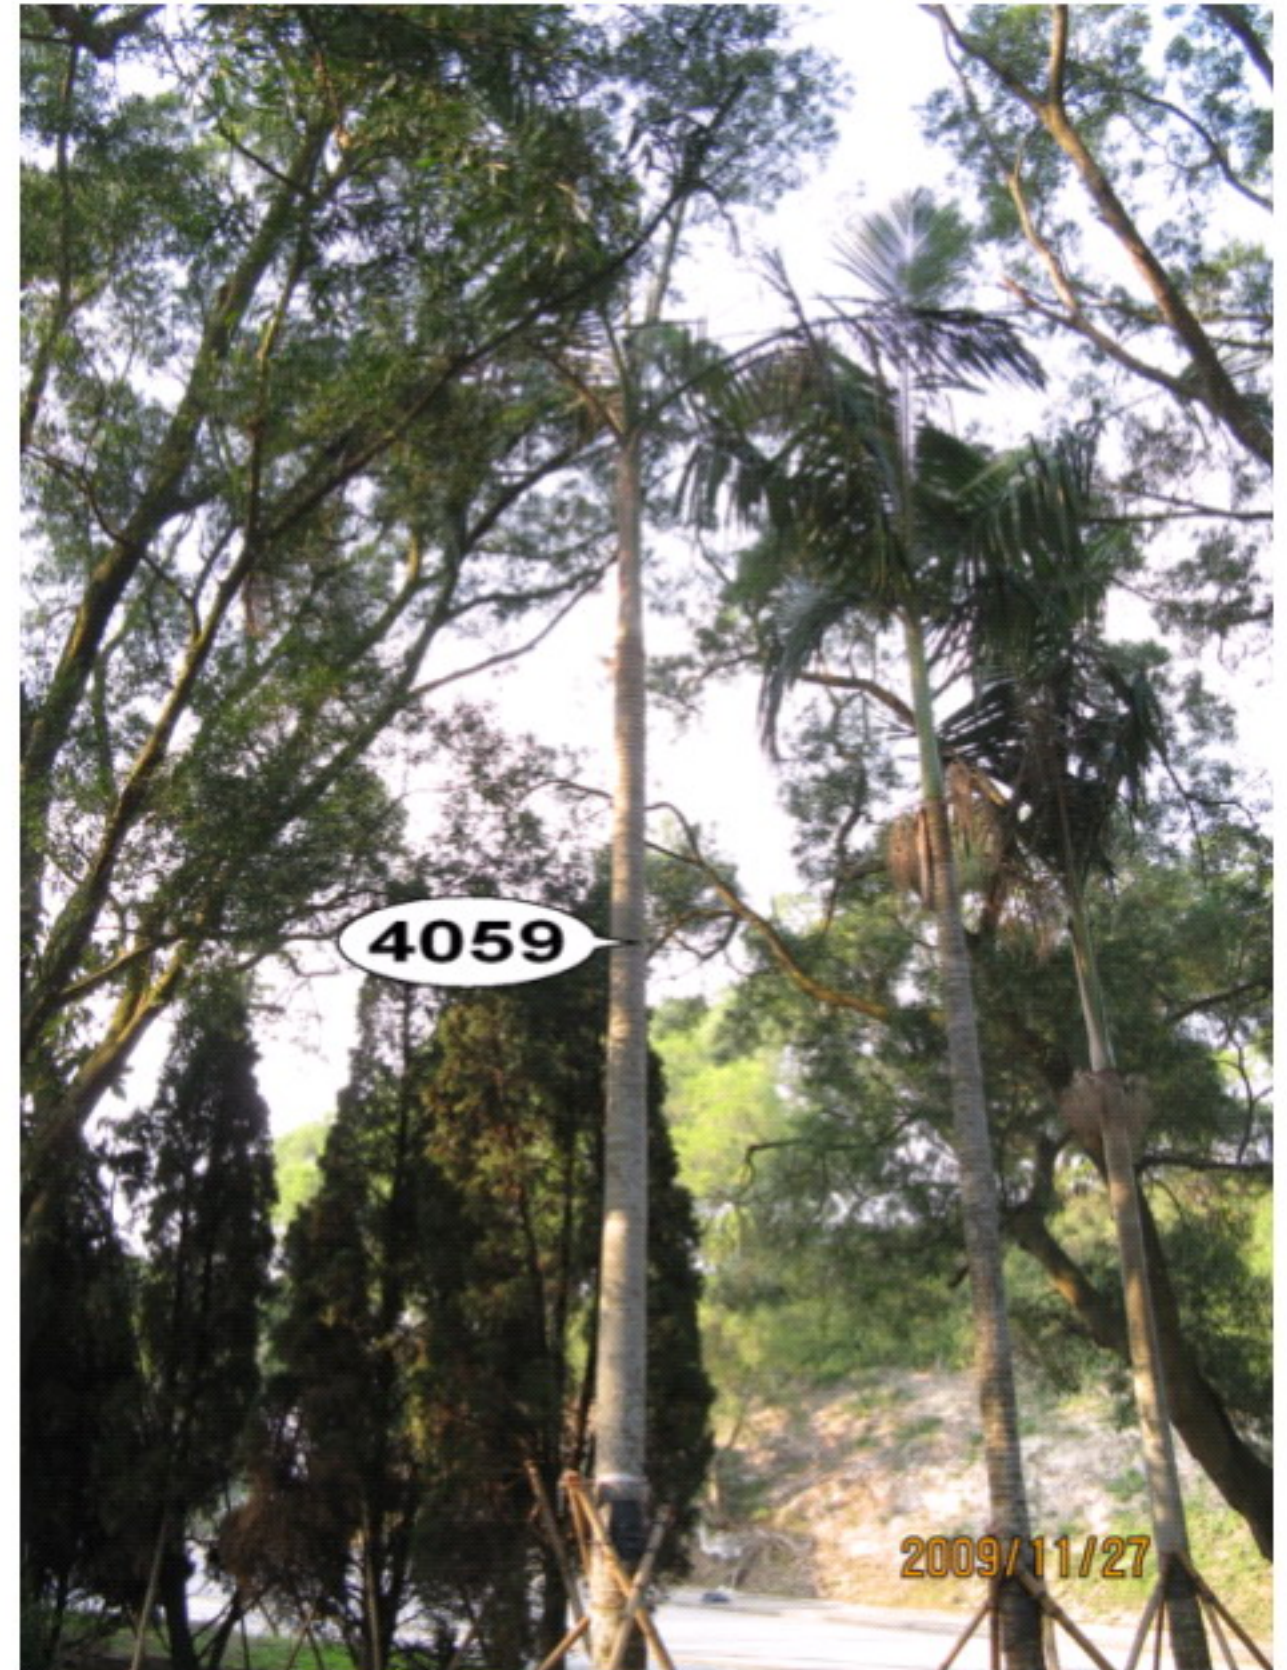
Tree No: 4059

| Tree Number | Species | Chinese name | Height (m) | Diameter (m) | Spread (m) | Remark | | |
|---|---|---|---|---|---|---|---|---|
| 4059 | <i>Archontophoenix alexandrae</i> | 假檳榔 | 6 | 0.23 | 4 | Fair condition, Yellow leave | Fair condition, Yellow leave | Fair condition, Yellow leave |

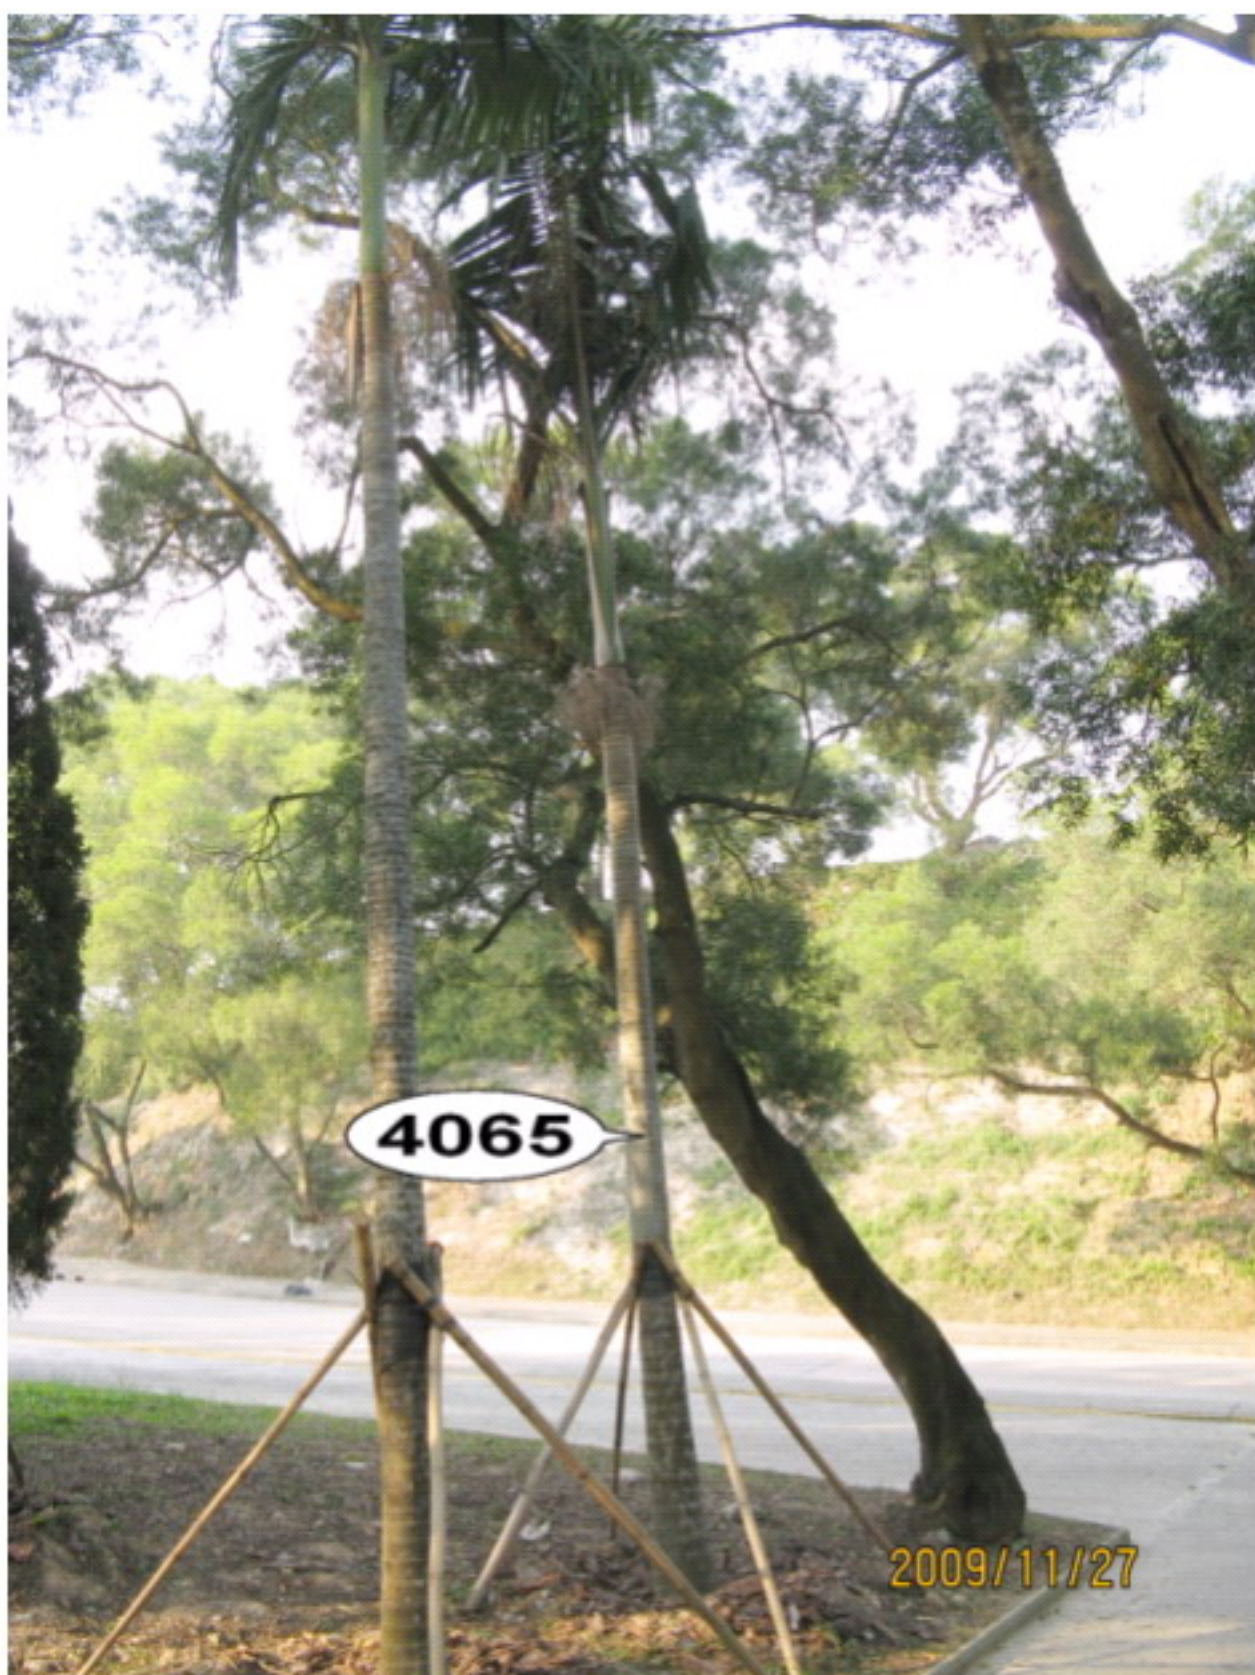
Tree No: 4065

| Tree Number | Species | Chinese name | Height (m) | Diameter (m) | Spread (m) | Remark | | |
|---|---|---|---|---|---|---|---|---|
| 4065 | <i>Archontophoenix alexandrae</i> | 假檳榔 | 7 | 0.21 | 4 | Fair condition, Yellow leave | Fair condition, Yellow leave | Fair condition, Yellow leave |

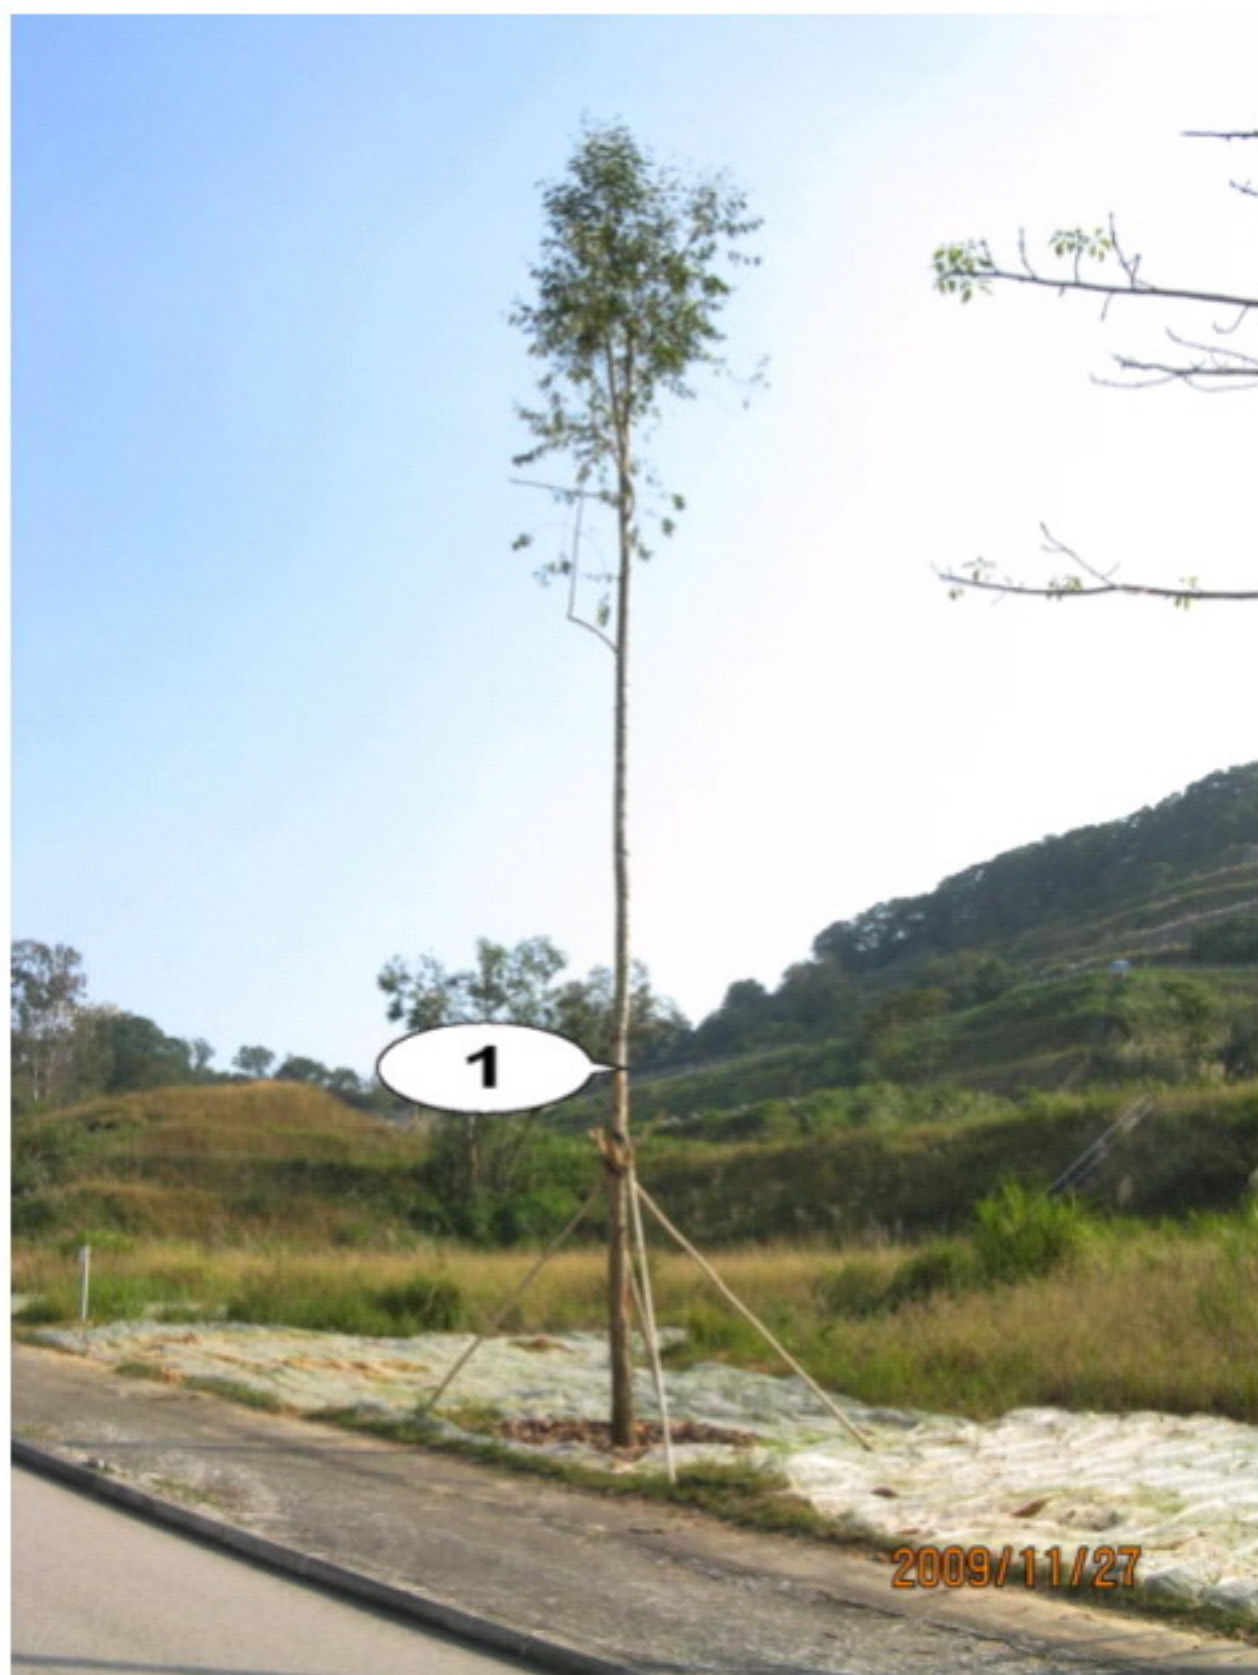
Tree No: 0001

| Tree Number | Species | Chinese name | Height (m) | Diameter (m) | Spread (m) | Remark | | |
|---|---|---|---|---|---|---|---|---|
| 1 | <i>Eucalyptus citriodora</i> | 檸檬桉 | 6 | 0.2 | 1.5 | Not found on site | Fair condition | Fair condition |

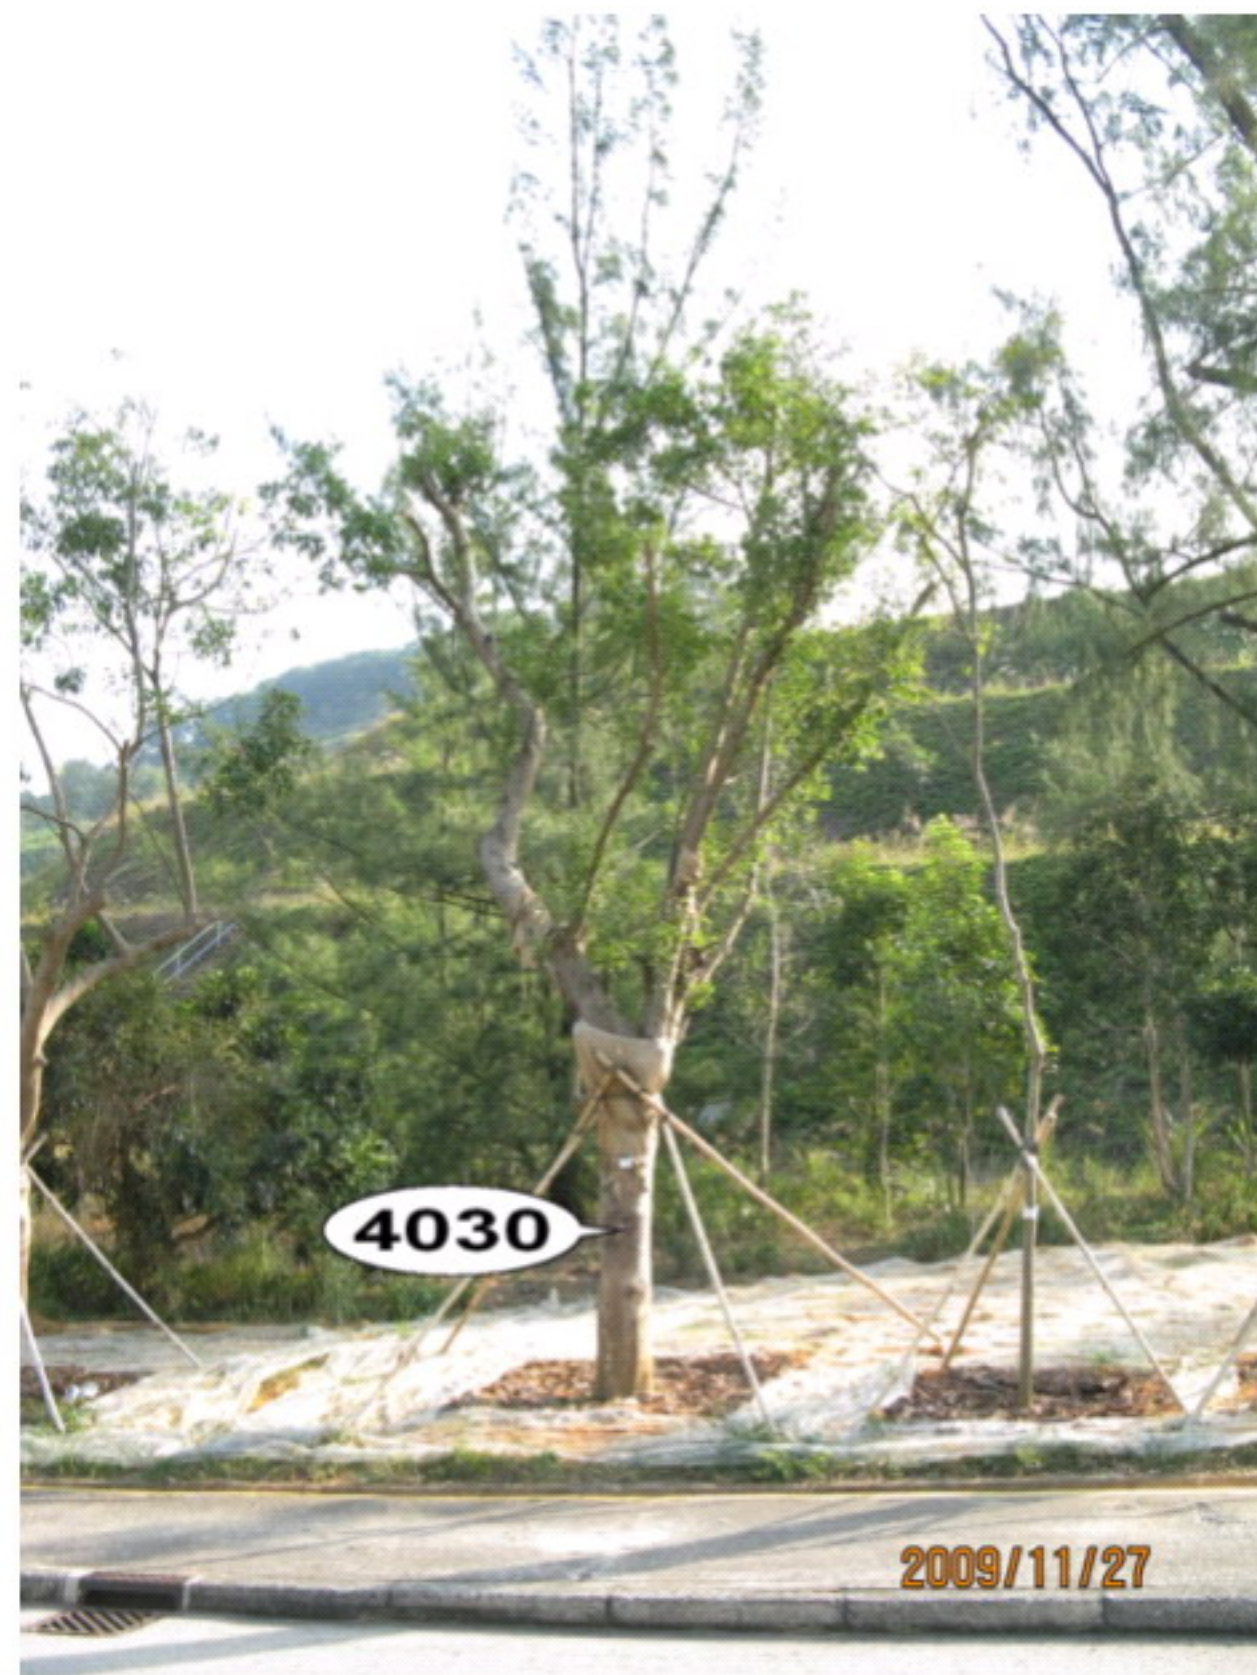
Tree No: 4030

| Tree Number | Species | Chinese name | Height (m) | Diameter (m) | Spread (m) | Remark | | |
|---|---|---|---|---|---|---|---|---|
| 4030 | <i>Cinnamomum burmannii</i> | 陰香 | 5.5 | 0.16 | 4 | Poor condition, Fork, Pruned | Poor condition, Fork, Pruned | Poor condition, Fork, Pruned, Decay |

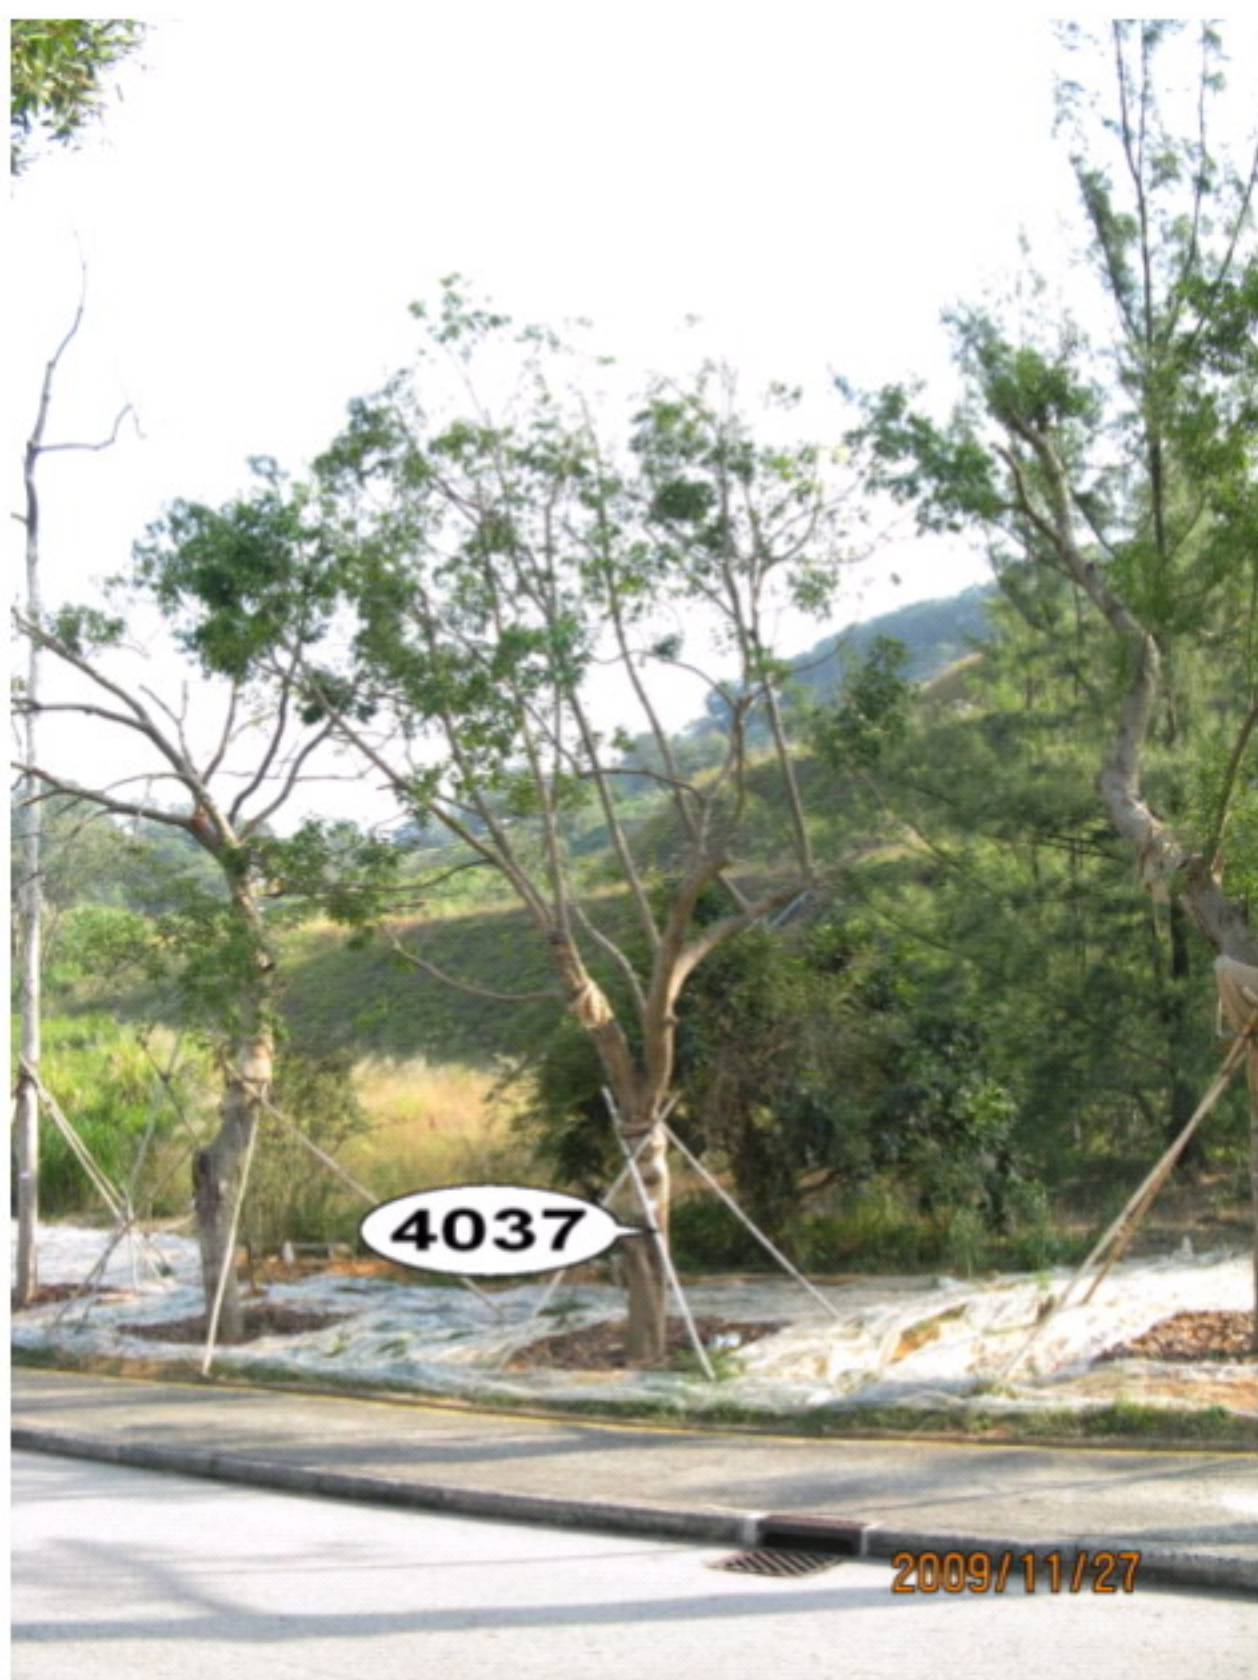
Tree No: 4037

| Tree Number | Species | Chinese name | Height (m) | Diameter (m) | Spread (m) | Remark | | |
|---|---|---|---|---|---|---|---|---|
| 4037 | <i>Cinnamomum burmannii</i> | 陰香 | 6 | 0.25 | 4 | Fair condition, Fork, Pruned | Fair condition, Fork, Pruned | Fair condition, Fork, Pruned |

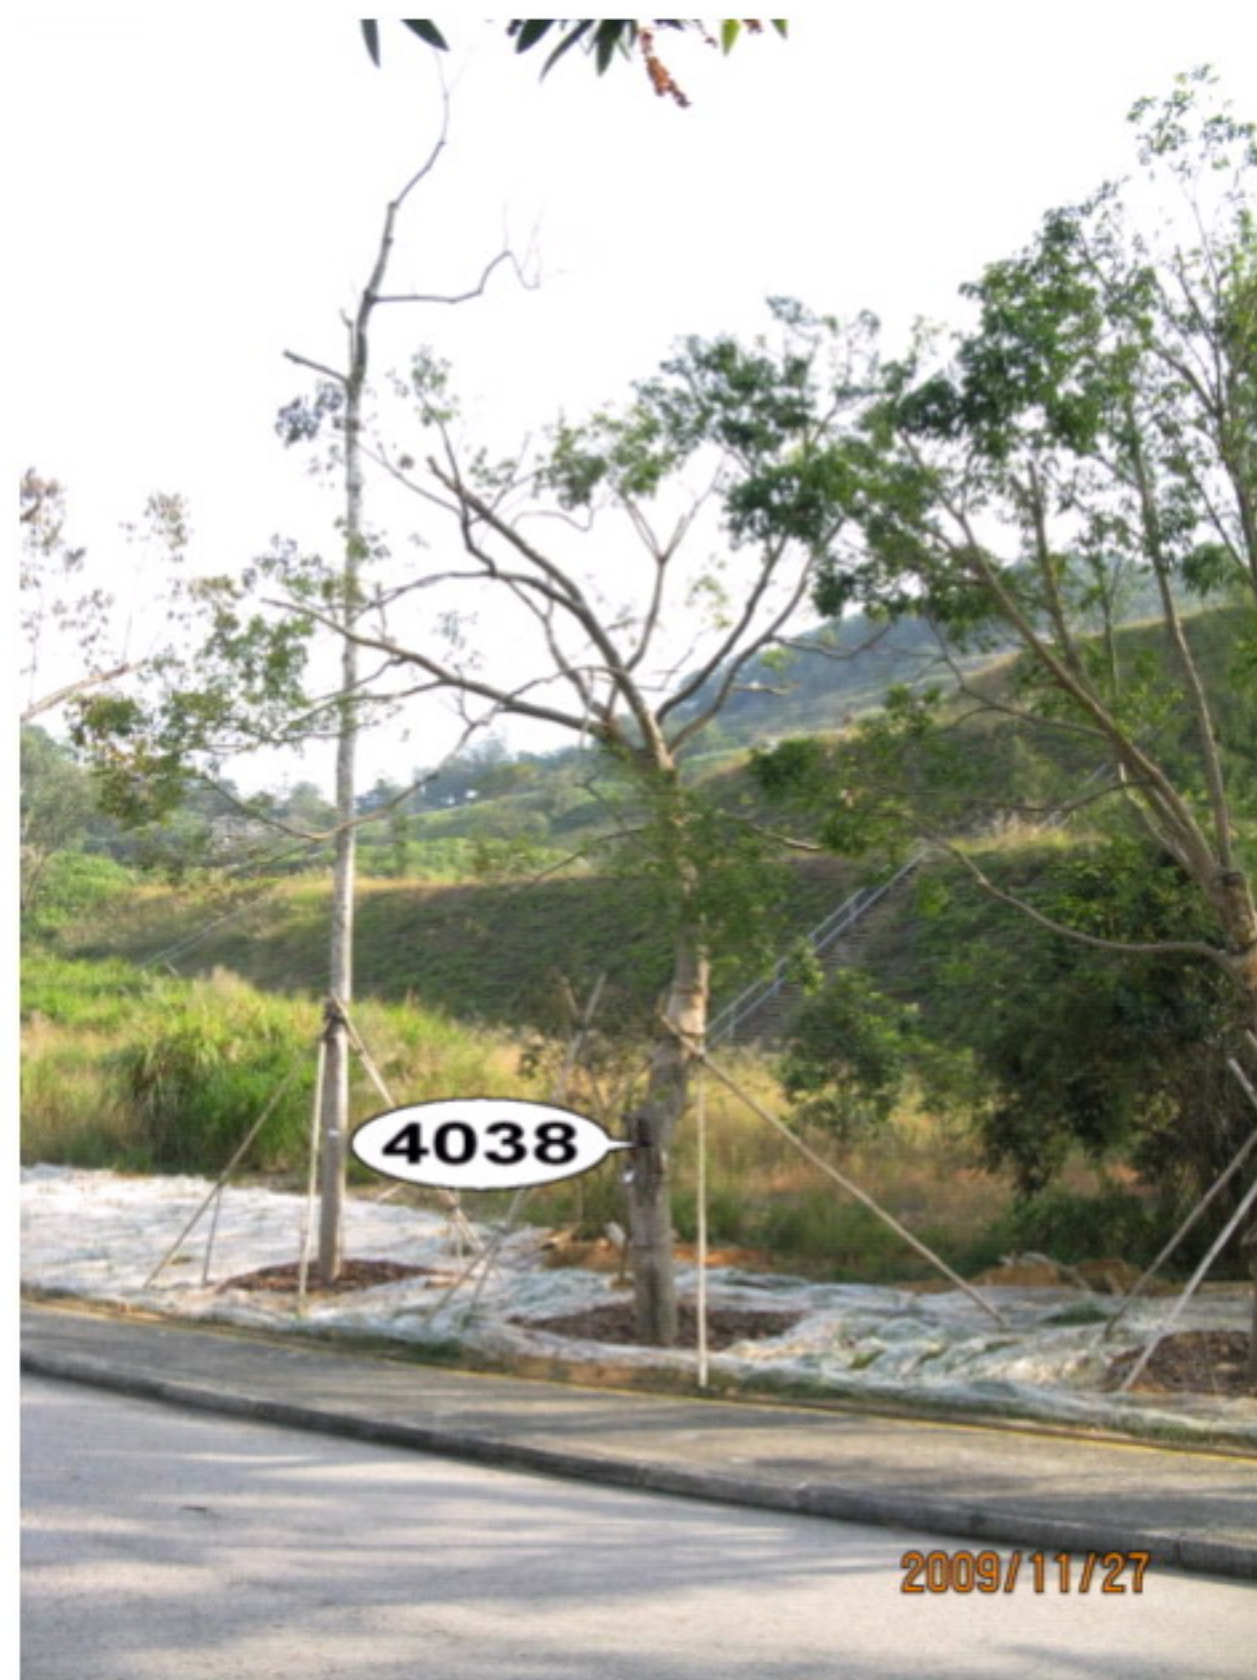
Tree No: 4038

| Tree Number | Species | Chinese name | Height (m) | Diameter (m) | Spread (m) | Remark | | |
|---|---|---|---|---|---|---|---|---|
| 4038 | <i>Cinnamomum burmannii</i> | 陰香 | 6 | 0.25 | 4 | Poor condition, Bark damage | Poor condition, Bark damage, leave generating | Poor condition, Bark damage, leave generating |
