**PROVISION OF CREMATORS AT  
WO HOP SHEK CREMATORIUM**

**ENVIRONMENTAL MONITORING &  
AUDIT REPORT (NOVEMBER 2009)**

**ALLIED ENVIRONMENTAL CONSULTANTS LTD.**

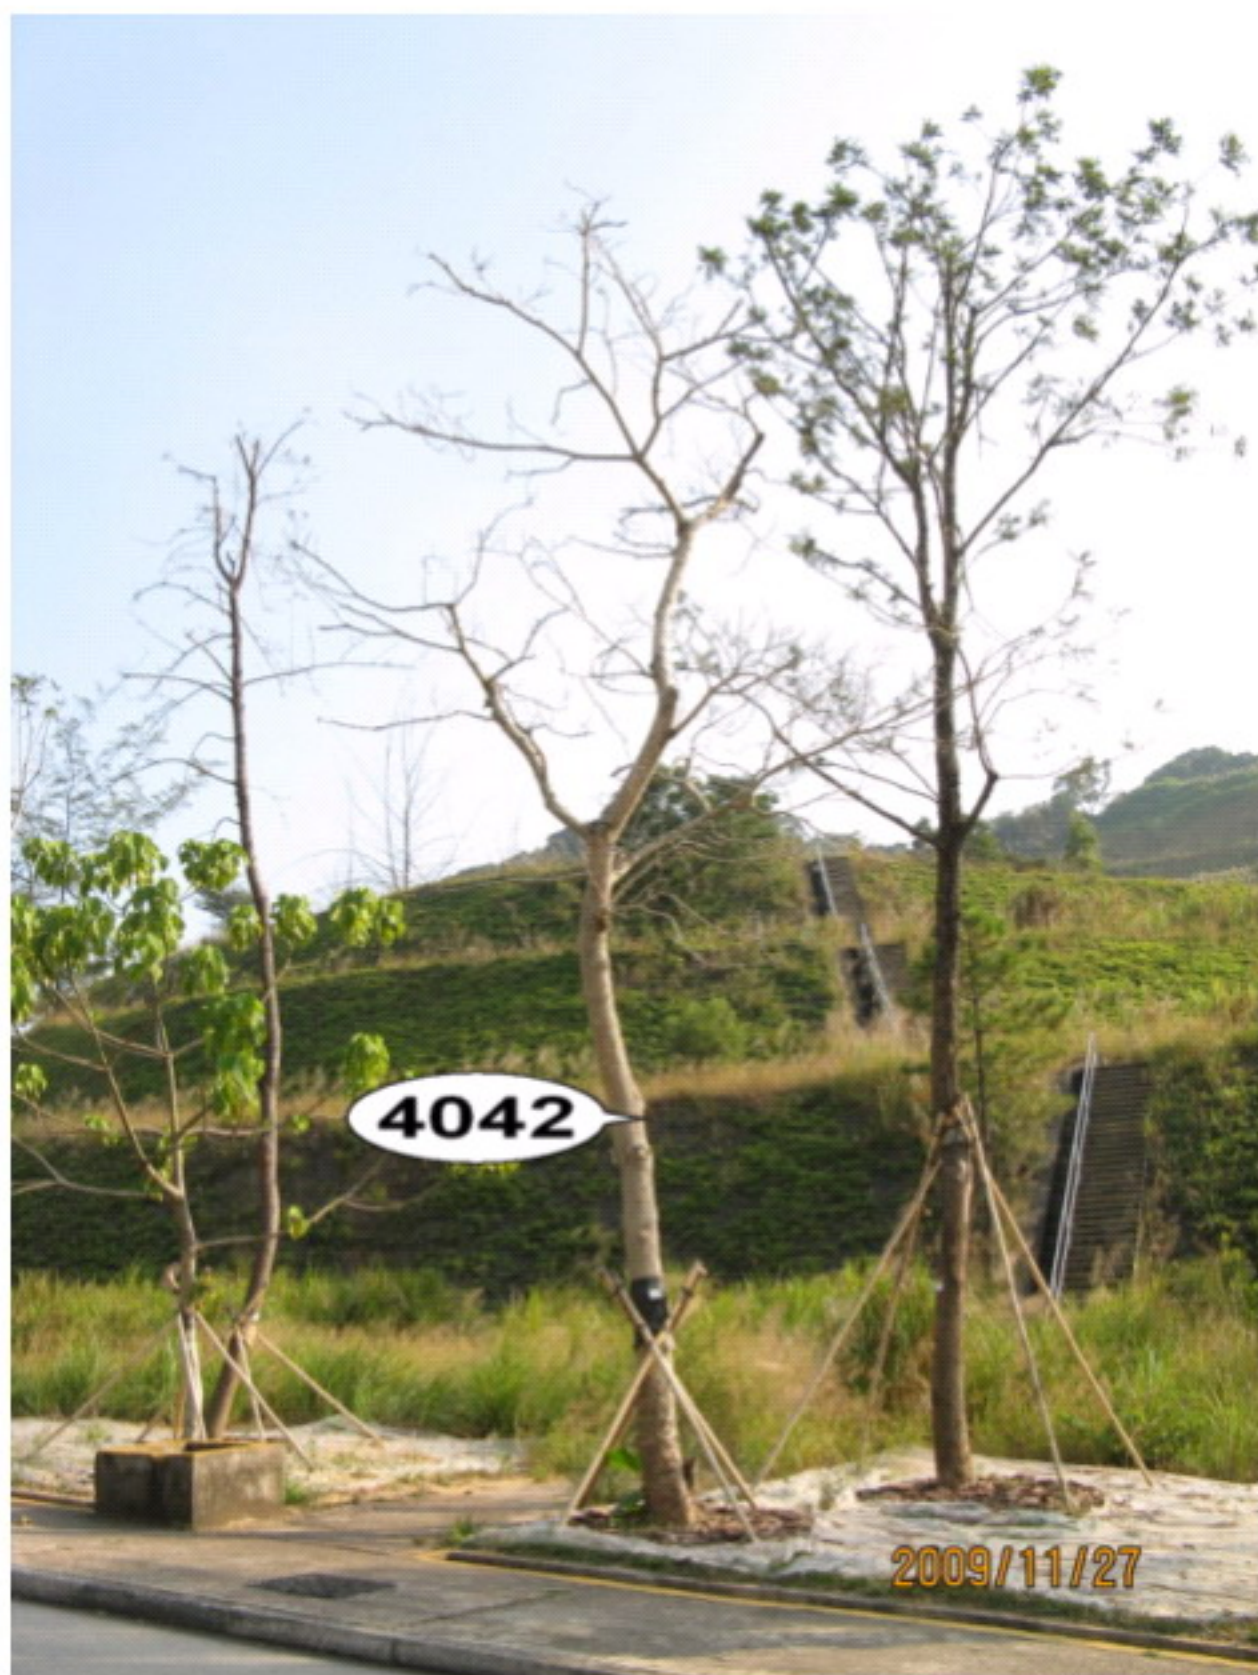
Tree No: 4042

| Tree Number | Species | Chinese name | Height (m) | Diameter (m) | Spread (m) | Remark | | |
|---|---|---|---|---|---|---|---|---|
| 4042 | <i>Albizia lebbeck</i> | 大葉合歡 | 8 | 0.16 | 4 | Poor condition, No leave | Poor condition, No leave | Poor condition, No leave |

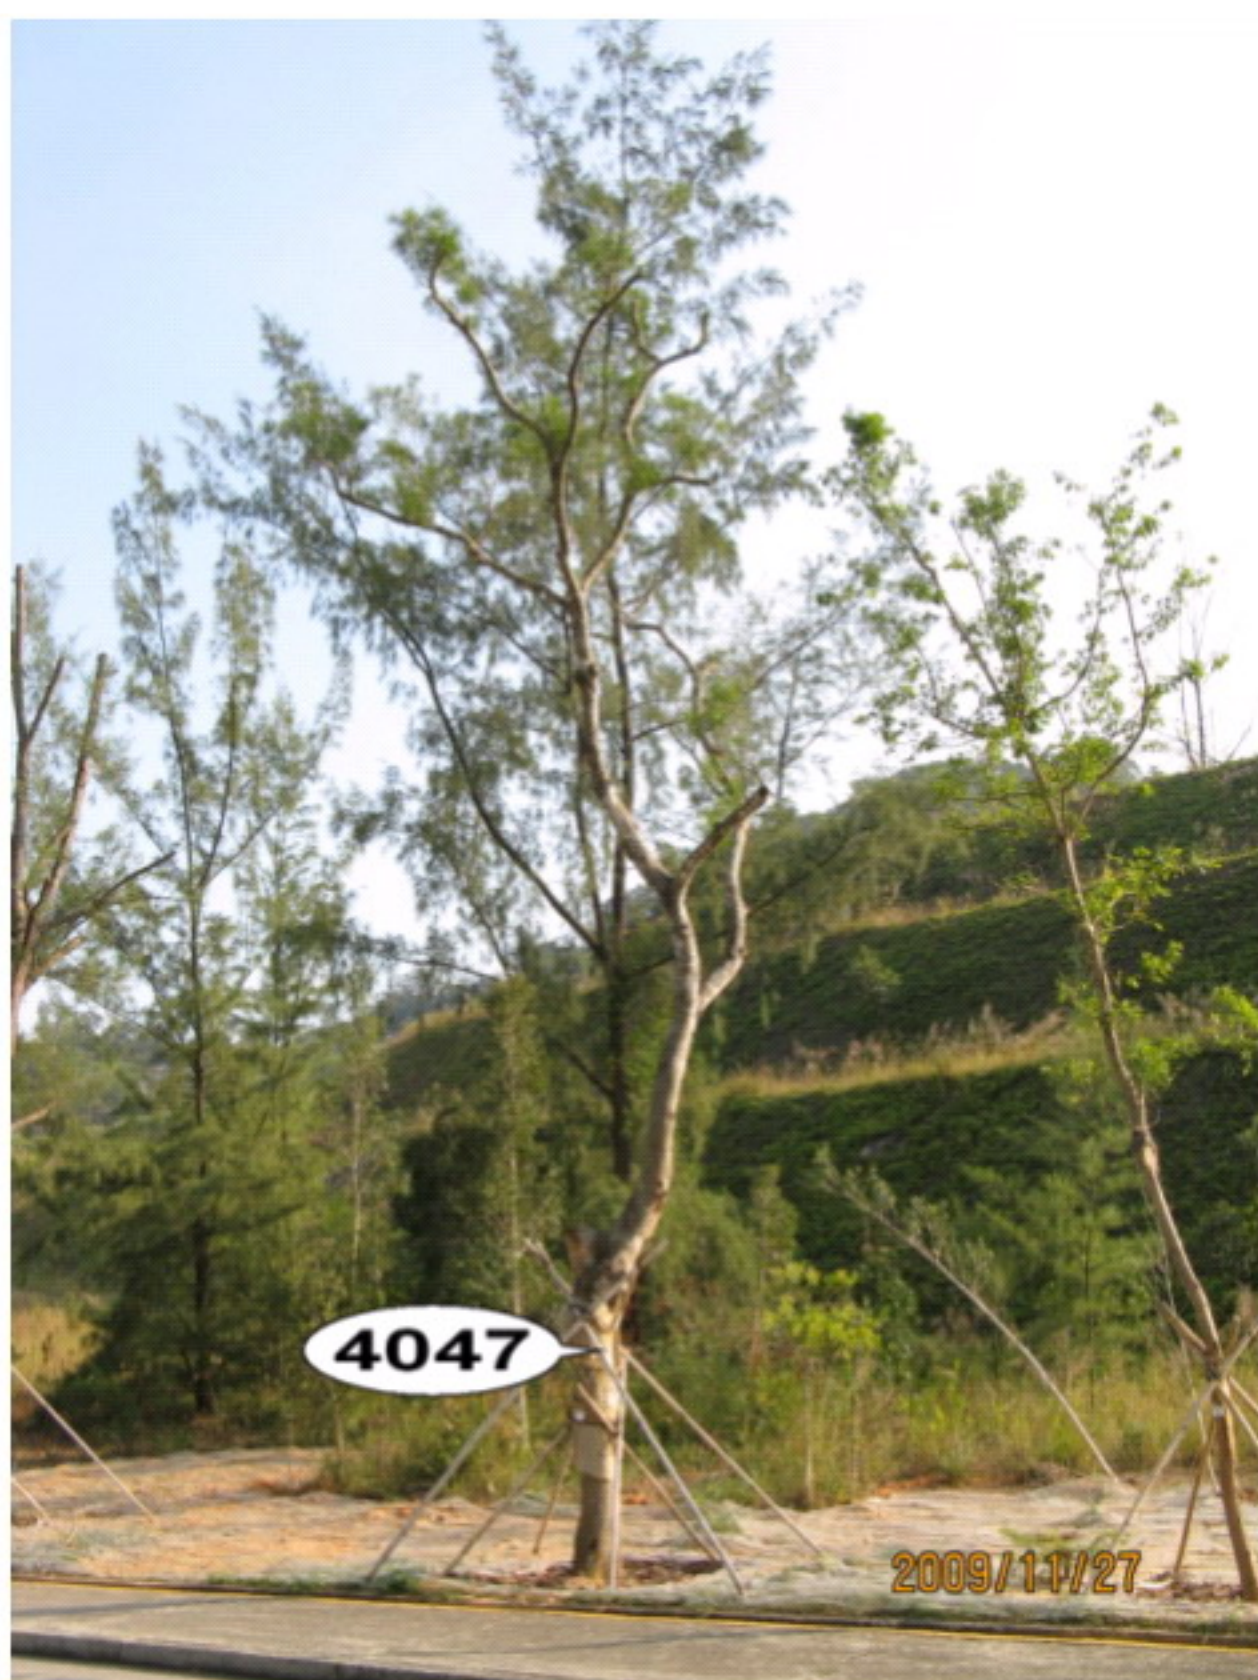
Tree No: 4047

| Tree Number | Species | Chinese name | Height (m) | Diameter (m) | Spread (m) | Remark | | |
|---|---|---|---|---|---|---|---|---|
| 4047 | <i>Acacia confusa</i> | 台灣相思 | 9 | 0.19 | 5 | Poor condition, Fork, Pruned, Heavy sparse crown | Poor condition, Fork, Pruned, Heavy sparse crown, loose bark | Poor condition, Fork, Pruned, Heavy sparse crown, loose bark |

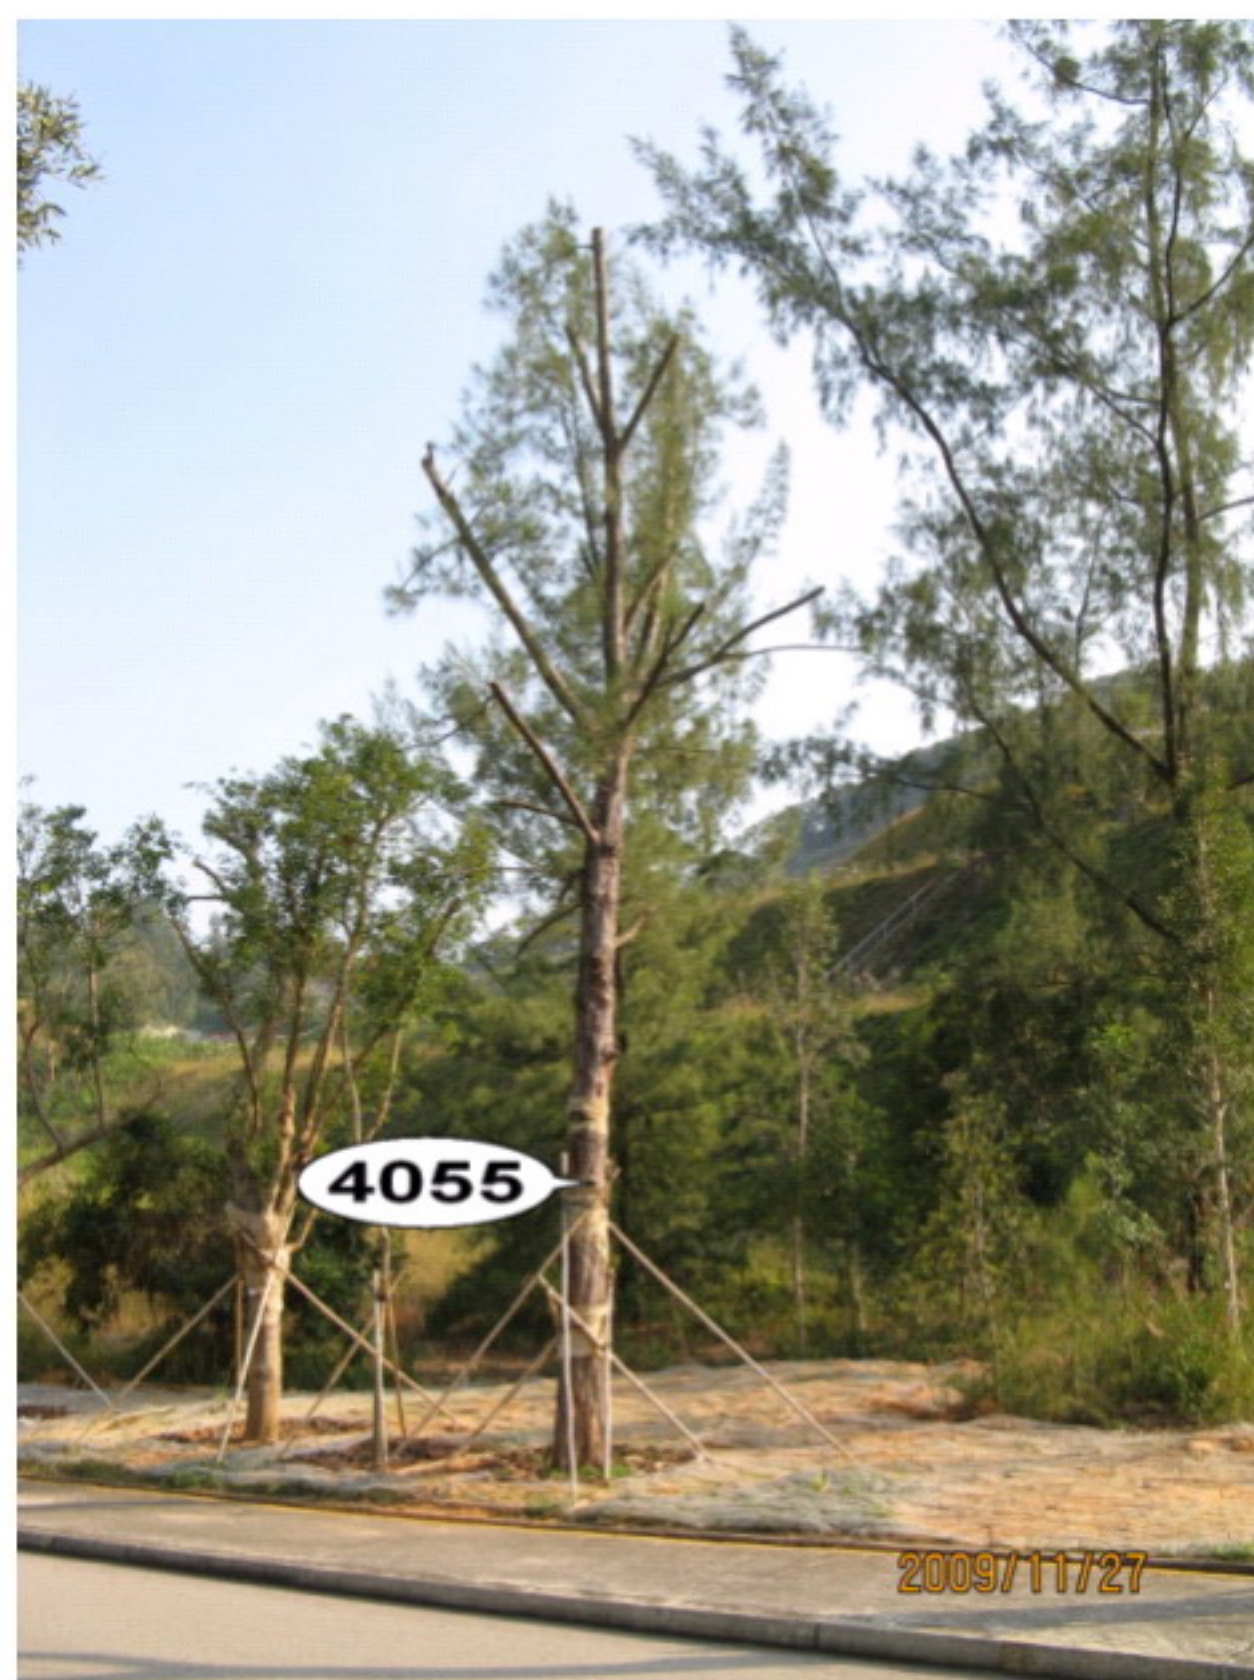
Tree No: 4055

| Tree Number | Species | Chinese name | Height (m) | Diameter (m) | Spread (m) | Remark | | |
|---|---|---|---|---|---|---|---|---|
| 4055 | <i>Casuarina equisetifolia</i> | 木麻黃 | 10 | 0.3 | 5 | Fair condition, Pruned | Fair condition, Pruned | Fair condition, Pruned |

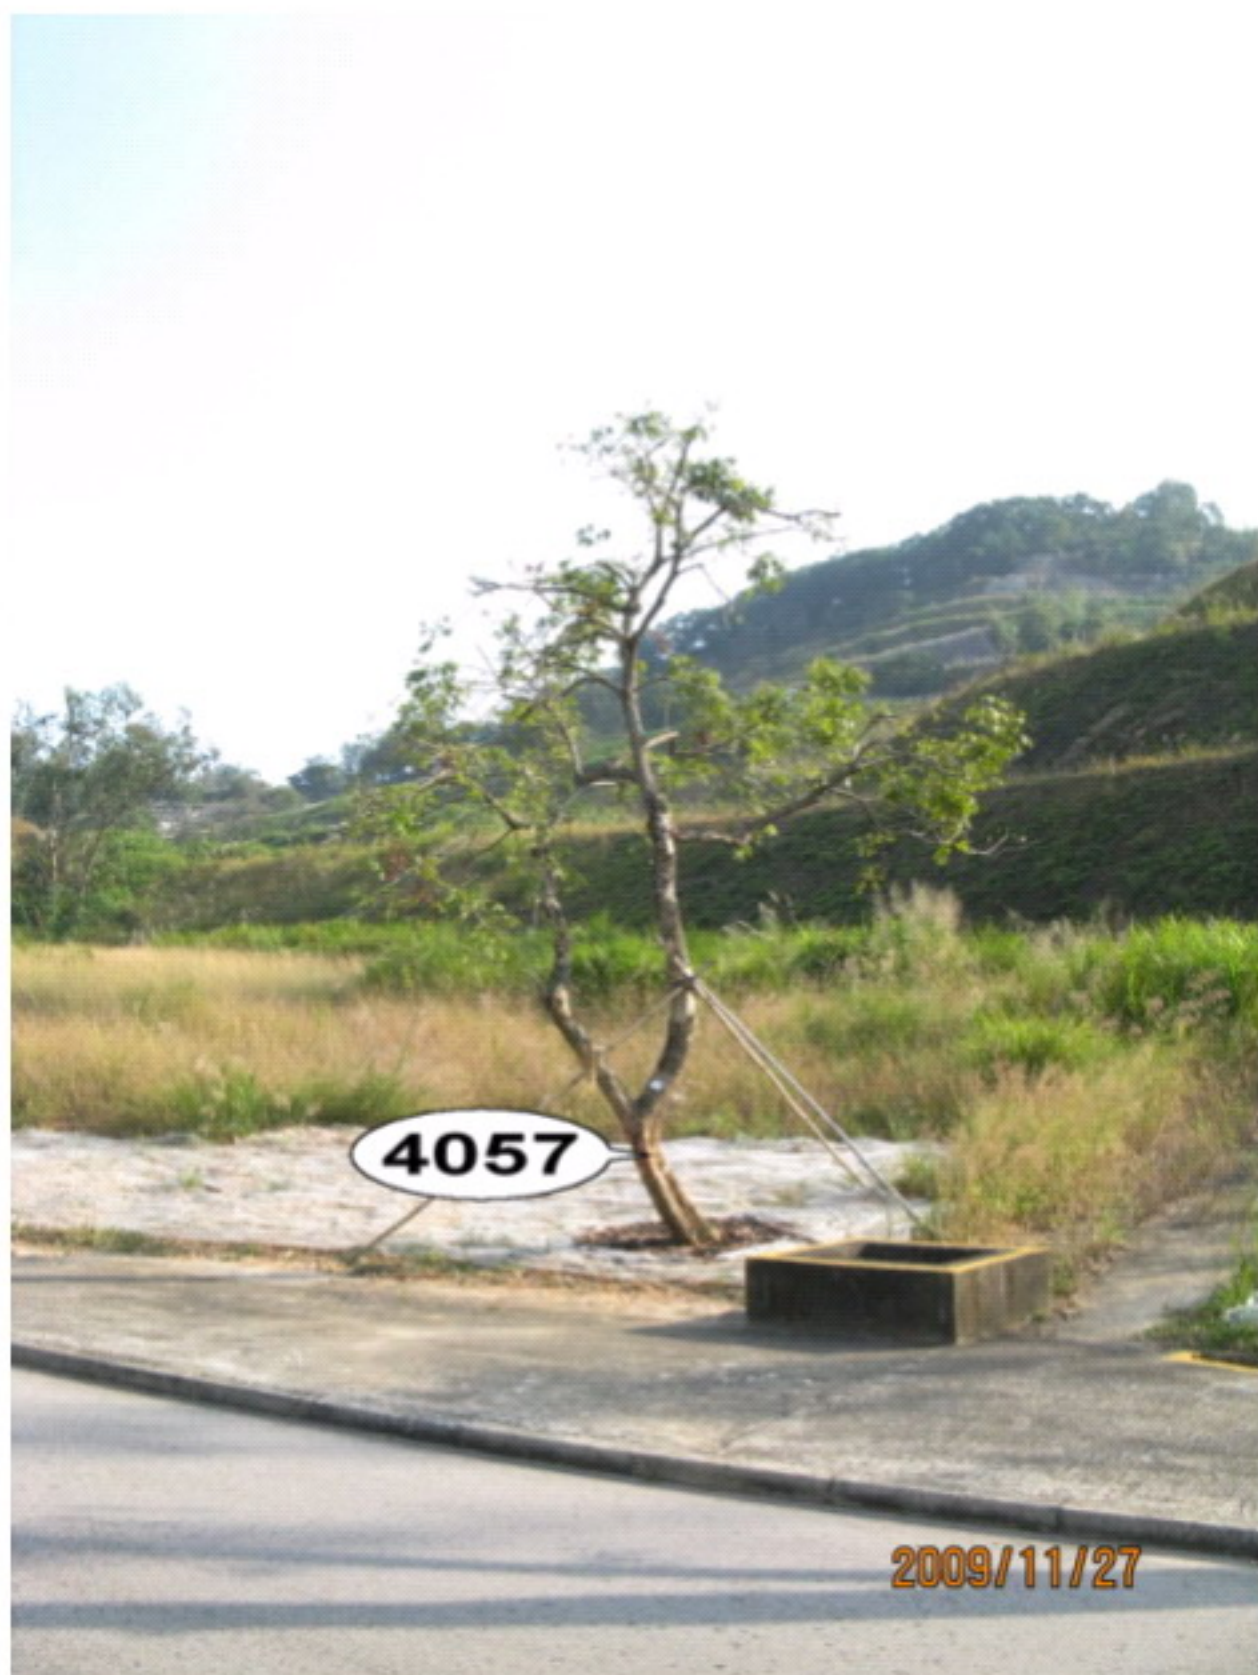
Tree No: 4057

| Tree Number | Species | Chinese name | Height (m) | Diameter (m) | Spread (m) | Remark | | |
|---|---|---|---|---|---|---|---|---|
| 4057 | <i>Dimocarpus longan</i> | 龍眼 | 6 | 0.16 | 4 | Poor condition, Bark damage, Fork | Leave infected by insect. | Leave infected by insect. |

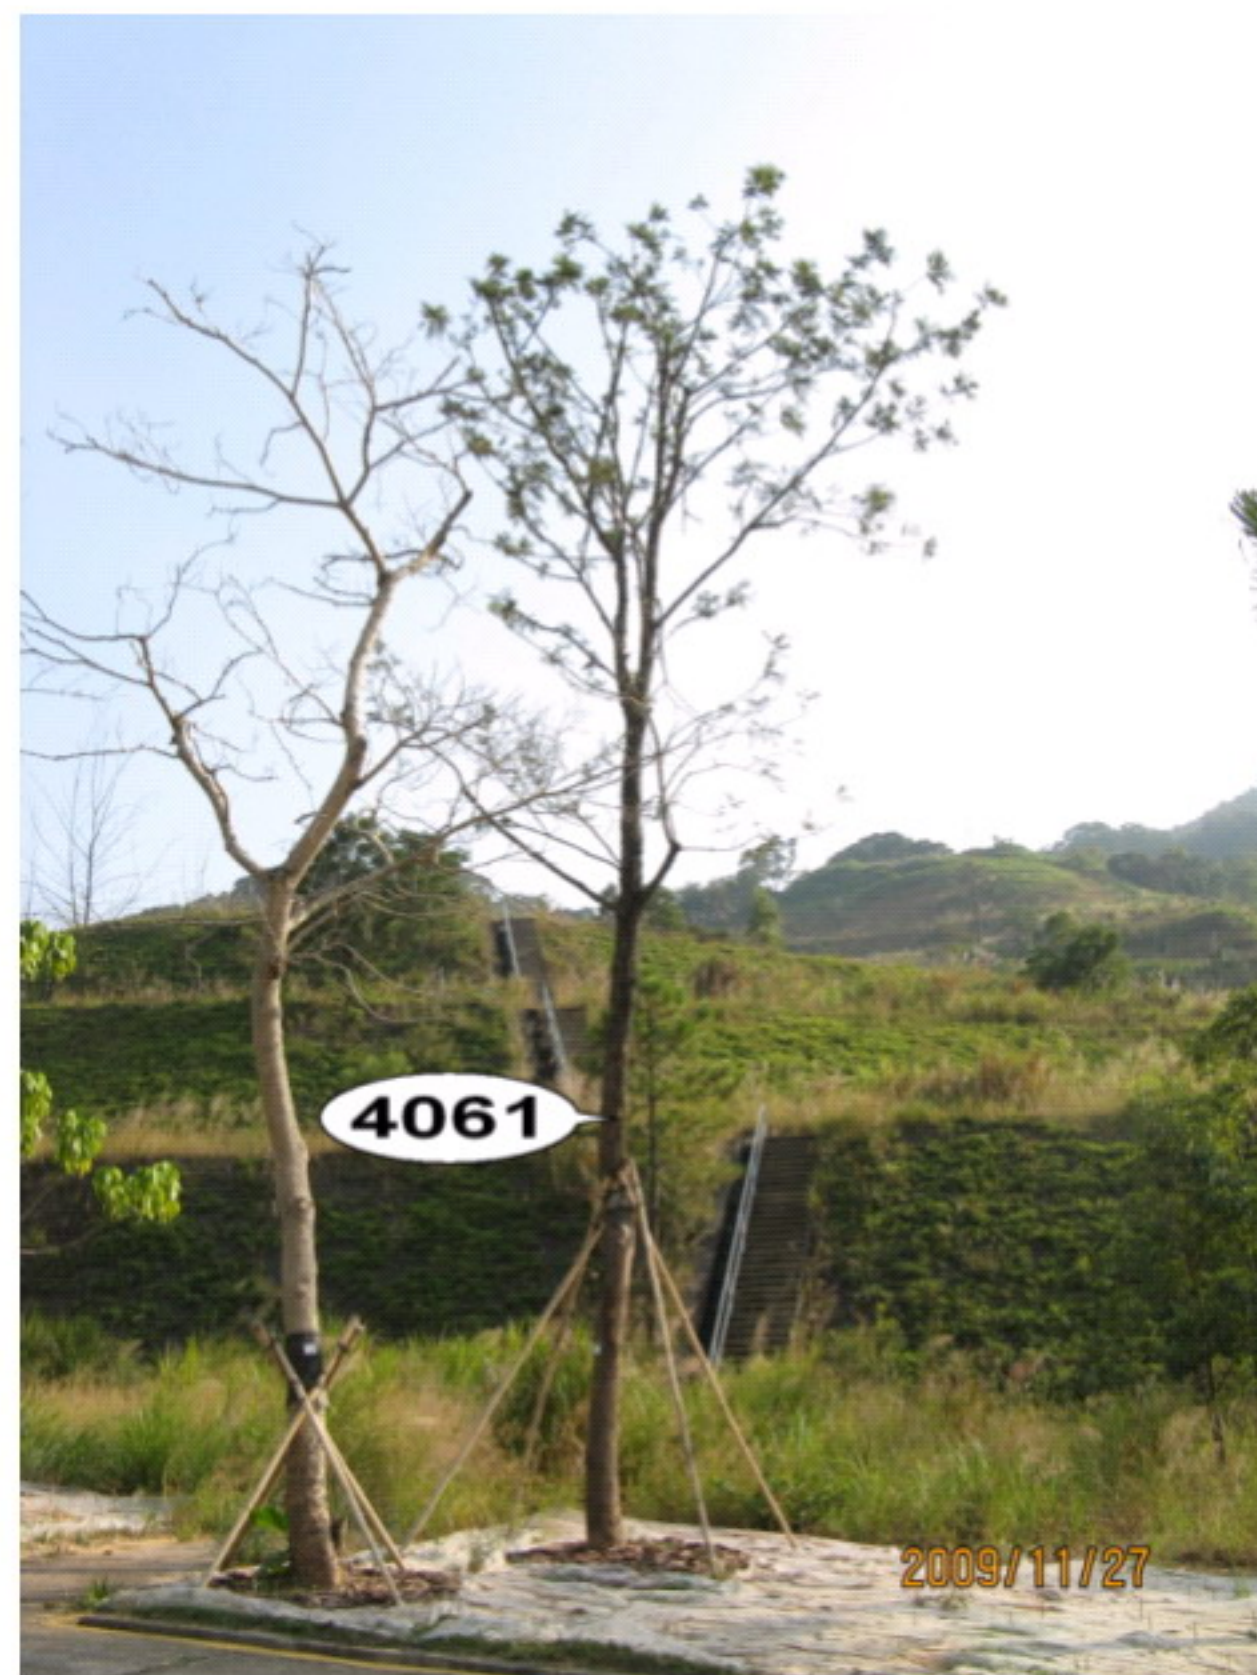
Tree No: 4061

| Tree Number | Species | Chinese name | Height (m) | Diameter (m) | Spread (m) | Remark | | |
|---|---|---|---|---|---|---|---|---|
| 4061 | <i>Grevillea robusta</i> | 銀樺 | 7 | 0.13 | 4 | Fair condition | Fair condition | Fair condition |

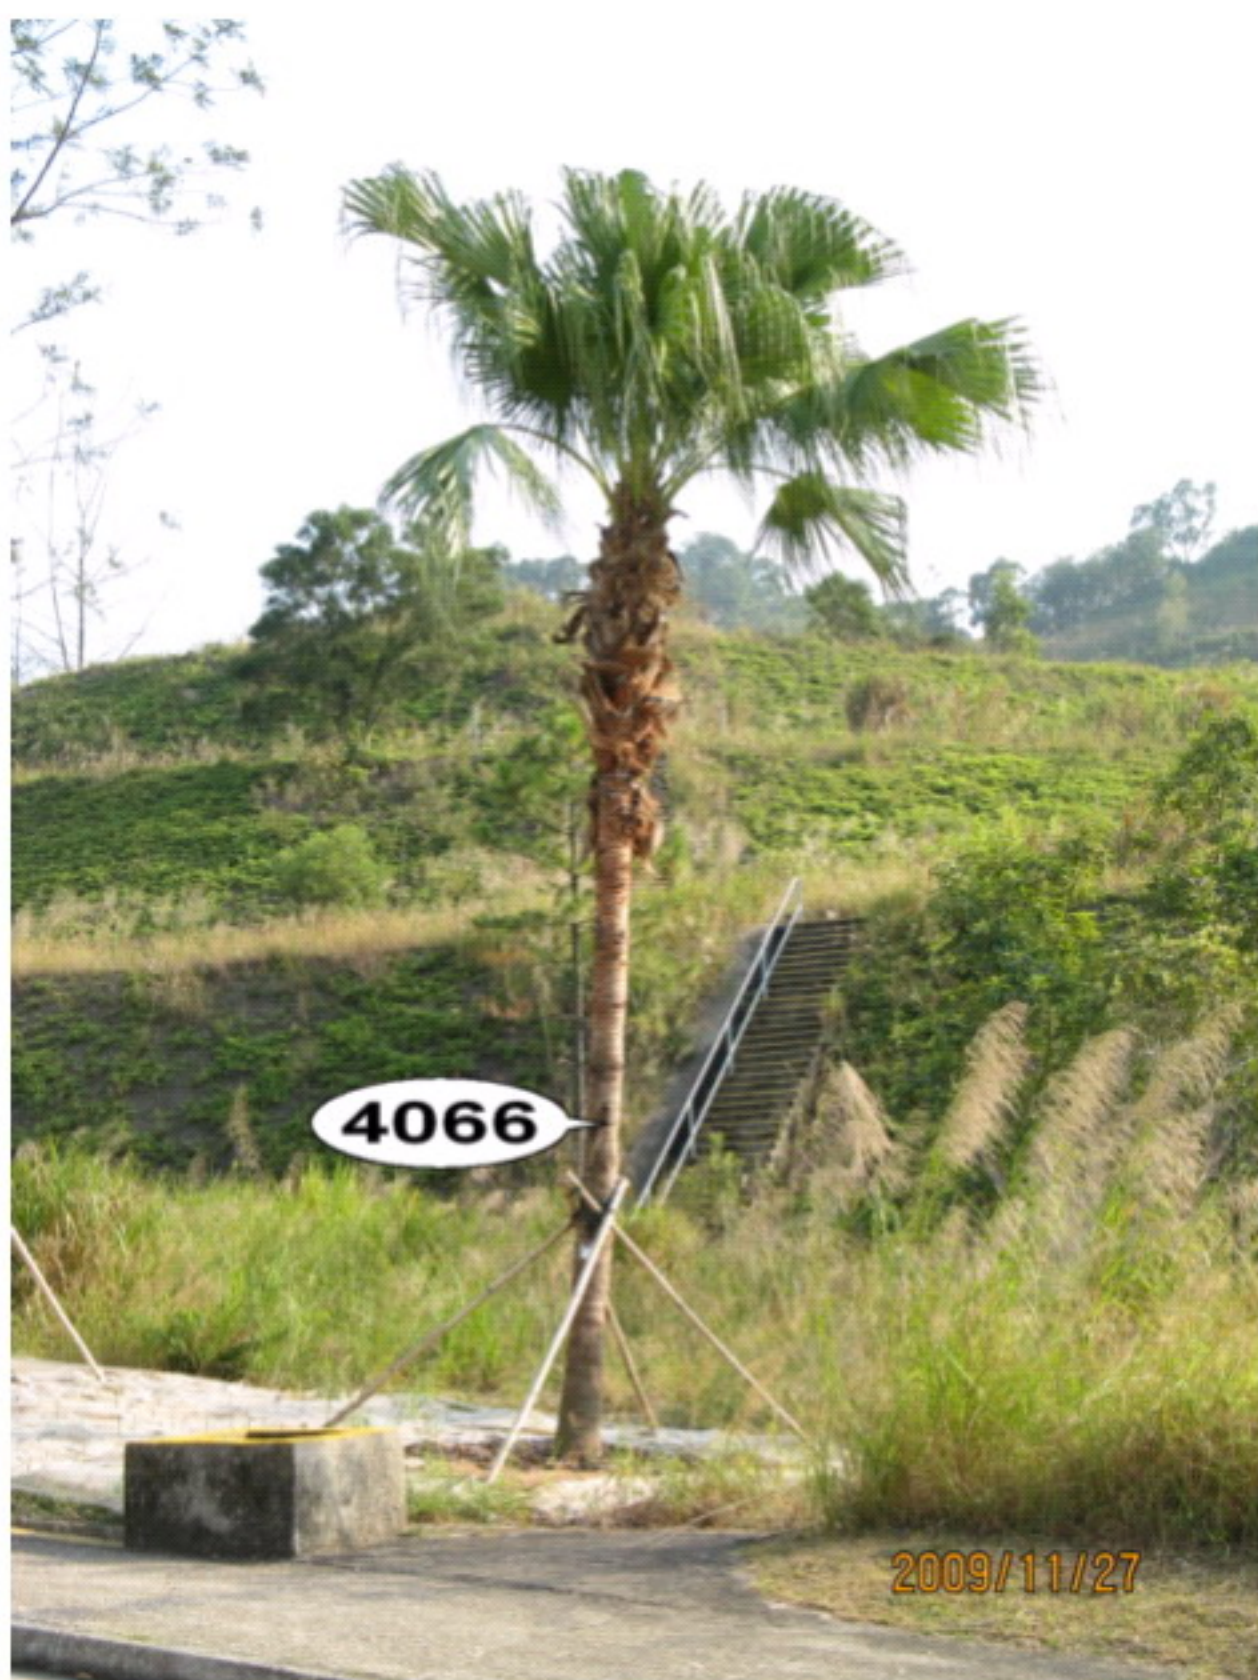
Tree No: 4066

| Tree Number | Species | Chinese name | Height (m) | Diameter (m) | Spread (m) | Remark | | |
|---|---|---|---|---|---|---|---|---|
| 4066 | <i>Livistona chinensis</i> | 蒲葵 | 6 | 0.21 | 2 | Fair condition | Fair condition | Fair condition |

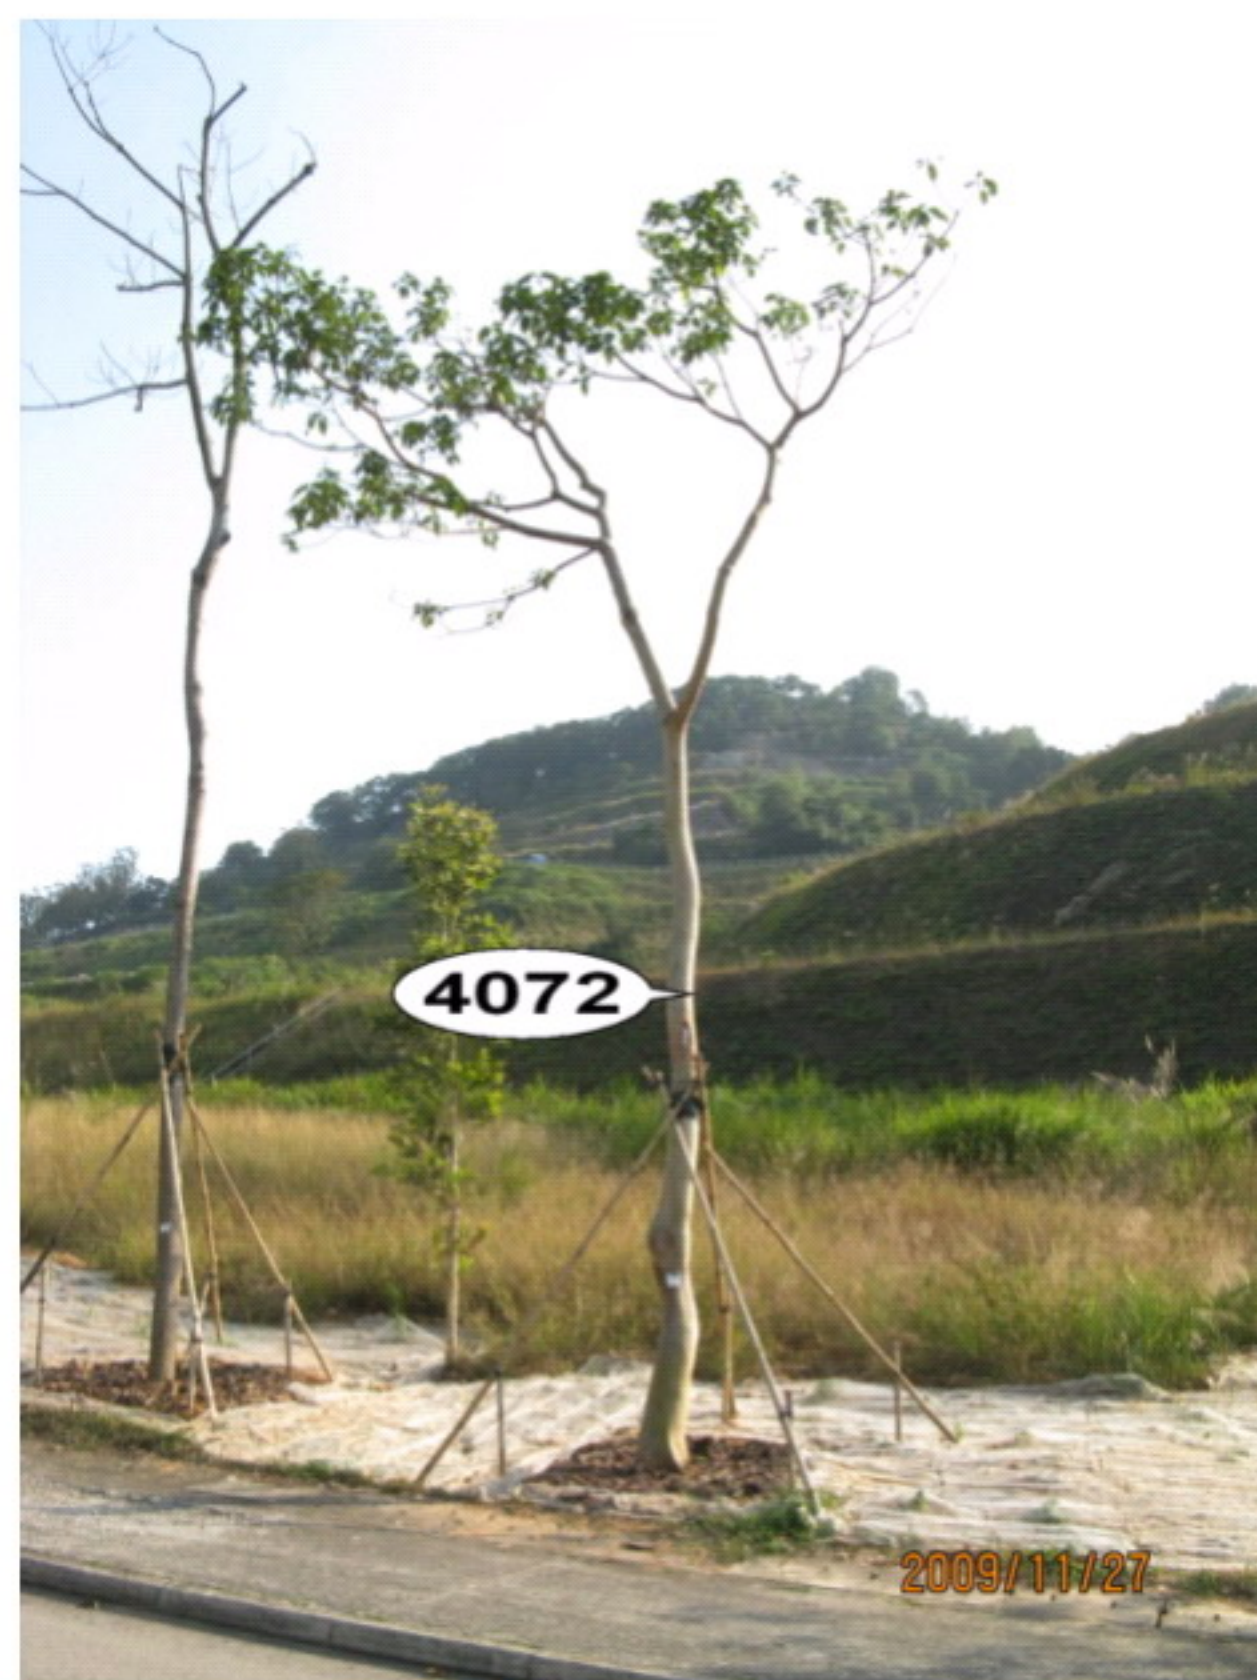
Tree No: 4072

| Tree Number | Species | Chinese name | Height (m) | Diameter (m) | Spread (m) | Remark | | |
|---|---|---|---|---|---|---|---|---|
| 4072 | <i>Ficus variegata</i> | 青果榕 | 6 | 0.13 | 3 | Poor condition, Leave generating, Fork | Poor condition, Sparse crown, loose bark, bark damage | Poor condition, Sparse crown, loose bark, bark damage |
