**PROVISION OF CREMATORS AT
WO HOP SHEK CREMATORIUM**

**ENVIRONMENTAL MONITORING &
AUDIT REPORT (JANUARY 2010)**

Quotation Contract No. 9/2009/AB1
Provision of Cremators at Wo Hop Shek Crematorium - Independent Environmental Checker Service
Monthly EM&A Report (January 2010)

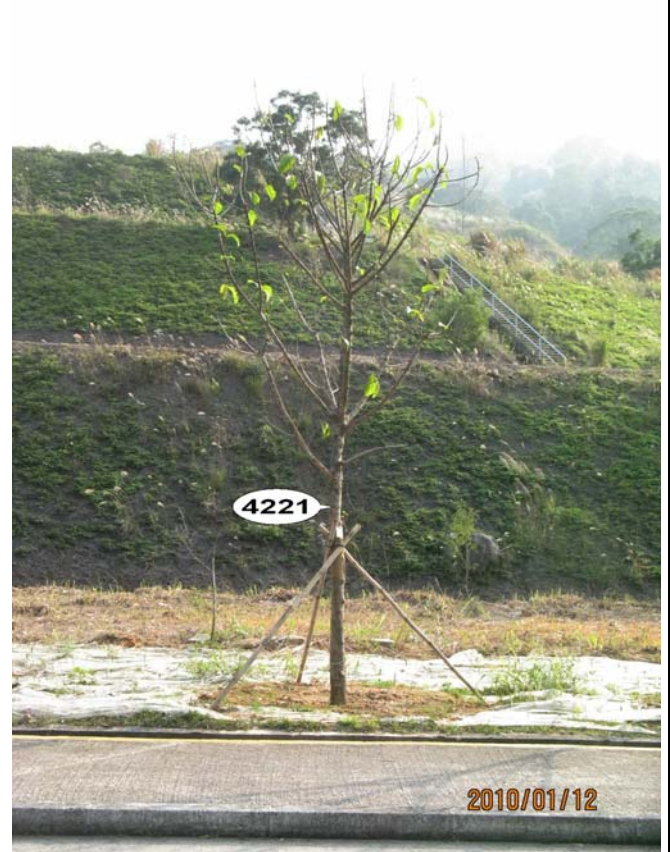
Tree No: 4221

Tree Number	Species	Chinese name	Height (m)	Diameter (m)	Spread (m)	Remark
						12 th Jan-2010
4054	<i>Grevillea robusta</i>	銀樺	7	0.13	4	Fair condition
4055	<i>Casuarina equisetifolia</i>	木麻黃	10	0.3	5	Fair condition, Pruned
4057	<i>Dimocarpus longan</i>	龍眼	6	0.16	4	Fair condition, Loose bark, Leave regeneration
4060	<i>Grevillea robusta</i>	銀樺	8	0.11	2	Missing from monitoring site
4061	<i>Grevillea robusta</i>	銀樺	7	0.13	4	Fair condition
4066	<i>Livistona chinensis</i>	蒲葵	6	0.21	2	Fair condition
4072	<i>Ficus variegata</i>	青果榕	6	0.13	3	Poor condition, Sparse crown, loose bark, bark damage
4090	<i>Schefflera heptaphylla</i>	鴨腳木	6.5	0.18	4	Poor condition, Heavy sparse crown,
4093	<i>Eucalyptus robusta</i>	大葉桉	10	0.48	3	Missing from monitoring site
4195	<i>Ficus hispida</i>	對葉榕	7	0.14	3	Missing from monitoring site
4196	<i>Ficus hispida</i>	對葉榕	4	0.14	4.5	Missing from monitoring site
4221	<i>Ficus hispida</i>	對葉榕	7	0.12	3	Poor condition, Sparse crown

5.2 Organic soil or composite organic enriched soil should be applied to each transplanted tree, approx. 20kg to 40kg per tree is recommended. On top of organic soil should covered with tree barks and 5kg to 20kg tree bark is recommended according to tree size.

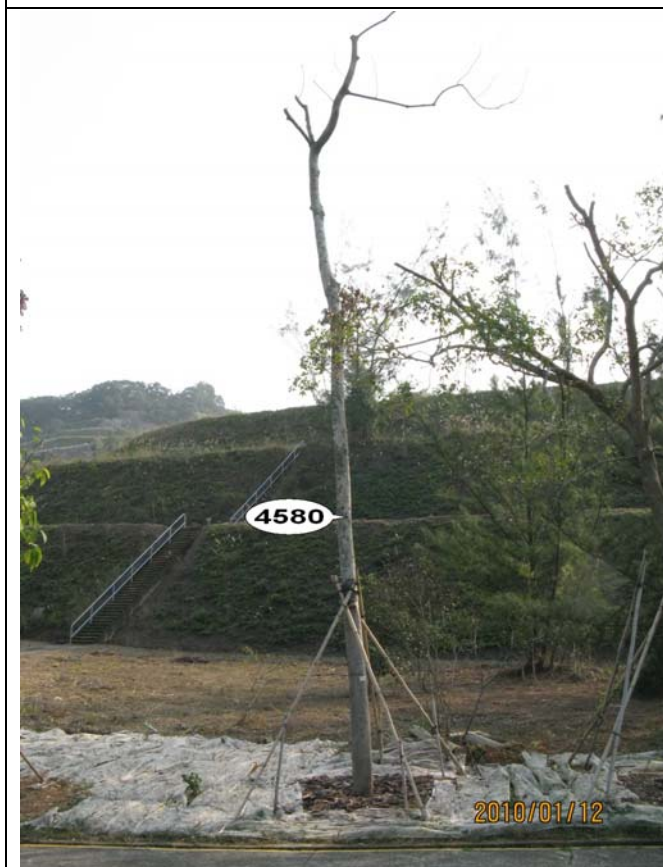
Tree No: 4580

4580	<i>Aleurites moluccana</i>	石栗	8	0.22	1	Poor condition, Pruned, Heavy sparse crown
4582	<i>Acacia confusa</i>	台灣相思	6	0.25	2	Missing from monitoring site

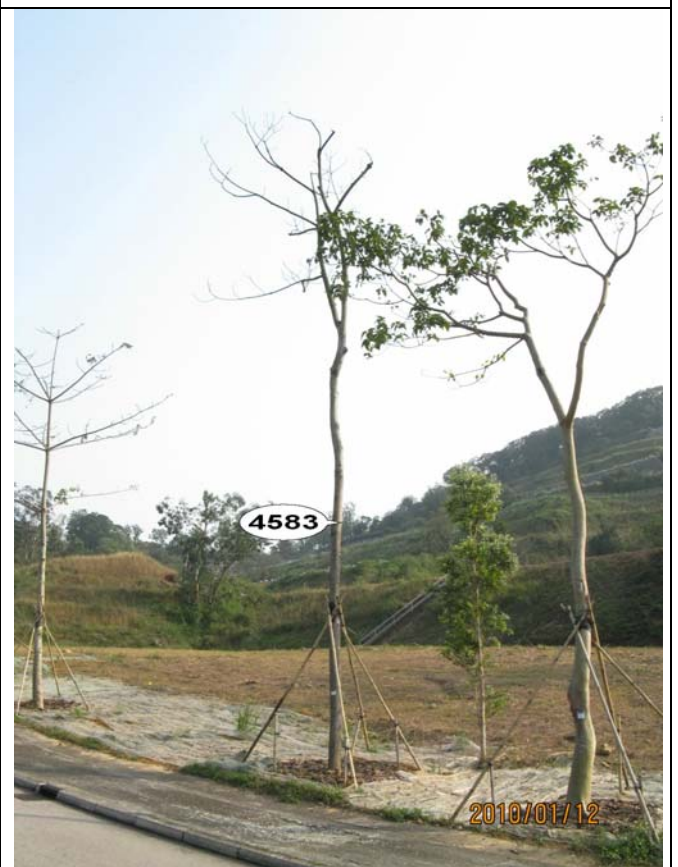
Tree No: 4583

Tree Number	Species	Chinese name	Height (m)	Diameter (m)	Spread (m)	Remark
						12 th Jan-2010
4583	<i>Aleurites moluccana</i>	石栗	8	0.28	3	Poor condition, Heavy sparse crown
4629	<i>Ficus hispida</i>	對葉榕	5	0.11	5	Missing from monitoring site
