**PROVISION OF CREMATORS AT  
WO HOP SHEK CREMATORIUM**

**ENVIRONMENTAL MONITORING &  
AUDIT REPORT (FEBRUARY 2010)**

Quotation Contract No. 9/2009/AB1  
Provision of Cremators at Wo Hop Shek Crematorium - Independent Environmental Checker Service  
Monthly EM&A Report (February 2010)

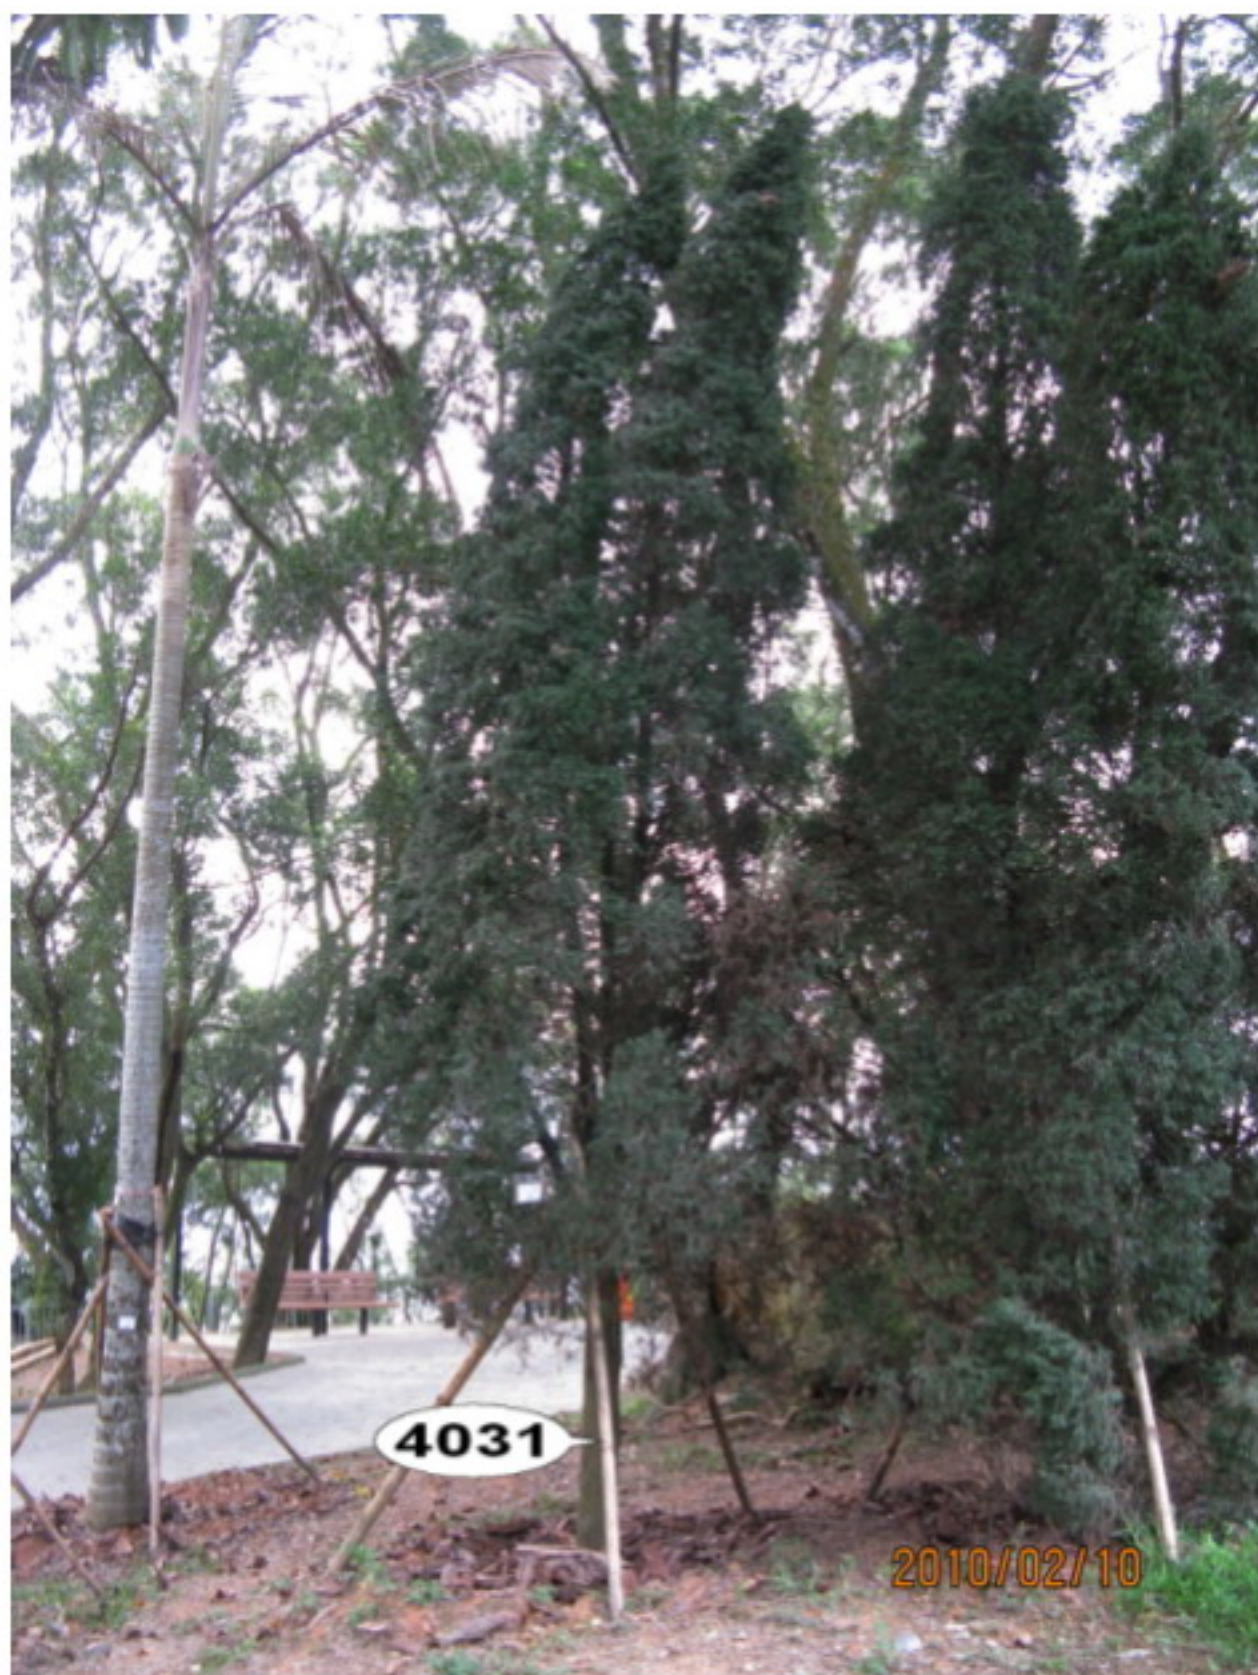
Tree No: 4031

| | | | | | | Remark |
|---|---|---|---|---|---|---|
| 4031 | <i>Juniperus chinensis var.kaizuca</i> | 龍柏 | 5 | 0.12 | 2 | Fair condition |

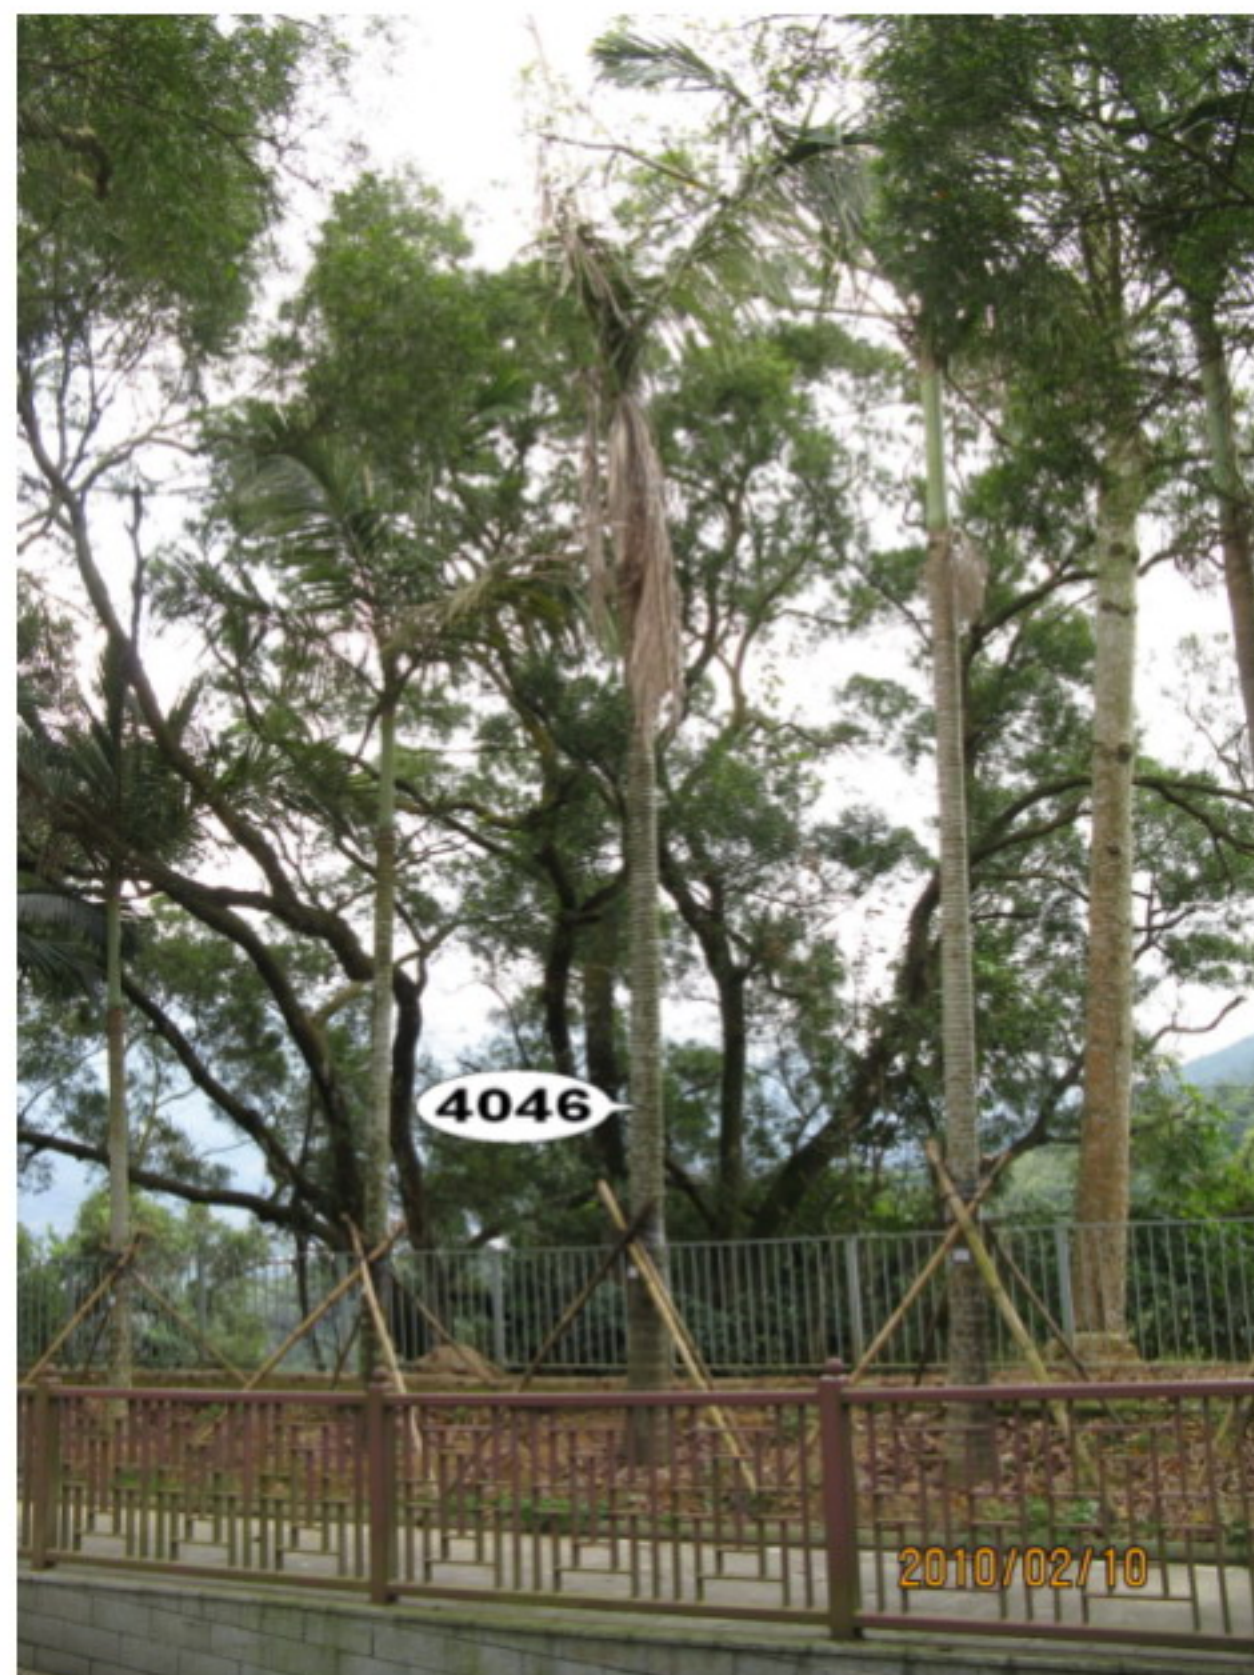
Tree No: 4046

| | | | | | | Remark |
|---|---|---|---|---|---|---|
| 4046 | <i>Archontophoenix alexandrae</i> | 假檳榔 | 5 | 0.19 | 4 | Poor condition, Yellow leave |

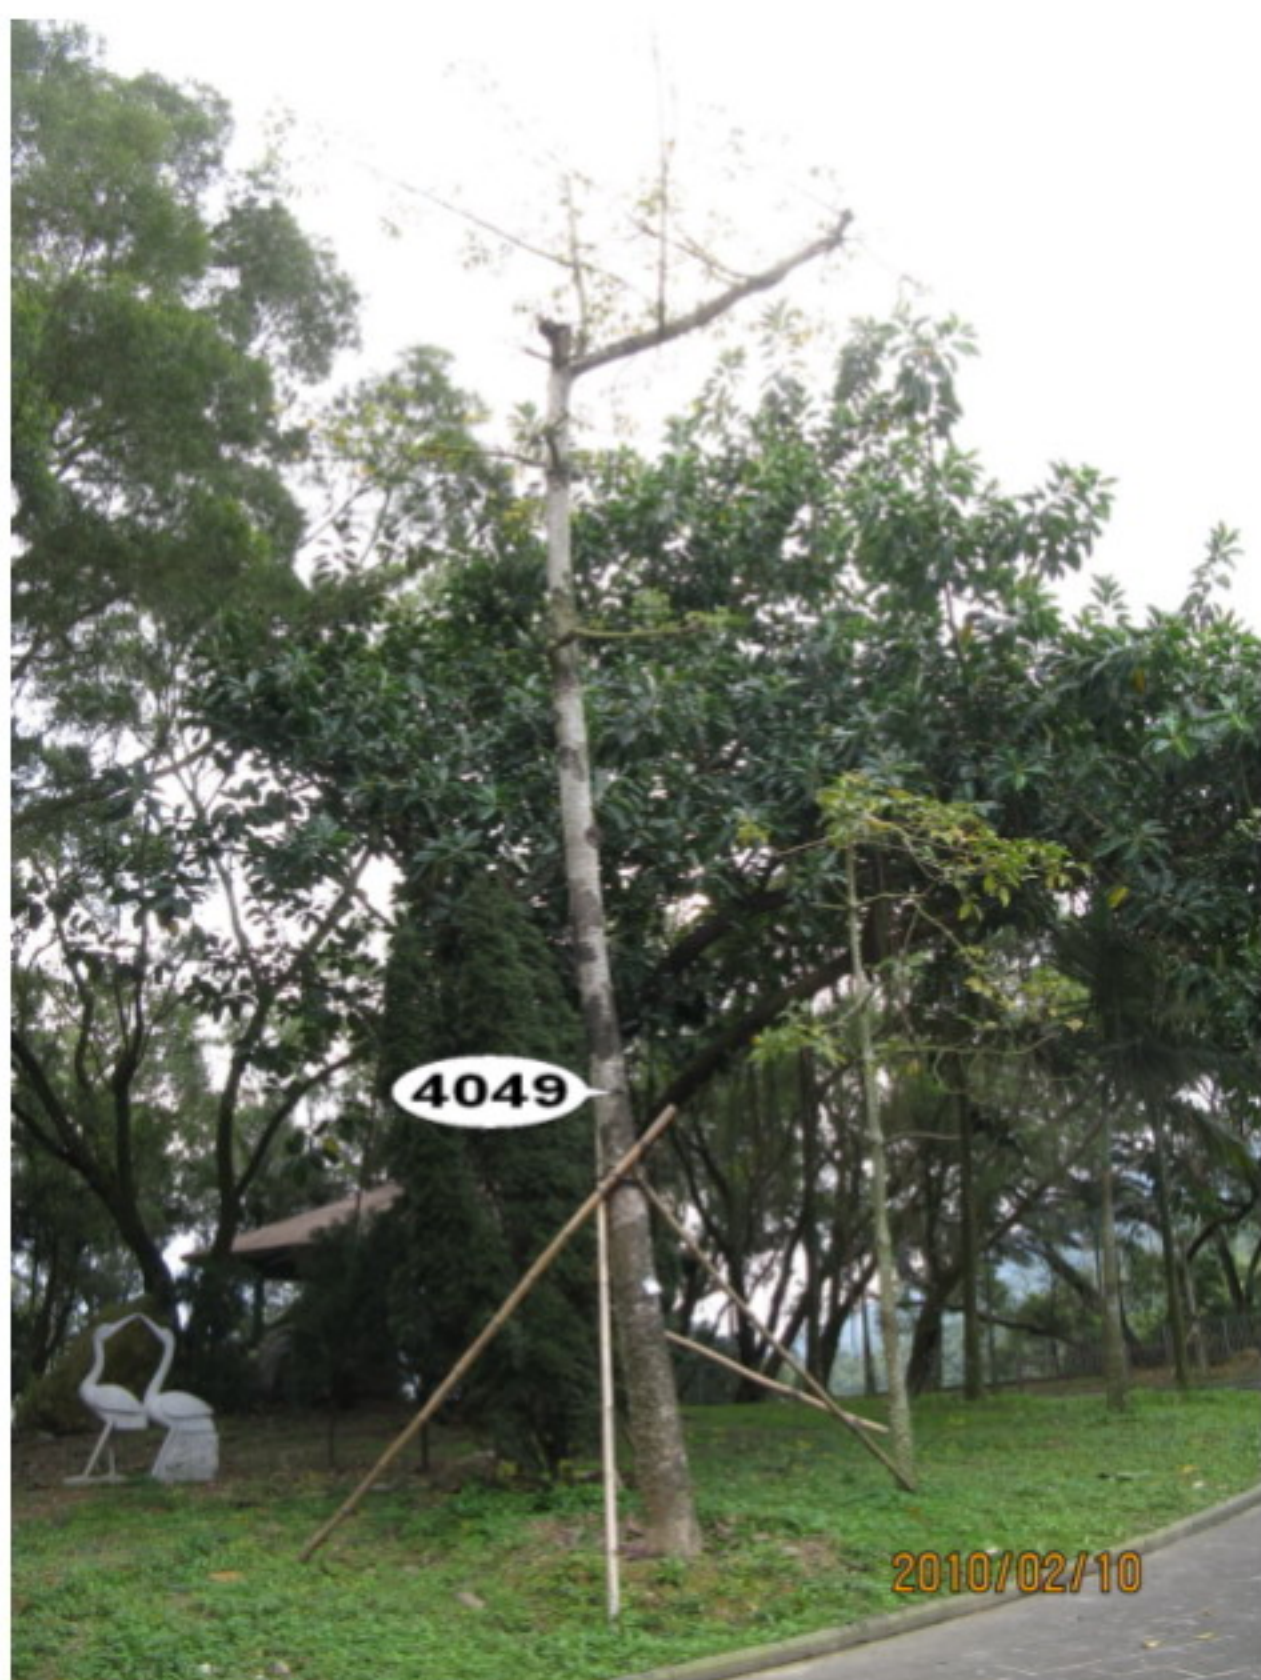
Tree No: 4049

| | | | | | | Remark |
|---|---|---|---|---|---|---|
| 4049 | <i>Bombax ceiba</i> | 木棉 | 6 | 0.16 | 4 | Poor condition, Sparse crown |

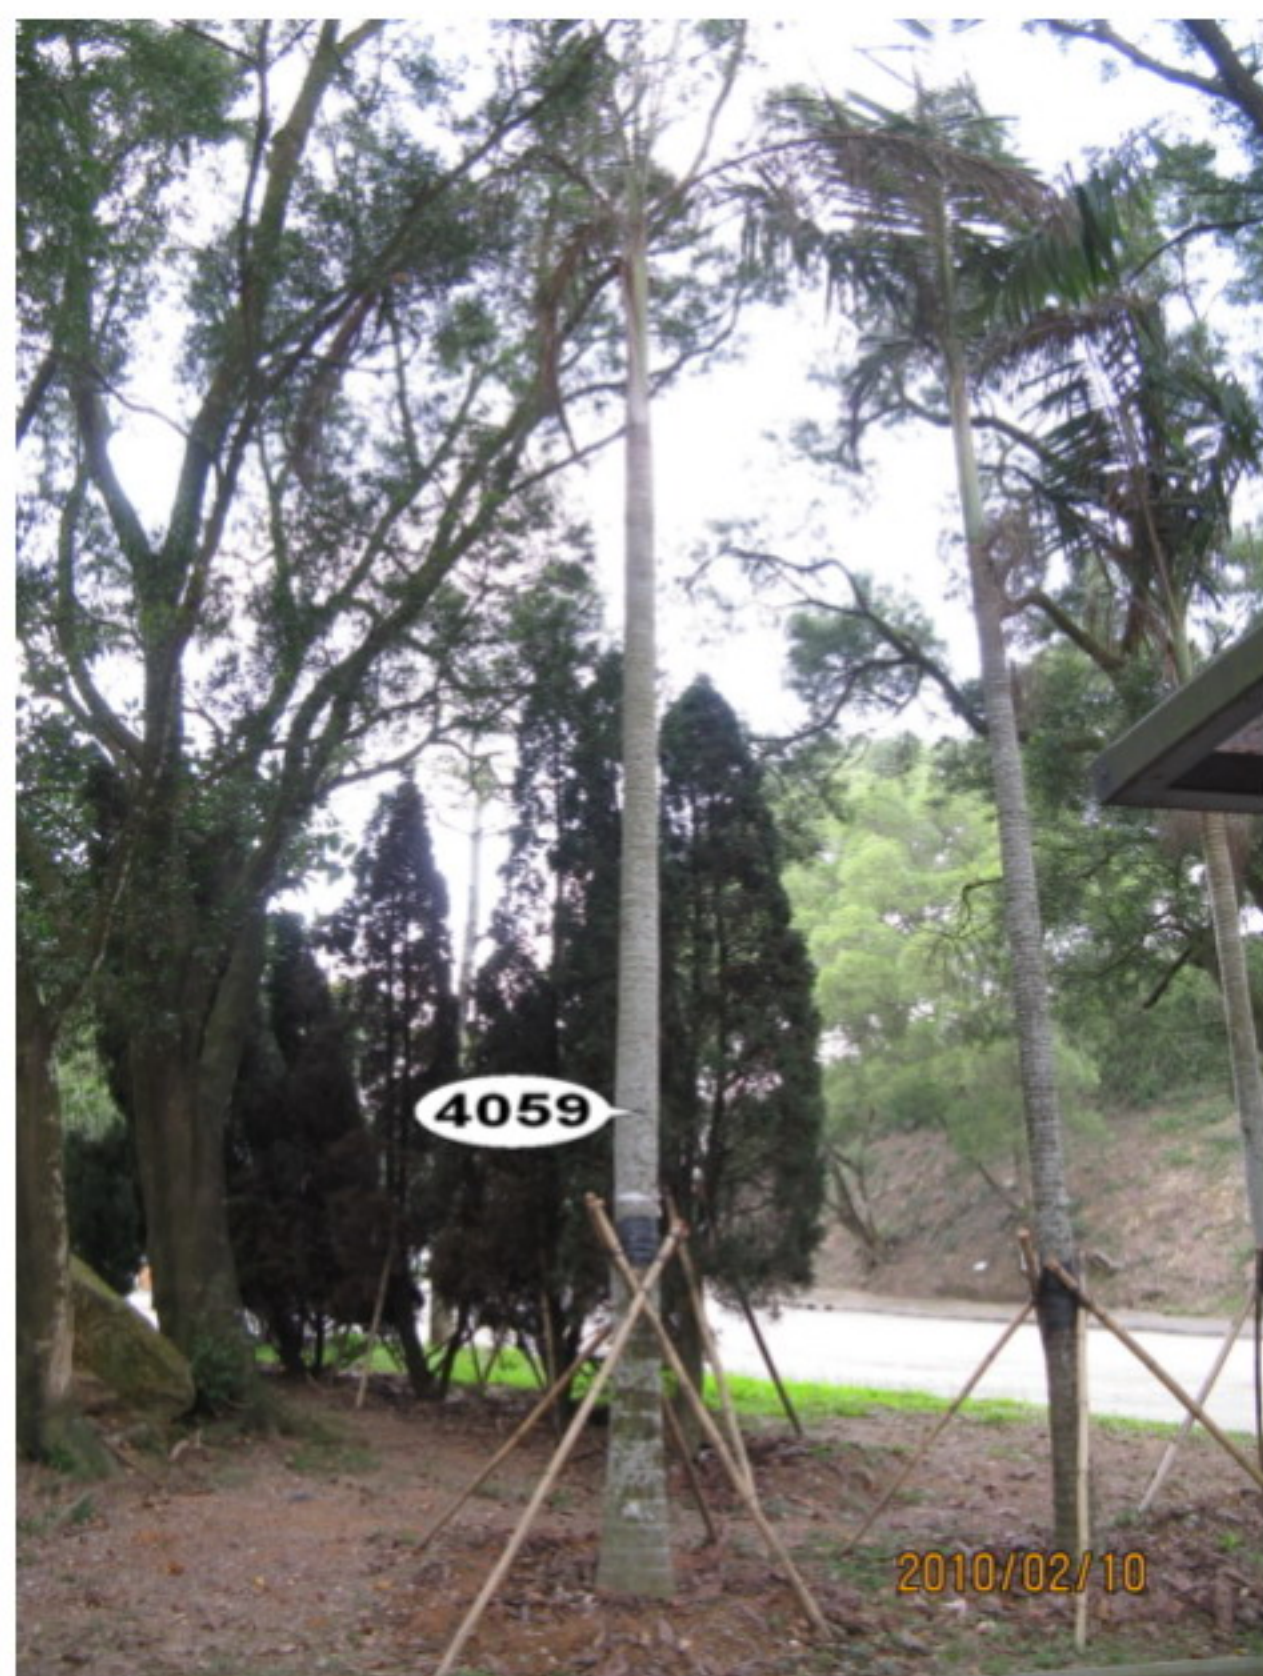
Tree No: 4059

| | | | | | | Remark |
|---|---|---|---|---|---|---|
| 4059 | <i>Archontophoenix alexandrae</i> | 假檳榔 | 6 | 0.23 | 4 | Fair condition, Yellow leave |

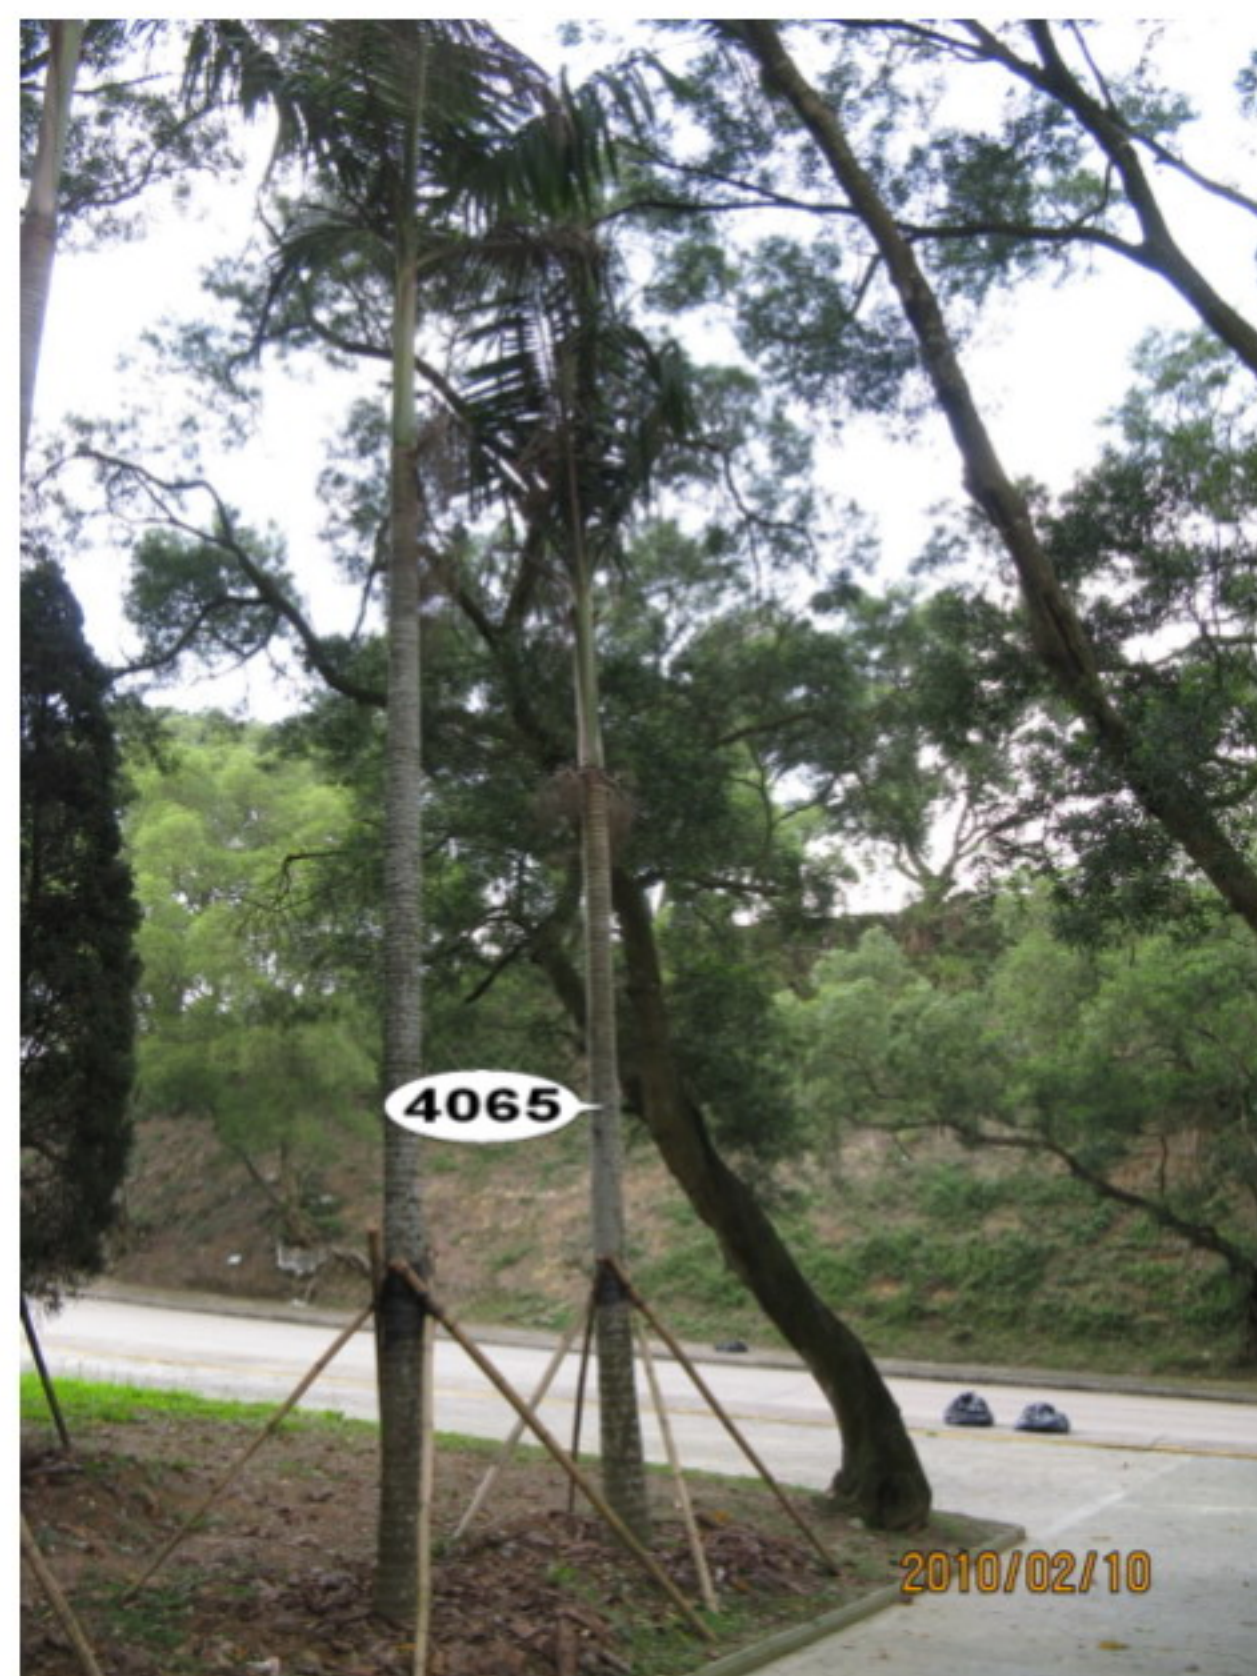
Tree No: 4065

| | | | | | | Remark |
|---|---|---|---|---|---|---|
| 4065 | <i>Archontophoenix alexandrae</i> | 假檳榔 | 7 | 0.21 | 4 | Fair condition, Yellow leave |

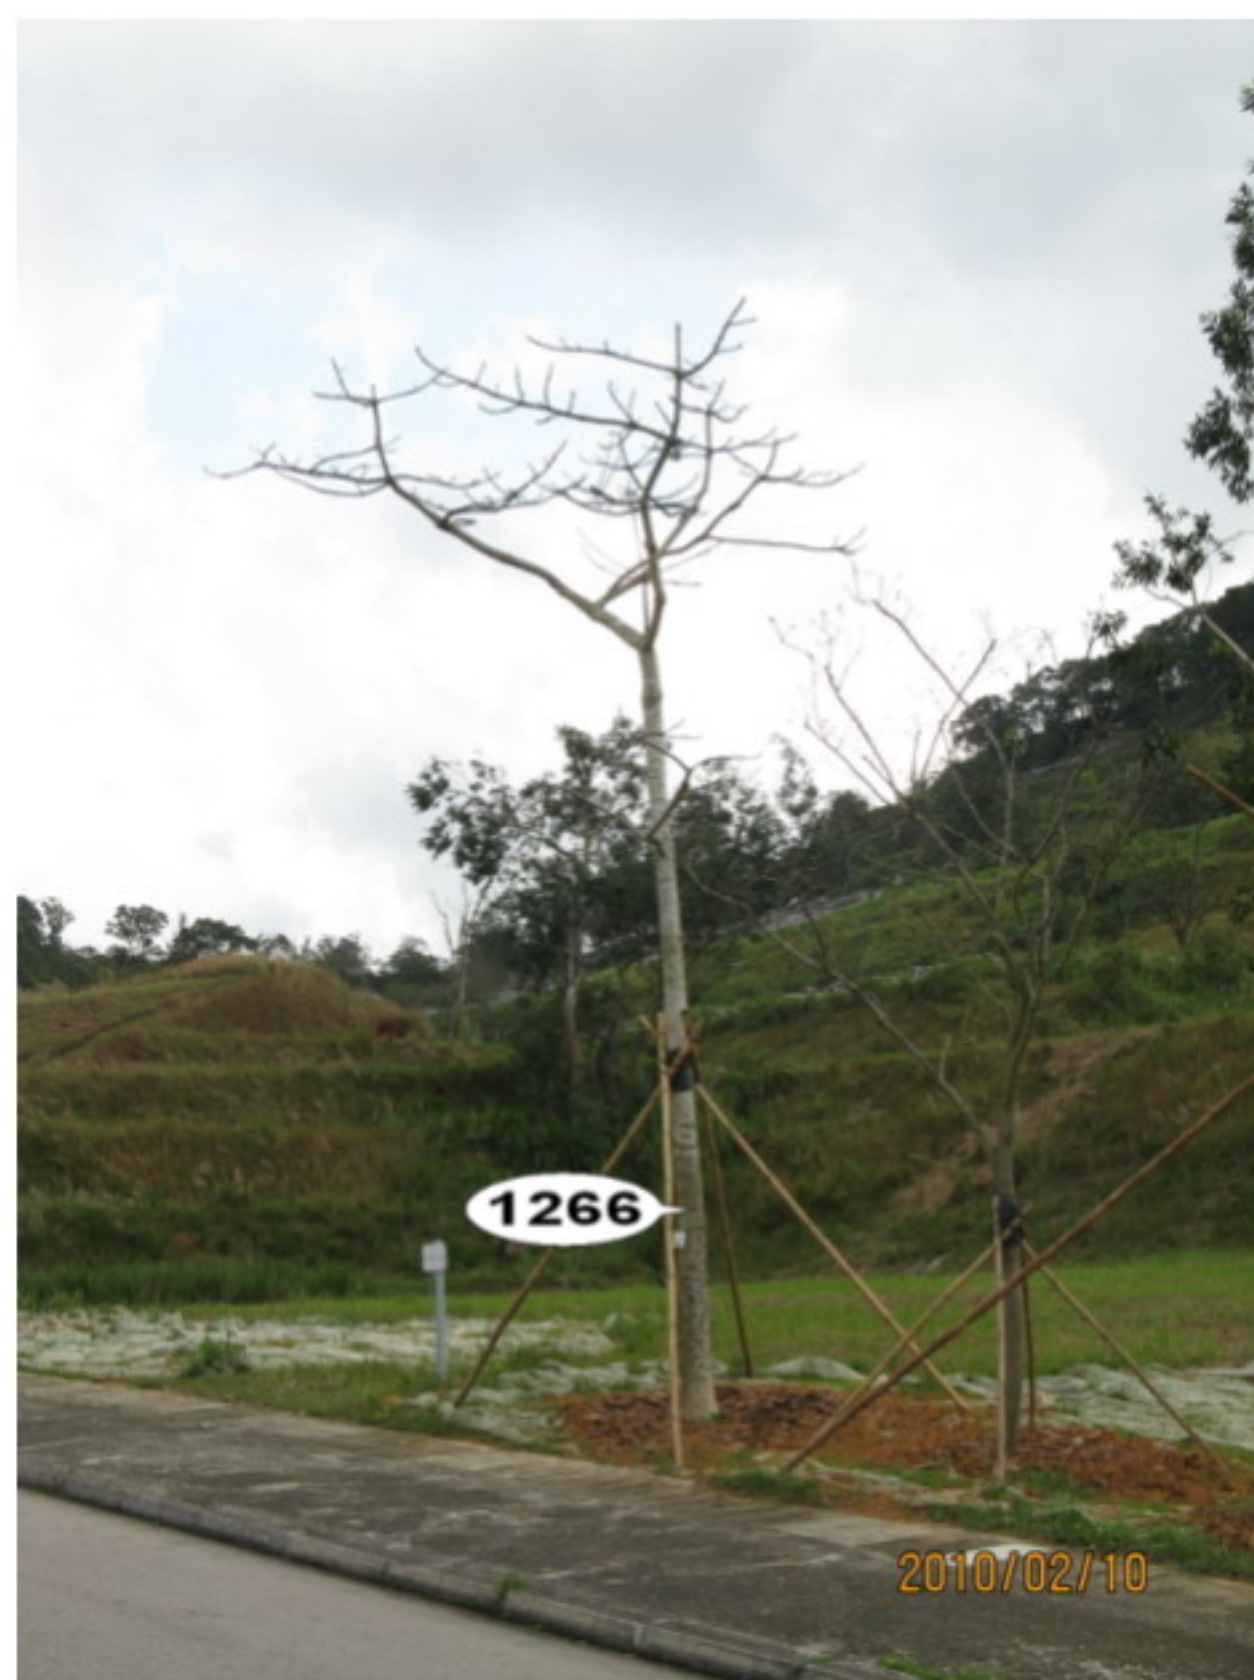
Tree No: 1266

| | | | | | | Remark |
|---|---|---|---|---|---|---|
| 1266 | <i>Bombax ceiba</i> | 木棉 | 4 | 0.15 | 3 | Poor condition, No leave |

- 5.1 As the transplanted trees were not recovered from injury of root systems caused during transplantation operation, and the new roots are not regenerated yet. The trees are still under environmental stress at the reception sites. It is important to watering regularly, at least twice a week, during the current dry season. Close monitoring of the trees needs to be continued and relevant mitigation measures will be proposed when necessary.
- 5.2 Organic soil or composite organic enriched soil should be applied to each transplanted tree, approx. 20kg to 40kg per tree is recommended. On top of organic soil should covered with tree barks and 5kg to 20kg tree bark is recommended according to tree size.

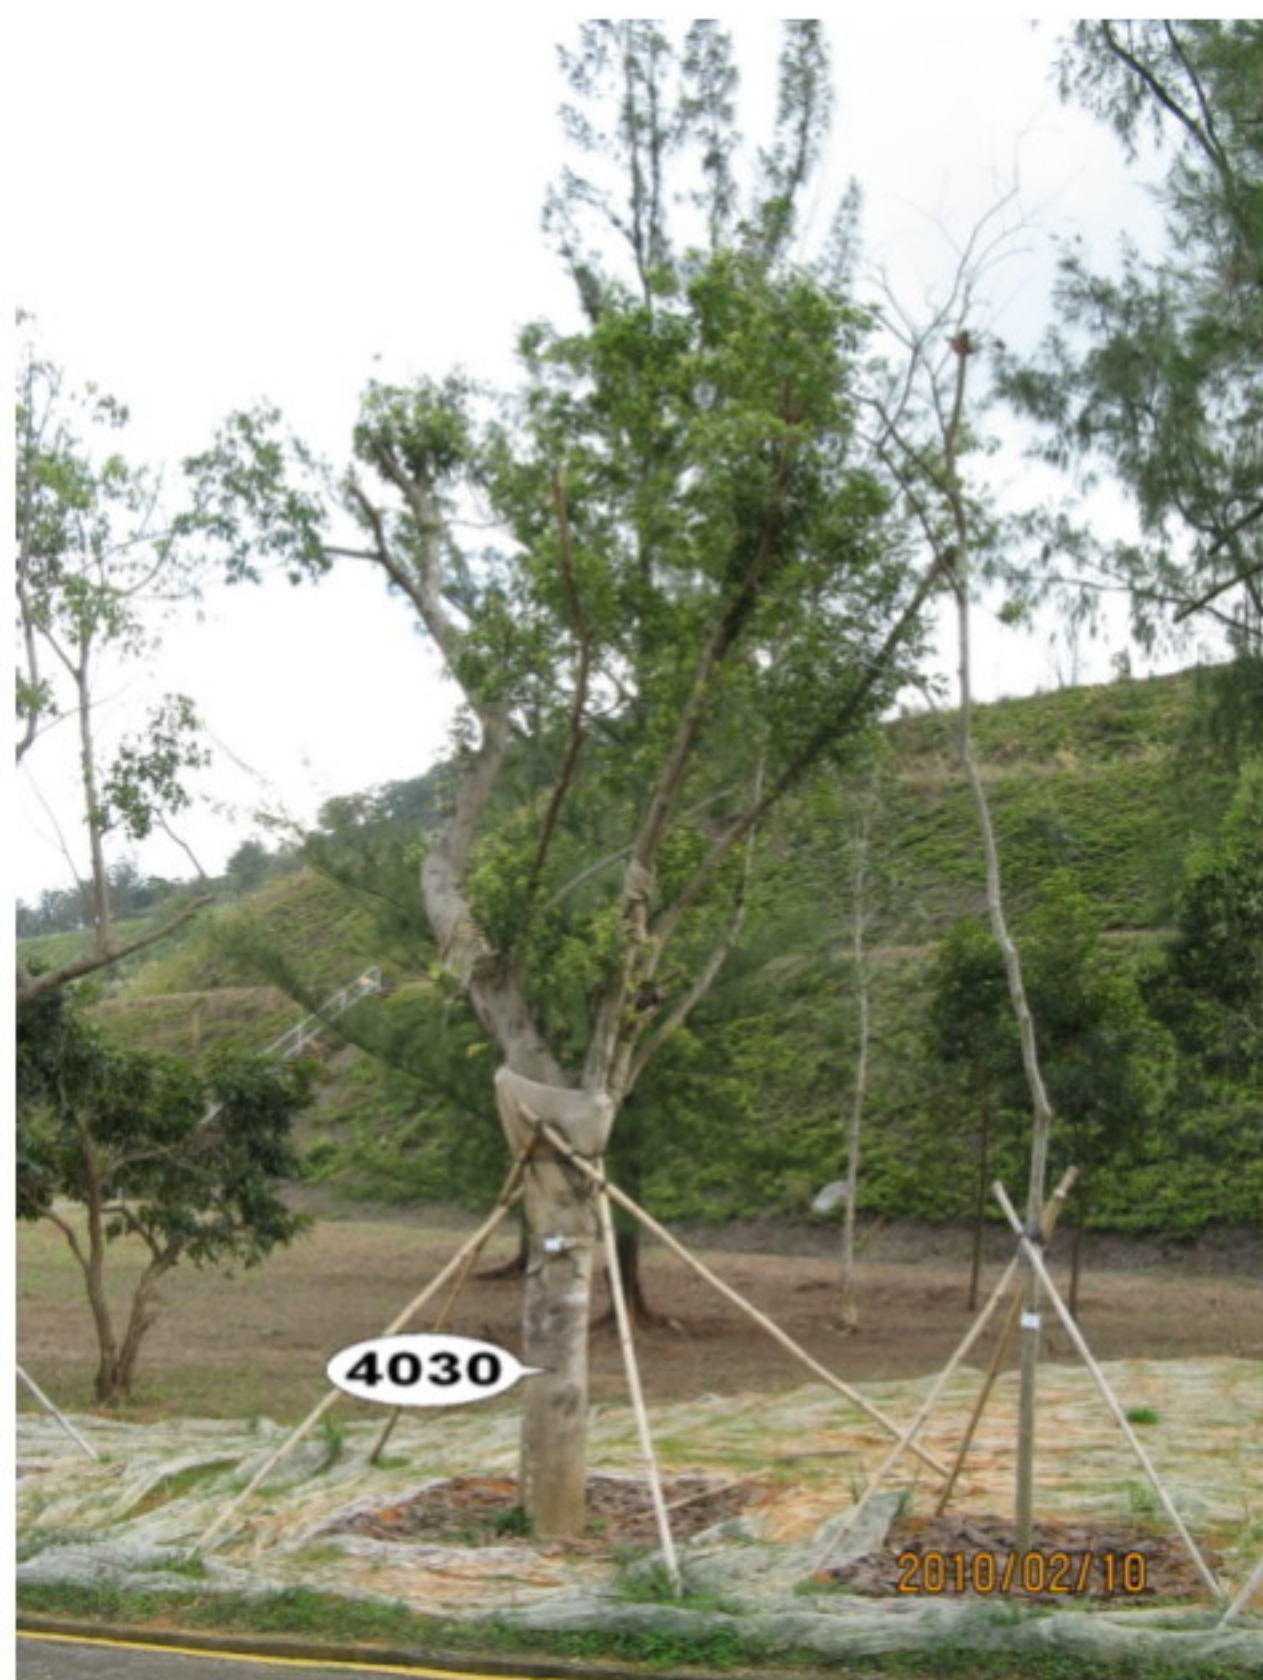
Tree No: 4030

| | | | | | | Remark |
|---|---|---|---|---|---|---|
| 4030 | <i>Cinnamomum burmannii</i> | 陰香 | 5.5 | 0.16 | 4 | Poor condition, Fork, Pruned, Decay, Leave regenerating |

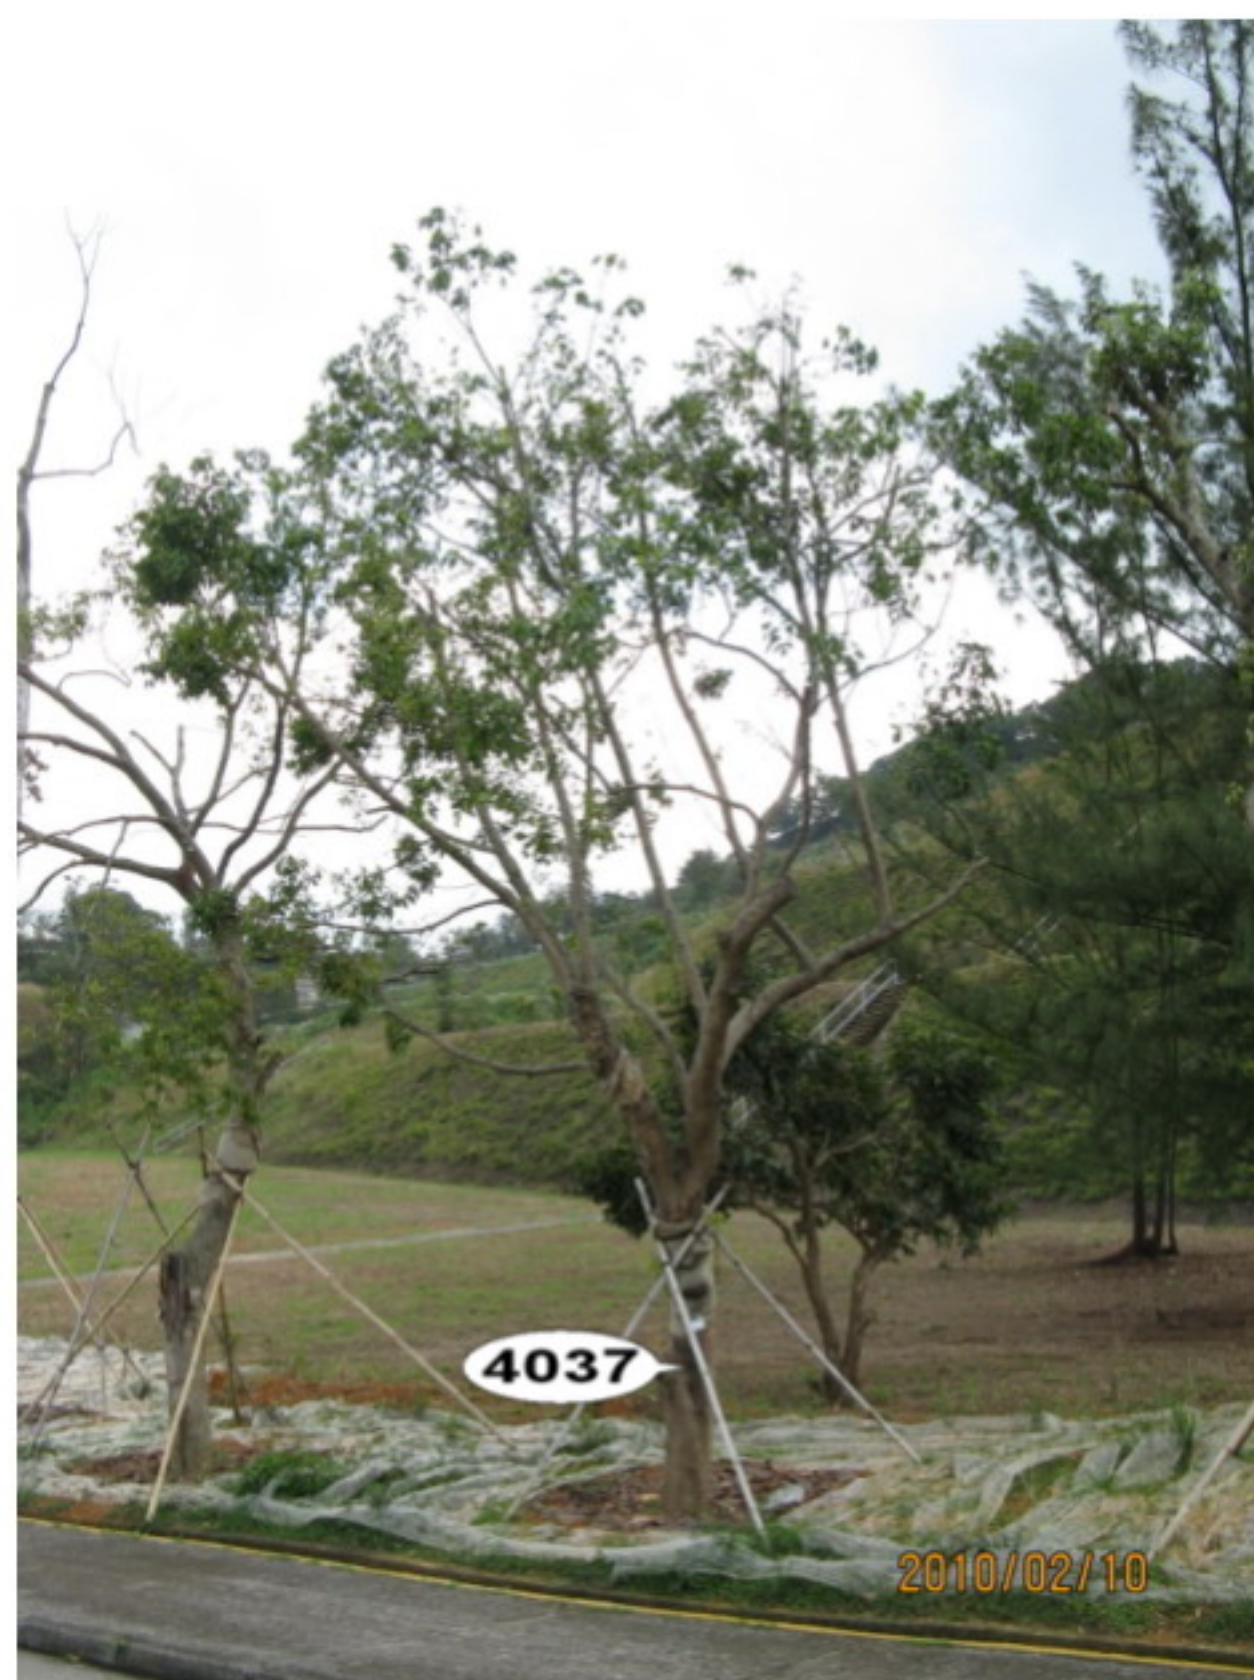
Tree No: 4037

| | | | | | | Remark |
|---|---|---|---|---|---|---|
| 4037 | <i>Cinnamomum burmannii</i> | 陰香 | 6 | 0.25 | 4 | Poor condition, Fork, Pruned, Cavity, Leave regenerating |

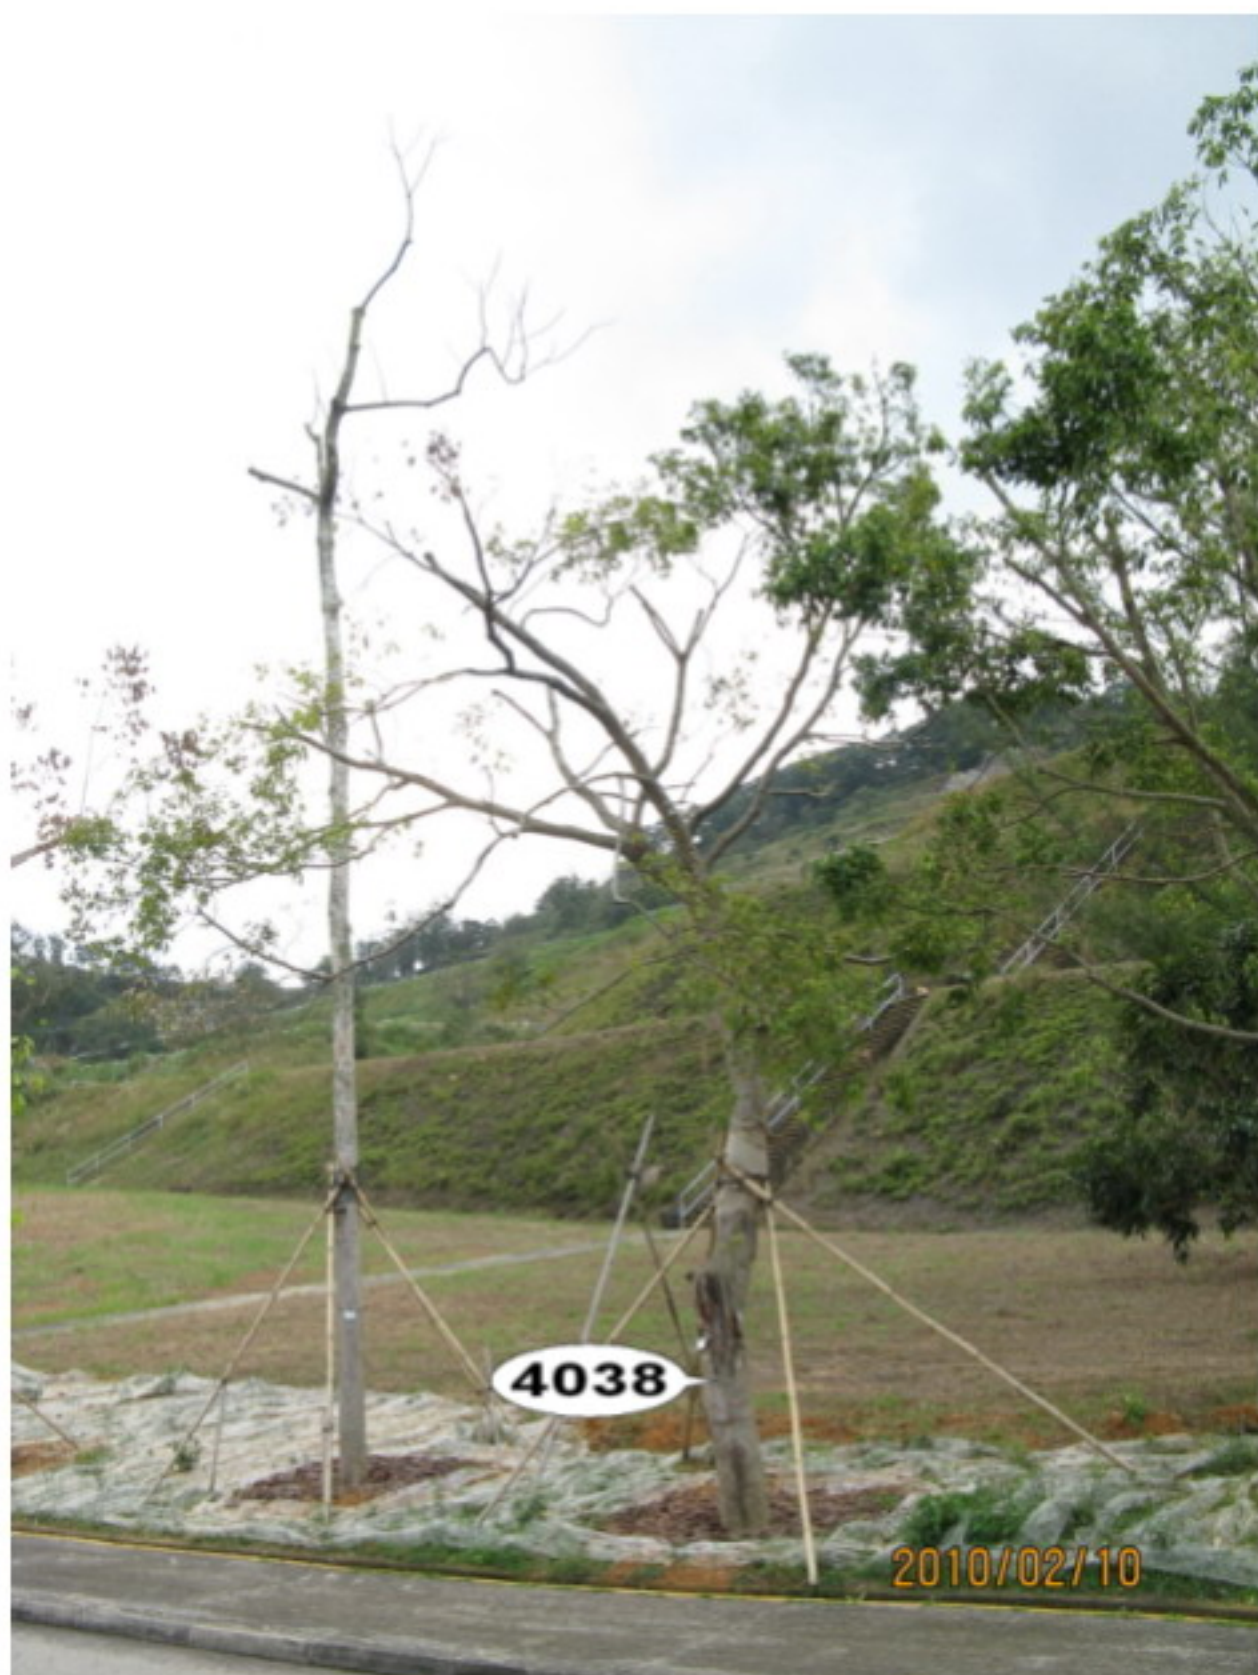
Tree No: 4038

| | | | | | | Remark |
|---|---|---|---|---|---|---|
| 4038 | <i>Cinnamomum burmannii</i> | 陰香 | 6 | 0.25 | 4 | Poor condition, Bark damage, leave regenerating, Heavy sparse crown |

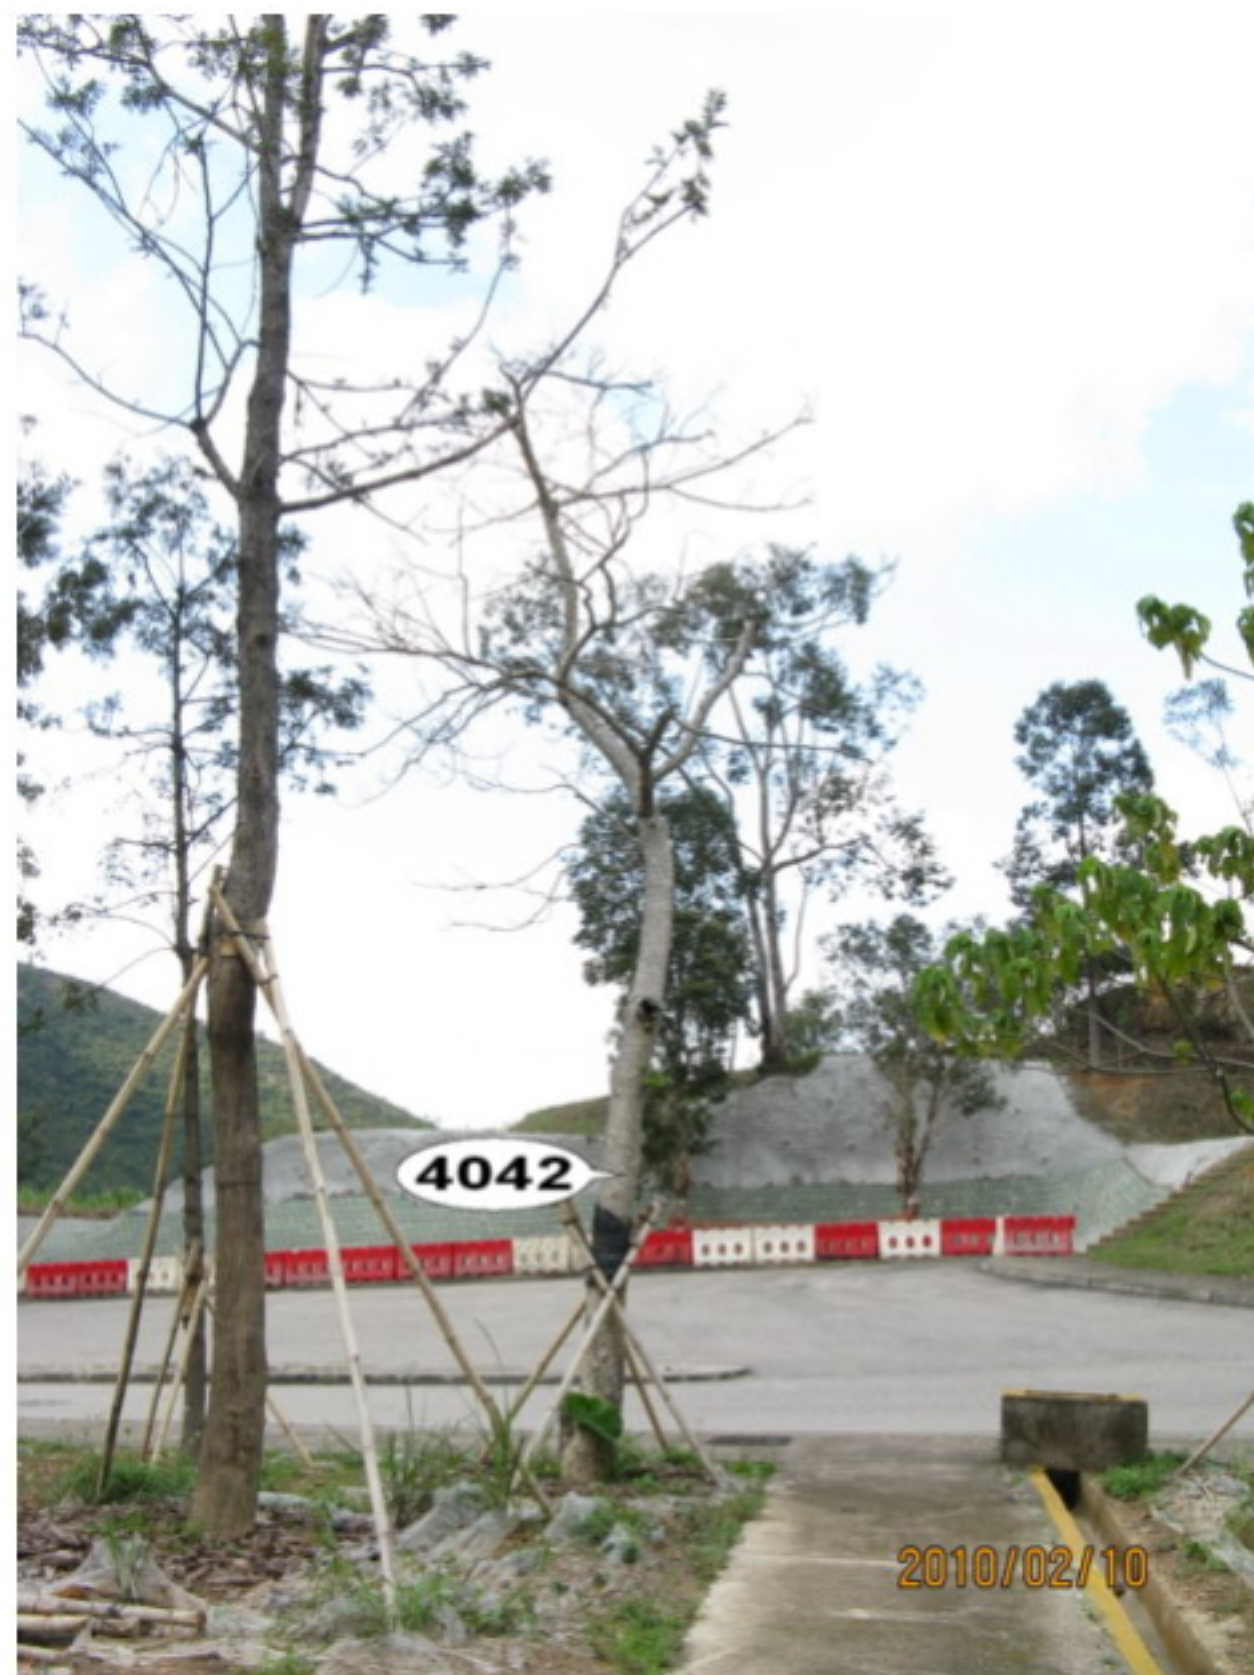
Tree No: 4042

| | | | | | | Remark |
|---|---|---|---|---|---|---|
| 4042 | <i>Albizia lebbek</i> | 大葉合歡 | 8 | 0.16 | 4 | Poor condition, Leave regenerating |
