**PROVISION OF CREMATORS AT  
WO HOP SHEK CREMATORIUM**

**ENVIRONMENTAL MONITORING &  
AUDIT REPORT (FEBRUARY 2010)**

Quotation Contract No. 9/2009/AB1  
Provision of Cremators at Wo Hop Shek Crematorium - Independent Environmental Checker Service  
Monthly EM&A Report (February 2010)

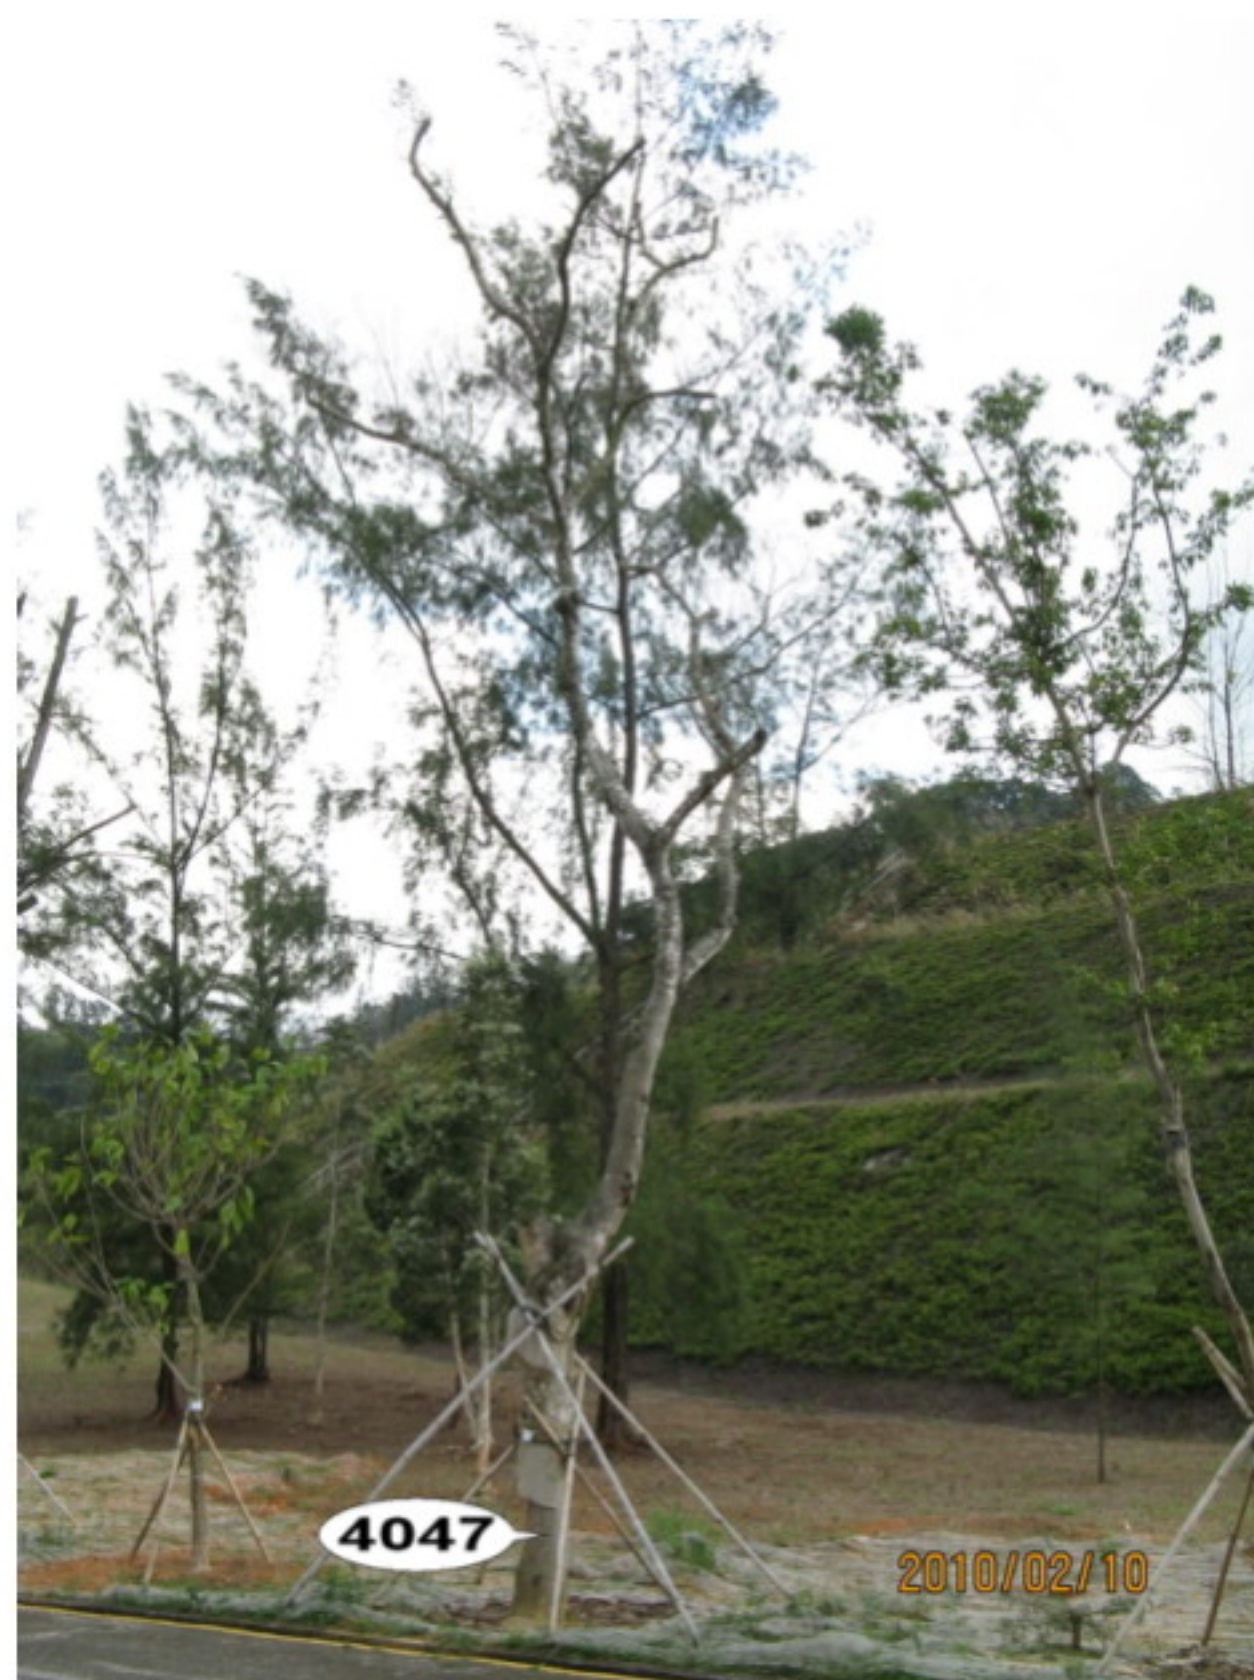
Tree No: 4047

| | | | | | | Remark |
|---|---|---|---|---|---|---|
| 4047 | <i>Acacia confusa</i> | 台灣相思 | 9 | 0.19 | 5 | Poor condition, Fork, Pruned, wilting, loose bark |

- 5.1 As the transplanted trees were not recovered from injury of root systems caused during transplantation operation, and the new roots are not regenerated yet. The trees are still under environmental stress at the reception sites. It is important to watering regularly, at least twice a week, during the current dry season. Close monitoring of the trees needs to be continued and relevant mitigation measures will be proposed when necessary.
- 5.2 Organic soil or composite organic enriched soil should be applied to each transplanted tree, approx. 20kg to 40kg per tree is recommended. On top of organic soil should covered with tree barks and 5kg to 20kg tree bark is recommended according to tree size.

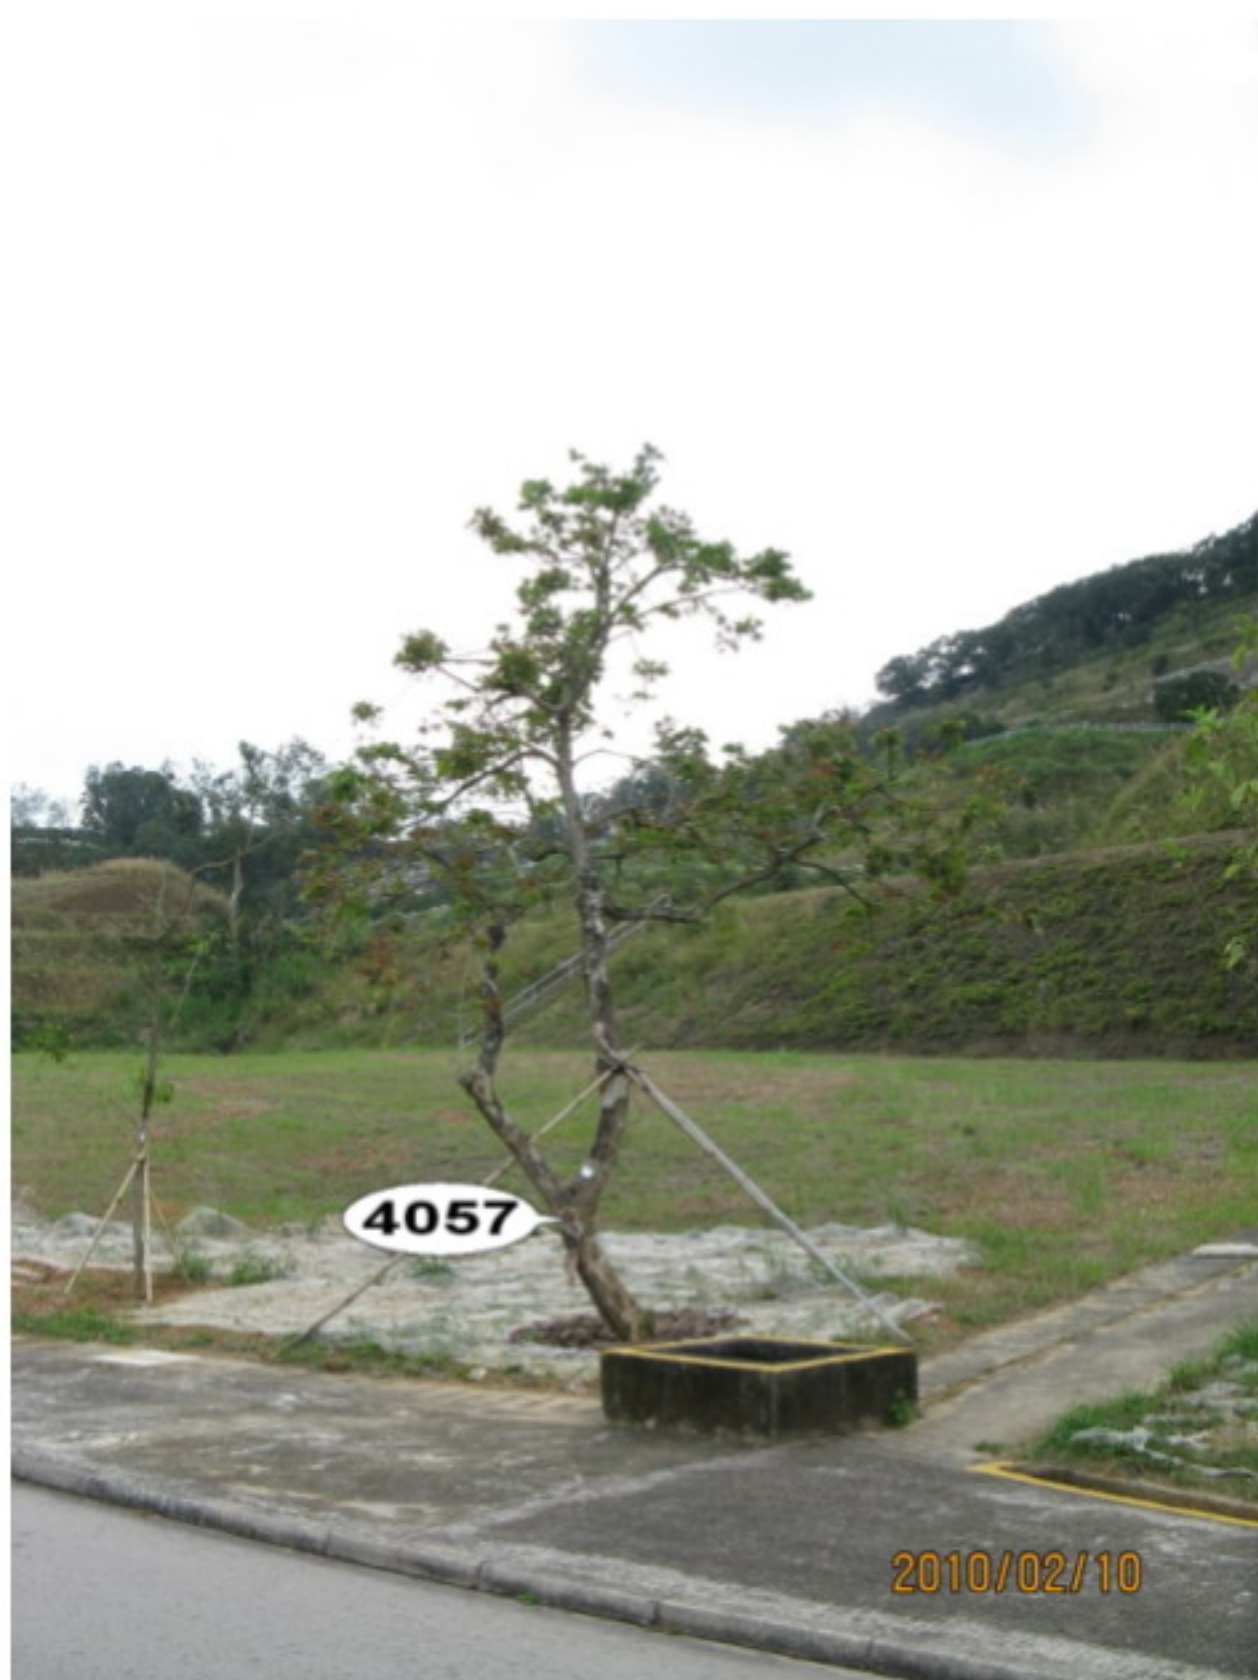
Tree No: 4057

| Tree Number | Species | Chinese name | Height (m) | Diameter (m) | Spread (m) | Remark |
|---|---|---|---|---|---|---|
| 4057 | <i>Dimocarpus longan</i> | 龍眼 | 6 | 0.16 | 4 | Fair condition, Loose bark, Leave regeneration |

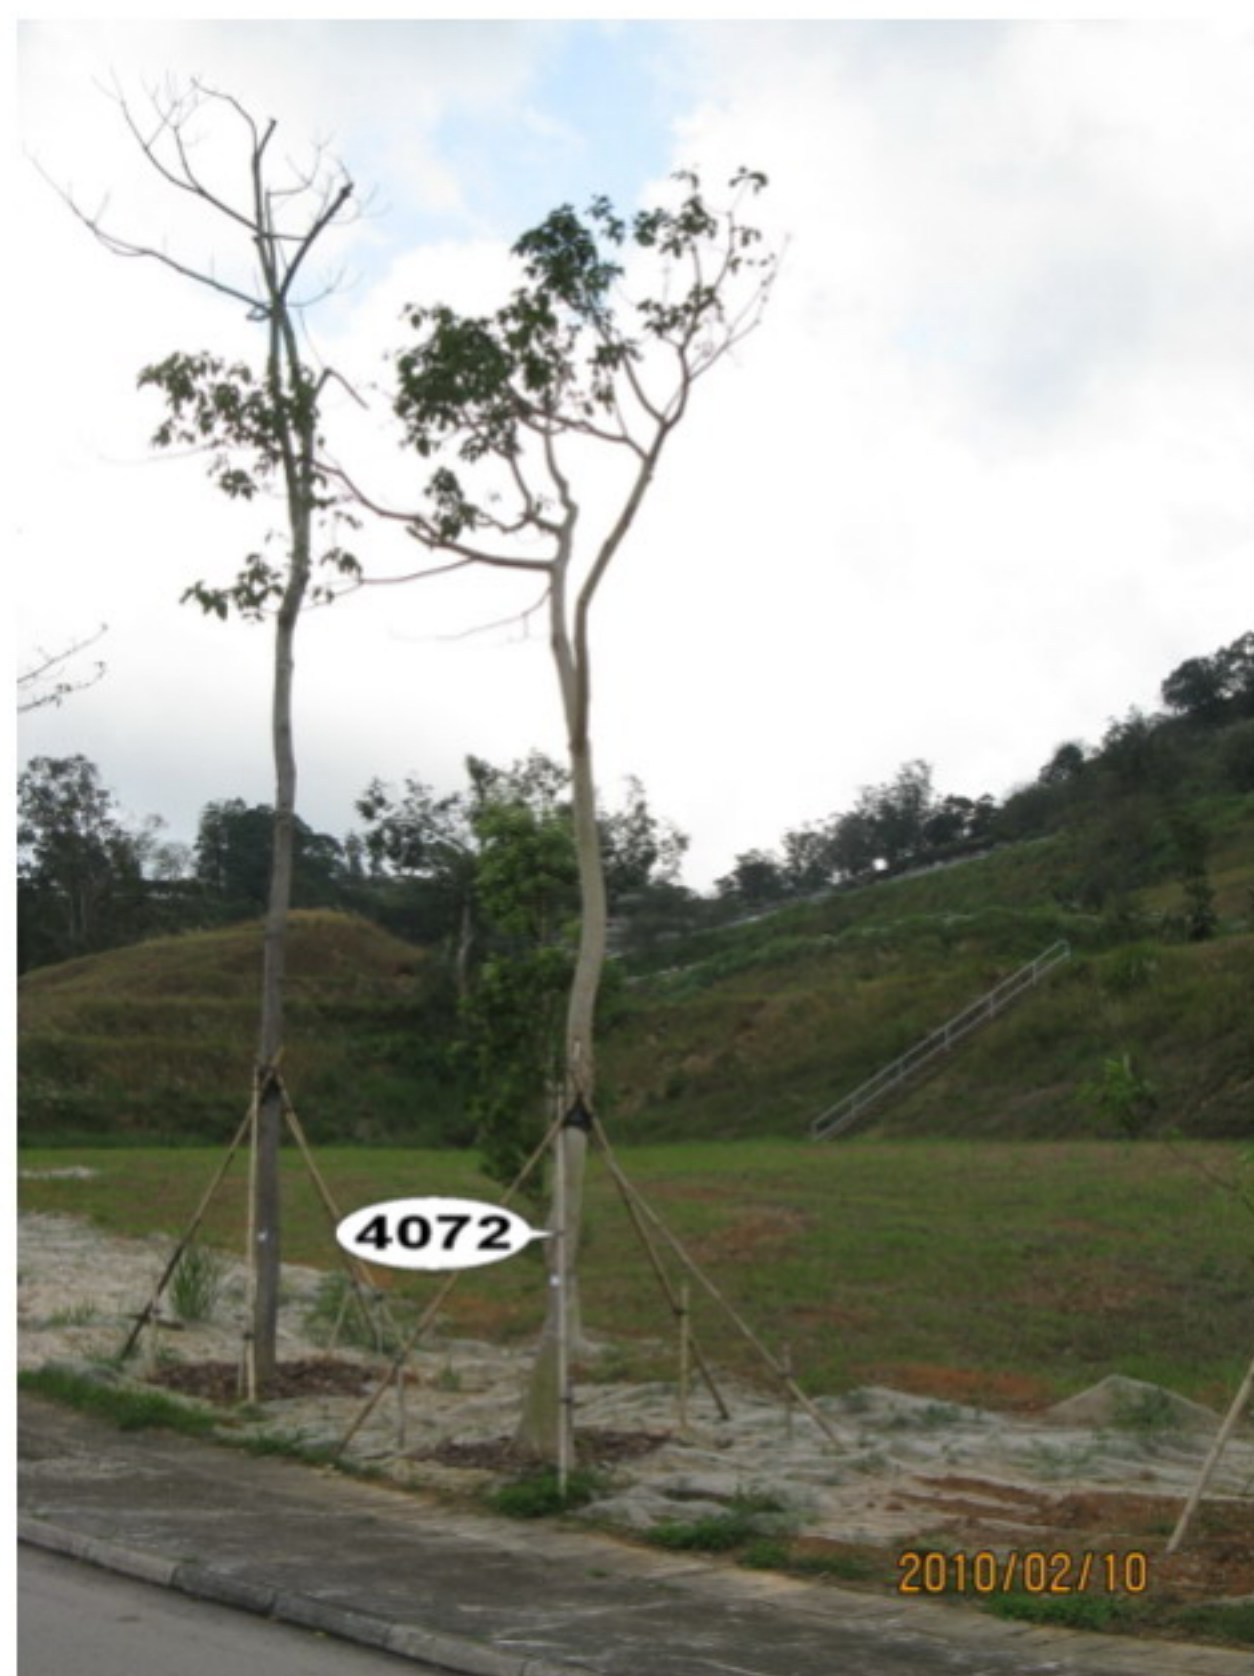
Tree No: 4072

| Tree Number | Species | Chinese name | Height (m) | Diameter (m) | Spread (m) | Remark |
|---|---|---|---|---|---|---|
| 4072 | <i>Ficus variegata</i> | 青果榕 | 6 | 0.13 | 3 | Poor condition, Sparse crown, loose bark, bark damage, cavity. |

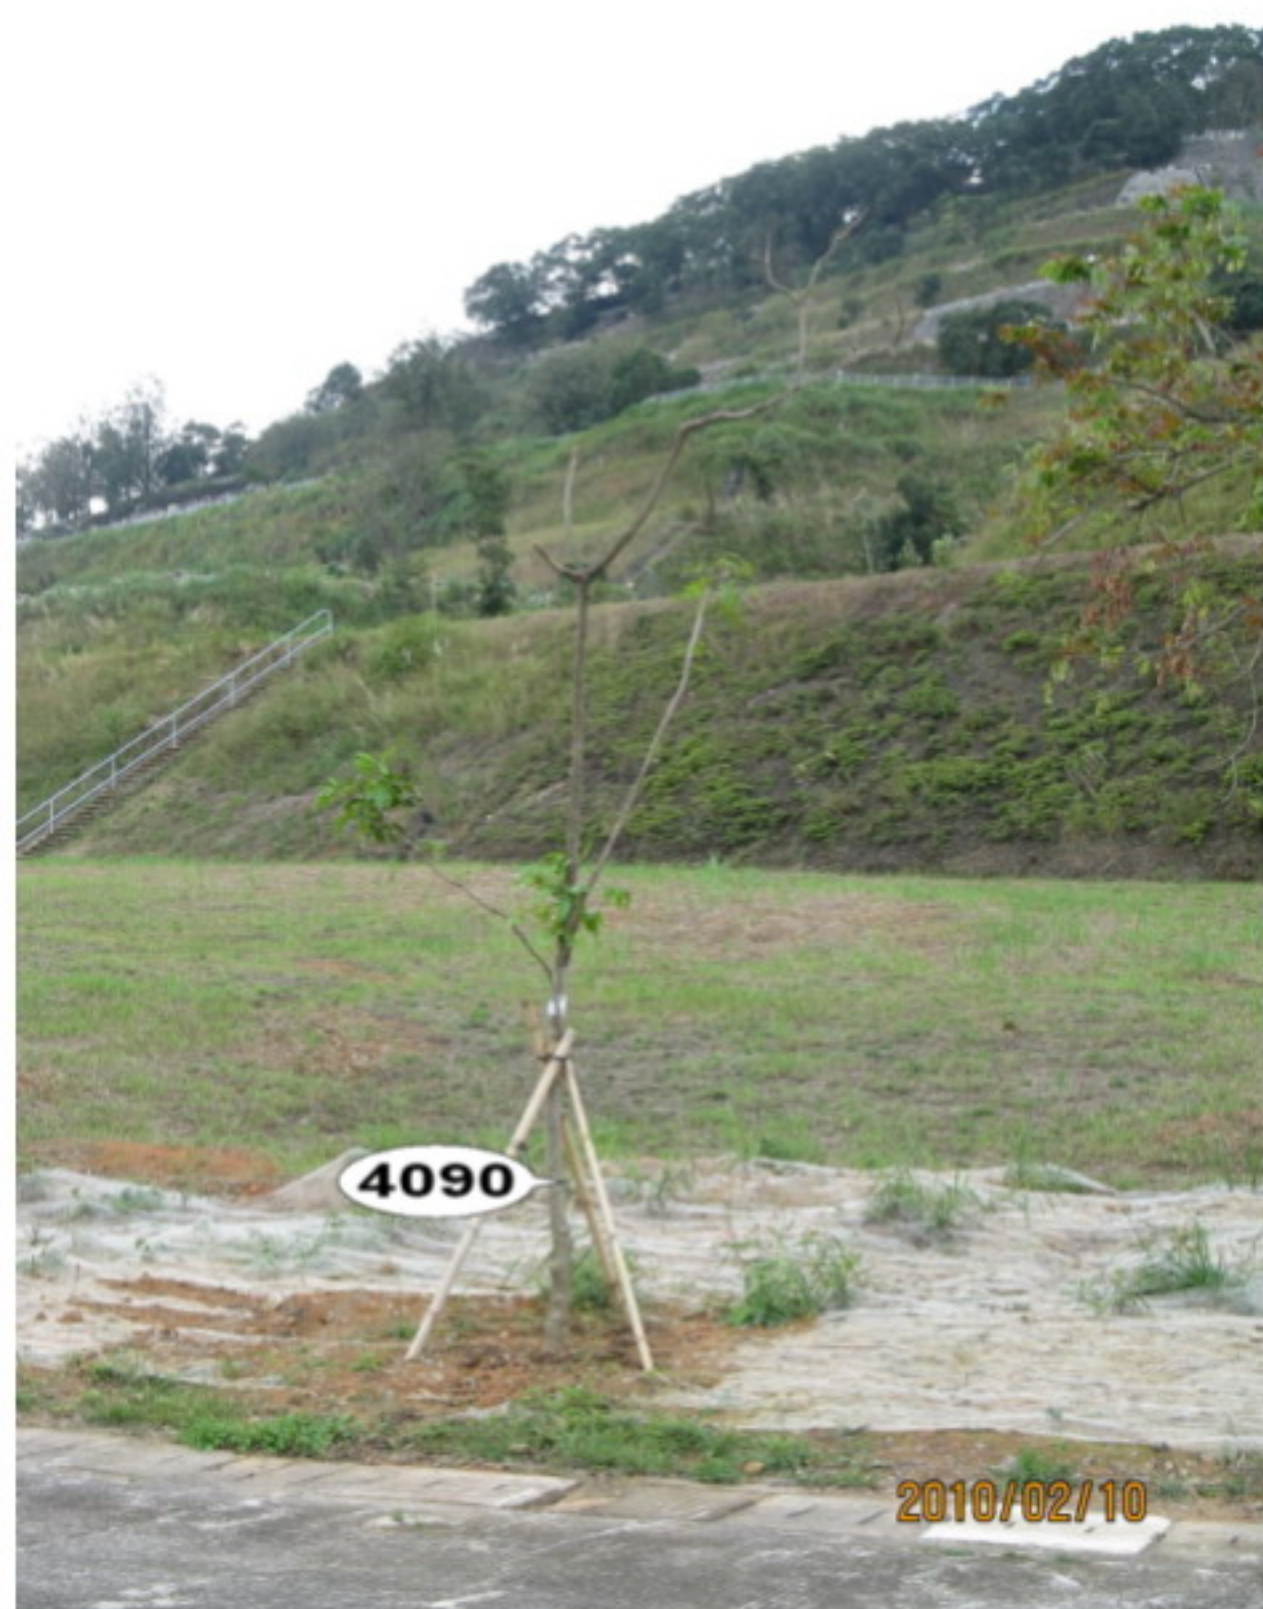
Tree No: 4090

| Tree Number | Species | Chinese name | Height (m) | Diameter (m) | Spread (m) | Remark |
|---|---|---|---|---|---|---|
| 4090 | <i>Schefflera heptaphylla</i> | 鴨腳木 | 6.5 | 0.18 | 4 | Poor condition, Heavy sparse crown, |

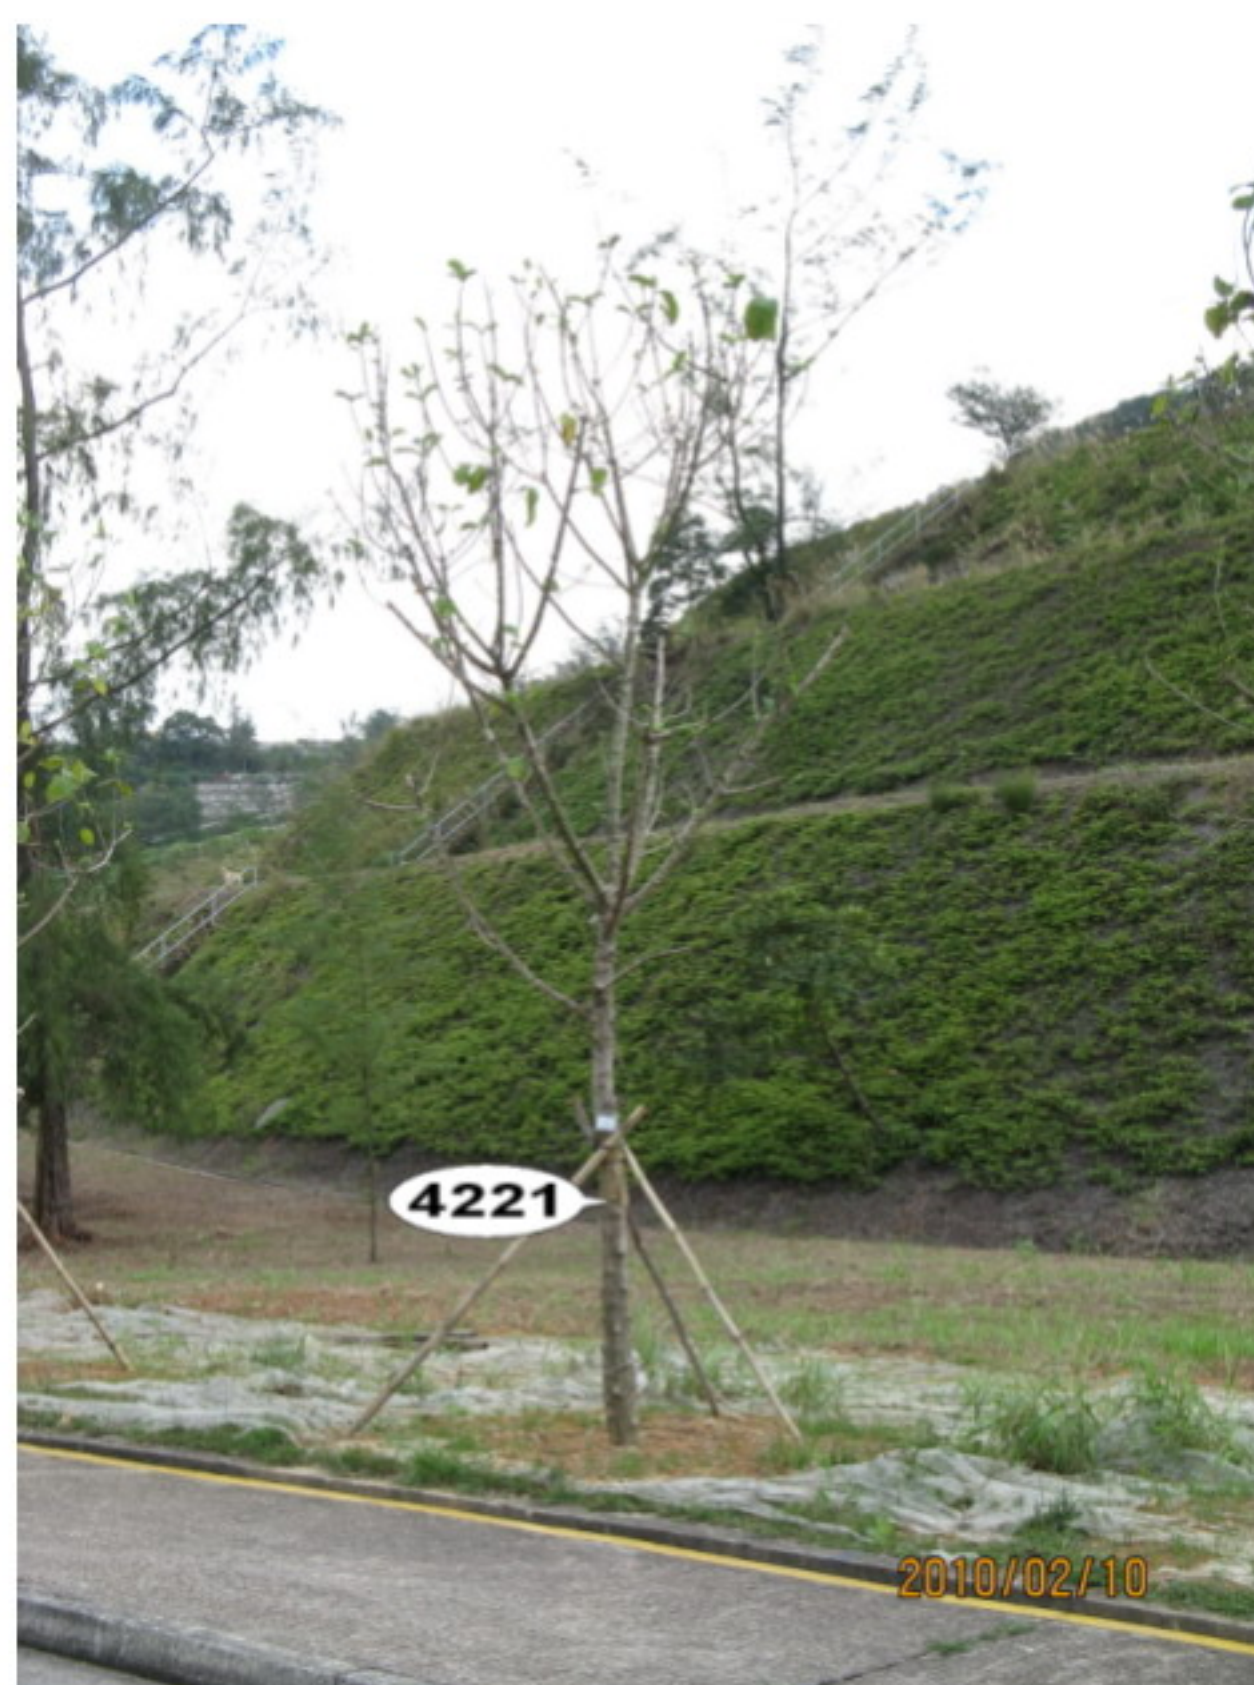
Tree No: 4221

| Tree Number | Species | Chinese name | Height (m) | Diameter (m) | Spread (m) | Remark |
|---|---|---|---|---|---|---|
| 4221 | <i>Ficus hispida</i> | 對葉榕 | 7 | 0.12 | 3 | Poor condition, Sparse crown |

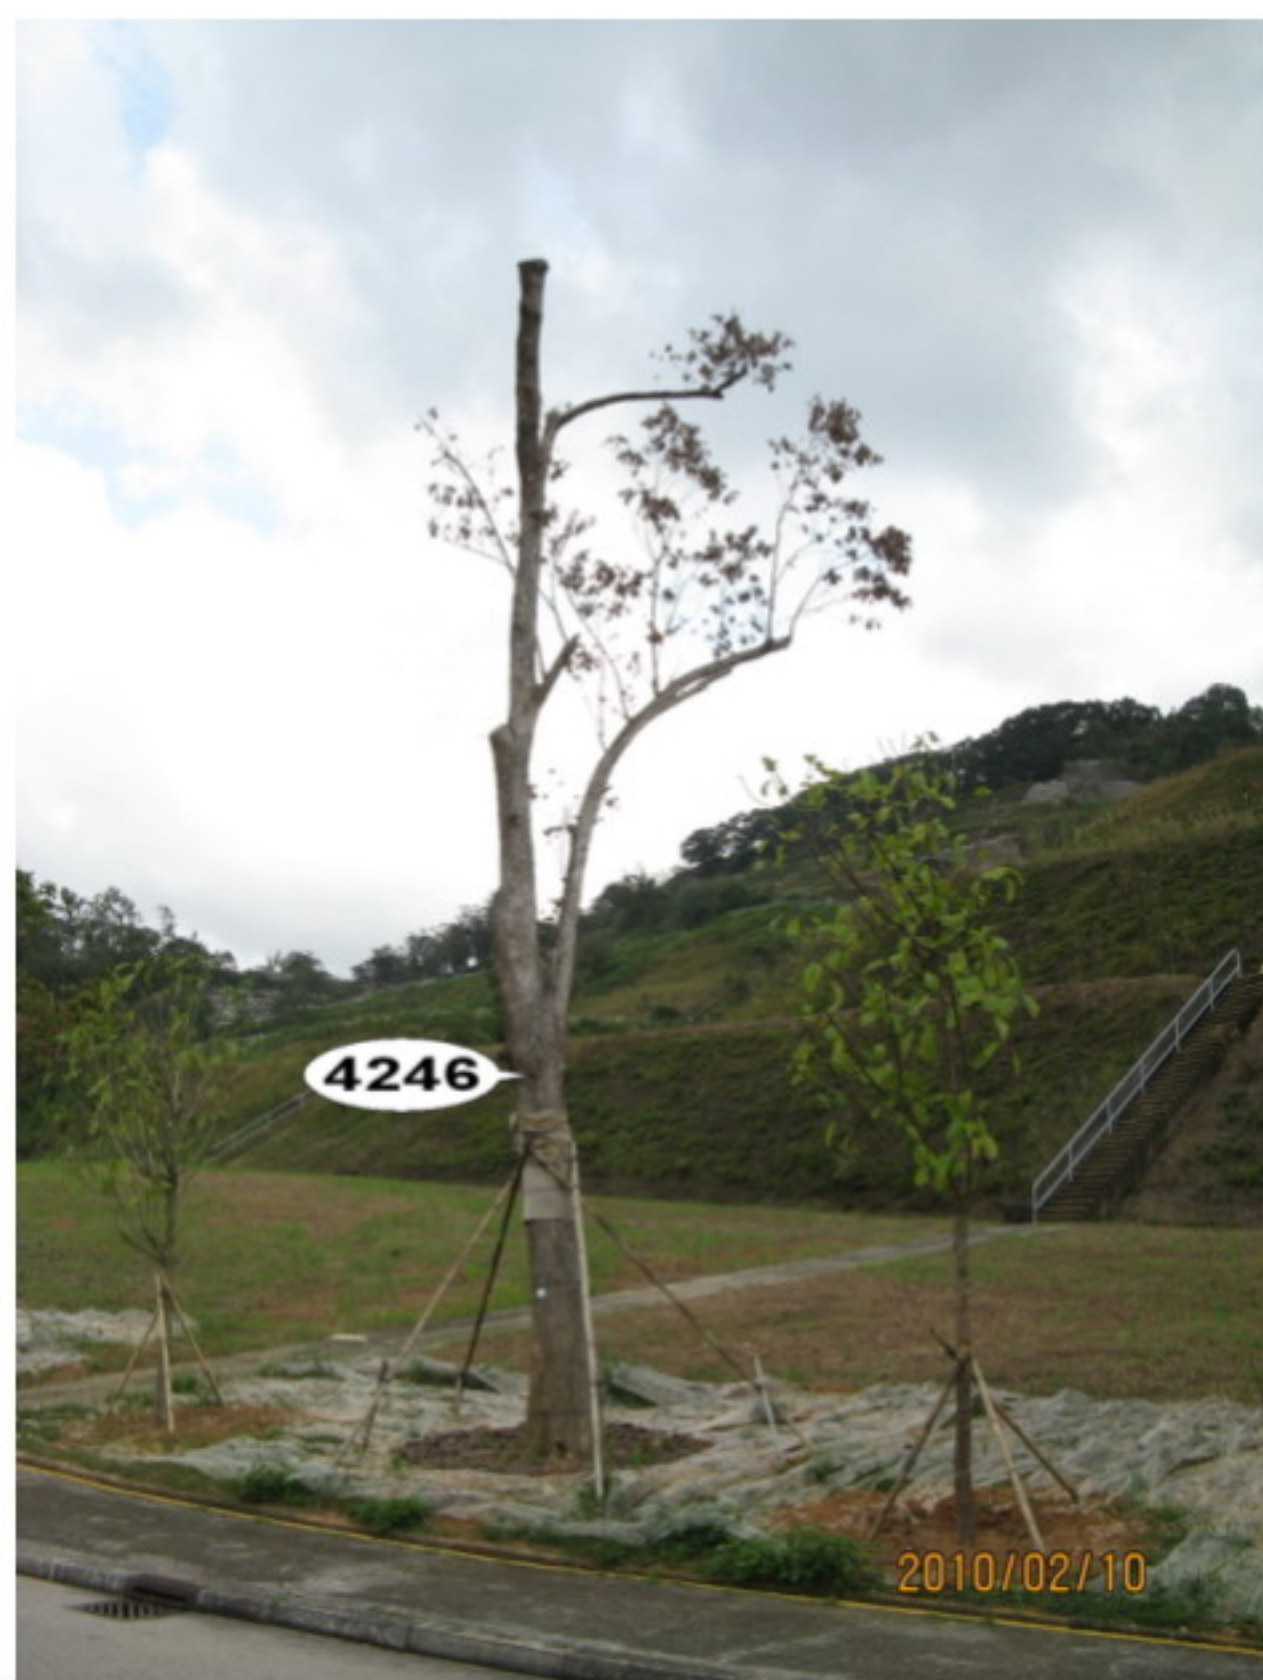
Tree No: 4246

| Tree Number | Species | Chinese name | Height (m) | Diameter (m) | Spread (m) | Remark |
|---|---|---|---|---|---|---|
| 4246 | <i>Lophostemon confertus</i> | 紅膠木 | 7 | 0.18 | 2 | Poor condition, Topping, Fork, sparse crown, wilt leave. |

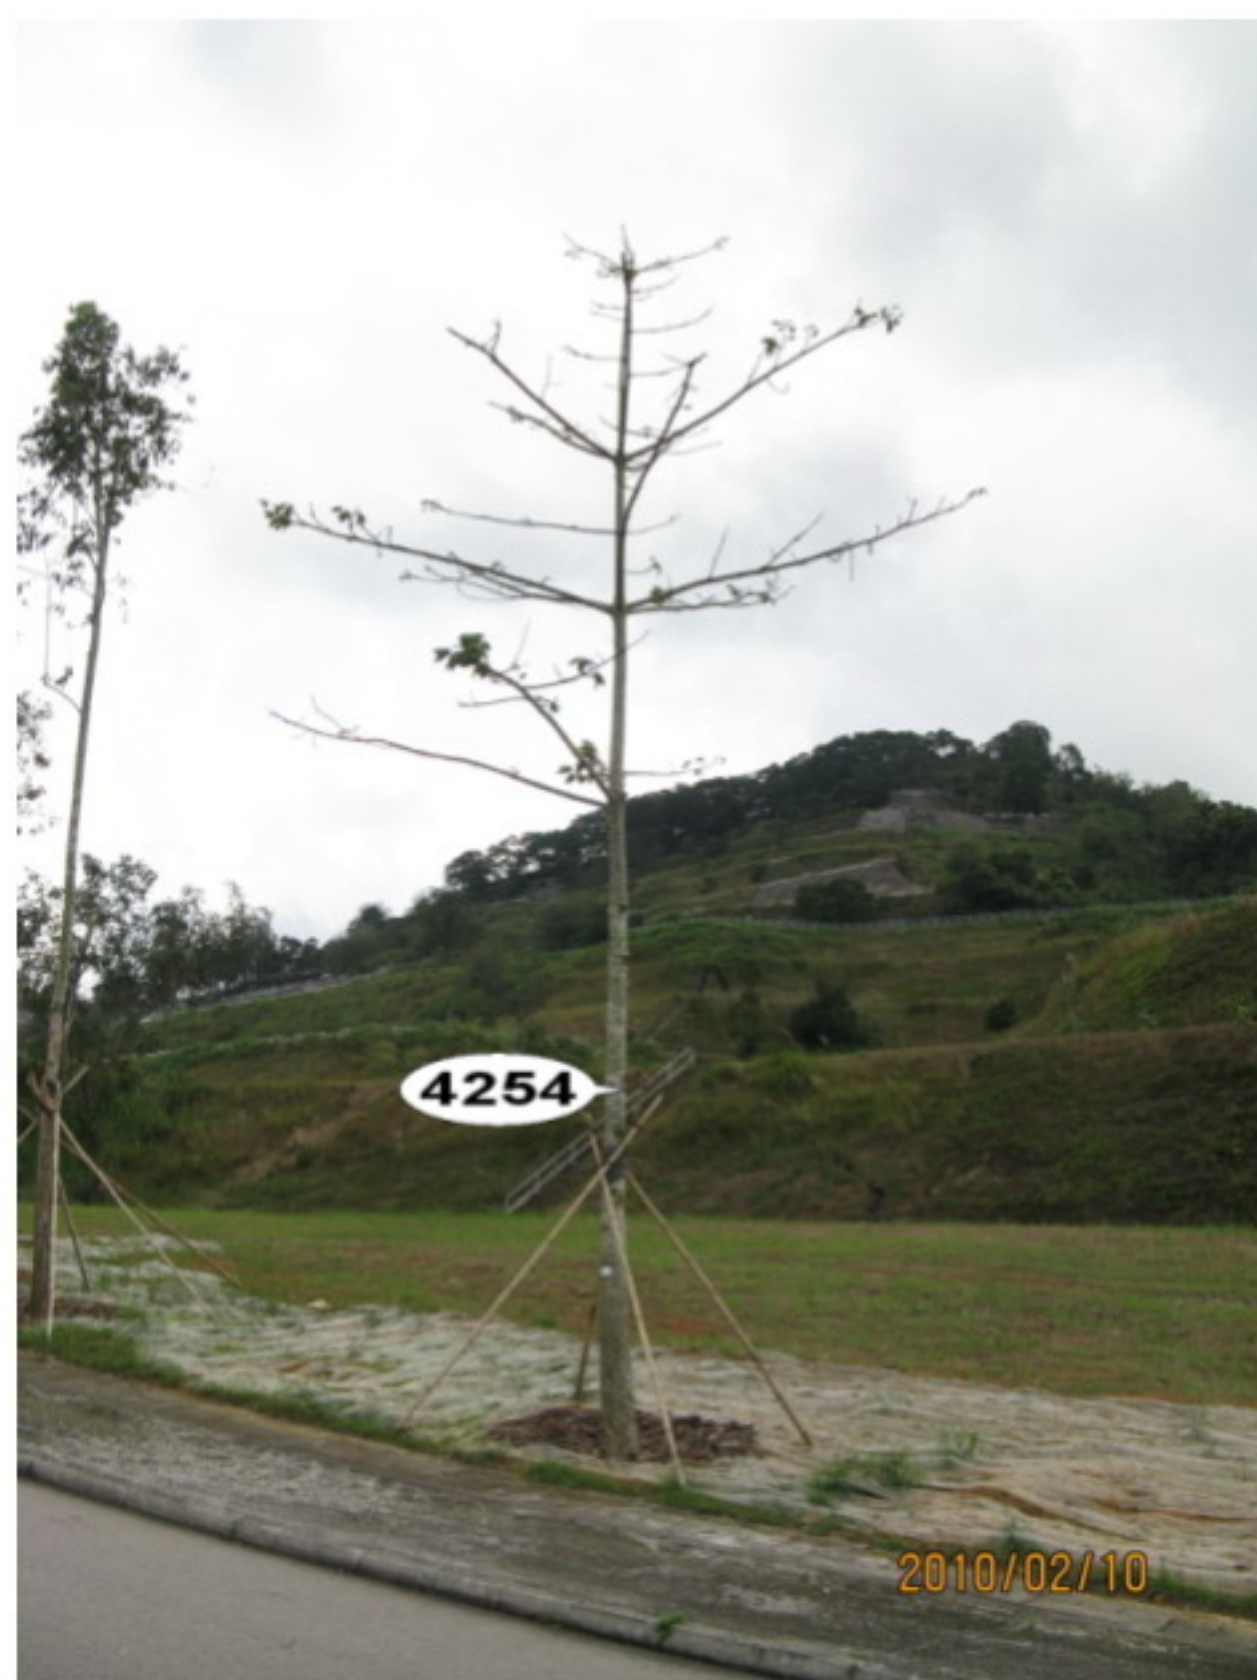
Tree No: 4254

| Tree Number | Species | Chinese name | Height (m) | Diameter (m) | Spread (m) | Remark |
|---|---|---|---|---|---|---|
| 4254 | <i>Bombax ceiba</i> | 木棉 | 7 | 0.37 | 4 | Fair condition, Broken branch, sparse crown , leave generating |

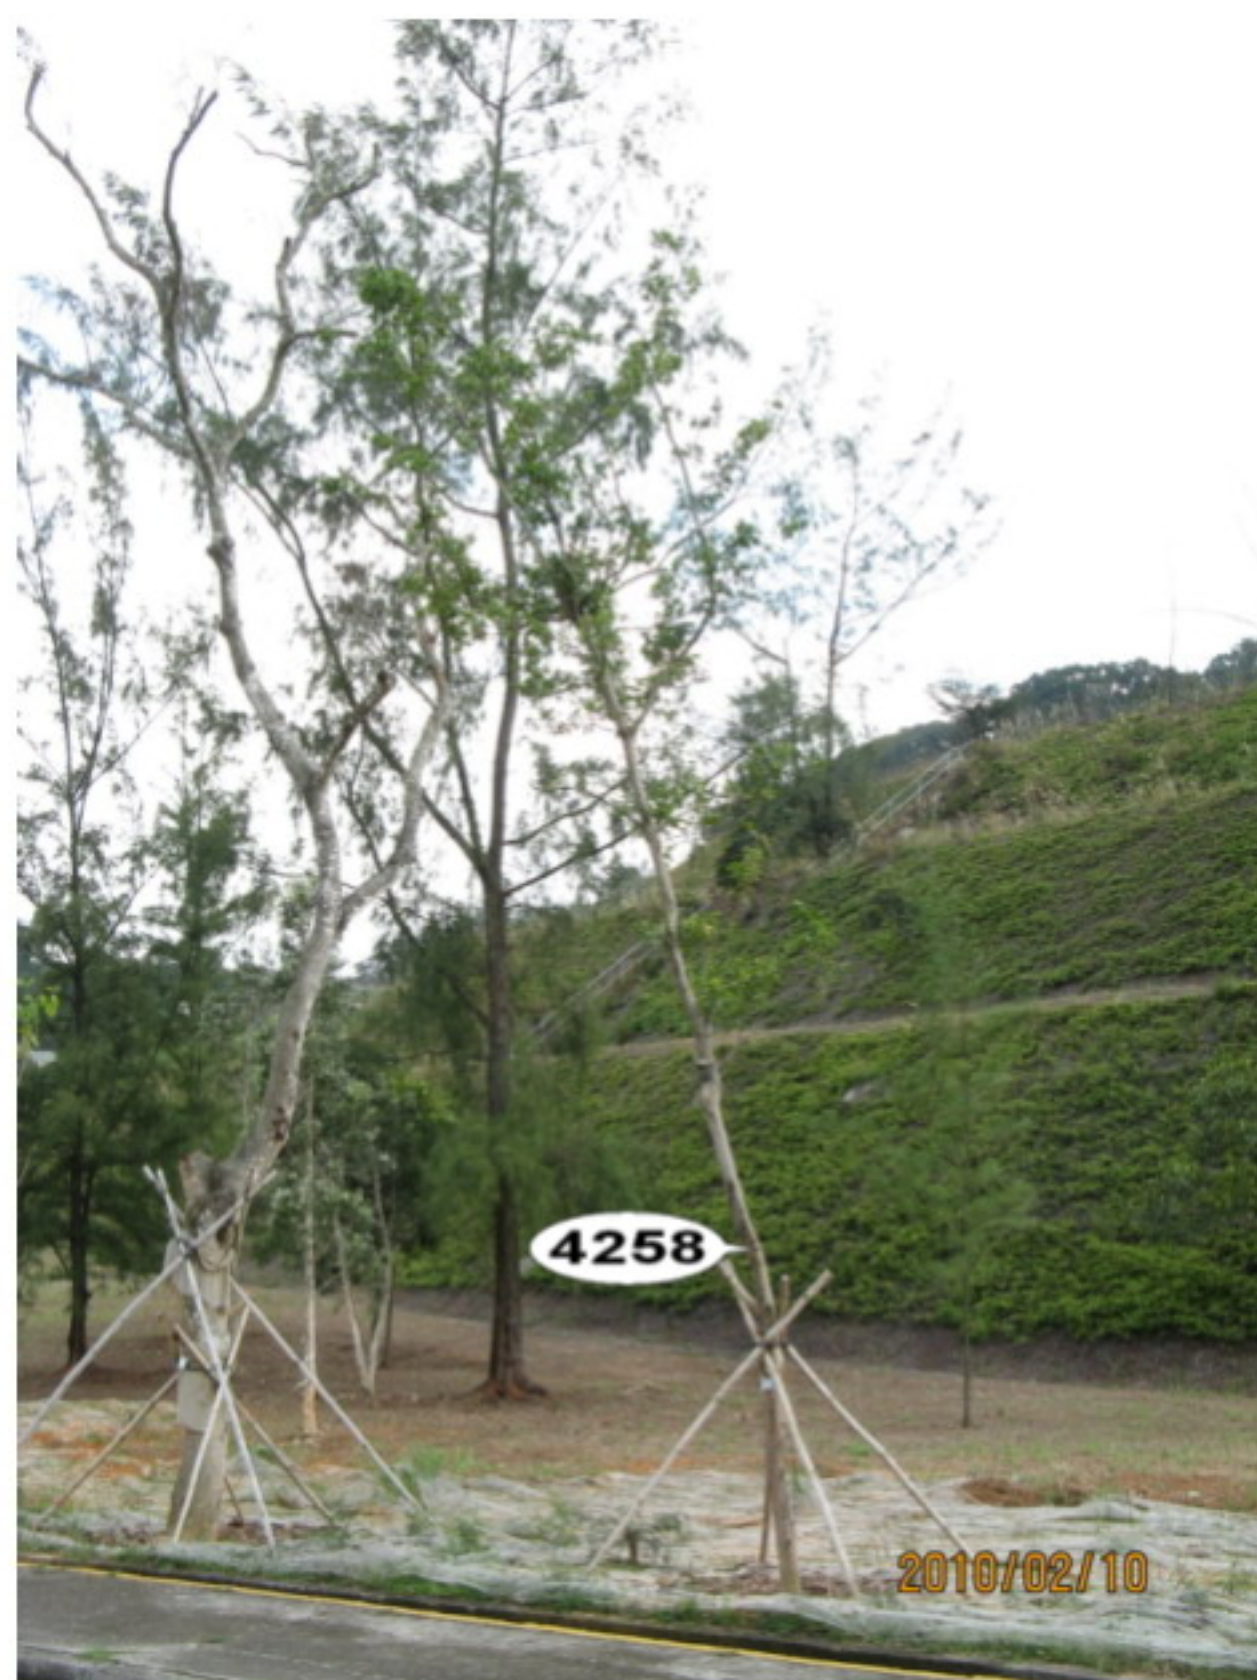
Tree No: 4258

| Tree Number | Species | Chinese name | Height (m) | Diameter (m) | Spread (m) | Remark |
|---|---|---|---|---|---|---|
| 4258 | <i>Cinnamomum burmannii</i> | 陰香 | 7 | 0.2 | 4 | Fair condition, Loose bark |
