**PROVISION OF CREMATORS AT  
WO HOP SHEK CREMATORIUM**

**ENVIRONMENTAL MONITORING &  
AUDIT REPORT (APRIL 2010)**

Quotation Contract No. 9/2009/AB1  
Provision of Cremators at Wo Hop Shek Crematorium - Independent Environmental Checker Service  
Monthly EM&A Report (April 2010)

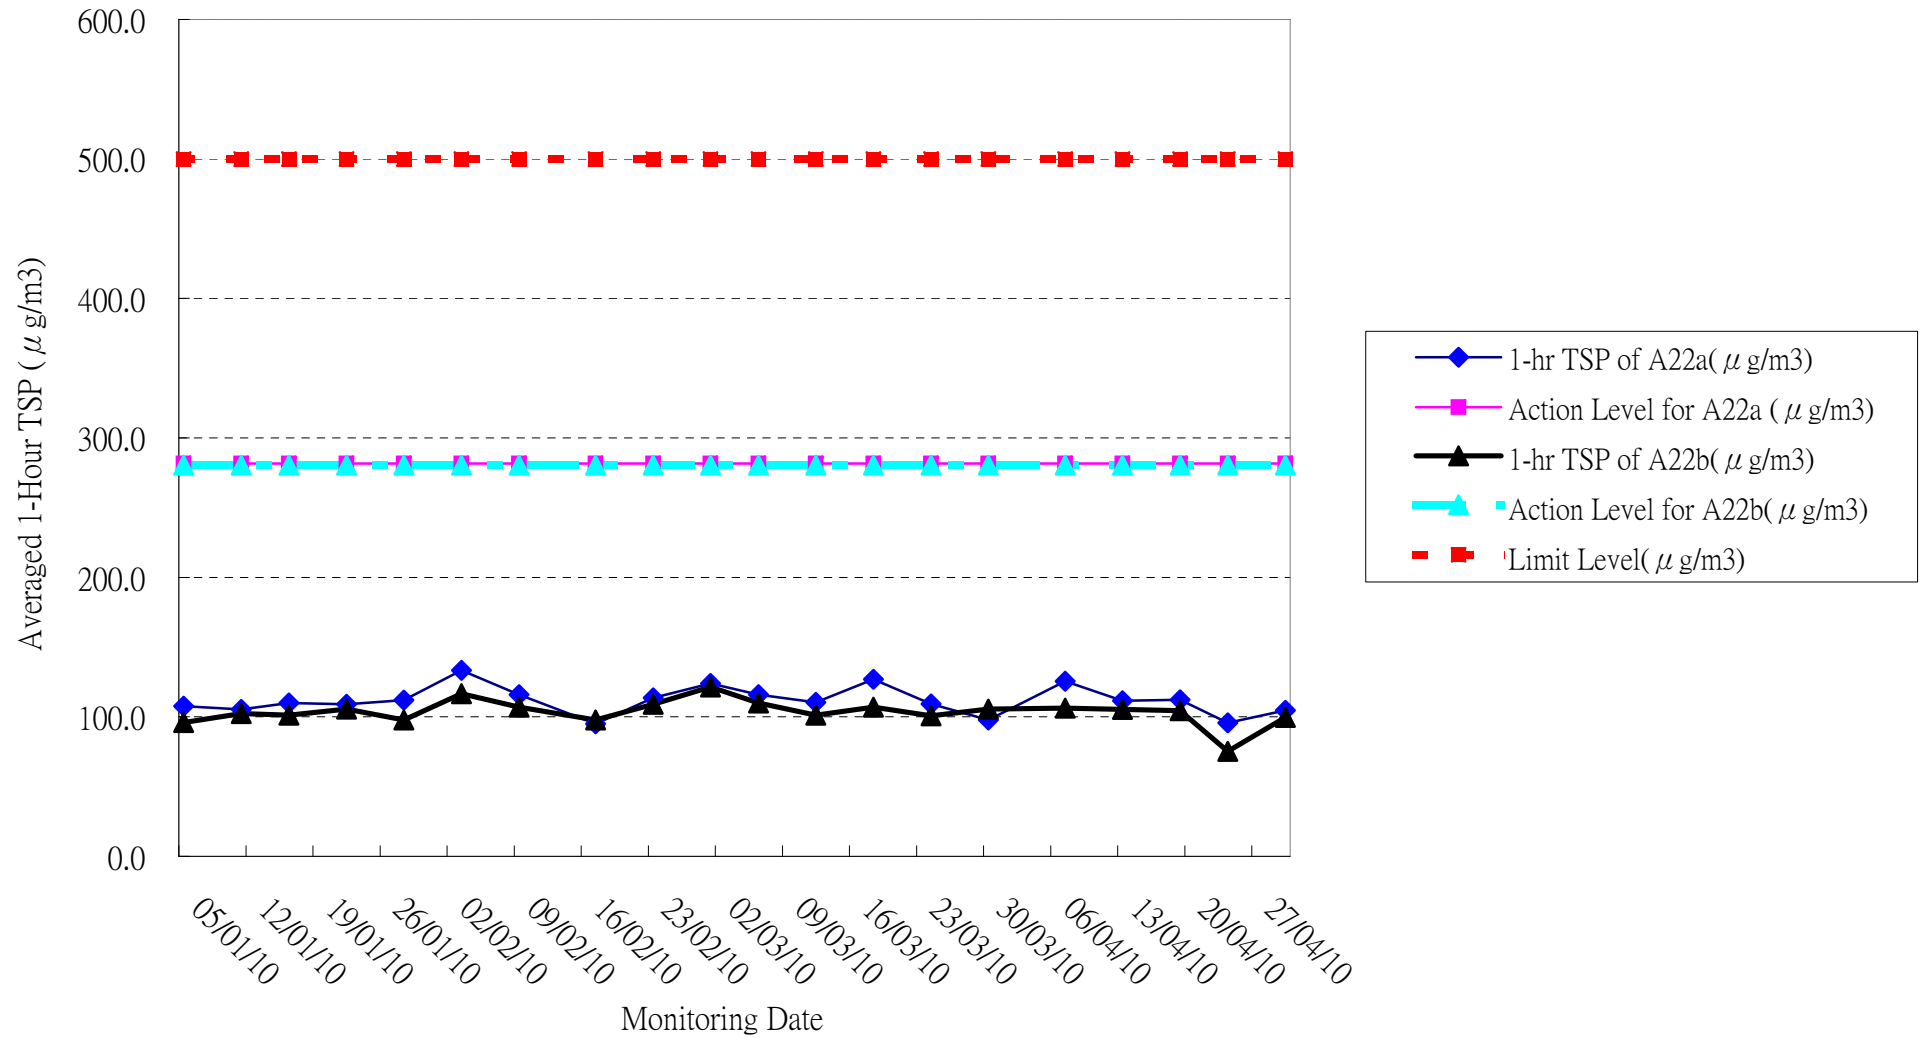
1-Hour TSP air quality monitoring data plot recorded at the designated monitoring points

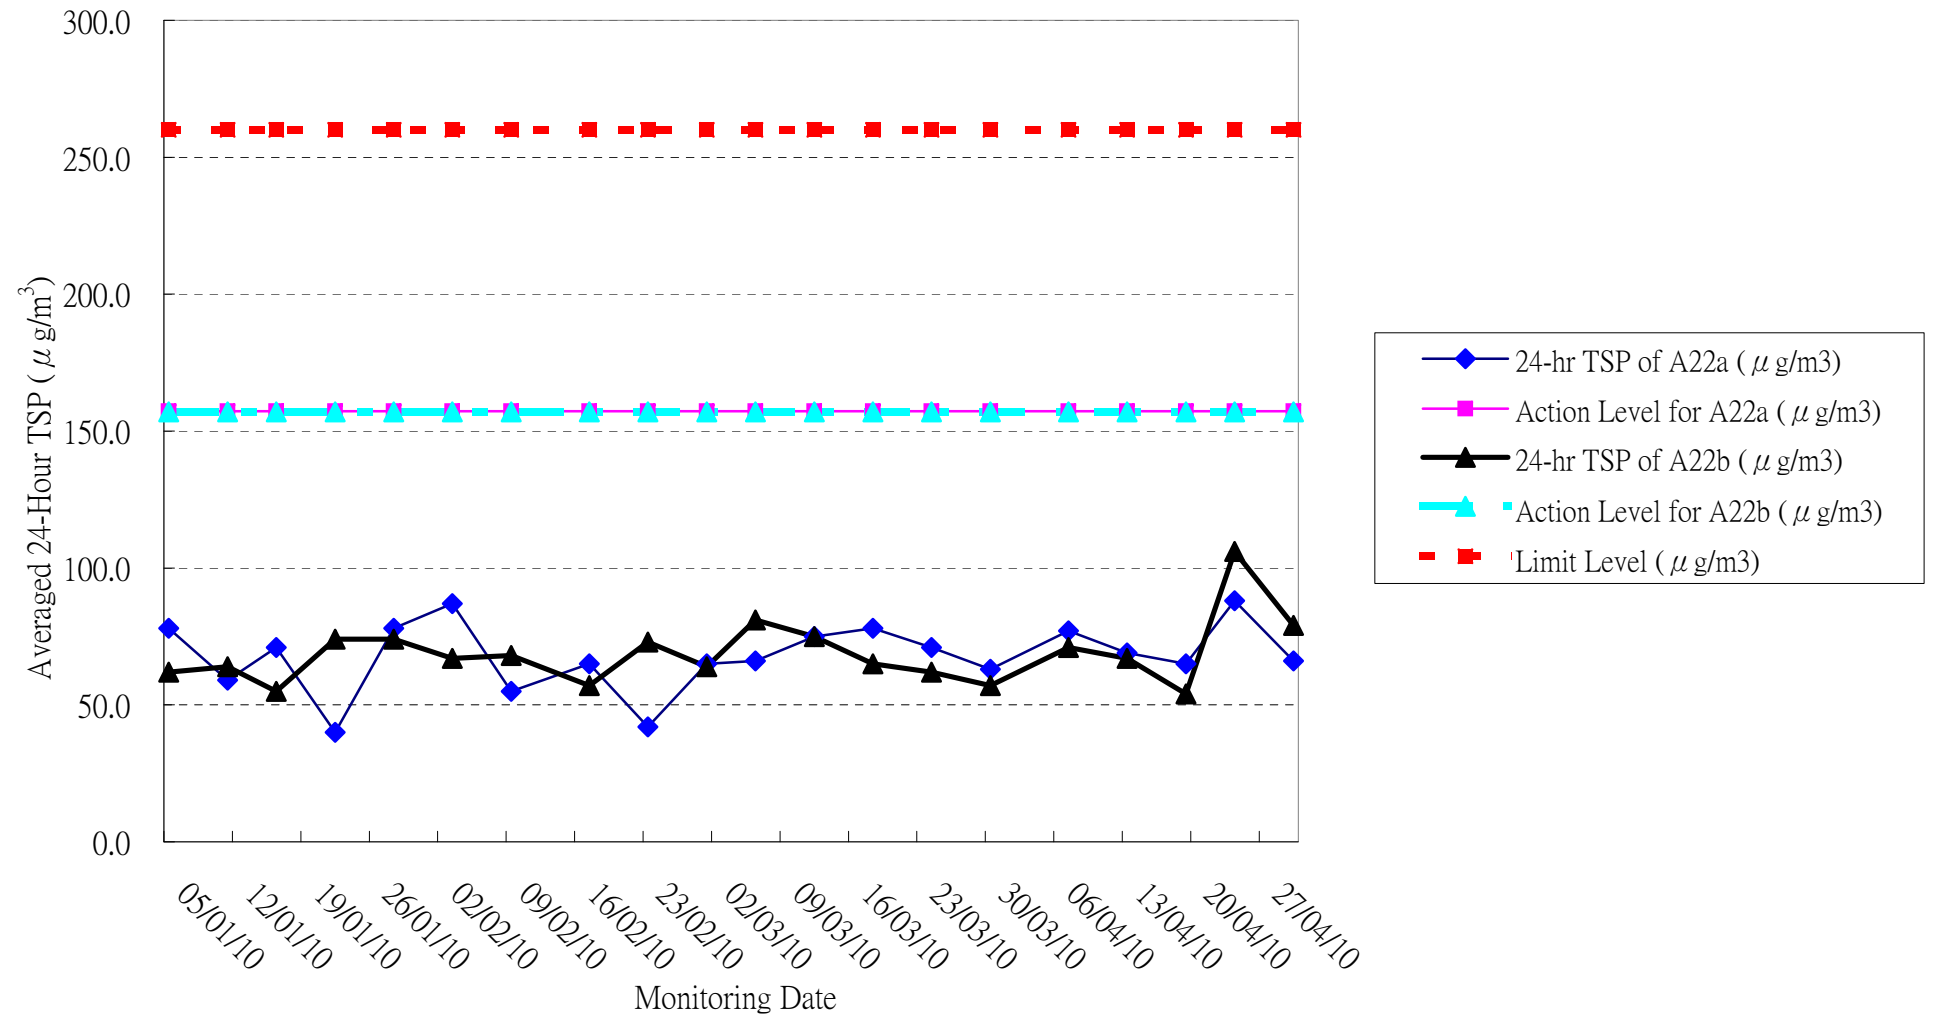
24-Hour TSP air quality monitoring data plot recorded at the designated monitoring points

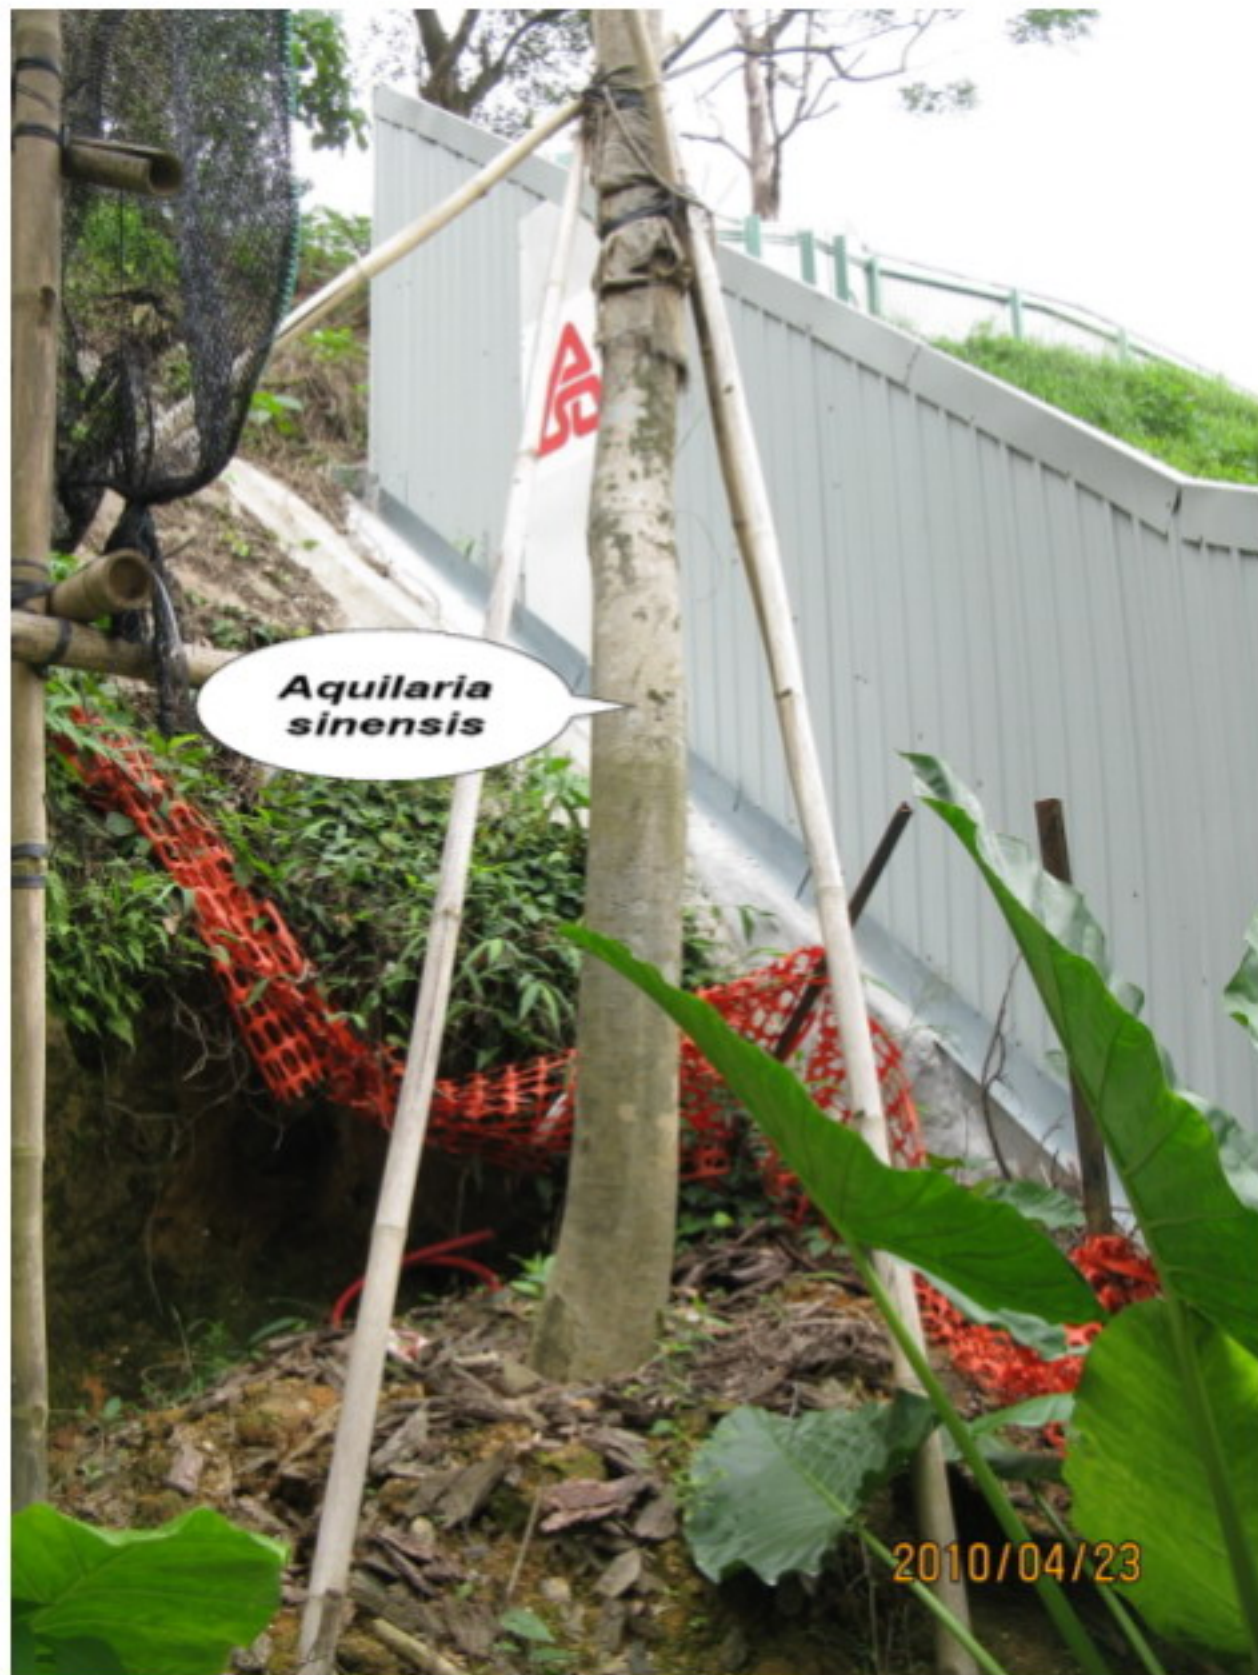
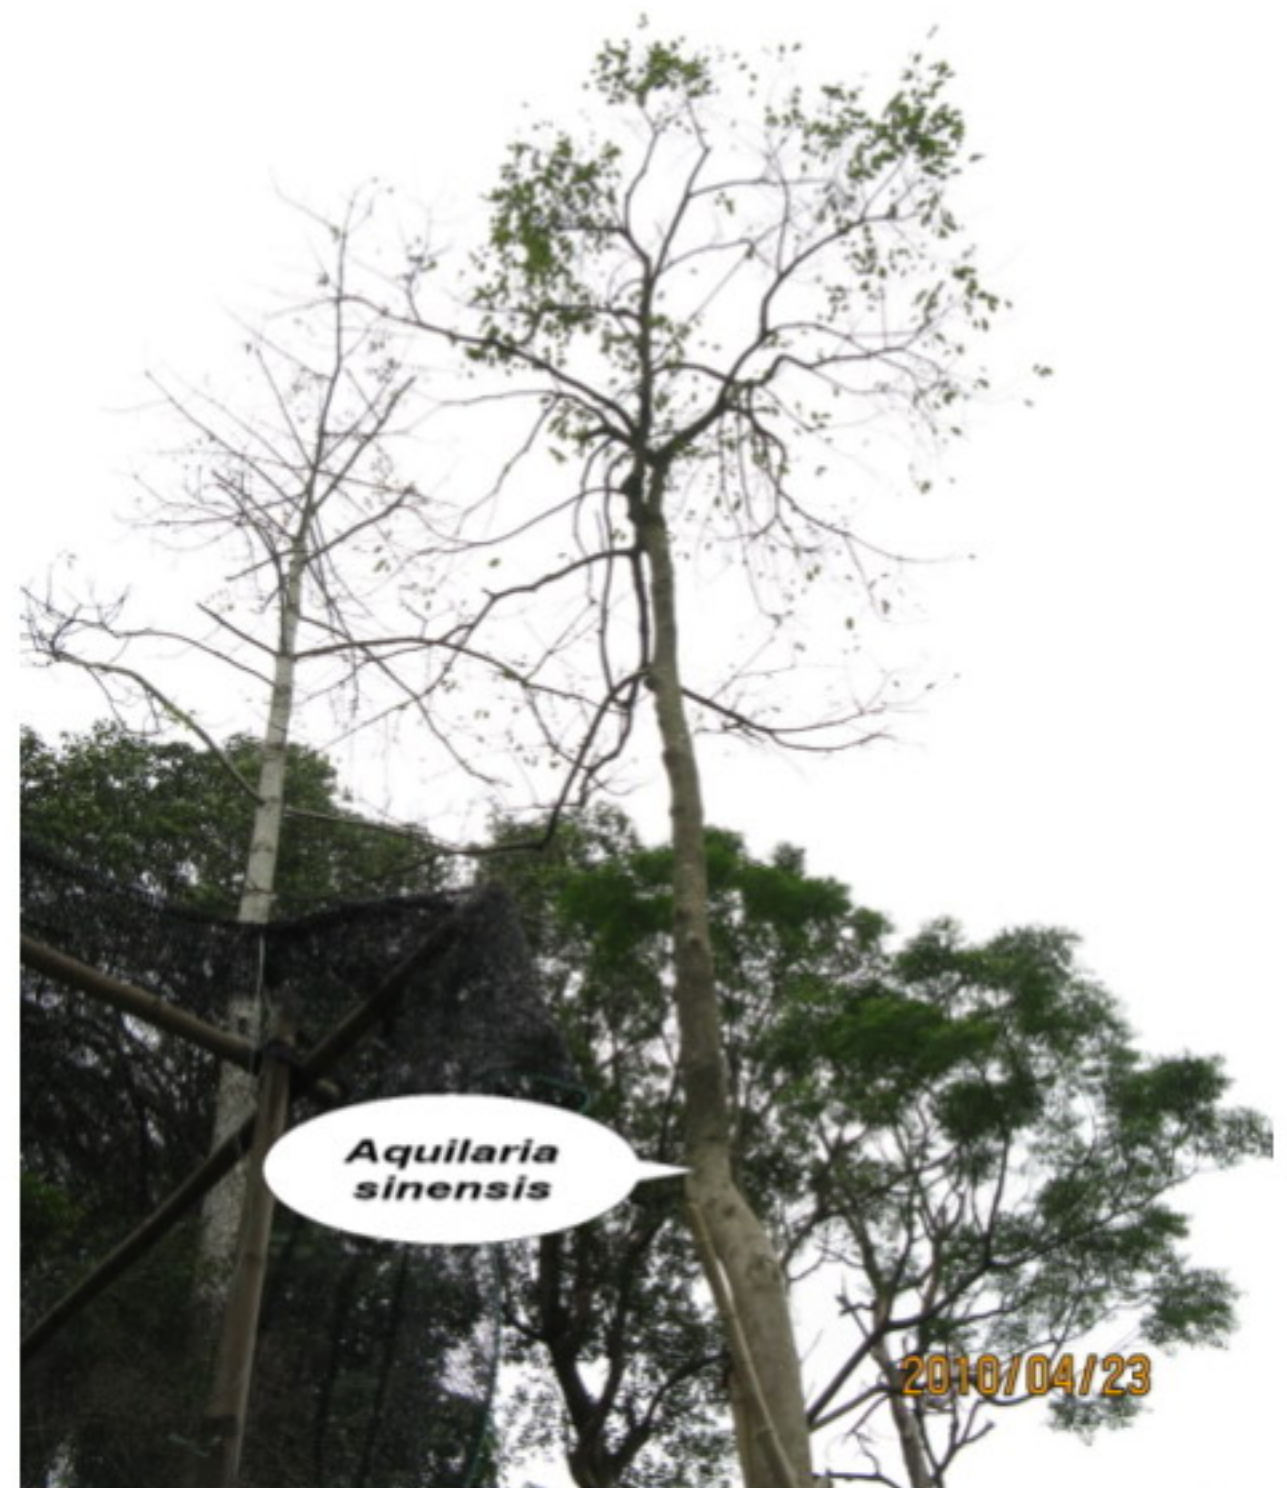
- 4.5 The transplanted *Aquilaria sinensis* showed stress and deterioration in health condition as indicated by foliage color. Daily watering and closely monitoring is recommended.

| | | | | Remark |
|---|---|---|---|---|
| <i>Aquilaria sinensis</i> | 8 | 0.2 | 4 | Poor condition |

*Aquilaria sinensis*

- 5.2 The transplanted *Aquilaria sinensis* showed stress and deterioration in health condition as indicated by foliage color. Daily watering and closely monitoring is recommended.

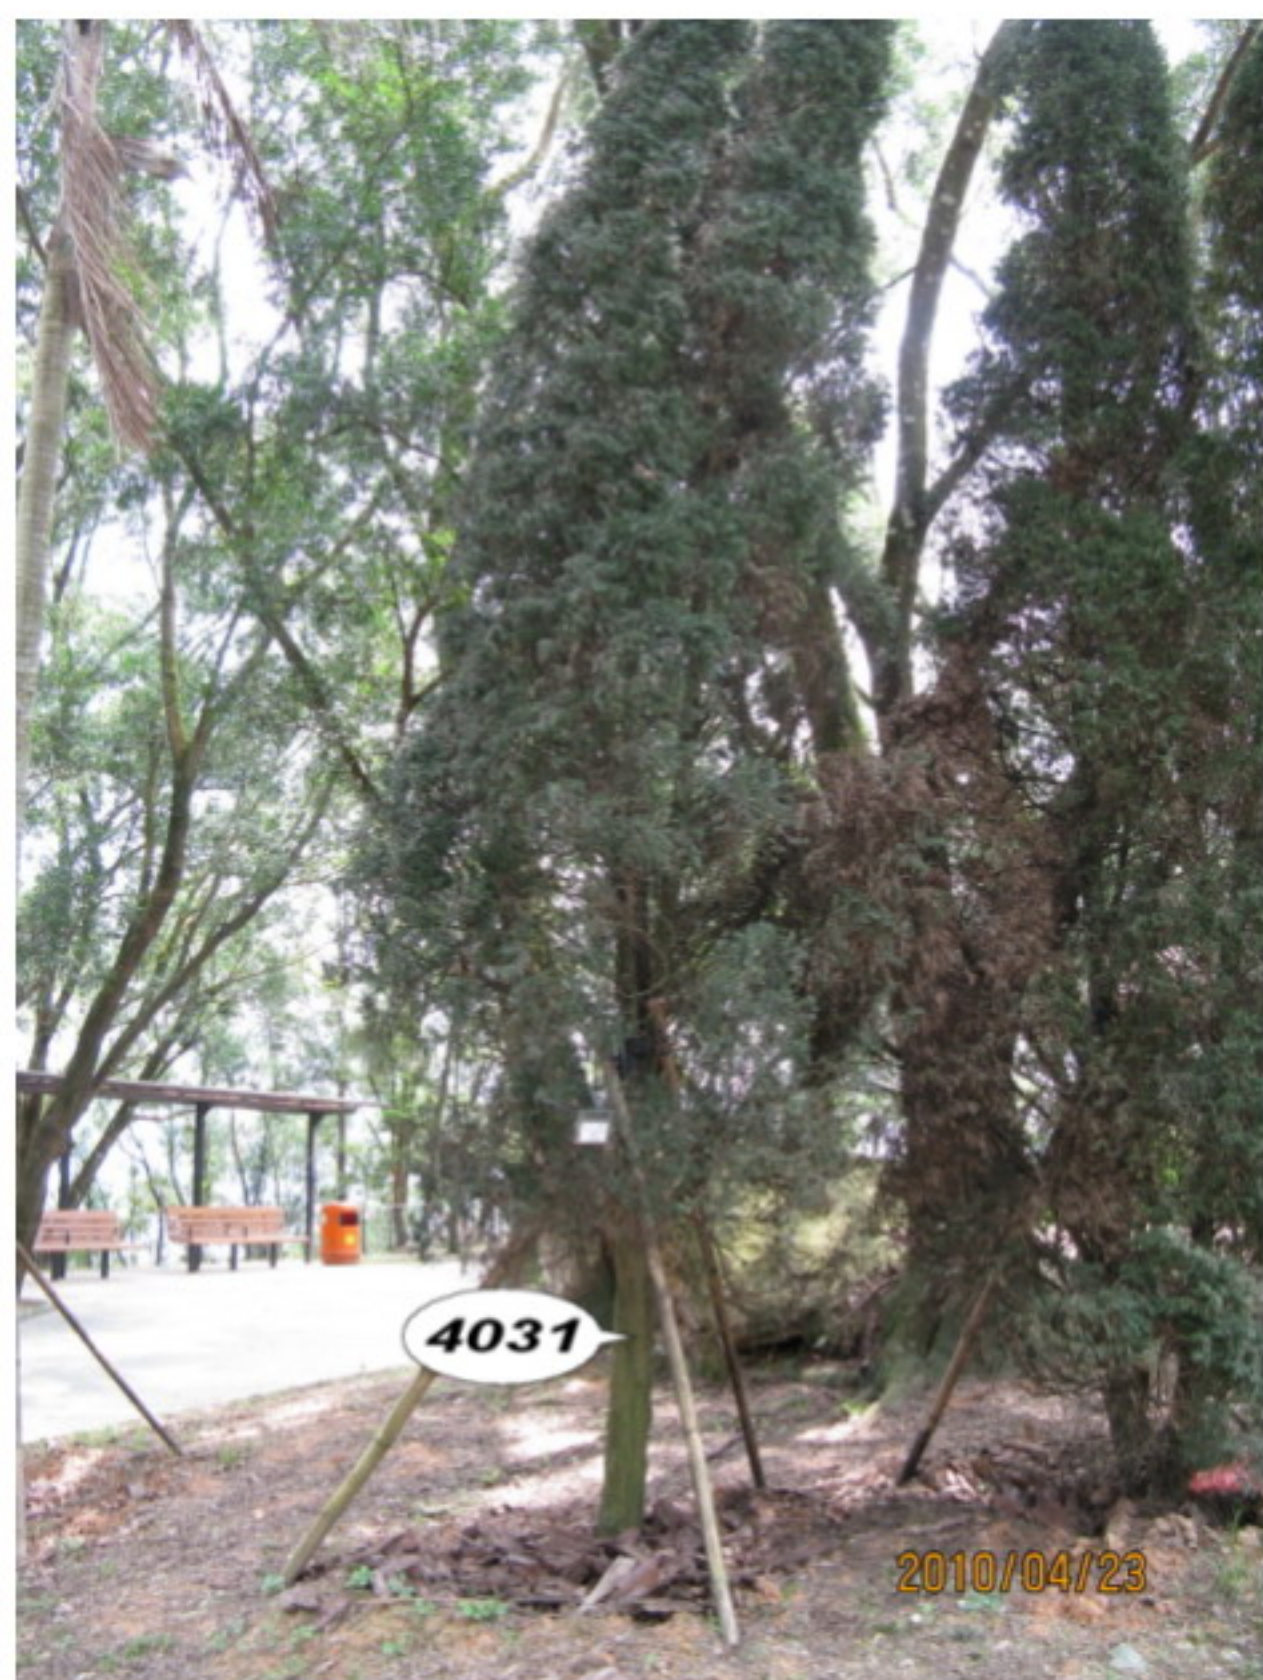
Tree No: 4031

| Tree Number | Species | Chinese name | Height (m) | Diameter (m) | Spread (m) | Remark |
|---|---|---|---|---|---|---|
| 4031 | <i>Juniperus chinensis var.kaizuca</i> | 龍柏 | 5 | 0.12 | 2 | Poor condition, Yellow leaves |

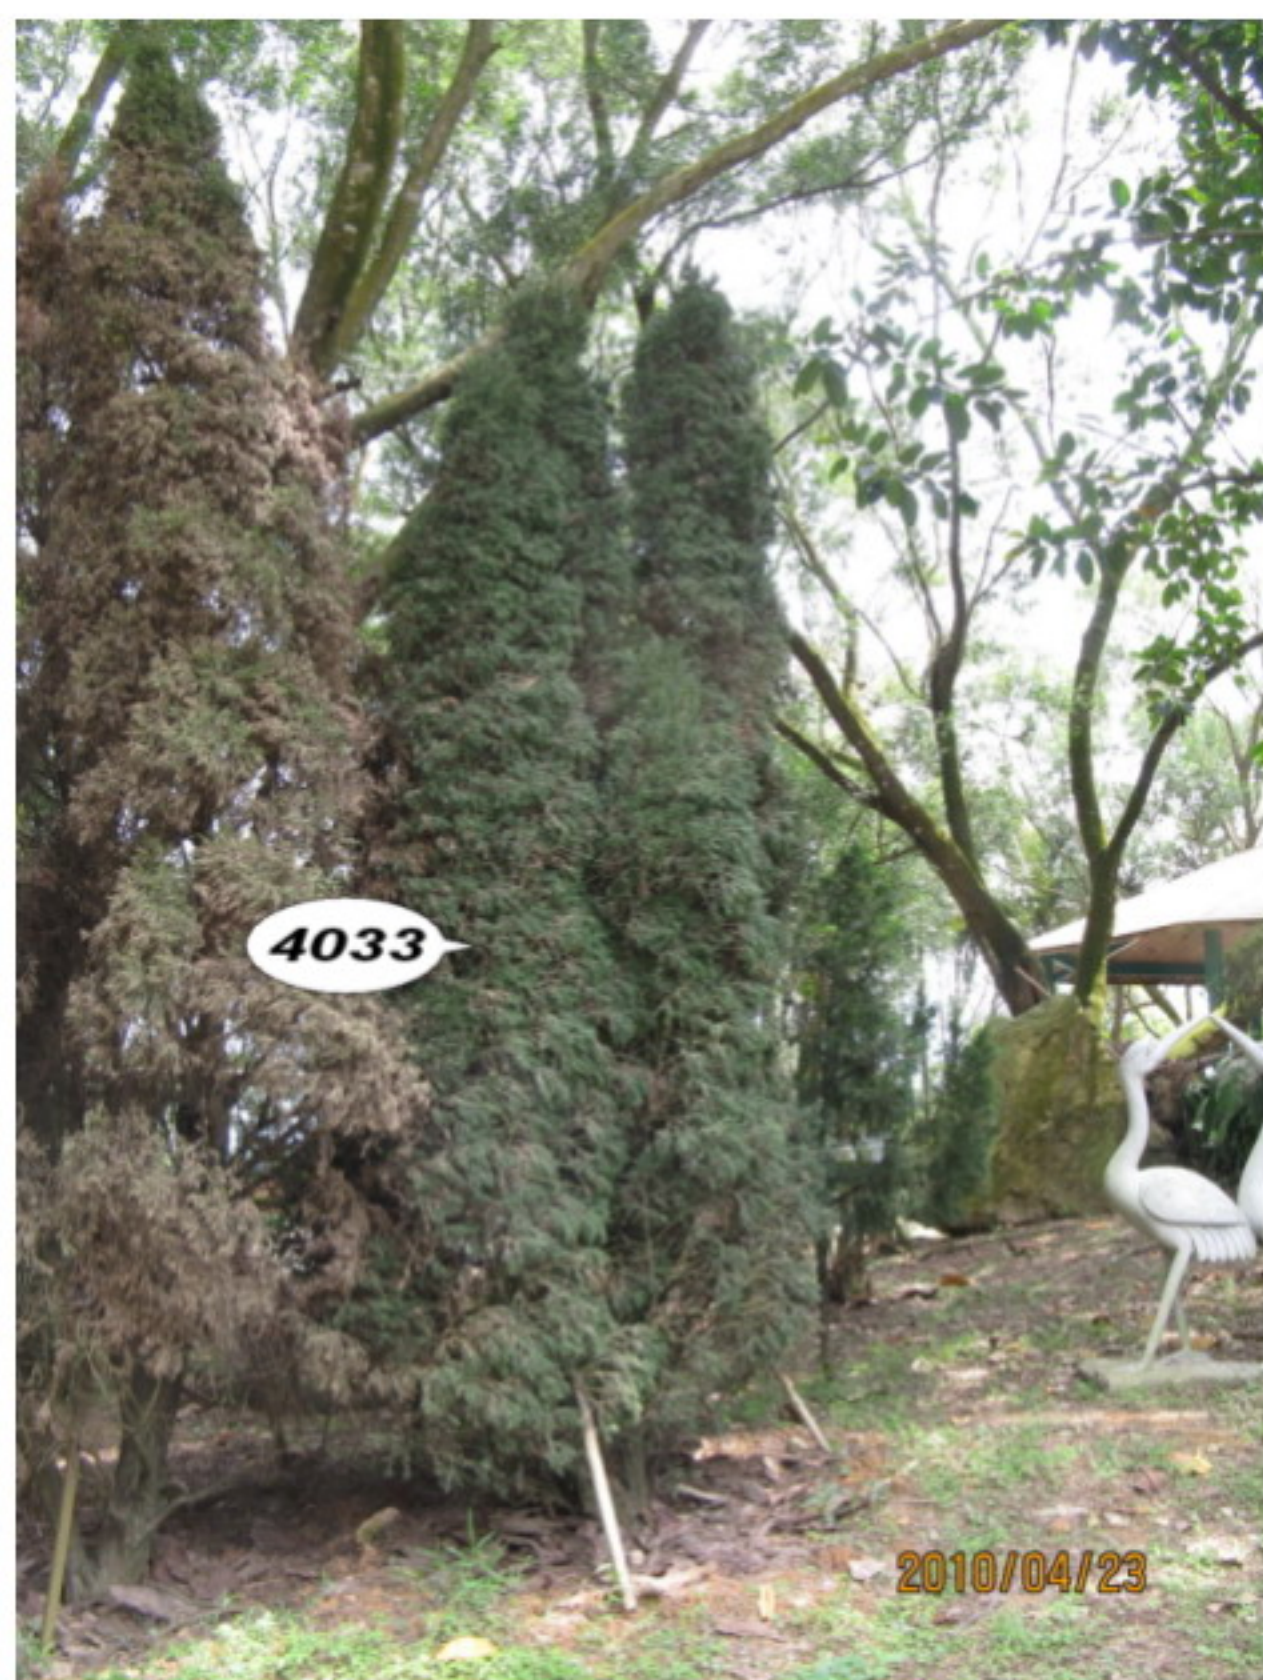
Tree No: 4033

| Tree Number | Species | Chinese name | Height (m) | Diameter (m) | Spread (m) | Remark |
|---|---|---|---|---|---|---|
| 4033 | <i>Juniperus chinensis var.kaizuca</i> | 龍柏 | 4 | 0.13 | 2 | Poor condition, Yellow leaves |

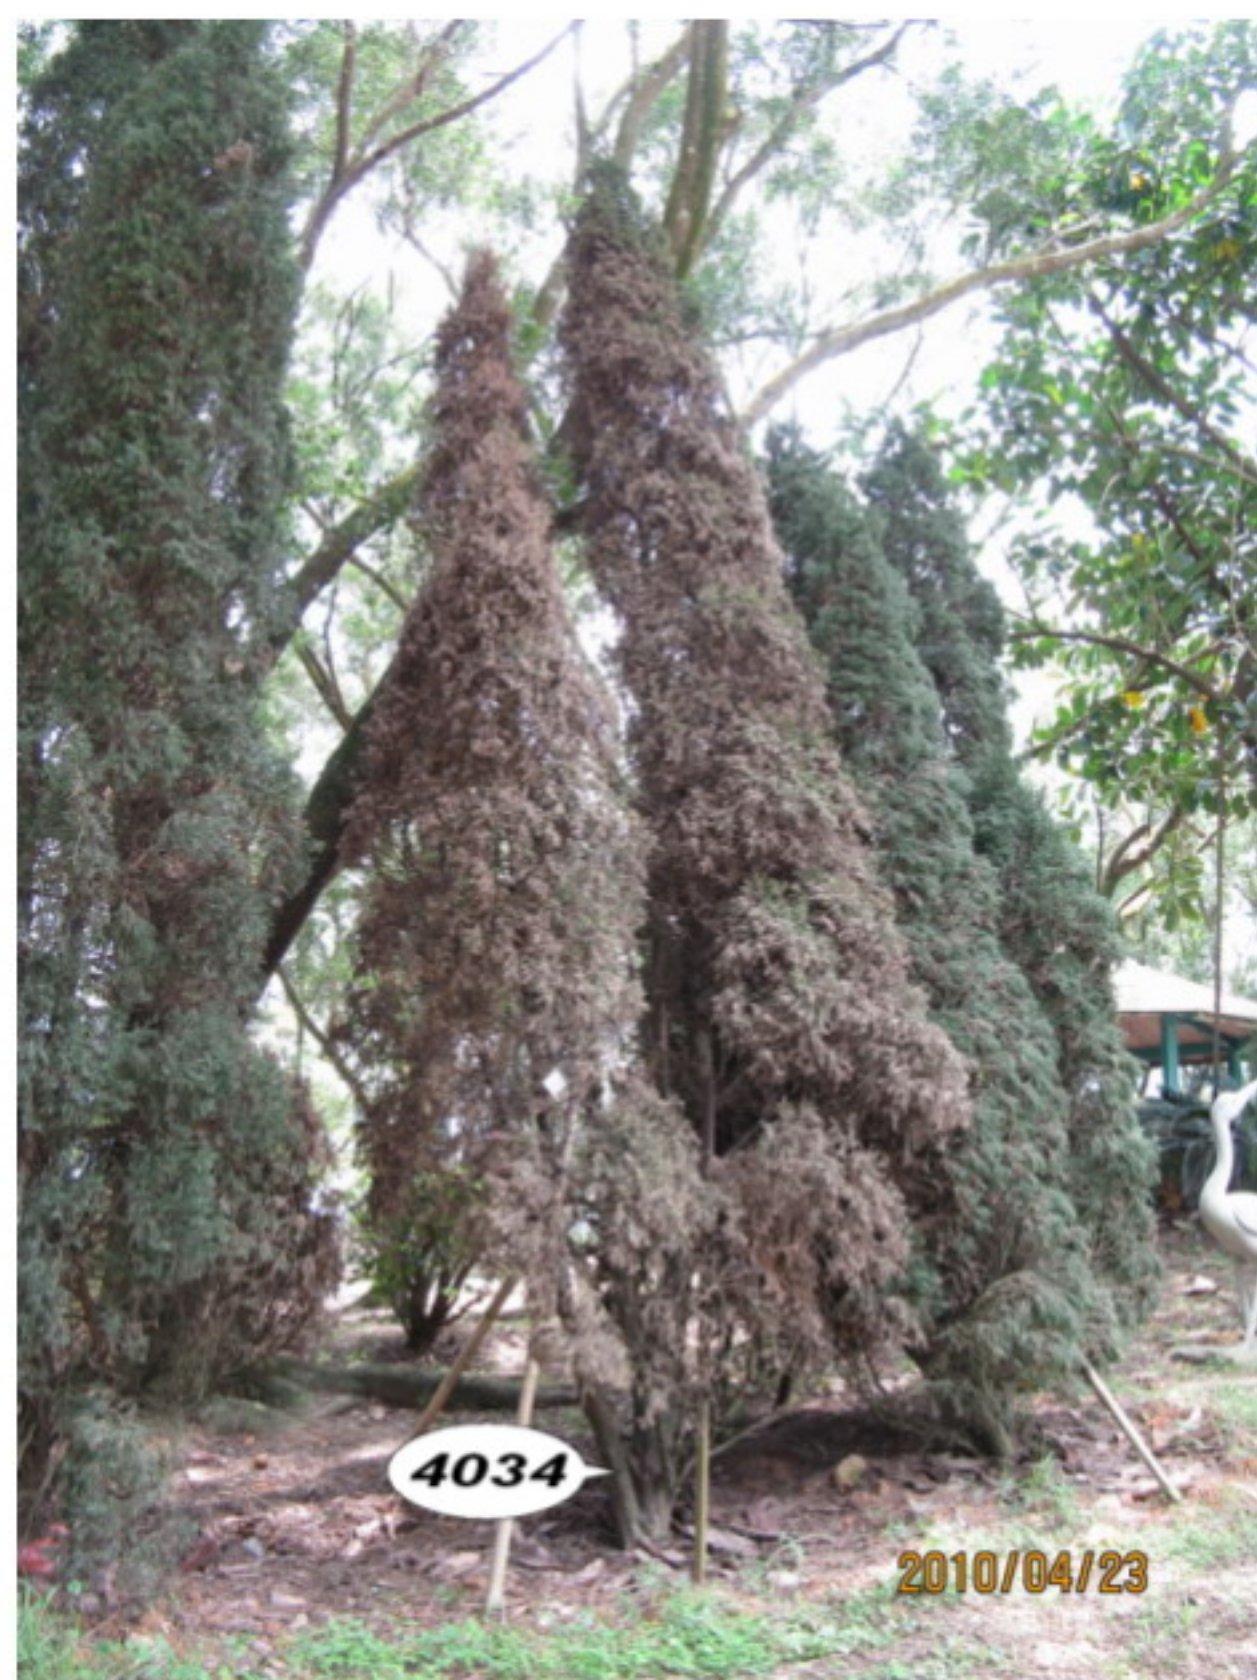
Tree No: 4034

| Tree Number | Species | Chinese name | Height (m) | Diameter (m) | Spread (m) | Remark |
|---|---|---|---|---|---|---|
| 4034 | <i>Juniperus chinensis var.kaizuca</i> | 龍柏 | 4 | 0.13 | 2 | Poor condition, Yellow leaves |

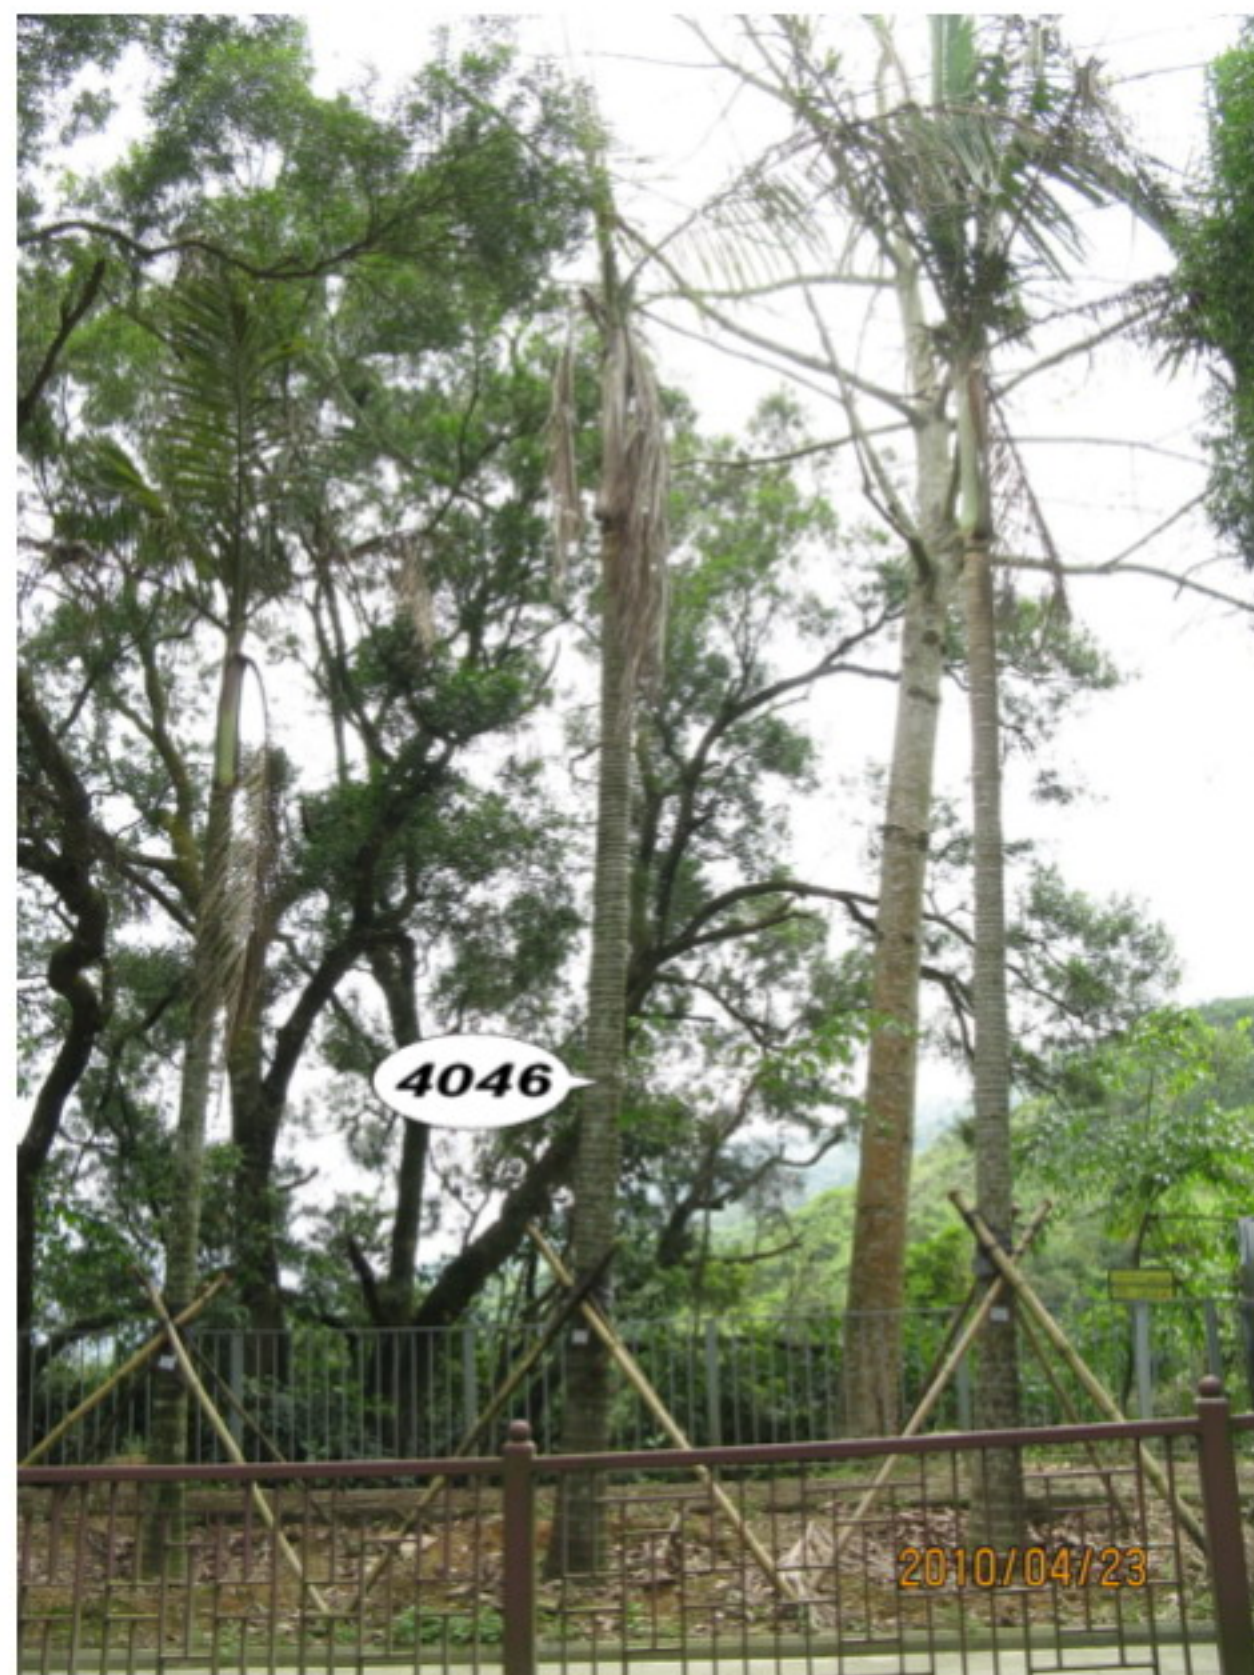
Tree No: 4046

| Tree Number | Species | Chinese name | Height (m) | Diameter (m) | Spread (m) | Remark |
|---|---|---|---|---|---|---|
| 4046 | <i>Archontophoenix alexandrae</i> | 假檳榔 | 5 | 0.19 | 4 | Poor condition, Yellow leave |

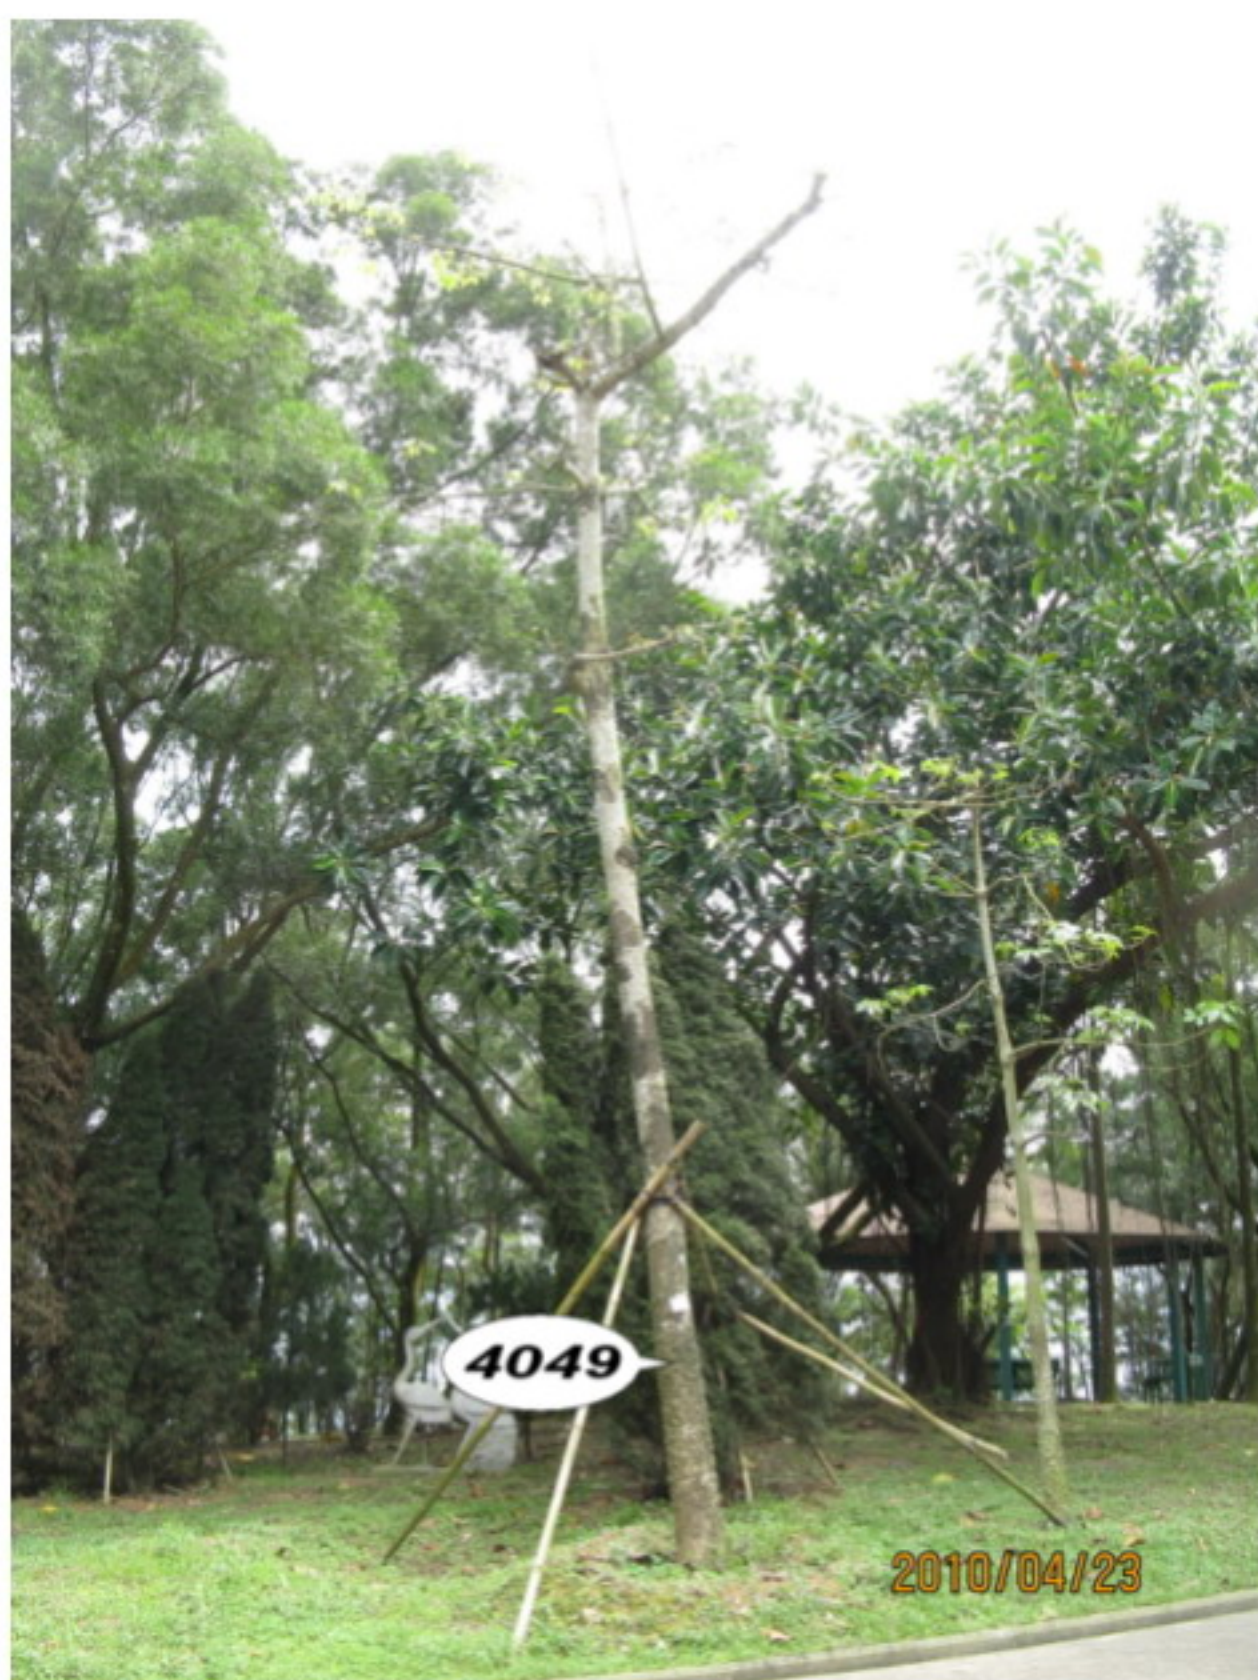
Tree No: 4049

| Tree Number | Species | Chinese name | Height (m) | Diameter (m) | Spread (m) | Remark |
|---|---|---|---|---|---|---|
| 4049 | <i>Bombax ceiba</i> | 木棉 | 6 | 0.16 | 4 | Poor condition, Sparse crown |

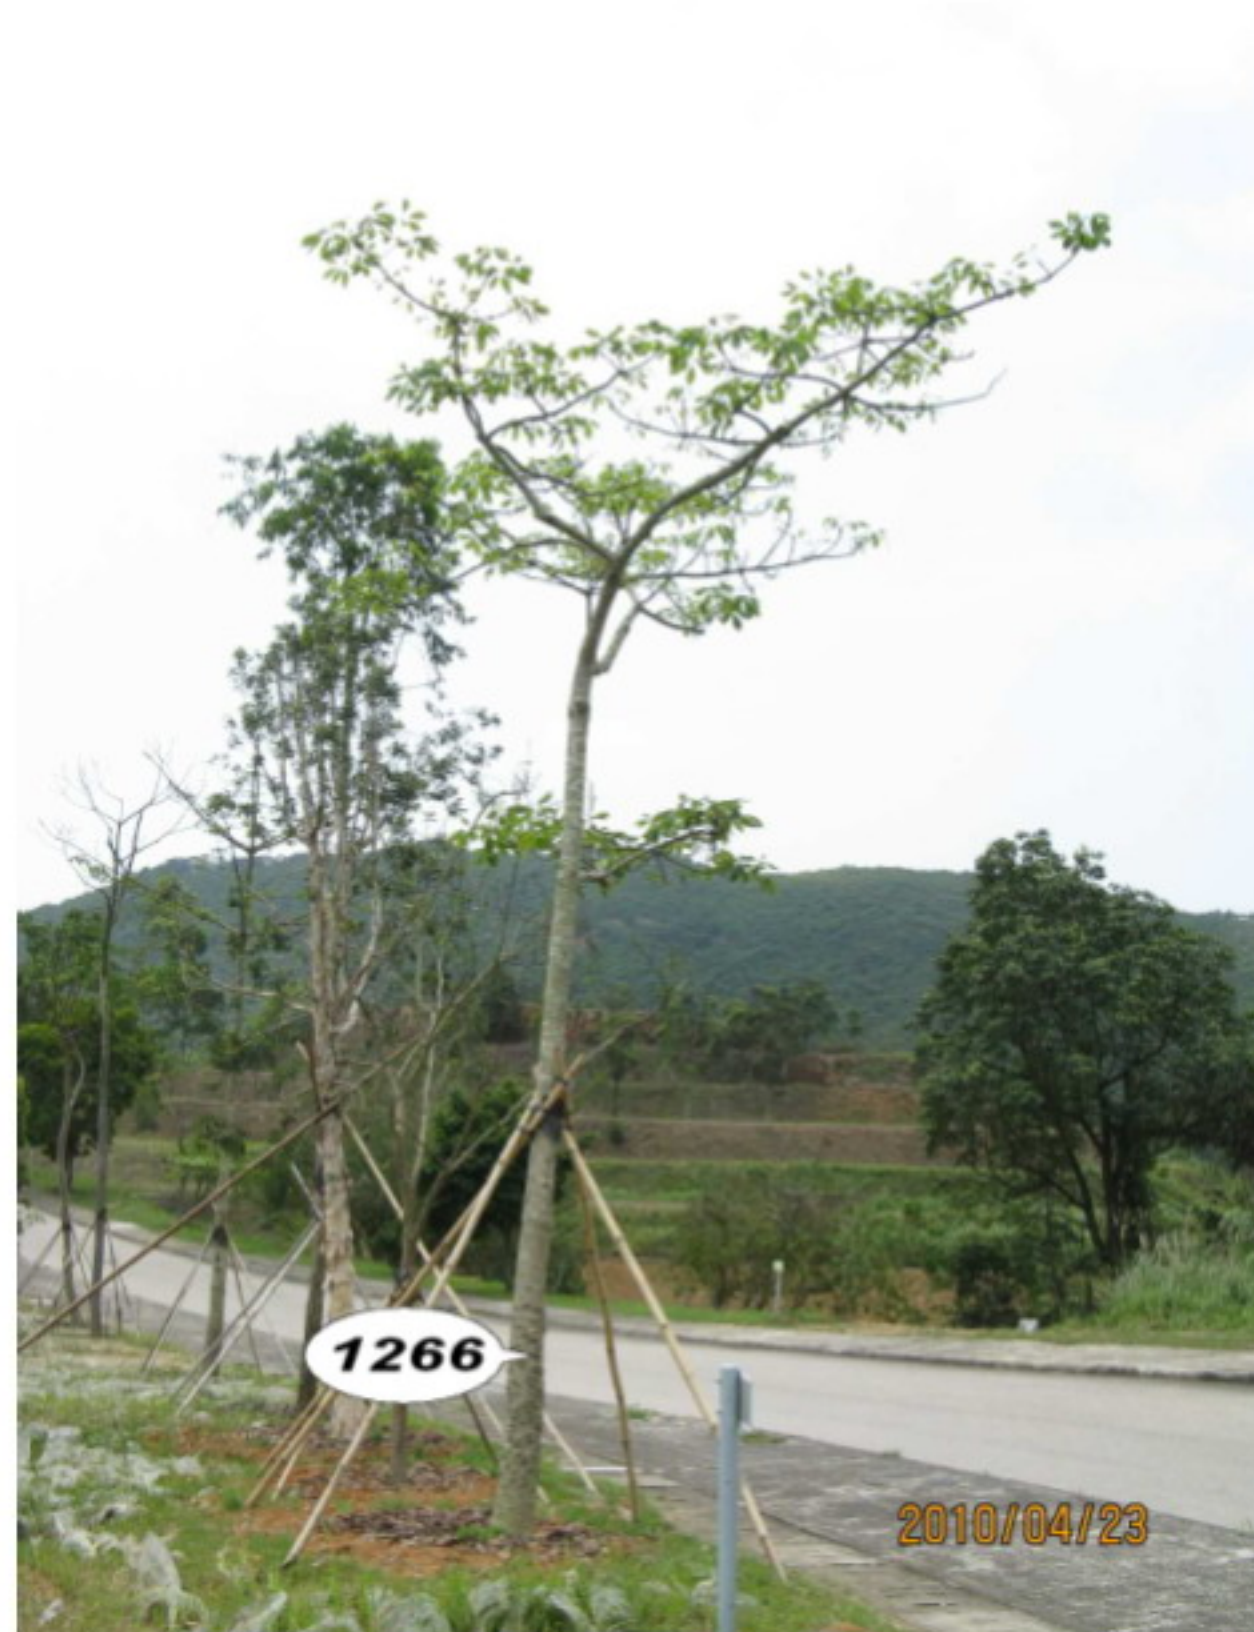
Tree No: 1266

| | | | | | | Remark |
|---|---|---|---|---|---|---|
| 1266 | <i>Bombax ceiba</i> | 木棉 | 4 | 0.15 | 3 | Poor condition, Leave regenerating |

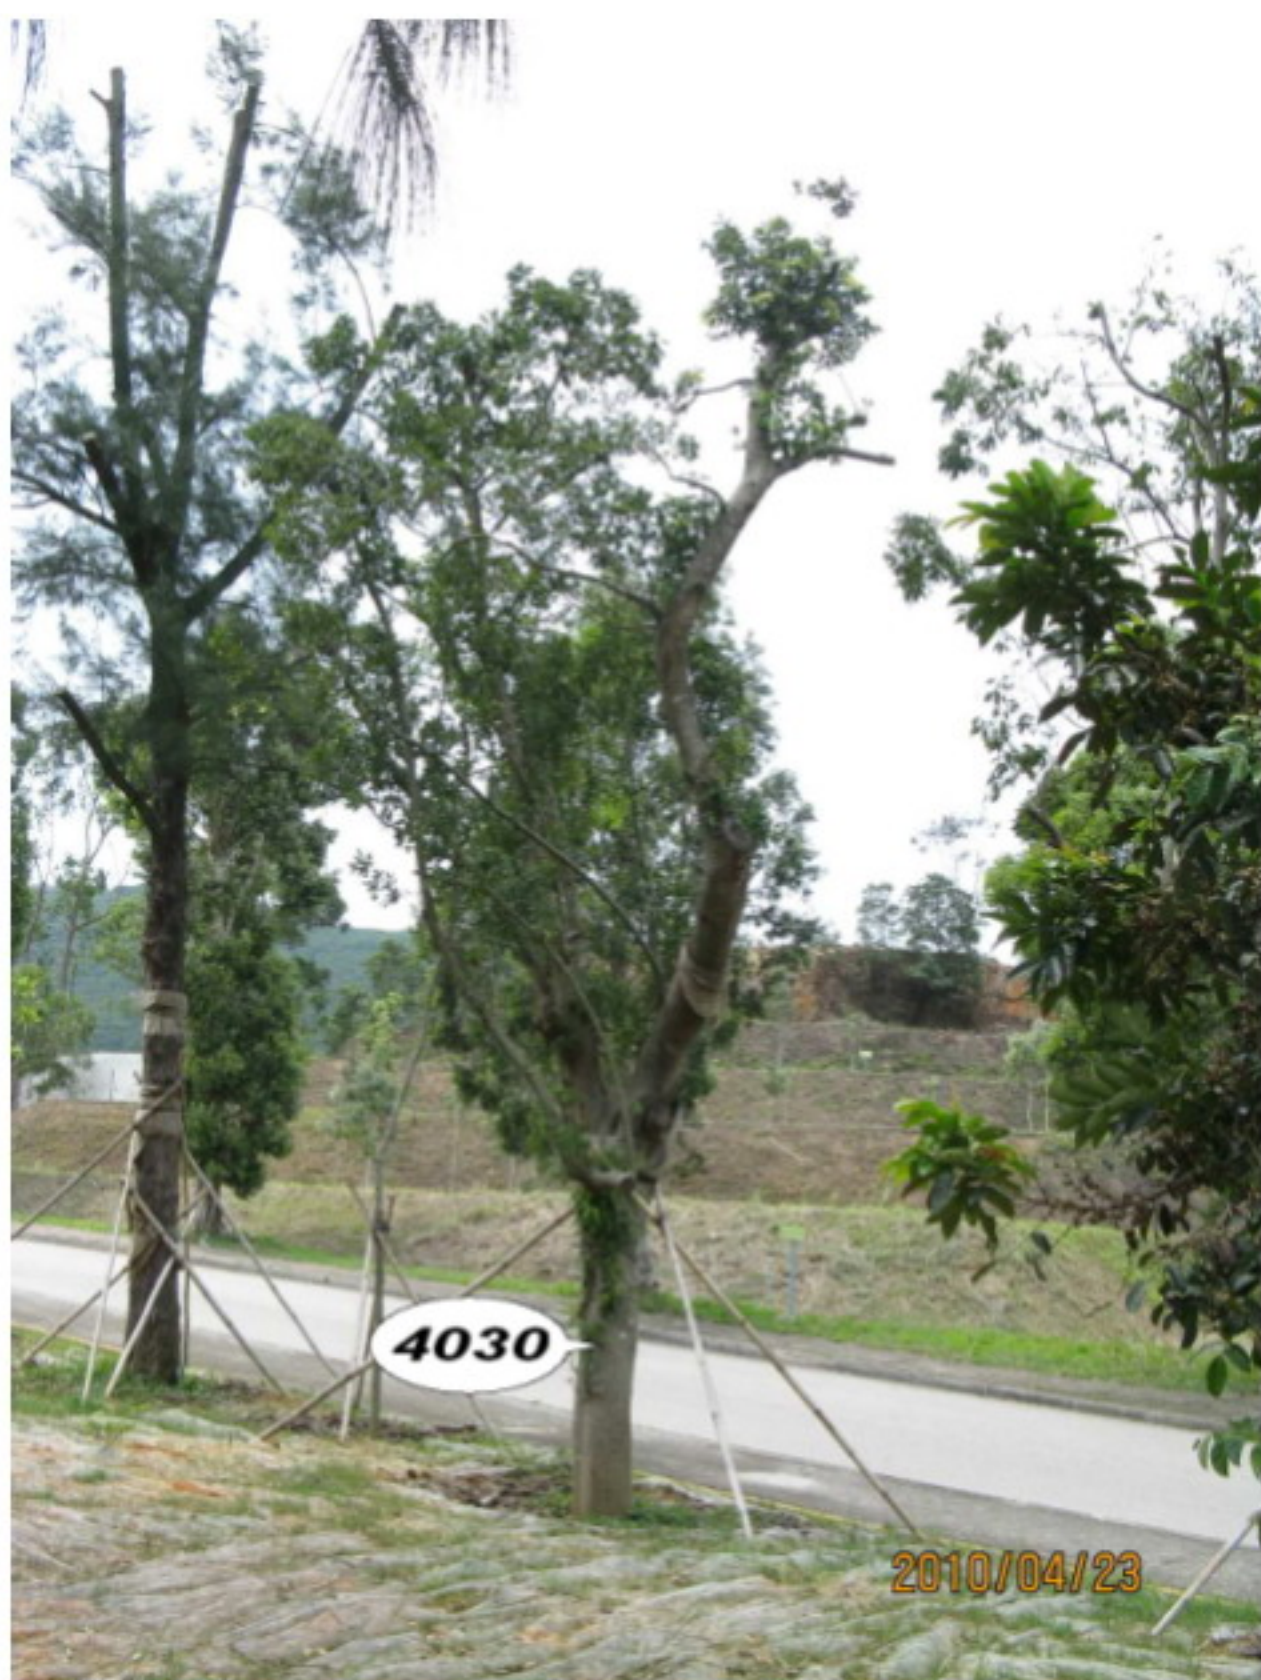
Tree No: 4030

| | | | | | | Remark |
|---|---|---|---|---|---|---|
| 4030 | <i>Cinnamomum burmannii</i> | 陰香 | 5.5 | 0.16 | 4 | Poor condition, Fork, Pruned, Decay, Leave regenerating |
