**PROVISION OF CREMATORS AT  
WO HOP SHEK CREMATORIUM**

**ENVIRONMENTAL MONITORING &  
AUDIT REPORT (APRIL 2010)**

Quotation Contract No. 9/2009/AB1  
Provision of Cremators at Wo Hop Shek Crematorium - Independent Environmental Checker Service  
Monthly EM&A Report (April 2010)

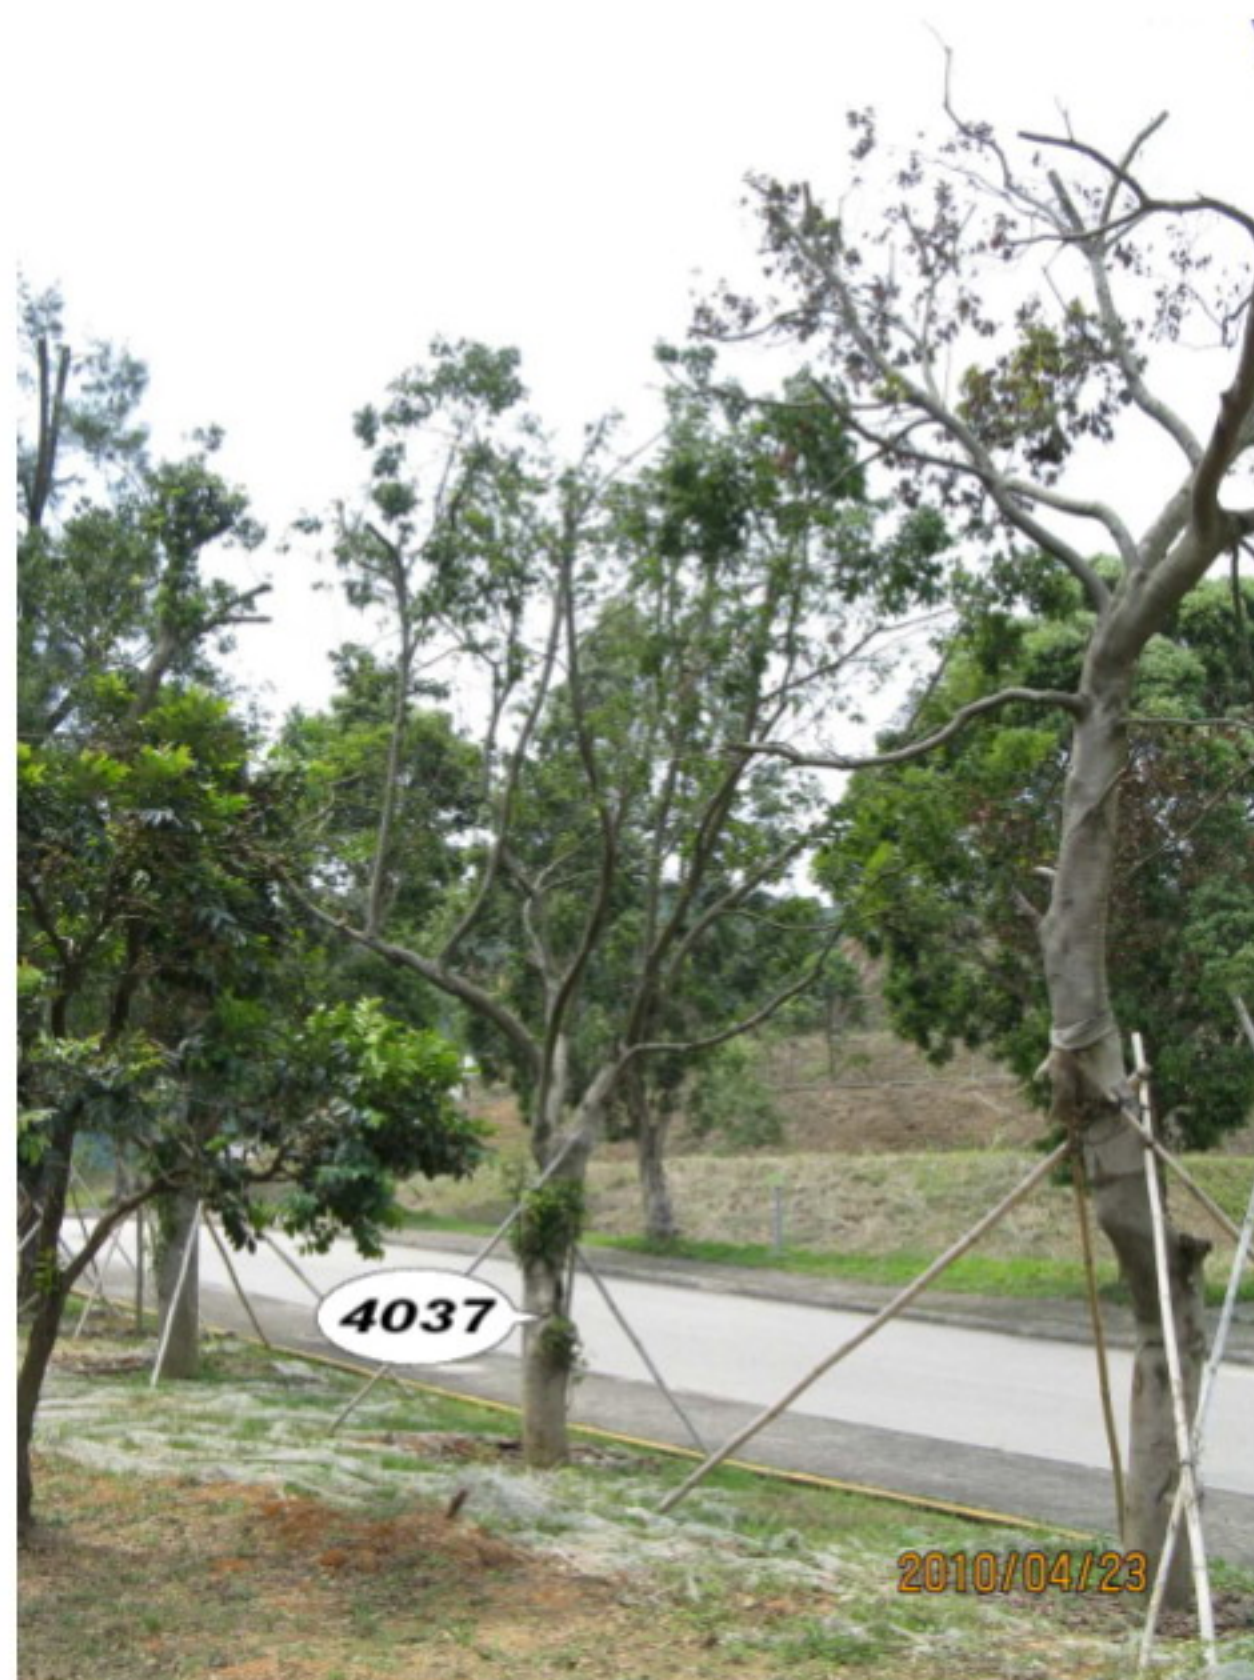
Tree No: 4037

| | | | | | | Remark |
|---|---|---|---|---|---|---|
| 4037 | <i>Cinnamomum burmannii</i> | 陰香 | 6 | 0.25 | 4 | Poor condition, Fork, Pruned, Cavity, Leave regenerating |
