**PROVISION OF CREMATORS AT  
WO HOP SHEK CREMATORIUM**

**ENVIRONMENTAL MONITORING &  
AUDIT REPORT (MAY 2010)**

# Reprovisioning of Wo Hop Shek Crematorium Tree Monitoring and Maintenance

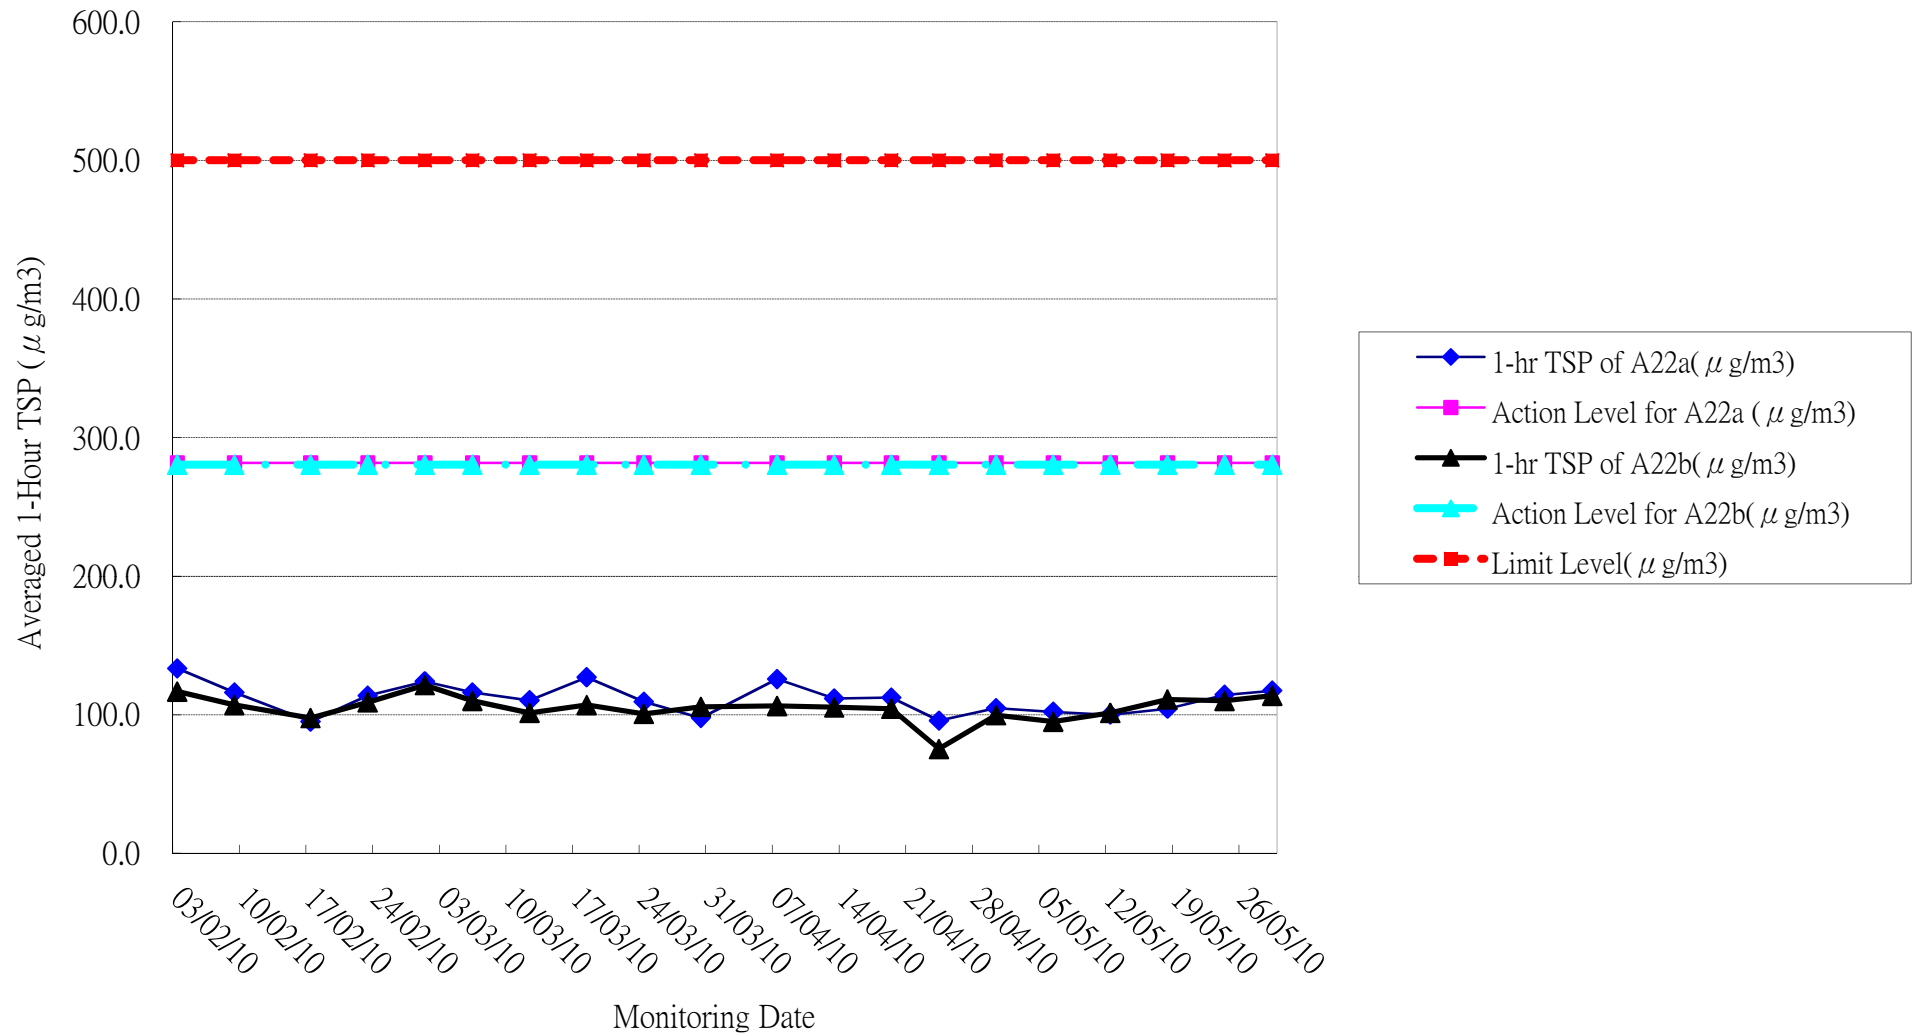
1-Hour TSP air quality monitoring data plot recorded at the designated monitoring points

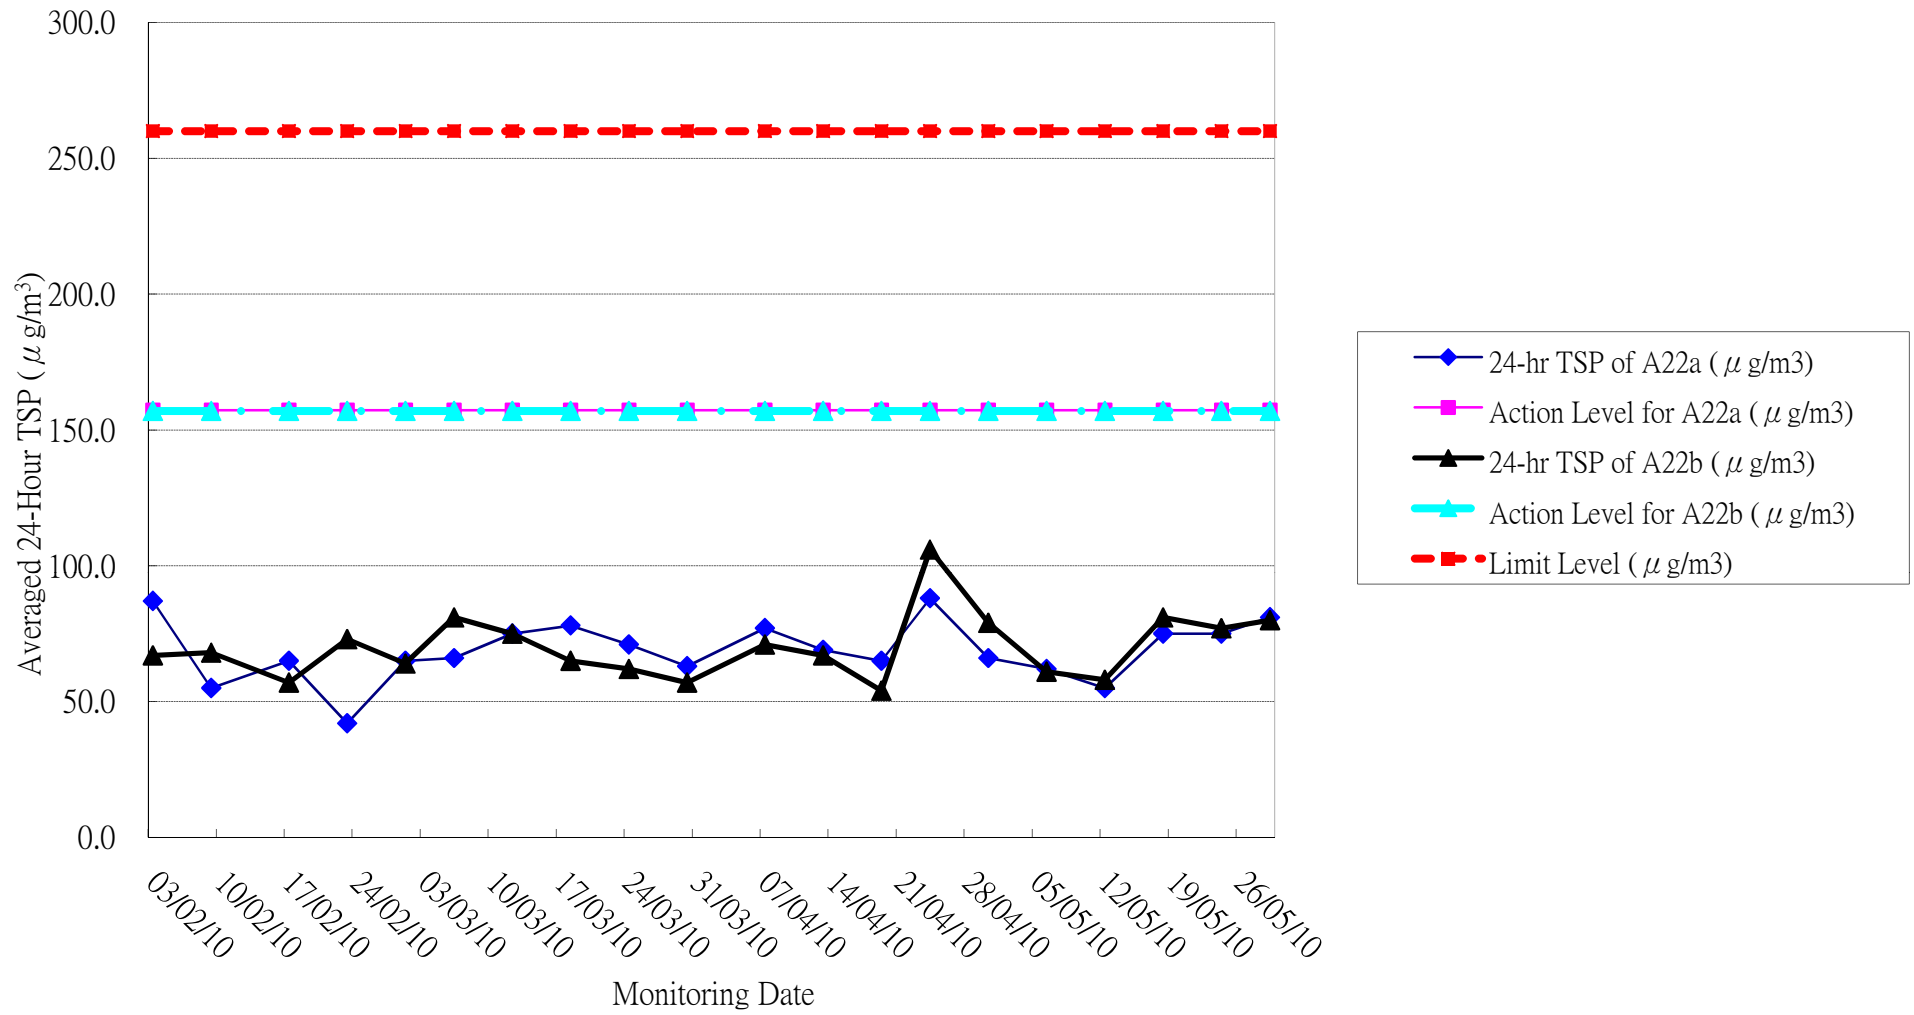
24-Hour TSP air quality monitoring data plot recorded at the designated monitoring points

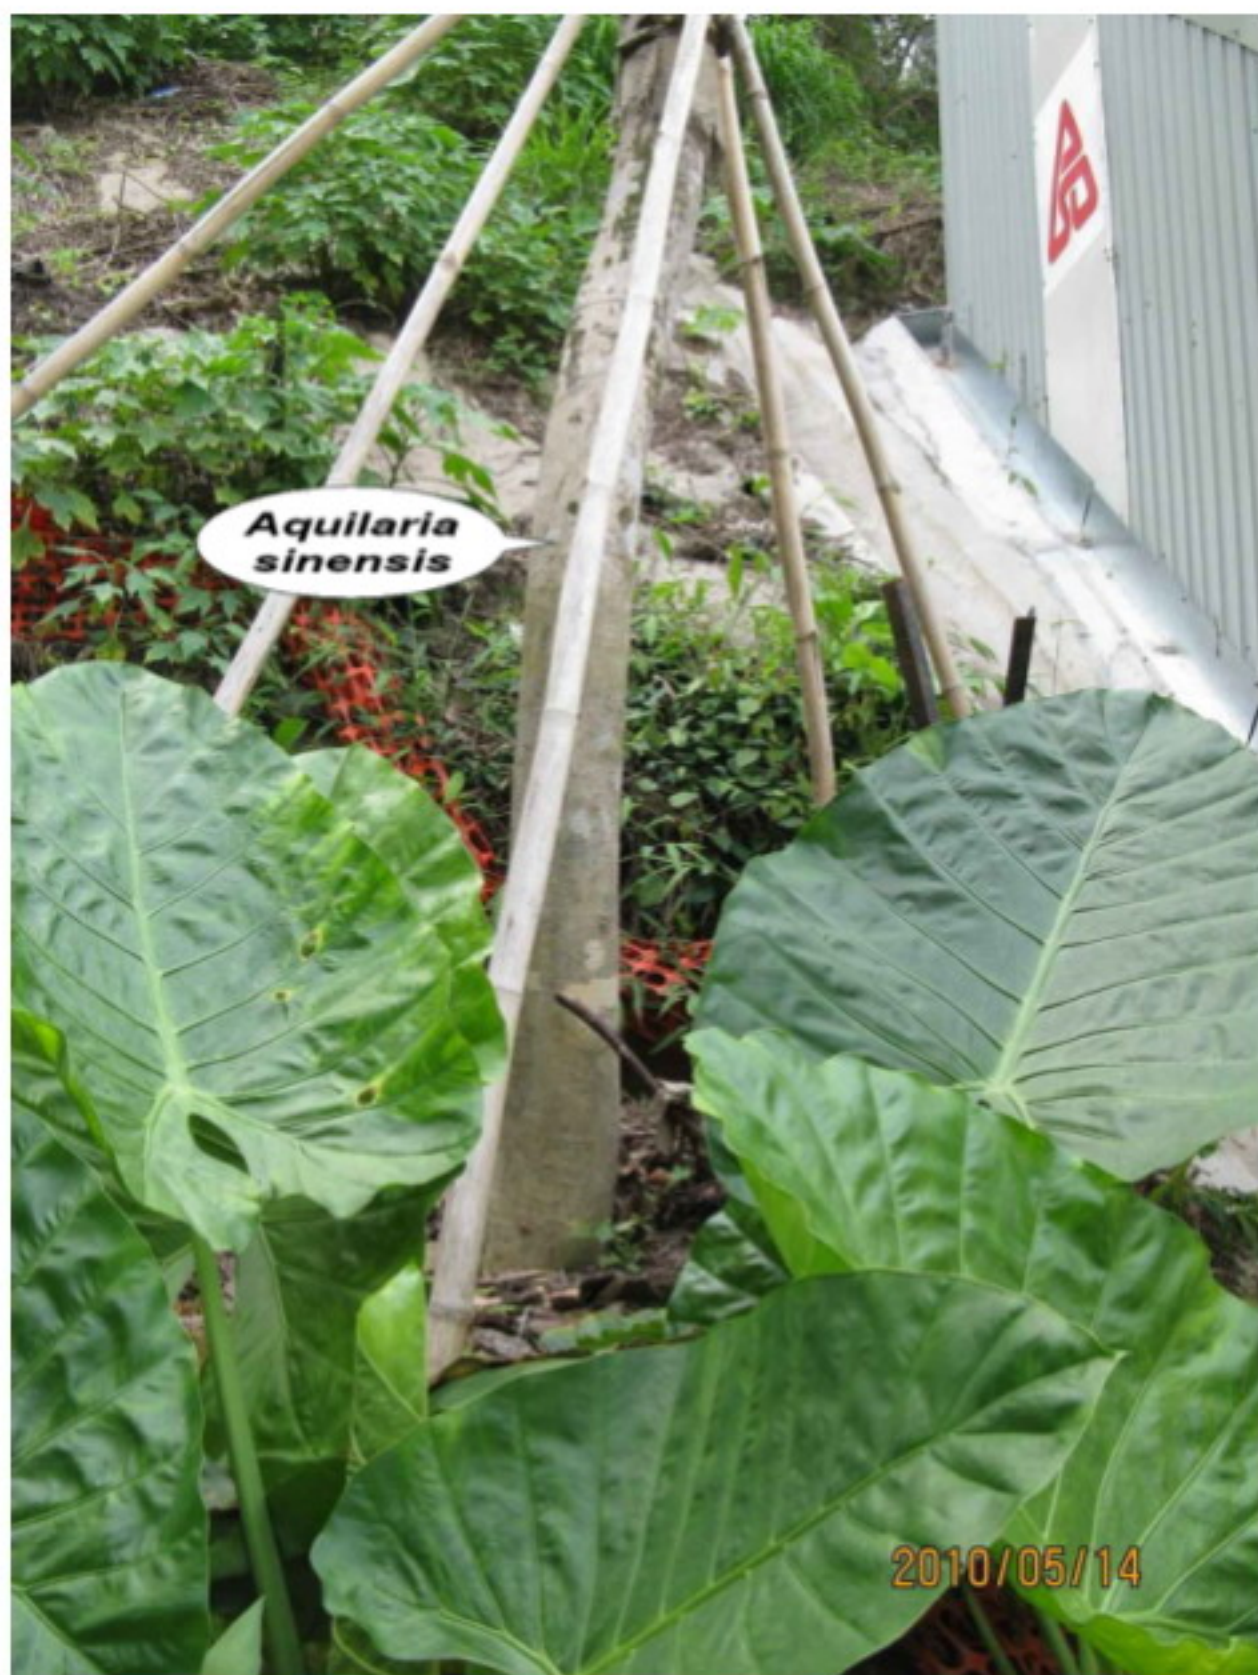
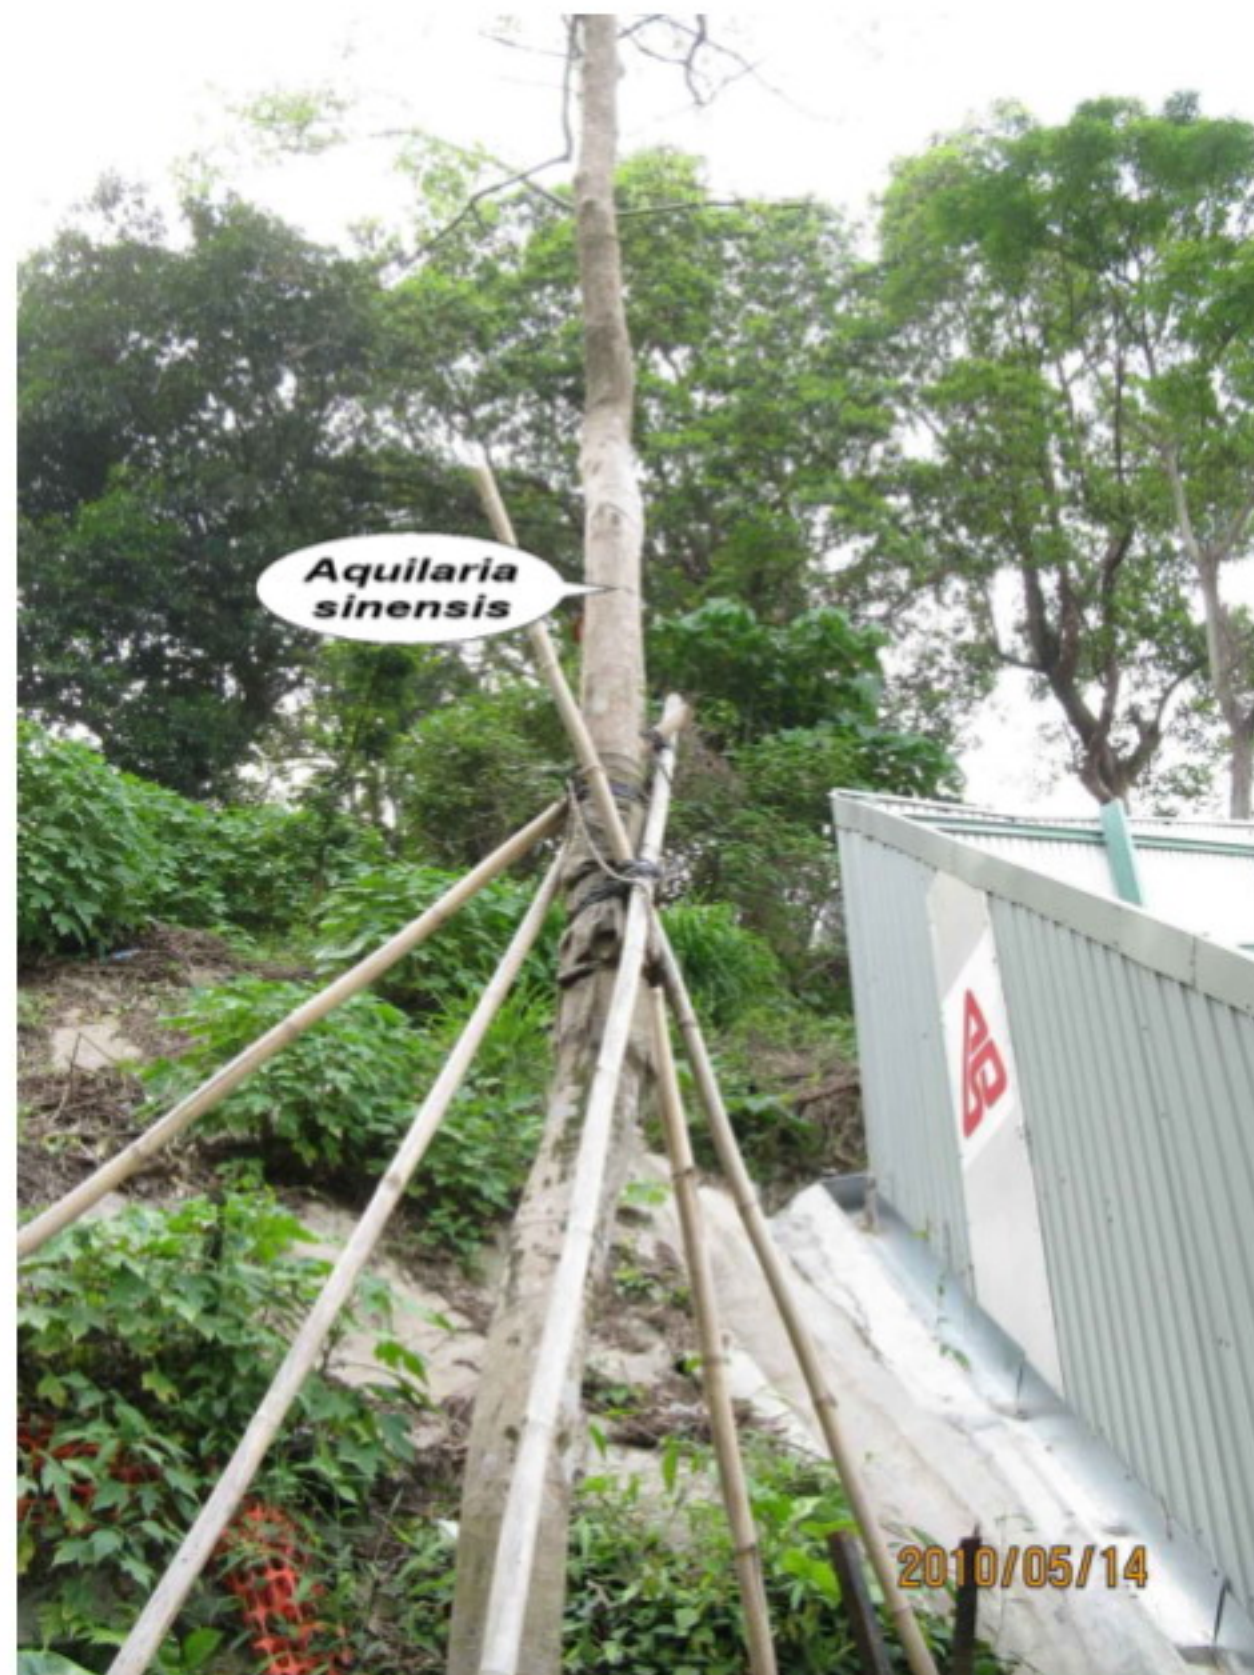
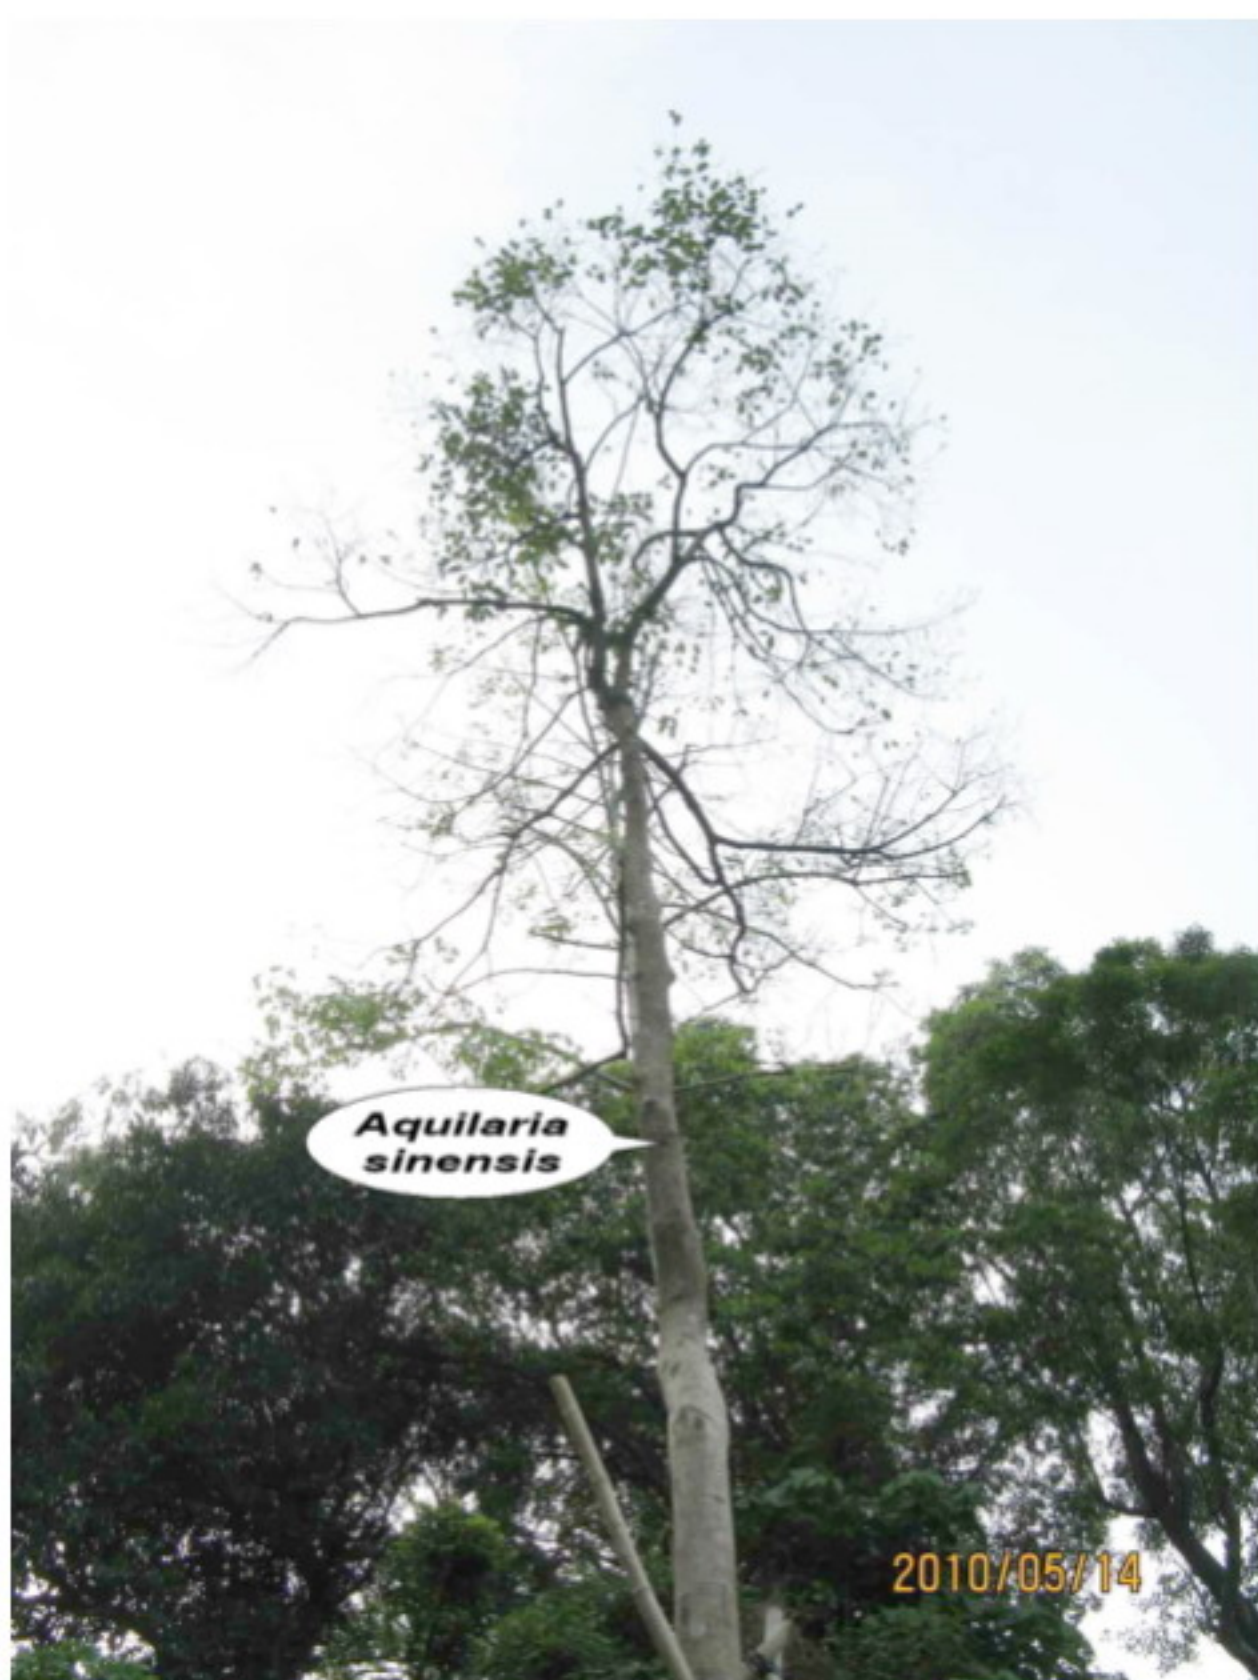
- 4.5 The transplanted *Aquilaria sinensis* showed stress and deterioration in health condition as indicated by foliage color. Daily watering and closely monitoring is recommended.

| | | | | Remark |
|---|---|---|---|---|
| <i>Aquilaria sinensis</i> | 8 | 0.2 | 4 | Poor condition |

*Aquilaria sinensis*

- 5.2 The transplanted *Aquilaria sinensis* showed stress and deterioration in health condition as indicated by foliage color. Daily watering and closely monitoring is recommended.

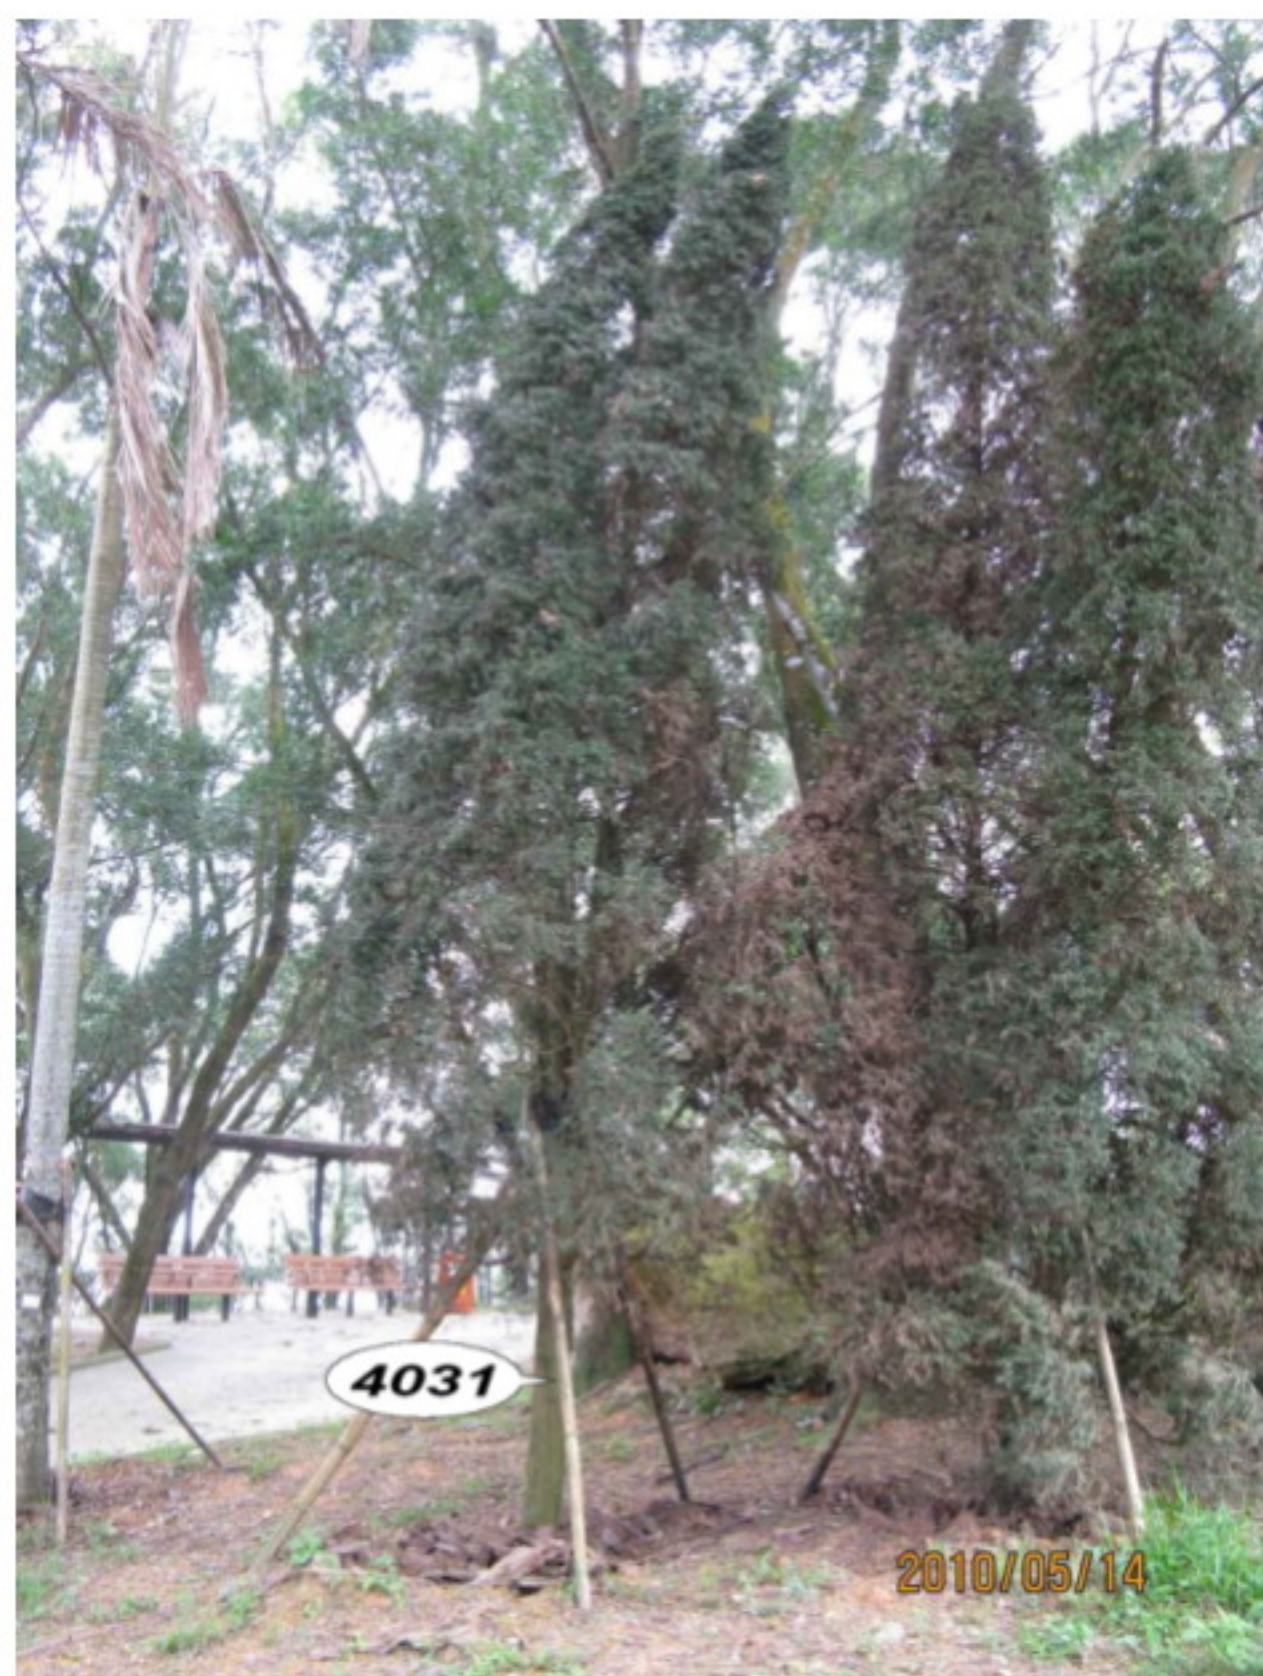
Tree No: 4031

- 4.6 Four individuals of *Juniperus chinensis* var. *kaizuca* (i.e. 4031-4034) seems infected with virus/fungi. Their leaves became yellow in color. Applying fungicides and closely monitoring were recommended.

| | | | | | | Remark |
|---|---|---|---|---|---|---|
| 4031 | <i>Juniperus chinensis var.kaizuca</i> | 龍柏 | 5 | 0.12 | 2 | Poor condition, Yellow leaves |

- 5.3 Four individuals of *Juniperus chinensis var.kaizuca* (i.e. 4031-4034) seems infected with virus/fungi. Their leaves were yellow in color currently. Applying fungicides and closely monitoring were recommended.

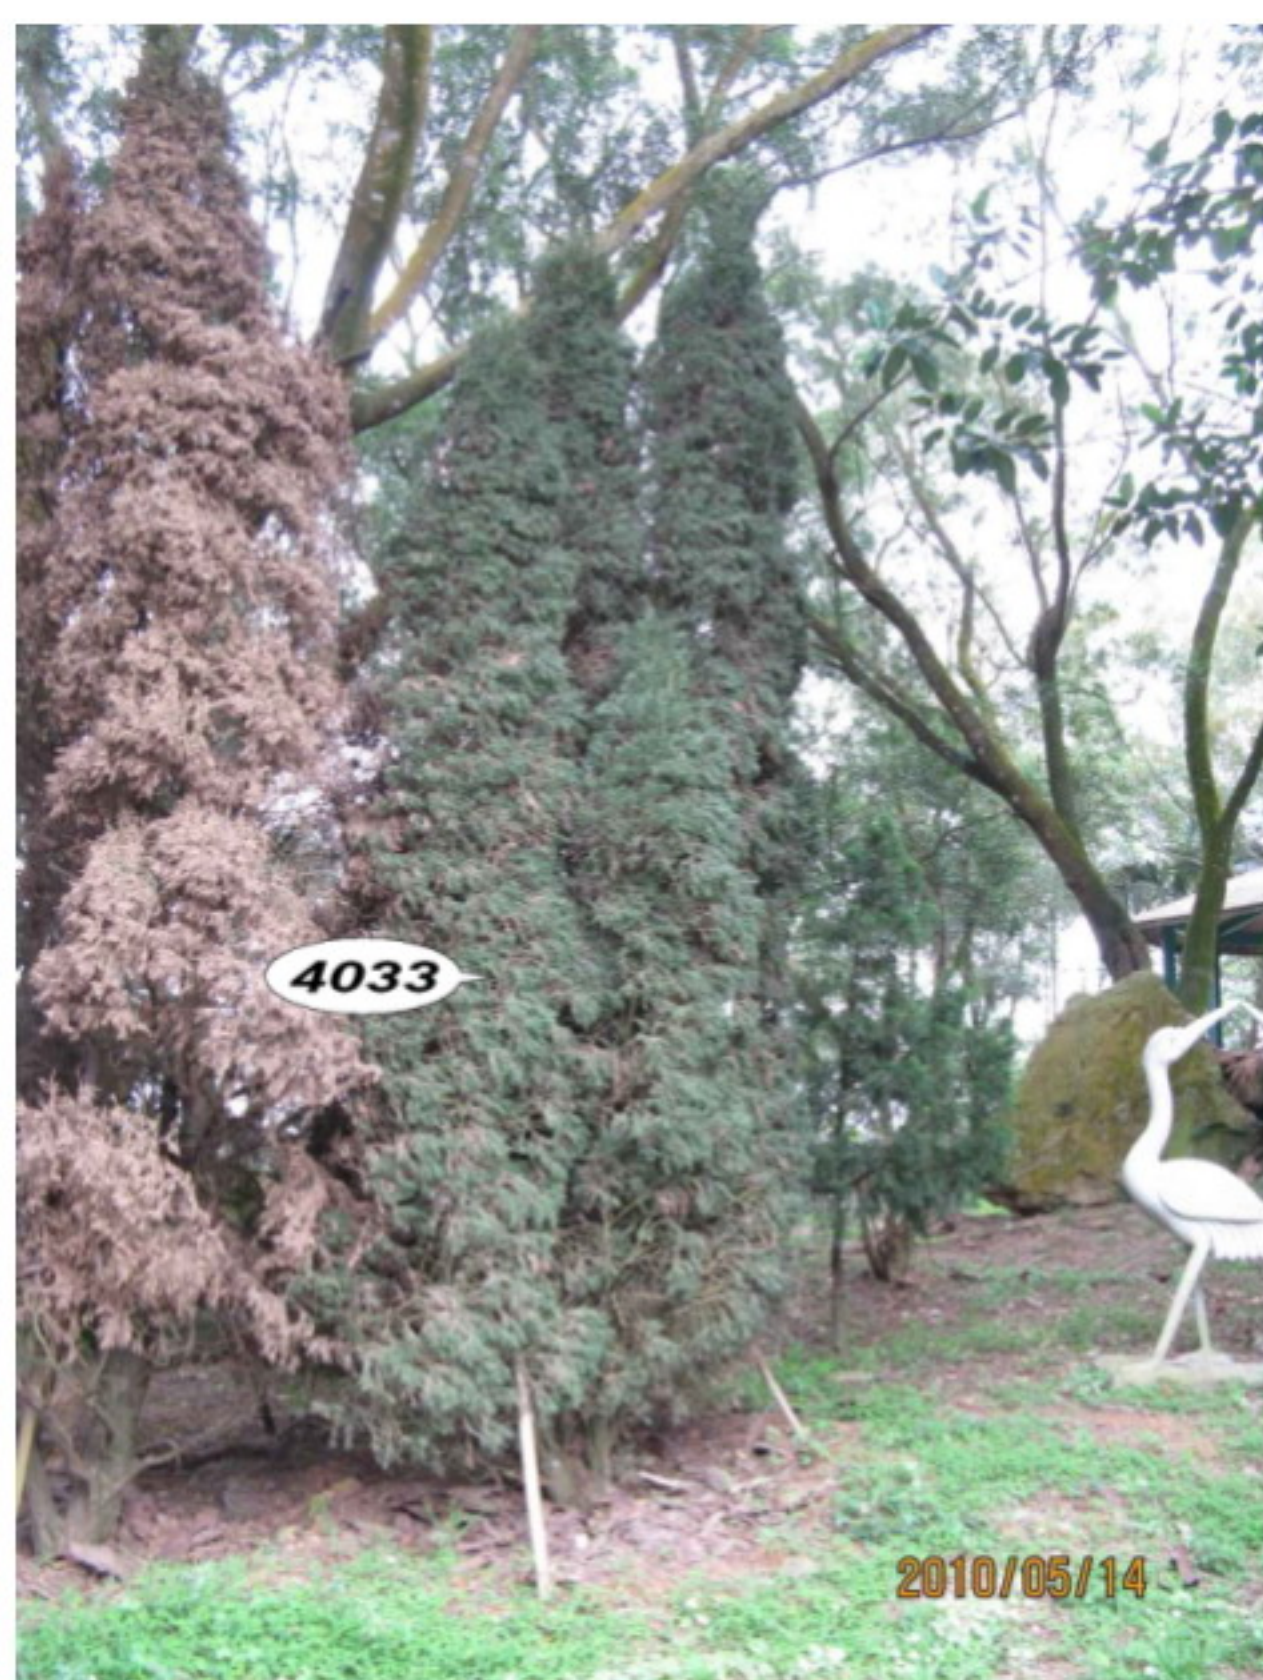
Tree No: 4033

| | | | | | | Remark |
|---|---|---|---|---|---|---|
| 4033 | <i>Juniperus chinensis var.kaizuca</i> | 龍柏 | 4 | 0.13 | 2 | Poor condition, Yellow leaves |

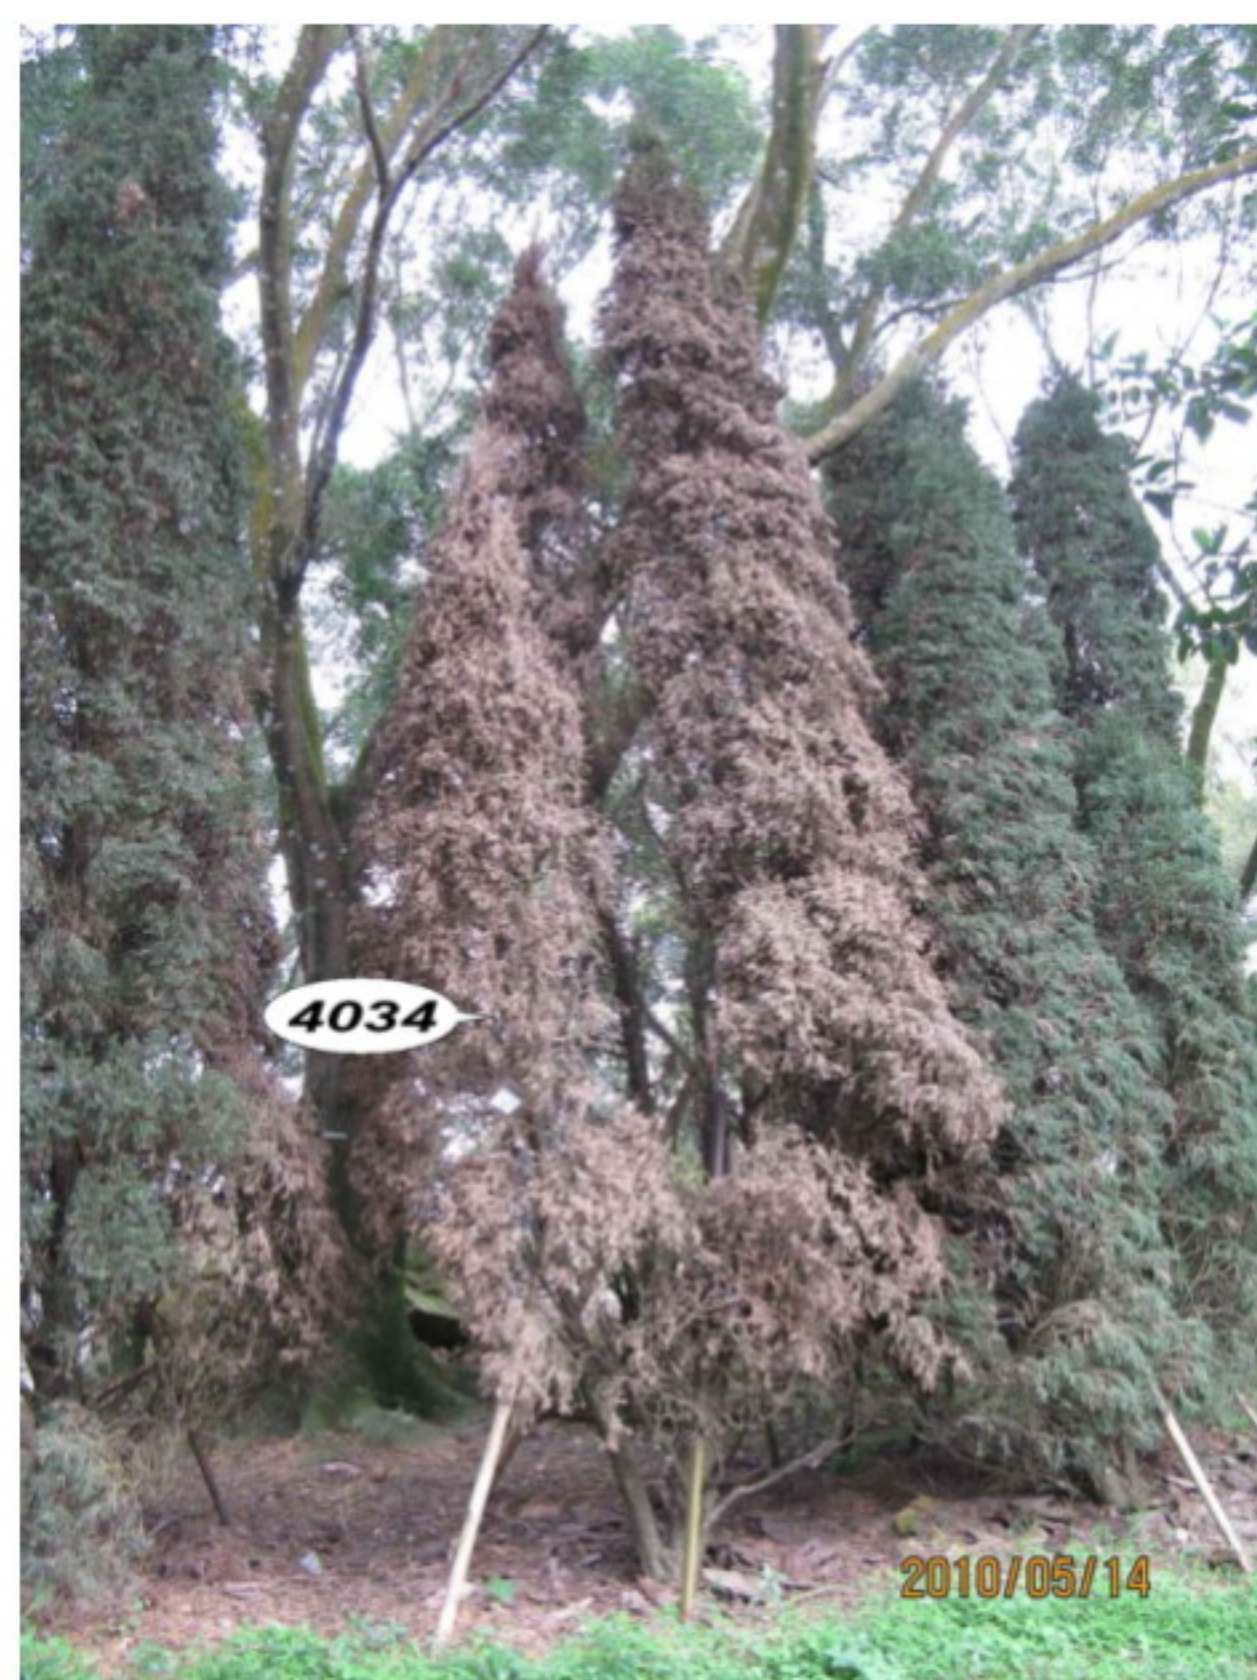
Tree No: 4034

| | | | | | | Remark |
|---|---|---|---|---|---|---|
| 4034 | <i>Juniperus chinensis var.kaizuca</i> | 龍柏 | 4 | 0.13 | 2 | Poor condition, Yellow leaves |

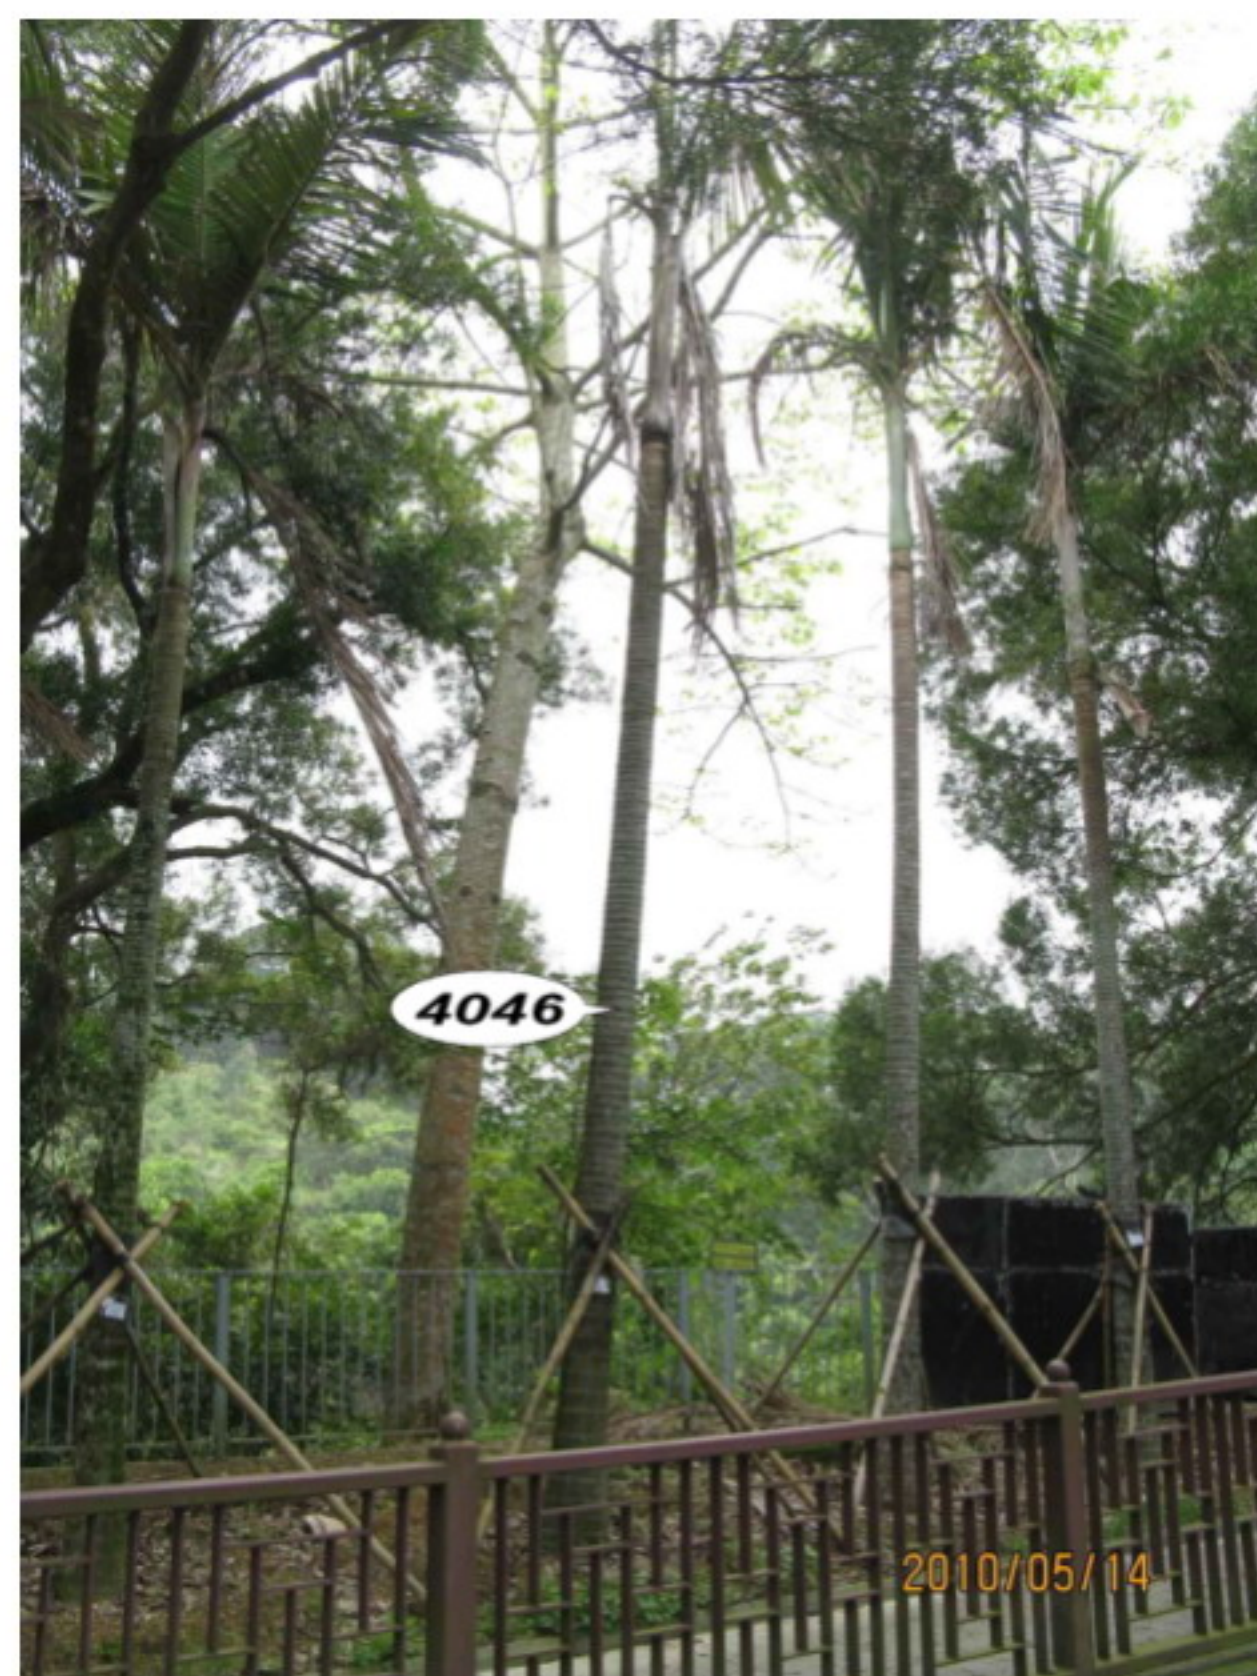
Tree No: 4046

| | | | | | | Remark |
|---|---|---|---|---|---|---|
| 4046 | <i>Archontophoenix alexandrae</i> | 假檳榔 | 5 | 0.19 | 4 | Poor condition, Yellow leave |

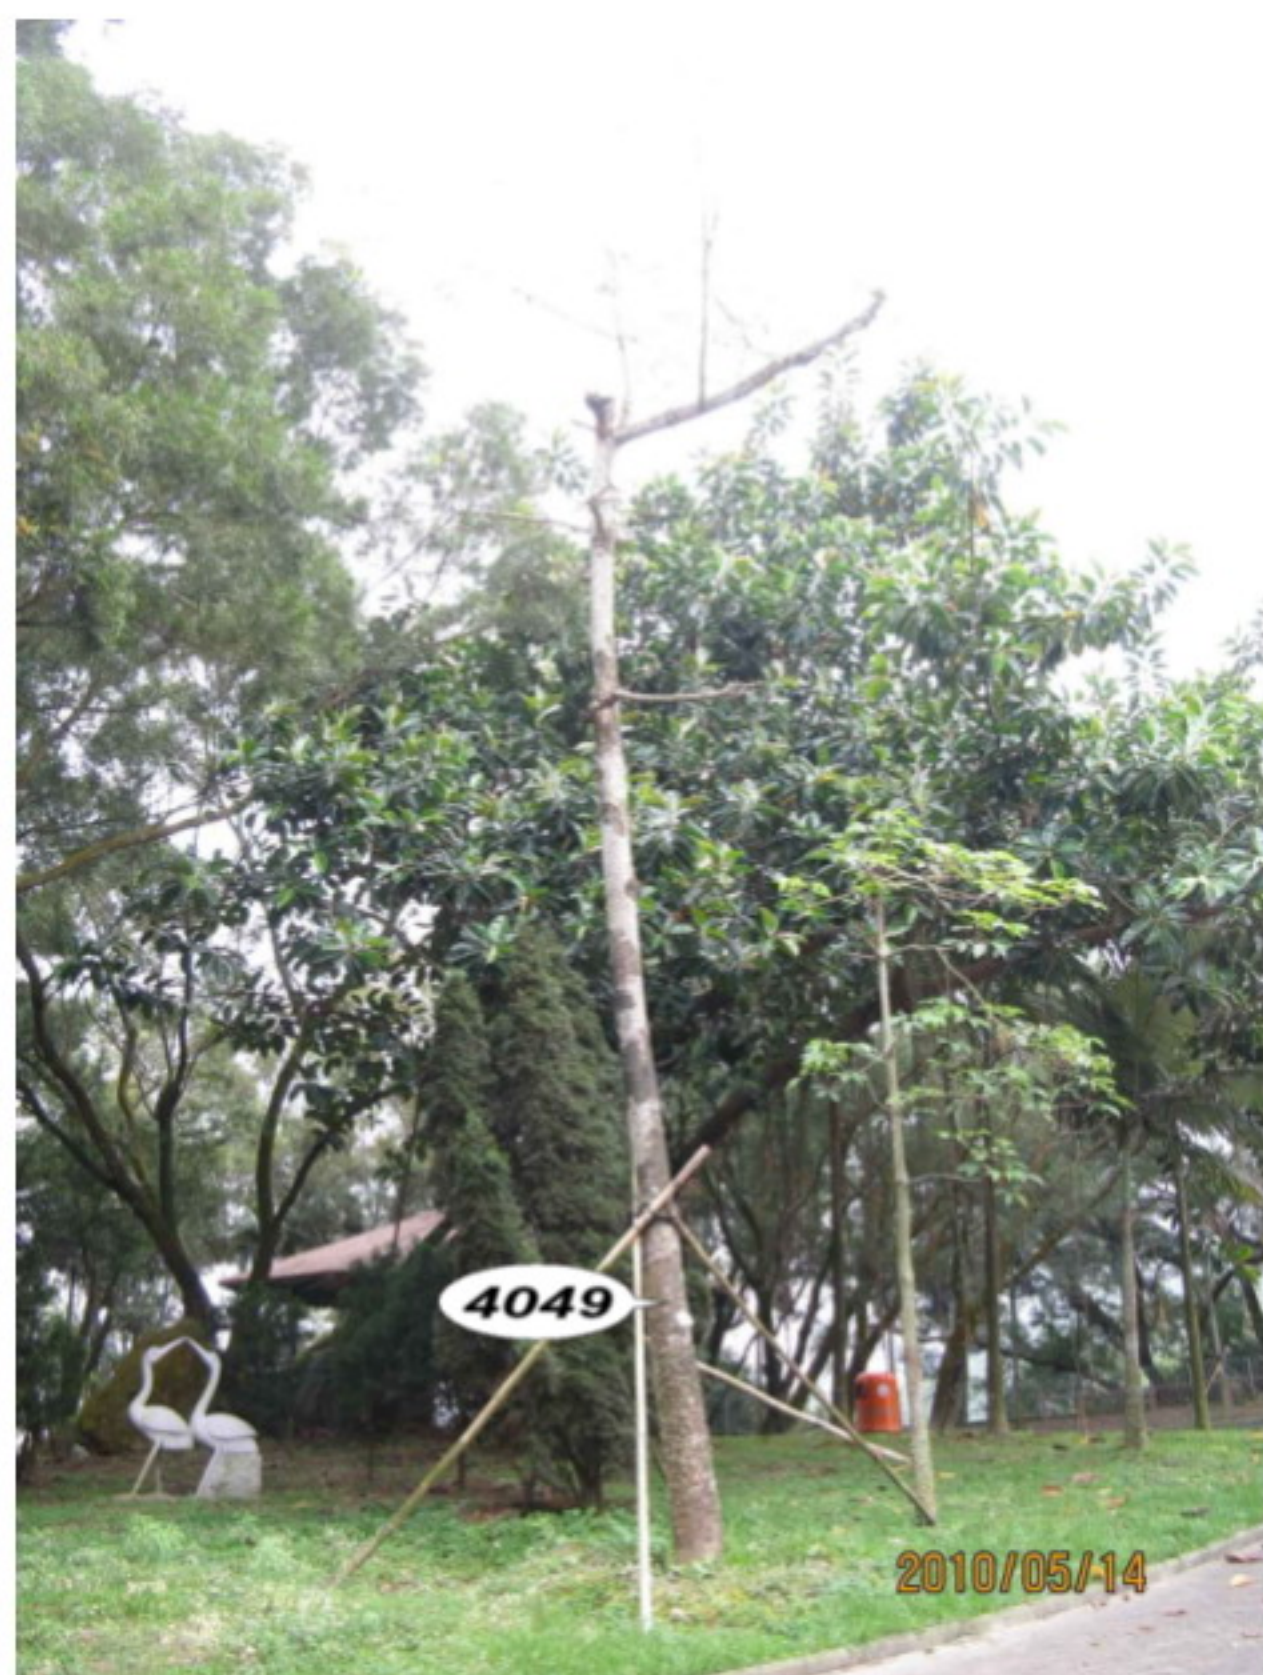
Tree No: 4049

| | | | | | | Remark |
|---|---|---|---|---|---|---|
| 4049 | <i>Bombax ceiba</i> | 木棉 | 6 | 0.16 | 4 | Poor condition, Sparse crown |
