**PROVISION OF CREMATORS AT  
WO HOP SHEK CREMATORIUM**

**ENVIRONMENTAL MONITORING &  
AUDIT REPORT (MAY 2010)**

# Reprovisioning of Wo Hop Shek Crematorium Tree Monitoring and Maintenance

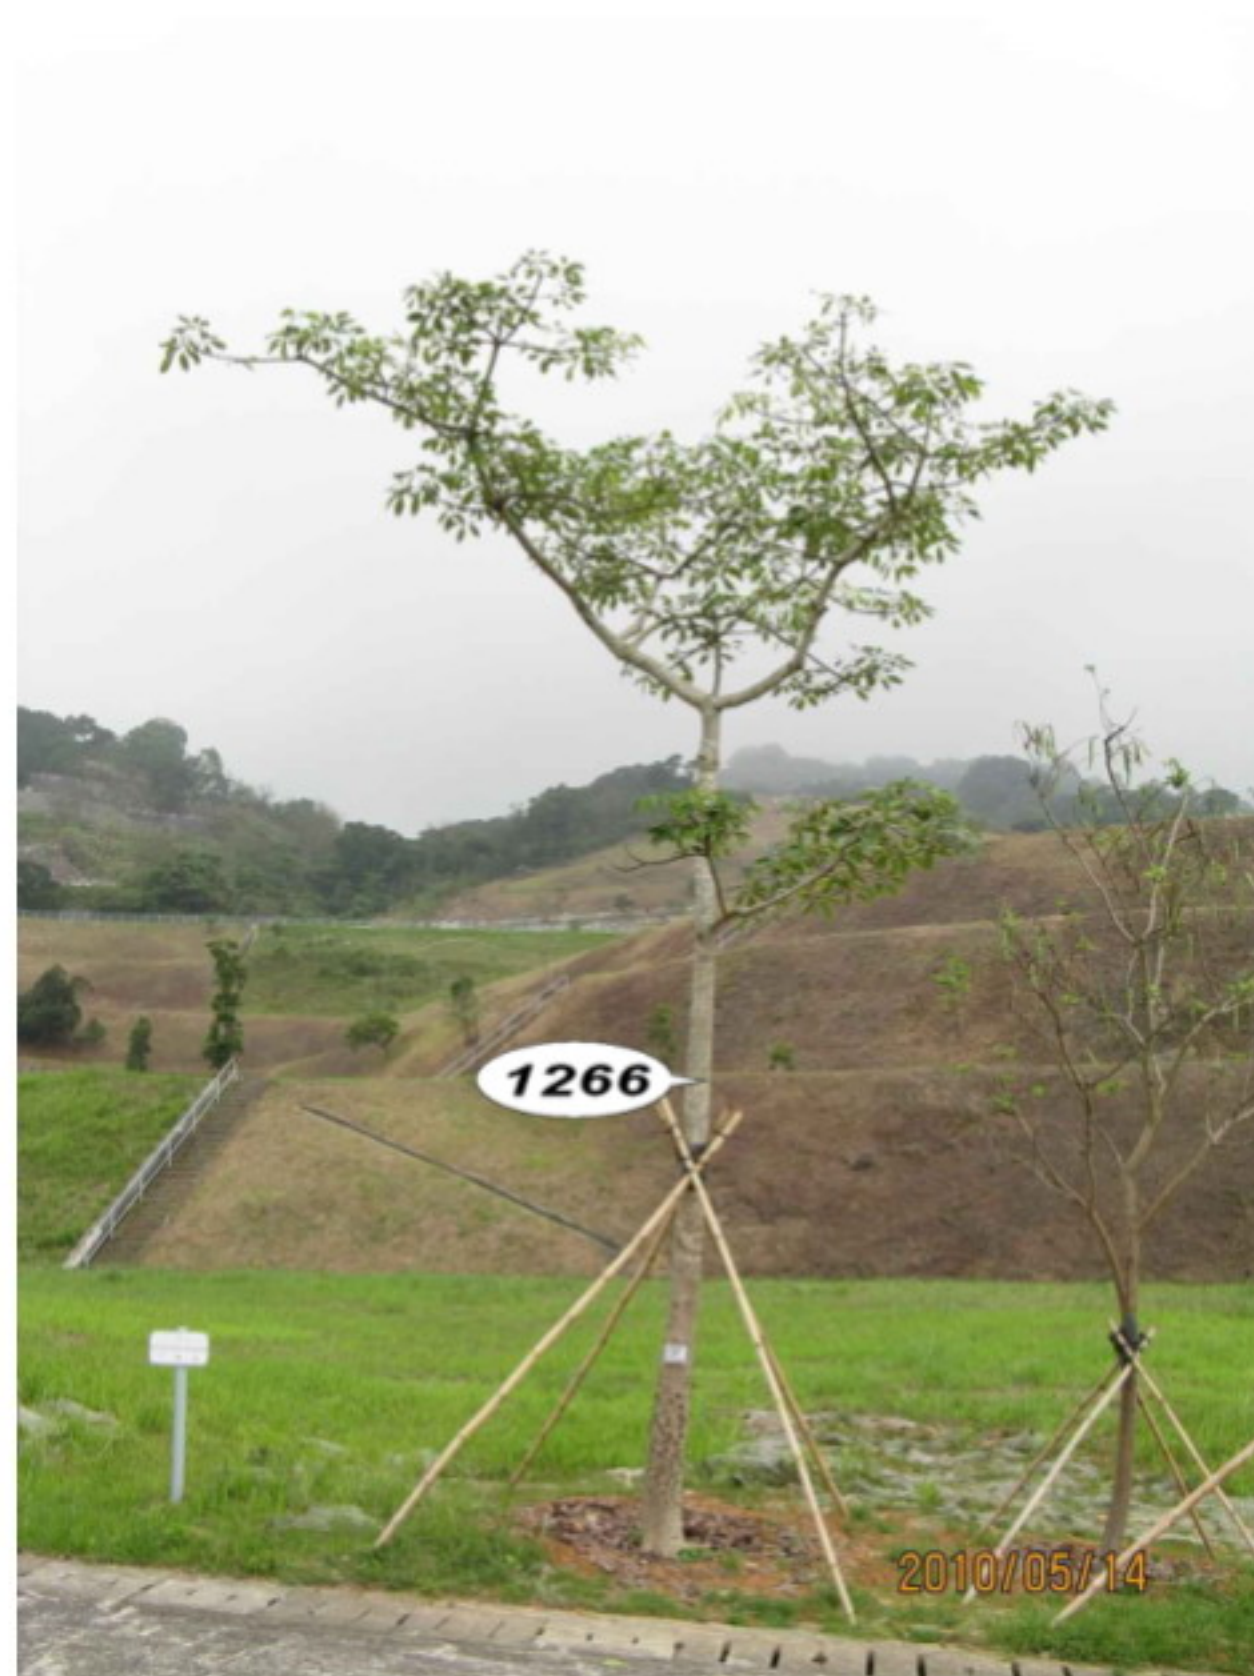
Tree No: 1266

| | | | | | | Remark |
|---|---|---|---|---|---|---|
| 1266 | <i>Bombax ceiba</i> | 木棉 | 4 | 0.15 | 3 | Poor condition, Leave regenerating |

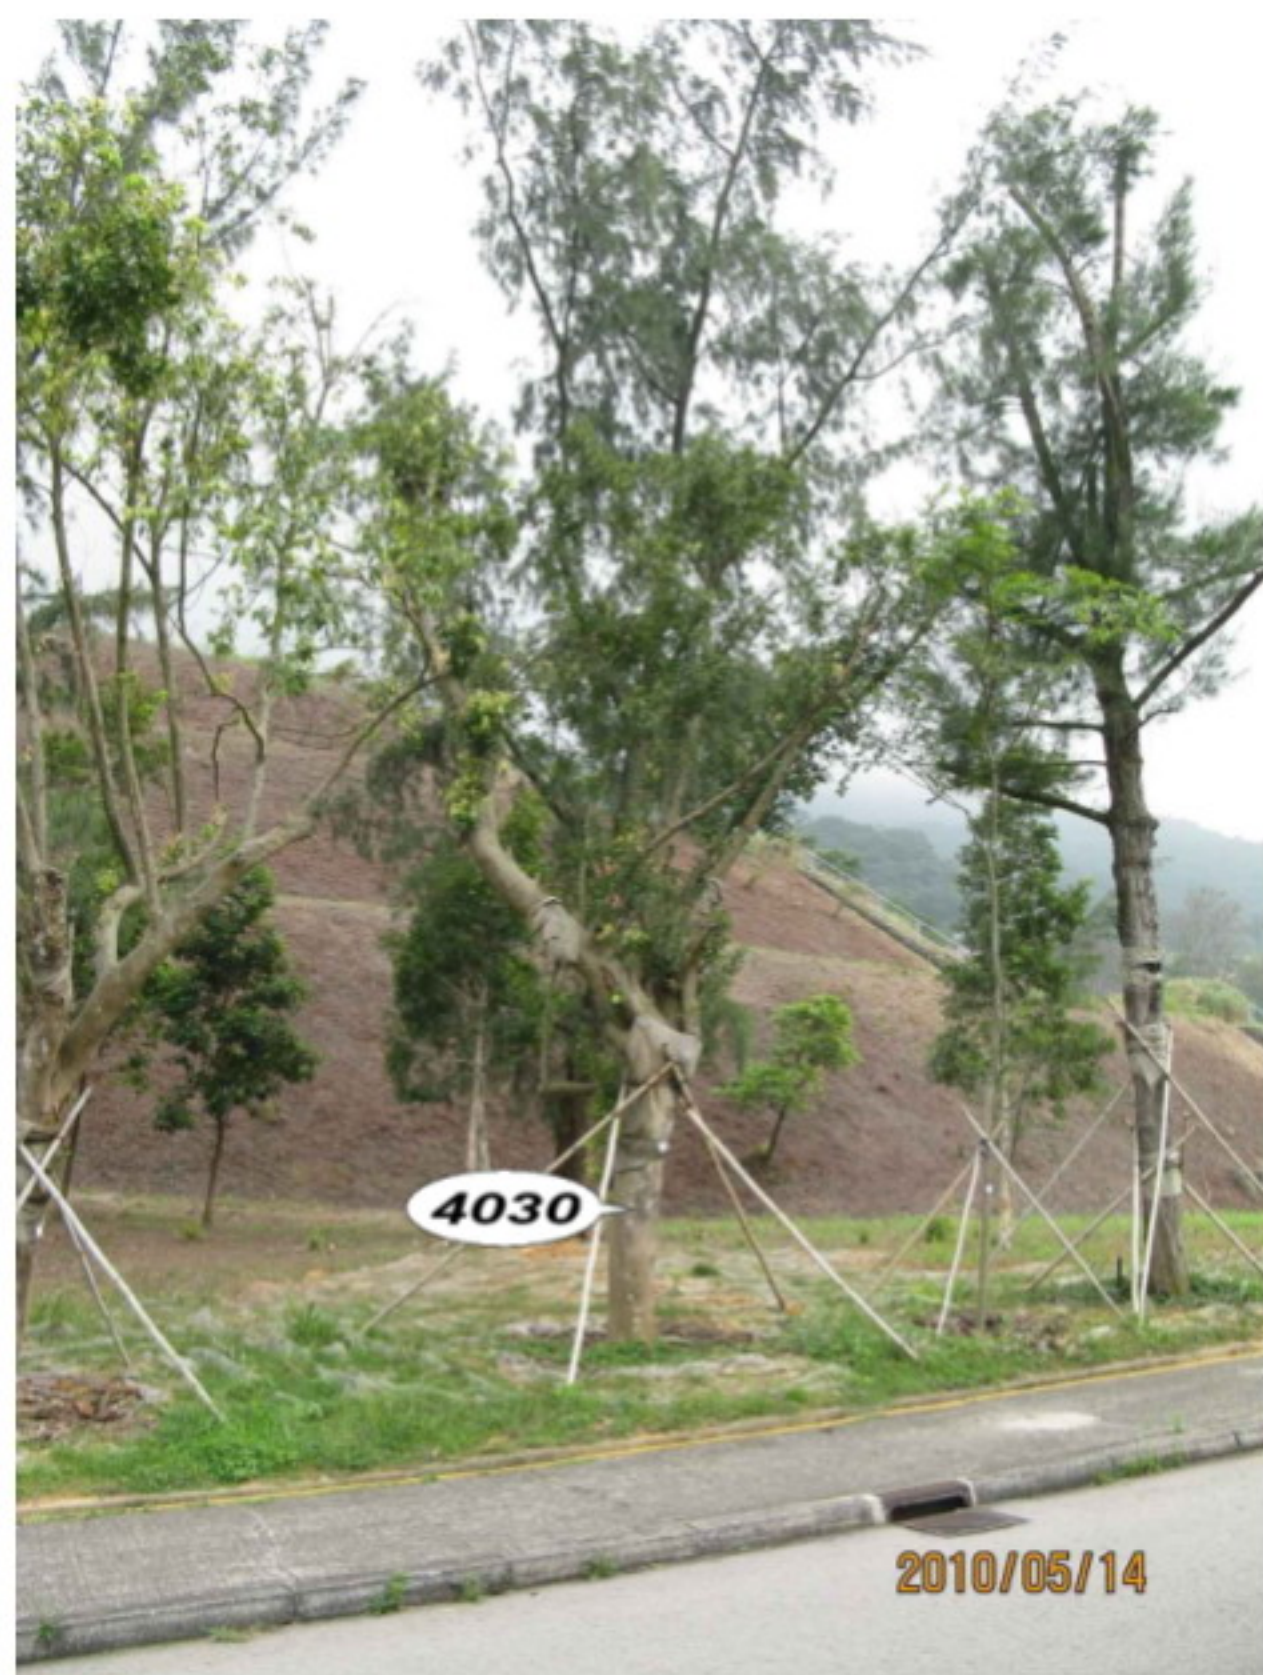
Tree No: 4030

| | | | | | | Remark |
|---|---|---|---|---|---|---|
| 4030 | <i>Cinnamomum burmannii</i> | 陰香 | 5.5 | 0.16 | 4 | Poor condition, Fork, Pruned, Decay, Leave regenerating |

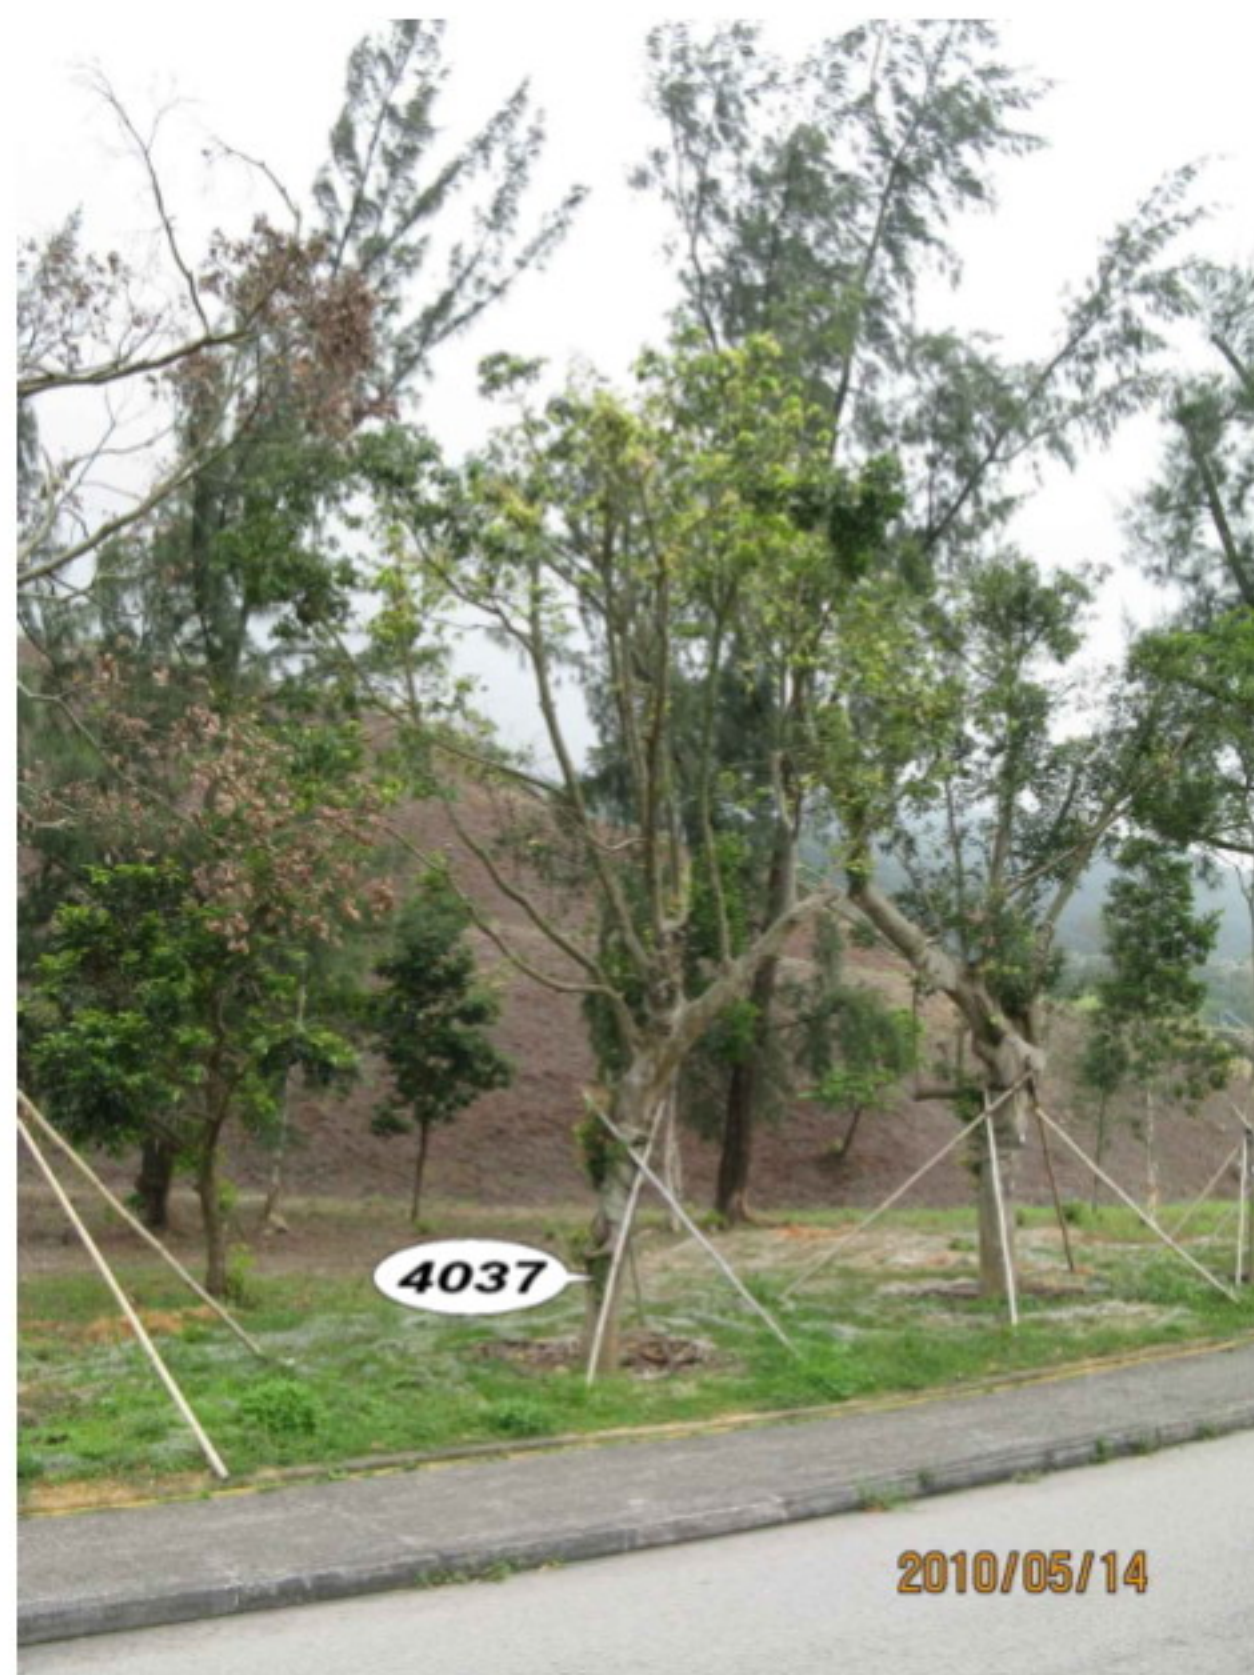
Tree No: 4037

| | | | | | | Remark |
|---|---|---|---|---|---|---|
| 4037 | <i>Cinnamomum burmannii</i> | 陰香 | 6 | 0.25 | 4 | Poor condition, Fork, Pruned, Cavity, Leave regenerating |
