**PROVISION OF CREMATORS AT  
WO HOP SHEK CREMATORIUM**

**ENVIRONMENTAL MONITORING &  
AUDIT REPORT (JUNE 2010)**

Quotation Contract No. 9/2009/AB1  
Provision of Cremators at Wo Hop Shek Crematorium - Independent Environmental Checker Service  
Monthly EM&A Report (June 2010)

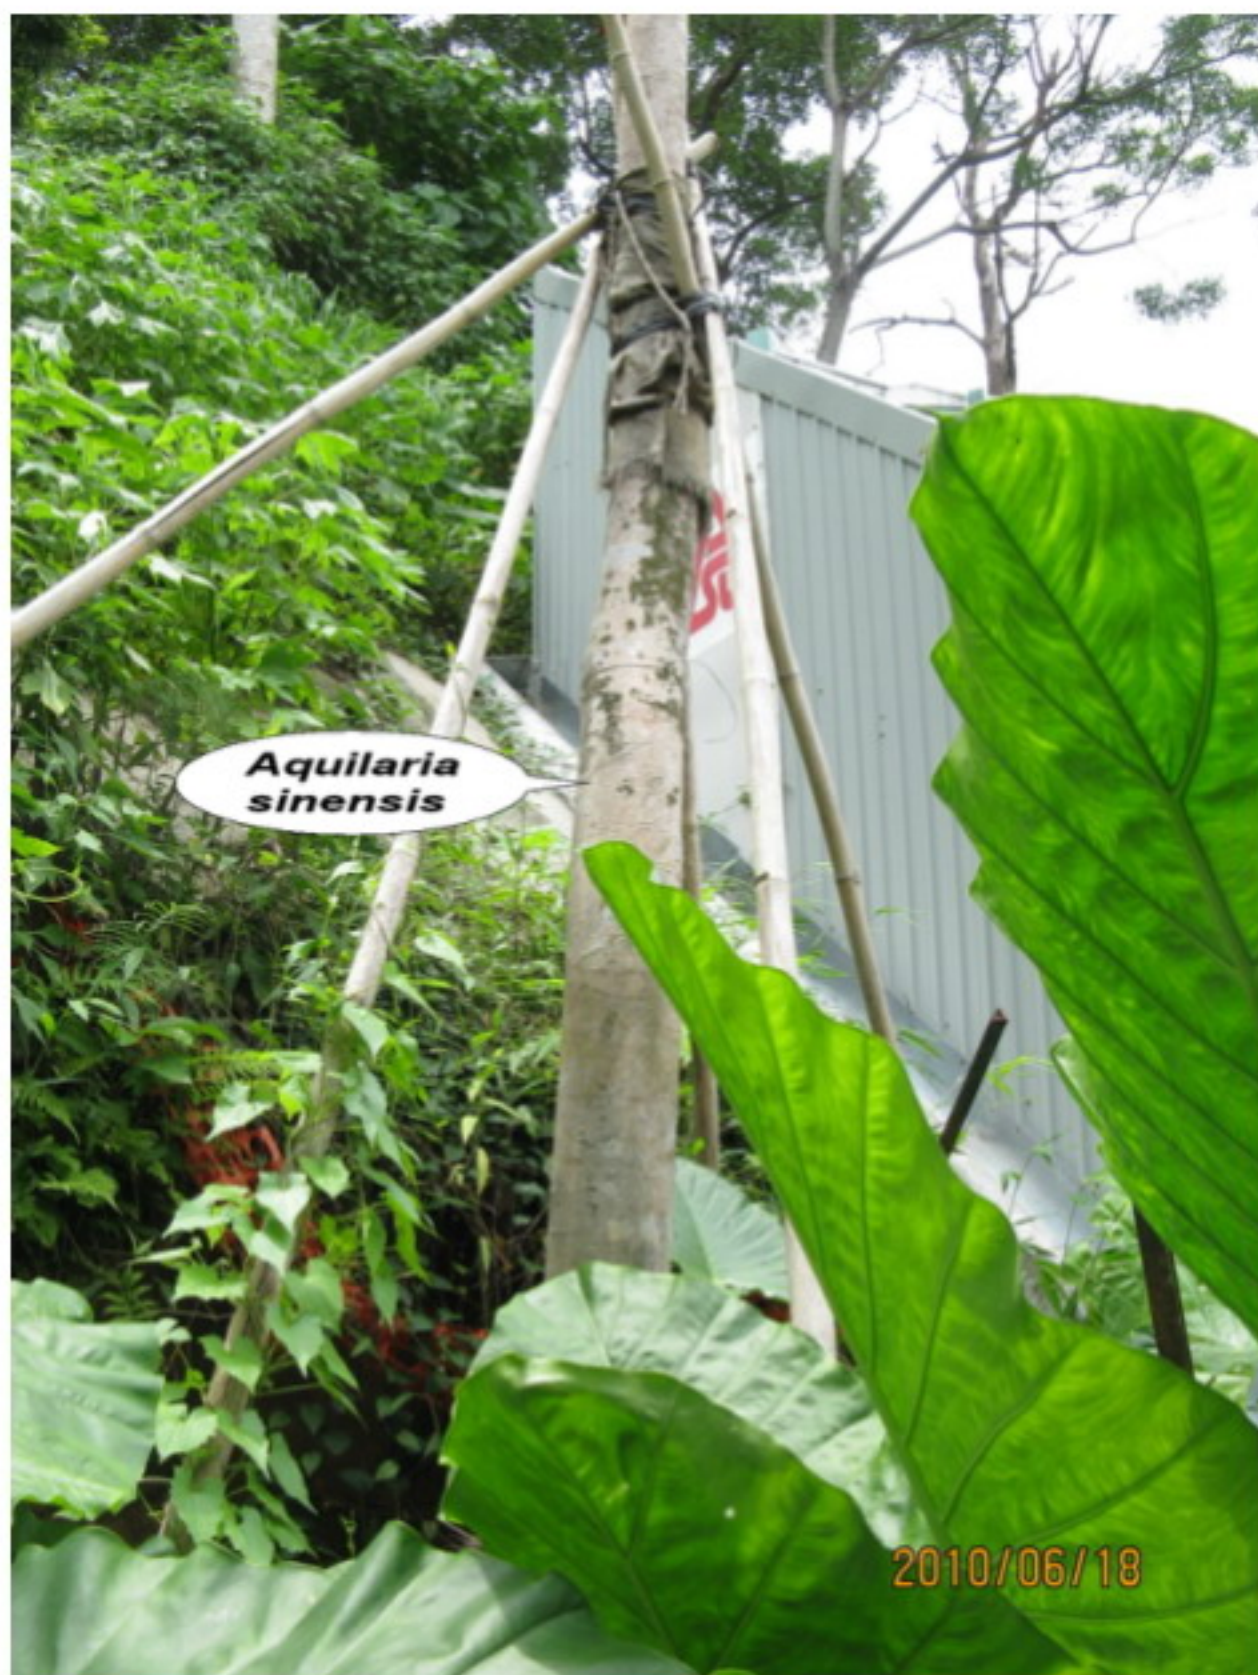
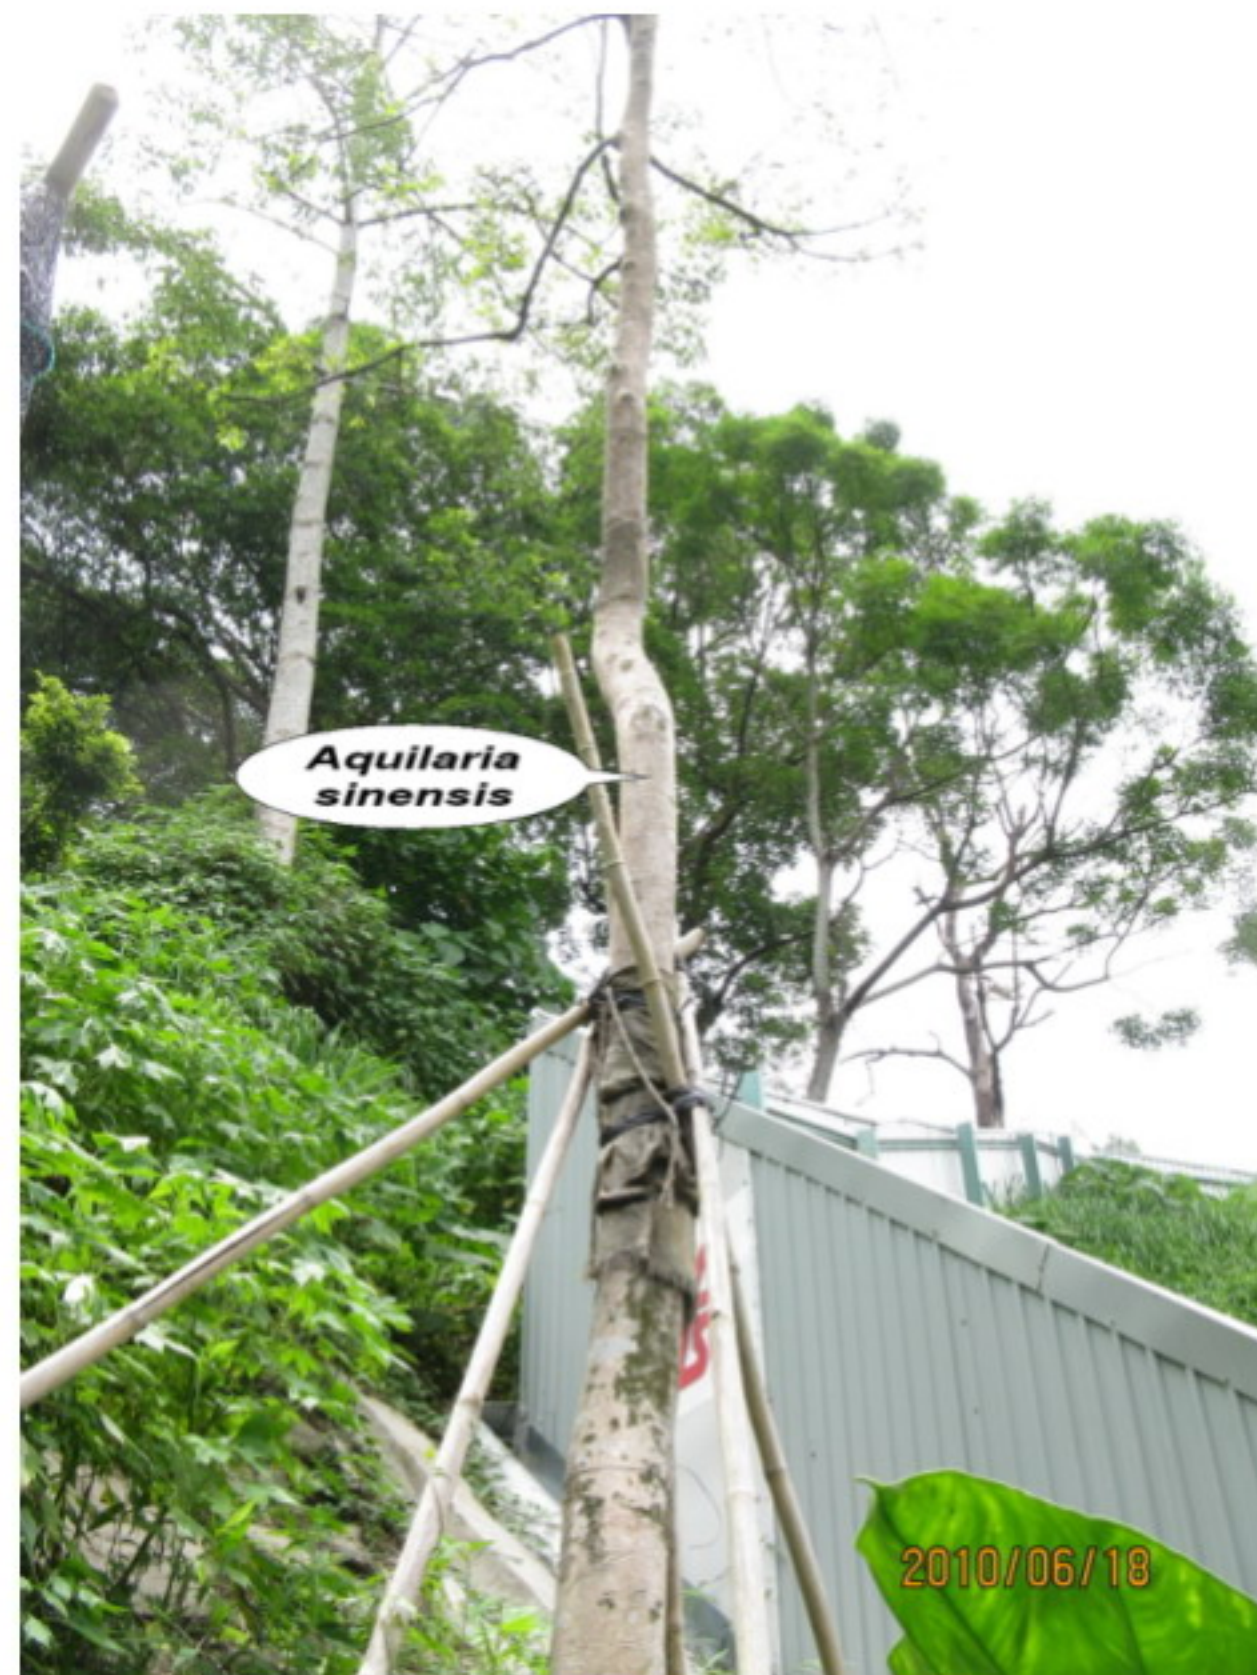
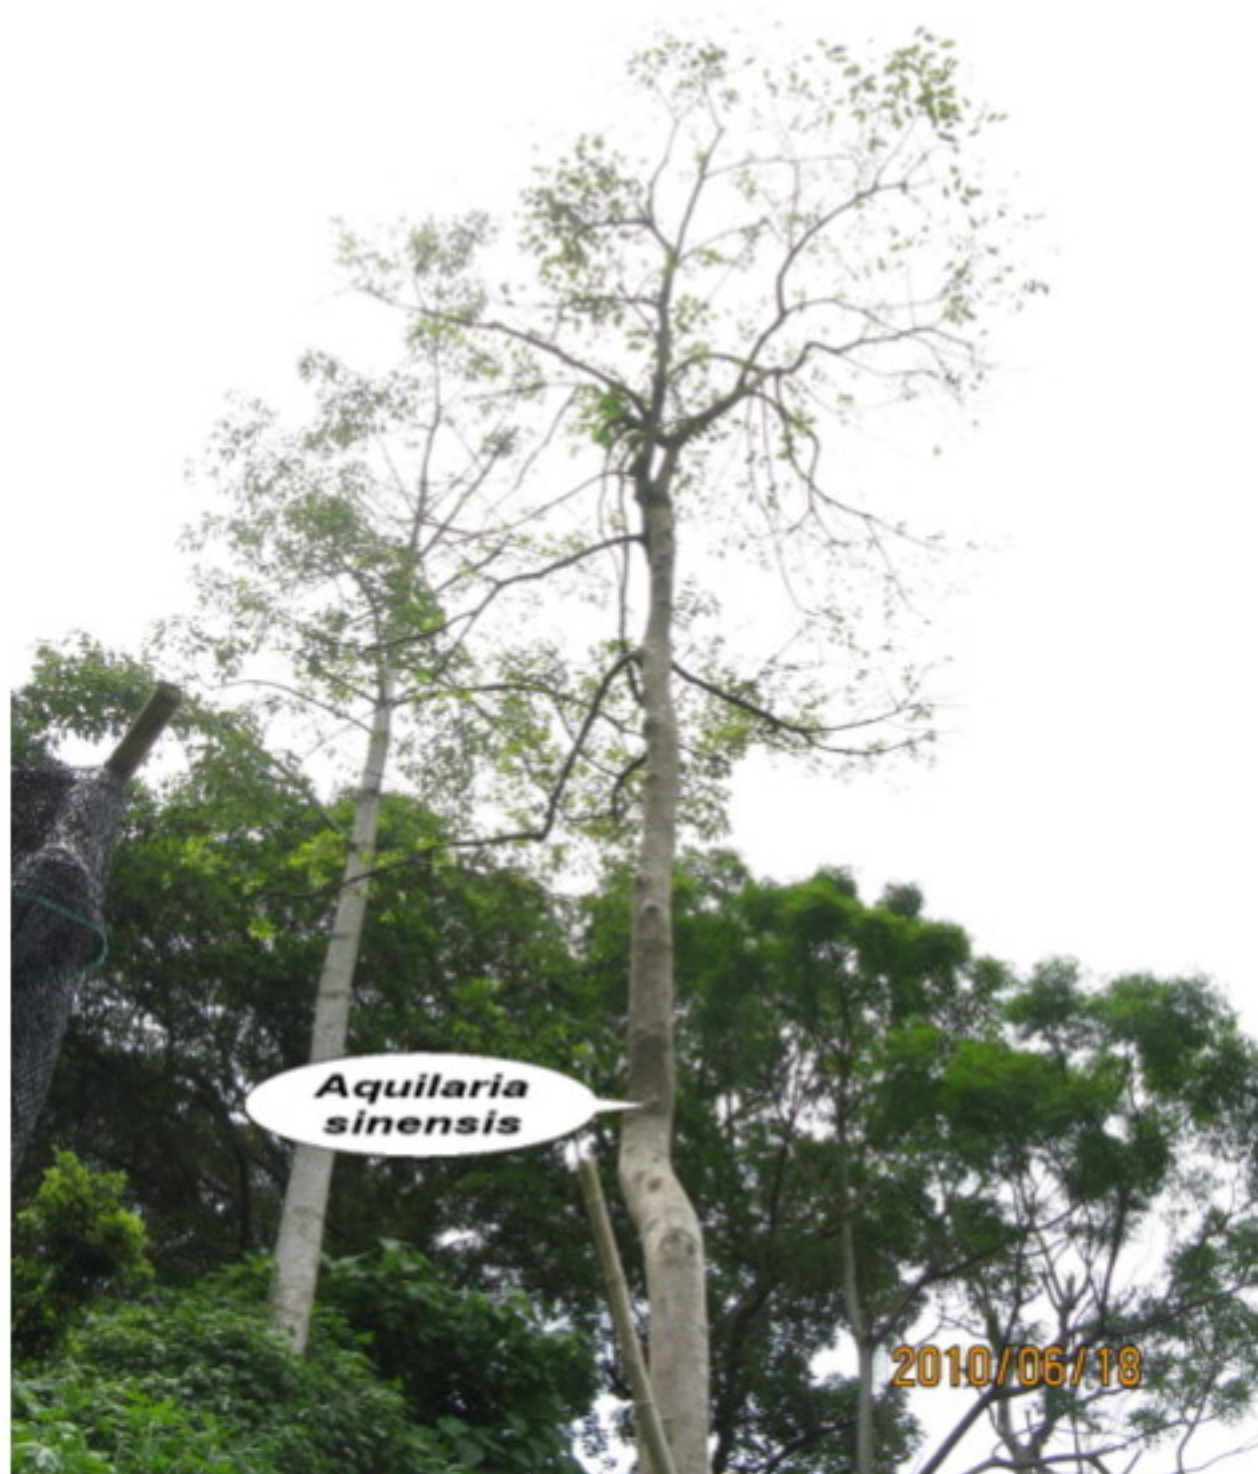
- 4.5 The transplanted *Aquilaria sinensis* showed stress and deterioration in health condition as indicated by foliage color. Daily watering and closely monitoring is recommended.

*Aquilaria sinensis*

- 5.2 The transplanted *Aquilaria sinensis* showed stress and deterioration in health condition as indicated by foliage color. Daily watering and closely monitoring is recommended.

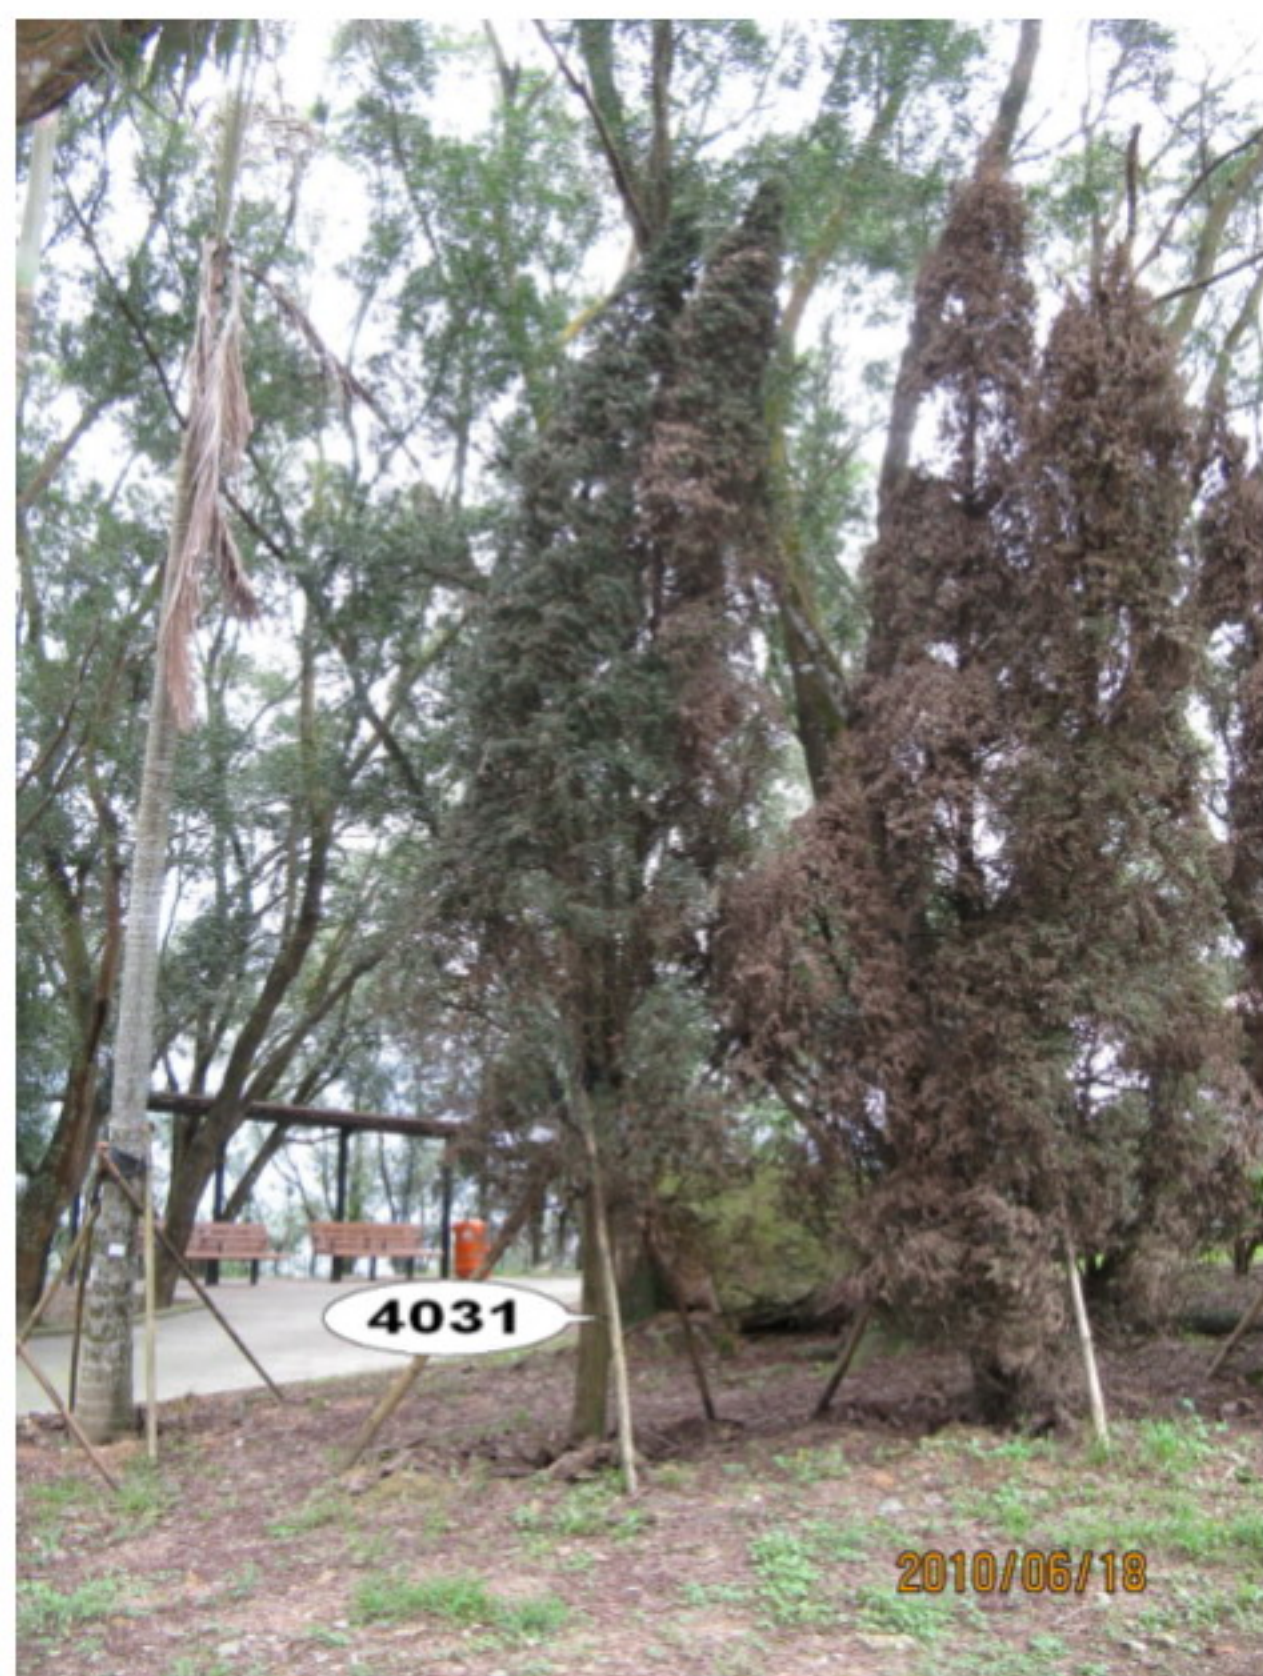
Tree No: 4031

- 4.6 Four individuals of *Juniperus chinensis* var. *kaizuca* (i.e. 4031-4034) seems infected with virus/fungi. Their leaves became yellow in color. Applying fungicides and closely monitoring were recommended.

| | | | | | | Remark |
|---|---|---|---|---|---|---|
| 4031 | <i>Juniperus chinensis var.kaizuca</i> | 龍柏 | 5 | 0.12 | 2 | Poor condition, Yellow leaves |

- 5.3 Four individuals of *Juniperus chinensis var.kaizuca* (i.e. 4031-4034) seems infected with virus/fungi. Their leaves were yellow in color currently. Applying fungicides and closely monitoring were recommended.

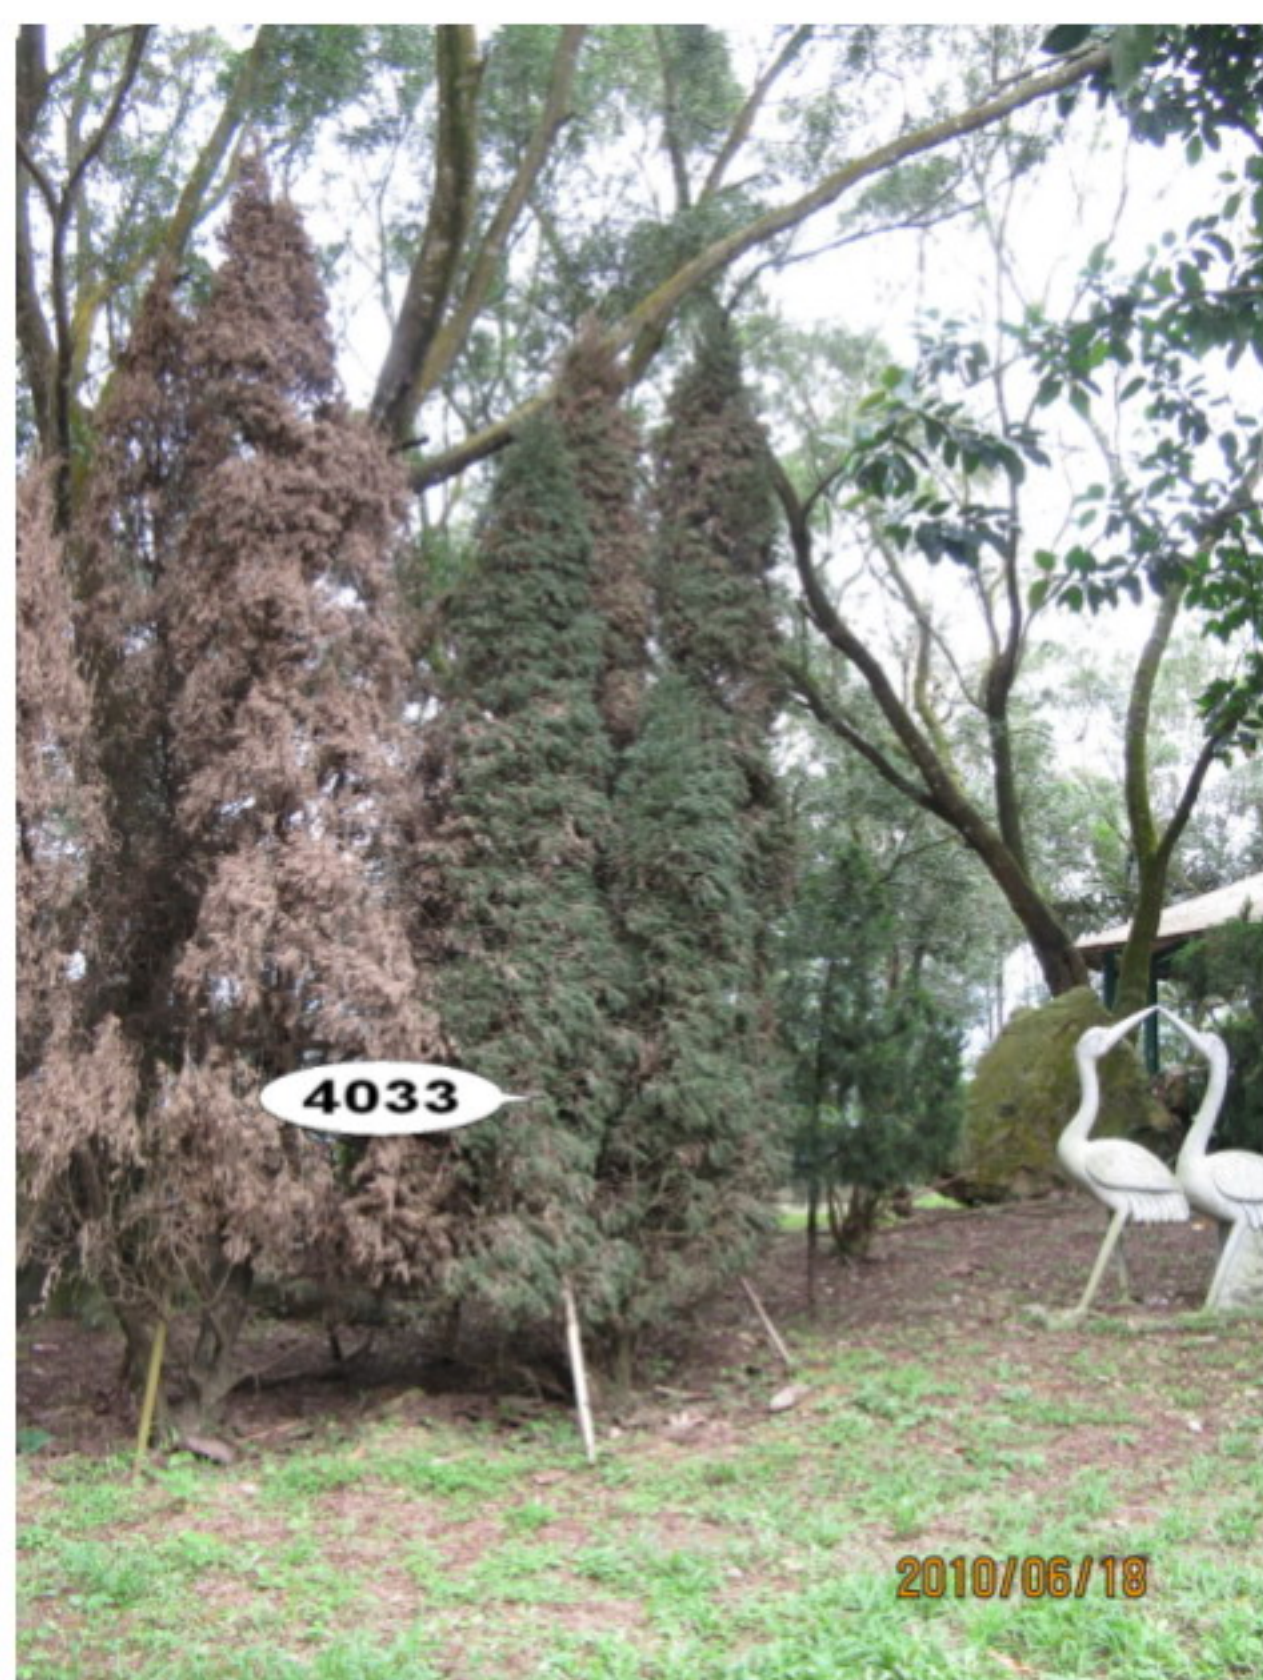
Tree No: 4033

| | | | | | | Remark |
|---|---|---|---|---|---|---|
| 4033 | <i>Juniperus chinensis var.kaizuca</i> | 龍柏 | 4 | 0.13 | 2 | Poor condition, Yellow leaves |

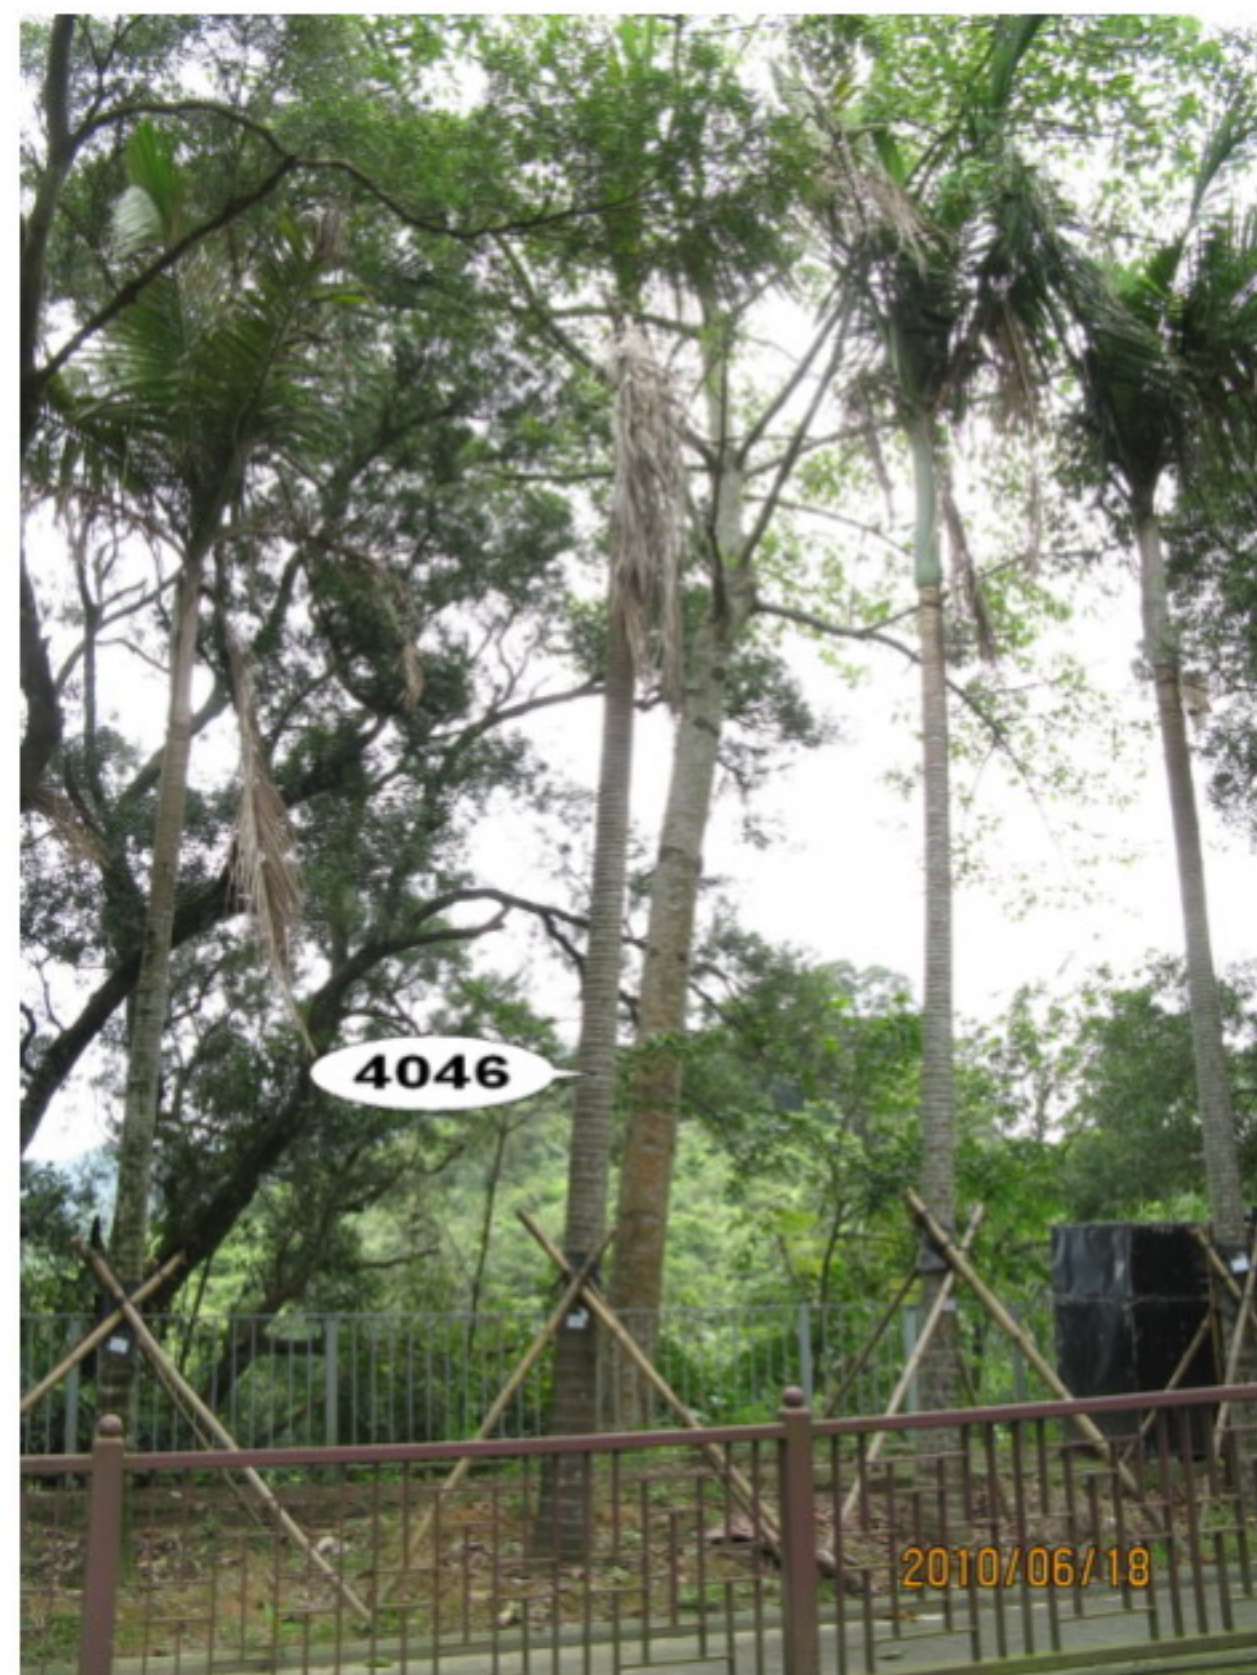
Tree No: 4046

| | | | | | | Remark |
|---|---|---|---|---|---|---|
| 4046 | <i>Archontophoenix alexandrae</i> | 假檳榔 | 5 | 0.19 | 4 | Poor condition, Yellow leave |

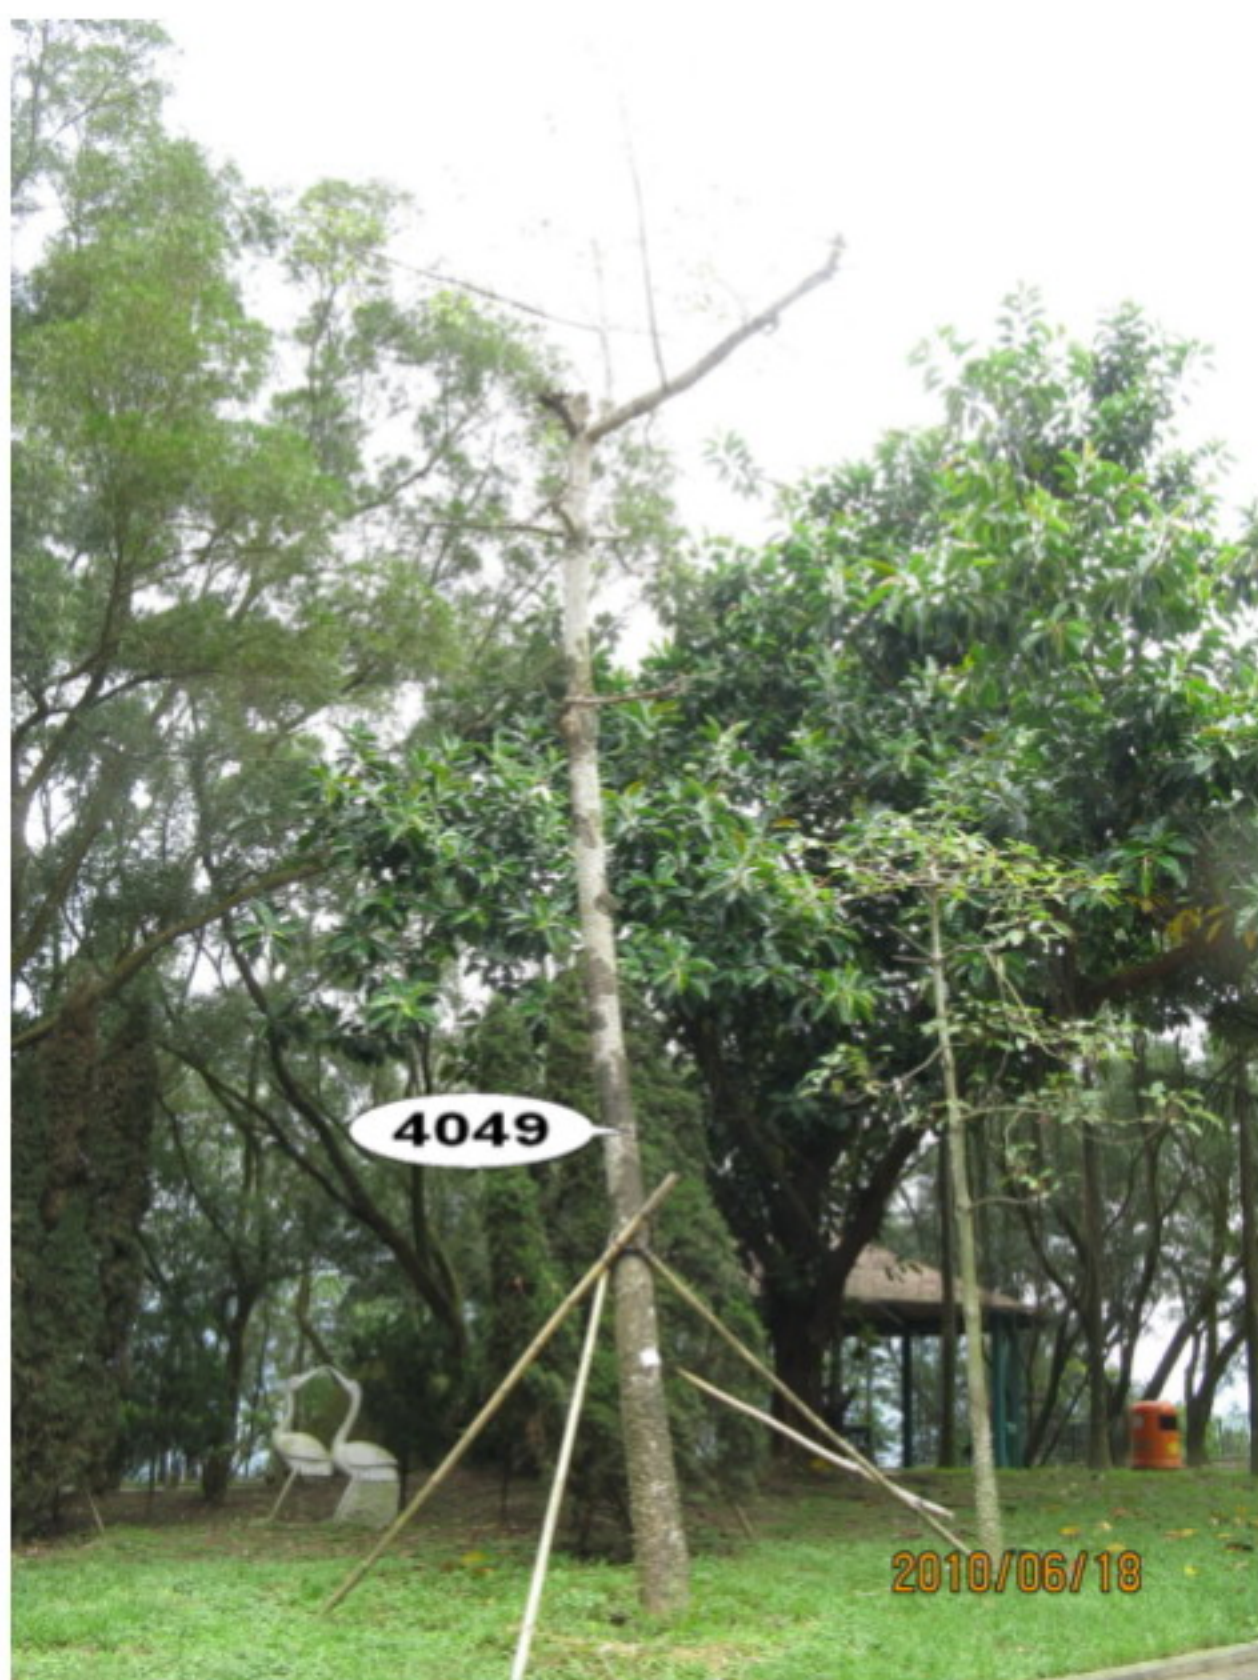
Tree No: 4049

| | | | | | | Remark |
|---|---|---|---|---|---|---|
| 4049 | <i>Bombax ceiba</i> | 木棉 | 6 | 0.16 | 4 | Poor condition, Sparse crown |

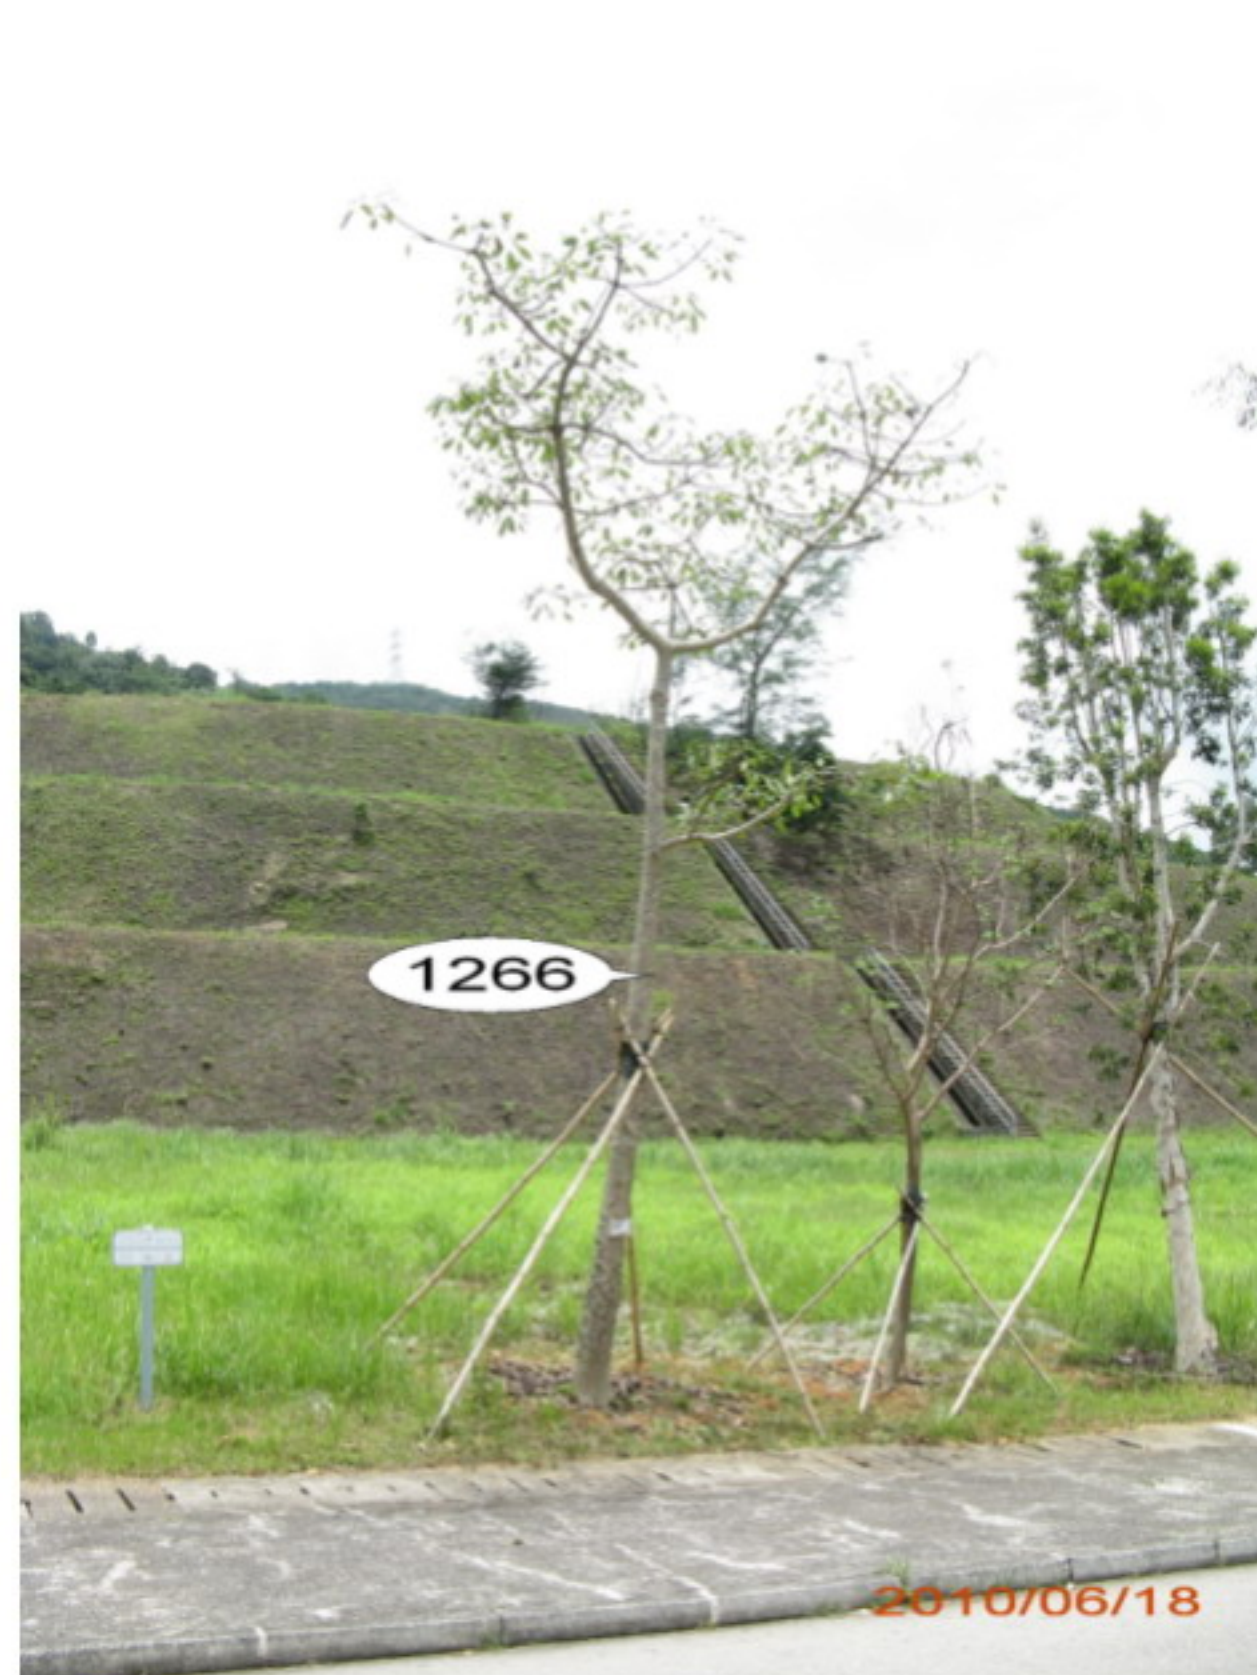
Tree No: 1266

| | | | | | | Remark |
|---|---|---|---|---|---|---|
| 1266 | <i>Bombax ceiba</i> | 木棉 | 4 | 0.15 | 3 | Poor condition, Leave regenerating |

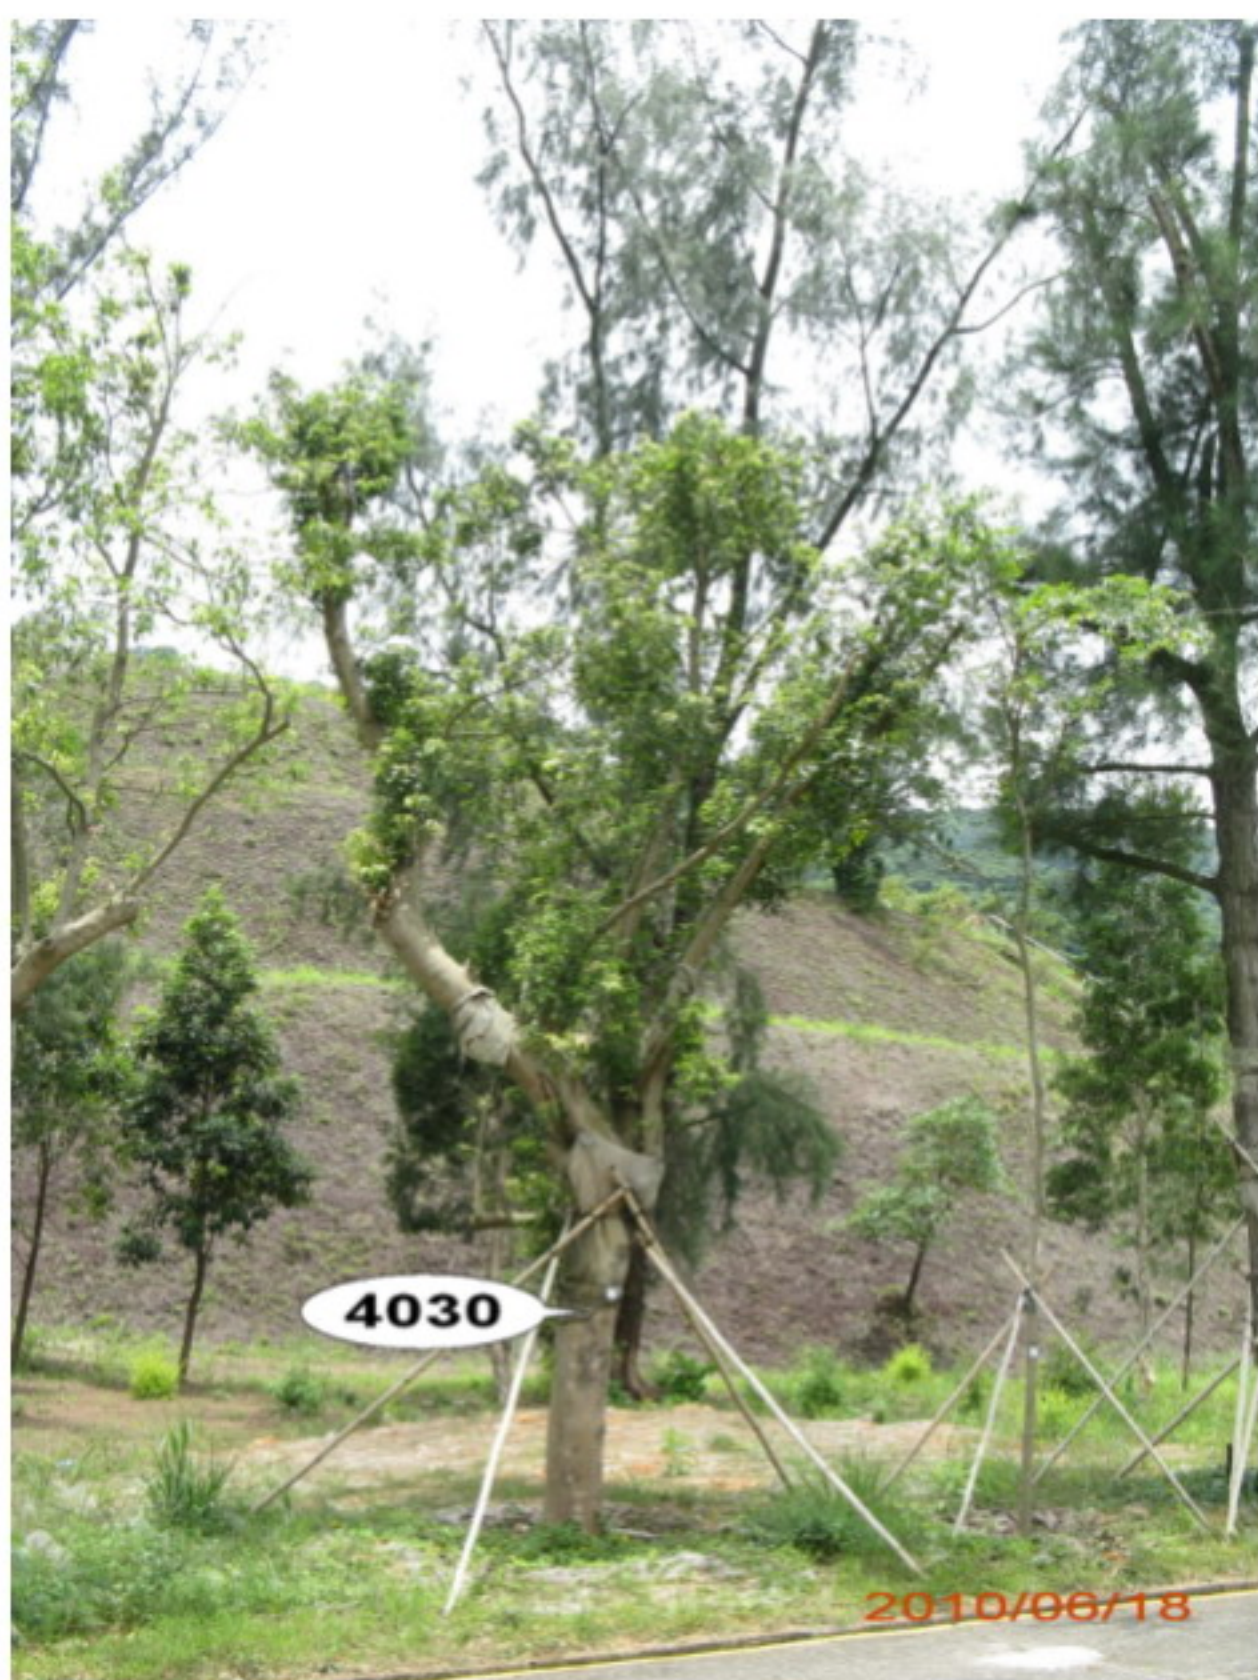
Tree No: 4030

| | | | | | | Remark |
|---|---|---|---|---|---|---|
| 4030 | <i>Cinnamomum burmannii</i> | 陰香 | 5.5 | 0.16 | 4 | Poor condition, Fork, Pruned, Decay, Leave regenerating |

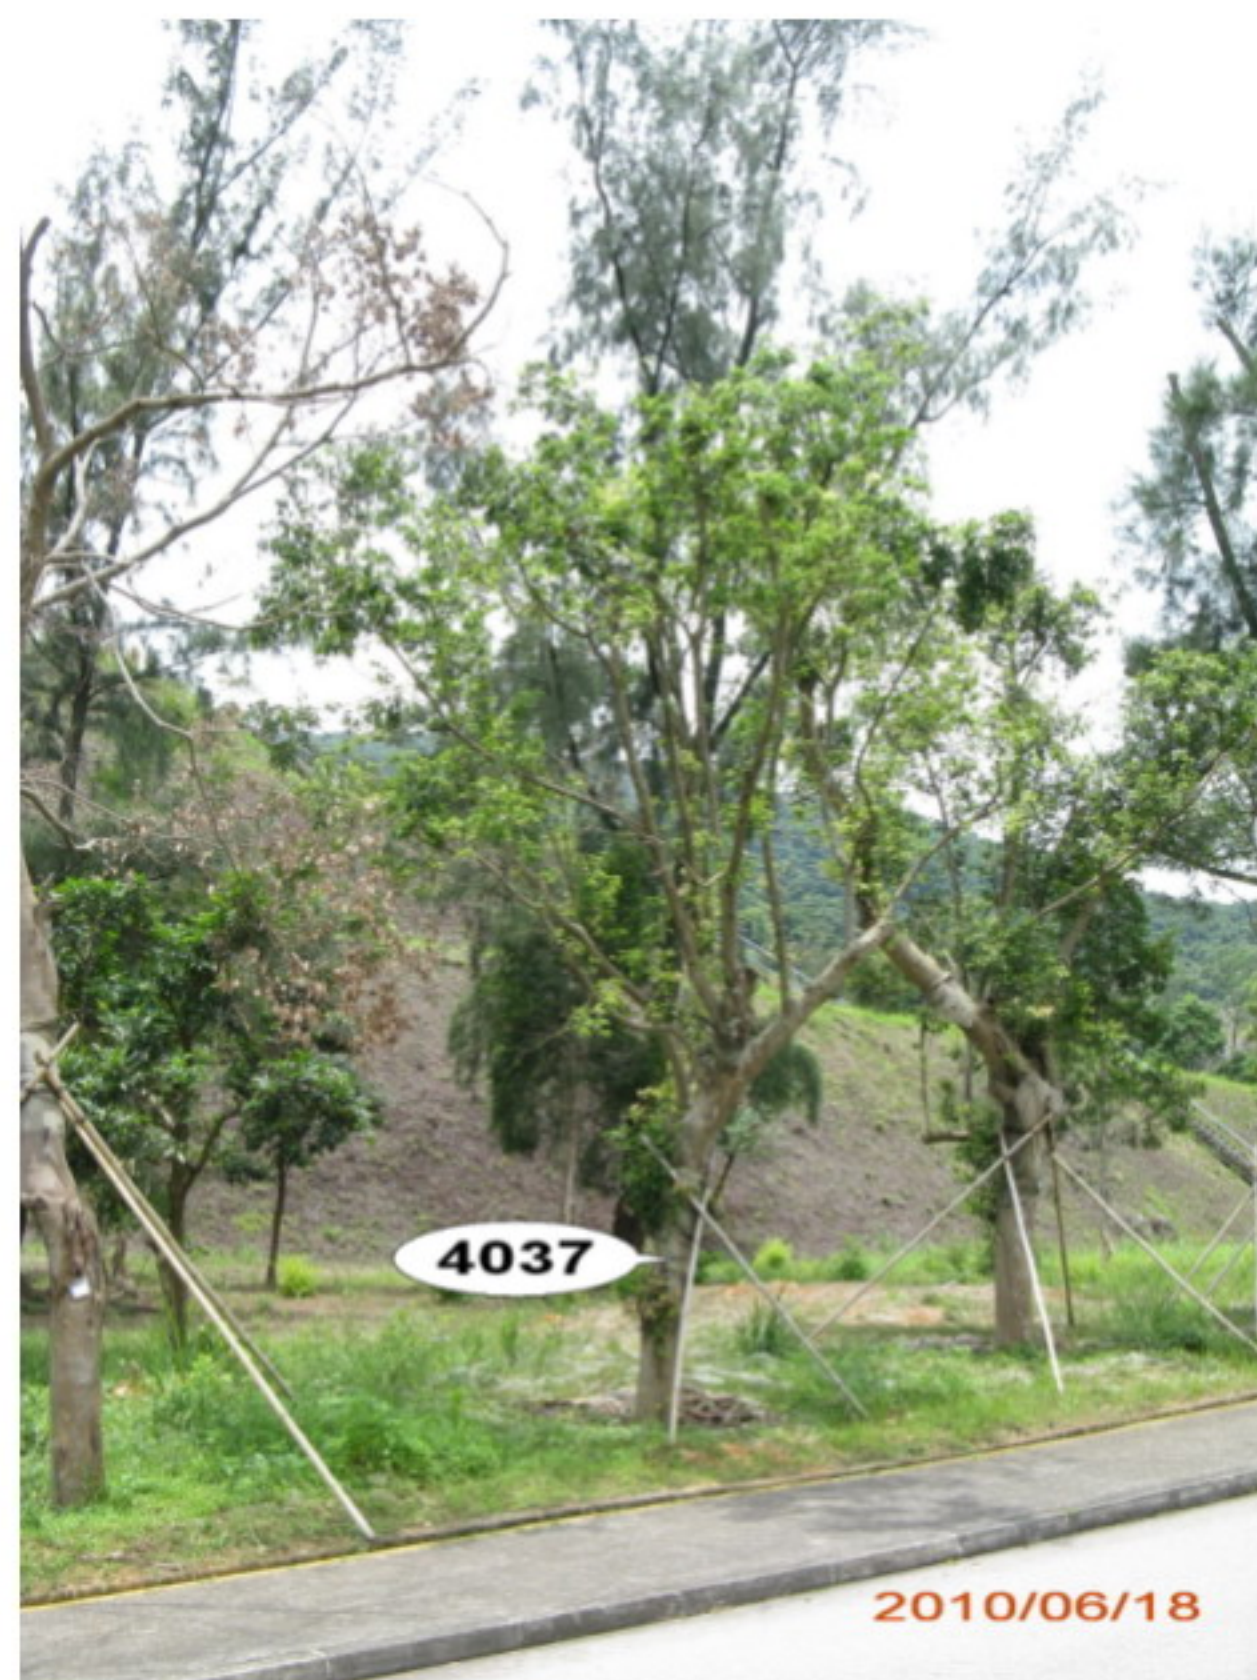
Tree No: 4037

| | | | | | | Remark |
|---|---|---|---|---|---|---|
| 4037 | <i>Cinnamomum burmannii</i> | 陰香 | 6 | 0.25 | 4 | Poor condition, Fork, Pruned, Cavity, Leave regenerating |
