**PROVISION OF CREMATORS AT  
WO HOP SHEK CREMATORIUM**

**ENVIRONMENTAL MONITORING &  
AUDIT REPORT (JULY 2010)**

Quotation Contract No. 9/2009/AB1  
Provision of Cremators at Wo Hop Shek Crematorium - Independent Environmental Checker Service  
Monthly EM&A Report (July 2010)

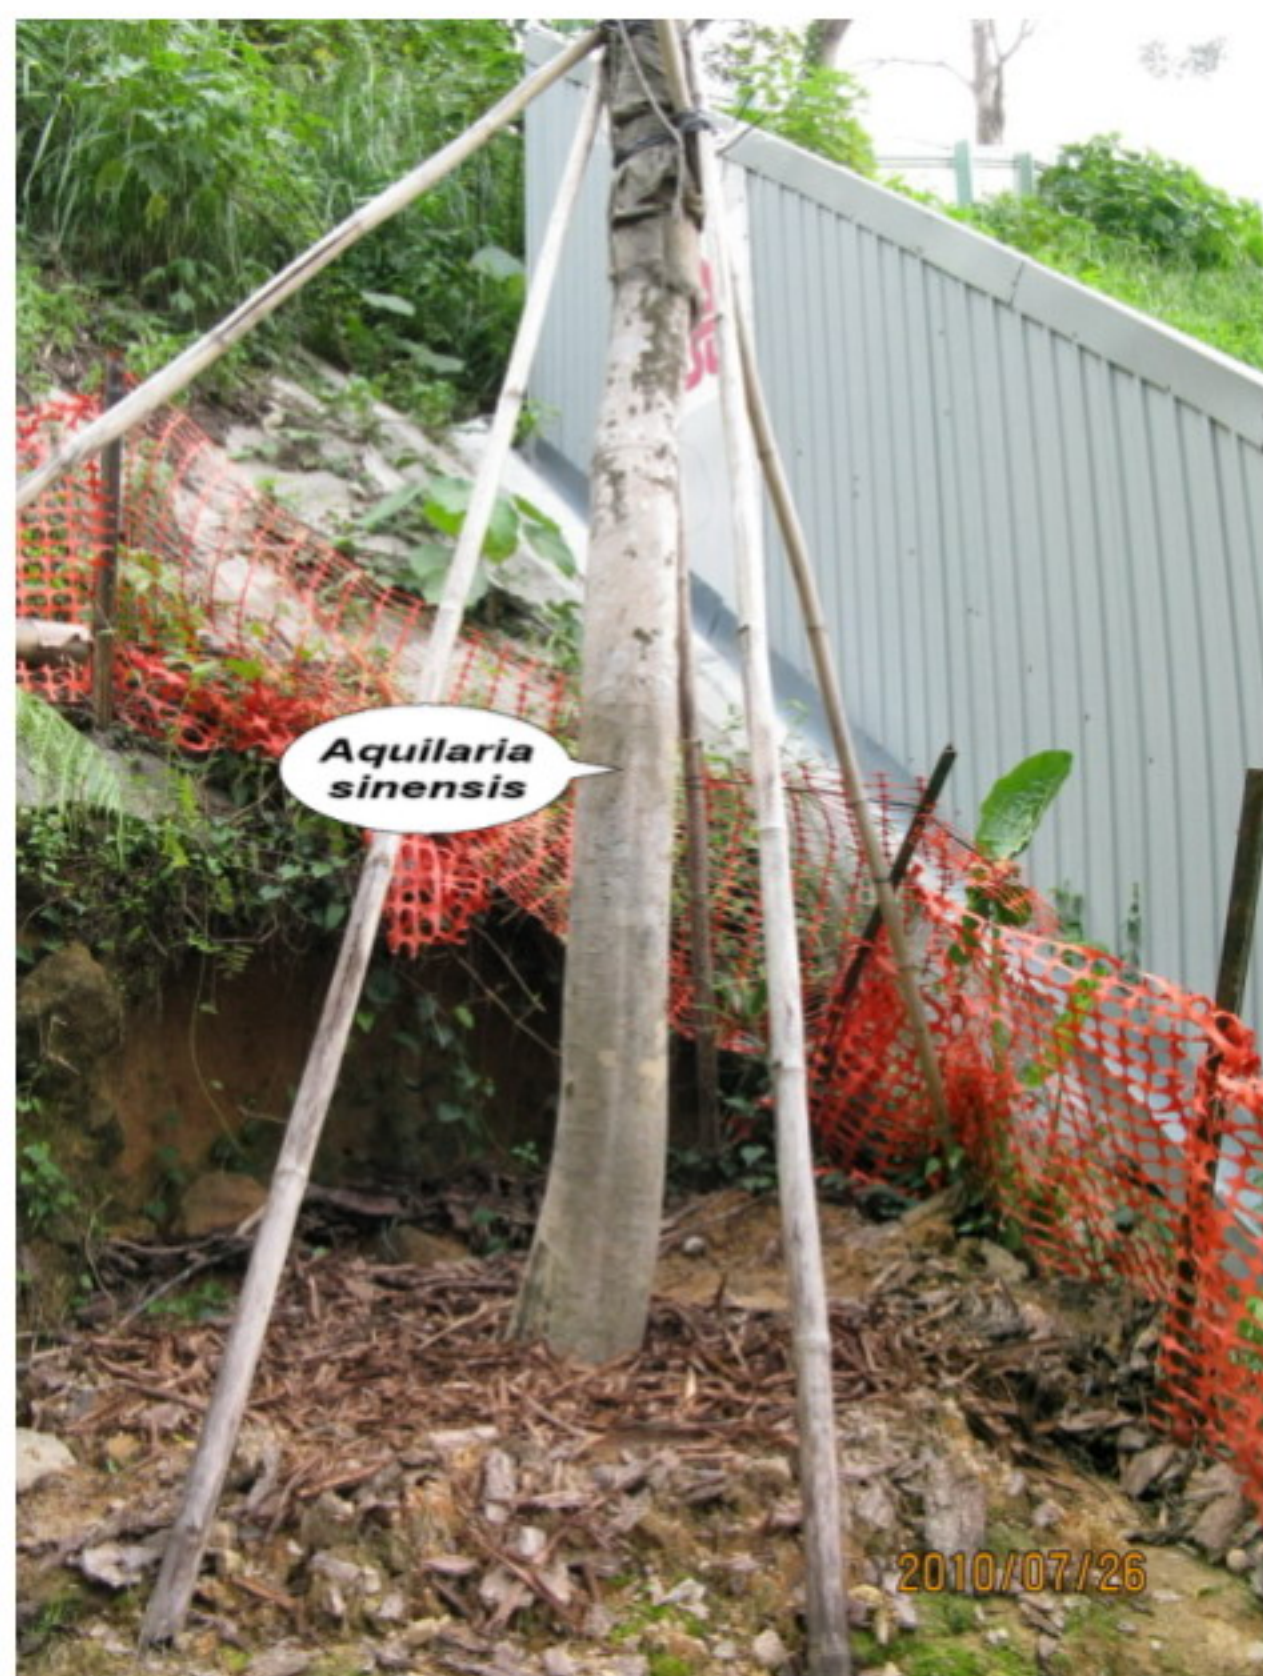
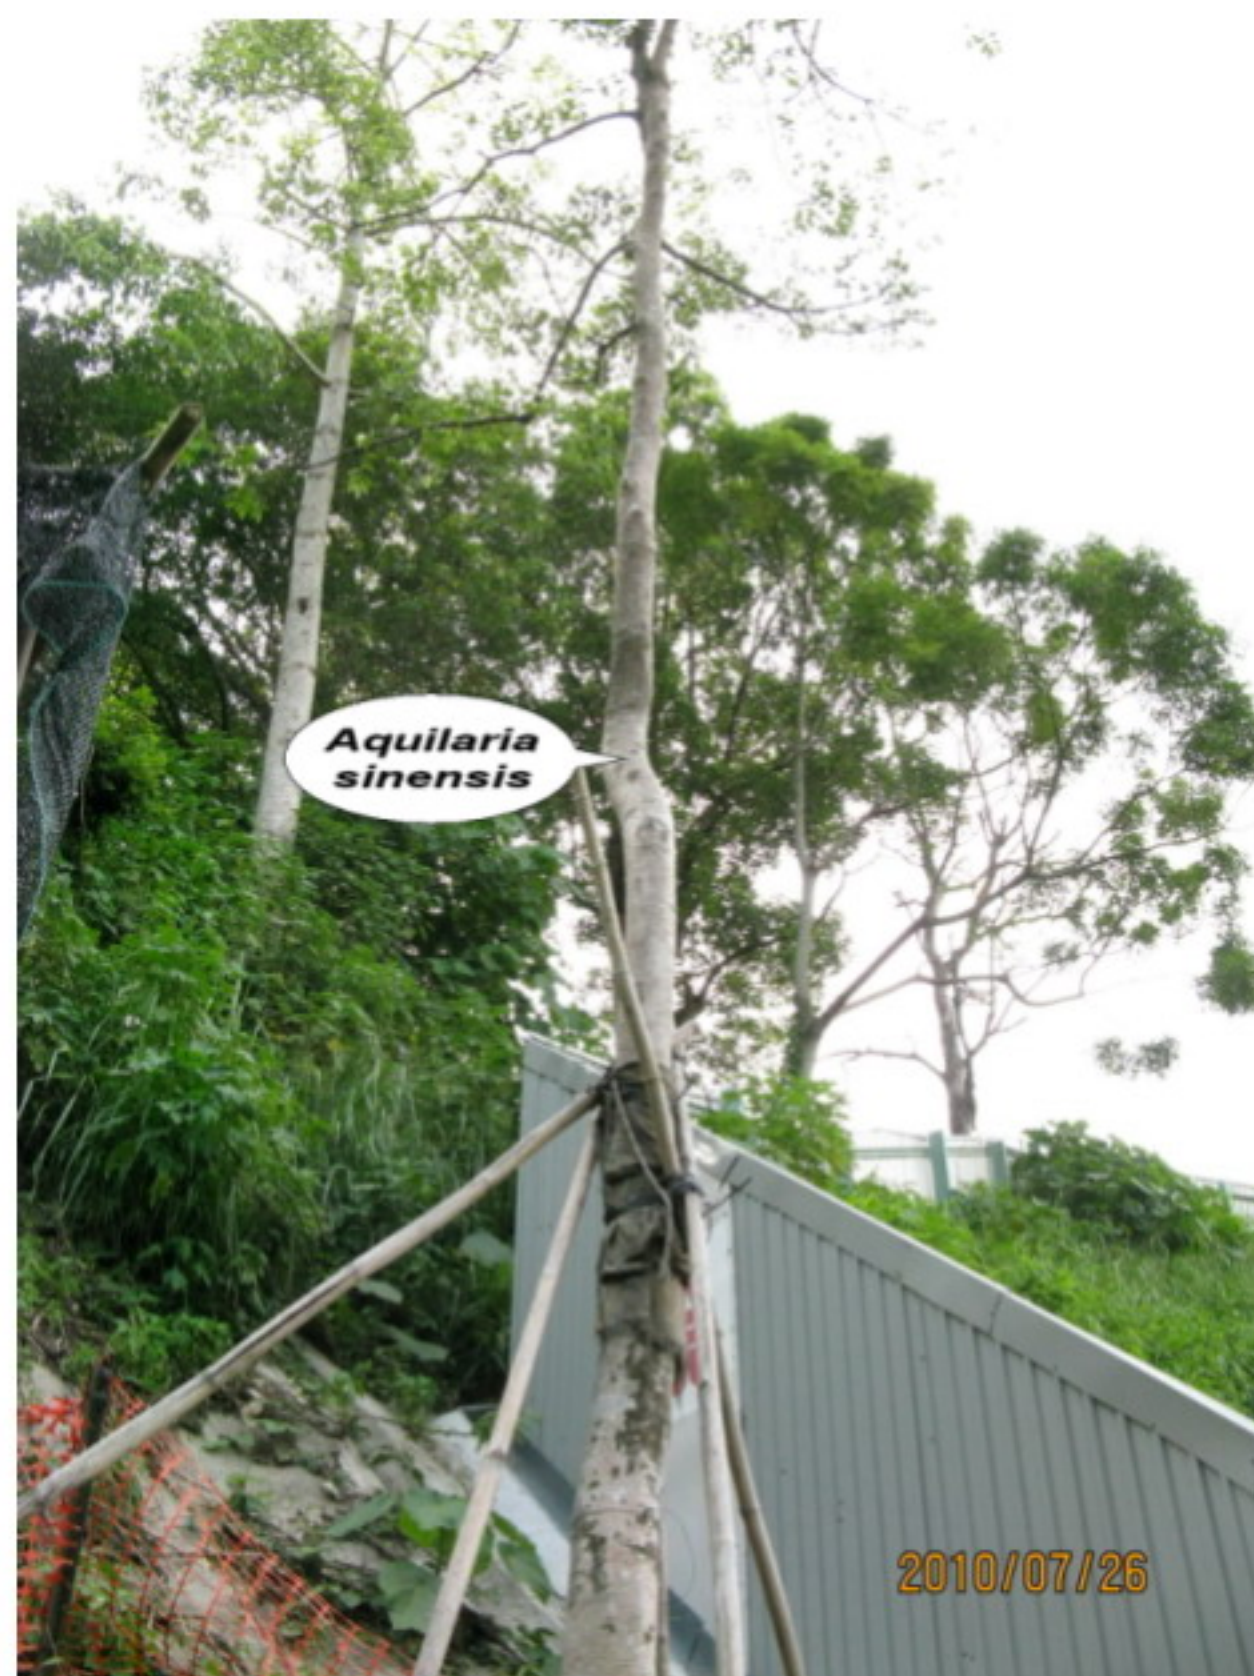
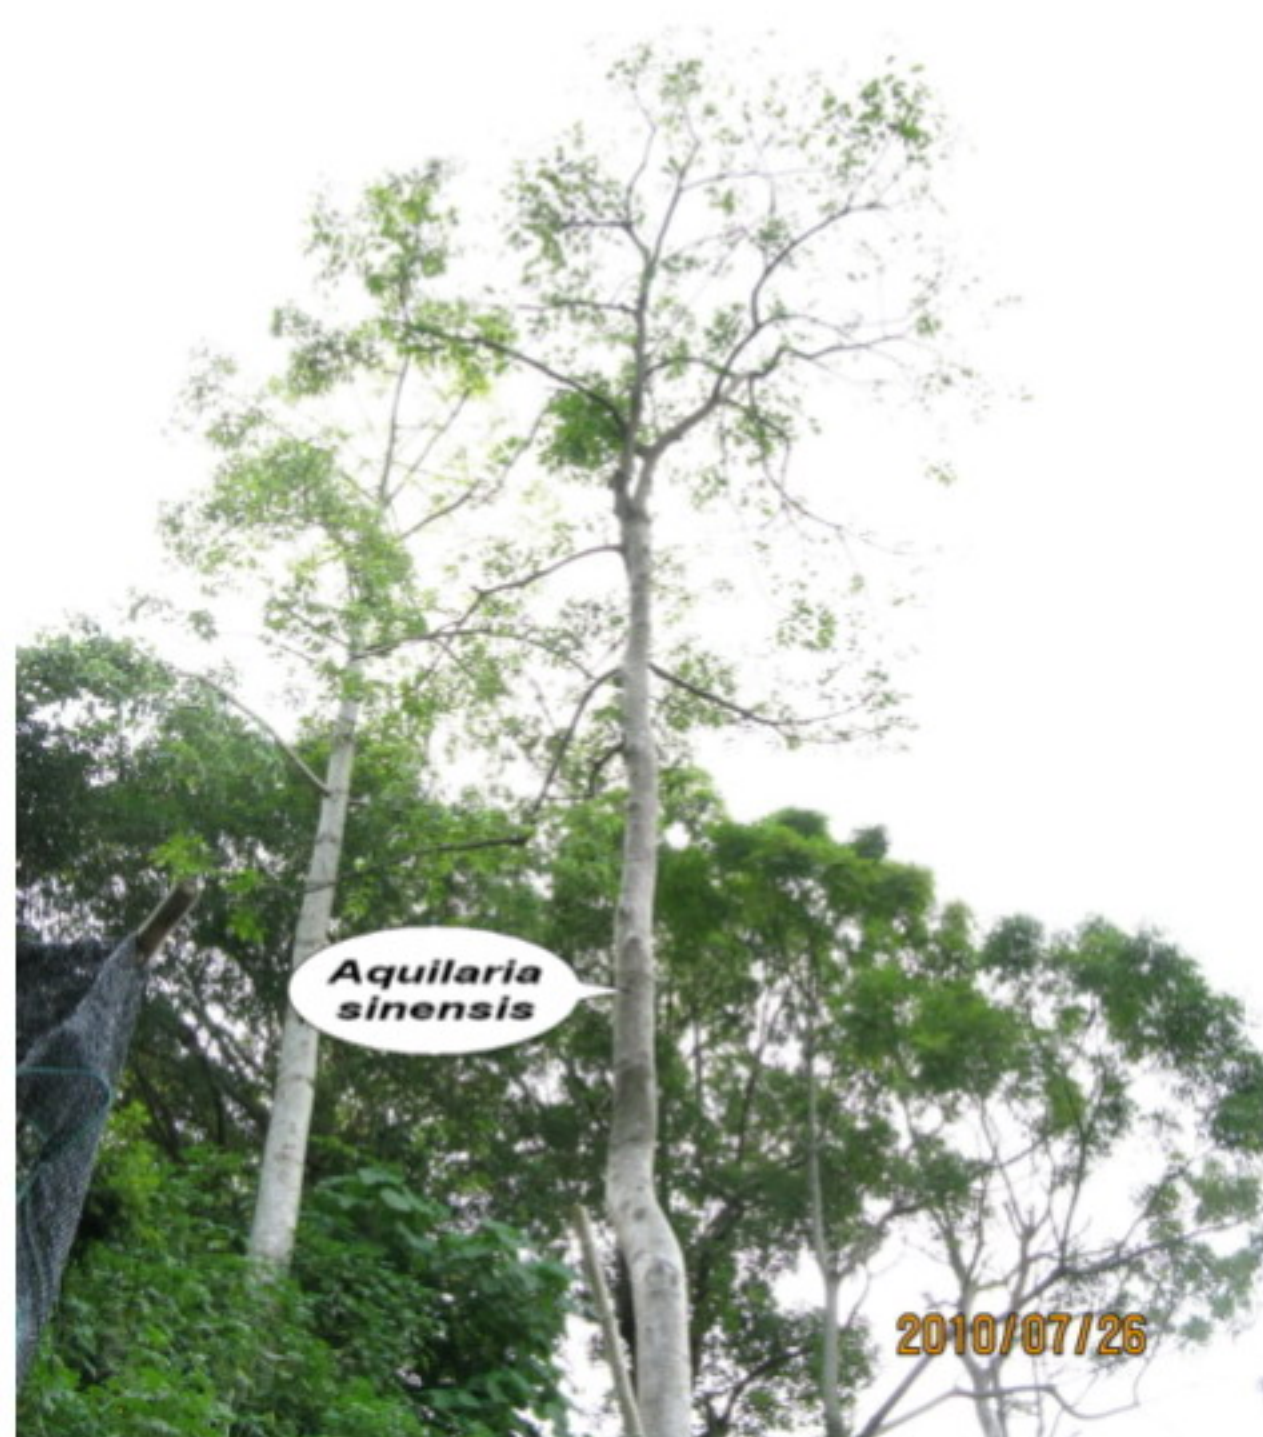
- 4.4 Tree tag was found lost on 3 monitoring trees. Non-tagging trees were labeled as “1”, “2” and “3” on the tree schedule.
- 4.5 The transplanted *Aquilaria sinensis* showed stress and deterioration in health condition as indicated by foliage color. Daily watering and closely monitoring is recommended.

| | | | | Remark |
|---|---|---|---|---|
| <i>Aquilaria sinensis</i> | 8 | 0.2 | 4 | Poor condition |

- 5.1 As the transplanted trees were not recovered from injury of root systems caused during transplantation operation, and the new roots are not regenerated yet. The trees are still under environmental stress at the reception sites. It is important to watering regularly. Close monitoring of the trees needs to be continued and relevant mitigation measures will be proposed when necessary.
- 5.2 The transplanted *Aquilaria sinensis* showed stress and deterioration in health condition as indicated by foliage color. Daily watering and closely monitoring is recommended.
- 5.3 Organic soil or composite organic enriched soil should be applied to each transplanted tree, approx. 20kg to 40kg per tree is recommended. On top of organic soil should covered with tree barks and 5kg to 20kg tree bark is recommended according to tree size.

In total, 38 tree species and one shrub species were recorded at the three transplantation receptor sites. The transplanted trees *Aquilaria sinensis* showed deterioration in health condition at transplanting receptor site “T1”. Daily watering and closely monitoring is recommended. Some trees have recorded as poor condition with no leave attached on tree crown at the transplanting receptor “T3” site. Regular watering, apply organic soil, tree bark and closely monitoring was recommended.

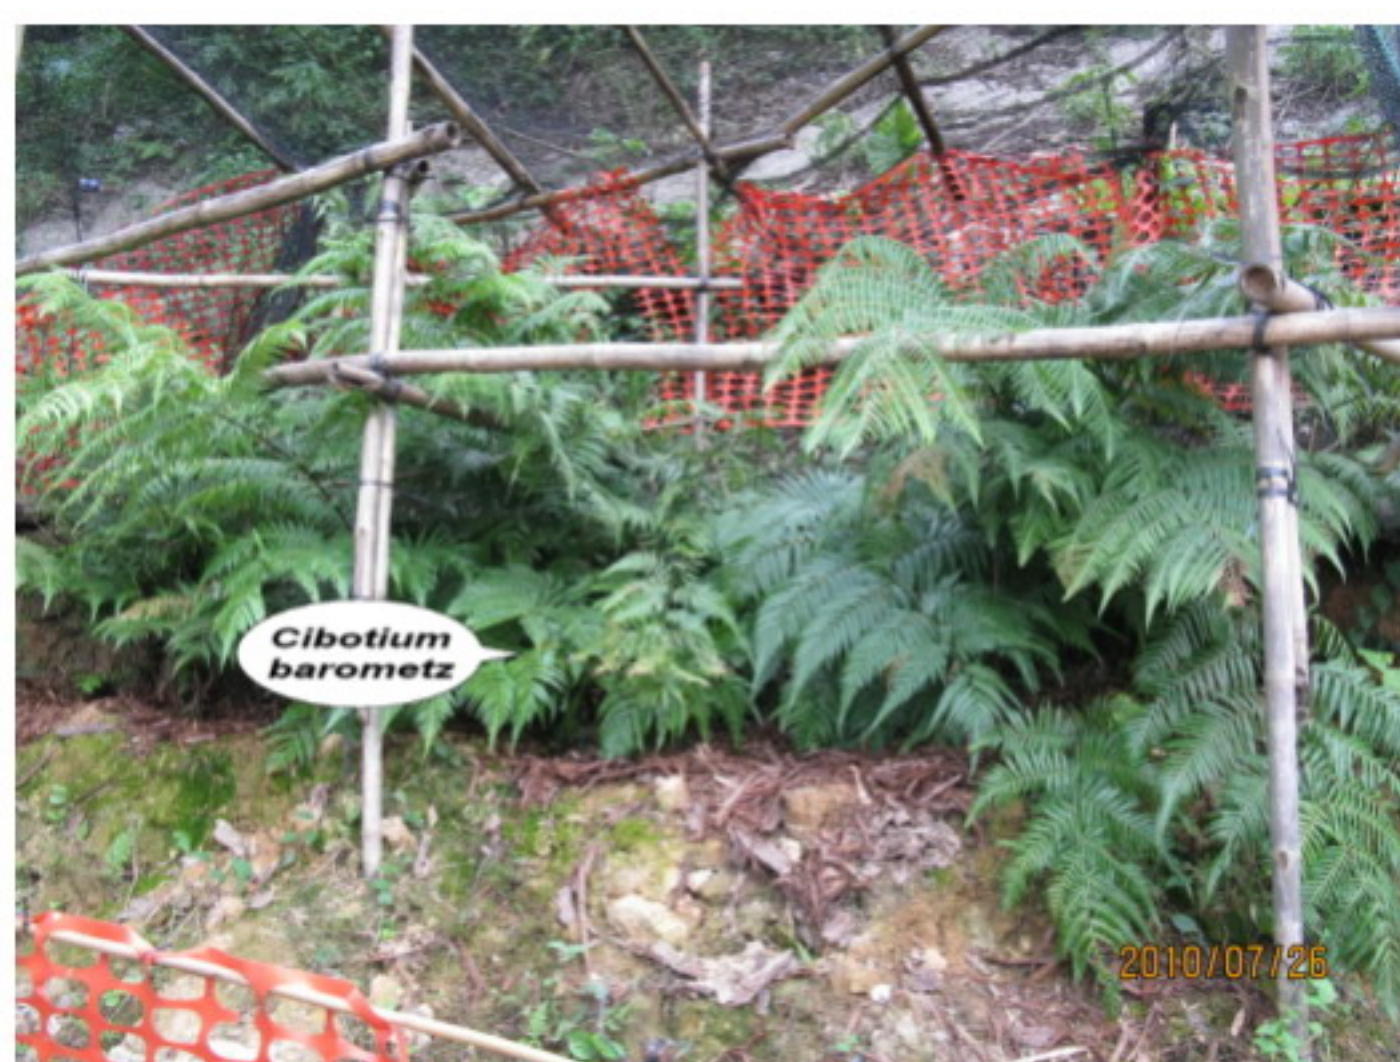
*Cibotium barometz*

| | | | | Remark |
|---|---|---|---|---|
| <i>Cibotium barometz</i> | 1 | -- | -- | Fair condition |

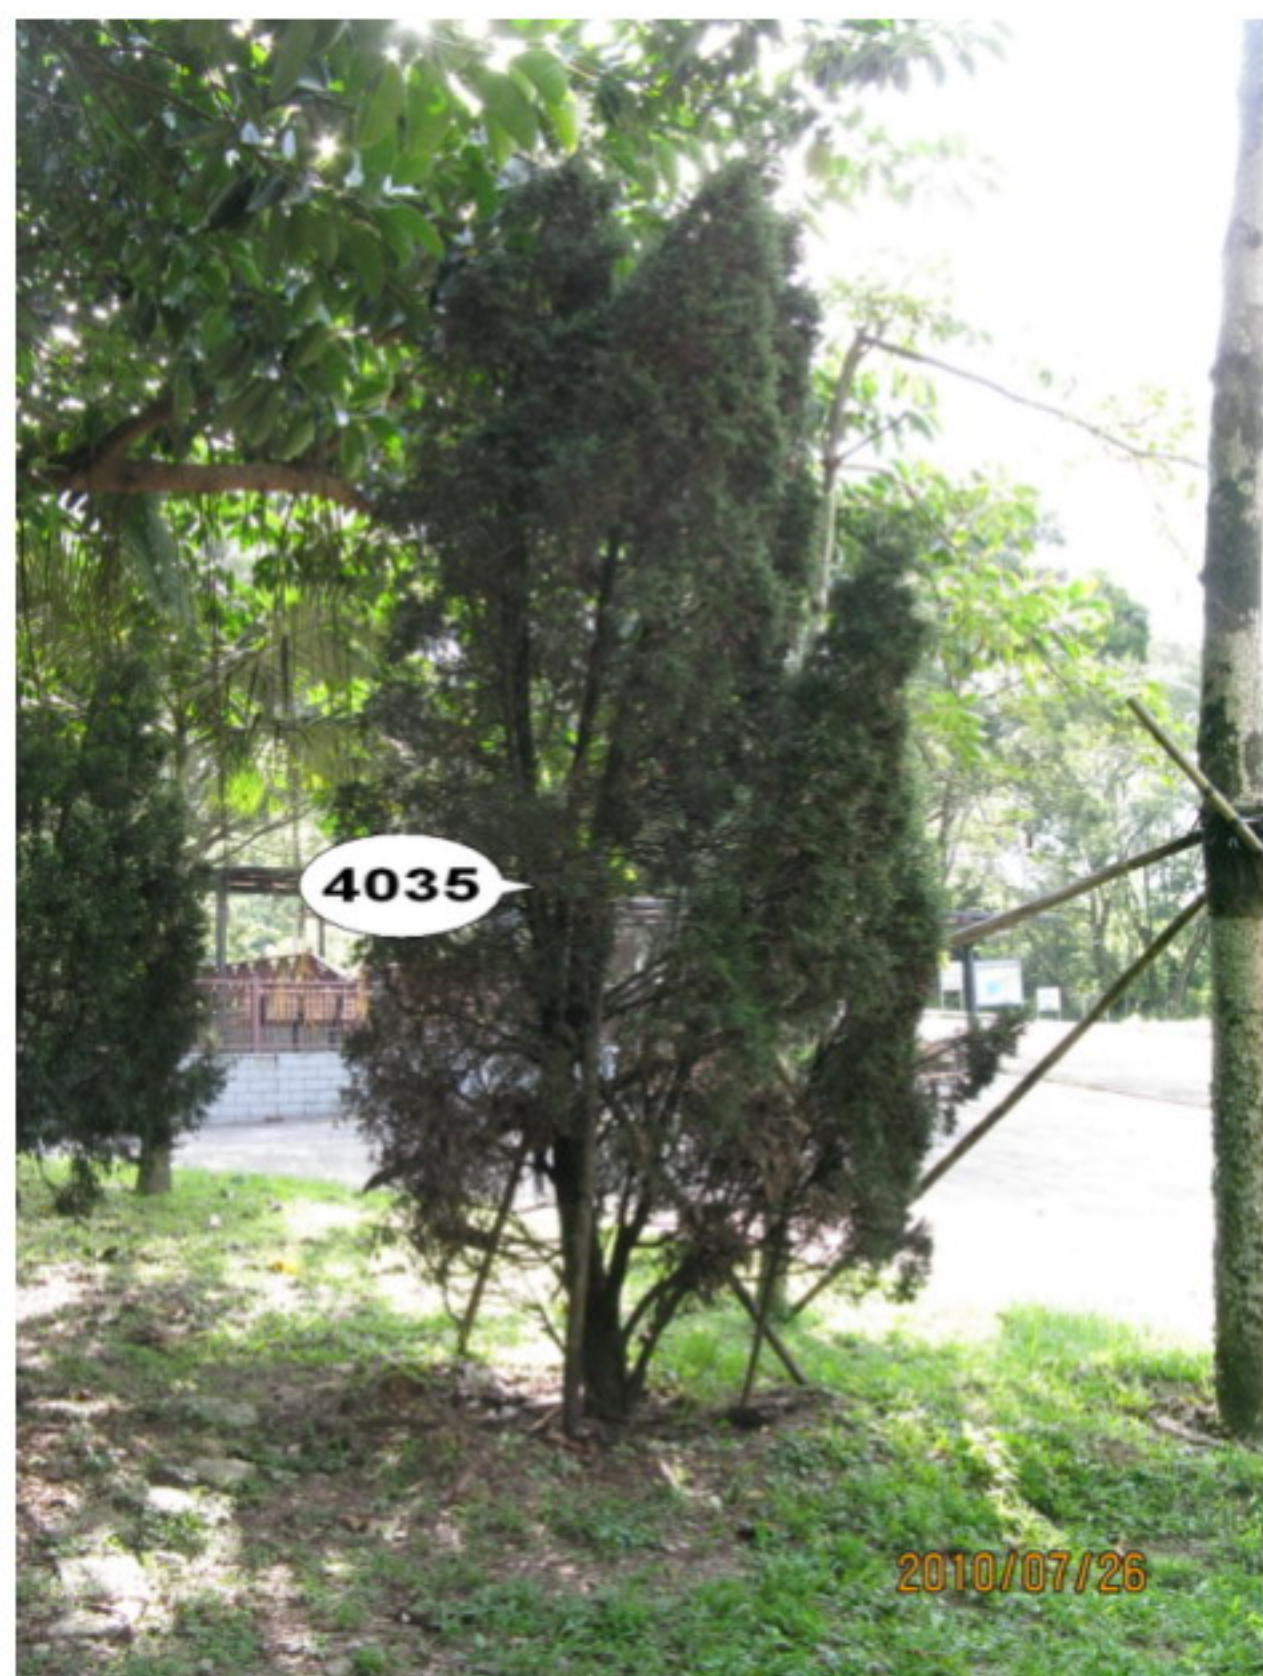
Tree No: 4035

| | | | | | | Remark |
|---|---|---|---|---|---|---|
| 4035 | <i>Juniperus chinensis var.kaizuca</i> | 龍柏 | 4 | 0.16 | 2 | Fair condition |

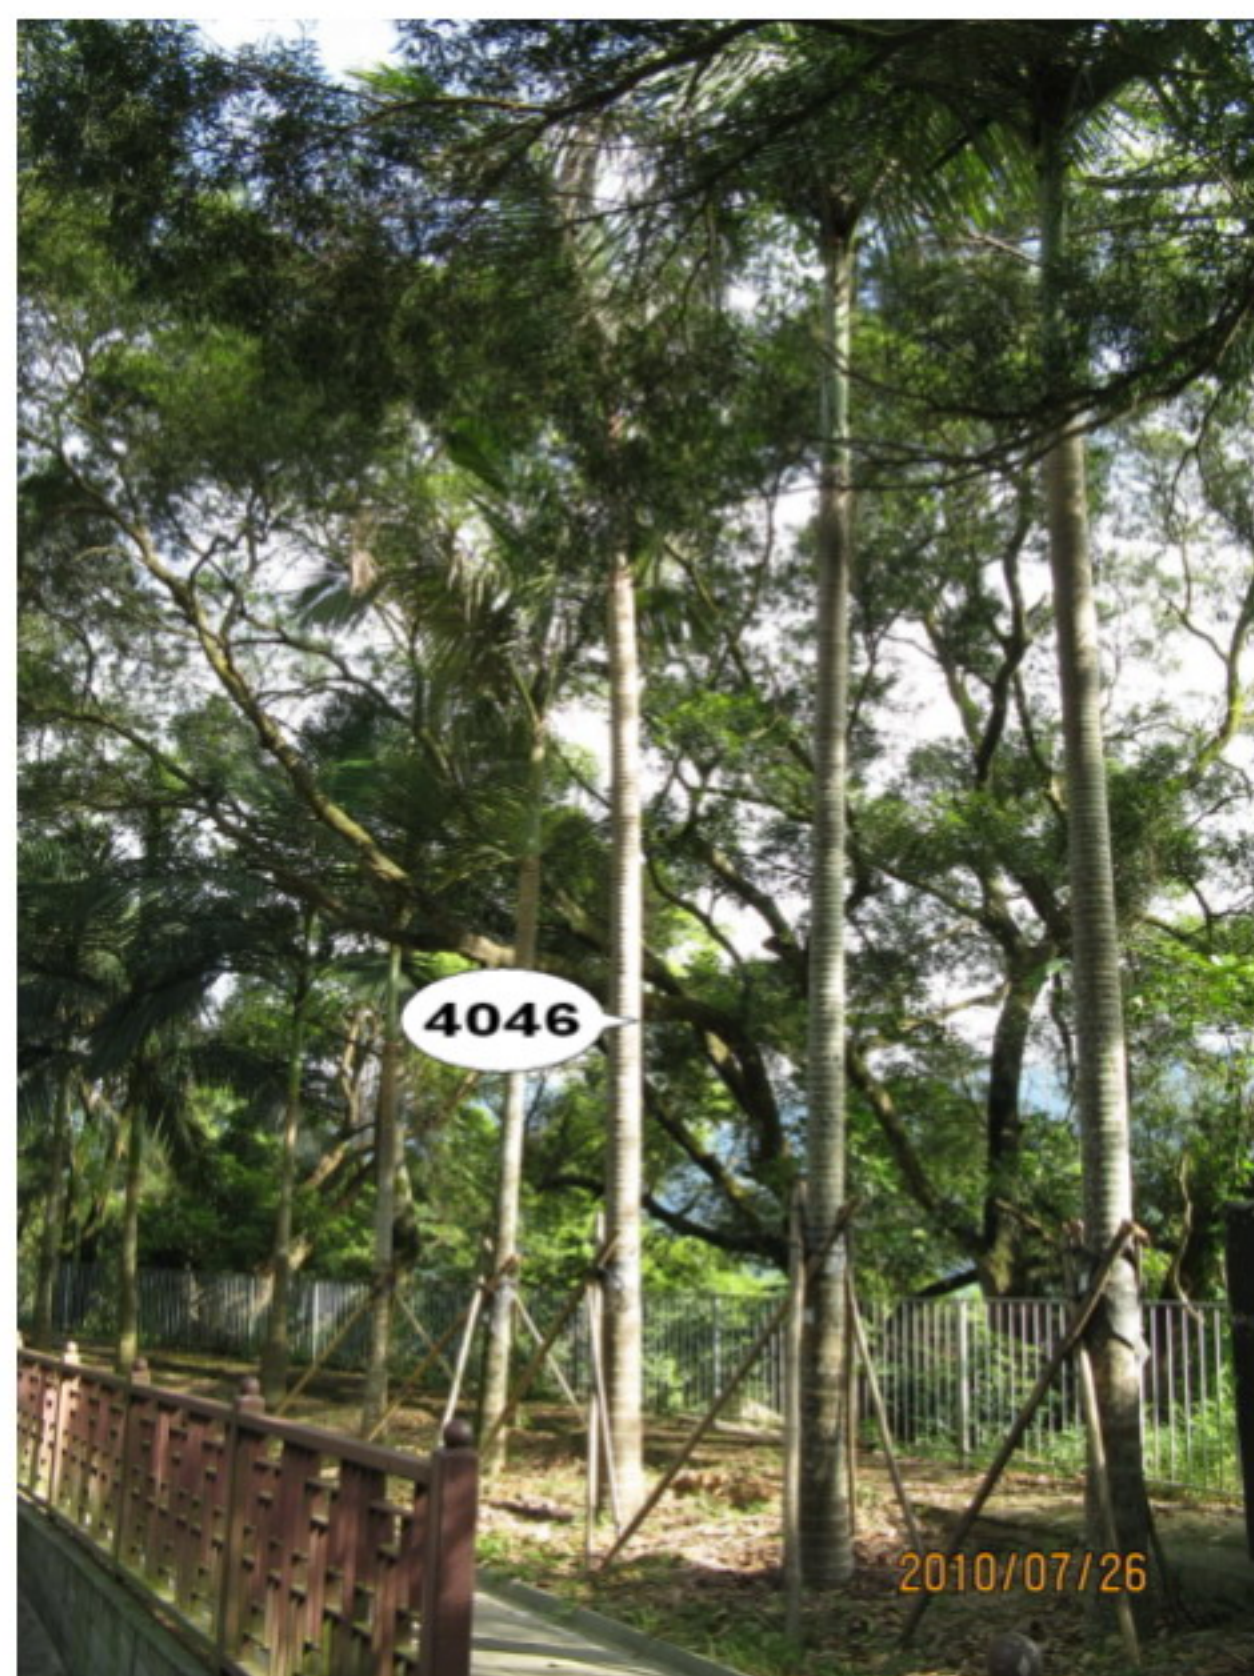
Tree No: 4046

| | | | | | | Remark |
|---|---|---|---|---|---|---|
| 4046 | <i>Archontophoenix alexandrae</i> | 假檳榔 | 5 | 0.19 | 4 | Poor condition, Yellow leave |

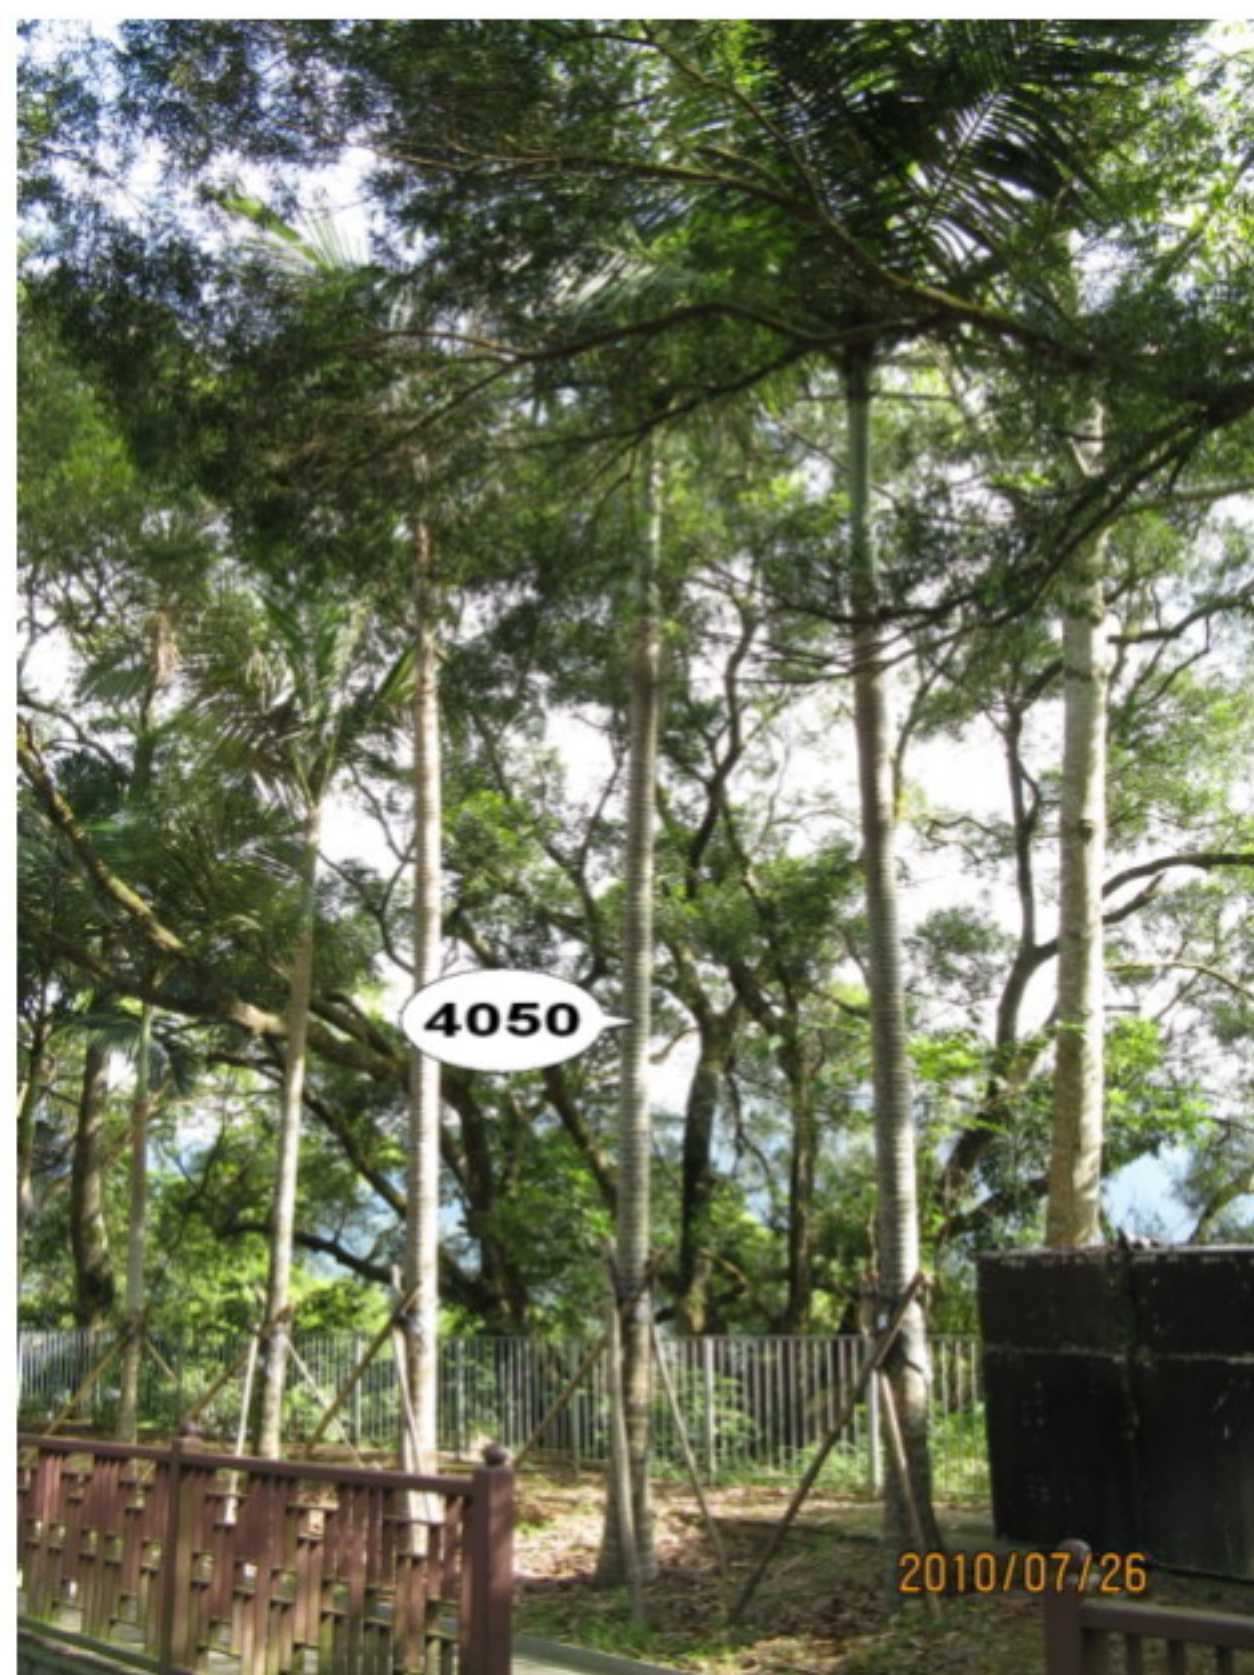
Tree No: 4050

| | | | | | | Remark |
|---|---|---|---|---|---|---|
| 4050 | <i>Archontophoenix alexandrae</i> | 假檳榔 | 5 | 0.16 | 4 | Fair condition, Yellow leave |

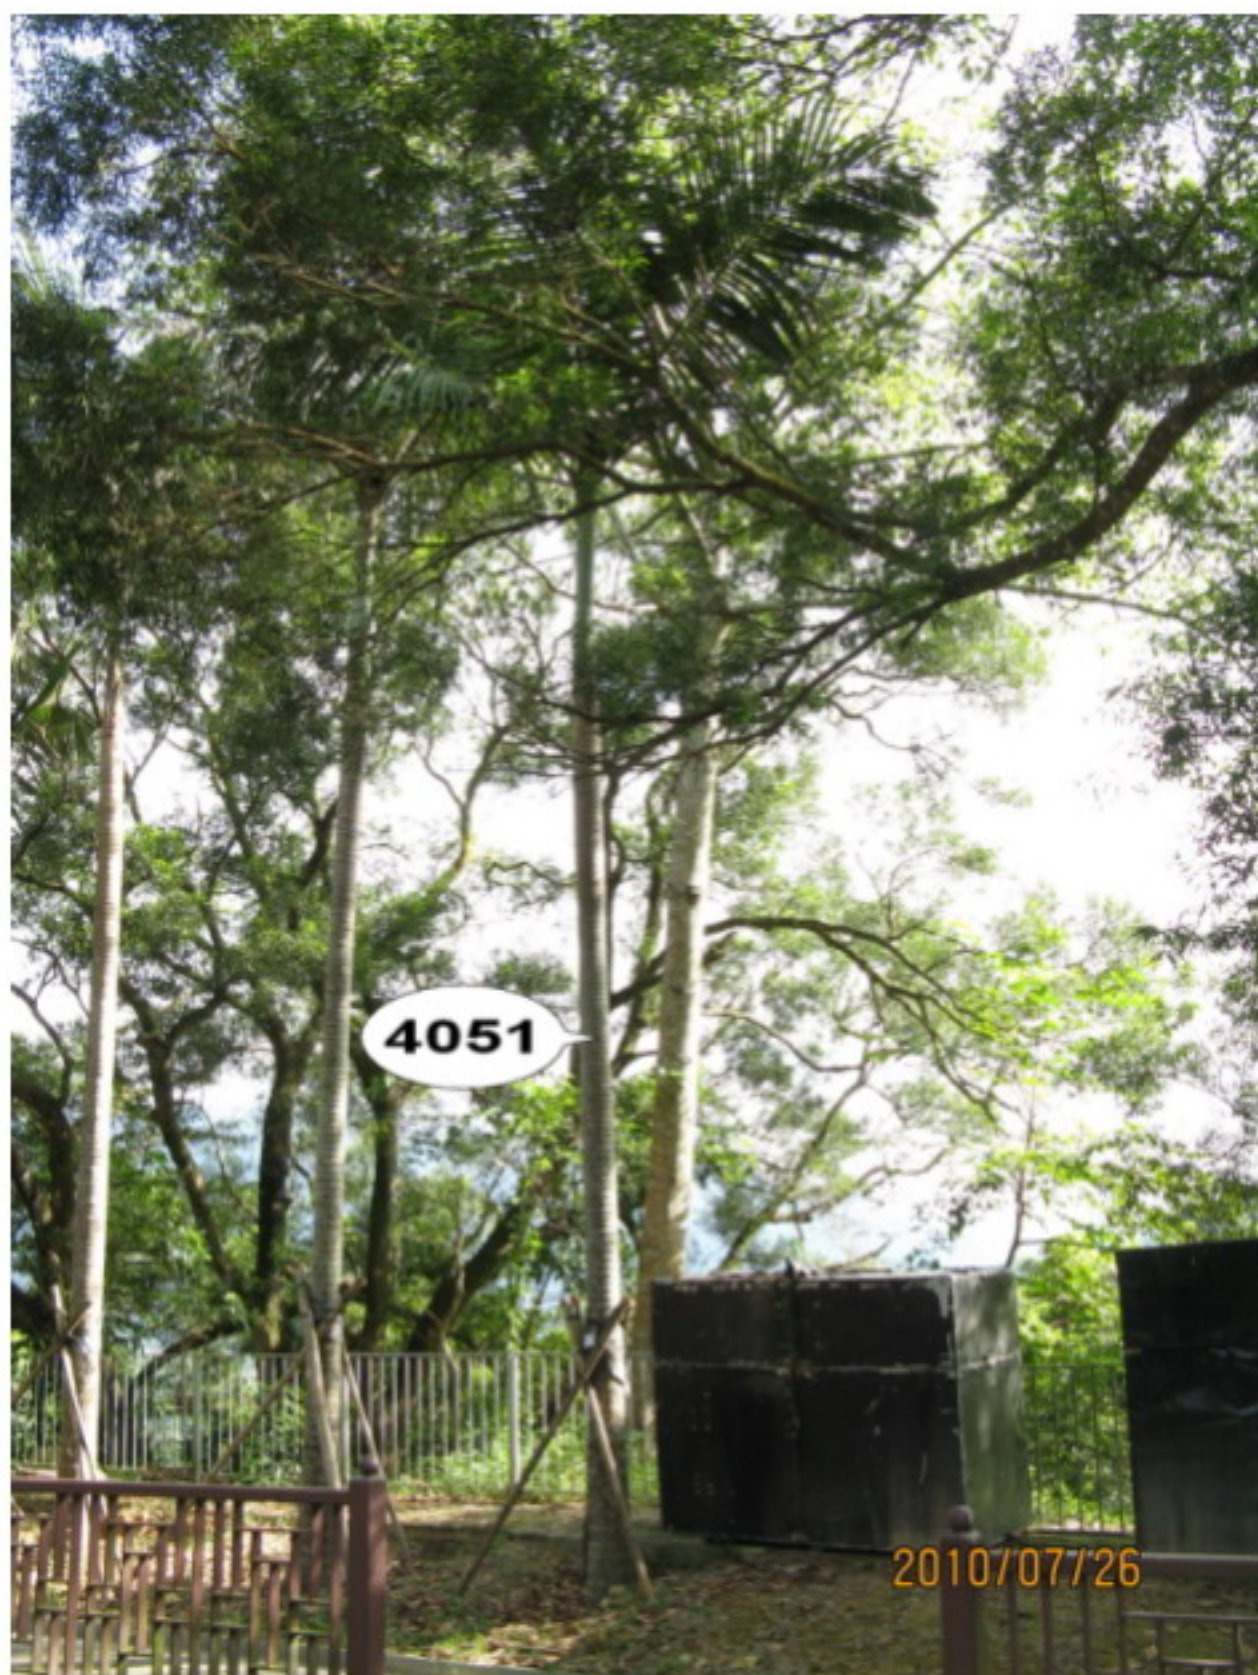
Tree No: 4051

| | | | | | | Remark |
|---|---|---|---|---|---|---|
| 4051 | <i>Archontophoenix alexandrae</i> | 假檳榔 | 5 | 0.18 | 3 | Fair condition, Yellow leave |

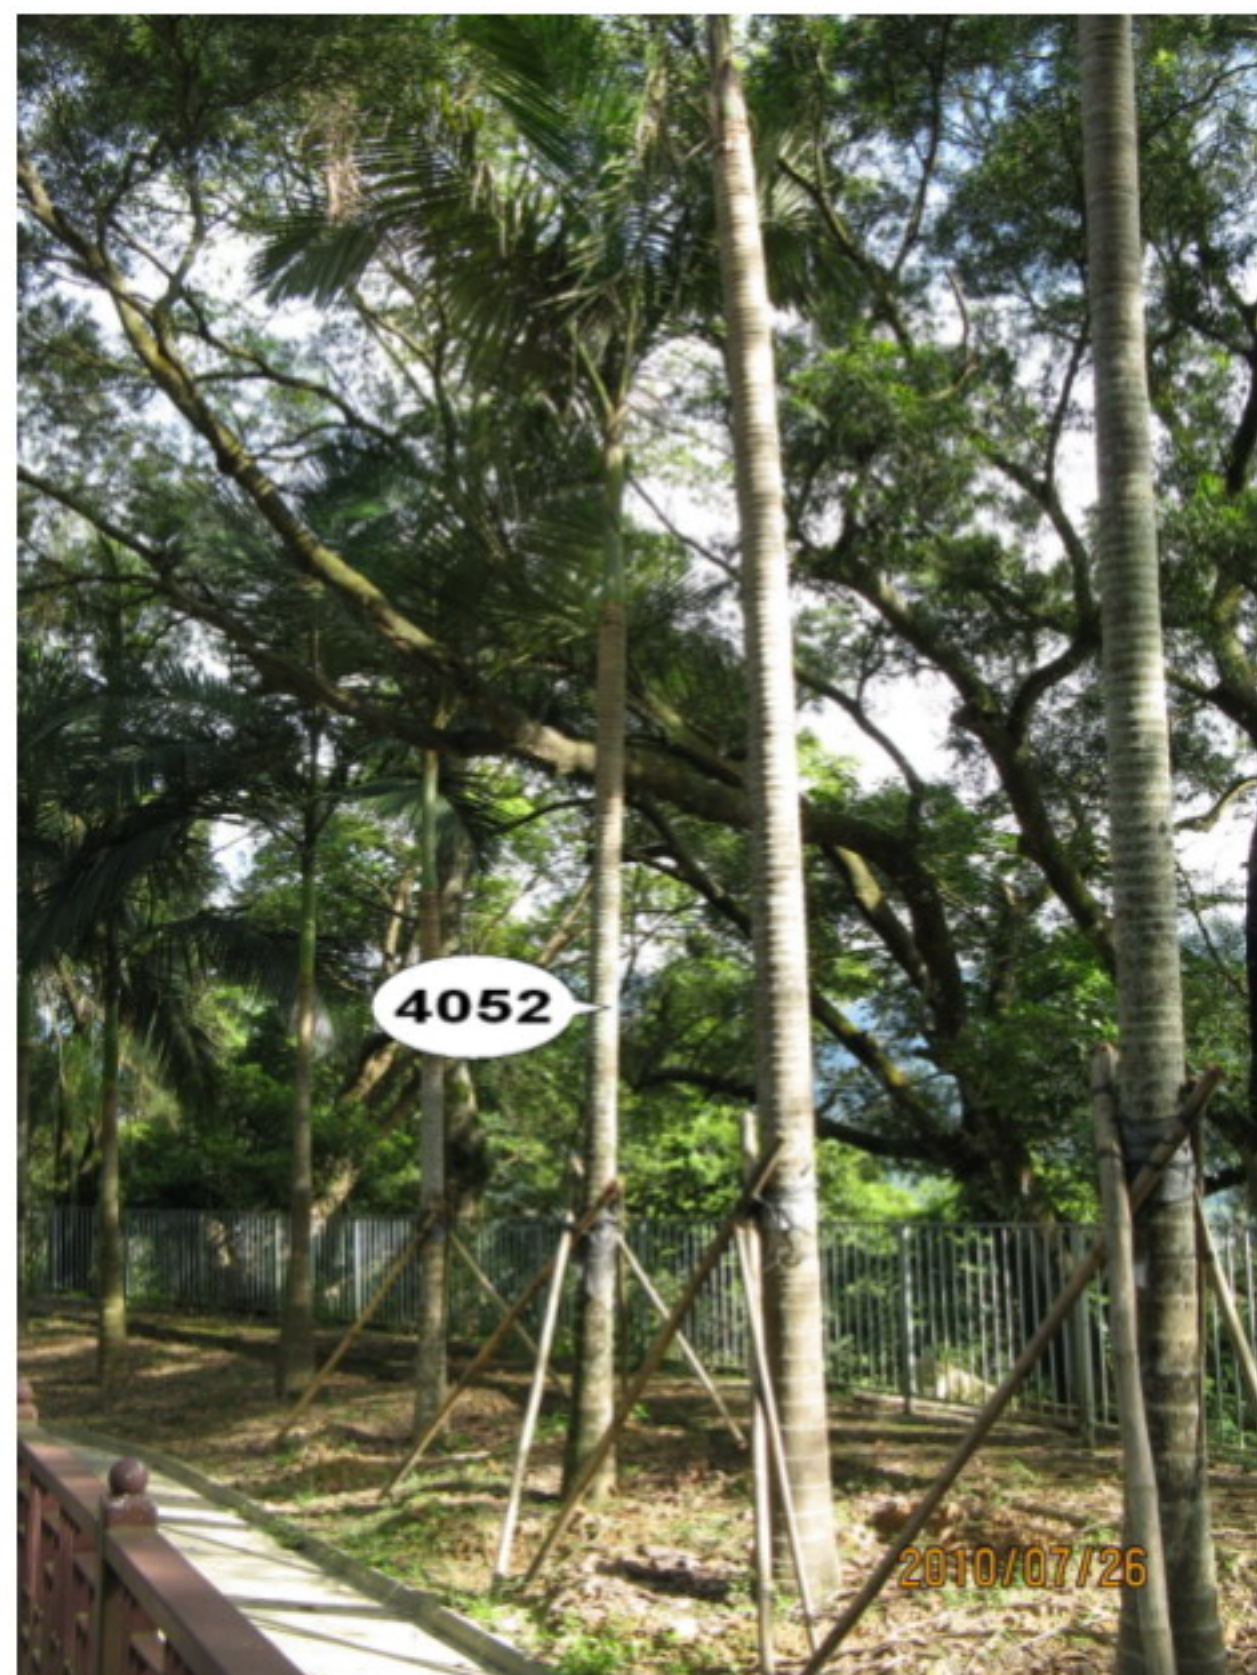
Tree No: 4052

| | | | | | | Remark |
|---|---|---|---|---|---|---|
| 4052 | <i>Archontophoenix alexandrae</i> | 假檳榔 | 5 | 0.17 | 3 | Fair condition, Yellow leave |

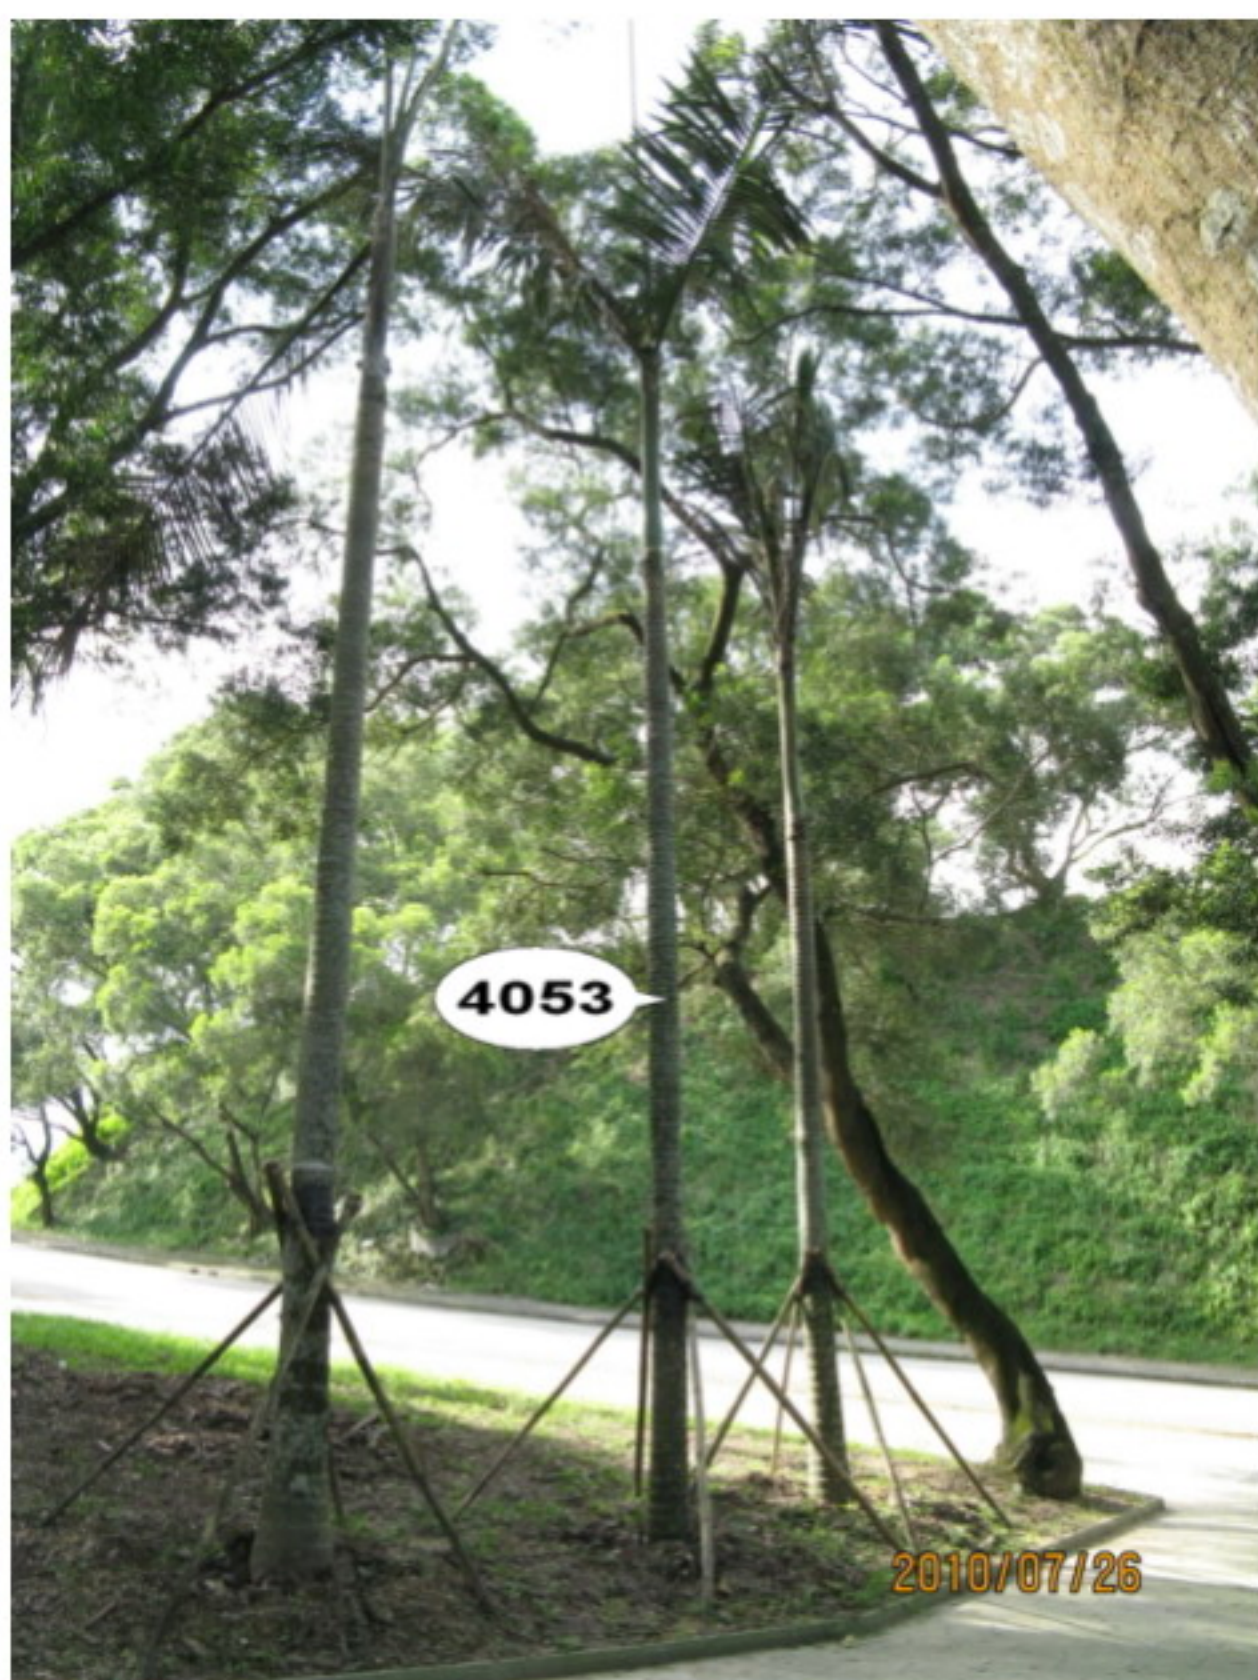
Tree No: 4053

| | | | | | | Remark |
|---|---|---|---|---|---|---|
| 4053 | <i>Archontophoenix alexandrae</i> | 假檳榔 | 4 | 0.2 | 3 | Fair condition, Yellow leave |

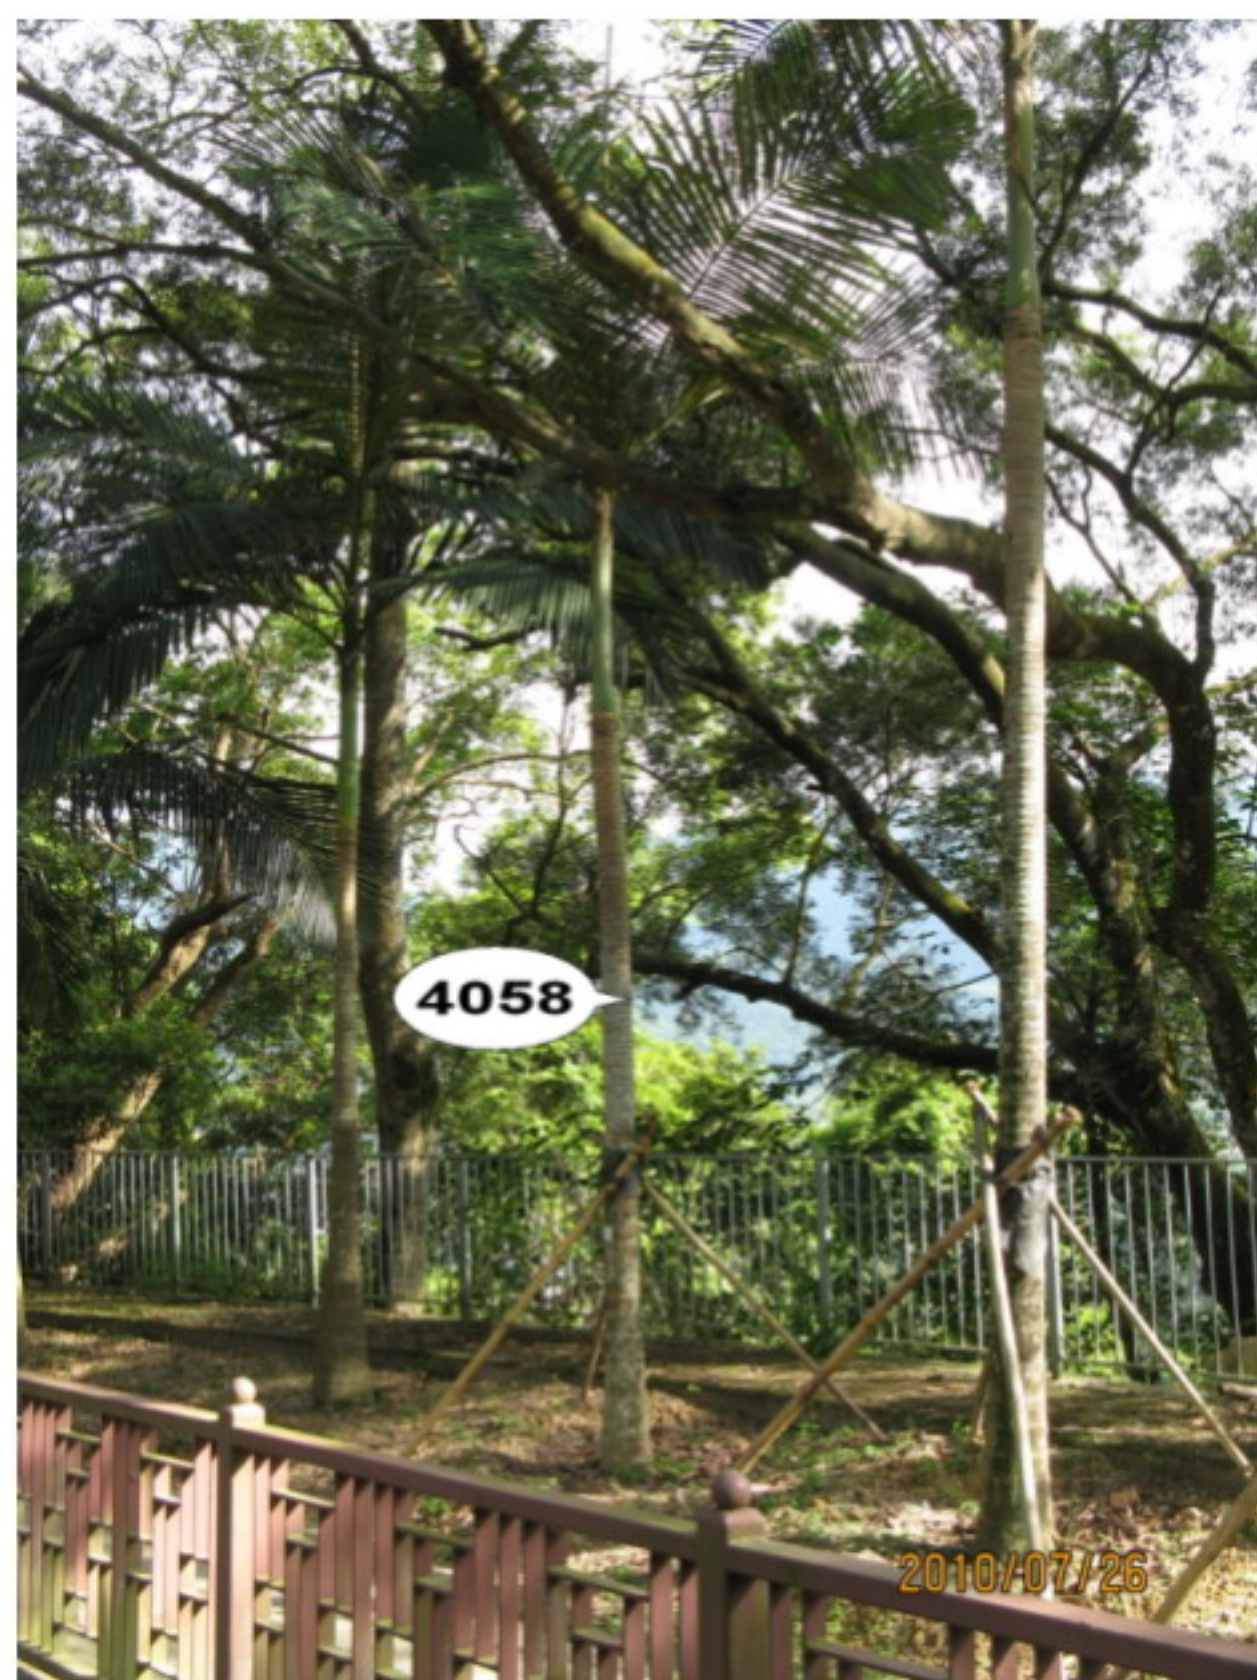
Tree No: 4058

| | | | | | | Remark |
|---|---|---|---|---|---|---|
| 4058 | <i>Archontophoenix alexandrae</i> | 假檳榔 | 4 | 0.15 | 3 | Fair condition, Yellow leave |
