**PROVISION OF CREMATORS AT  
WO HOP SHEK CREMATORIUM**

**ENVIRONMENTAL MONITORING &  
AUDIT REPORT (JULY 2010)**

Quotation Contract No. 9/2009/AB1  
Provision of Cremators at Wo Hop Shek Crematorium - Independent Environmental Checker Service  
Monthly EM&A Report (July 2010)

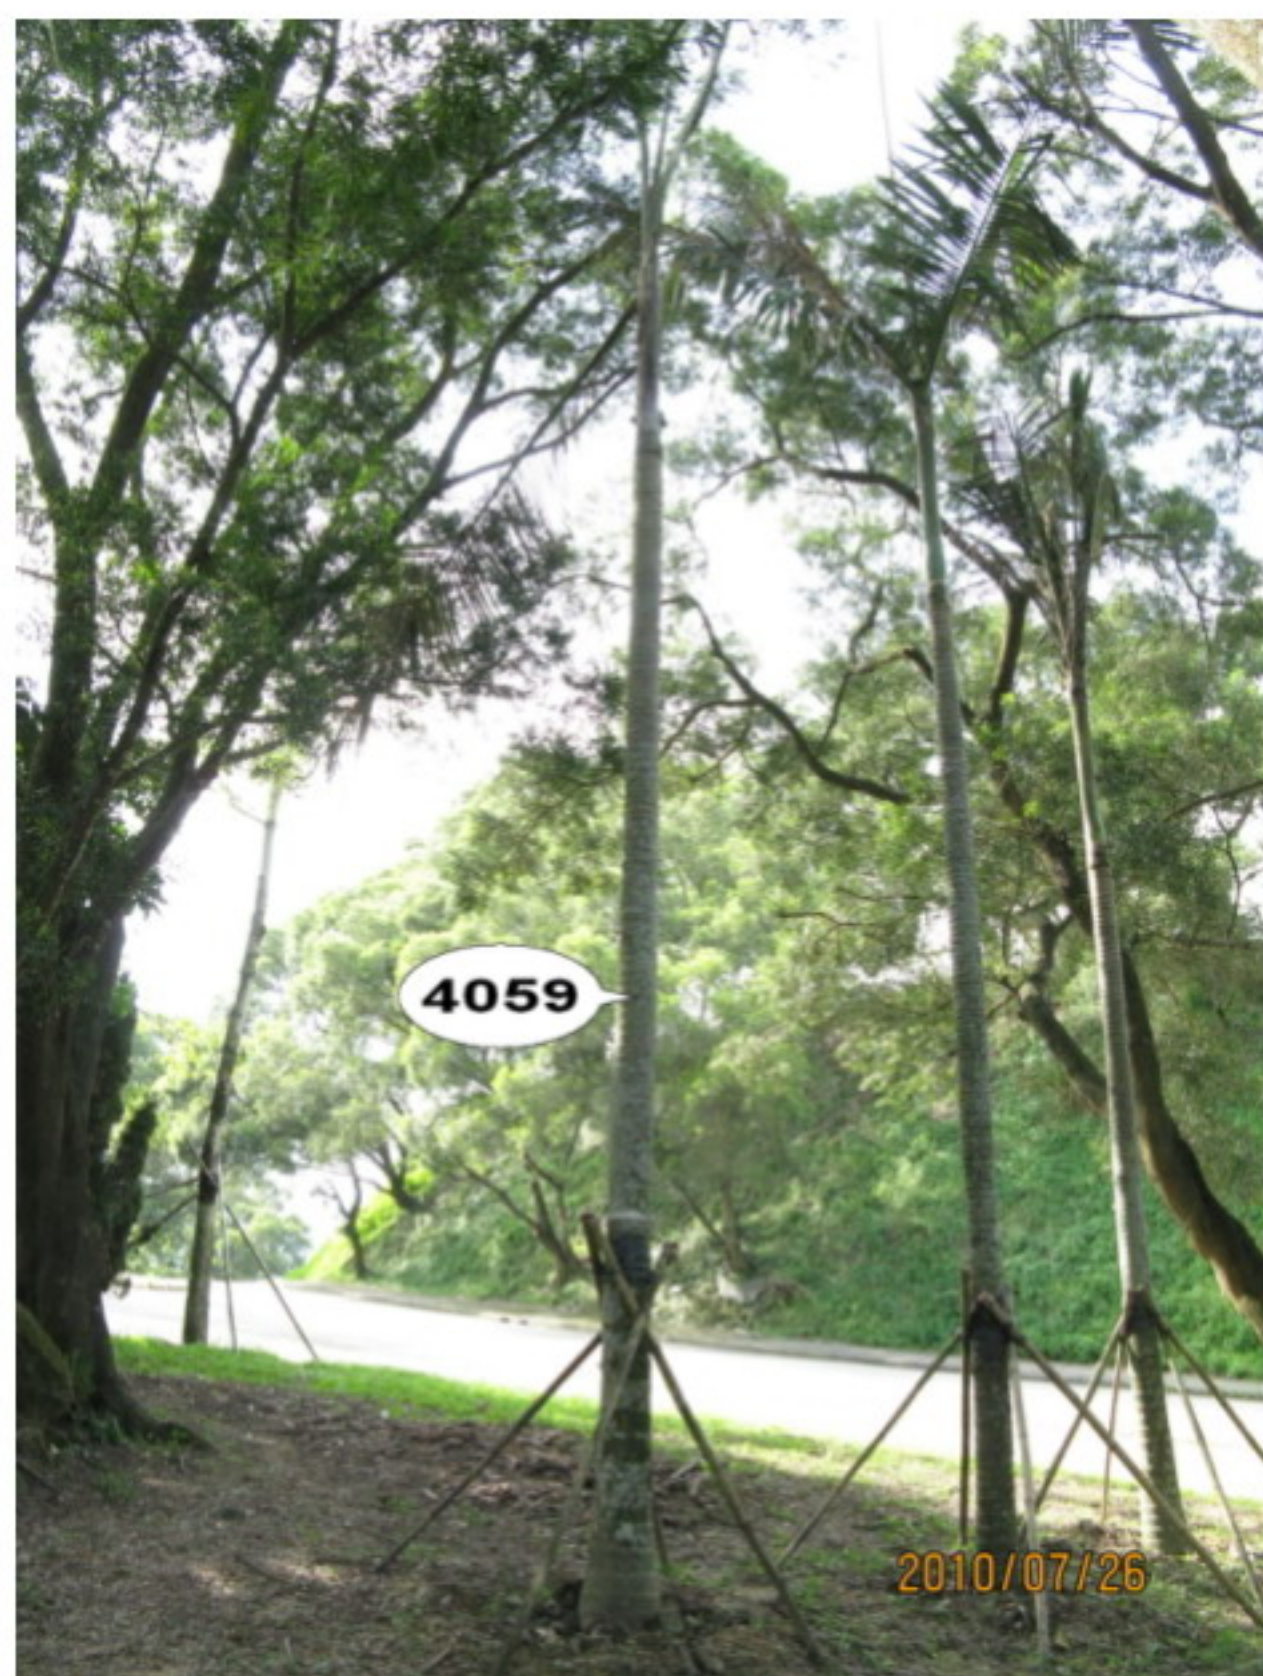
Tree No: 4059

| | | | | | | Remark |
|---|---|---|---|---|---|---|
| 4059 | <i>Archontophoenix alexandrae</i> | 假檳榔 | 6 | 0.23 | 4 | Poor condition, Yellow leave |

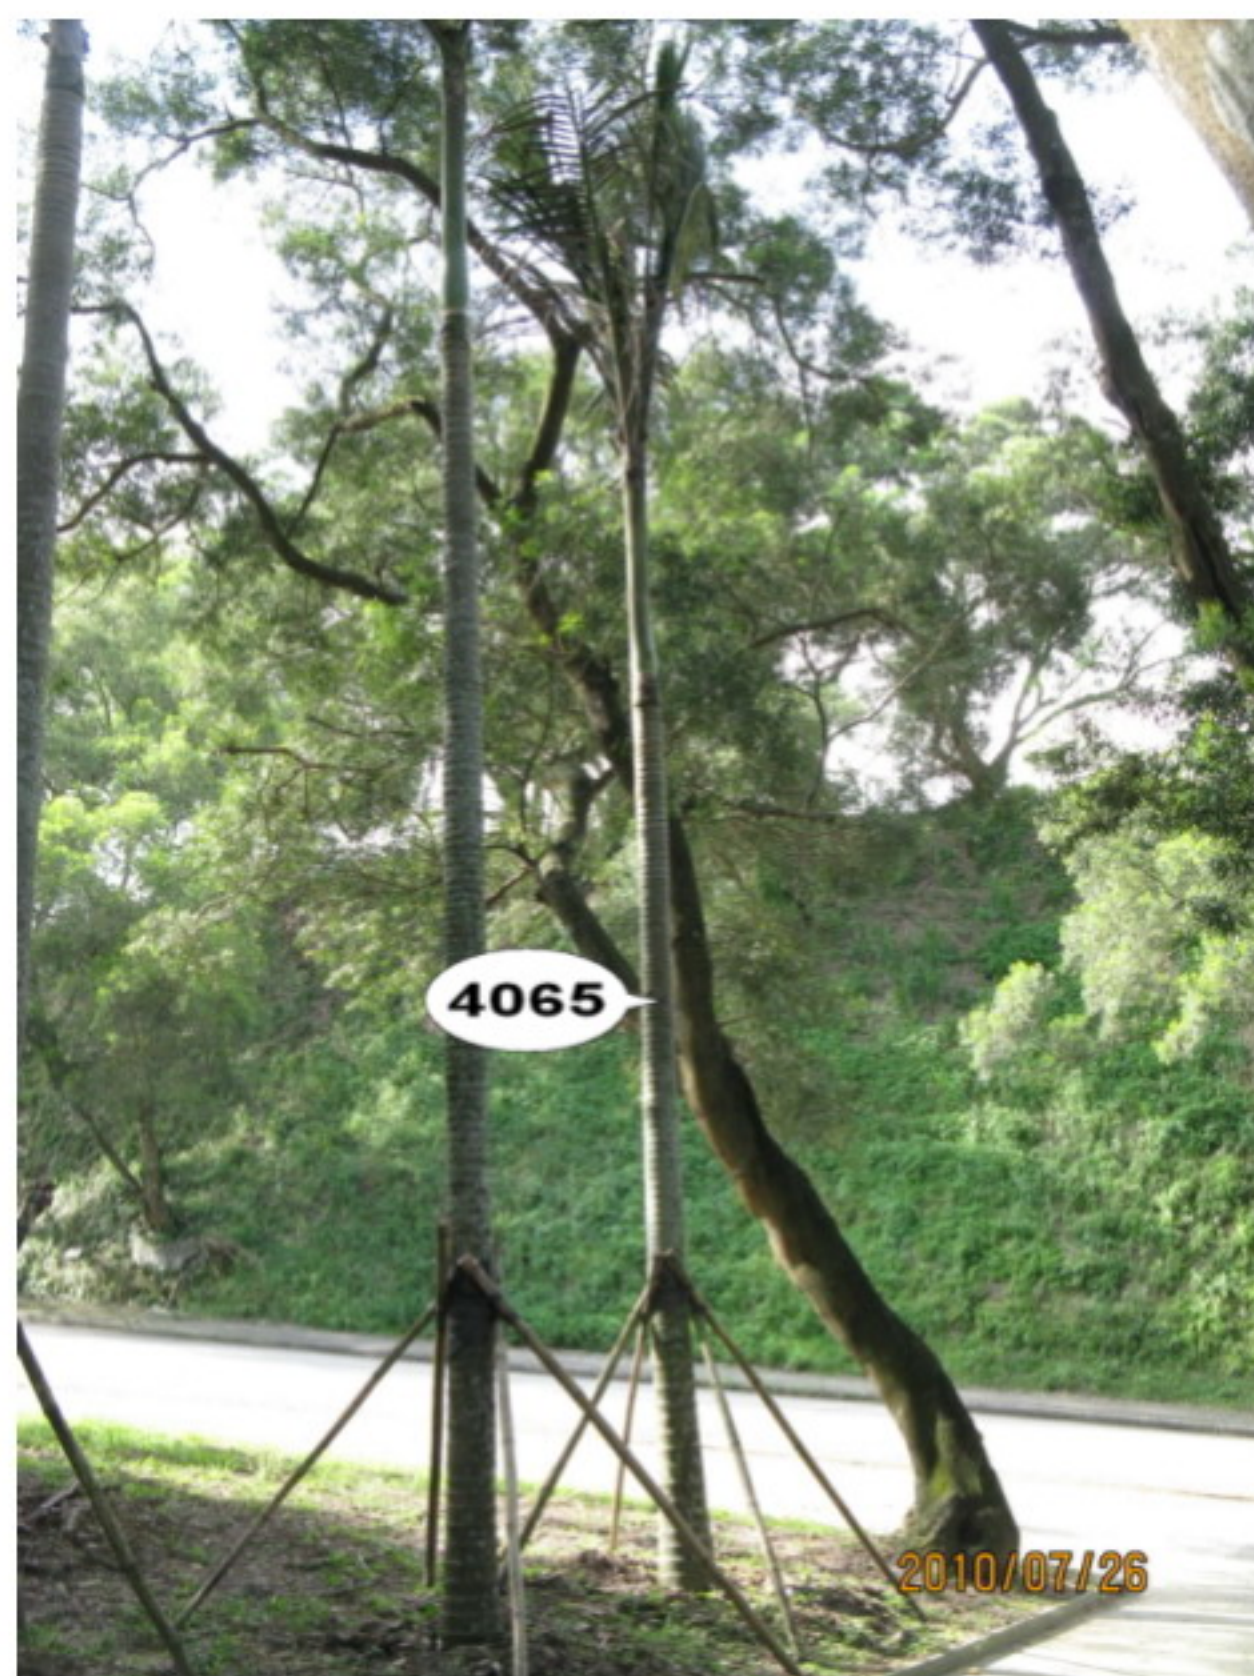
Tree No: 4065

| | | | | | | Remark |
|---|---|---|---|---|---|---|
| 4065 | <i>Archontophoenix alexandrae</i> | 假檳榔 | 7 | 0.21 | 4 | Fair condition, Yellow leave |

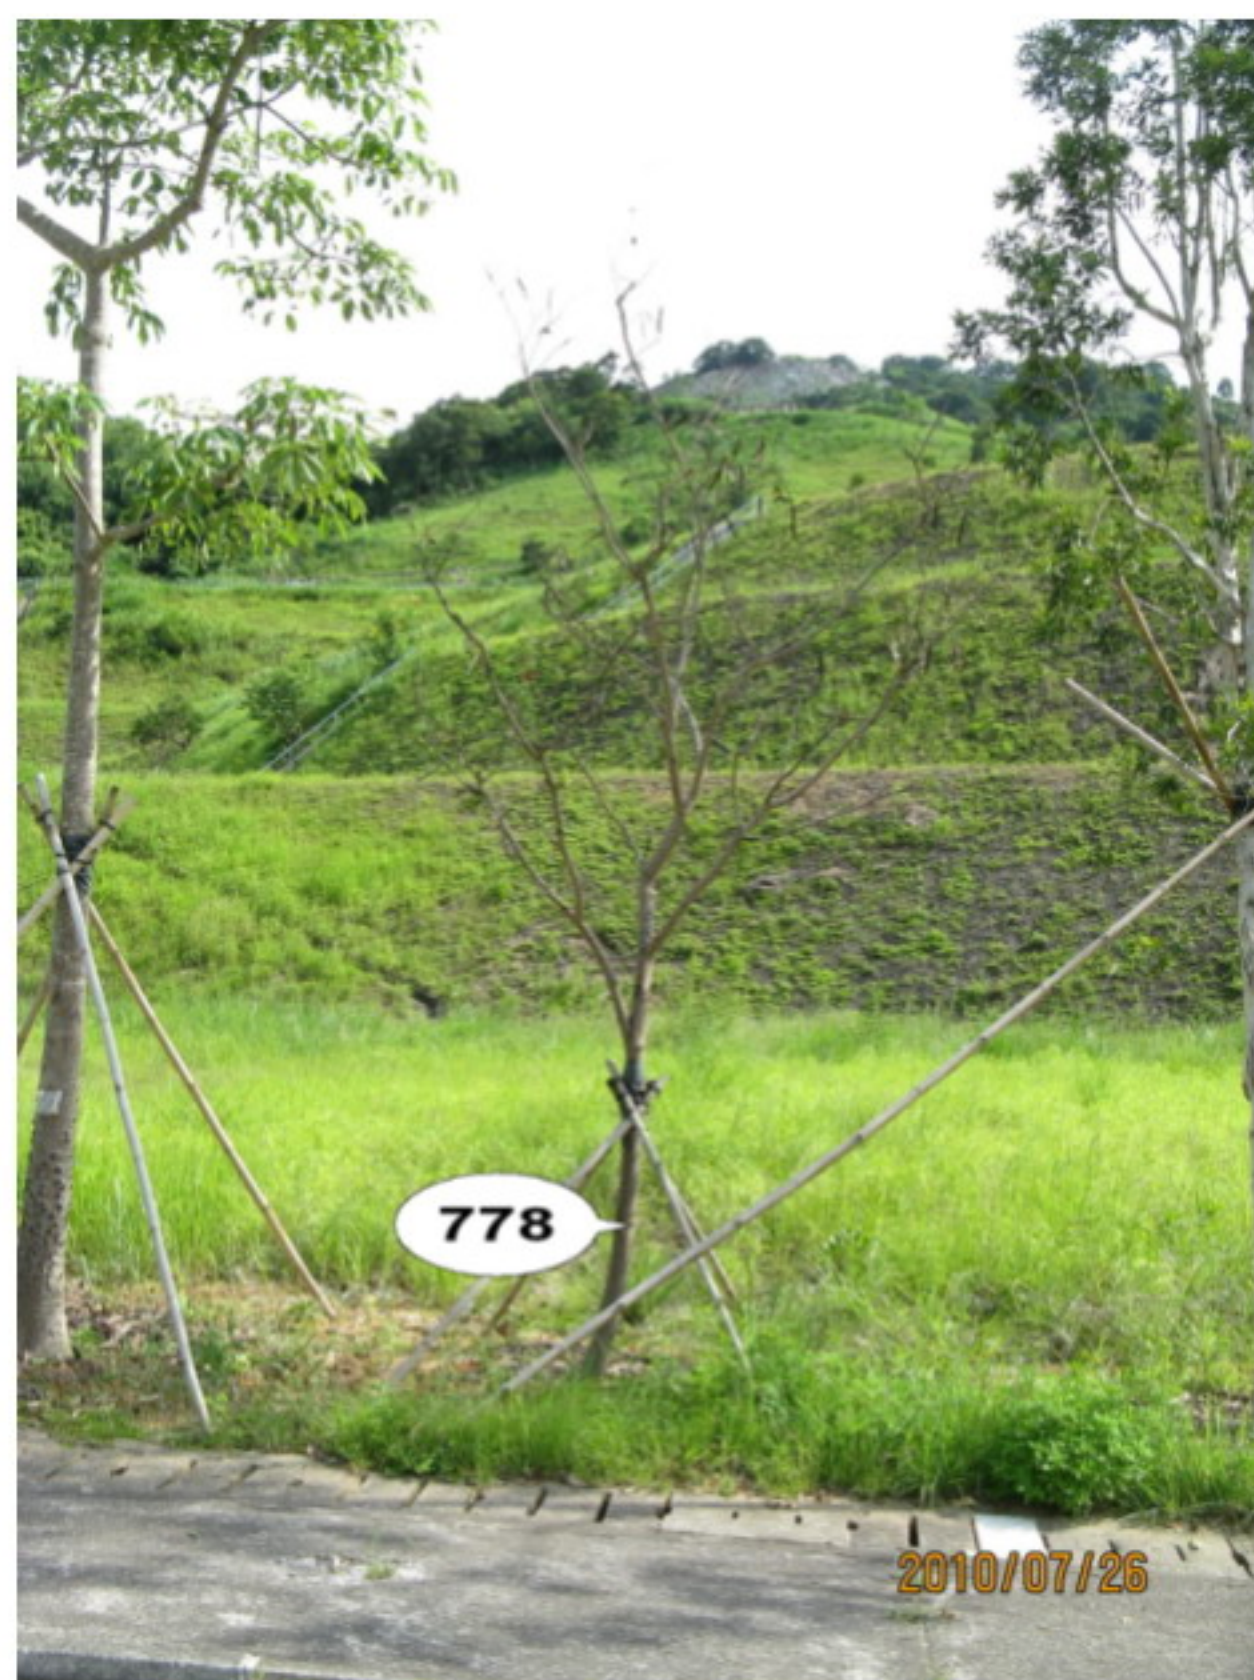
Tree No: 778

| | | | | | | Remark |
|---|---|---|---|---|---|---|
| 778 | <i>Bauhinia variegata</i> | 宮粉羊蹄甲 | 2.5 | 0.1 | 1.5 | Fair condition, Sparse crown |

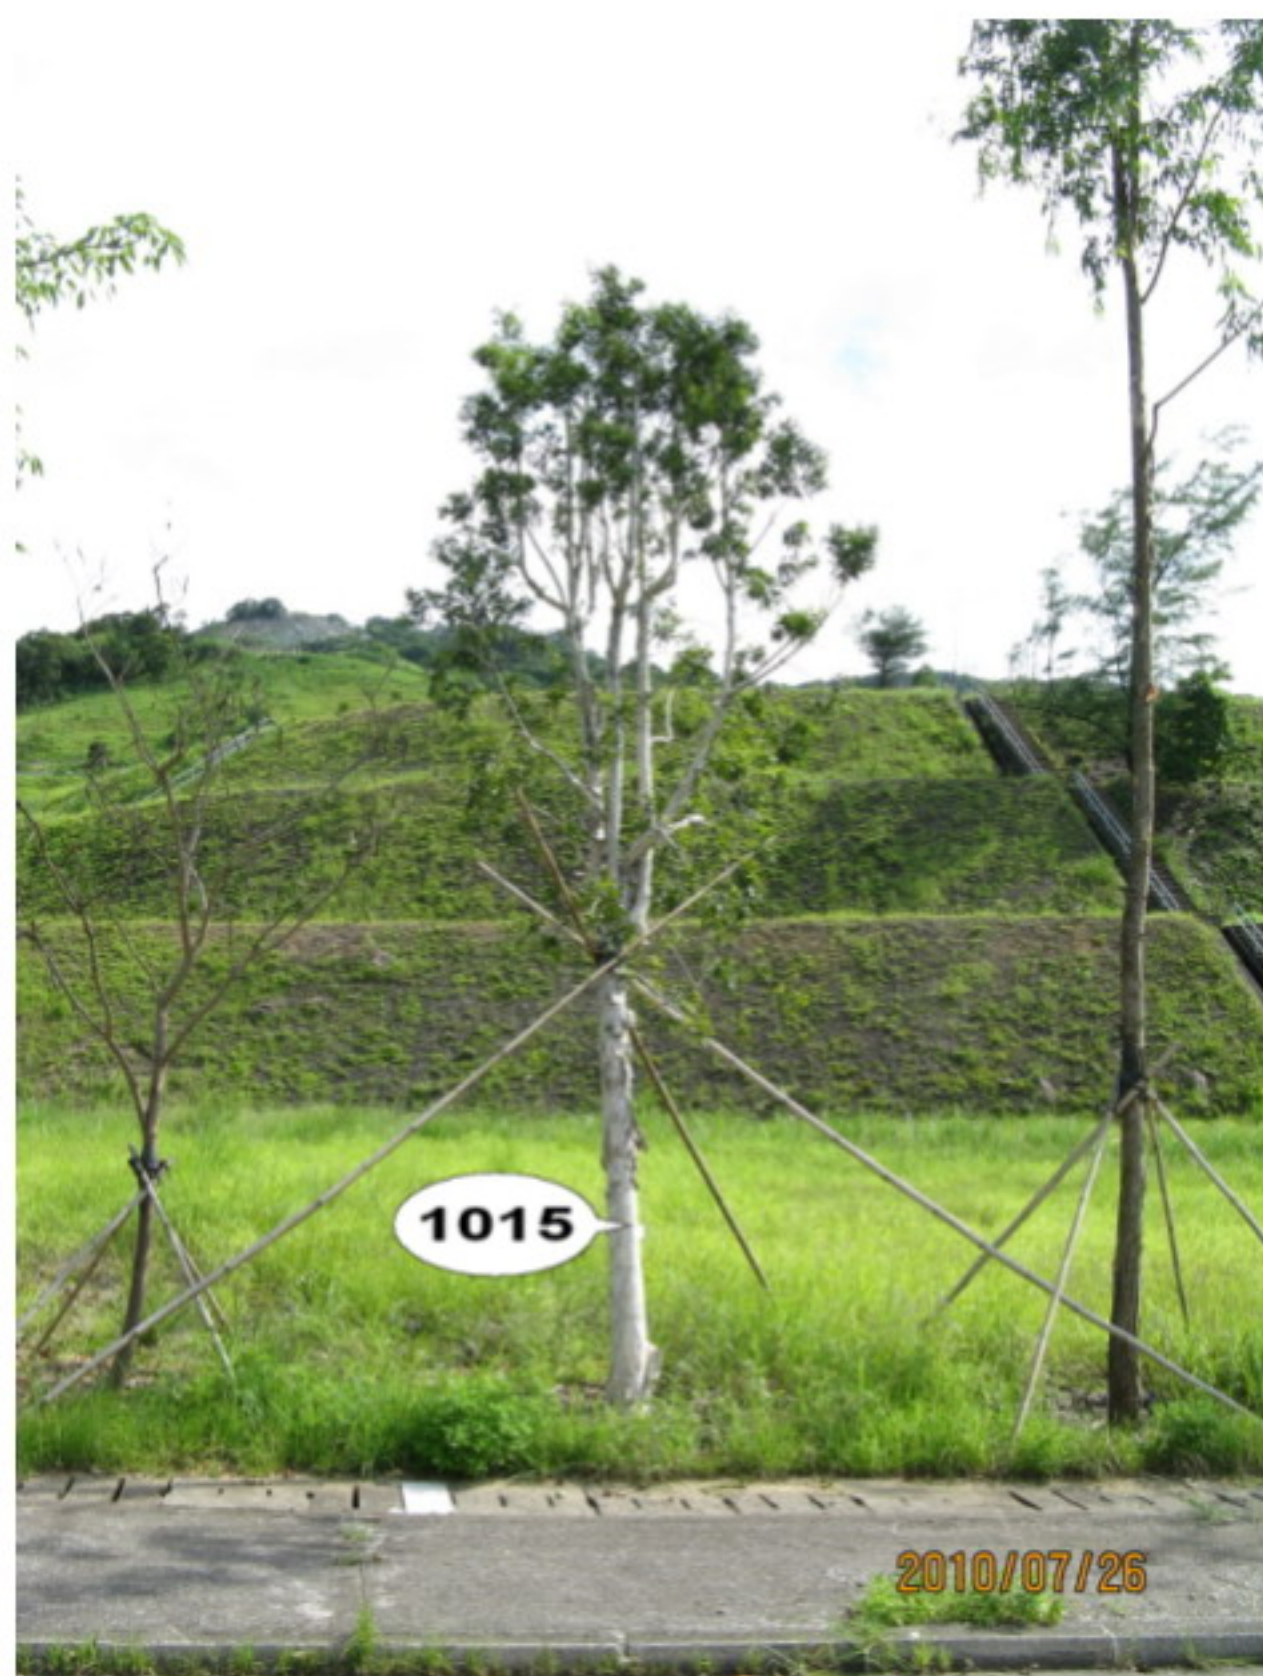
Tree No: 1015

| | | | | | | Remark |
|---|---|---|---|---|---|---|
| 1015 | <i>Melaleuca quinquenervia</i> | 白千層 | 4 | 0.1 | 1.5 | Fair condition, Sparse crown |

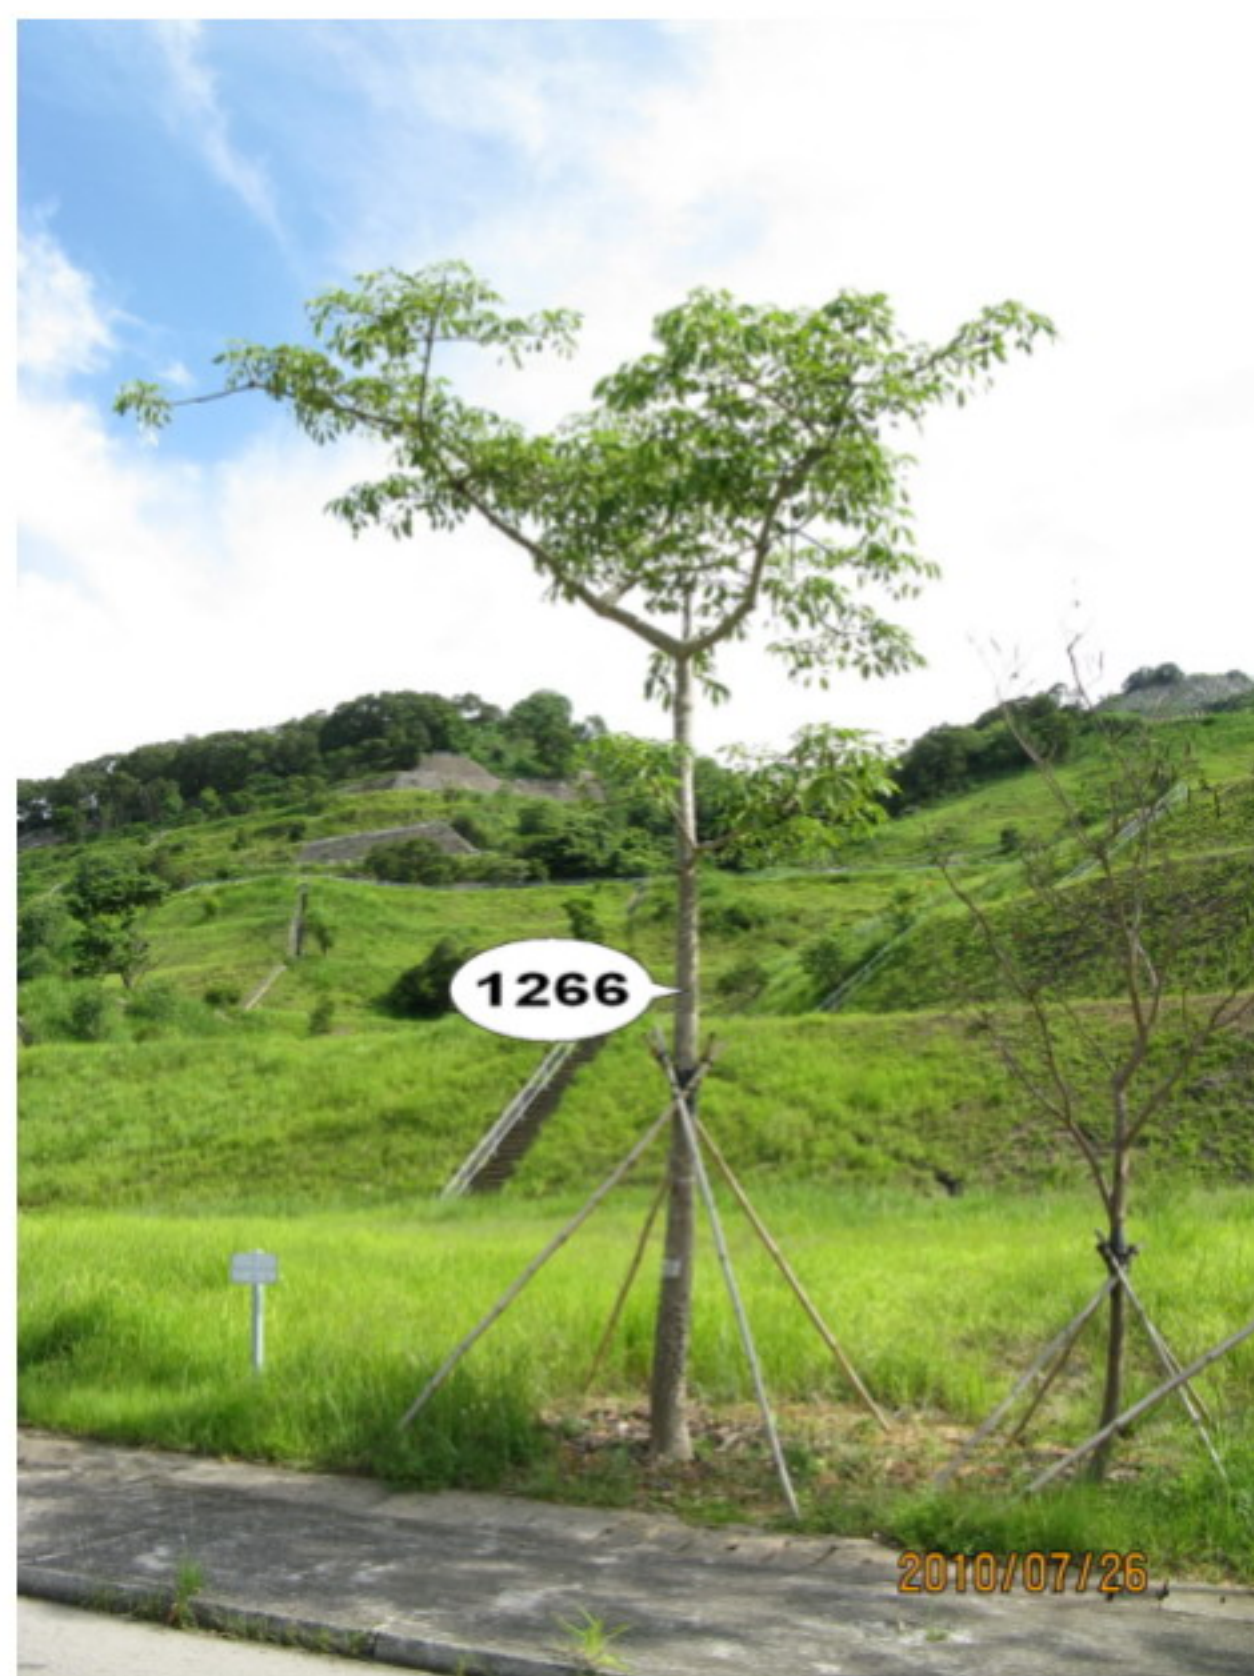
Tree No: 1266

| | | | | | | Remark |
|---|---|---|---|---|---|---|
| 1266 | <i>Bombax ceiba</i> | 木棉 | 4 | 0.15 | 3 | Poor condition, Leave regenerating |

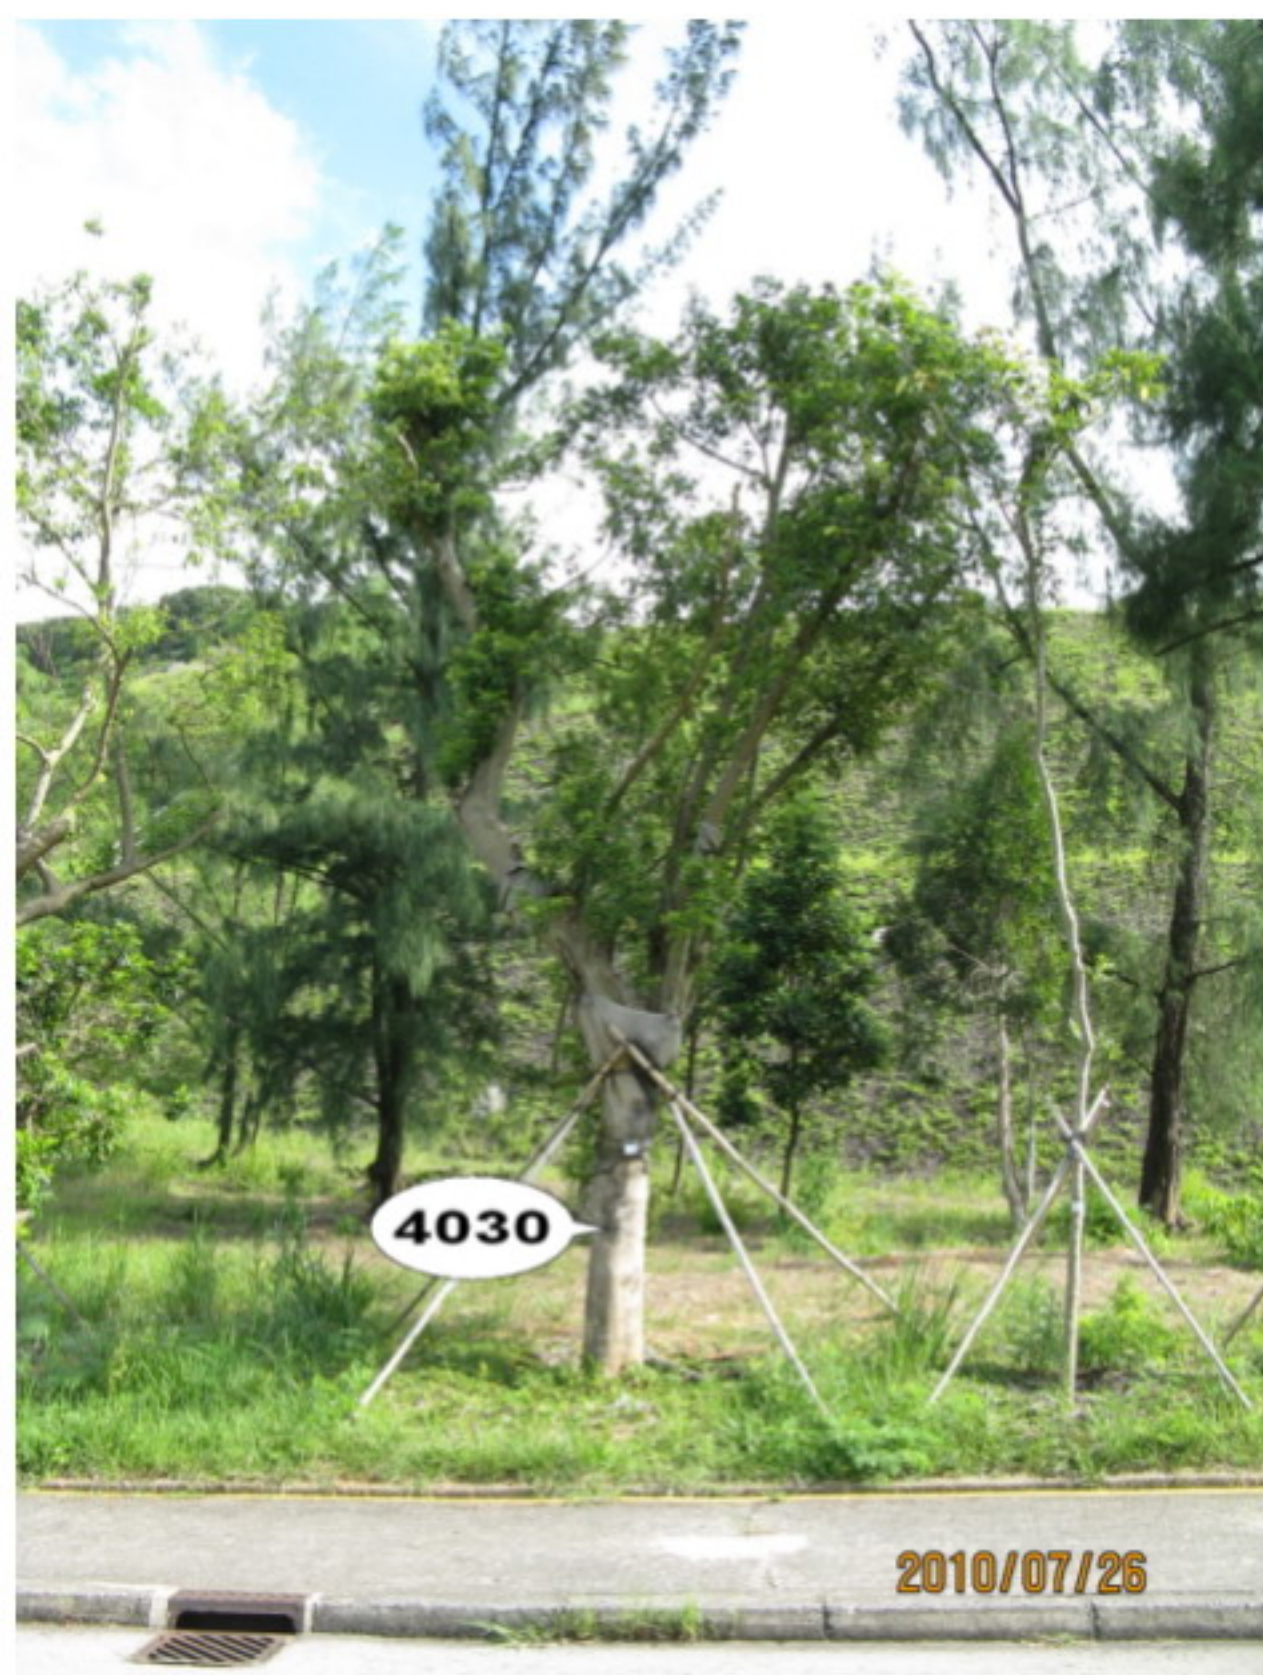
Tree No: 4030

| | | | | | | Remark |
|---|---|---|---|---|---|---|
| 4030 | <i>Cinnamomum burmannii</i> | 陰香 | 5.5 | 0.16 | 4 | Poor condition, Fork, Pruned, Decay, Leave regenerating |

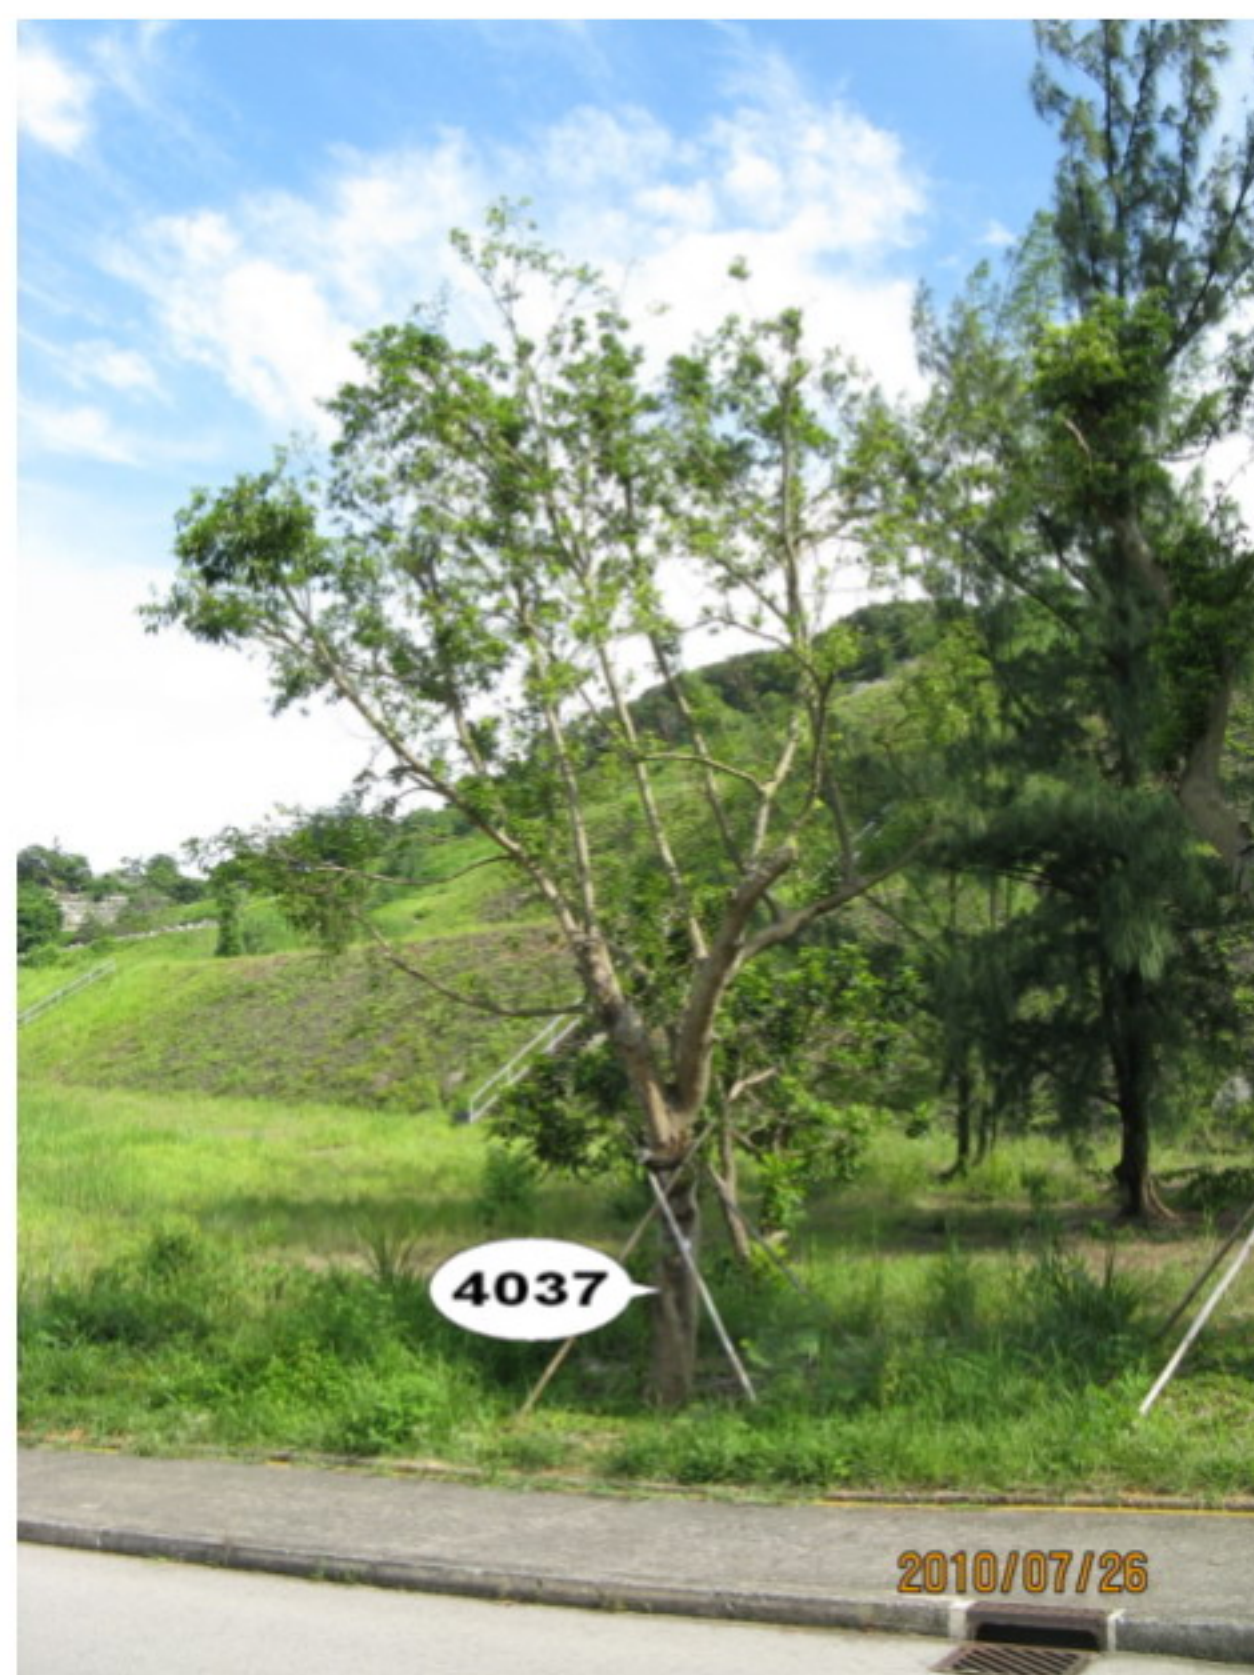
Tree No: 4037

| | | | | | | Remark |
|---|---|---|---|---|---|---|
| 4037 | <i>Cinnamomum burmannii</i> | 陰香 | 6 | 0.25 | 4 | Poor condition, Fork, Pruned, Cavity, Leave regenerating |

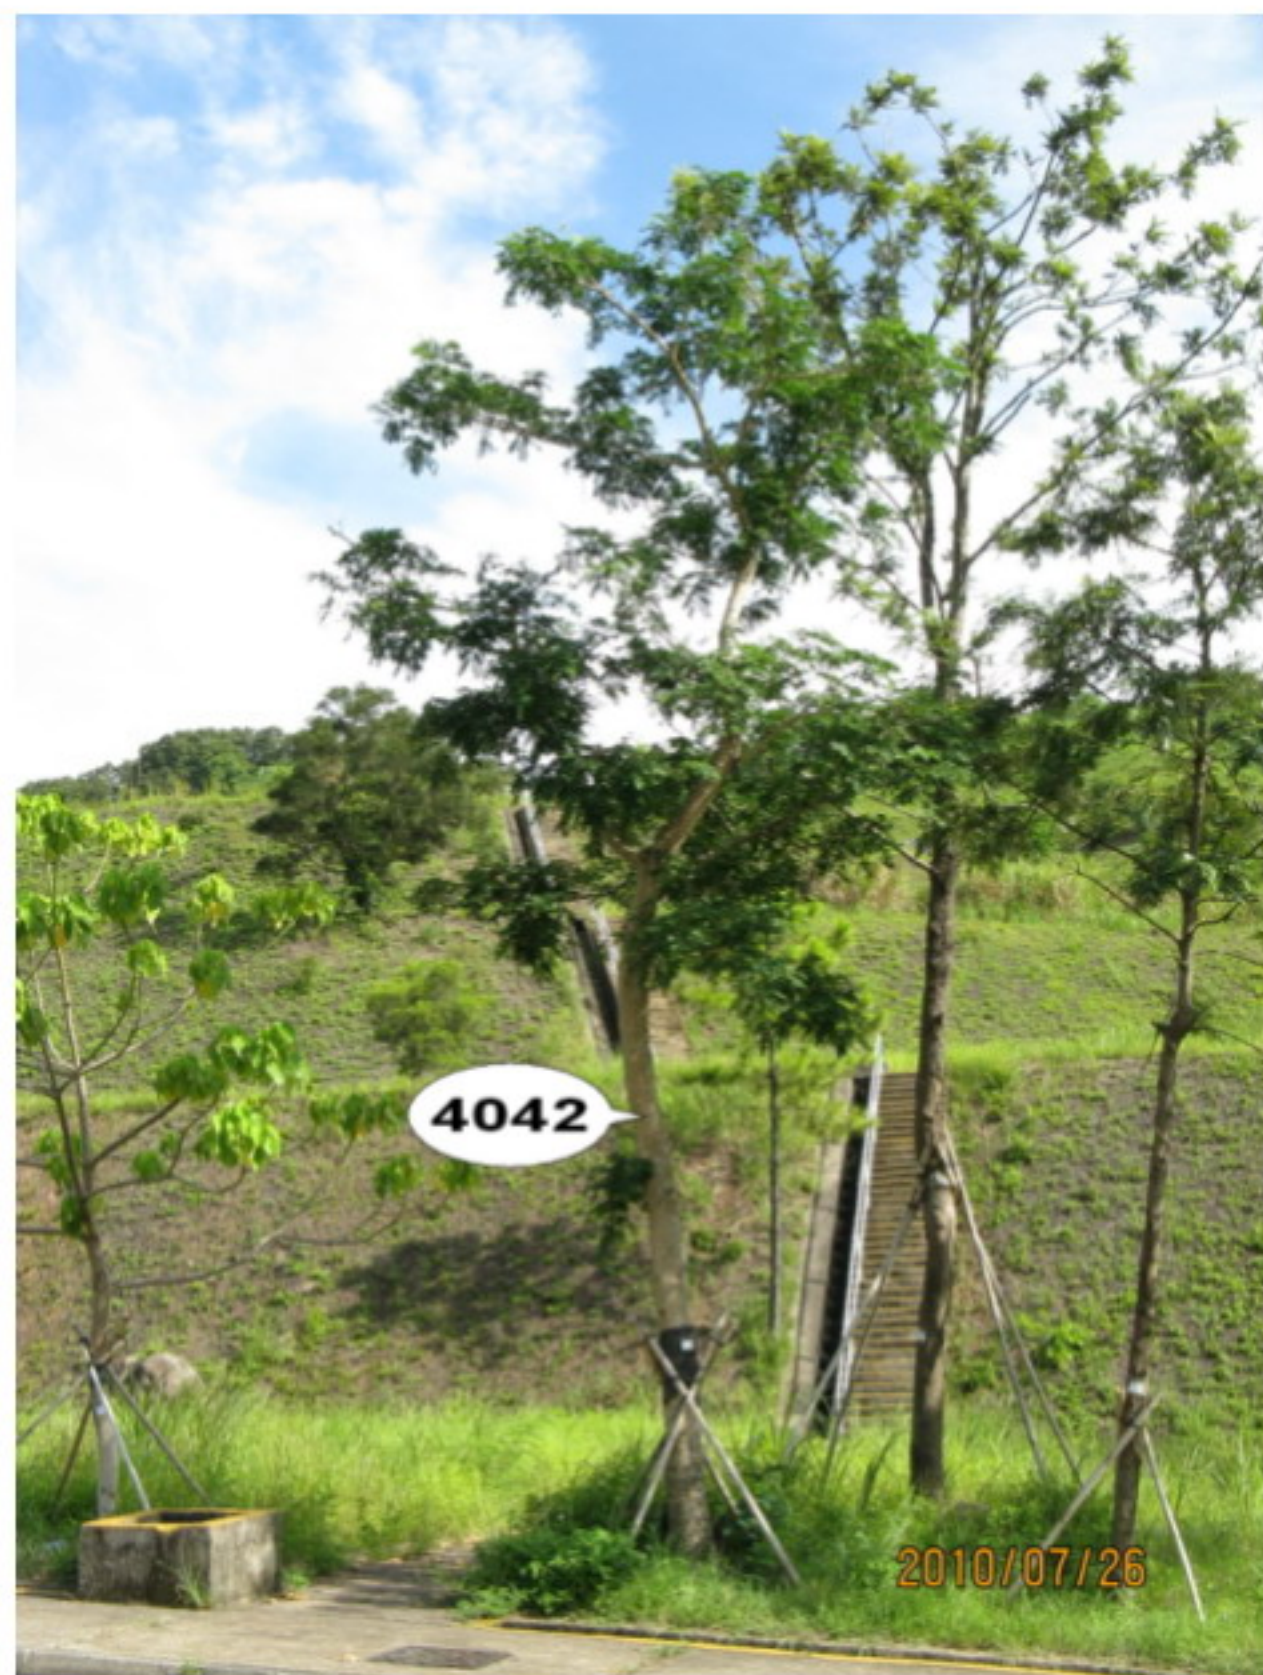
Tree No: 4042

| | | | | | | Remark |
|---|---|---|---|---|---|---|
| 4042 | <i>Albizia lebbbeck</i> | 大葉合歡 | 8 | 0.16 | 4 | Fair condition, Leave regenerating |

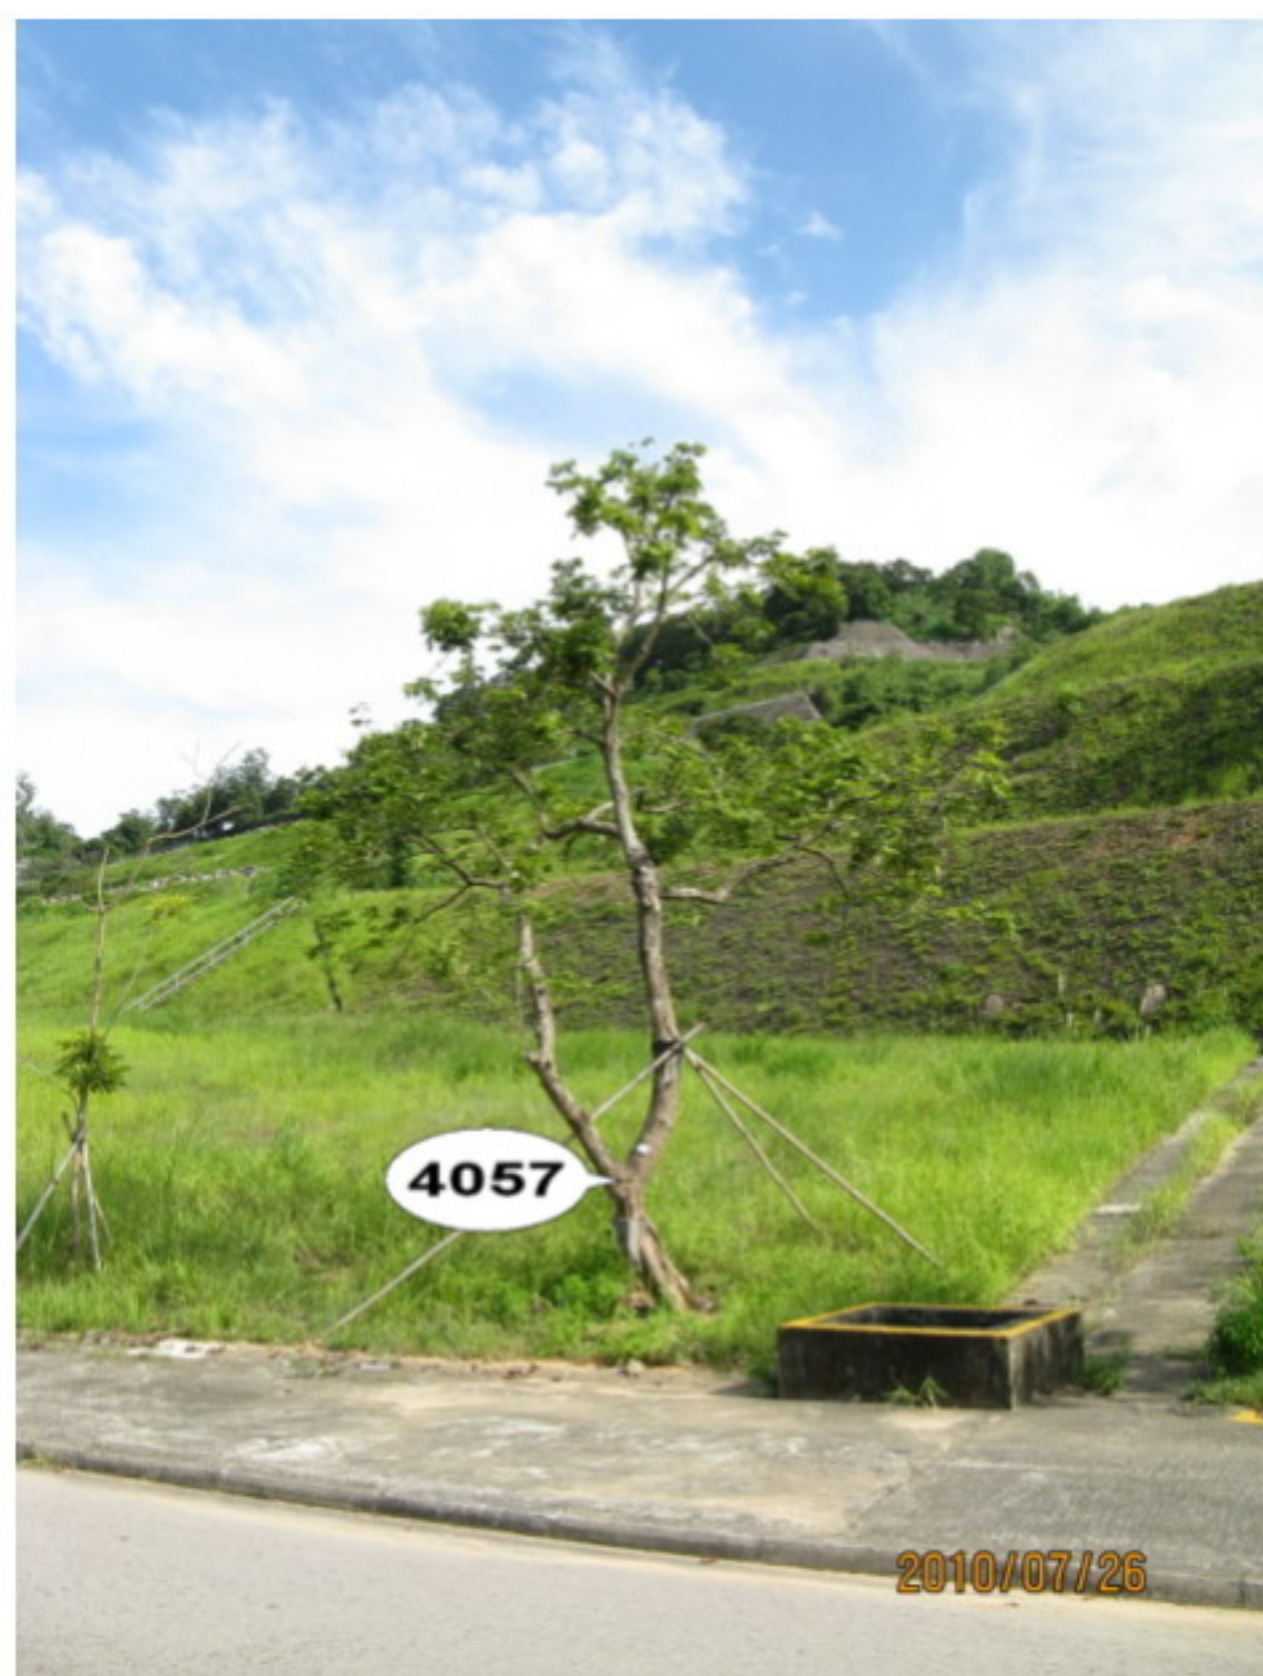
Tree No: 4057

| Tree Number | Species | Chinese name | Height (m) | Diameter (m) | Spread (m) | Remark |
|---|---|---|---|---|---|---|
| 4057 | <i>Dimocarpus longan</i> | 龍眼 | 6 | 0.16 | 4 | Fair condition, Loose bark, Leave regeneration |

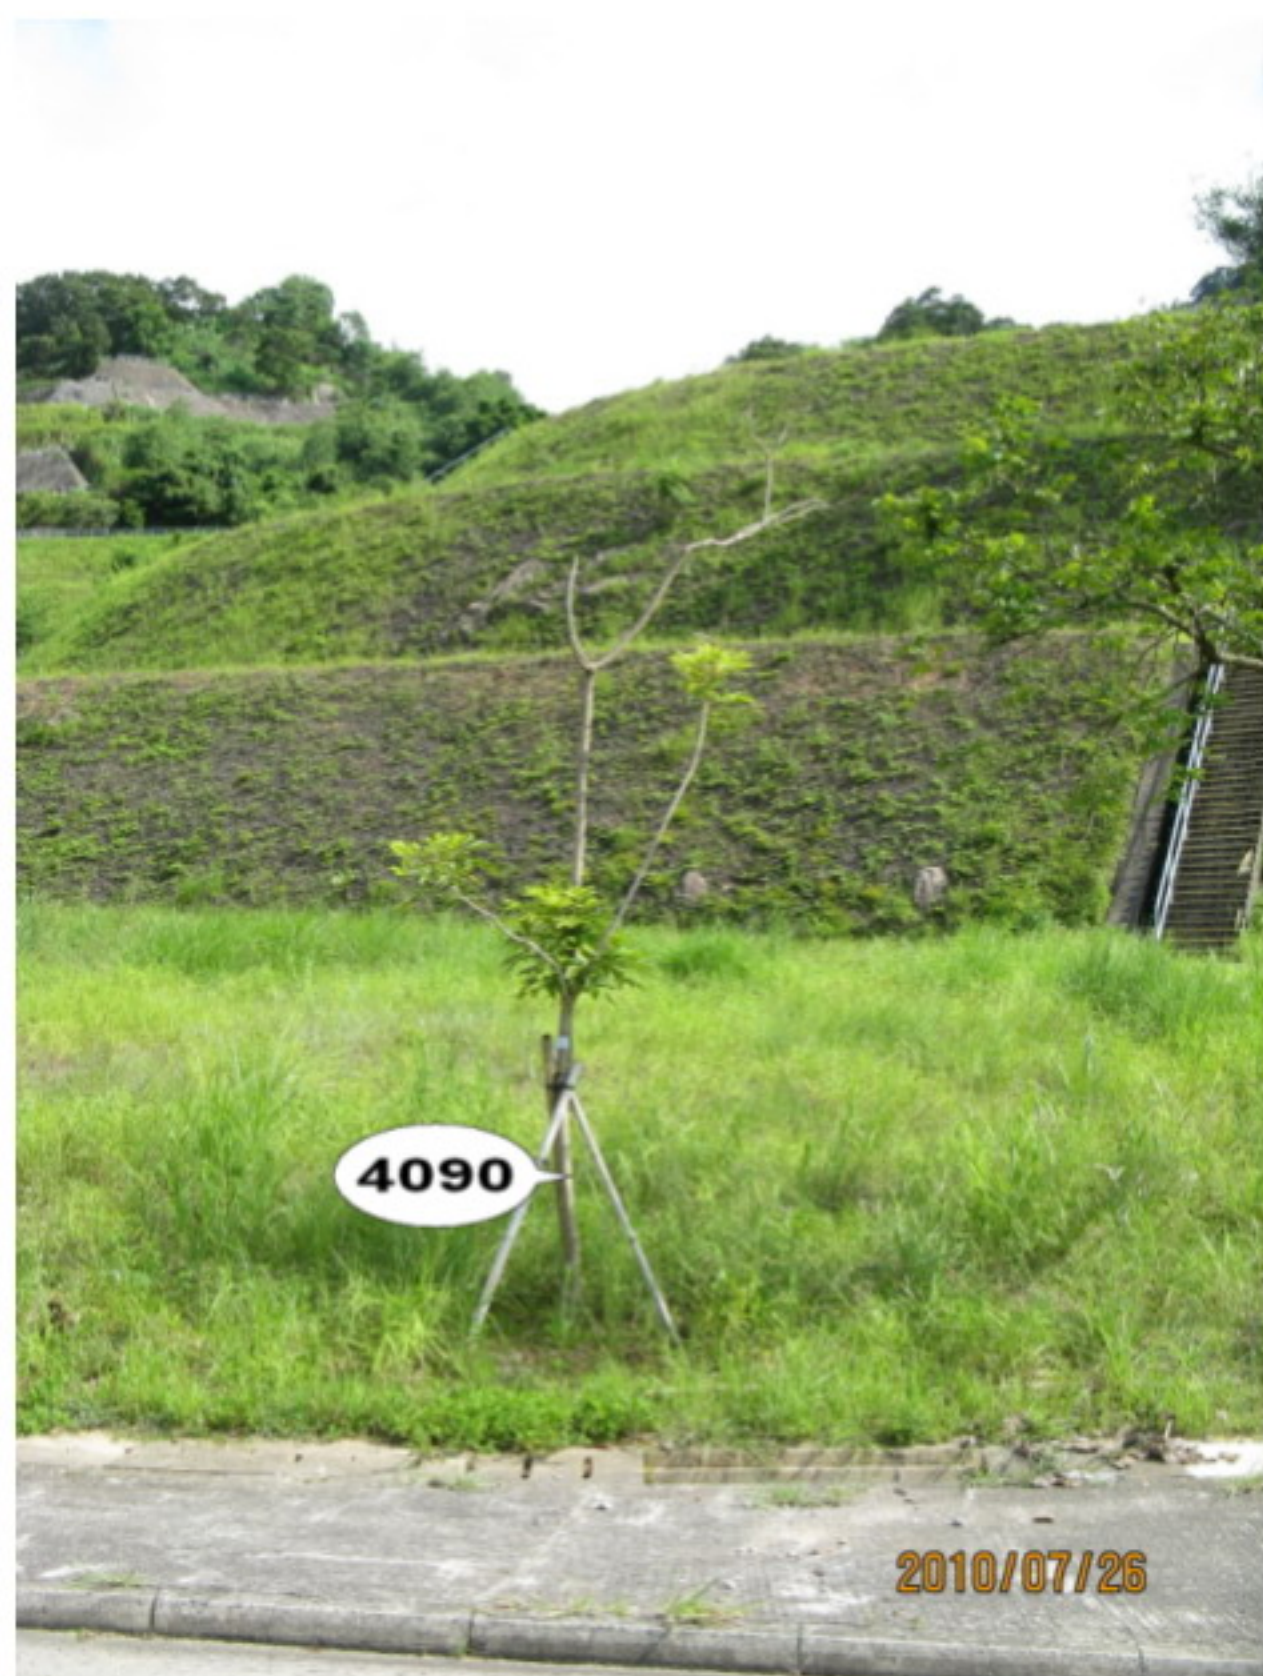
Tree No: 4090

| Tree Number | Species | Chinese name | Height (m) | Diameter (m) | Spread (m) | Remark |
|---|---|---|---|---|---|---|
| 4090 | <i>Schefflera heptaphylla</i> | 鴨腳木 | 6.5 | 0.18 | 4 | Poor condition, Heavy sparse crown, |
