**PROVISION OF CREMATORS AT  
WO HOP SHEK CREMATORIUM**

**ENVIRONMENTAL MONITORING &  
AUDIT REPORT (AUGUST 2010)**

**ALLIED ENVIRONMENTAL CONSULTANTS LTD.**

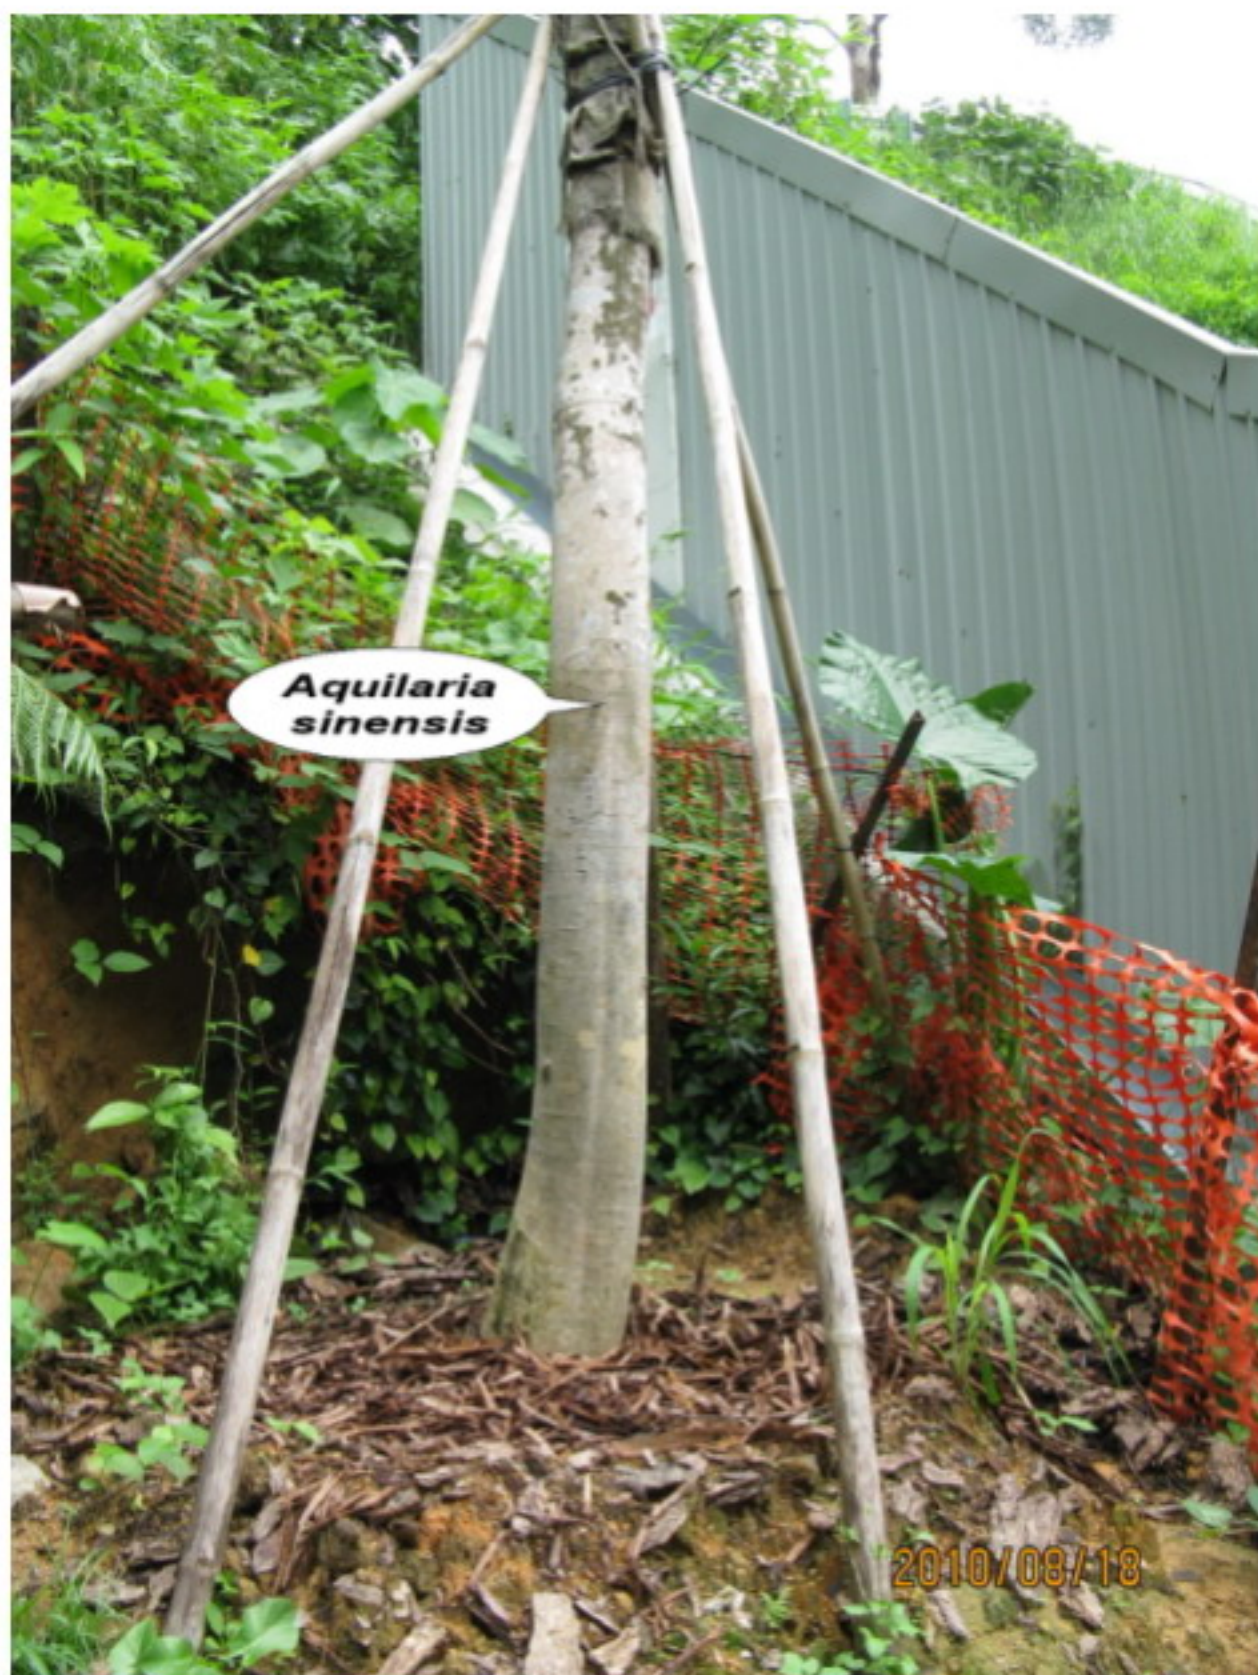
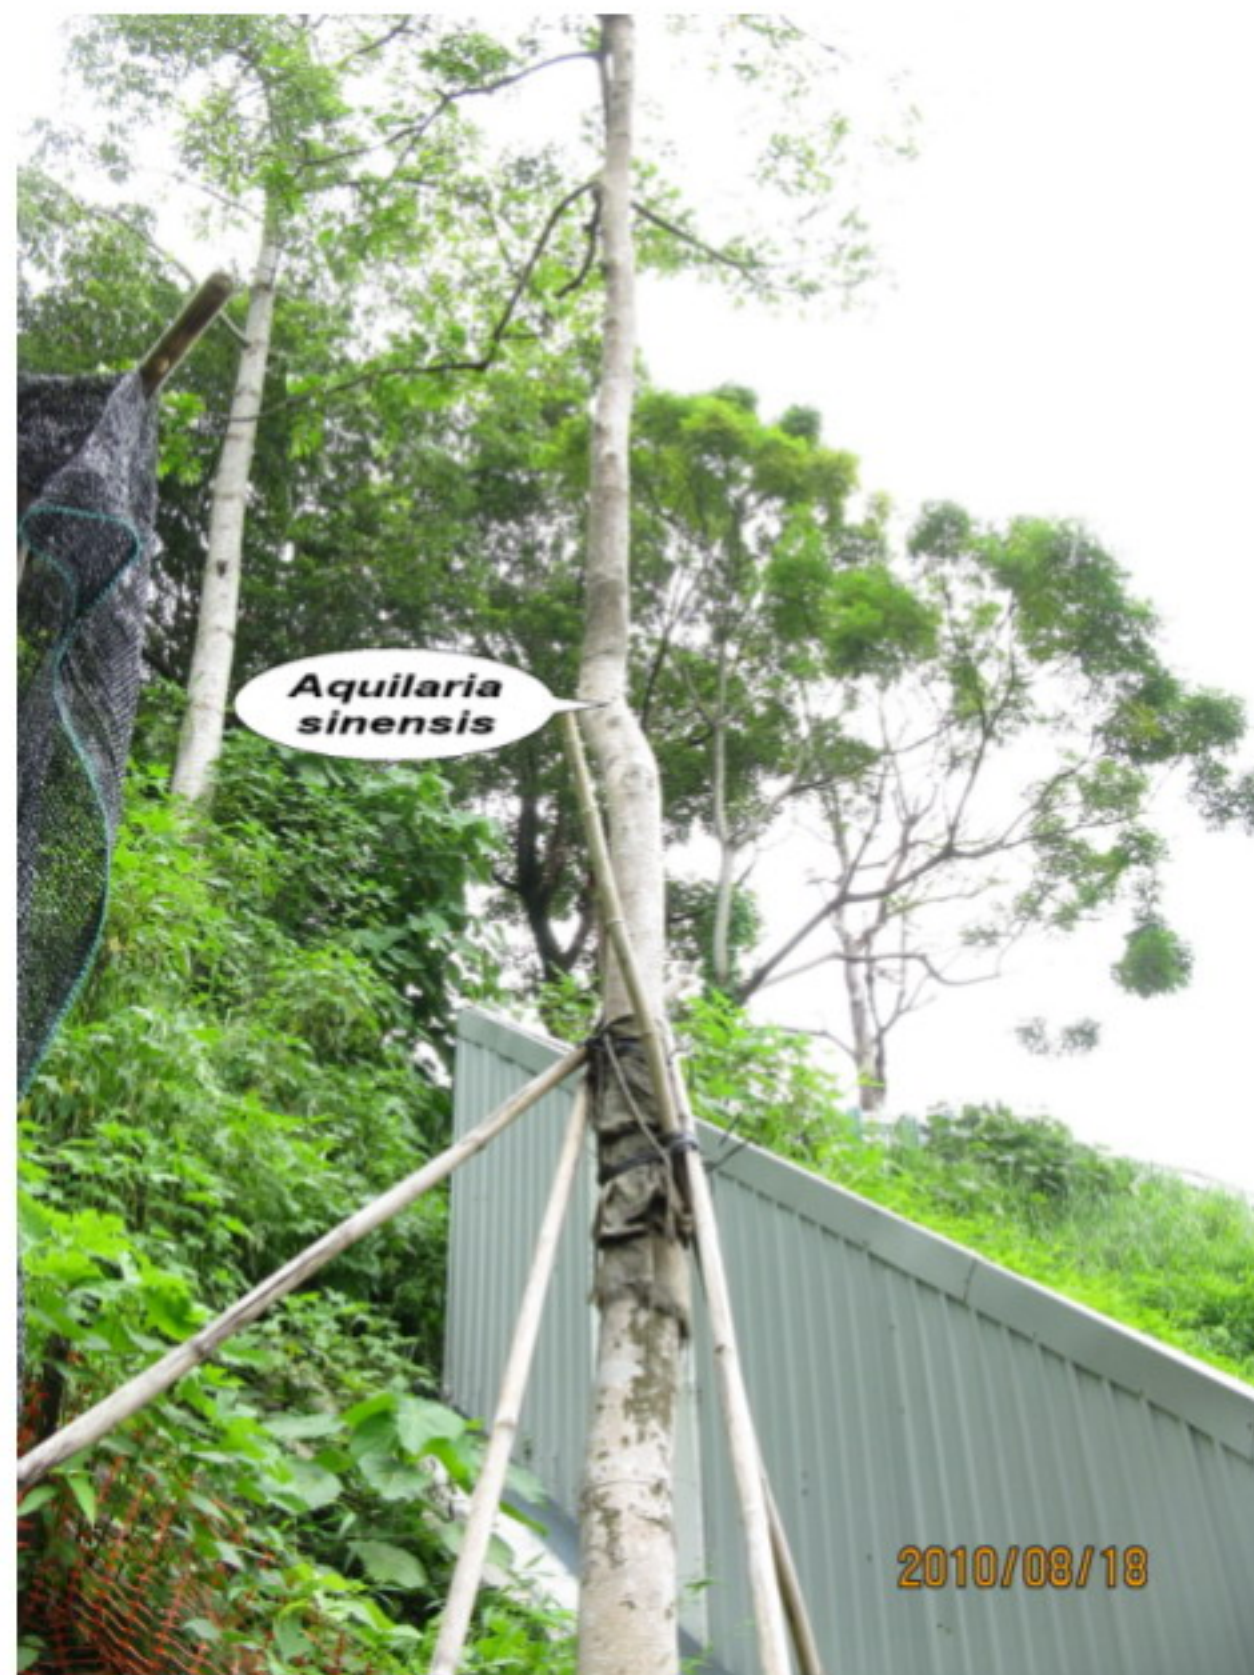
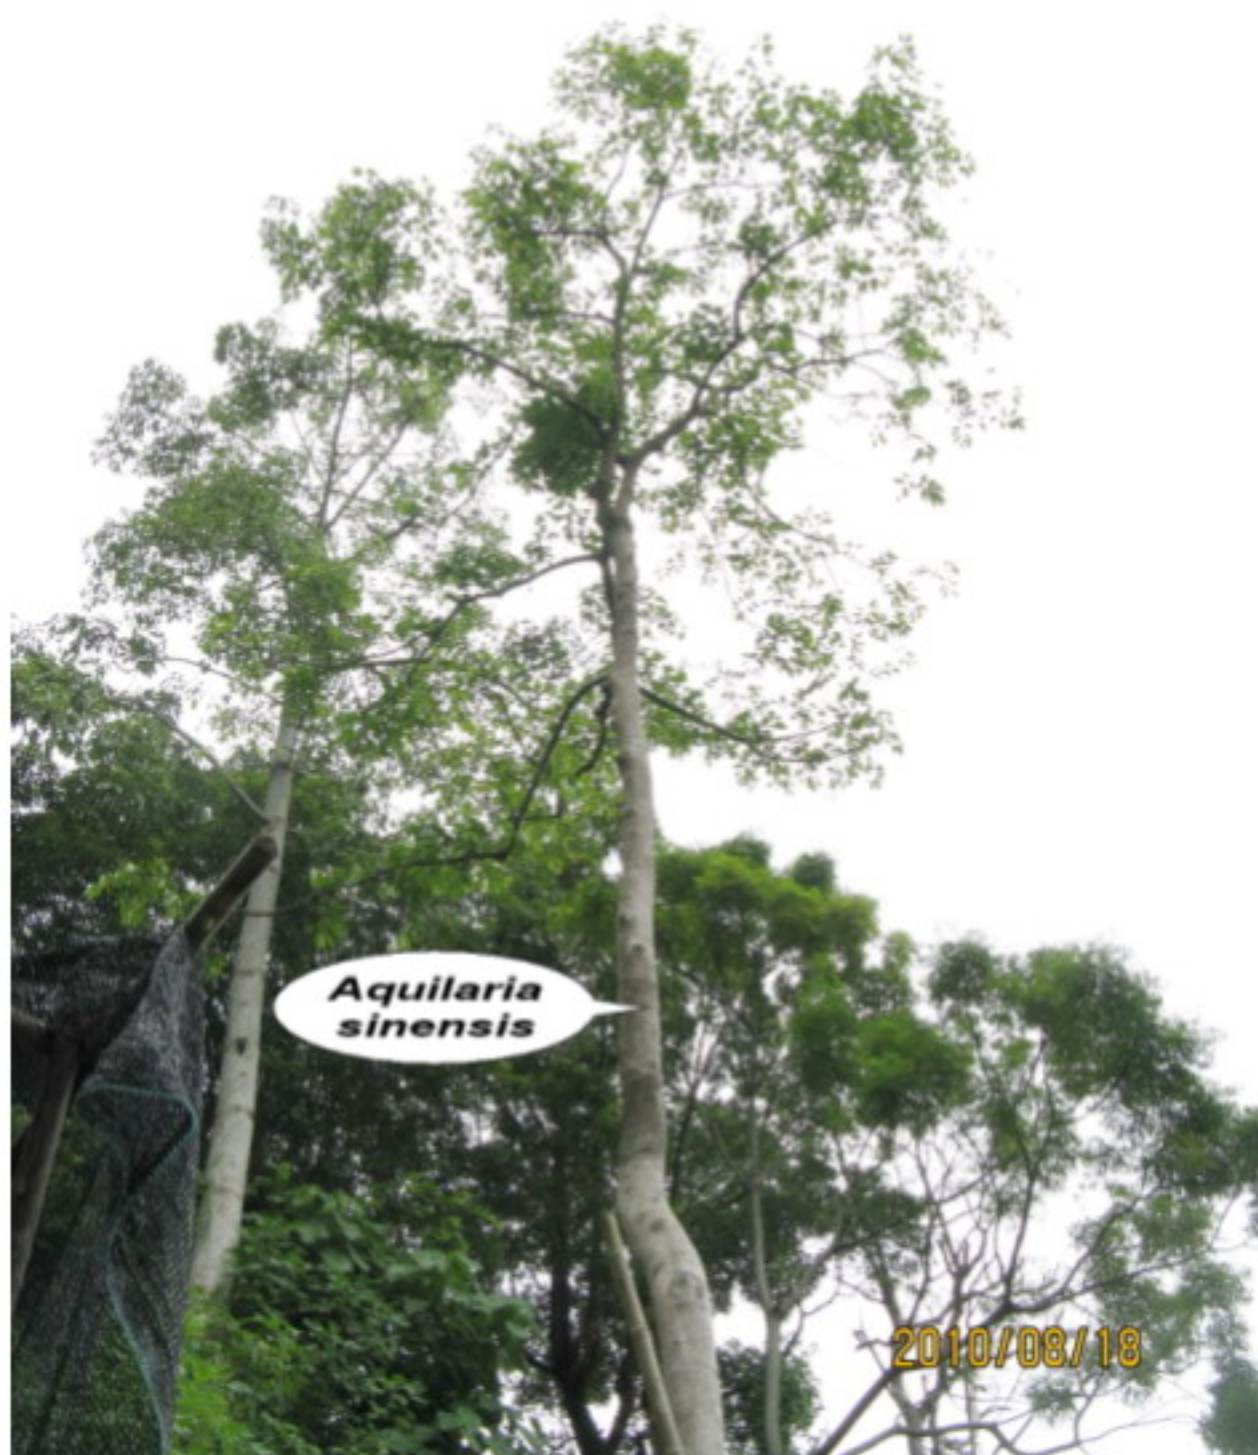
## Transplanting receptor "T1" site

- 4.4 Tree tag was found lost on 3 monitoring trees. Non-tagging trees were labeled as “1”, “2” and “3” on the tree schedule.
- 4.5 The transplanted *Aquilaria sinensis* showed stress and deterioration in health condition as indicated by foliage color. Daily watering and closely monitoring is recommended.

| | | | | Remark |
|---|---|---|---|---|
| <i>Aquilaria sinensis</i> | 8 | 0.2 | 4 | Poor condition |

*Aquilaria sinensis*

- 5.1 As the transplanted trees were not recovered from injury of root systems caused during transplantation operation, and the new roots are not regenerated yet. The trees are still under environmental stress at the reception sites. It is important to watering regularly. Close monitoring of the trees needs to be continued and relevant mitigation measures will be proposed when necessary.
- 5.2 The transplanted *Aquilaria sinensis* showed stress and deterioration in health condition as indicated by foliage color. Daily watering and closely monitoring is recommended.
- 5.3 Organic soil or composite organic enriched soil should be applied to each transplanted tree, approx. 20kg to 40kg per tree is recommended. On top of organic soil should covered with tree barks and 5kg to 20kg tree bark is recommended according to tree size.

In total, 38 tree species and one shrub species were recorded at the three transplantation receptor sites. The transplanted trees *Aquilaria sinensis* showed deterioration in health condition at transplanting receptor site “T1”. Daily watering and closely monitoring is recommended. Some trees have recorded as poor condition with no leave attached on tree crown at the transplanting receptor “T3” site. Regular watering, apply organic soil, tree bark and closely monitoring was recommended.

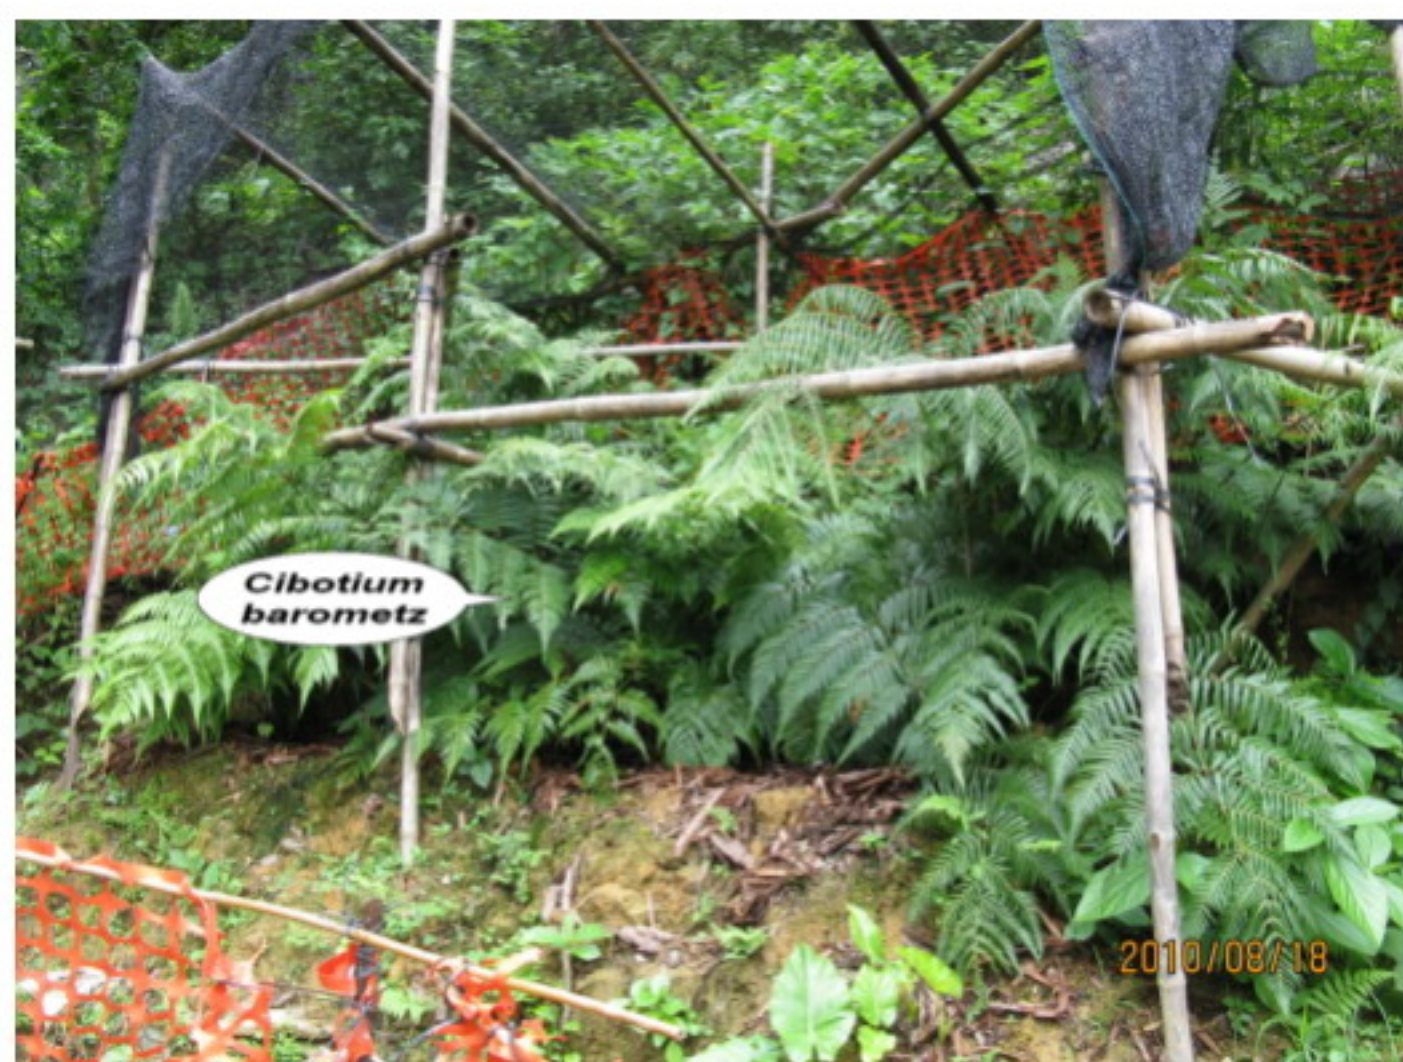
*Cibotium barometz*

| | | | | Remark |
|---|---|---|---|---|
| <i>Cibotium barometz</i> | 1 | -- | -- | Fair condition |

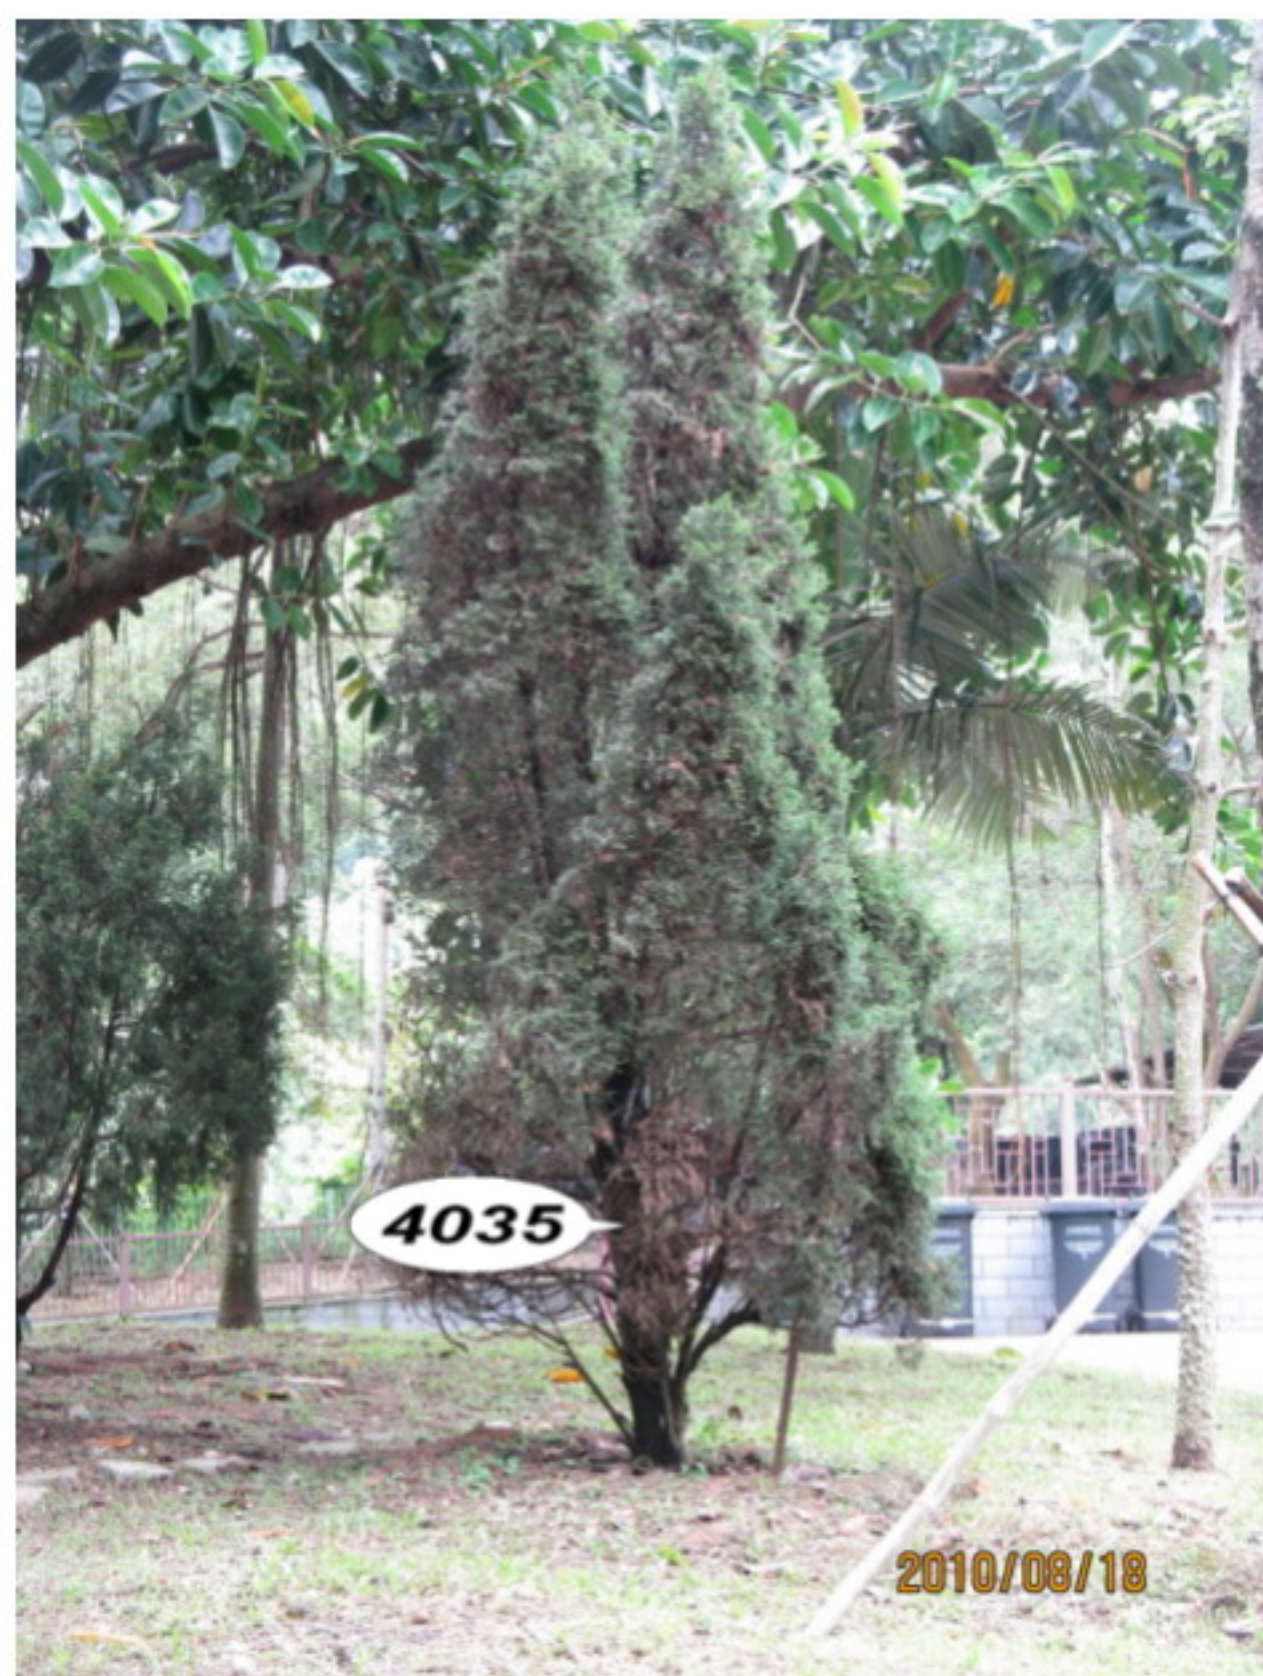
Tree No: 4035

| Tree Number | Species | Chinese name | Height (m) | Diameter (m) | Spread (m) | Remark |
|---|---|---|---|---|---|---|
| 4035 | <i>Juniperus chinensis var.kaizuca</i> | 龍柏 | 4 | 0.16 | 2 | Fair condition |

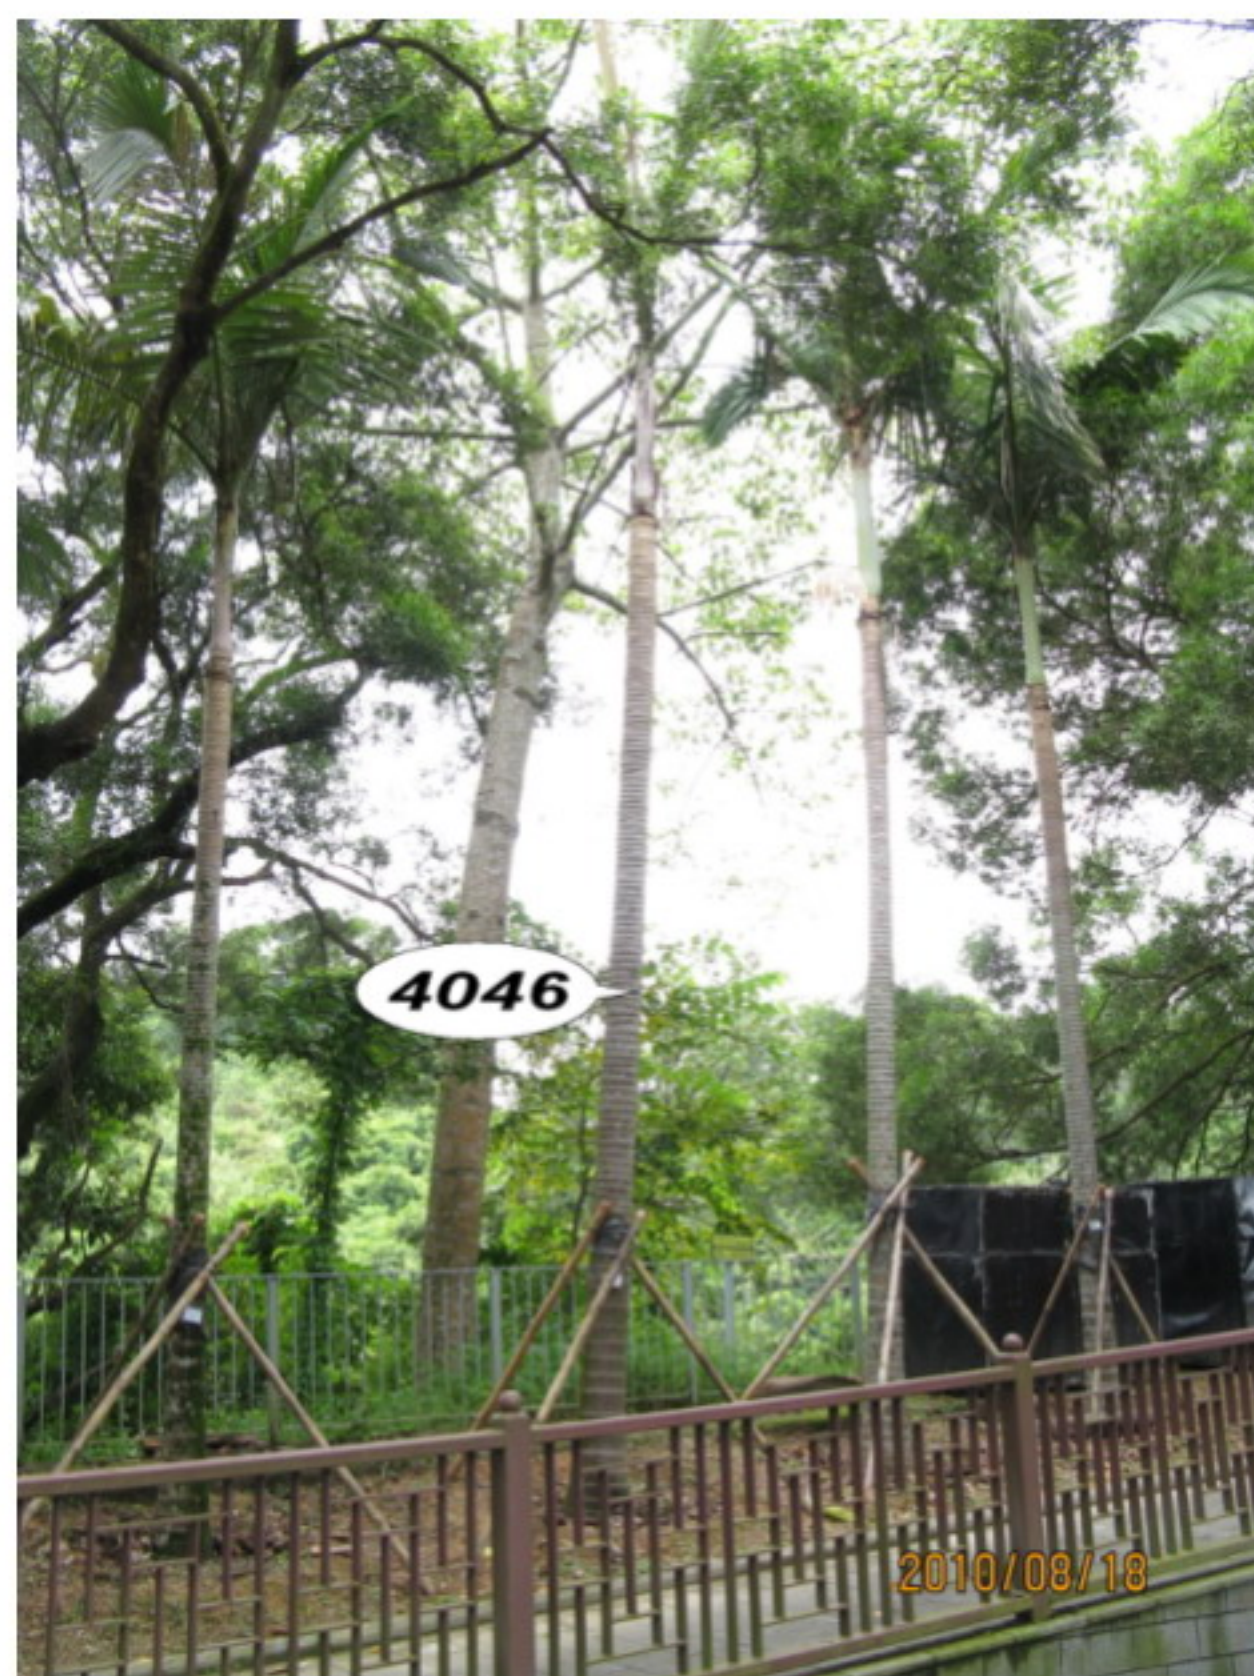
Tree No: 4046

| Tree Number | Species | Chinese name | Height (m) | Diameter (m) | Spread (m) | Remark |
|---|---|---|---|---|---|---|
| 4046 | <i>Archontophoenix alexandrae</i> | 假檳榔 | 5 | 0.19 | 4 | Poor condition, Yellow leave |

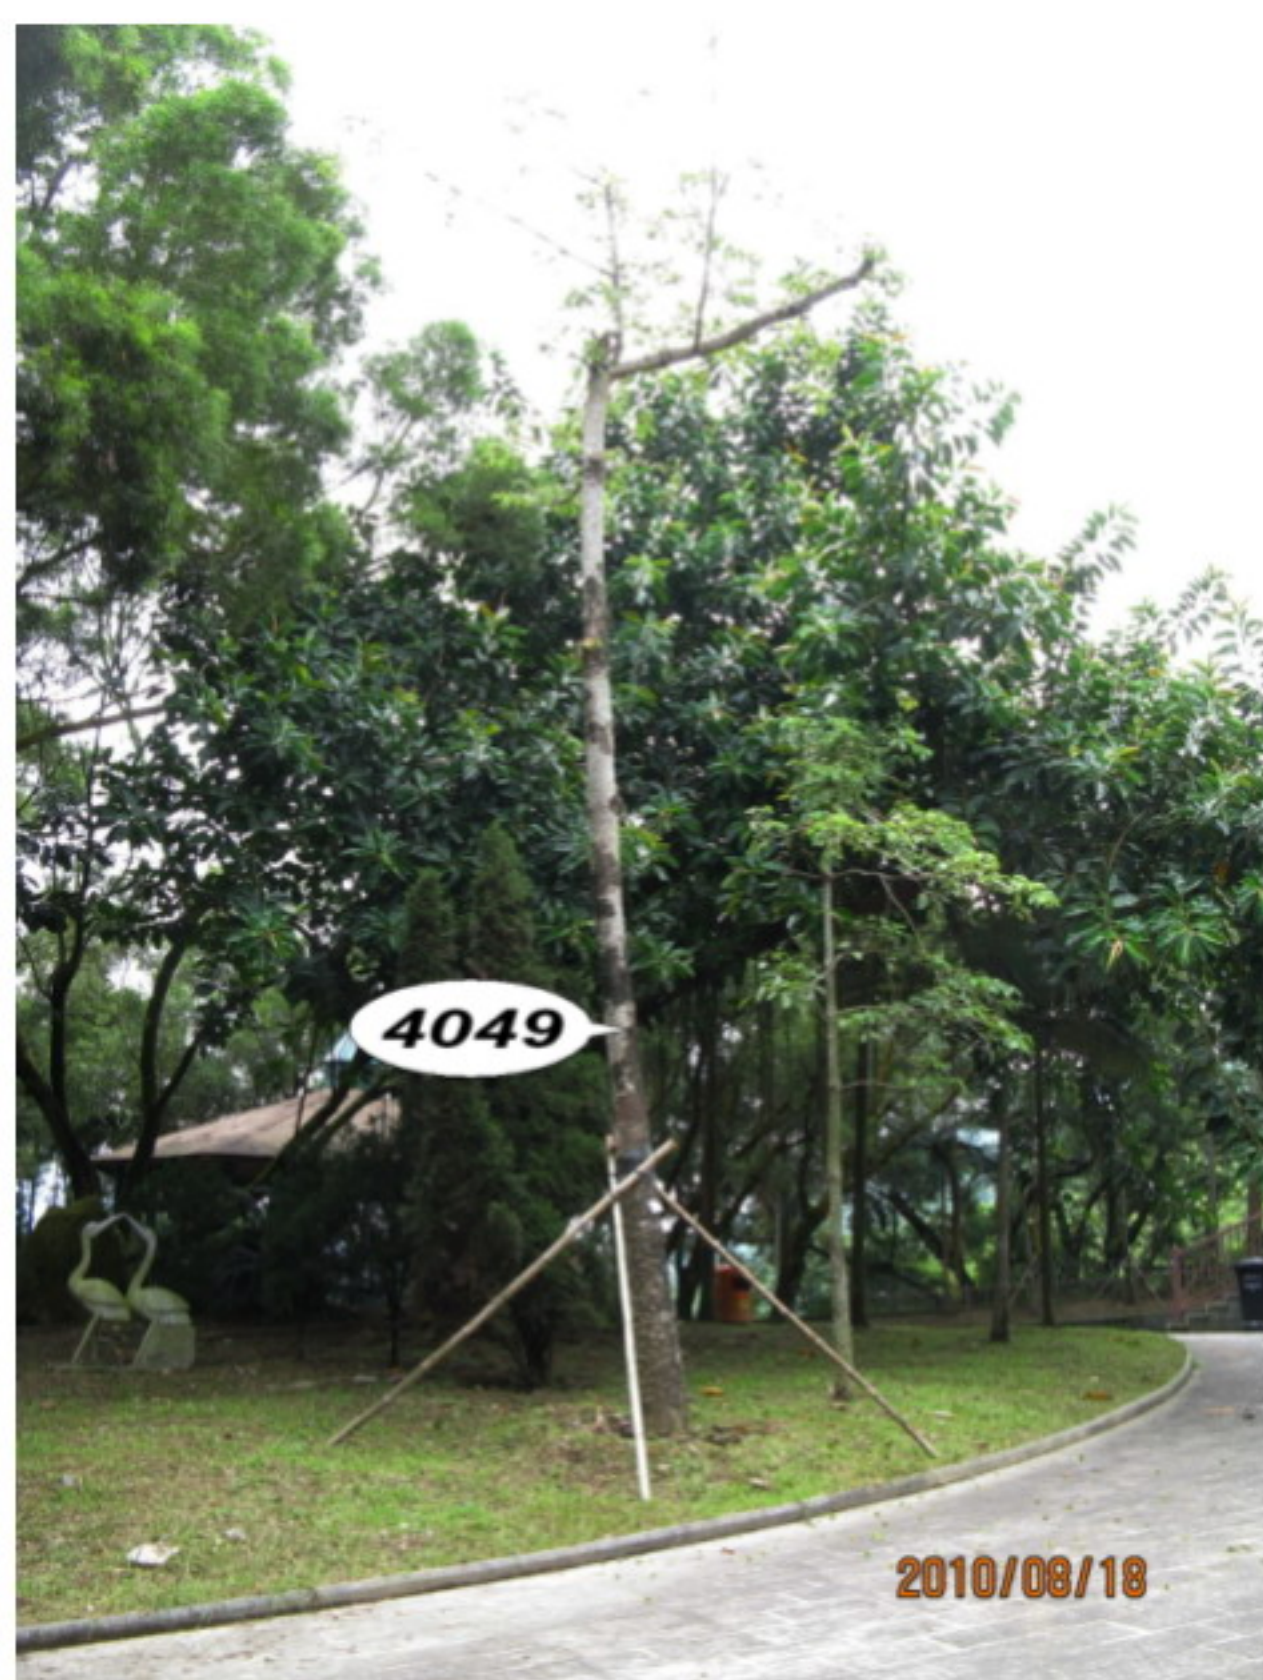
Tree No: 4049

| Tree Number | Species | Chinese name | Height (m) | Diameter (m) | Spread (m) | Remark |
|---|---|---|---|---|---|---|
| 4049 | <i>Bombax ceiba</i> | 木棉 | 6 | 0.16 | 4 | Fair condition |

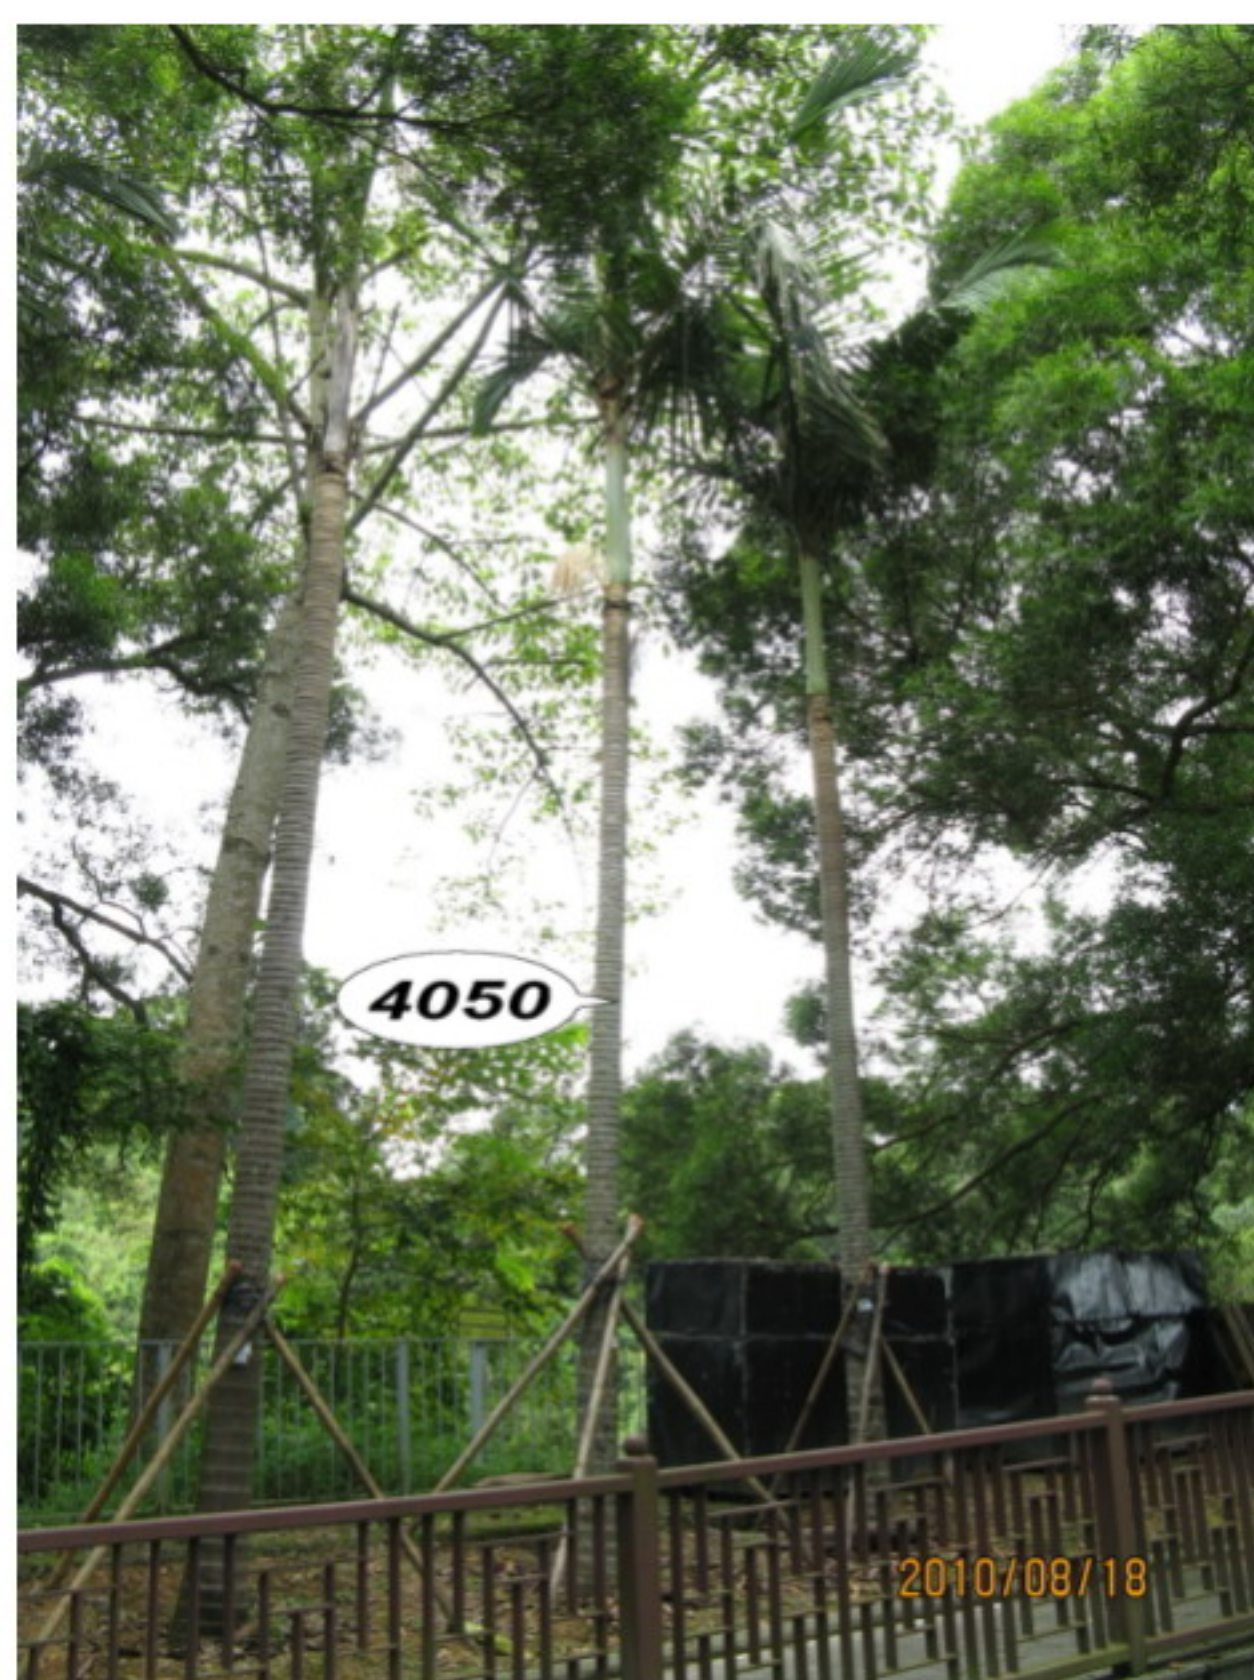
Tree No: 4050

| Tree Number | Species | Chinese name | Height (m) | Diameter (m) | Spread (m) | Remark |
|---|---|---|---|---|---|---|
| 4050 | <i>Archontophoenix alexandrae</i> | 假檳榔 | 5 | 0.16 | 4 | Fair condition, Yellow leave |

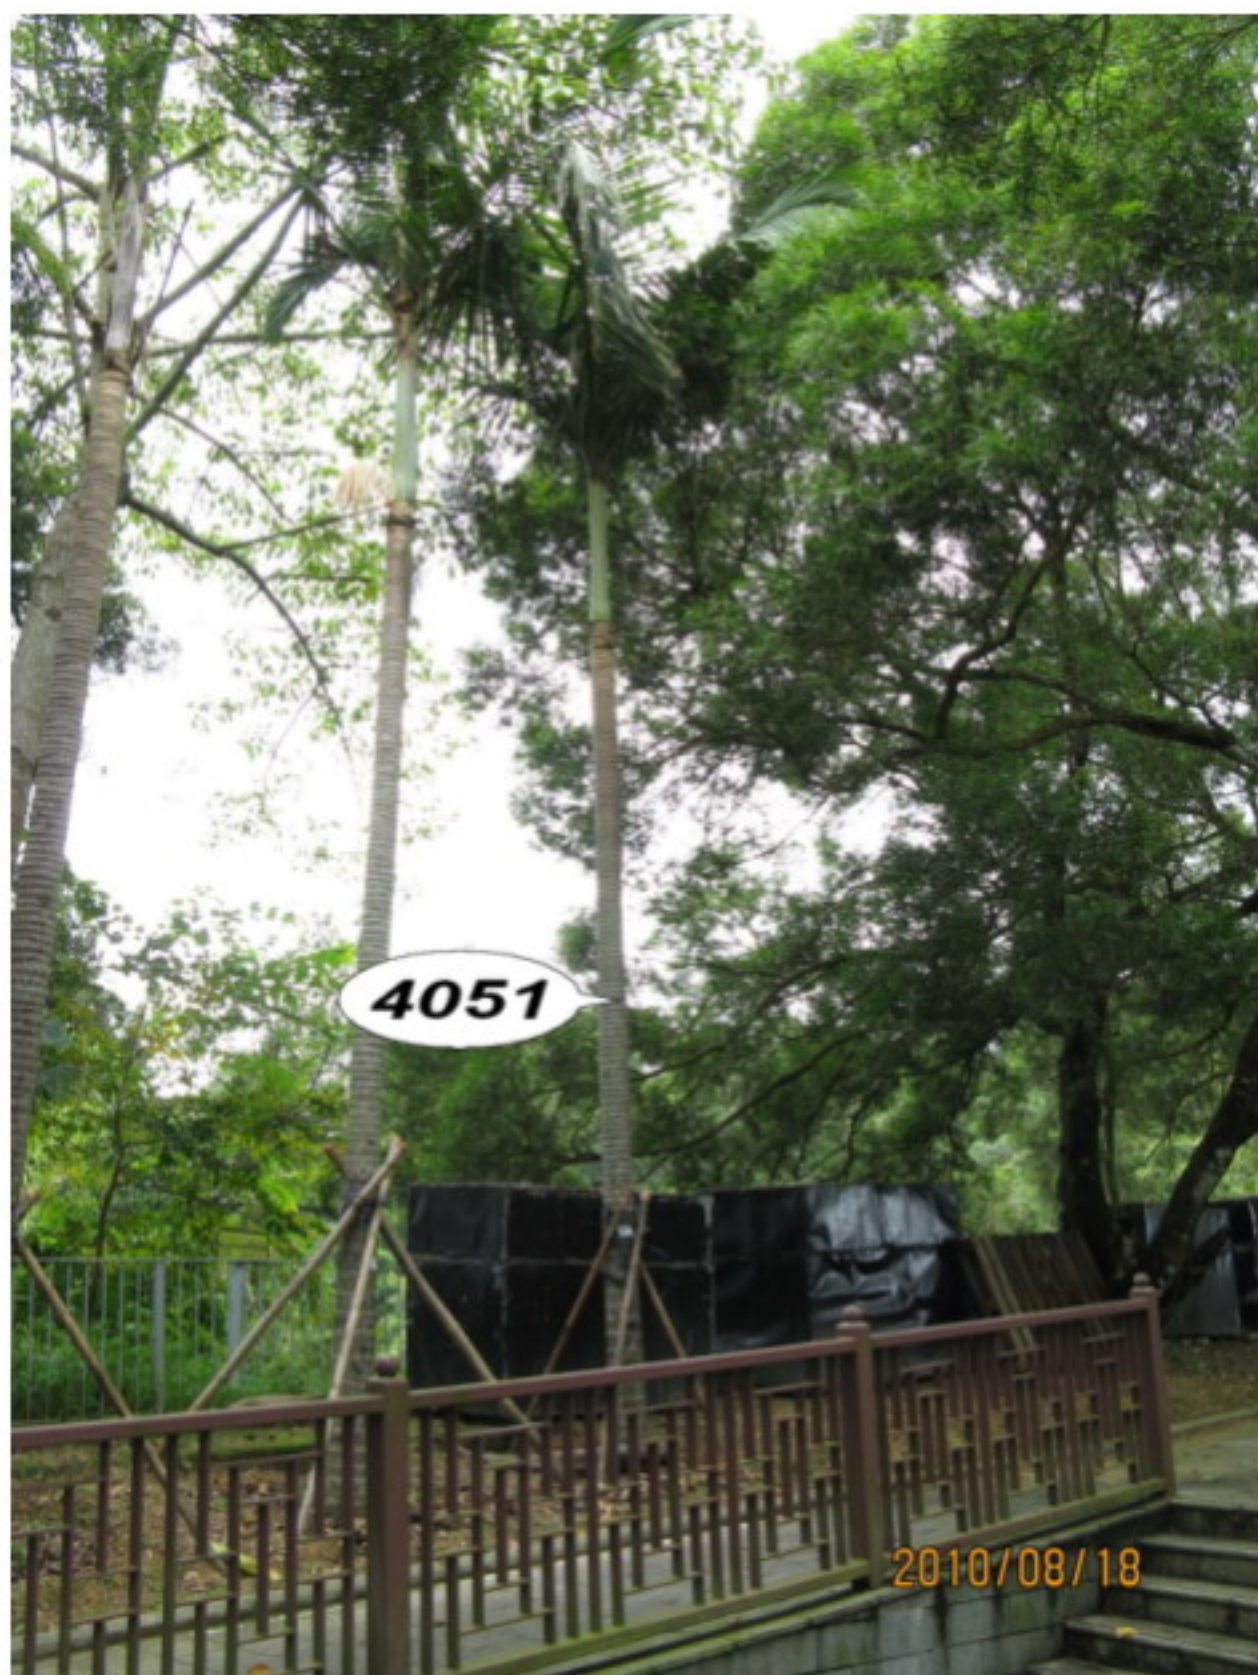
Tree No: 4051

| Tree Number | Species | Chinese name | Height (m) | Diameter (m) | Spread (m) | Remark |
|---|---|---|---|---|---|---|
| 4051 | <i>Archontophoenix alexandrae</i> | 假檳榔 | 5 | 0.18 | 3 | Fair condition, Yellow leave |

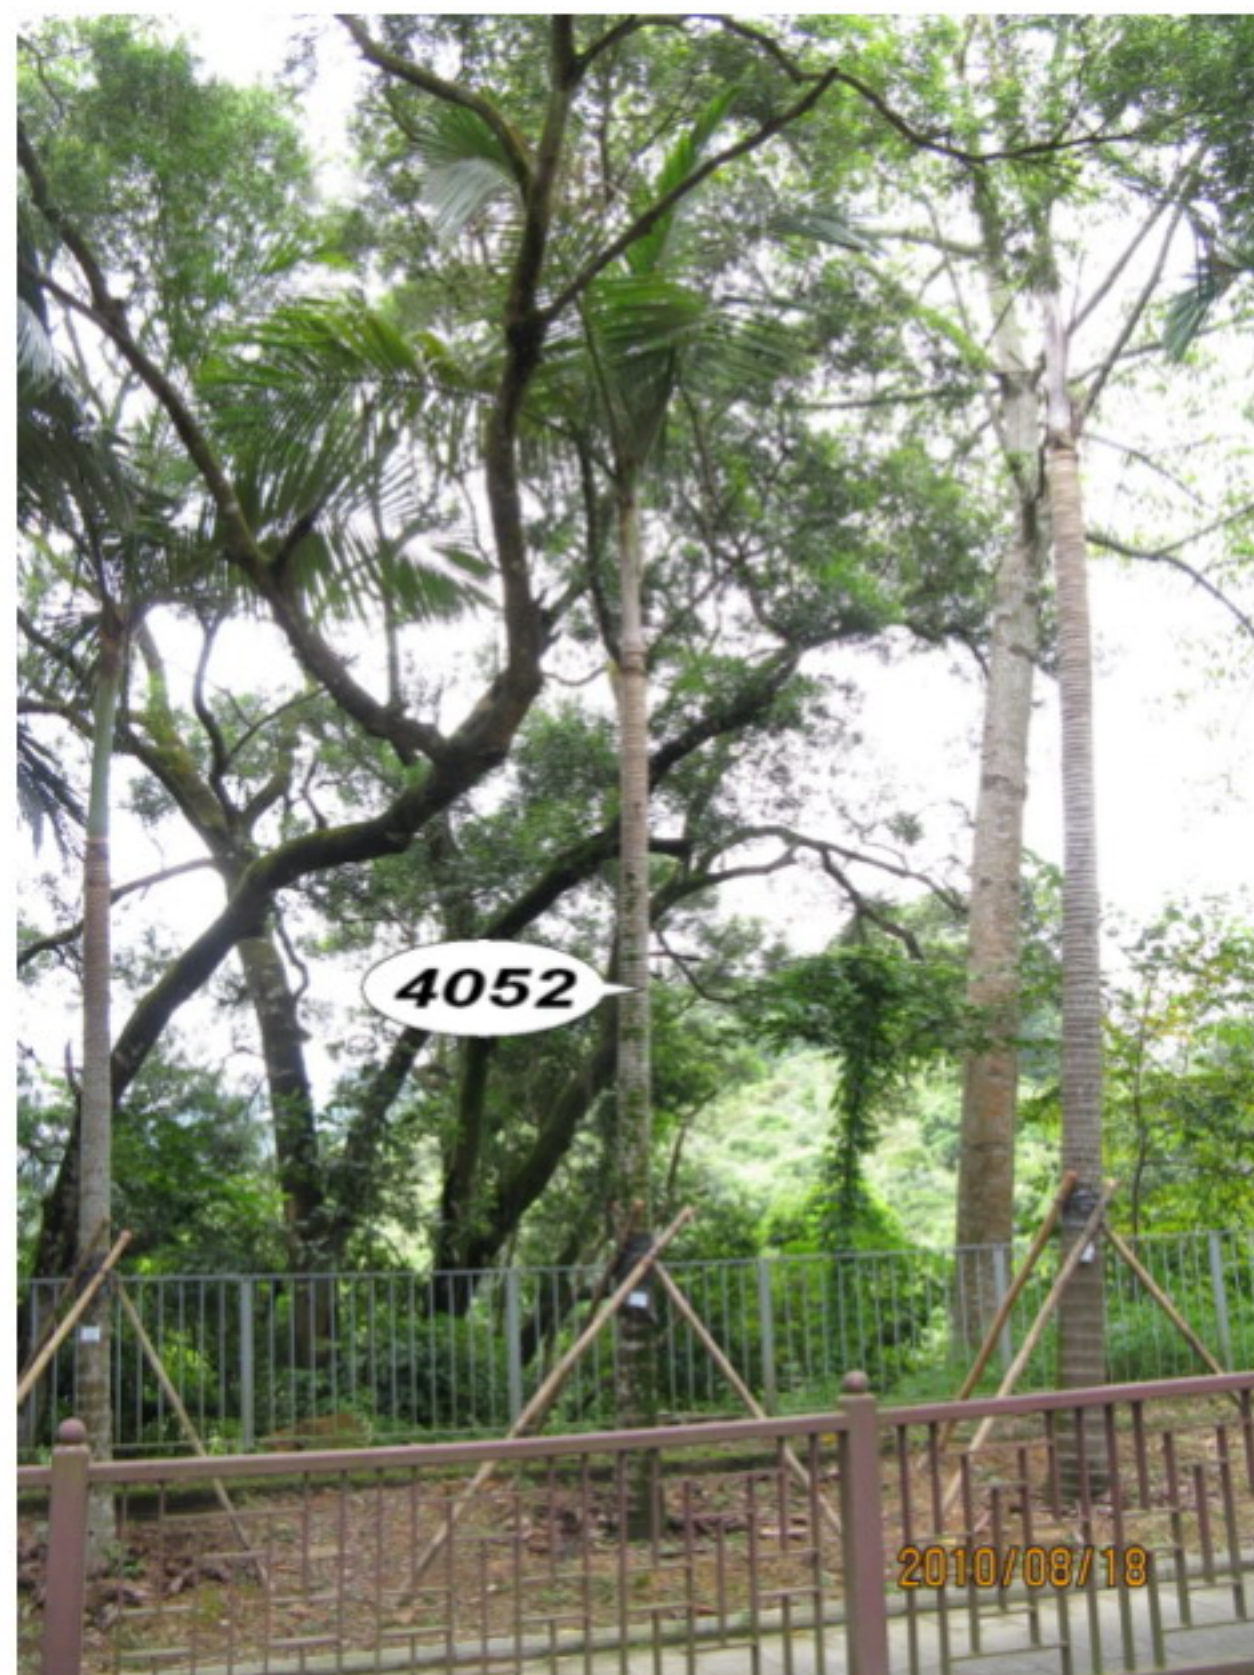
Tree No: 4052

| Tree Number | Species | Chinese name | Height (m) | Diameter (m) | Spread (m) | Remark |
|---|---|---|---|---|---|---|
| 4052 | <i>Archontophoenix alexandrae</i> | 假檳榔 | 5 | 0.17 | 3 | Fair condition, Yellow leave |

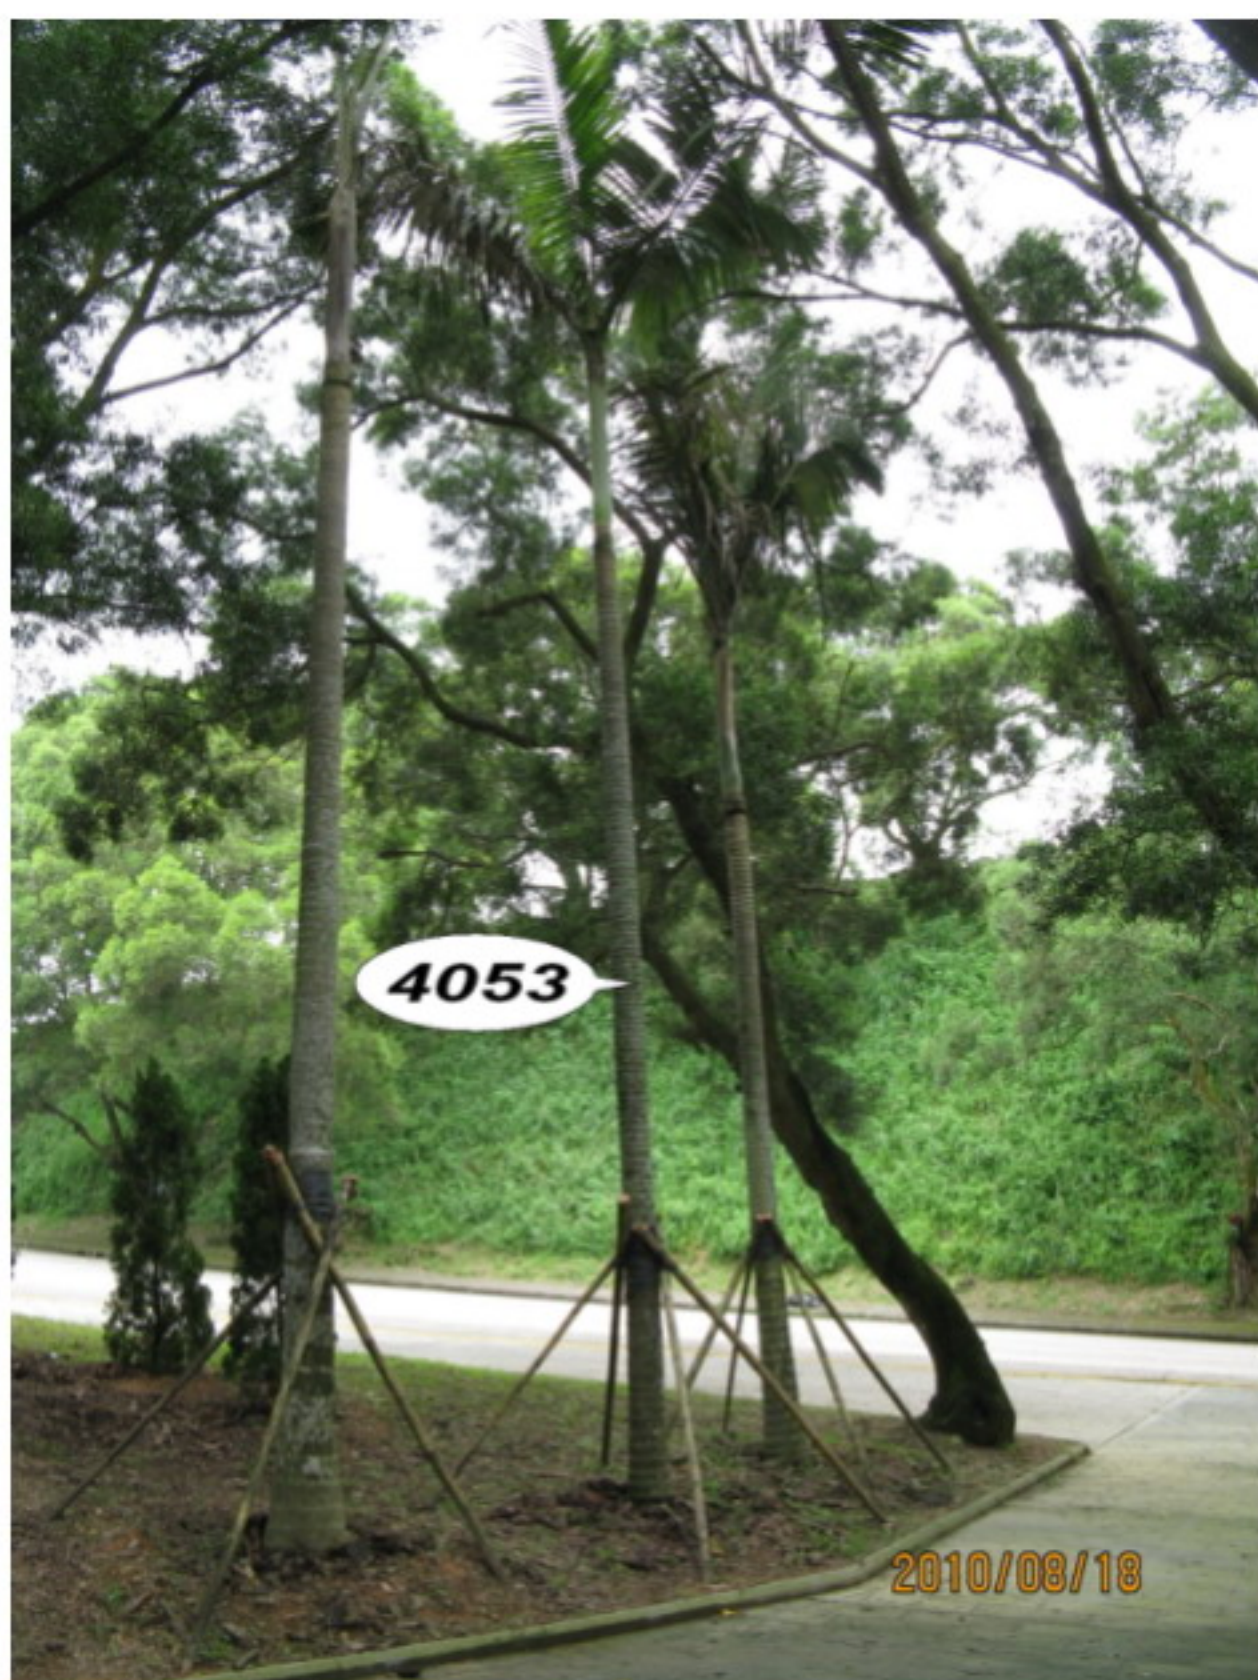
Tree No: 4053

| Tree Number | Species | Chinese name | Height (m) | Diameter (m) | Spread (m) | Remark |
|---|---|---|---|---|---|---|
| 4053 | <i>Archontophoenix alexandrae</i> | 假檳榔 | 4 | 0.2 | 3 | Fair condition, Yellow leave |
