**PROVISION OF CREMATORS AT  
WO HOP SHEK CREMATORIUM**

**ENVIRONMENTAL MONITORING &  
AUDIT REPORT (AUGUST 2010)**

**ALLIED ENVIRONMENTAL CONSULTANTS LTD.**

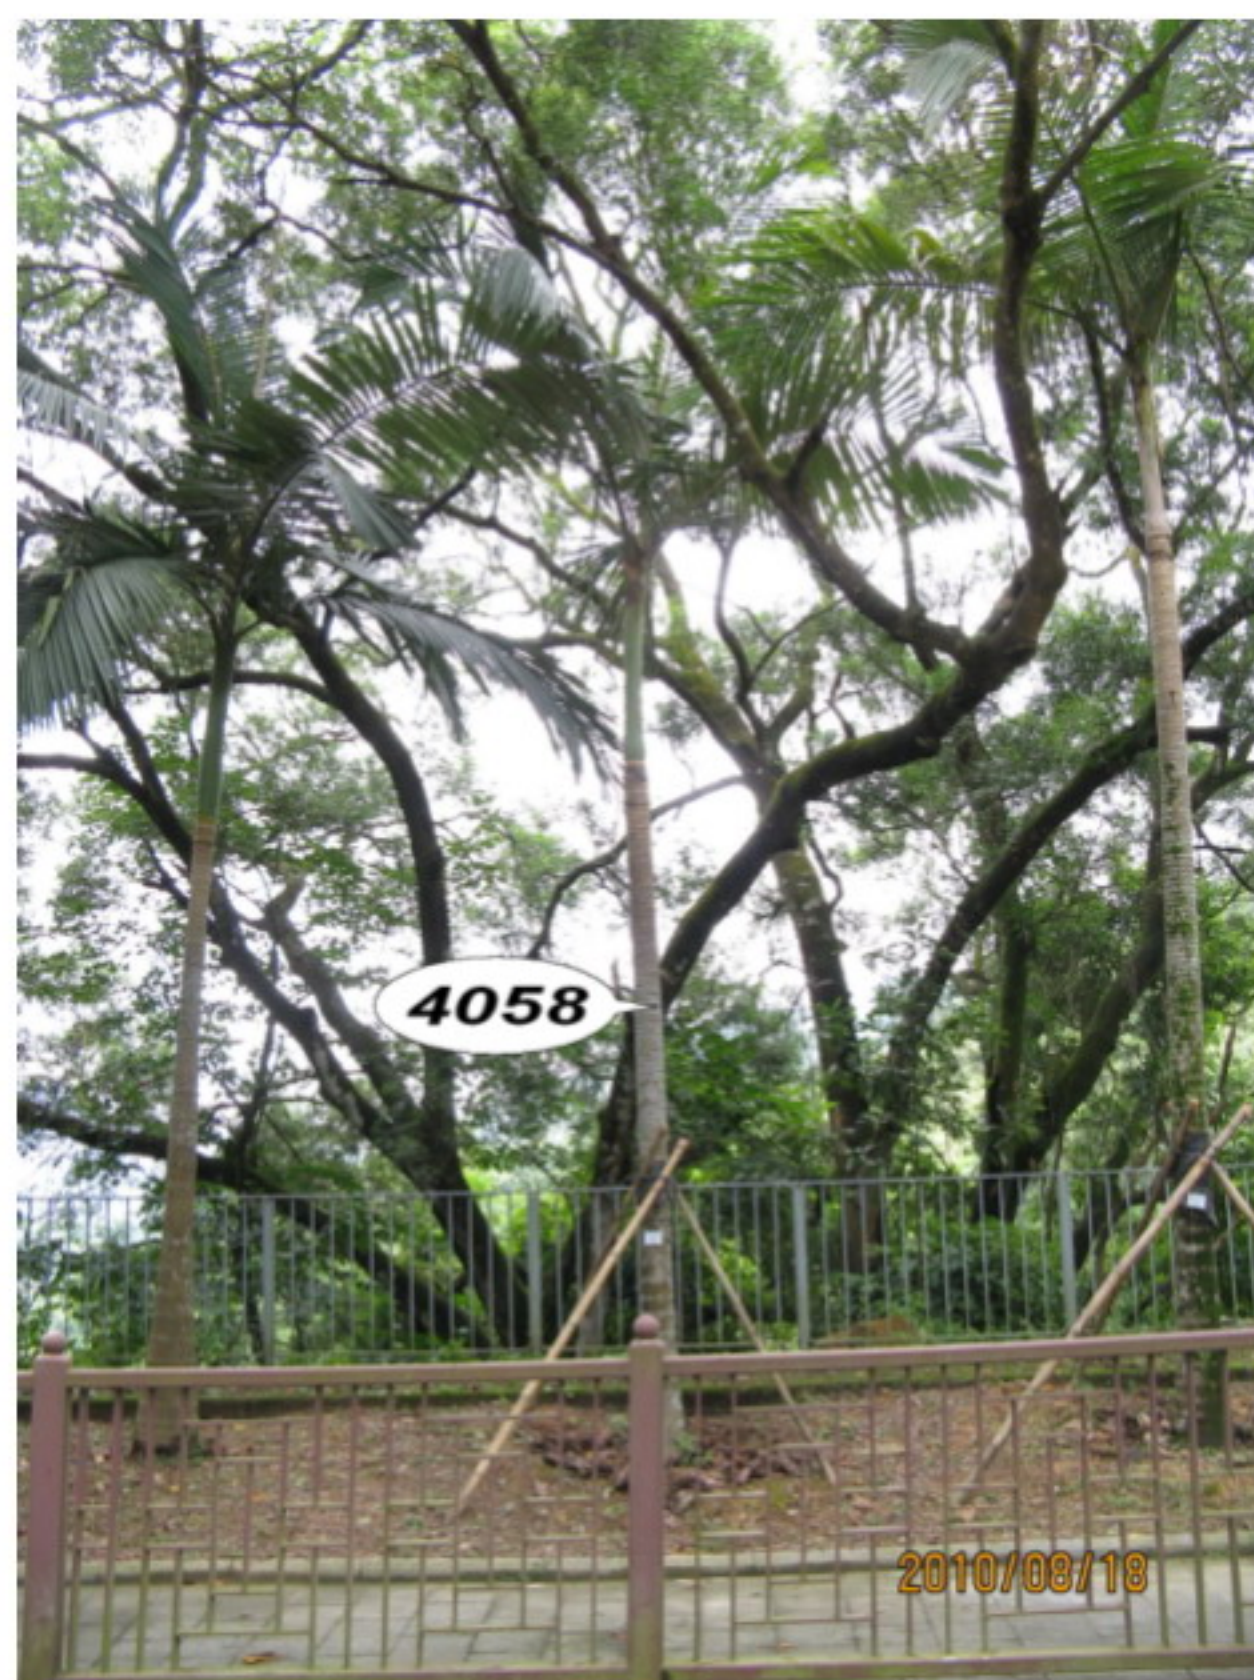
Tree No: 4058

| Tree Number | Species | Chinese name | Height (m) | Diameter (m) | Spread (m) | Remark |
|---|---|---|---|---|---|---|
| 4058 | <i>Archontophoenix alexandrae</i> | 假檳榔 | 4 | 0.15 | 3 | Fair condition, Yellow leave |

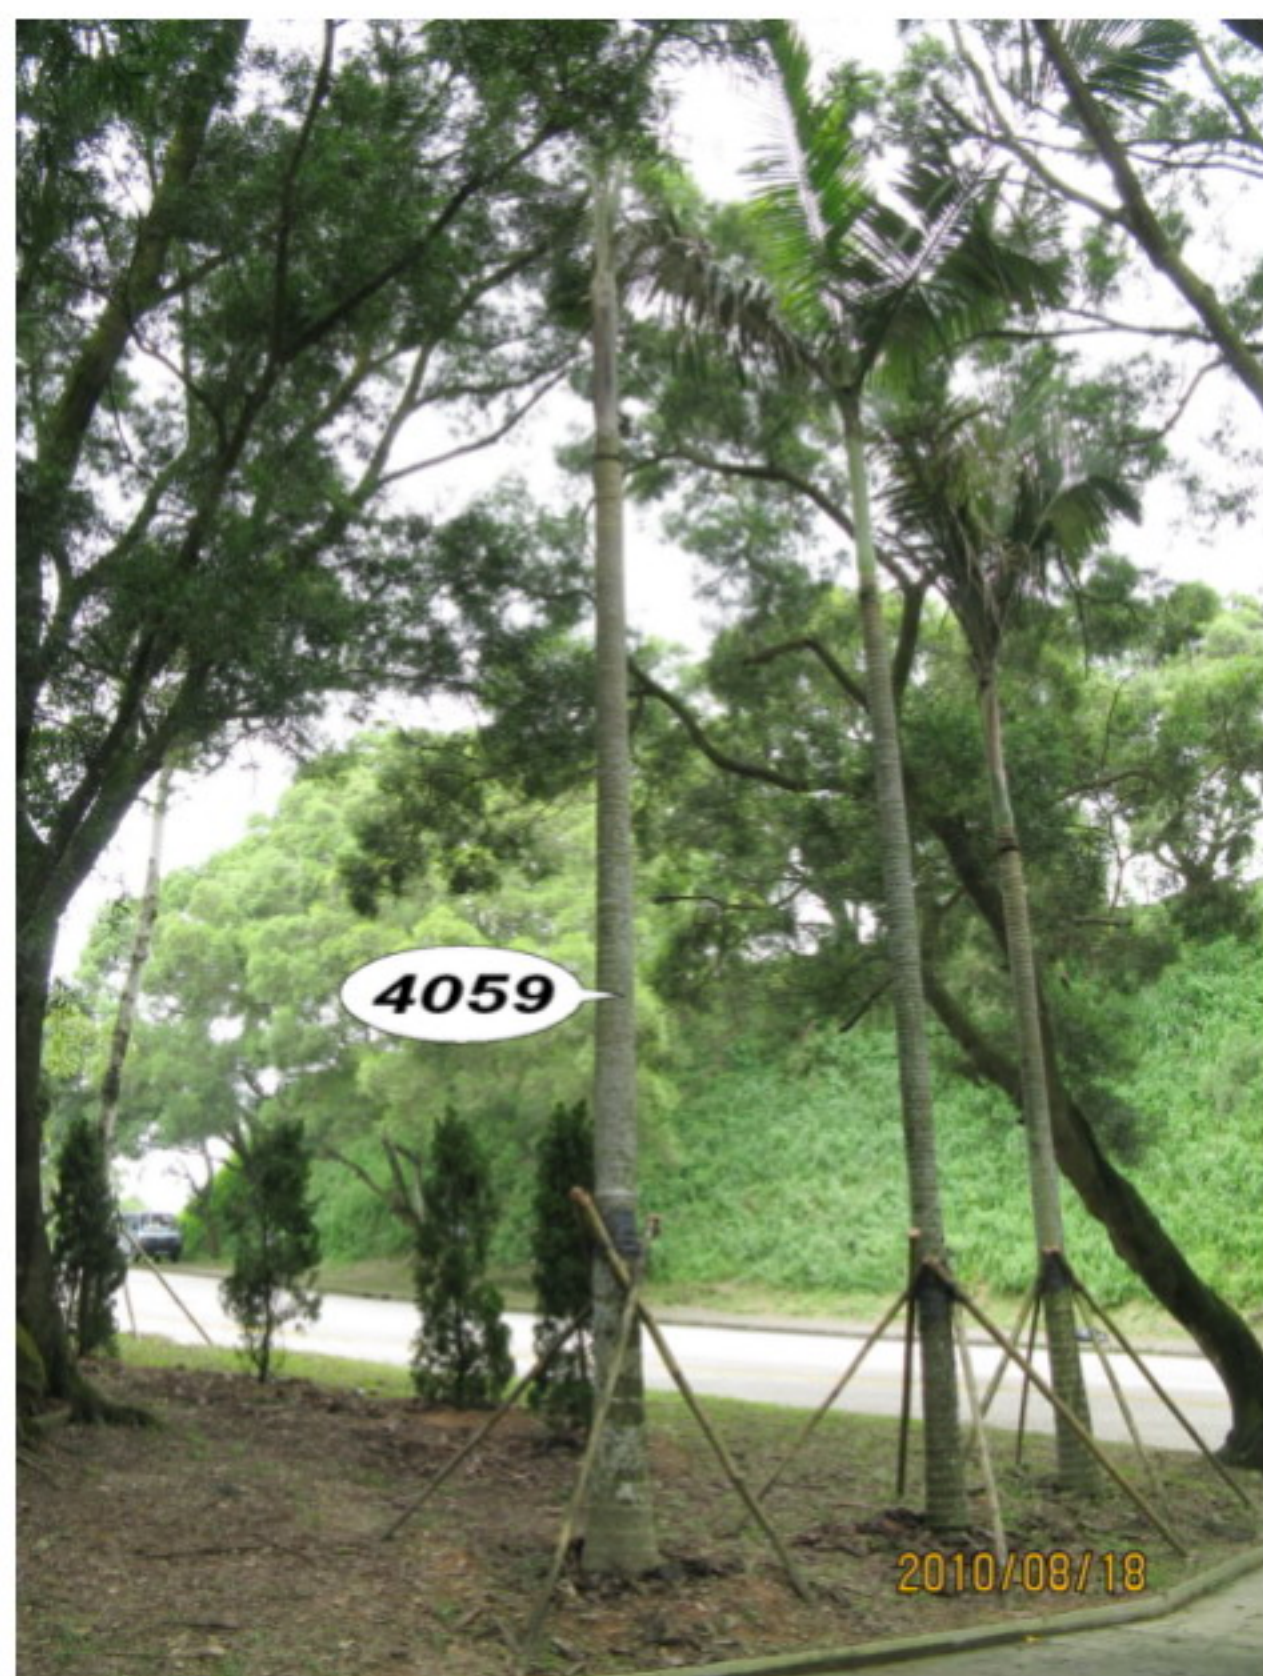
Tree No: 4059

| Tree Number | Species | Chinese name | Height (m) | Diameter (m) | Spread (m) | Remark |
|---|---|---|---|---|---|---|
| 4059 | <i>Archontophoenix alexandrae</i> | 假檳榔 | 6 | 0.23 | 4 | Poor condition, Yellow leave |

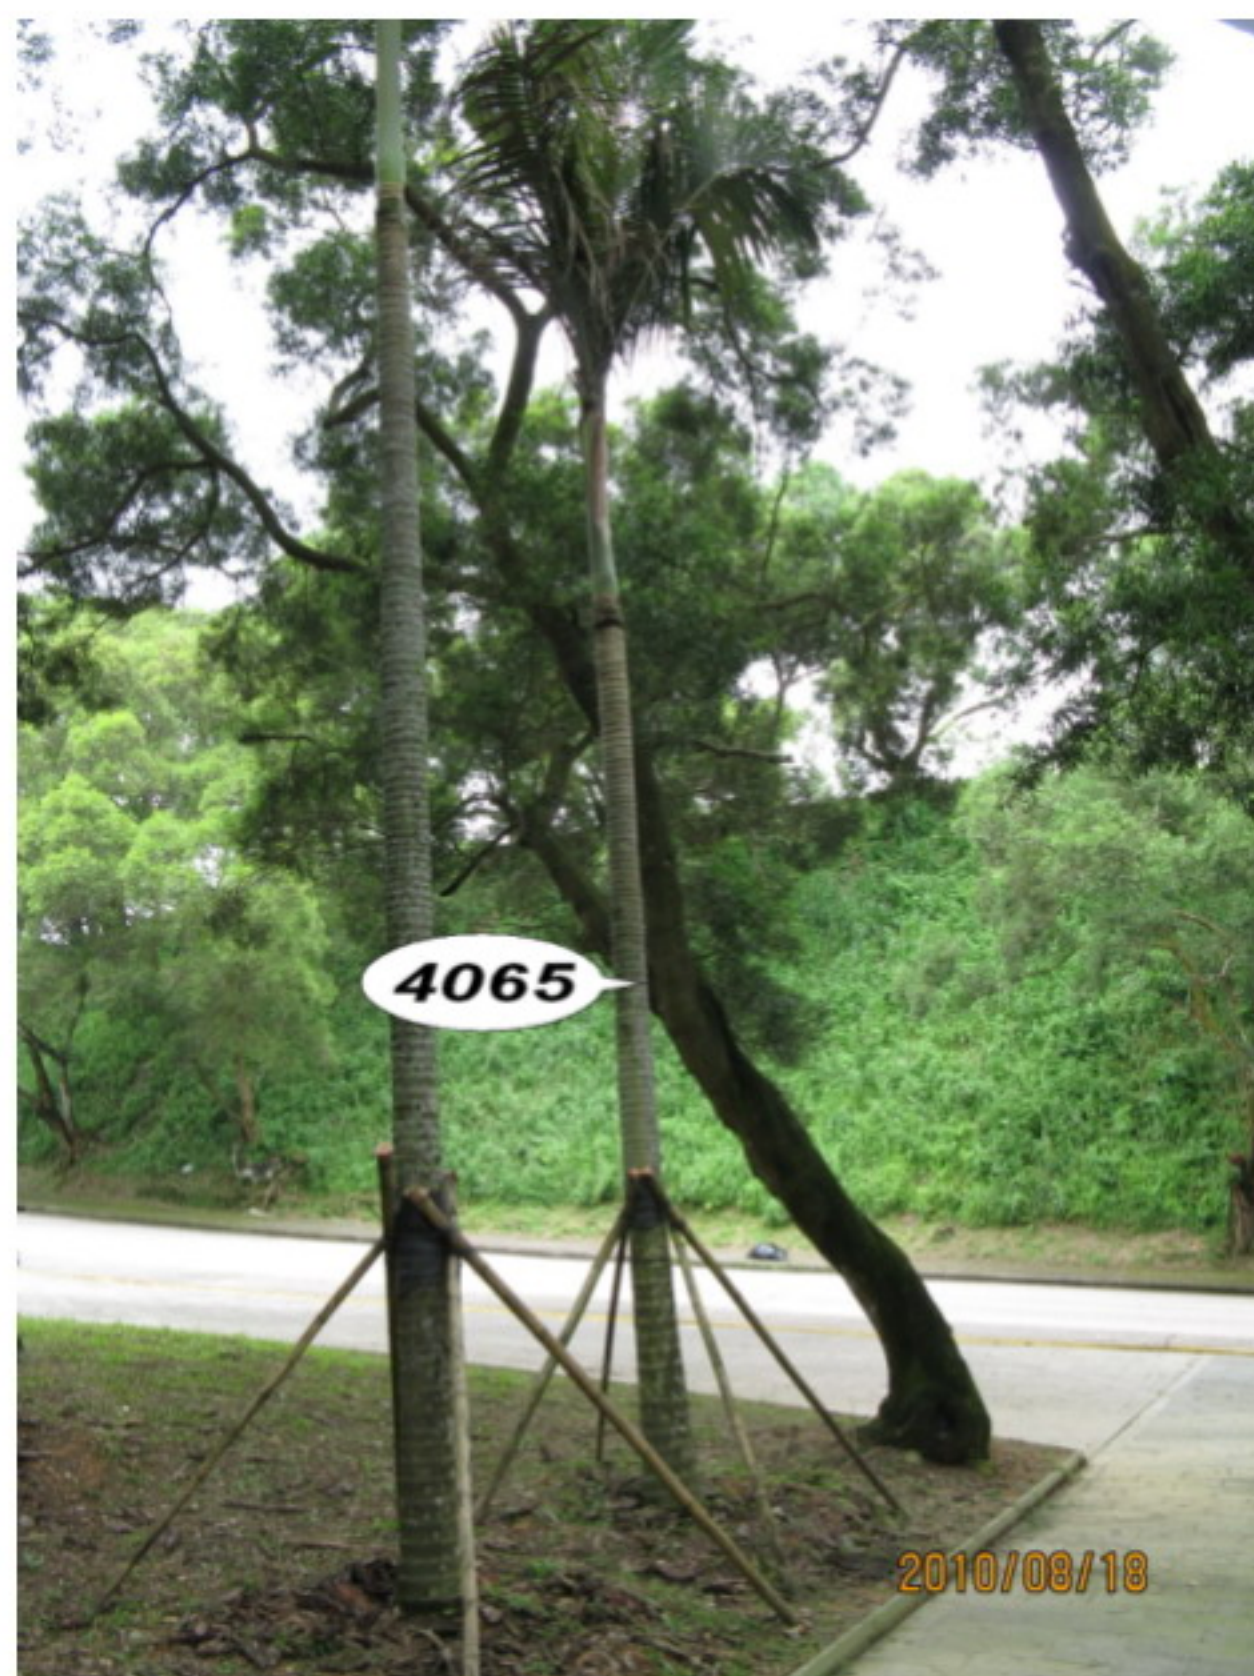
Tree No: 4065

| Tree Number | Species | Chinese name | Height (m) | Diameter (m) | Spread (m) | Remark |
|---|---|---|---|---|---|---|
| 4065 | <i>Archontophoenix alexandrae</i> | 假檳榔 | 7 | 0.21 | 4 | Fair condition, Yellow leave |

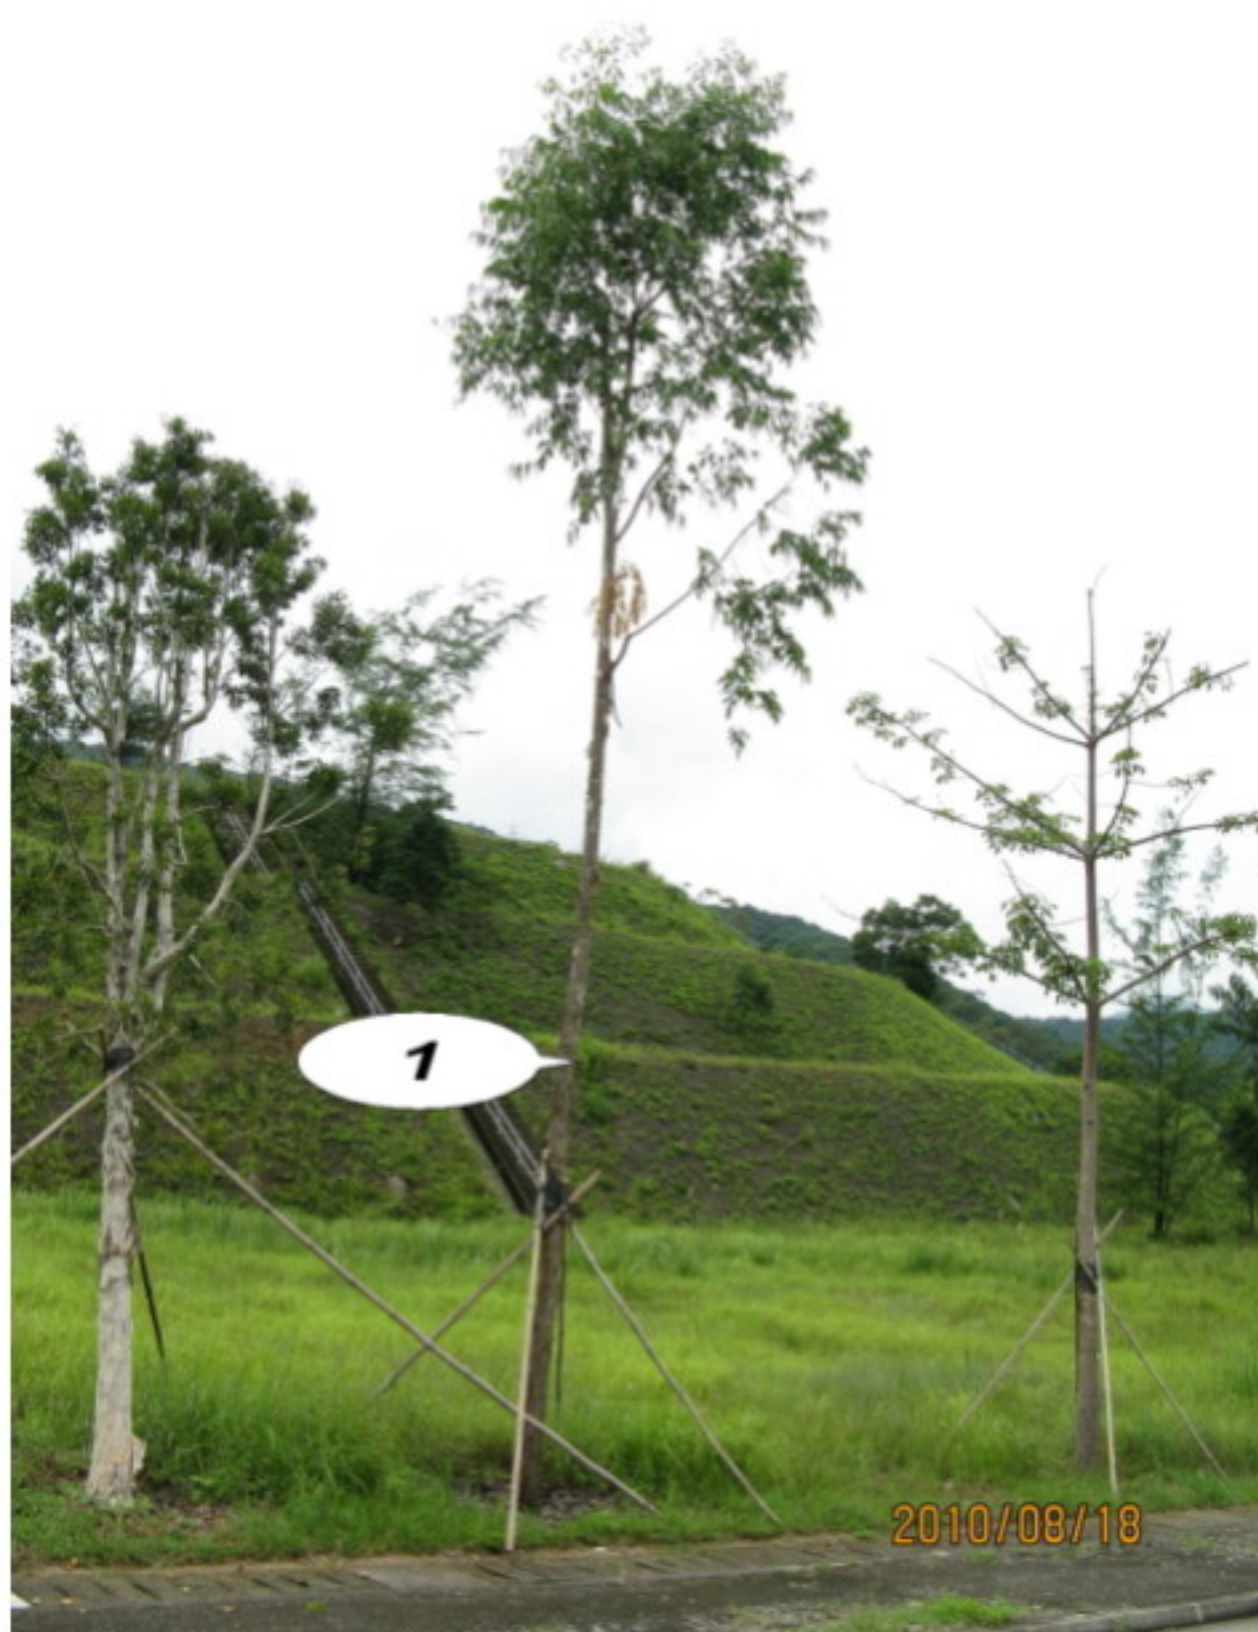
Tree No: 1

| | | | | | | Remark |
|---|---|---|---|---|---|---|
| 1 | <i>Eucalyptus citriodora</i> | 檸檬桉 | 6 | 0.2 | 1.5 | Fair condition |

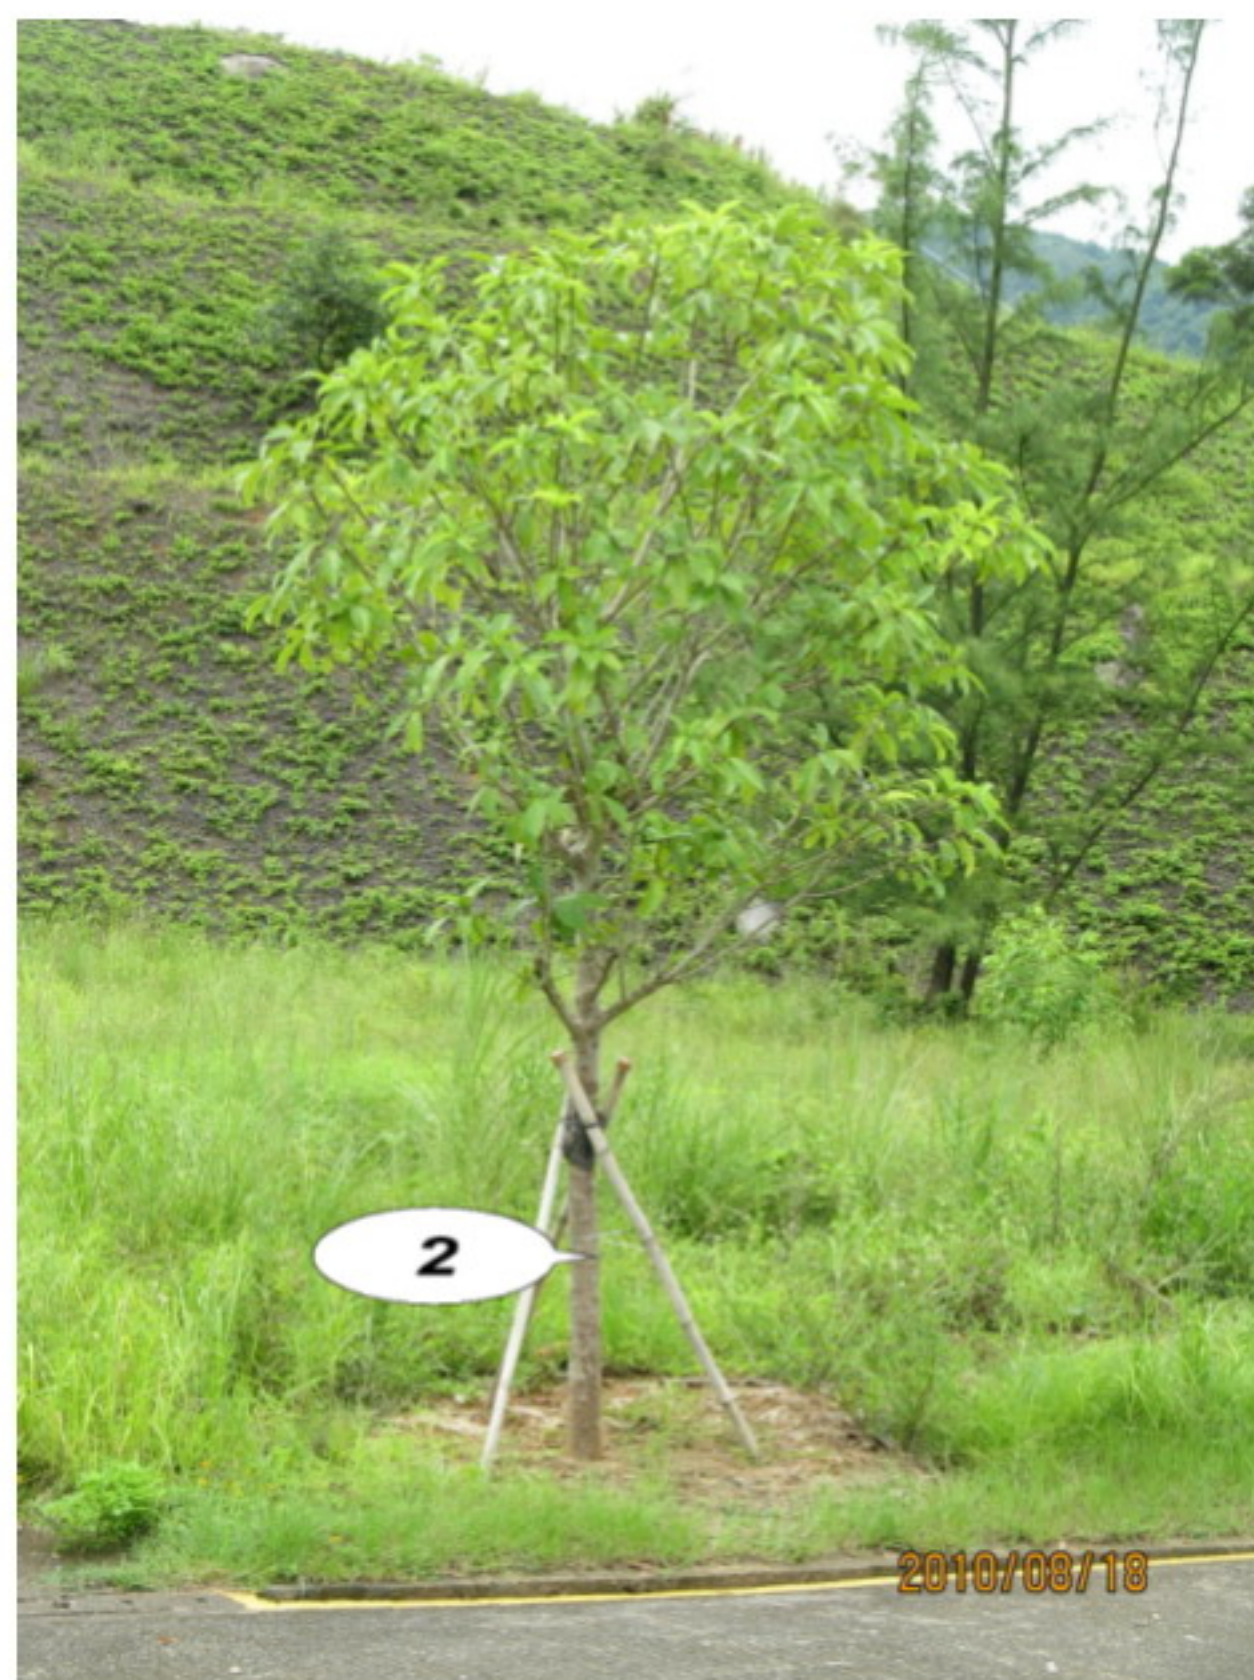
Tree No: 2

| | | | | | | Remark |
|---|---|---|---|---|---|---|
| 2 | <i>Ficus hispida</i> | 對葉榕 | 2 | 0.1 | 1.5 | Fair condition |

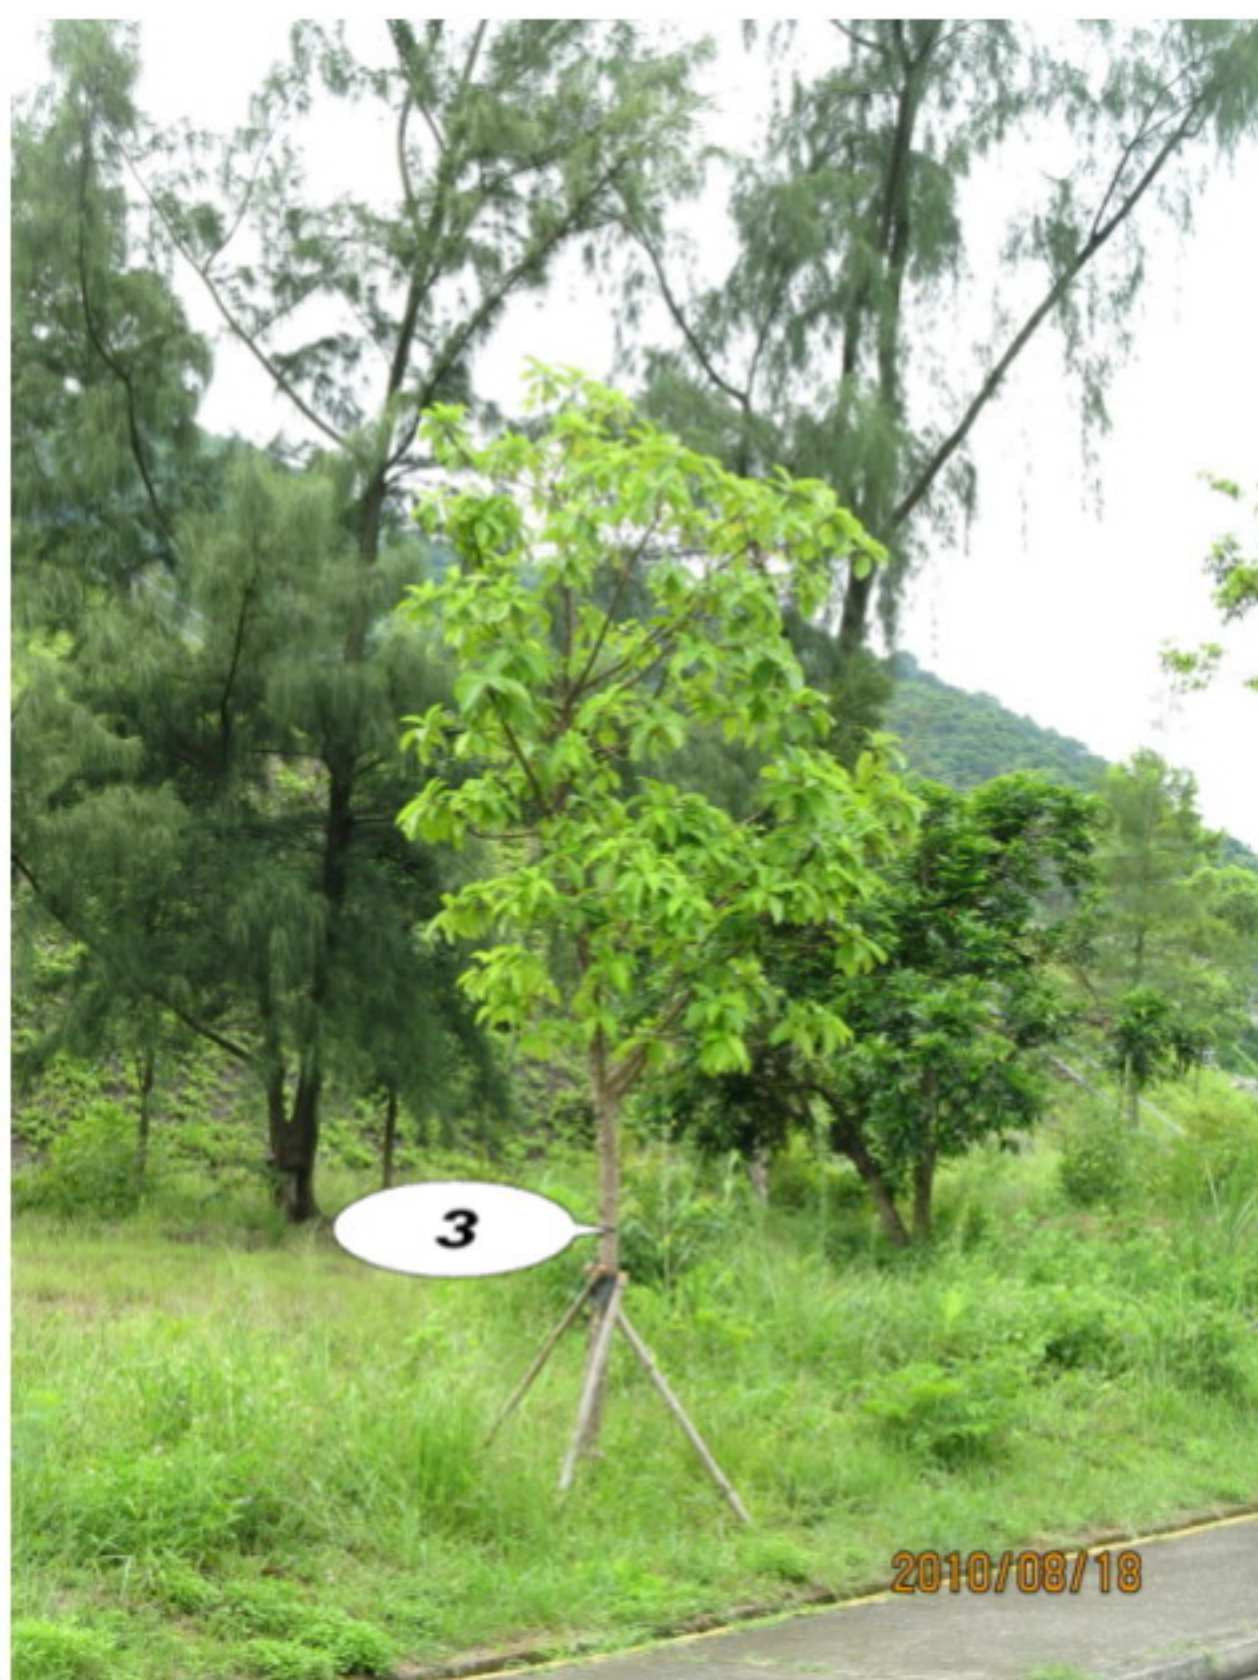
Tree No: 3

| | | | | | | Remark |
|---|---|---|---|---|---|---|
| 3 | <i>Ficus hispida</i> | 對葉榕 | 2 | 0.1 | 1.5 | Fair condition |

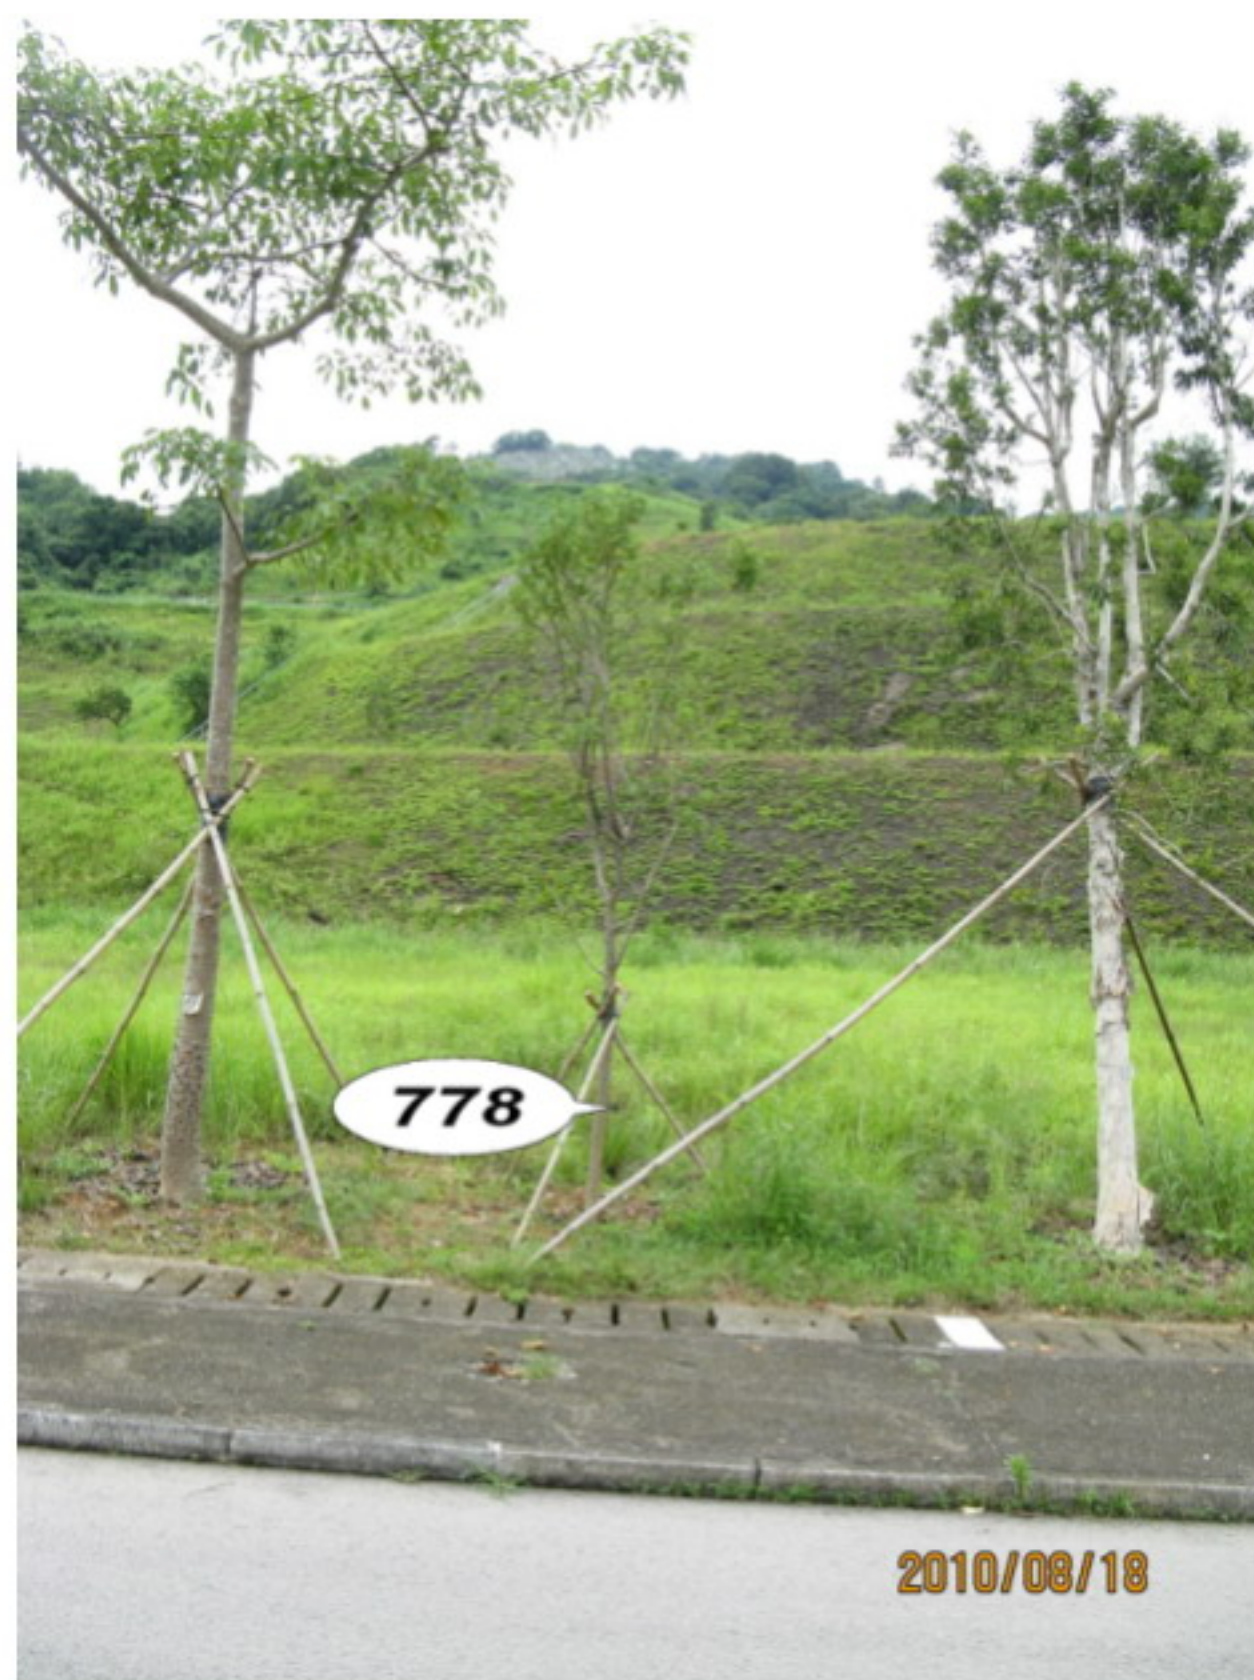
Tree No: 778

| | | | | | | Remark |
|---|---|---|---|---|---|---|
| 778 | <i>Bauhinia variegata</i> | 宮粉羊蹄甲 | 2.5 | 0.1 | 1.5 | Fair condition, Sparse crown |

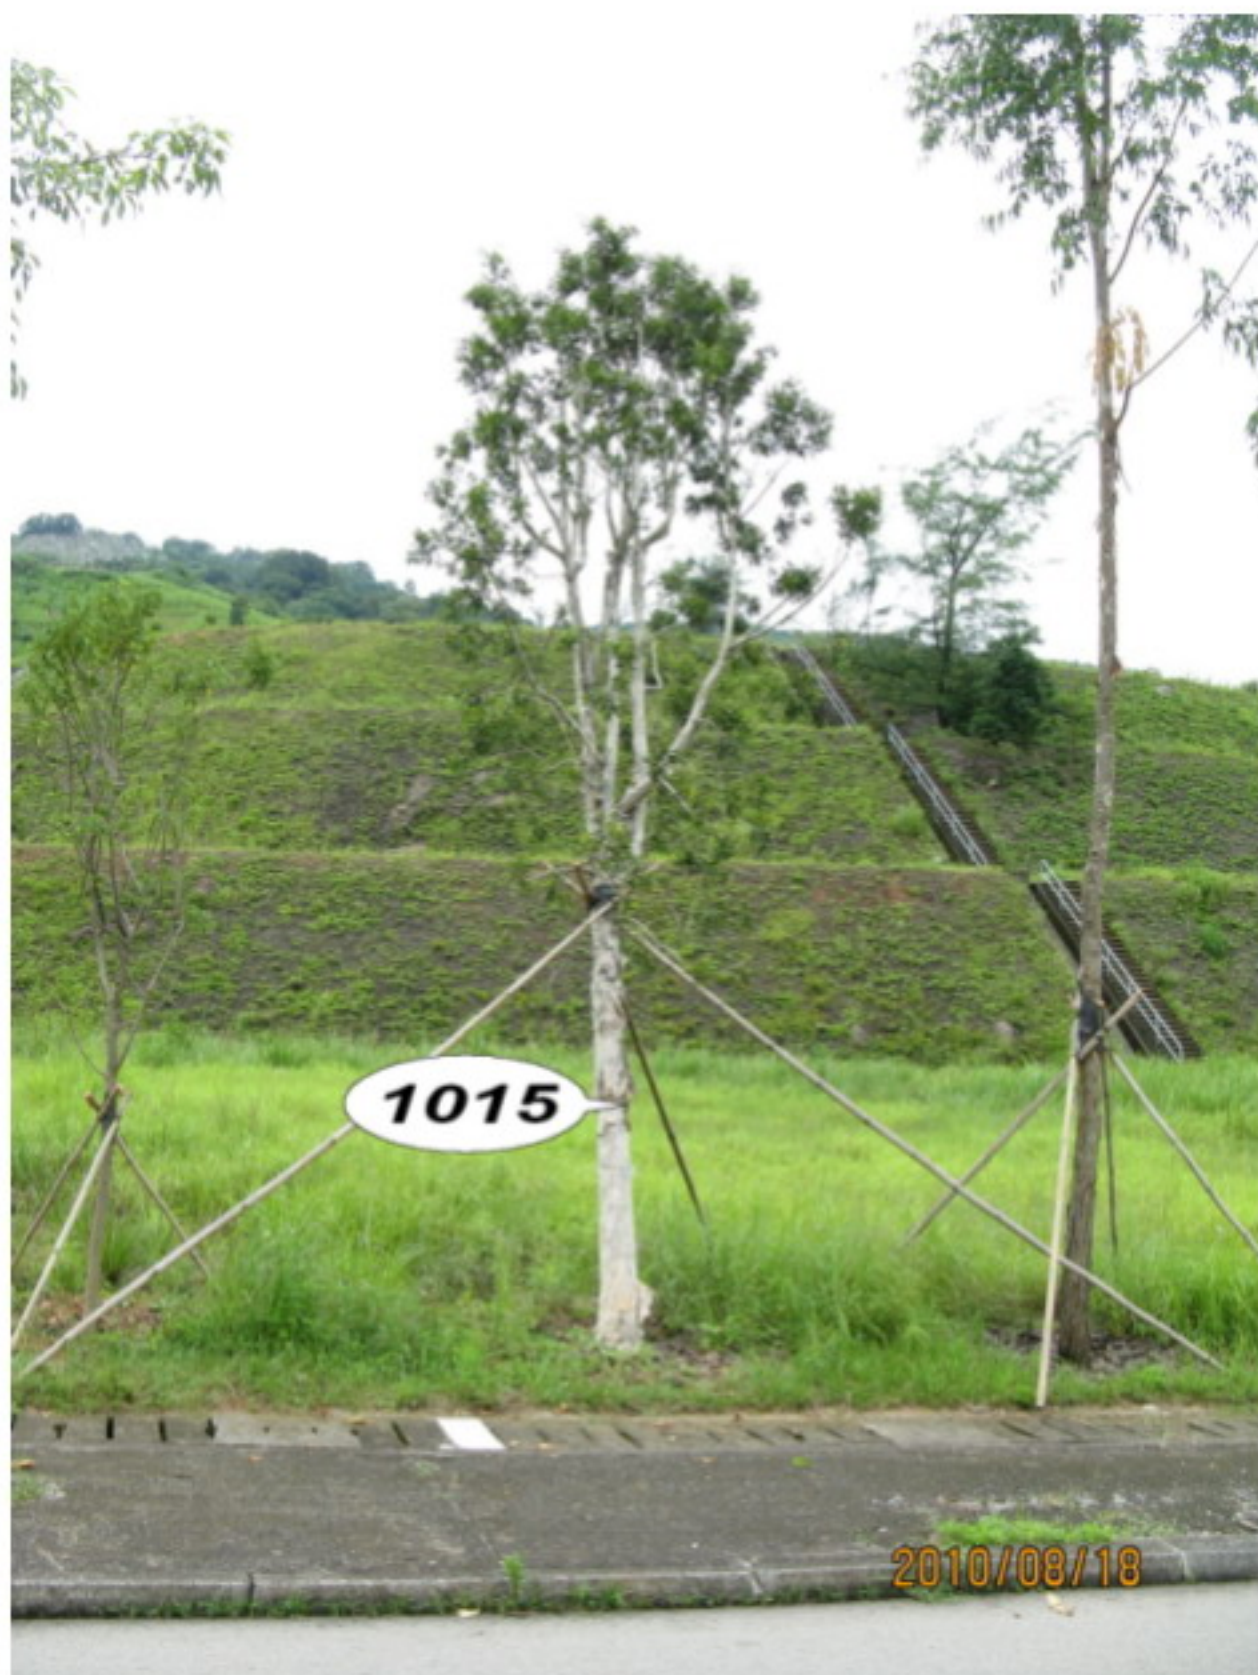
Tree No: 1015

| | | | | | | Remark |
|---|---|---|---|---|---|---|
| 1015 | <i>Melaleuca quinquenervia</i> | 白千層 | 4 | 0.1 | 1.5 | Fair condition, Sparse crown |

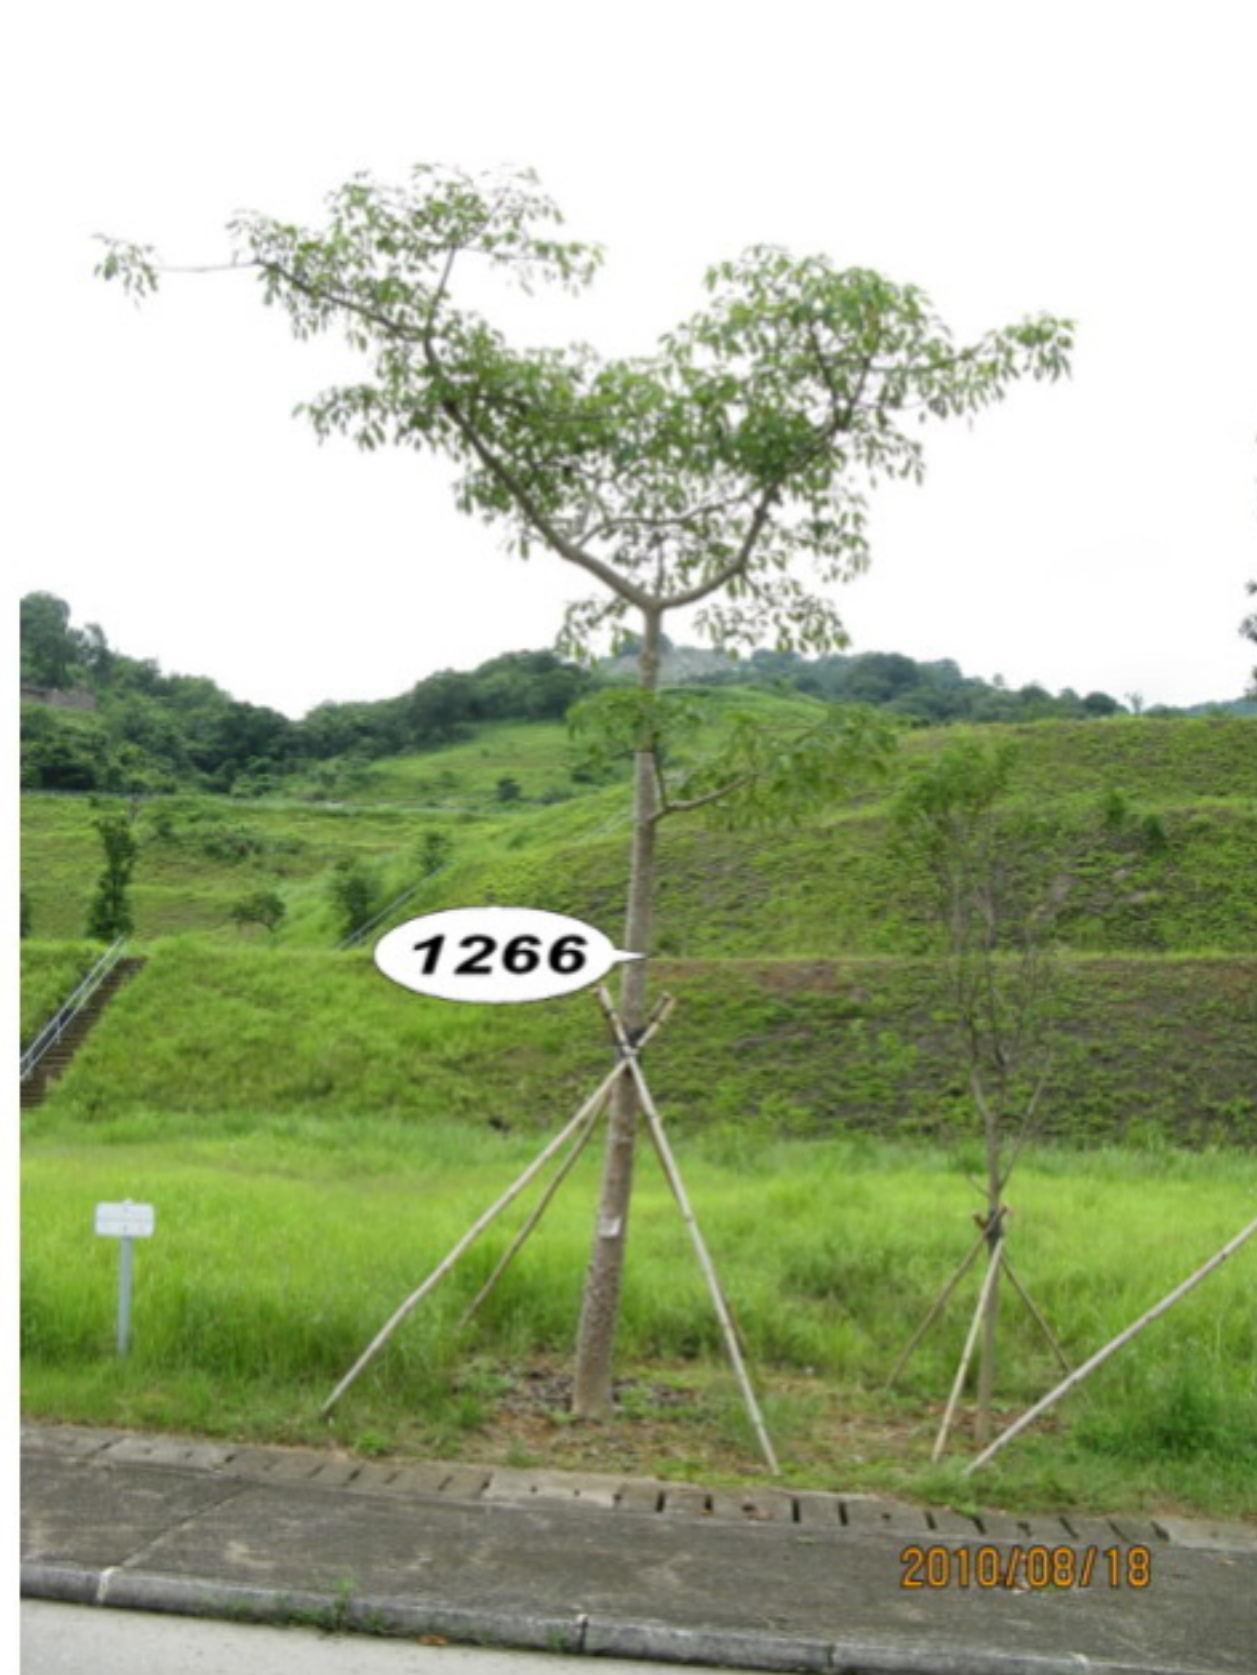
Tree No: 1266

| | | | | | | Remark |
|---|---|---|---|---|---|---|
| 1266 | <i>Bombax ceiba</i> | 木棉 | 4 | 0.15 | 3 | Poor condition, Leave regenerating |

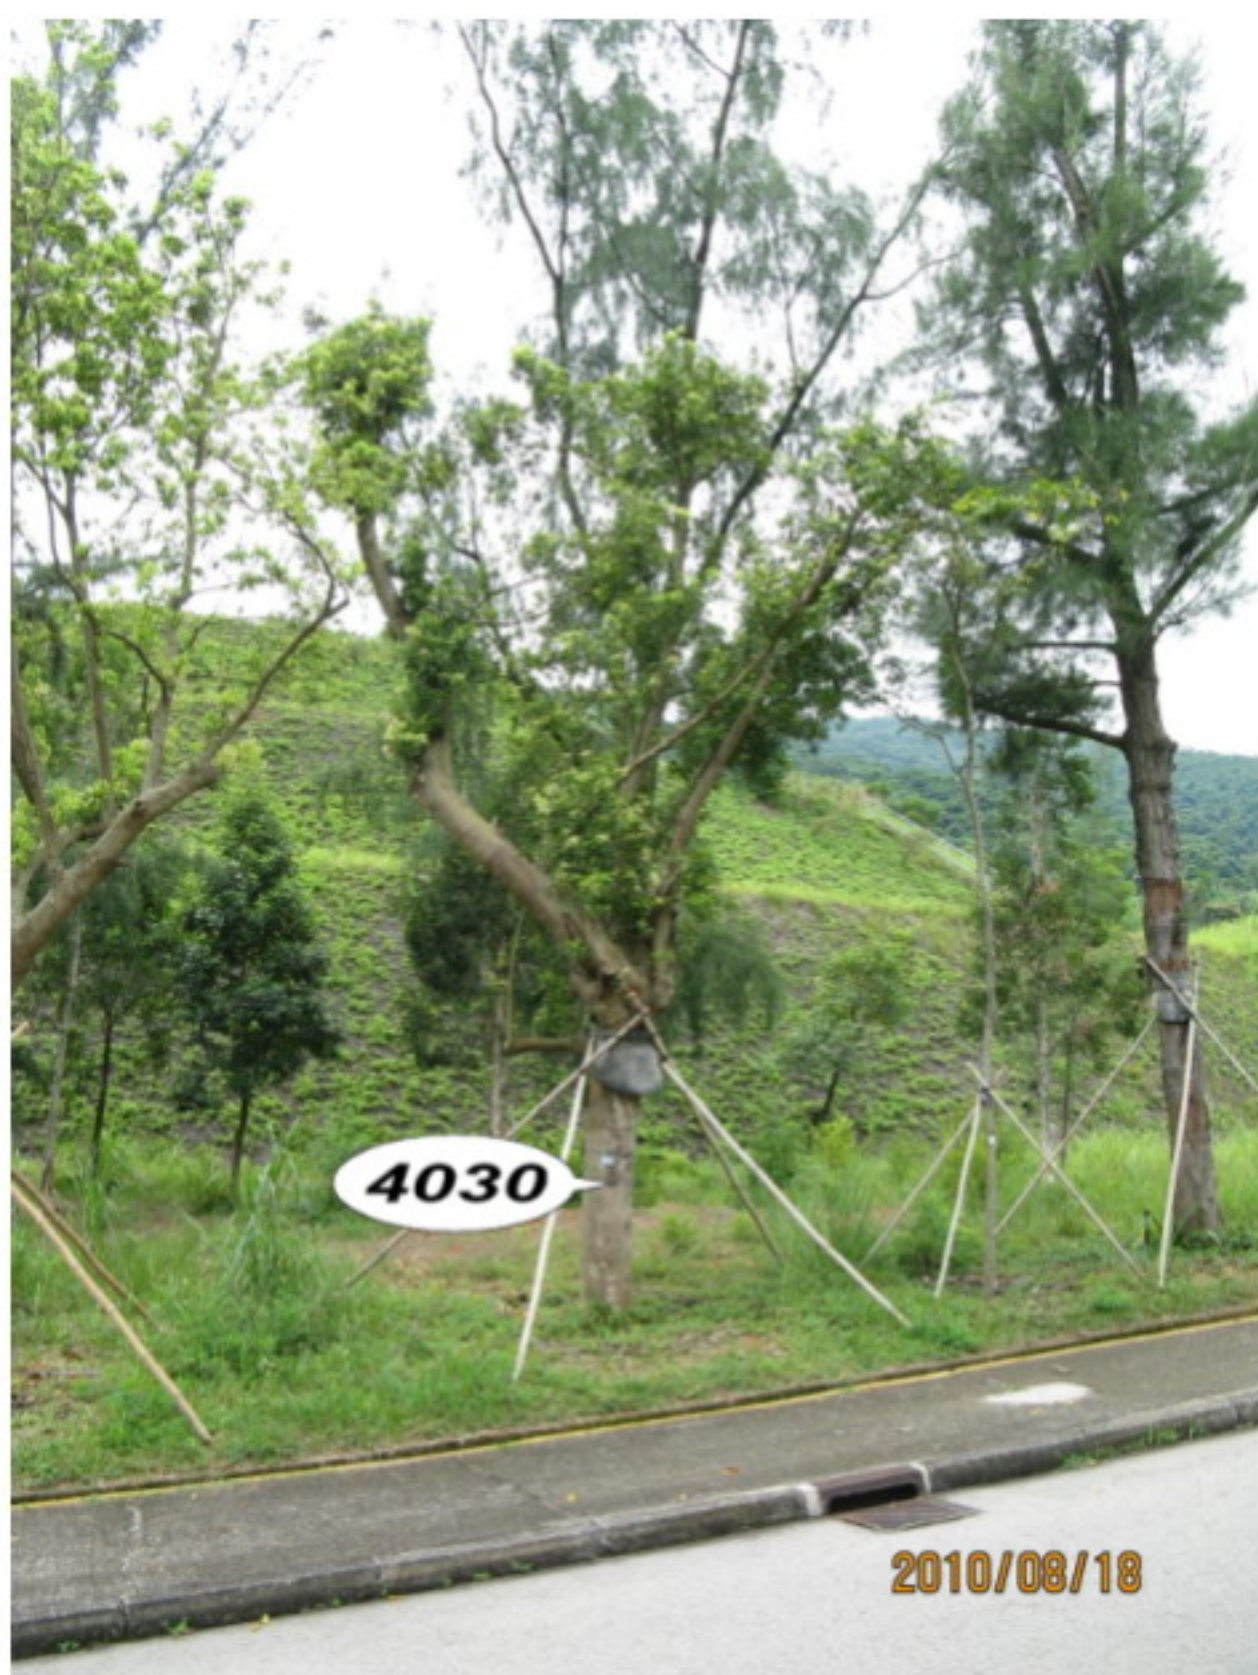
Tree No: 4030

| | | | | | | Remark |
|---|---|---|---|---|---|---|
| 4030 | <i>Cinnamomum burmannii</i> | 陰香 | 5.5 | 0.16 | 4 | Poor condition, Fork, Pruned, Decay, Leave regenerating |
