**PROVISION OF CREMATORS AT  
WO HOP SHEK CREMATORIUM**

**ENVIRONMENTAL MONITORING &  
AUDIT REPORT (AUGUST 2010)**

**ALLIED ENVIRONMENTAL CONSULTANTS LTD.**

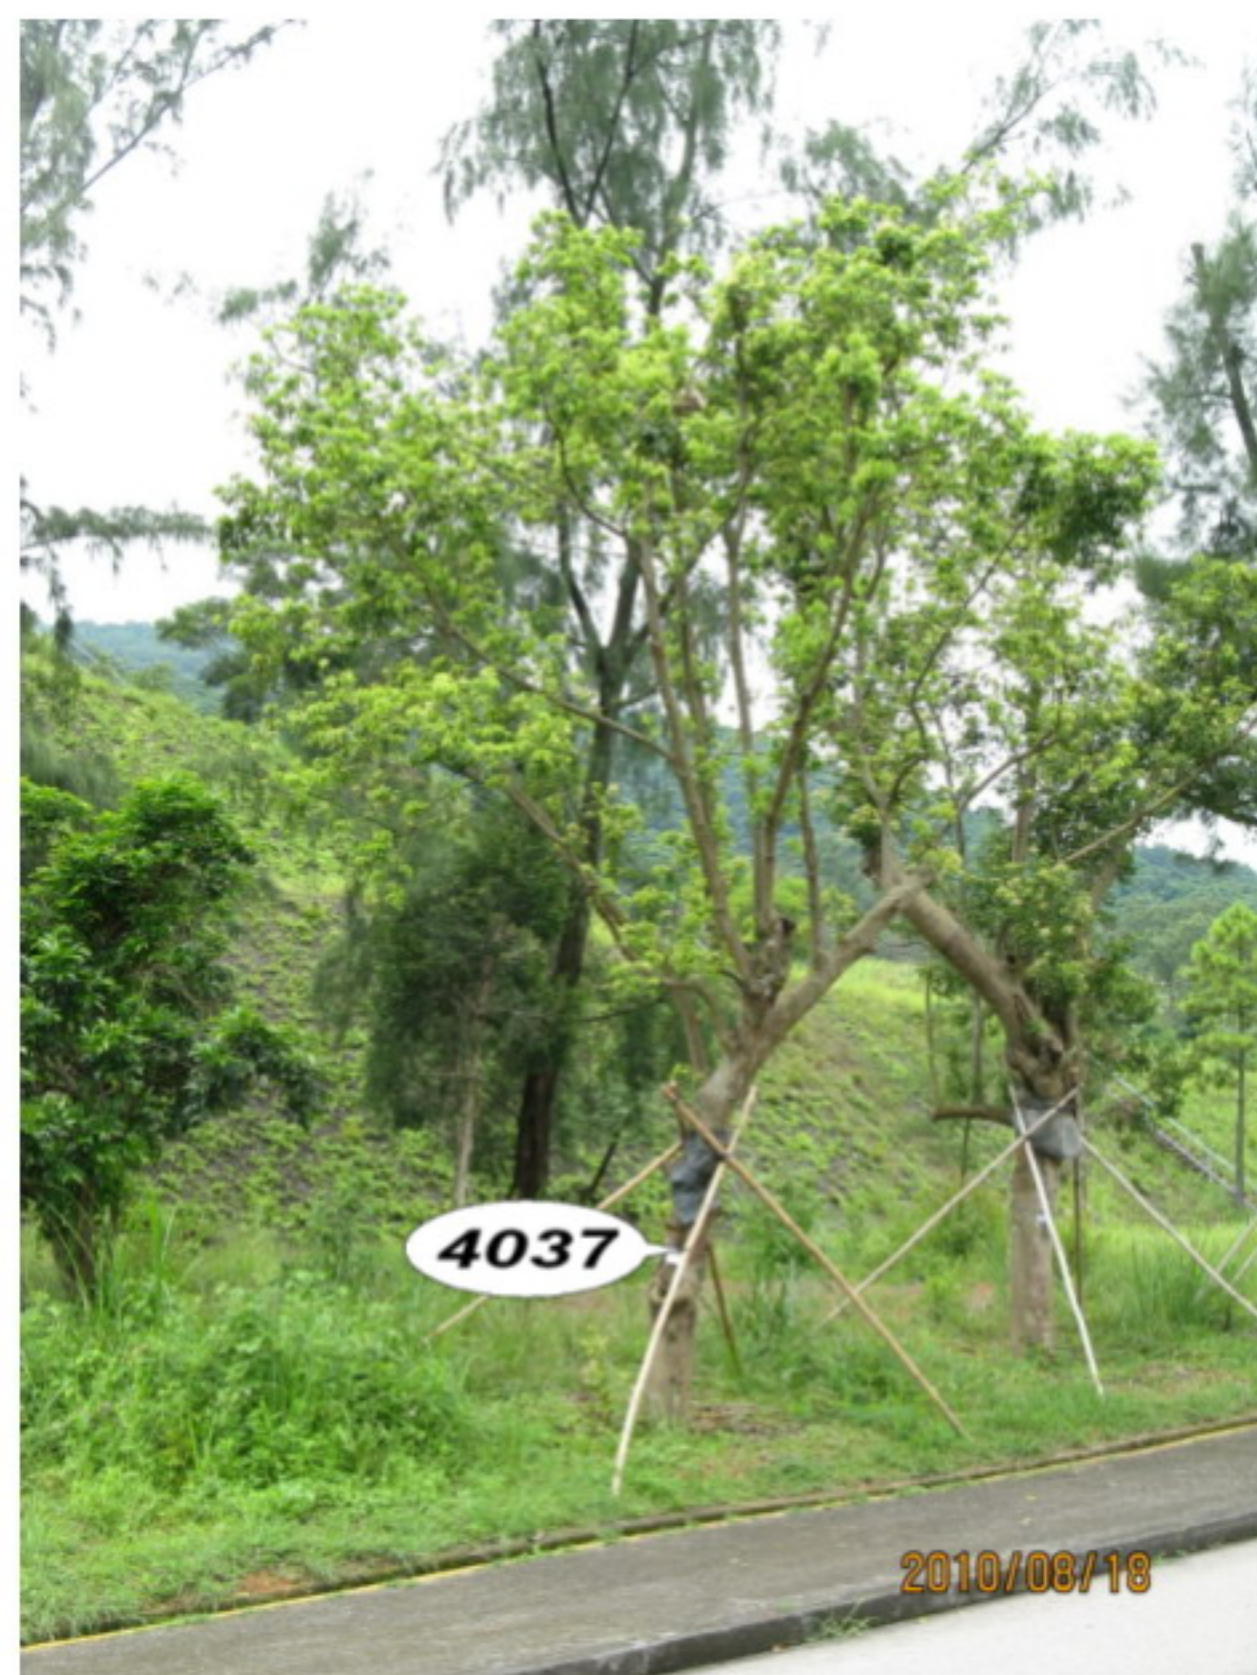
Tree No: 4037

| | | | | | | Remark |
|---|---|---|---|---|---|---|
| 4037 | <i>Cinnamomum burmannii</i> | 陰香 | 6 | 0.25 | 4 | Poor condition, Fork, Pruned, Cavity, Leave regenerating |

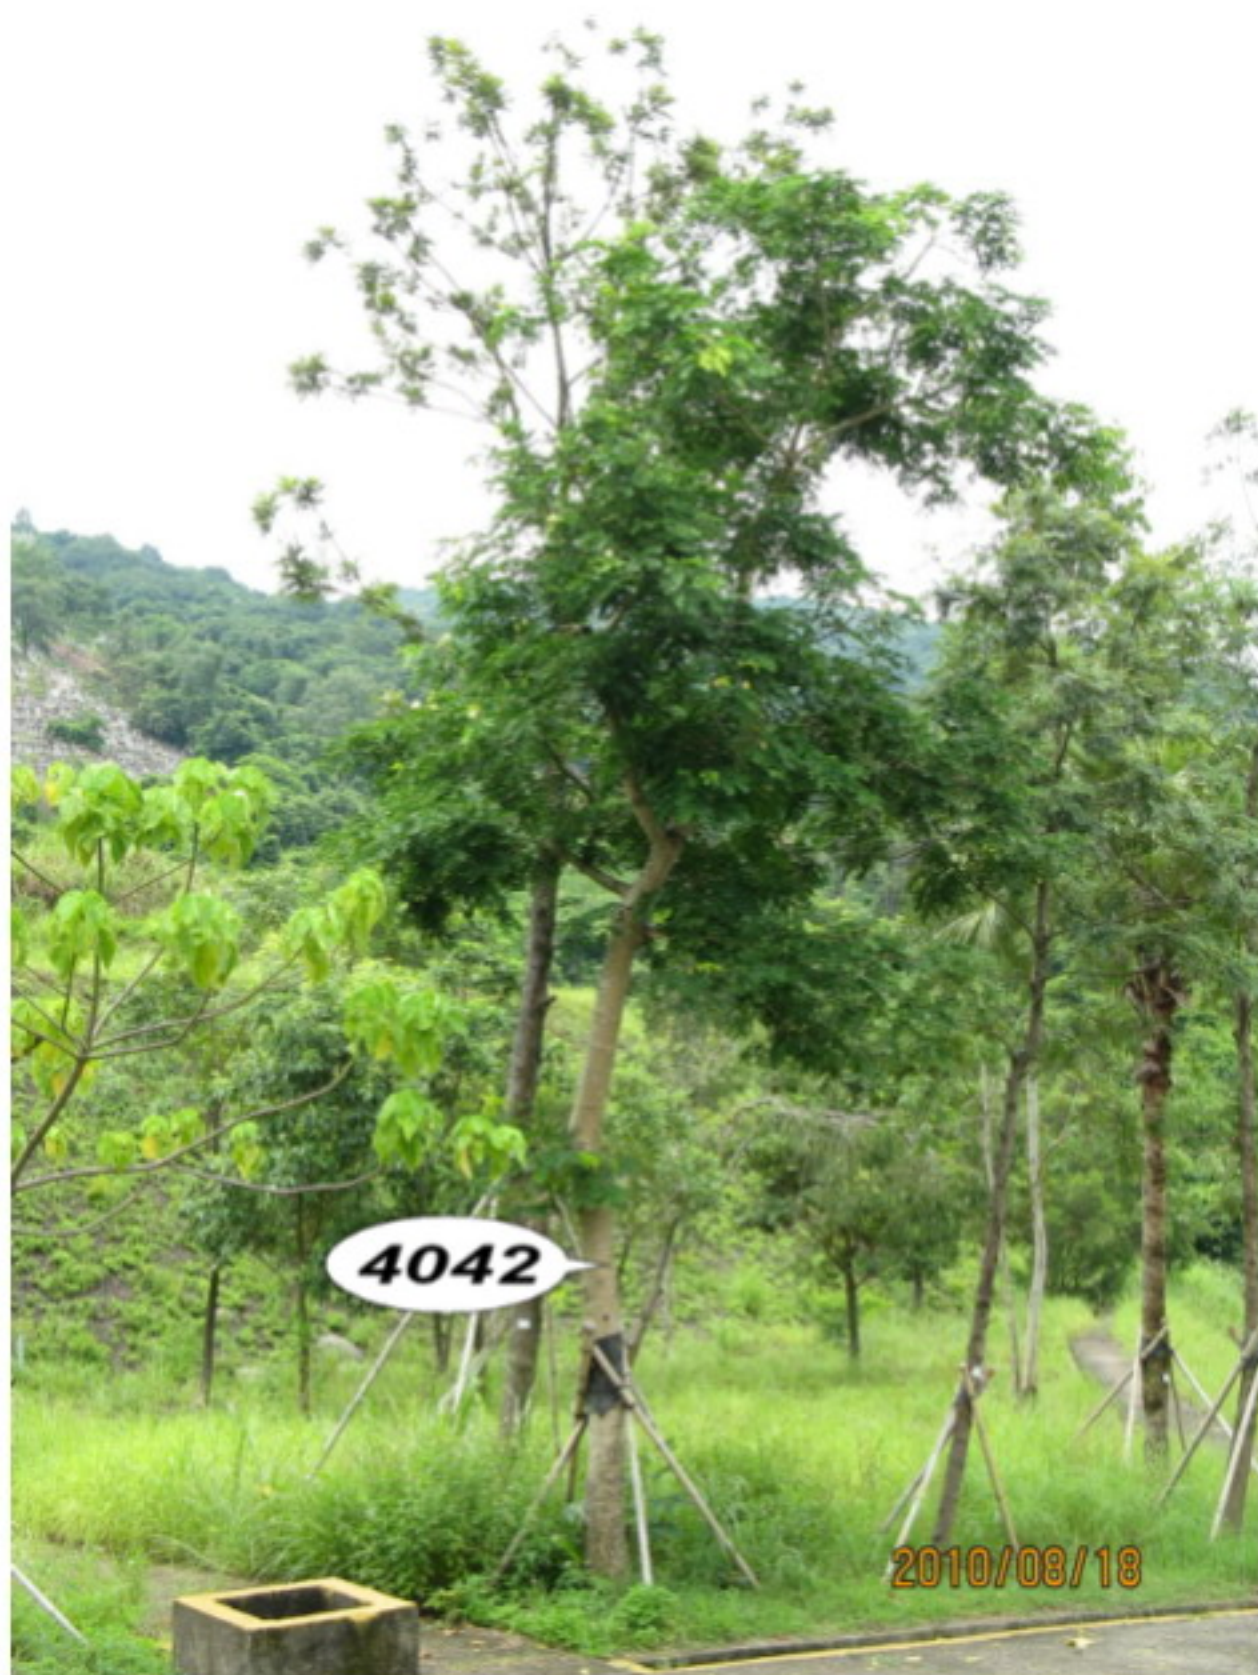
Tree No: 4042

| | | | | | | Remark |
|---|---|---|---|---|---|---|
| 4042 | <i>Albizia lebbek</i> | 大葉合歡 | 8 | 0.16 | 4 | Fair condition, Leave regenerating |

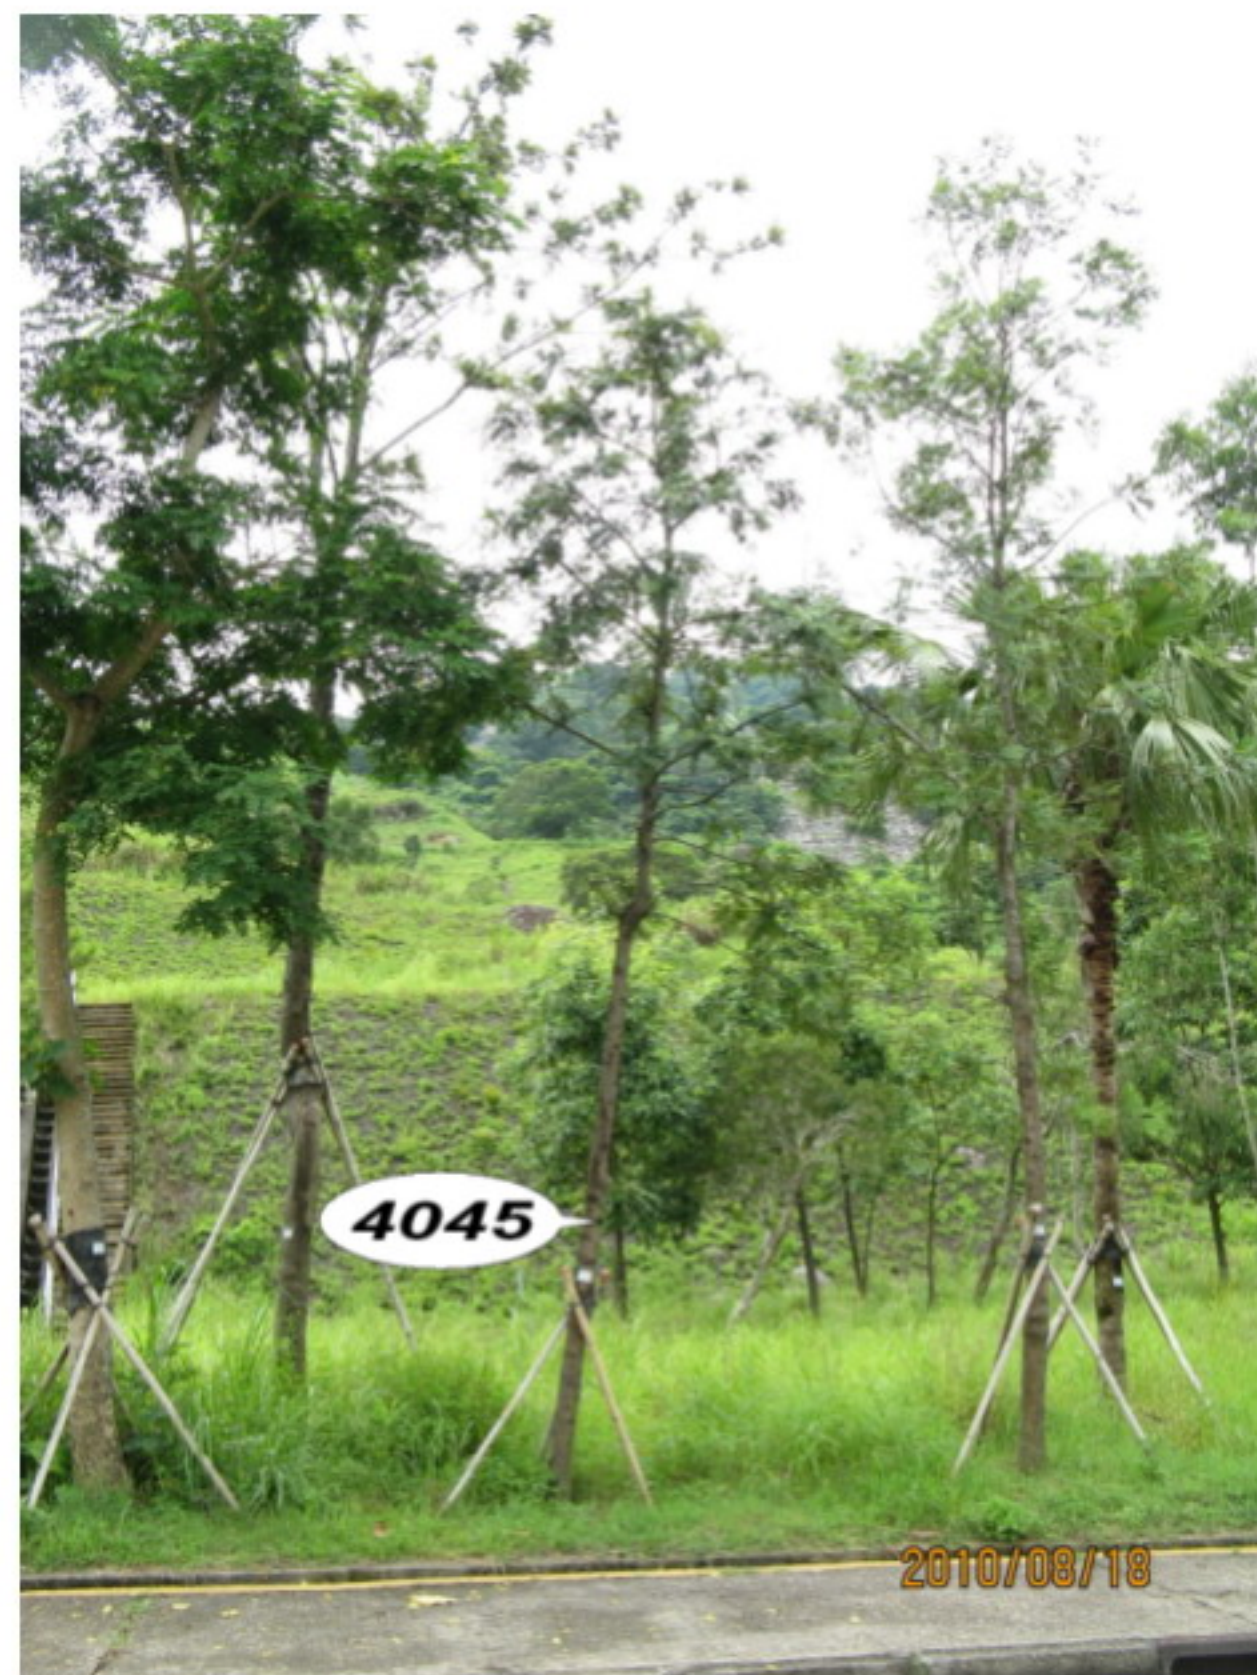
Tree No: 4045

| | | | | | | Remark |
|---|---|---|---|---|---|---|
| 4045 | <i>Grevillea robusta</i> | 銀樺 | 9 | 0.16 | 3 | Fair condition |

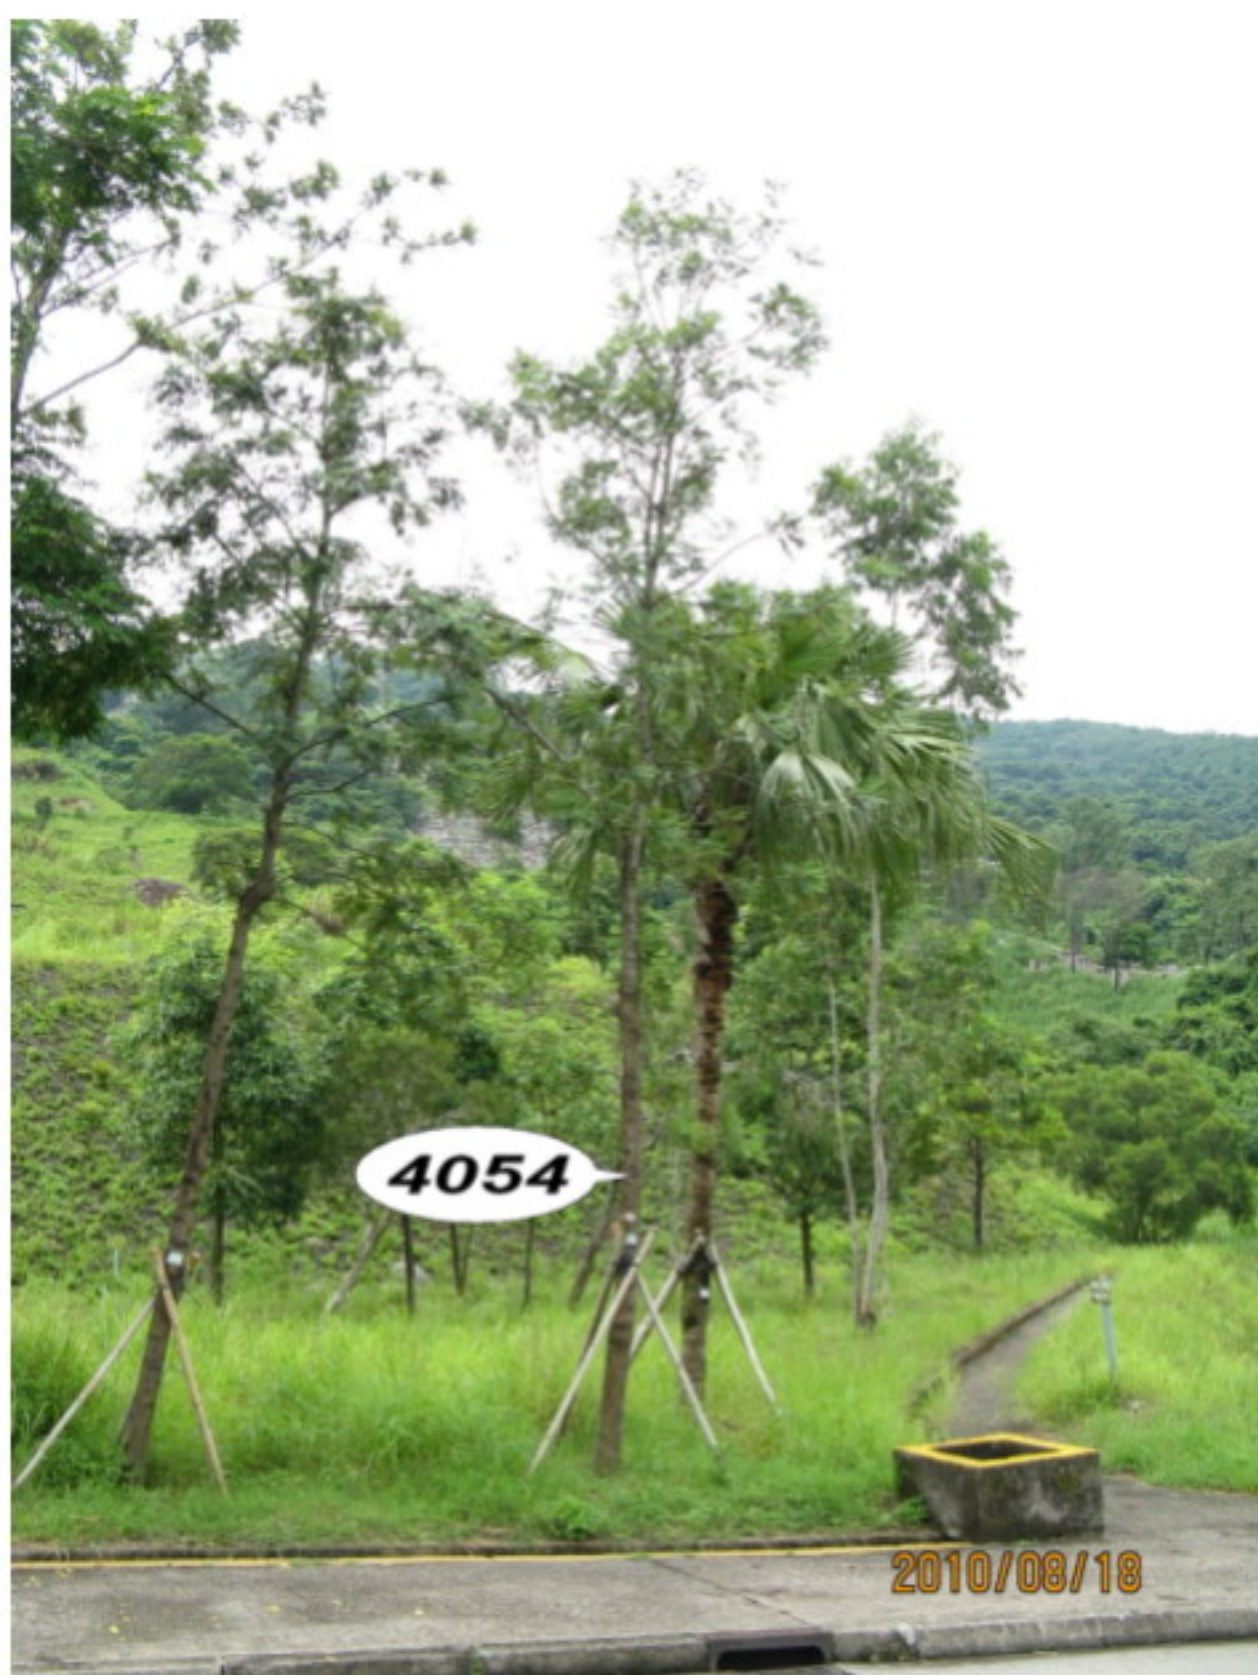
Tree No: 4054

| Tree Number | Species | Chinese name | Height (m) | Diameter (m) | Spread (m) | Remark |
|---|---|---|---|---|---|---|
| 4054 | <i>Grevillea robusta</i> | 銀樺 | 7 | 0.13 | 4 | Fair condition |

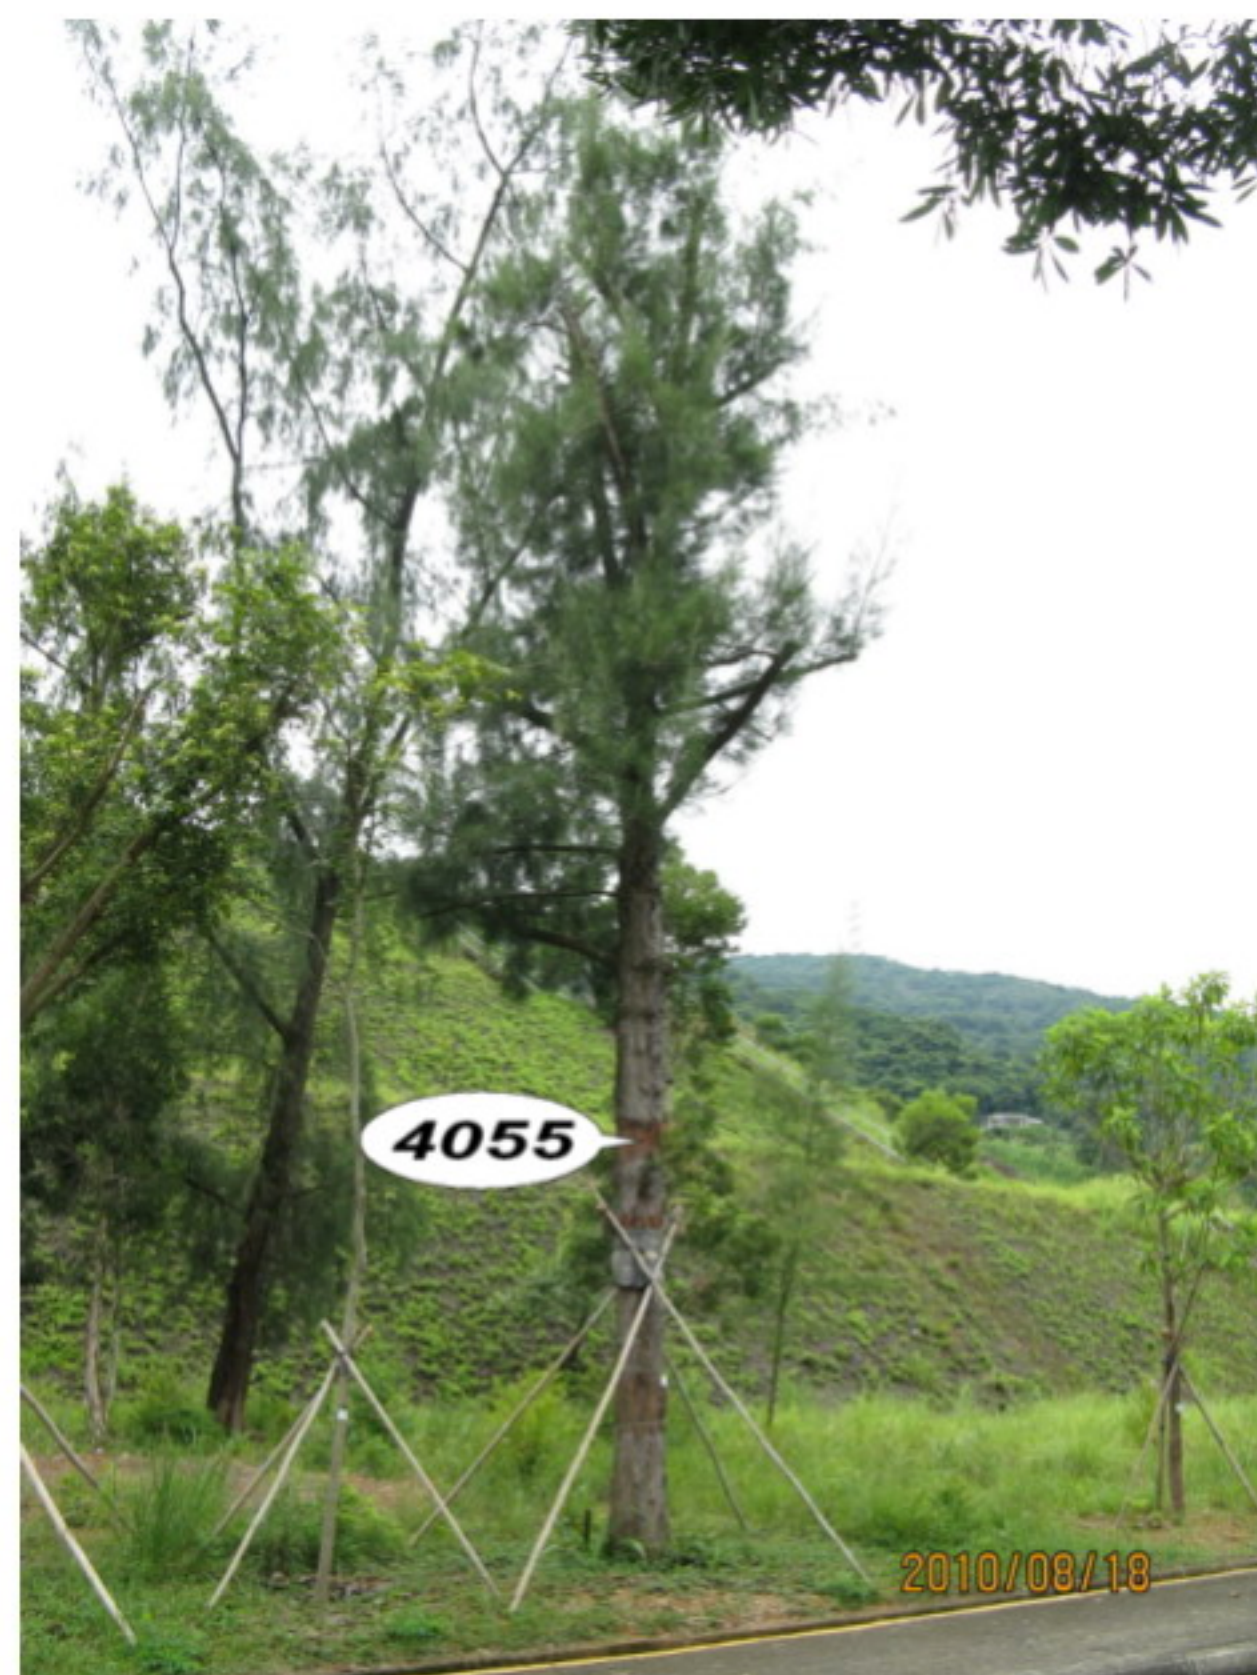
Tree No: 4055

| Tree Number | Species | Chinese name | Height (m) | Diameter (m) | Spread (m) | Remark |
|---|---|---|---|---|---|---|
| 4055 | <i>Casuarina equisetifolia</i> | 木麻黃 | 10 | 0.3 | 5 | Fair condition, Pruned |

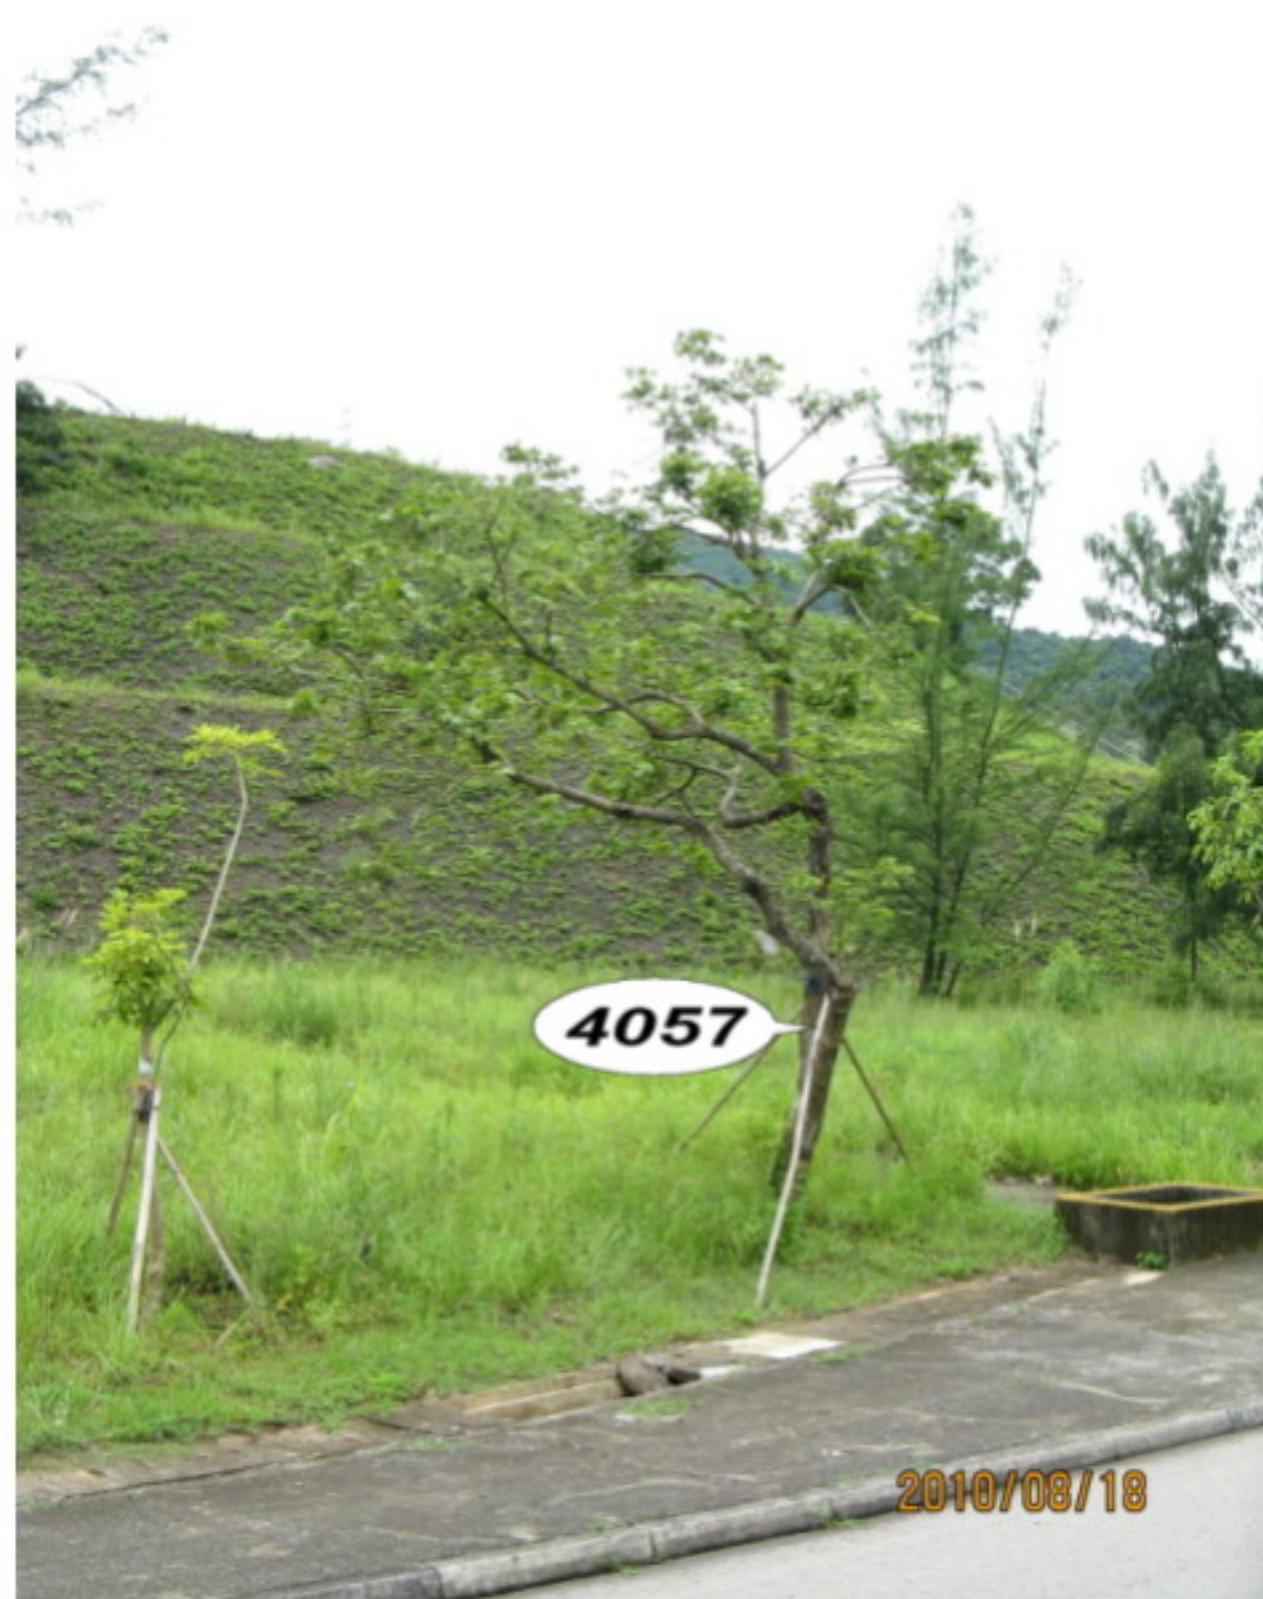
Tree No: 4057

| Tree Number | Species | Chinese name | Height (m) | Diameter (m) | Spread (m) | Remark |
|---|---|---|---|---|---|---|
| 4057 | <i>Dimocarpus longan</i> | 龍眼 | 6 | 0.16 | 4 | Fair condition, Loose bark, Leave regeneration |

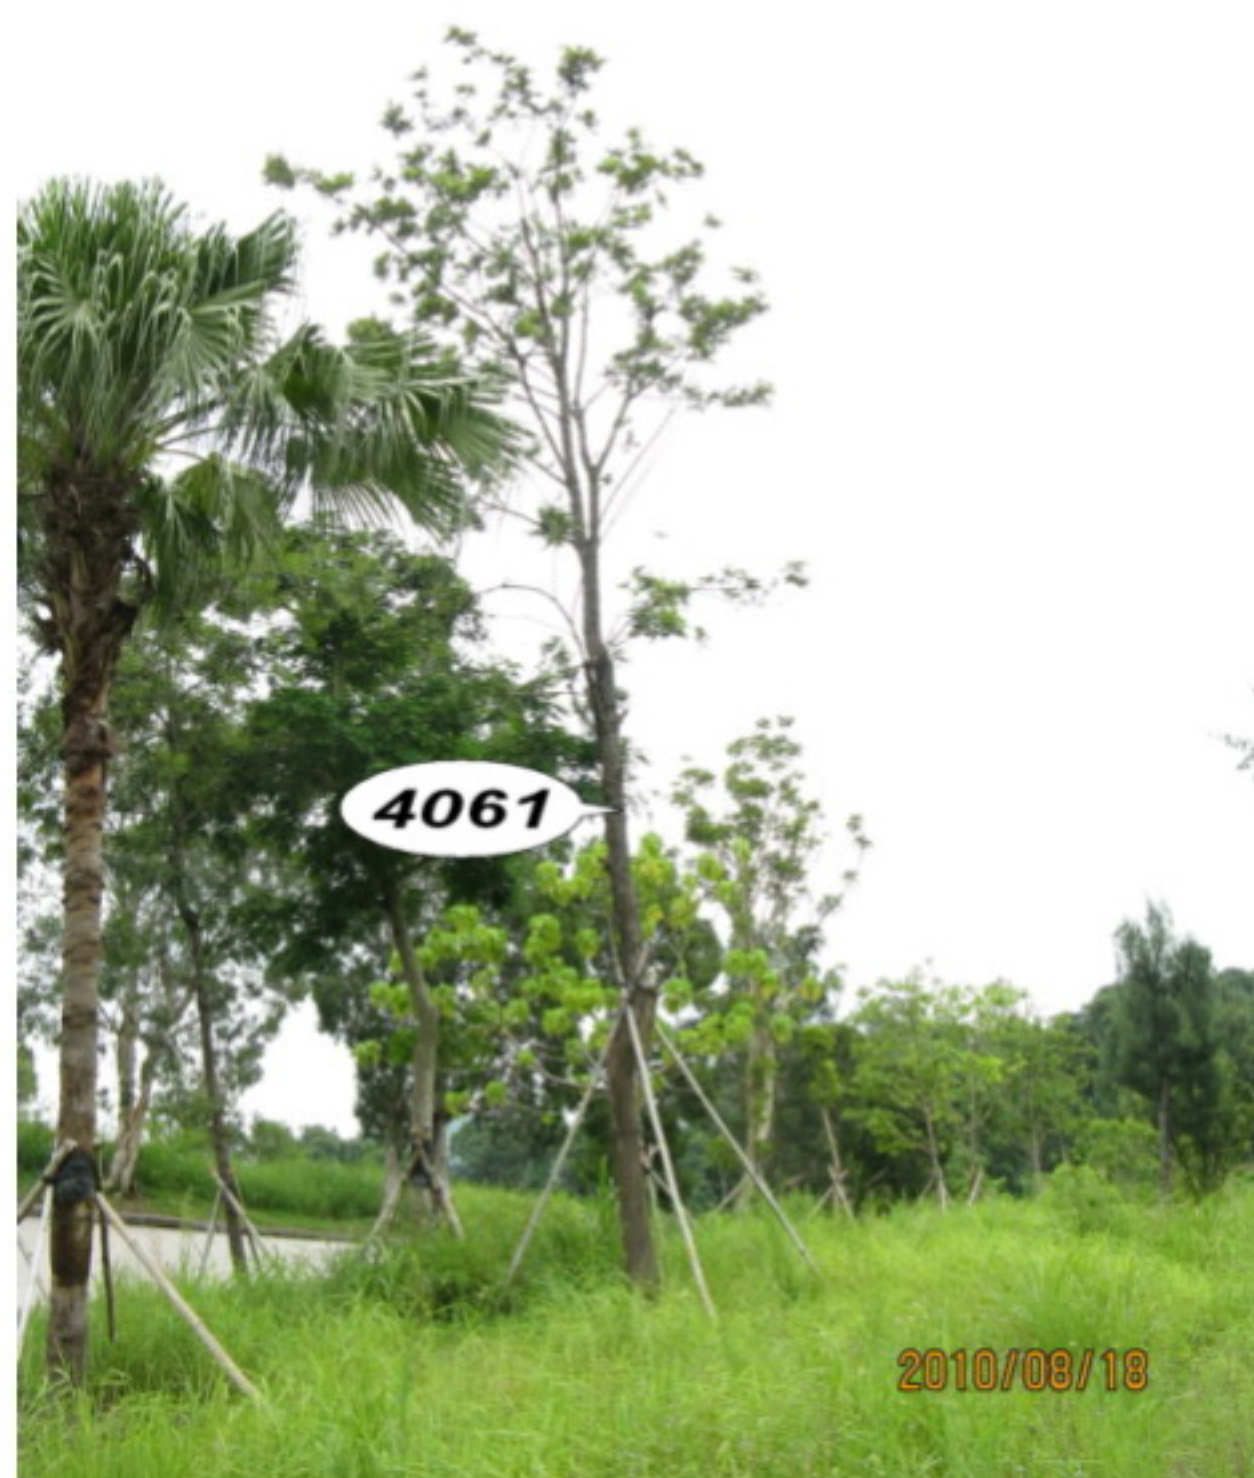
Tree No: 4061

| Tree Number | Species | Chinese name | Height (m) | Diameter (m) | Spread (m) | Remark |
|---|---|---|---|---|---|---|
| 4061 | <i>Grevillea robusta</i> | 銀樺 | 7 | 0.13 | 4 | Fair condition |

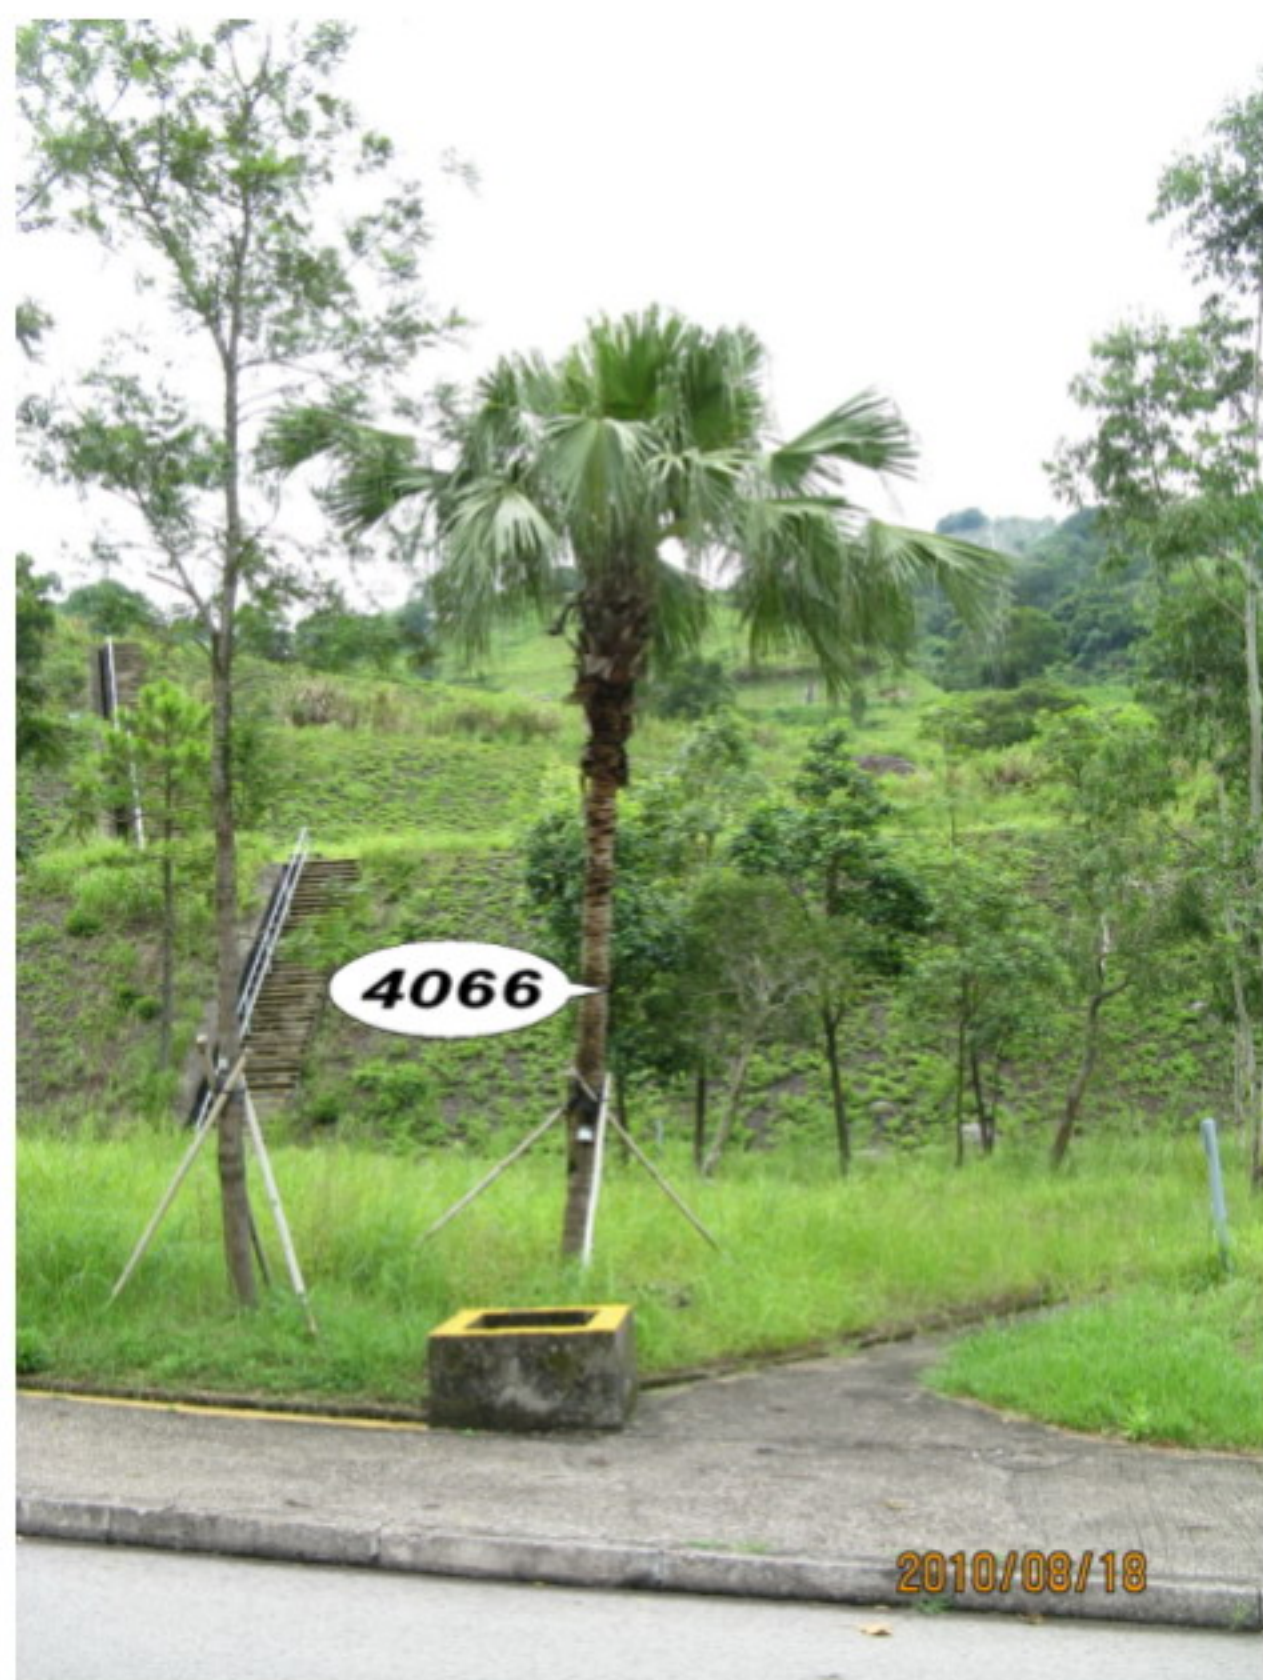
Tree No: 4066

| Tree Number | Species | Chinese name | Height (m) | Diameter (m) | Spread (m) | Remark |
|---|---|---|---|---|---|---|
| 4066 | <i>Livistona chinensis</i> | 蒲葵 | 6 | 0.21 | 2 | Fair condition |

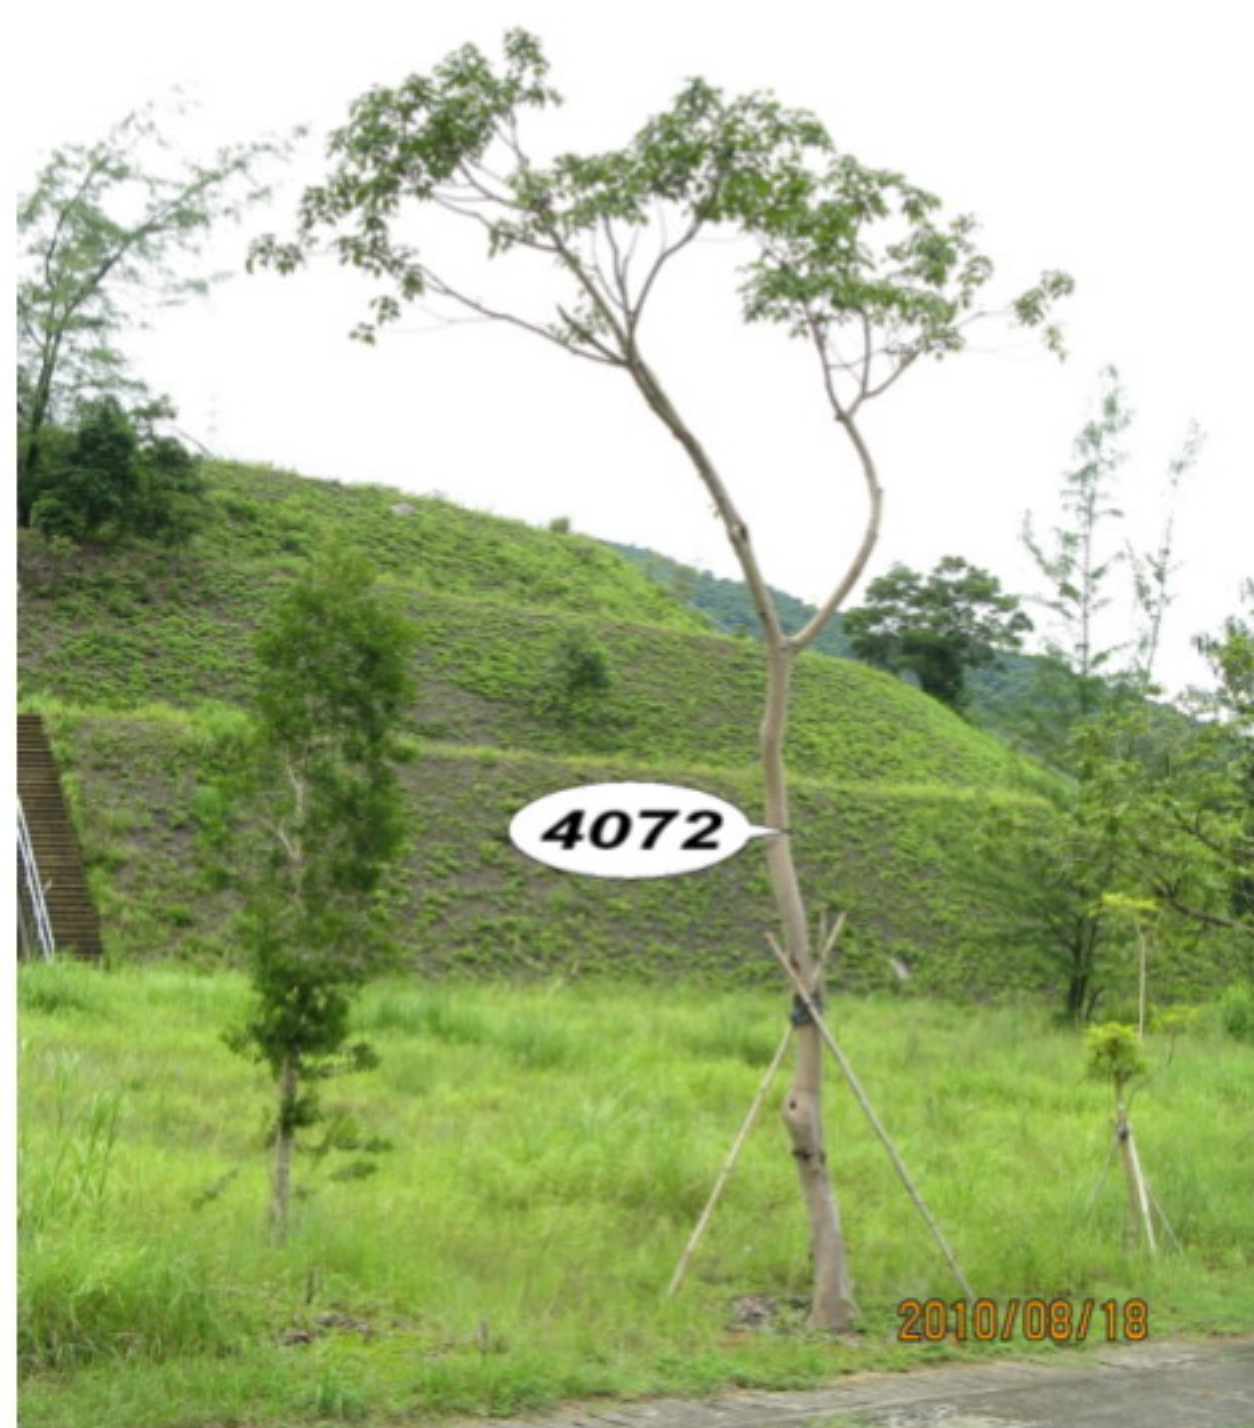
Tree No: 4072

| Tree Number | Species | Chinese name | Height (m) | Diameter (m) | Spread (m) | Remark |
|---|---|---|---|---|---|---|
| 4072 | <i>Ficus variegata</i> | 青果榕 | 6 | 0.13 | 3 | Poor condition, Sparse crown, loose bark, bark damage, cavity. |

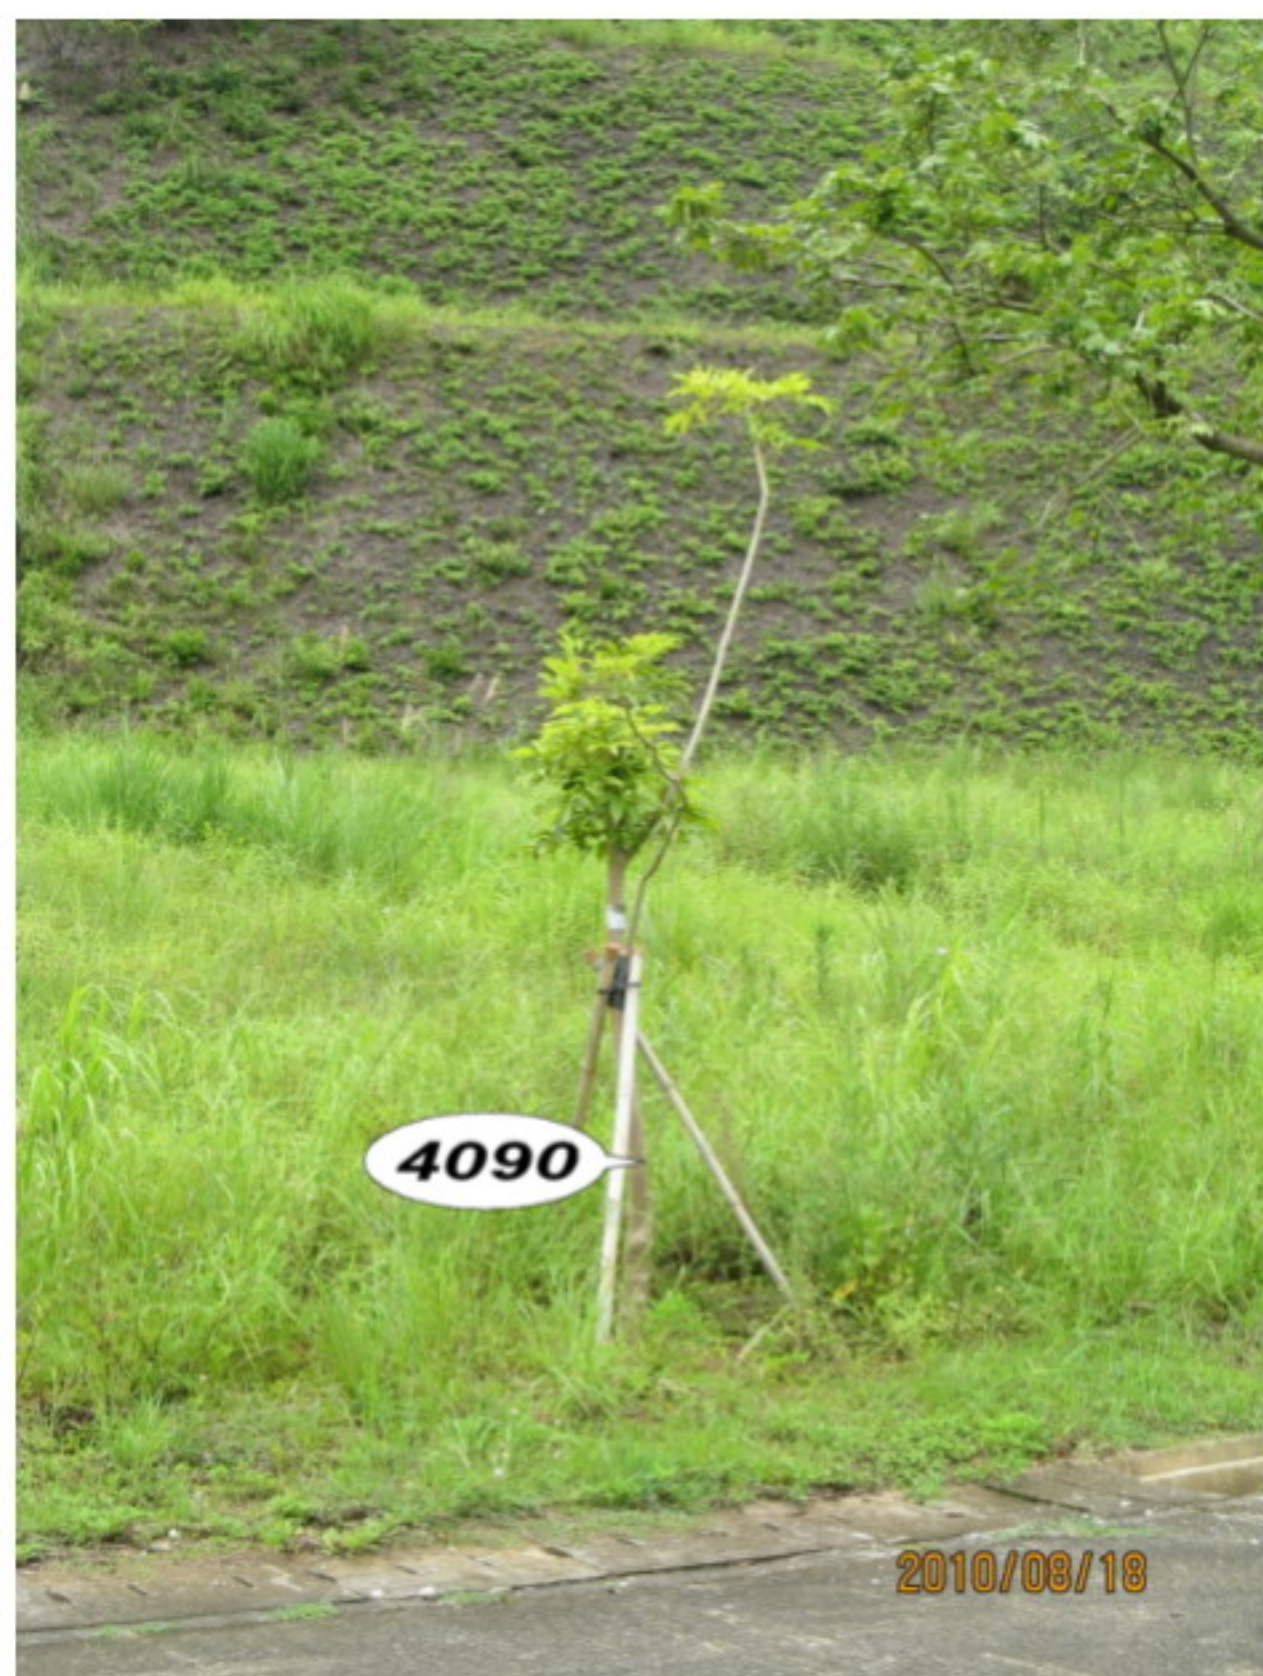
Tree No: 4090

| Tree Number | Species | Chinese name | Height (m) | Diameter (m) | Spread (m) | Remark |
|---|---|---|---|---|---|---|
| 4090 | <i>Schefflera heptaphylla</i> | 鴨腳木 | 6.5 | 0.18 | 4 | Poor condition, Heavy sparse crown, |
