EP-344/2009 – New Sewage Pumping Stations Serving KTD and
EP-337/2009 – New Distributor Roads Serving the Planned KTD

Contract No. KL/2012/03
Kai Tak Development –Stage 4 Infrastructure at
Former North Apron Area

Monthly EM&A Report

June 2014

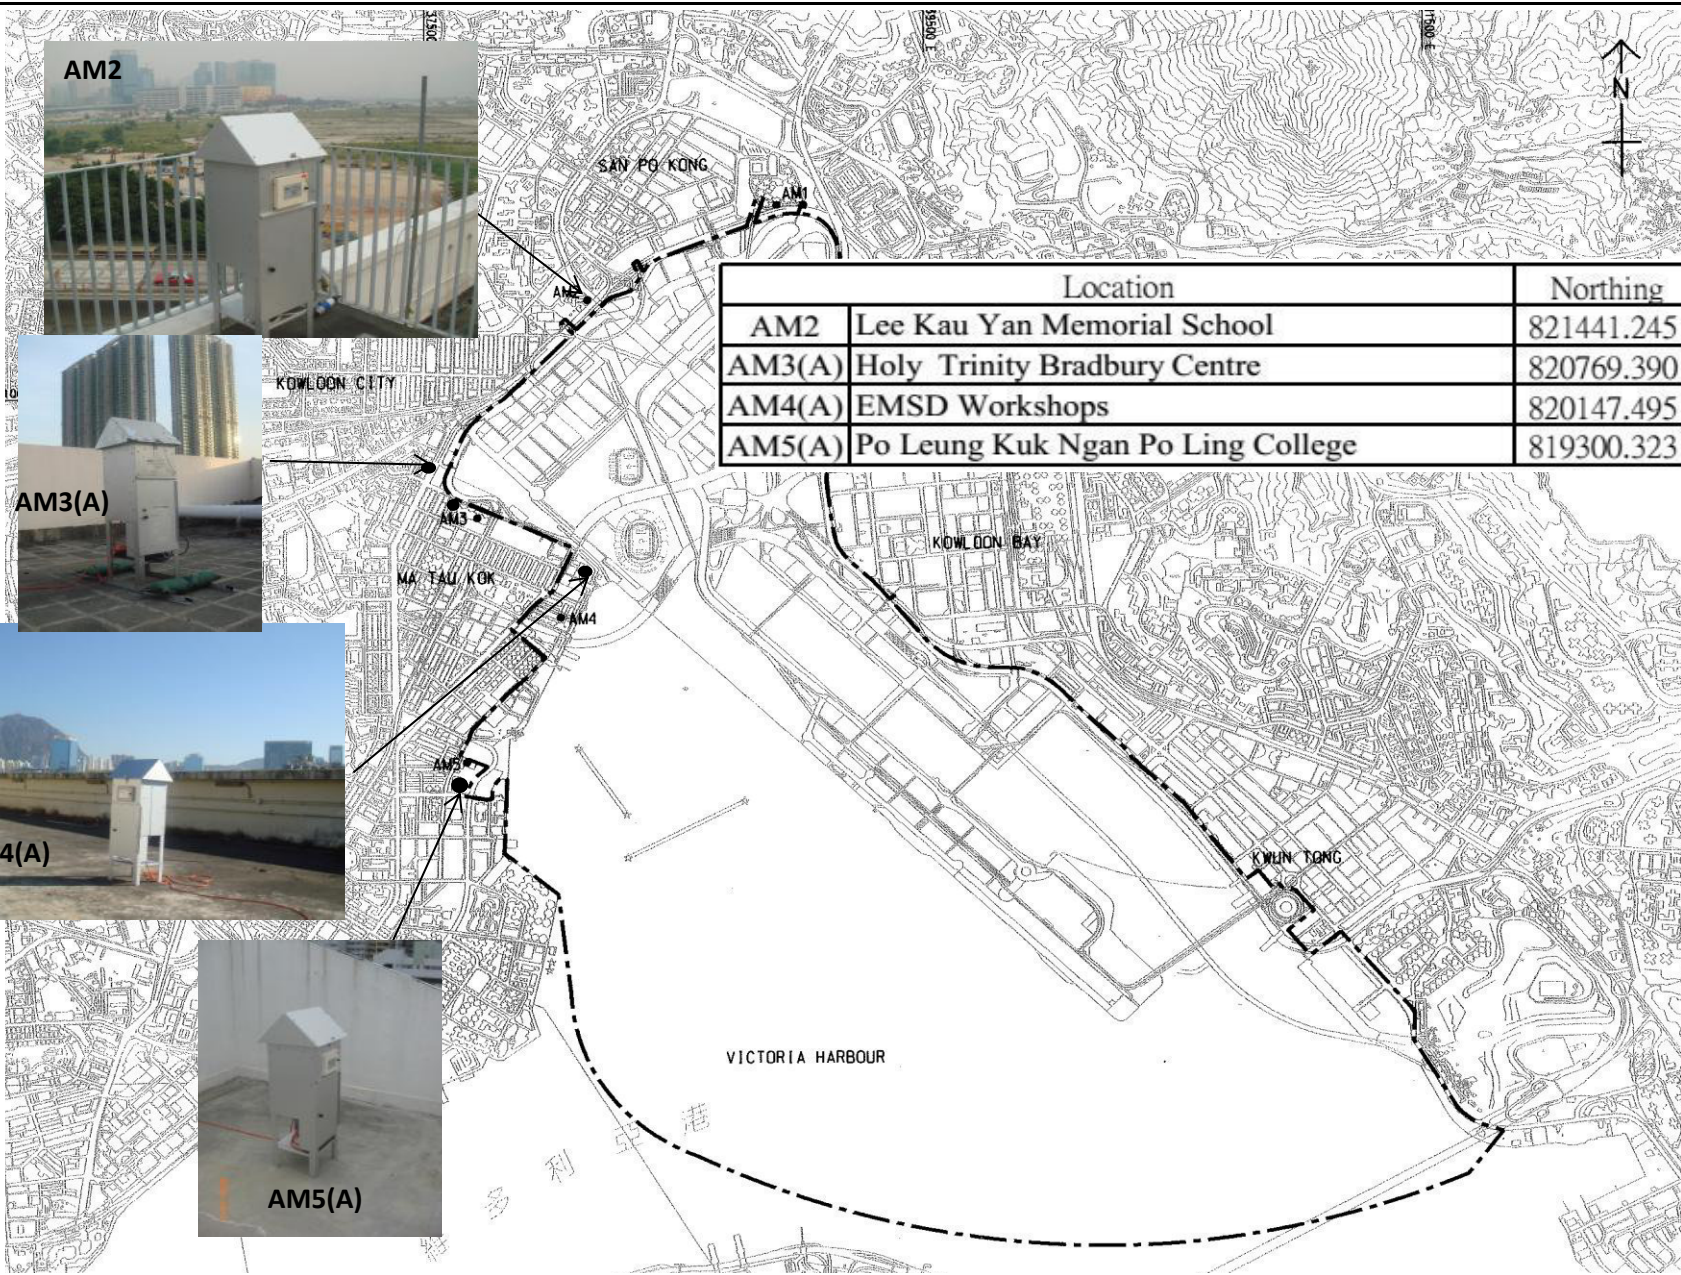
Scale	N.T.S	Project No.	MA13056
Date	Jan-14	Figure	2

Location		Northing	Easting
AM2	Lee Kau Yan Memorial School	821441.245	838153.917
AM3(A)	Holy Trinity Bradbury Centre	820769.390	837522.115
AM4(A)	EMSD Workshops	820147.495	838155.791
AM5(A)	Po Leung Kuk Ngan Po Ling College	819300.323	837659.613

Title Contract No. KL/2012/03
 Kai Tak Development –Stage 4 Infrastructure at Former North Apron Area
 Air Quality Monitoring Stations under this Project

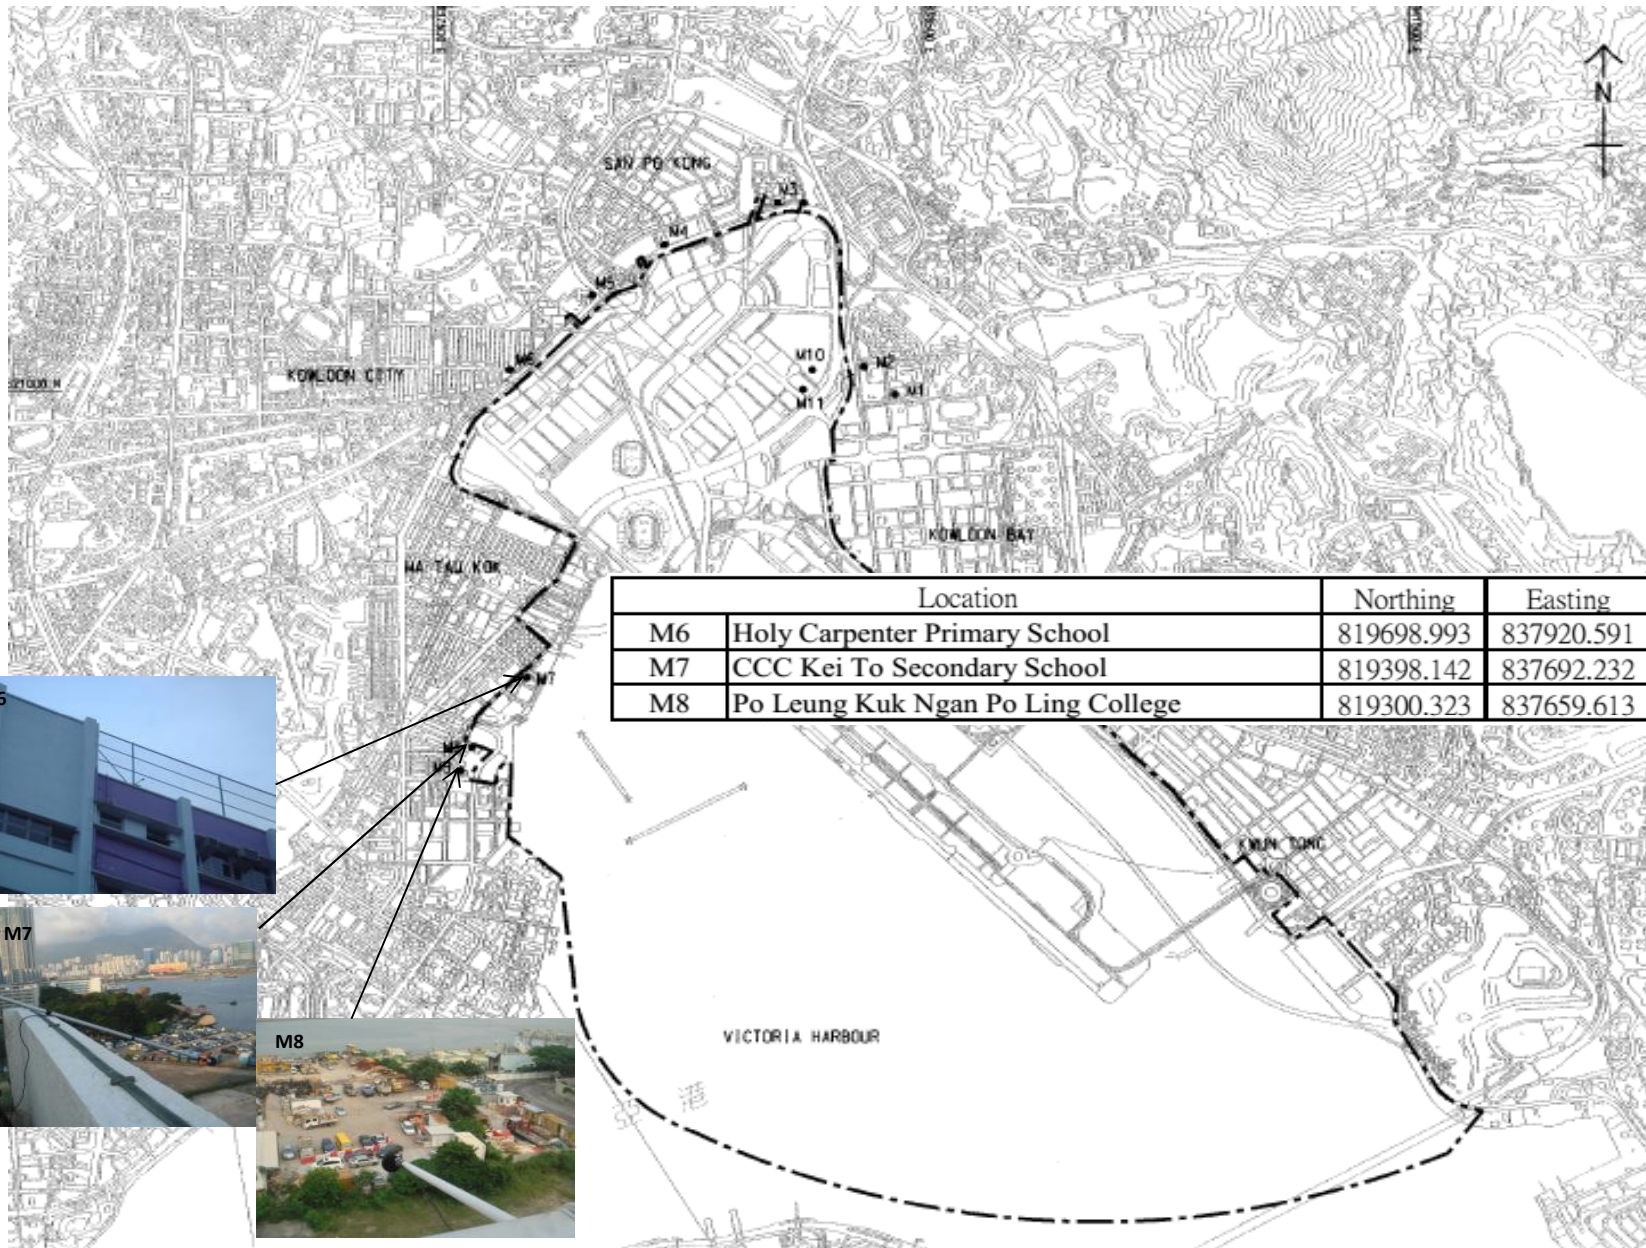
Scale	N.T.S	Project No.	MA13056
Date	Dec-13	Figure	3

Location		Northing	Easting
M6	Holy Carpenter Primary School	819698.993	837920.591
M7	CCC Kei To Secondary School	819398.142	837692.232
M8	Po Leung Kuk Ngan Po Ling College	819300.323	837659.613

Title Contract No. KL/2012/03
 Kai Tak Development –Stage 4 Infrastructure at Former North Apron Area
 Noise Monitoring Stations under this Project

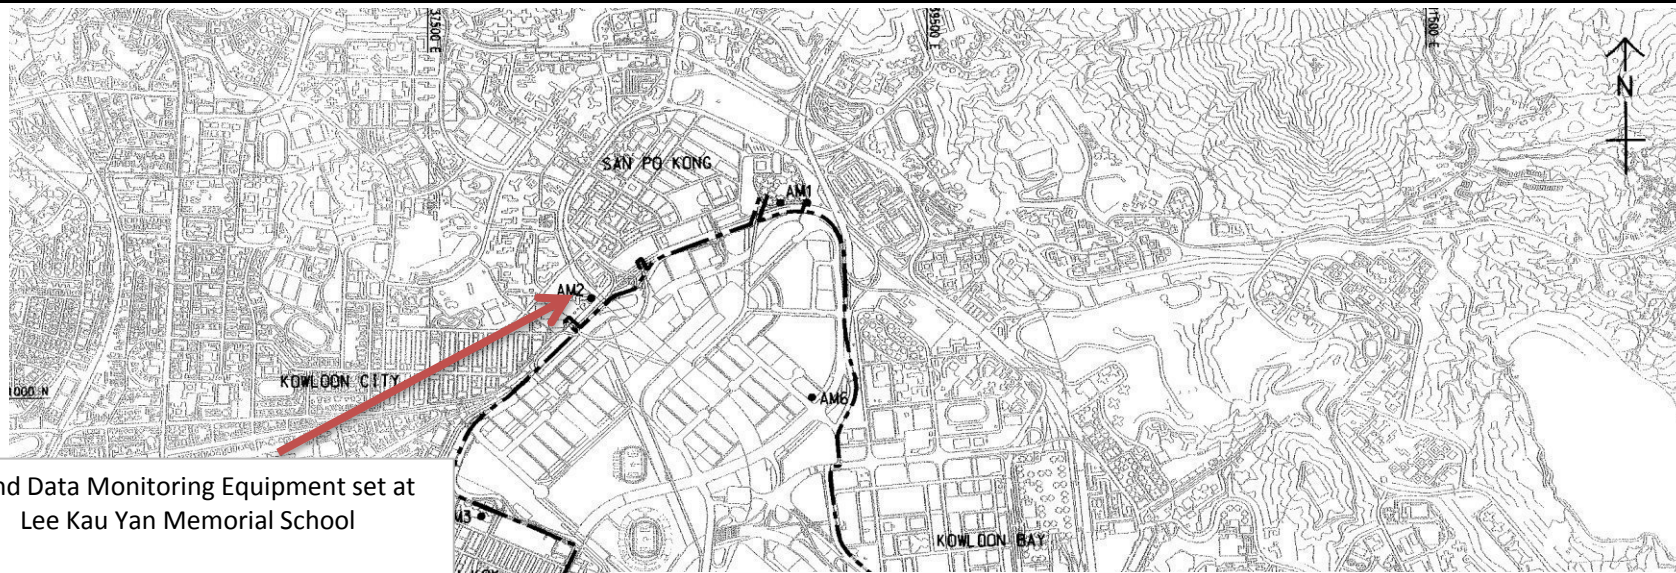
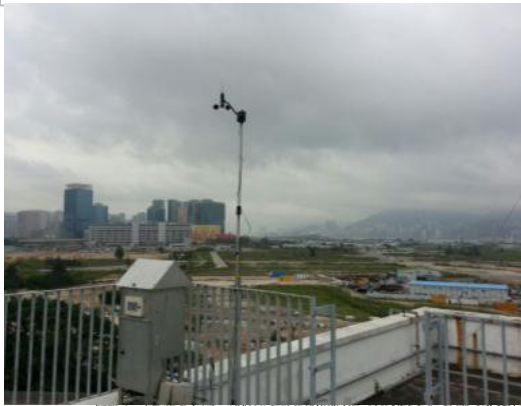
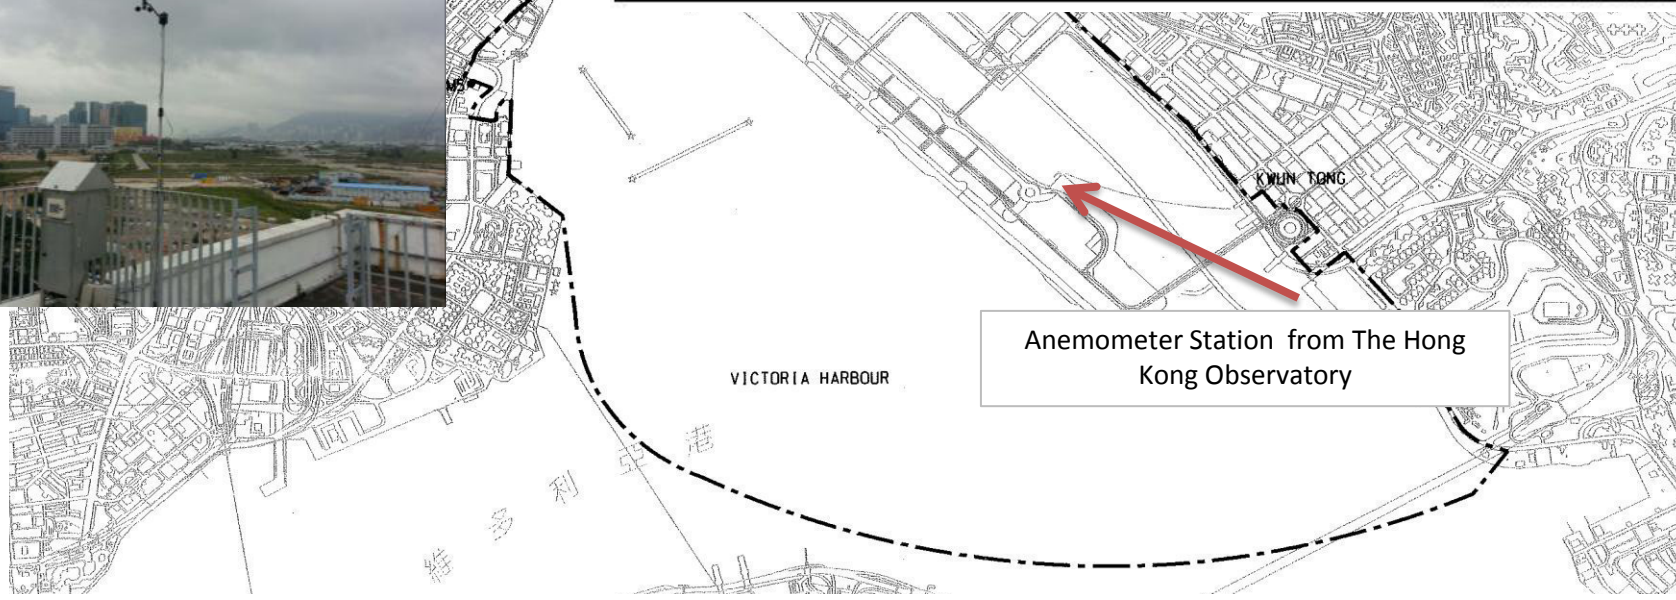
Scale	N.T.S	Project No.	MA13056
Date	Dec-13	Figure	4

Wind Data Monitoring Equipment set at Lee Kau Yan Memorial School

Wind Monitoring Location	Northing	Easting
Lee Kau Yan Memorial School	821441.245	838153.917

Anemometer Station from The Hong Kong Observatory

Title Contract No. KL/2012/03
 Kai Tak Development –Stage 4 Infrastructure at Former North Apron Area
 Location of Wind Data Monitoring Equipment

- 2.21 The air temperature, precipitation and the relative humidity data was obtained from Hong Kong Observatory where the wind speed and wind direction were recorded by the installed Wind Anemometer set at rooftop (about 8/F) Lee Kau Yan Memorial School. The location is shown in **Figure 4**. This weather information for the reporting month is summarized in **Appendix C**.

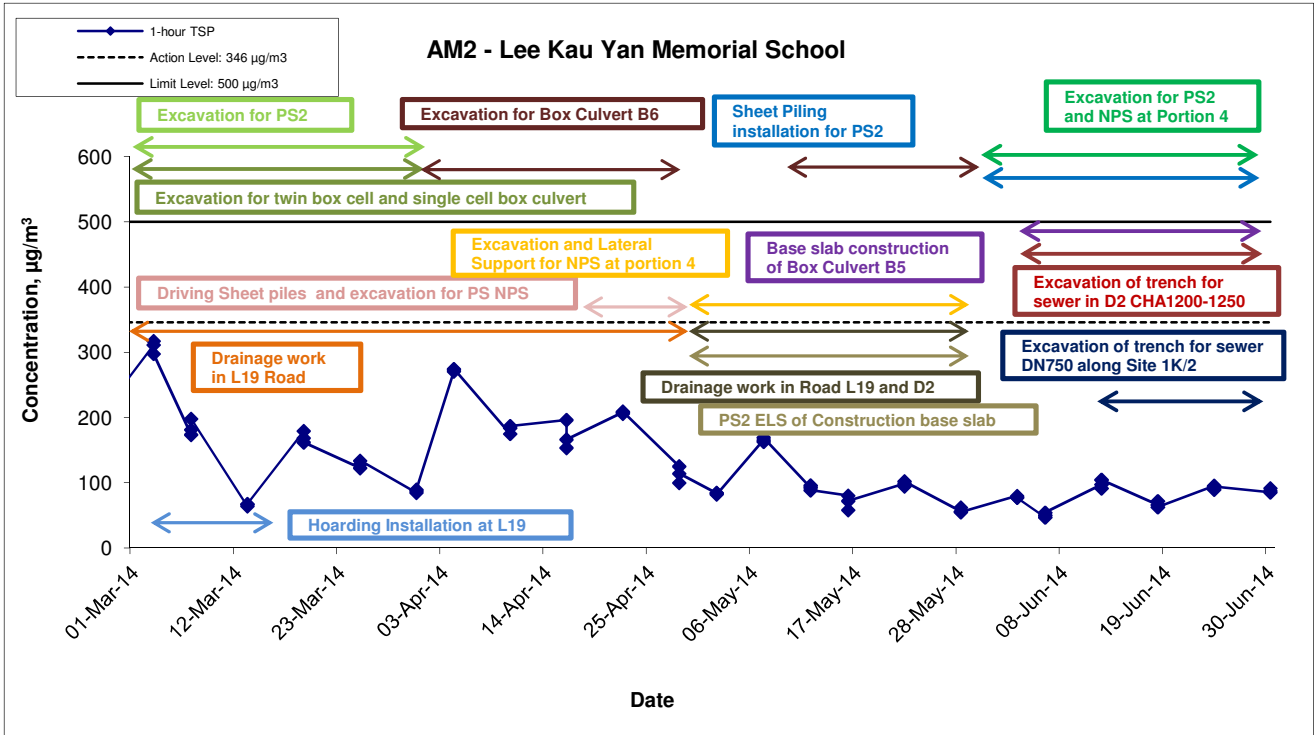
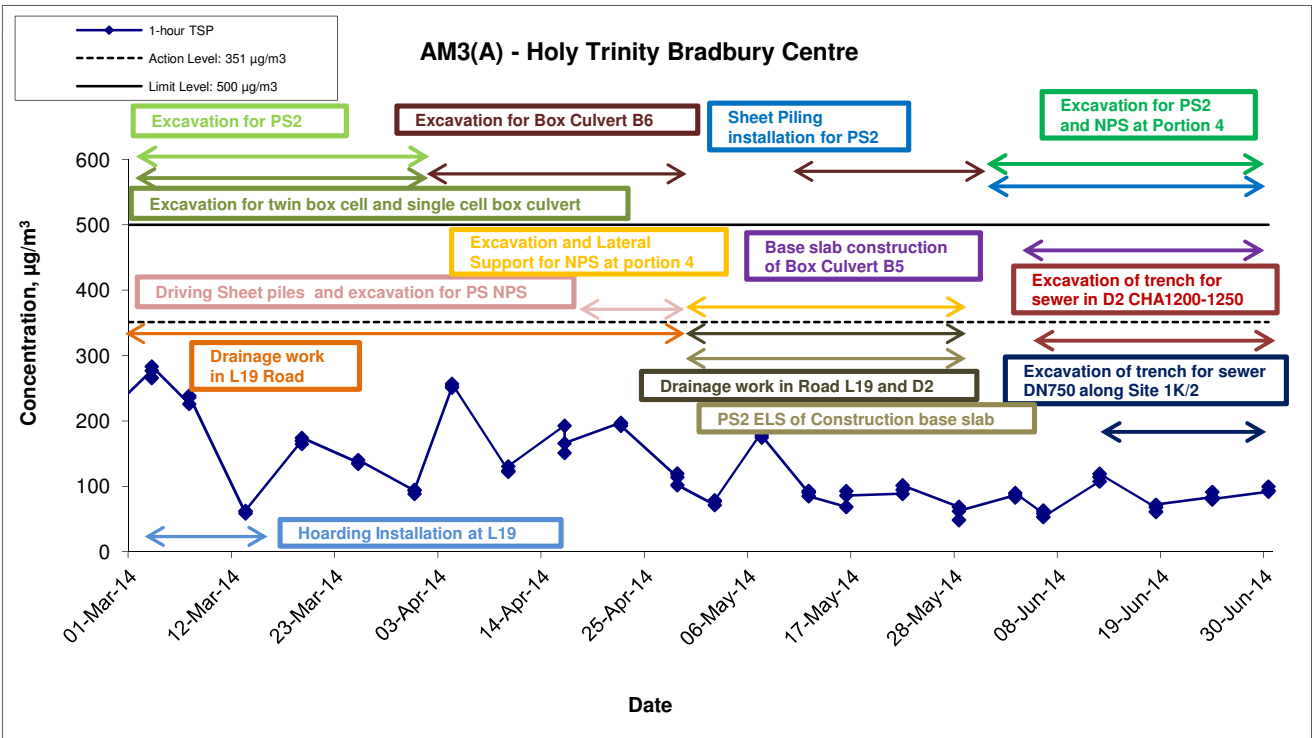
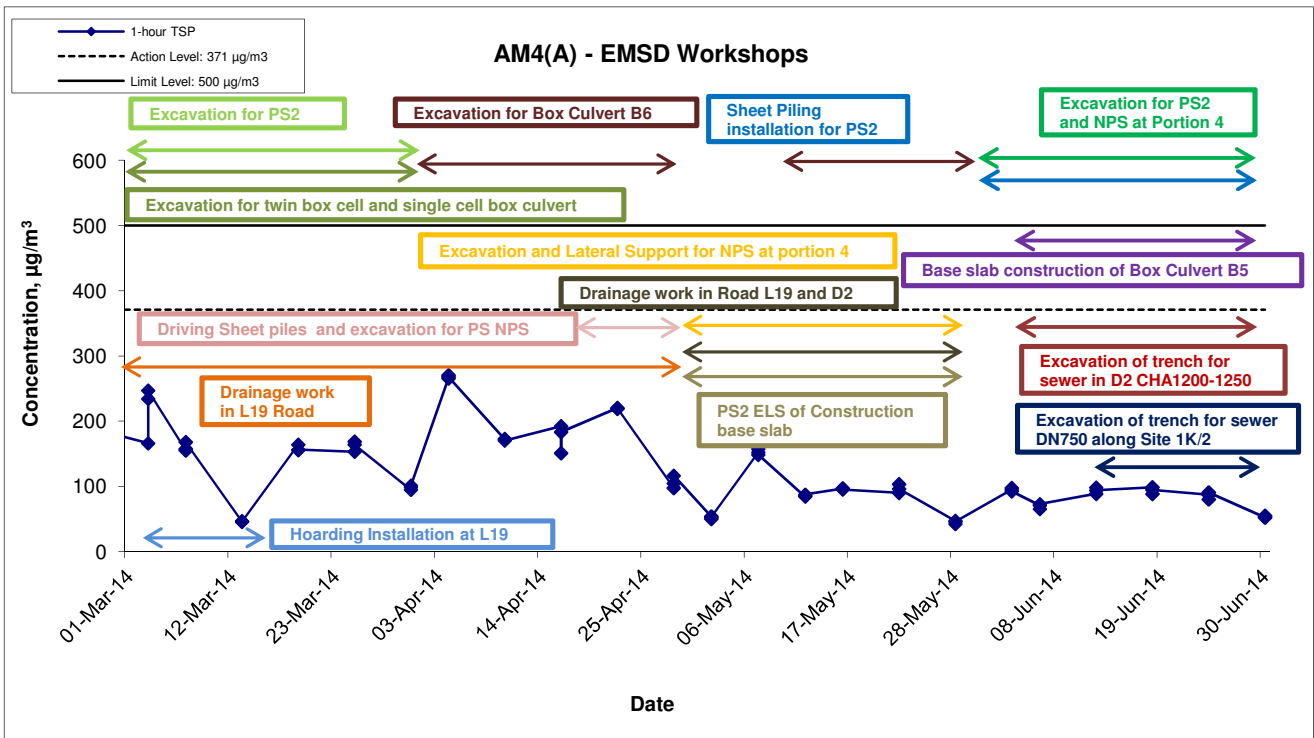
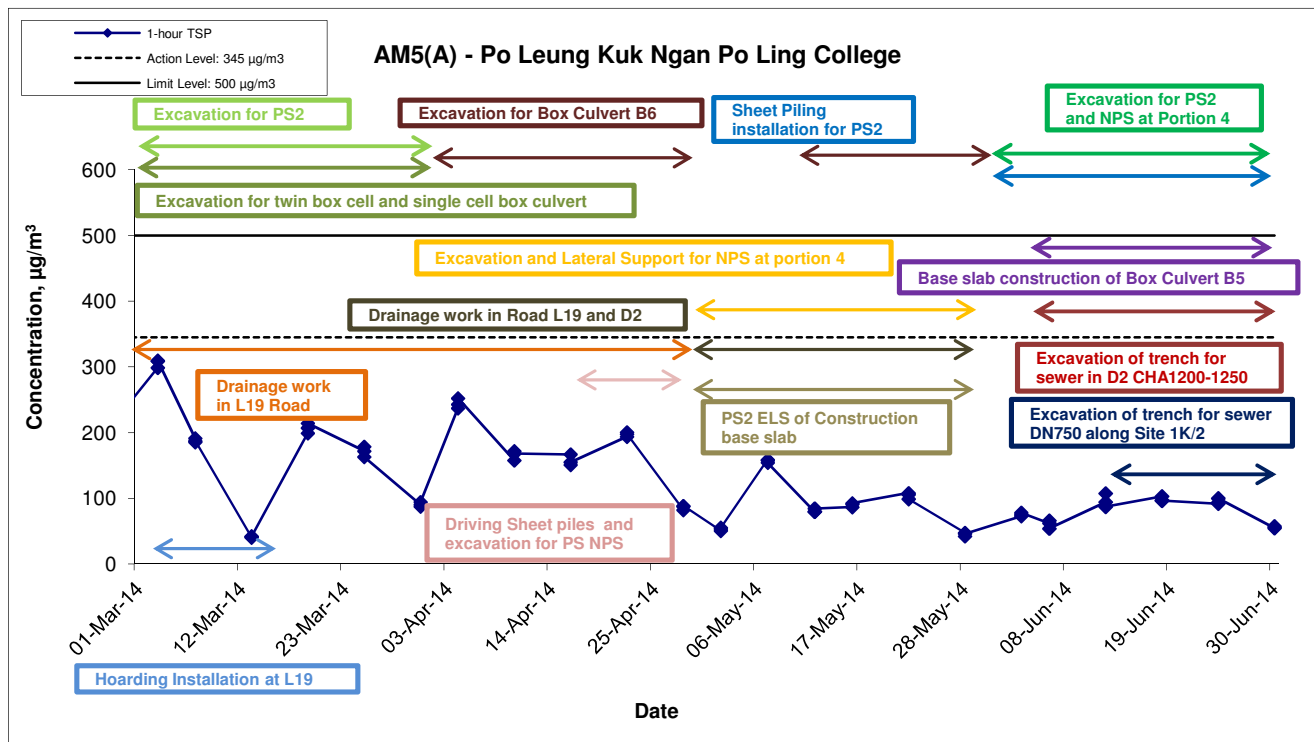
Title	Contract No. KL/2012/03	Scale	N.T.S	Project No.	MA13056	CINOTECH
	Kai Tak Development –Stage 4 Infrastructure at Former North Apron Area	Date	Jul 14	Appendix	E	
Graphical Presentation of 1-hour TSP Monitoring Results

1-hr TSP Concentration Levels

Title Contract No. KL/2012/03 Kai Tak Development –Stage 4 Infrastructure at Former North Apron Area Graphical Presentation of 1-hour TSP Monitoring Results	Scale N.T.S	Project No. MA13056	
	Date Jul 14	Appendix E

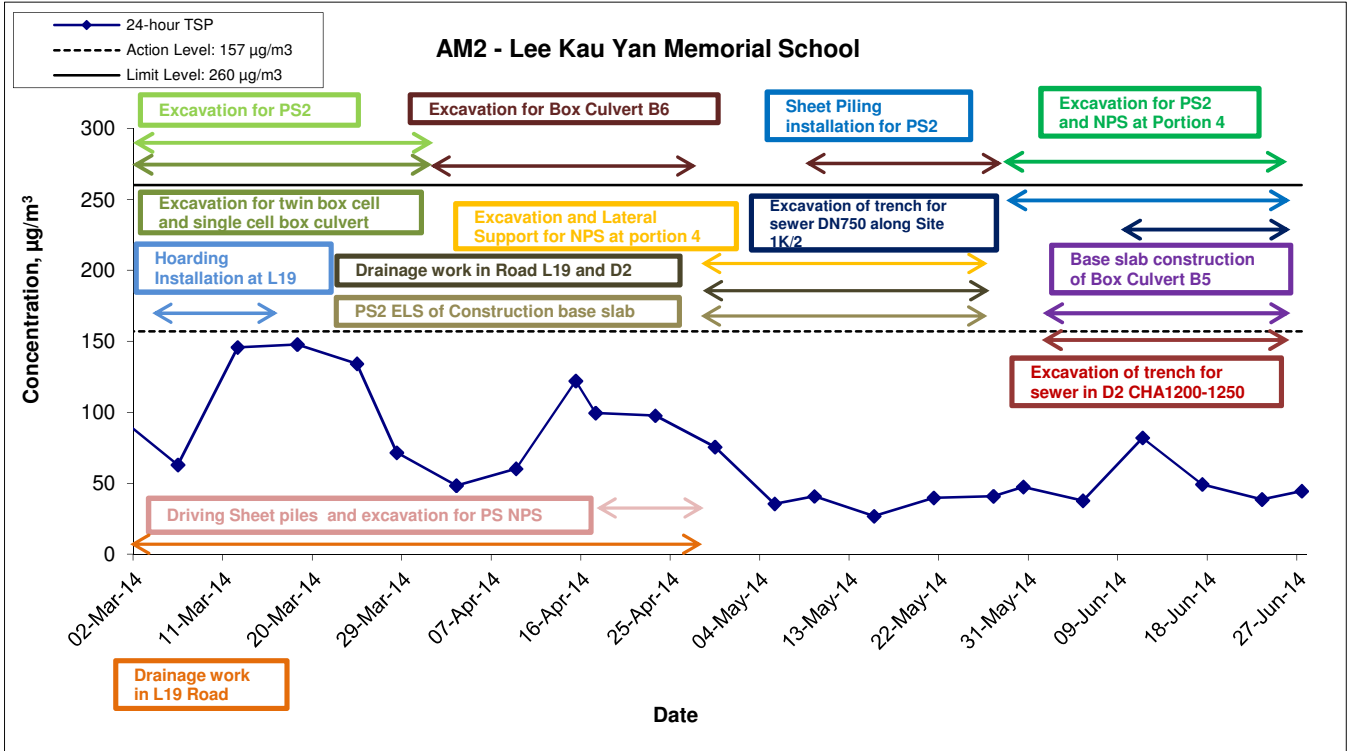
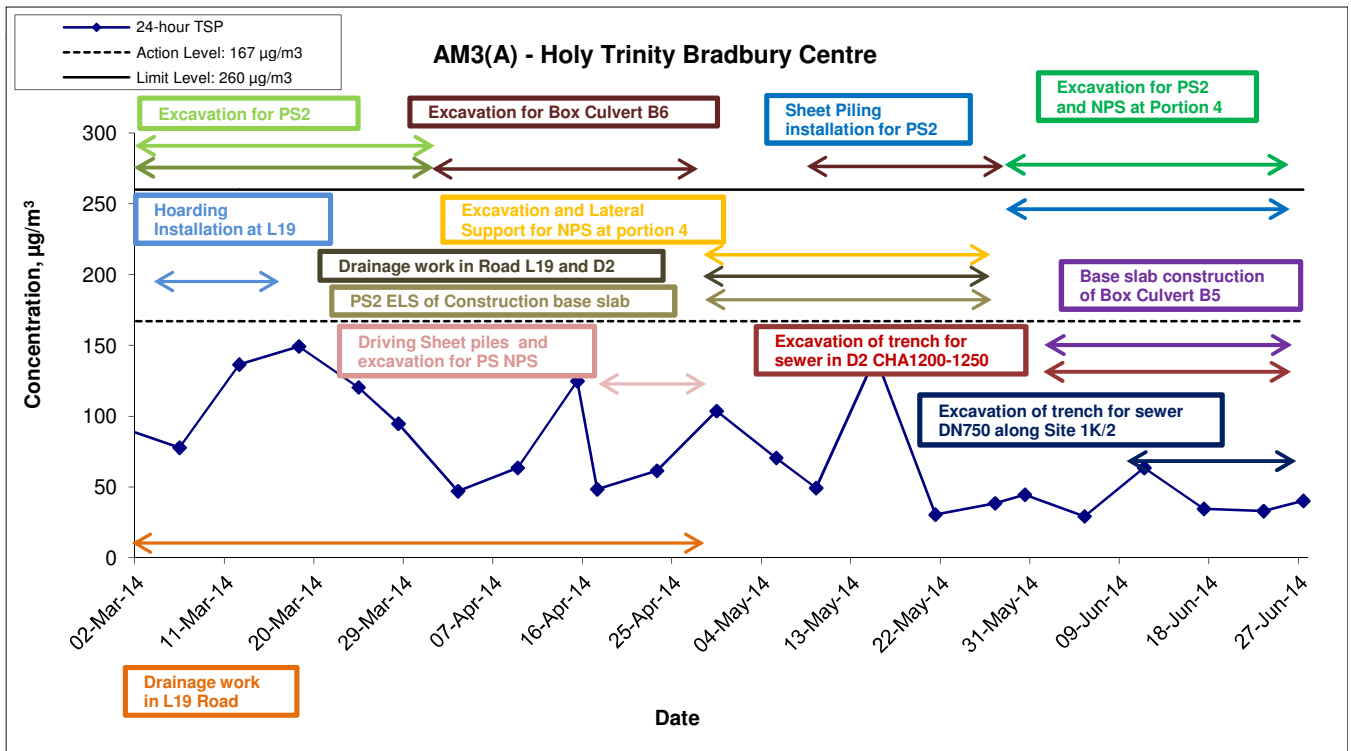
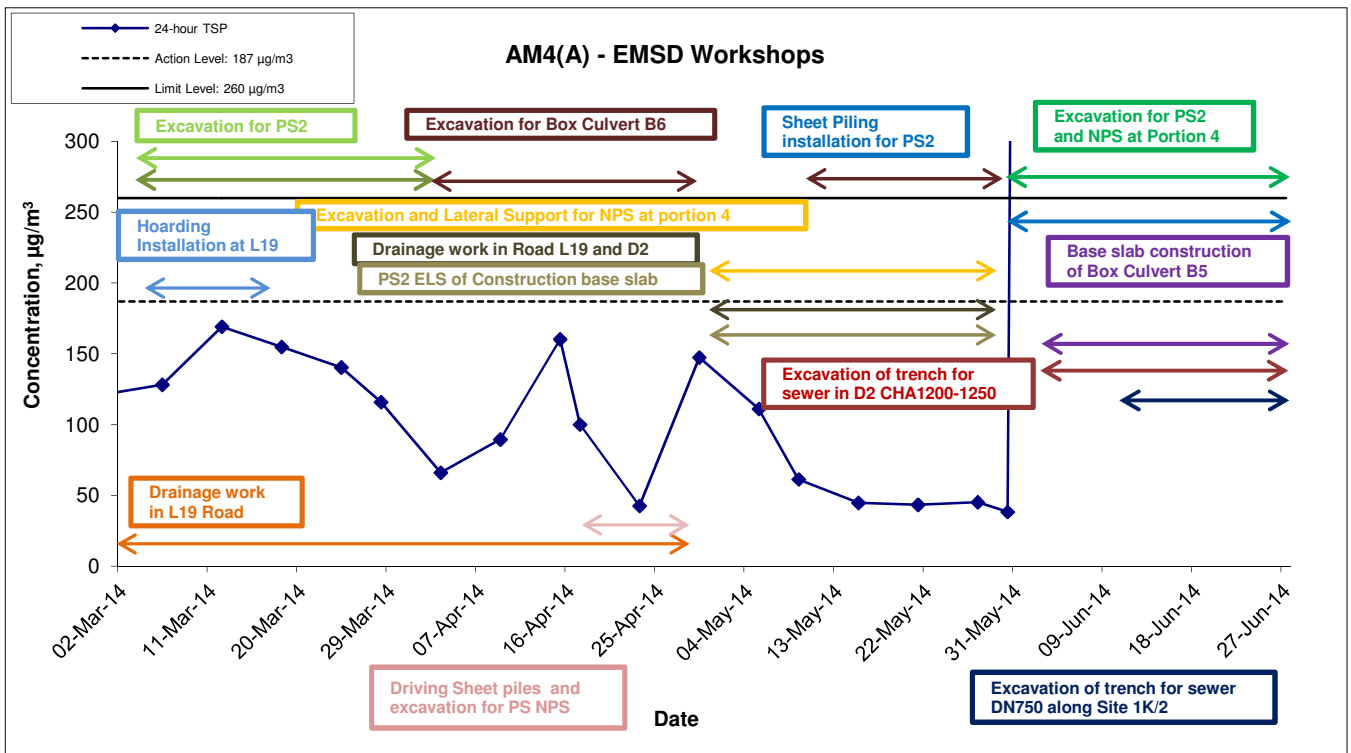
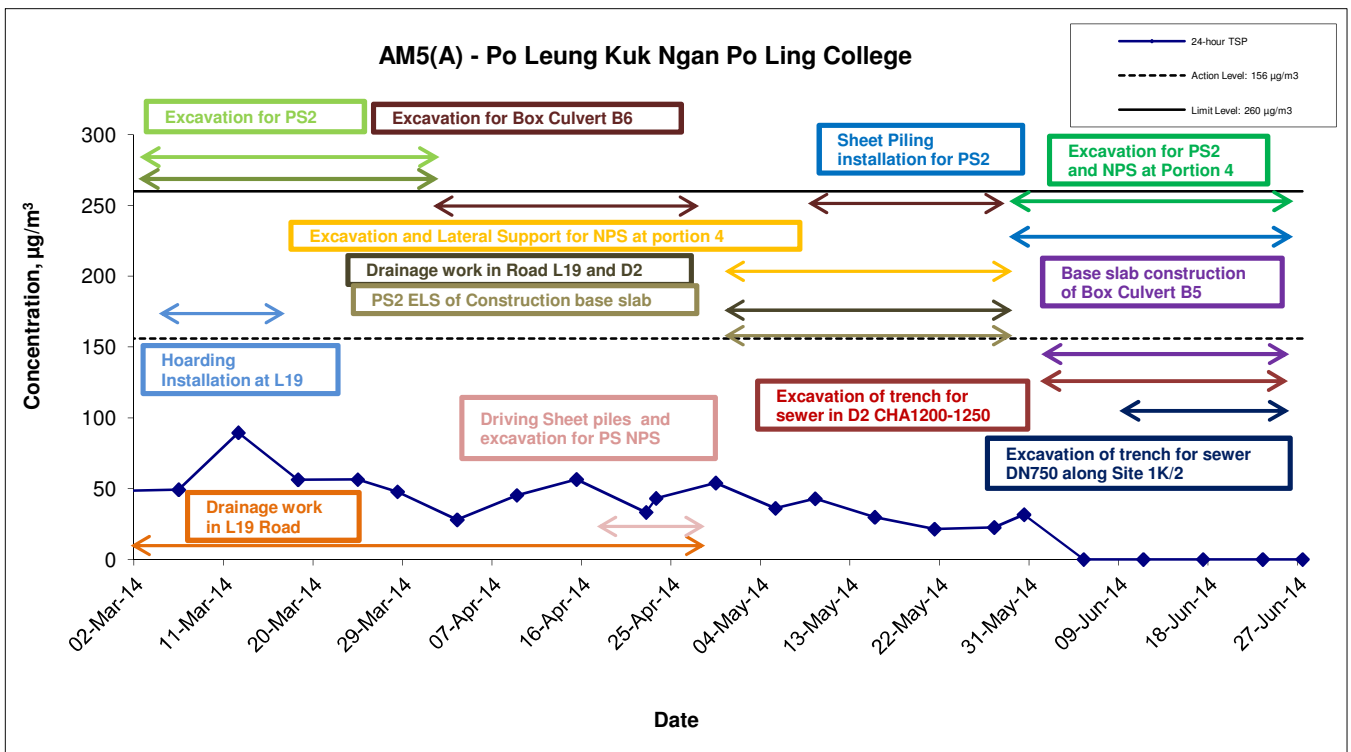
24-hr TSP Concentration Levels

Title Contract No. KL/2012/03 Kai Tak Development –Stage 4 Infrastructure at Former North Apron Area Graphical Presentation of 24-hour TSP Monitoring Results	Scale N.T.S	Project No. MA13056	CINOTECH
	Date Jul 14	Appendix F

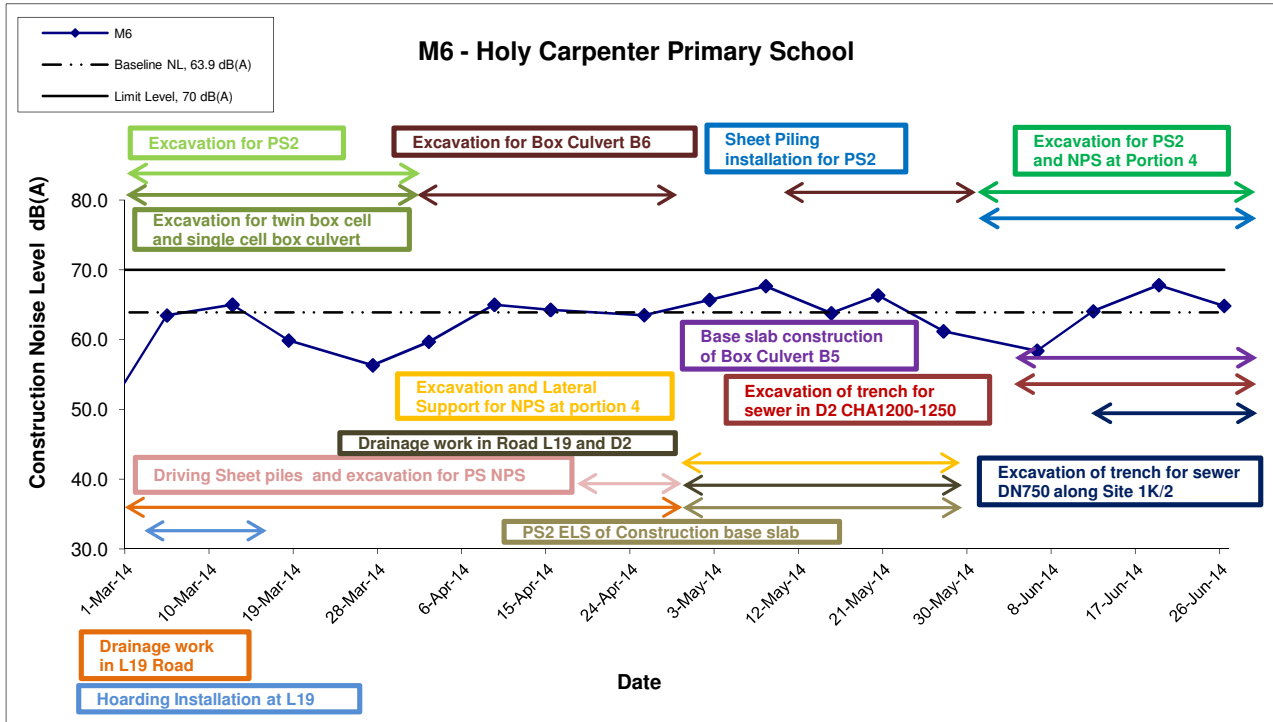
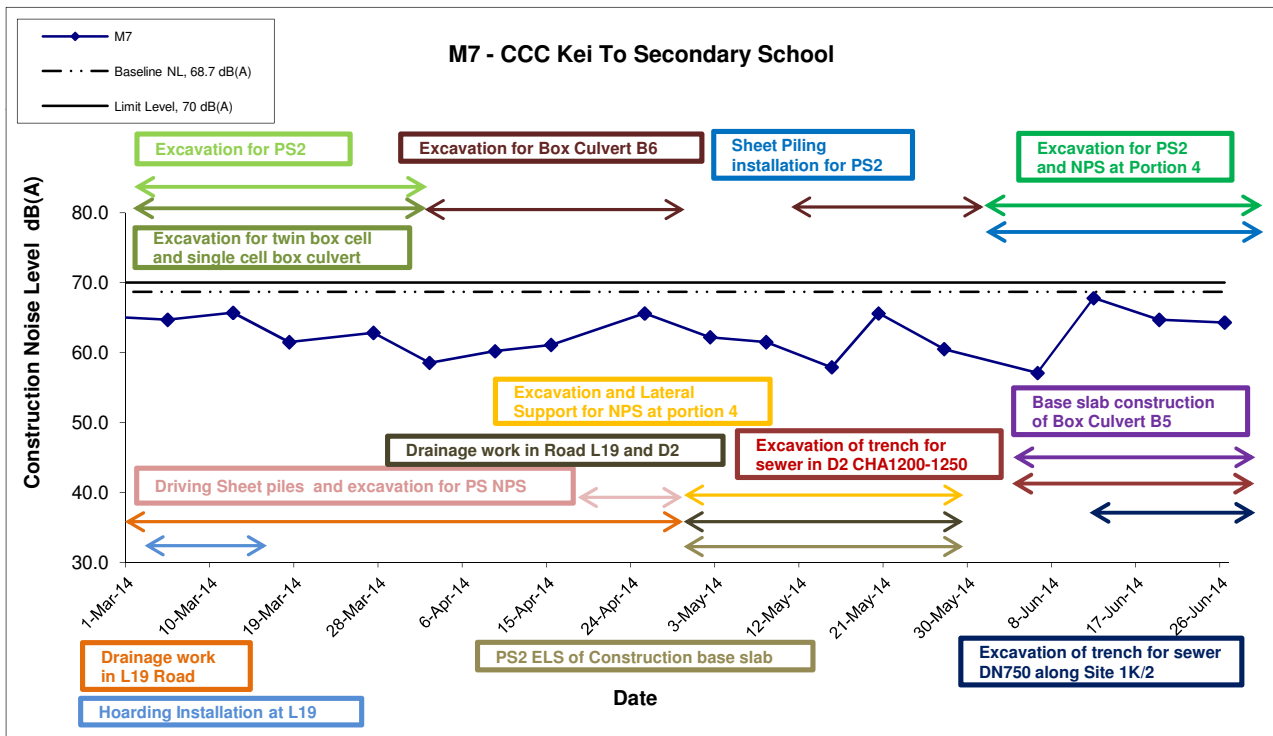
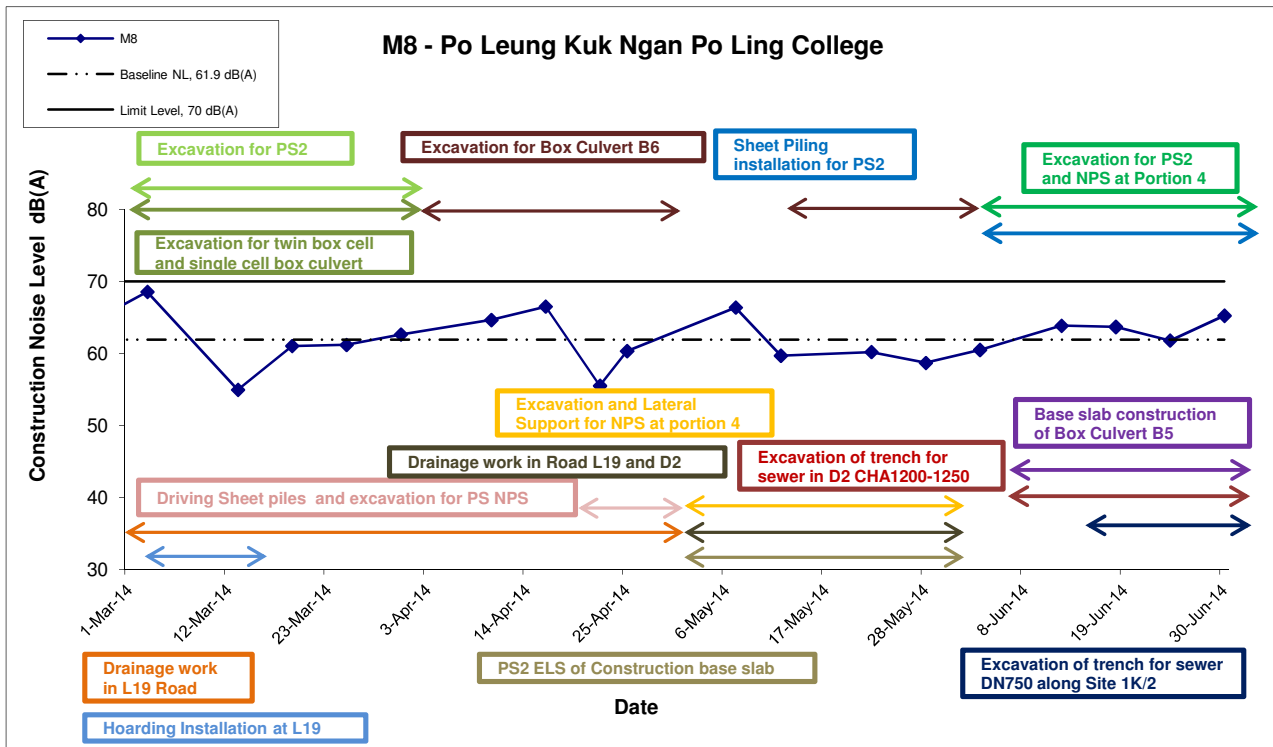
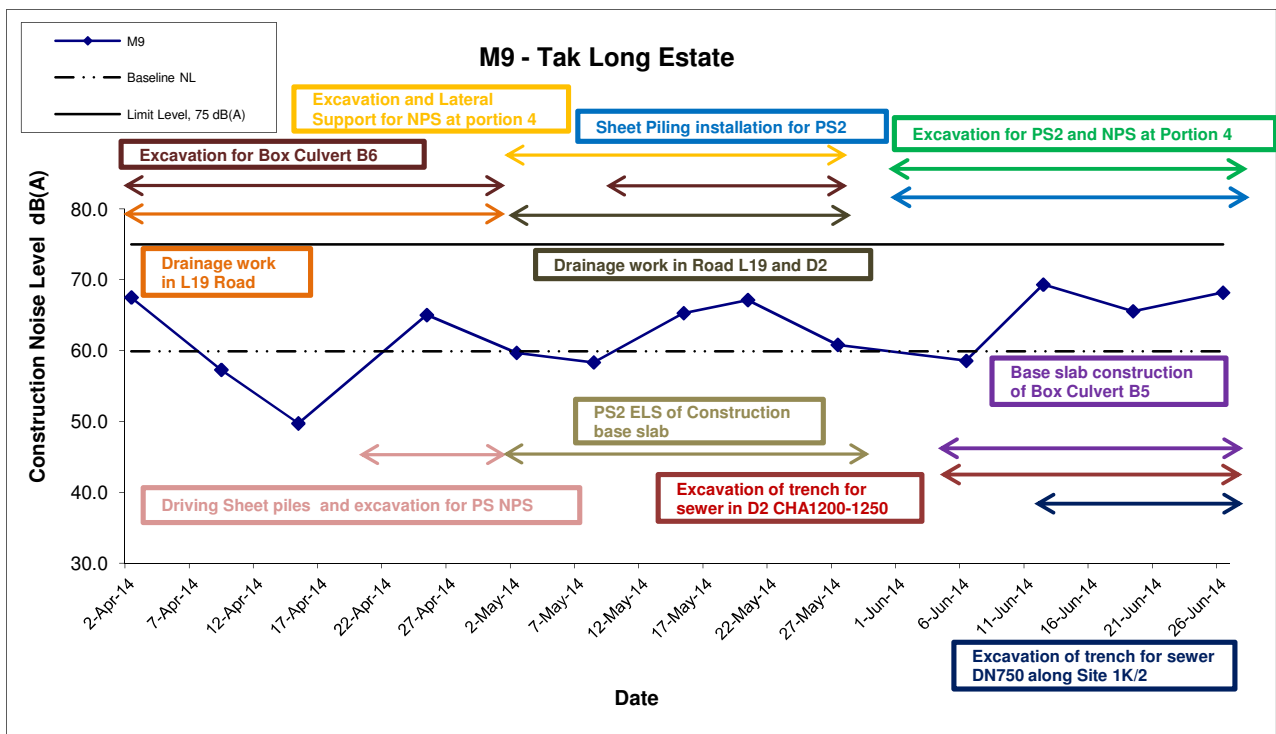
Title Contract No. KL/2012/03 Kai Tak Development –Stage 4 Infrastructure at Former North Apron Area Graphical Presentation of Construction Noise Monitoring Results	Scale N.T.S Date Jul 14	Project No. MA13056 Appendix G	
---	----------------------------------	---	--

Noise Levels

Remarks: The construction noise levels in the Tables in Appendix G were adopted for plotting the graphs

Title Contract No. KL/2012/03 Kai Tak Development –Stage 4 Infrastructure at Former North Apron Area Graphical Presentation of Construction Noise Monitoring Results	Scale N.T.S	Project No. MA13056	
	Date Jul 14	Appendix G
