EP-337/2009 – New Distributor Roads Serving the Planned KTD

Kai Tak Development –Stage 3A Infrastructure at Former  
North Apron Area

Monthly EM&A Report

August 2015

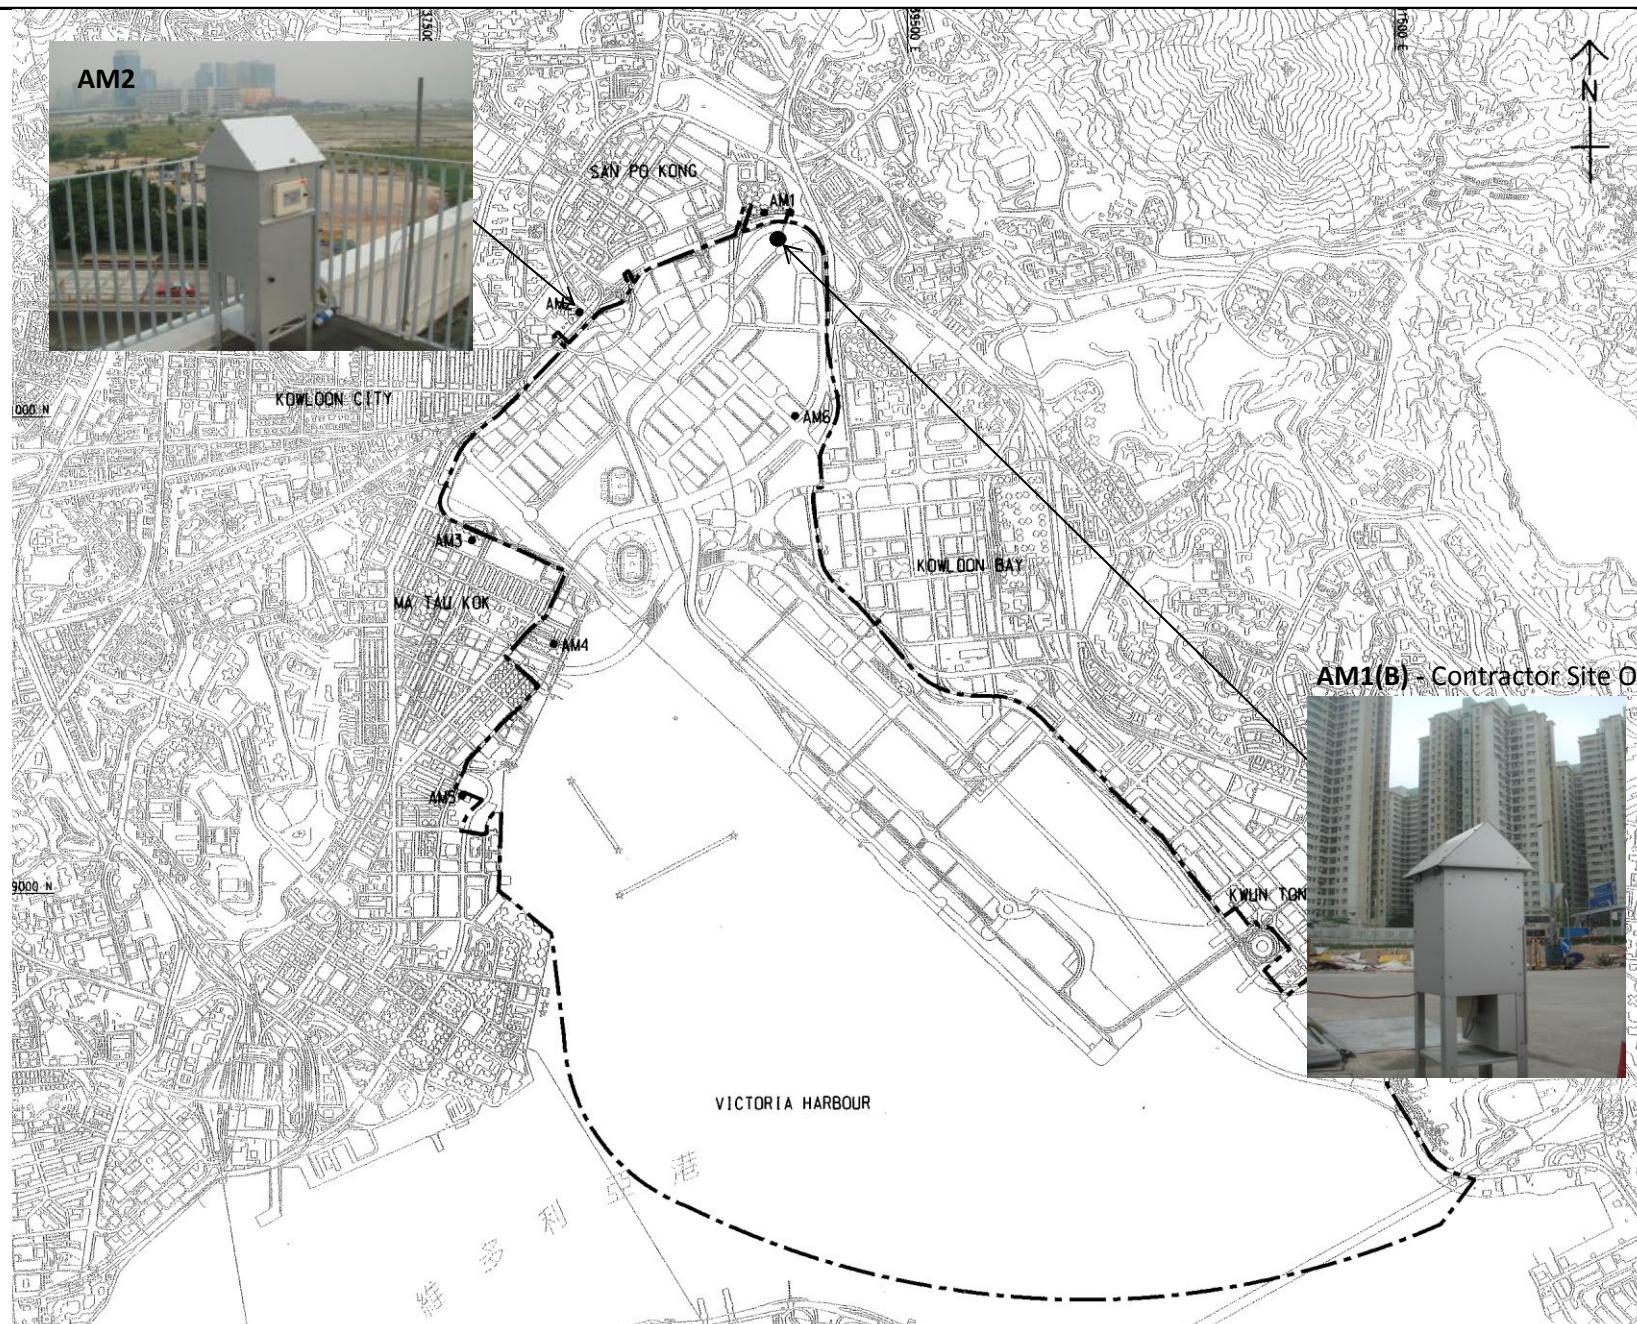
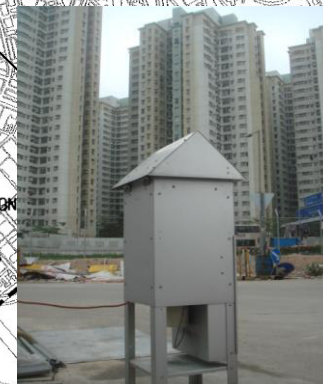
| | Air Quality Monitoring Stations under Contract No.: KLN/2013/16 | Apr-14 | 2 | |

AM1(B) - Contractor Site Office (KL/2012/02)

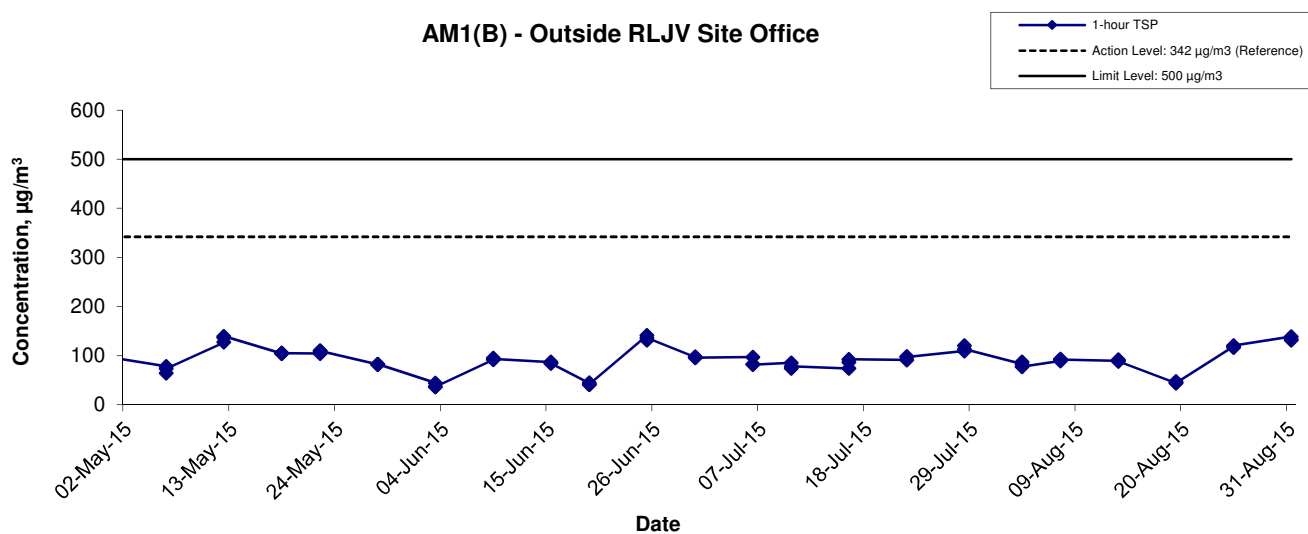
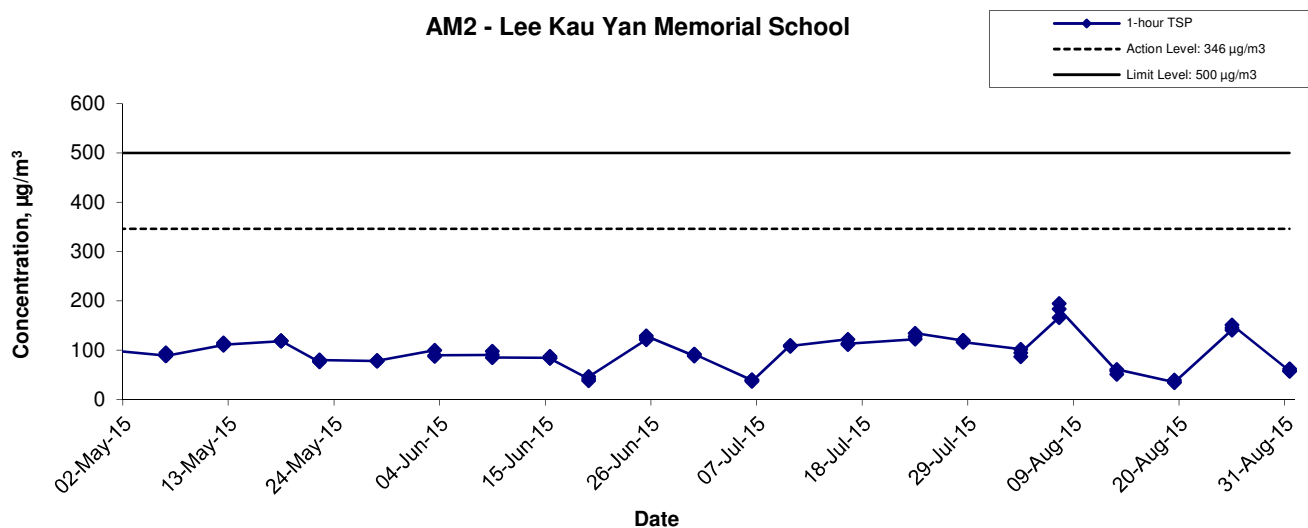
## 1-hr TSP Concentration Levels

**AM1(B) - Outside RLJV Site Office**

**AM2 - Lee Kau Yan Memorial School**

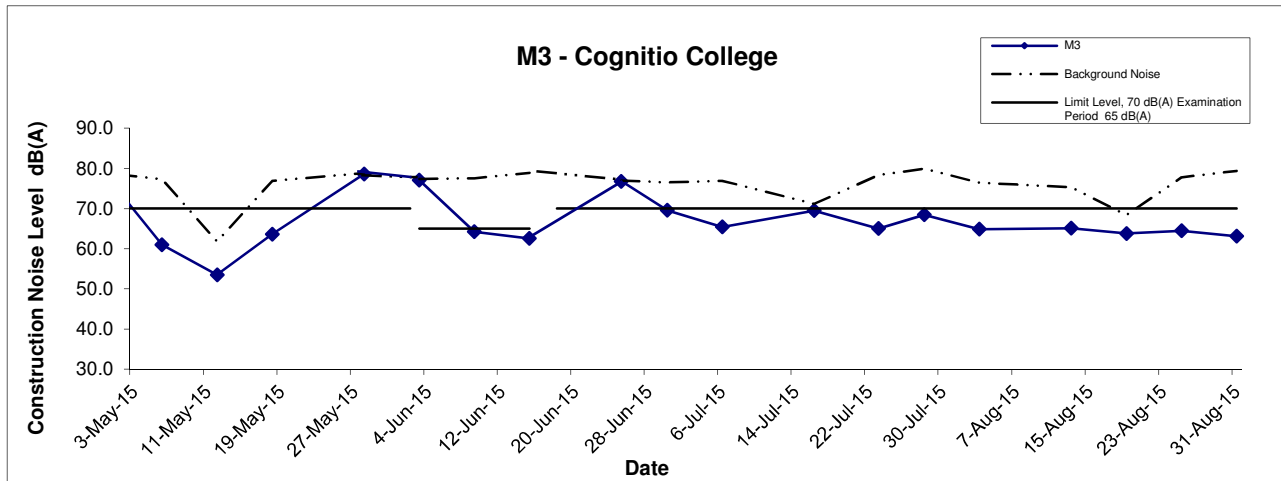
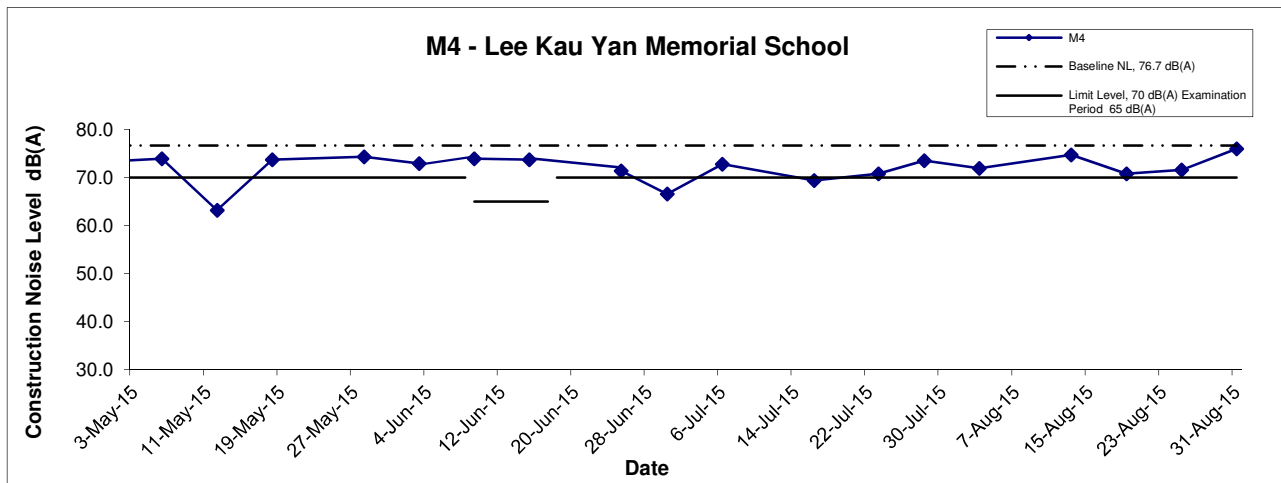
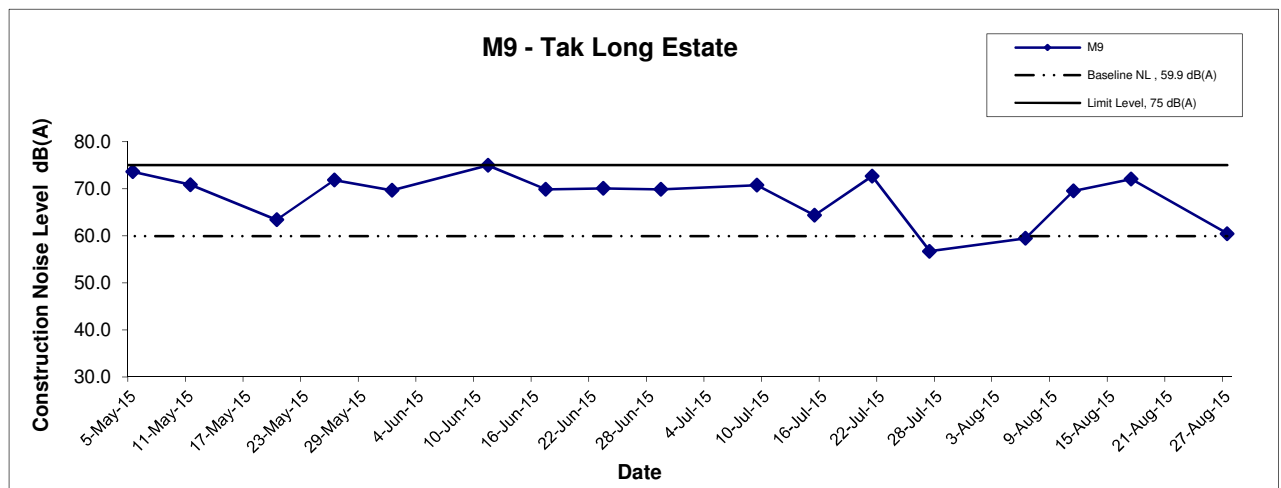
## Noise Levels

Remarks: The construction noise levels in the Tables in Appendix G were adopted for plotting the graphs
