# **Civil Engineering and Development Department**

**EP-344/2009 – New Sewage Pumping Stations  
Serving KTD EP-337/2009 – New Distributor  
Roads Serving the Planned KTD**

**Contract No. KL/2012/03  
Kai Tak Development –Stage 4 Infrastructure  
at Former North Apron Area**

Monthly EM&A Report

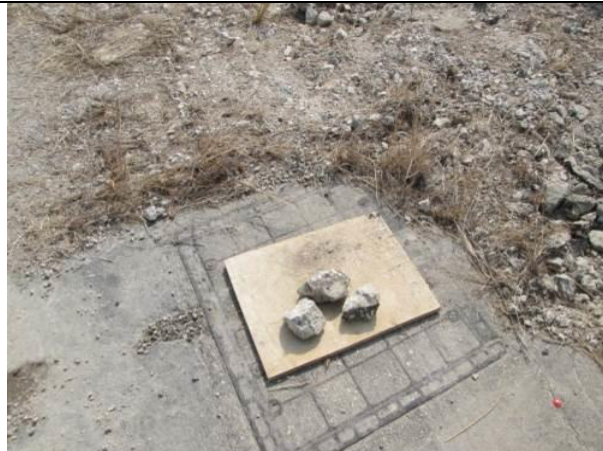
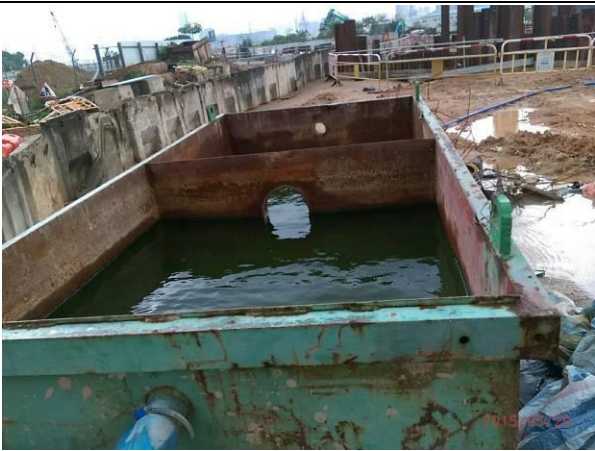
| To prevent any surface runoff discharge into any stream course. | Follow-up measure(s) after identification of wastewater discharges from site. |

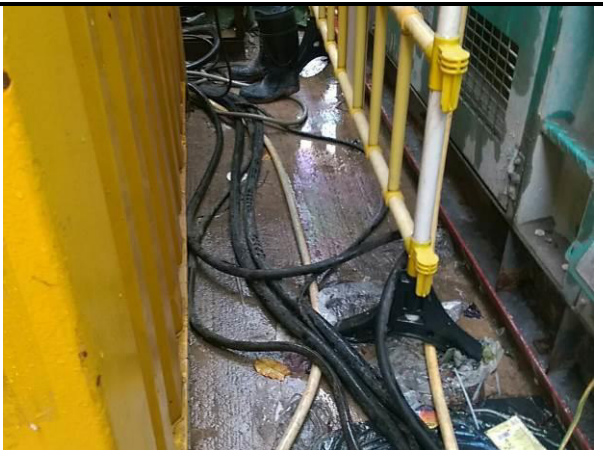
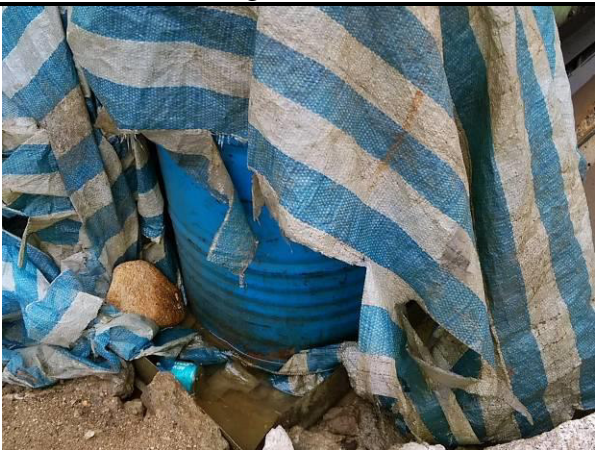
| To avoid any discharge or accidental spillage of chemical waste or oil directly from the site | To avoid improper handling or storage of oil drum on site |
