**EP-344/2009 – New Sewage Pumping Stations  
Serving KTD  
EP-337/2009 – New Distributor Roads Serving the  
Planned KTD**

**Contract No. KL/2012/03  
Kai Tak Development –Stage 4 Infrastructure at  
Former North Apron Area**

Monthly EM&A Report

June 2018

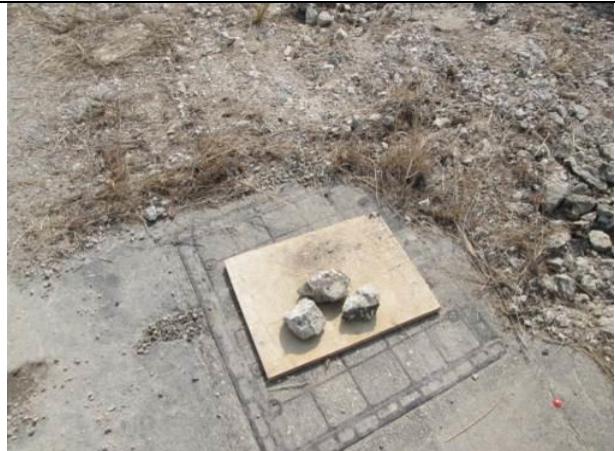
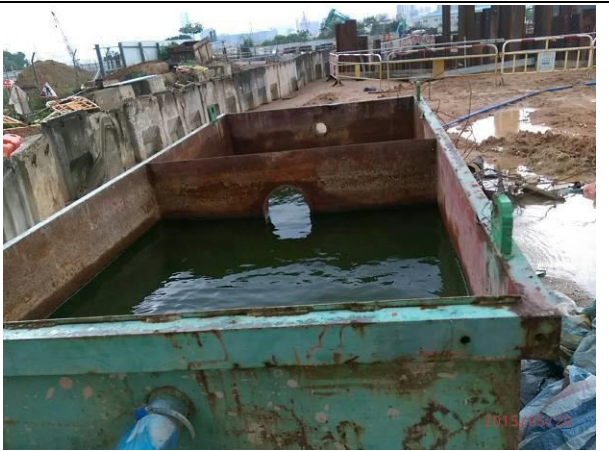
| To prevent any surface runoff discharge into any stream course. | Follow-up measure(s) after identification of wastewater discharges from site. |

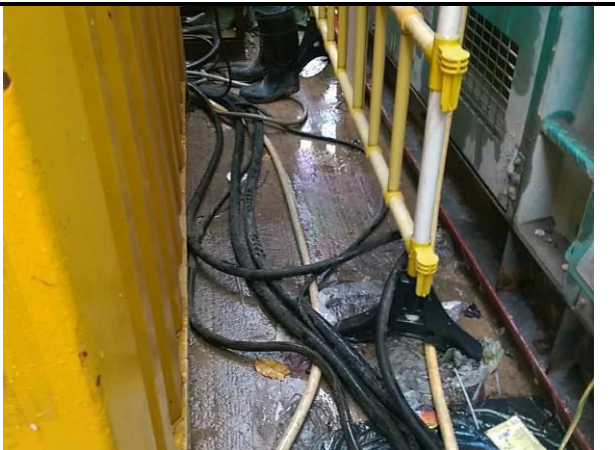
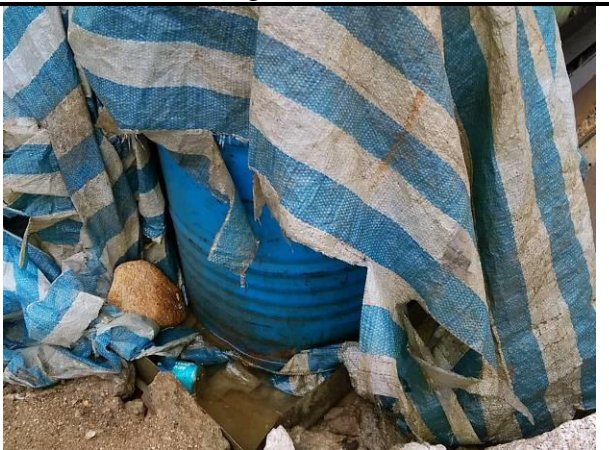
| To avoid any discharge or accidental spillage of chemical waste or oil directly from the site | To avoid improper handling or storage of oil drum on site |

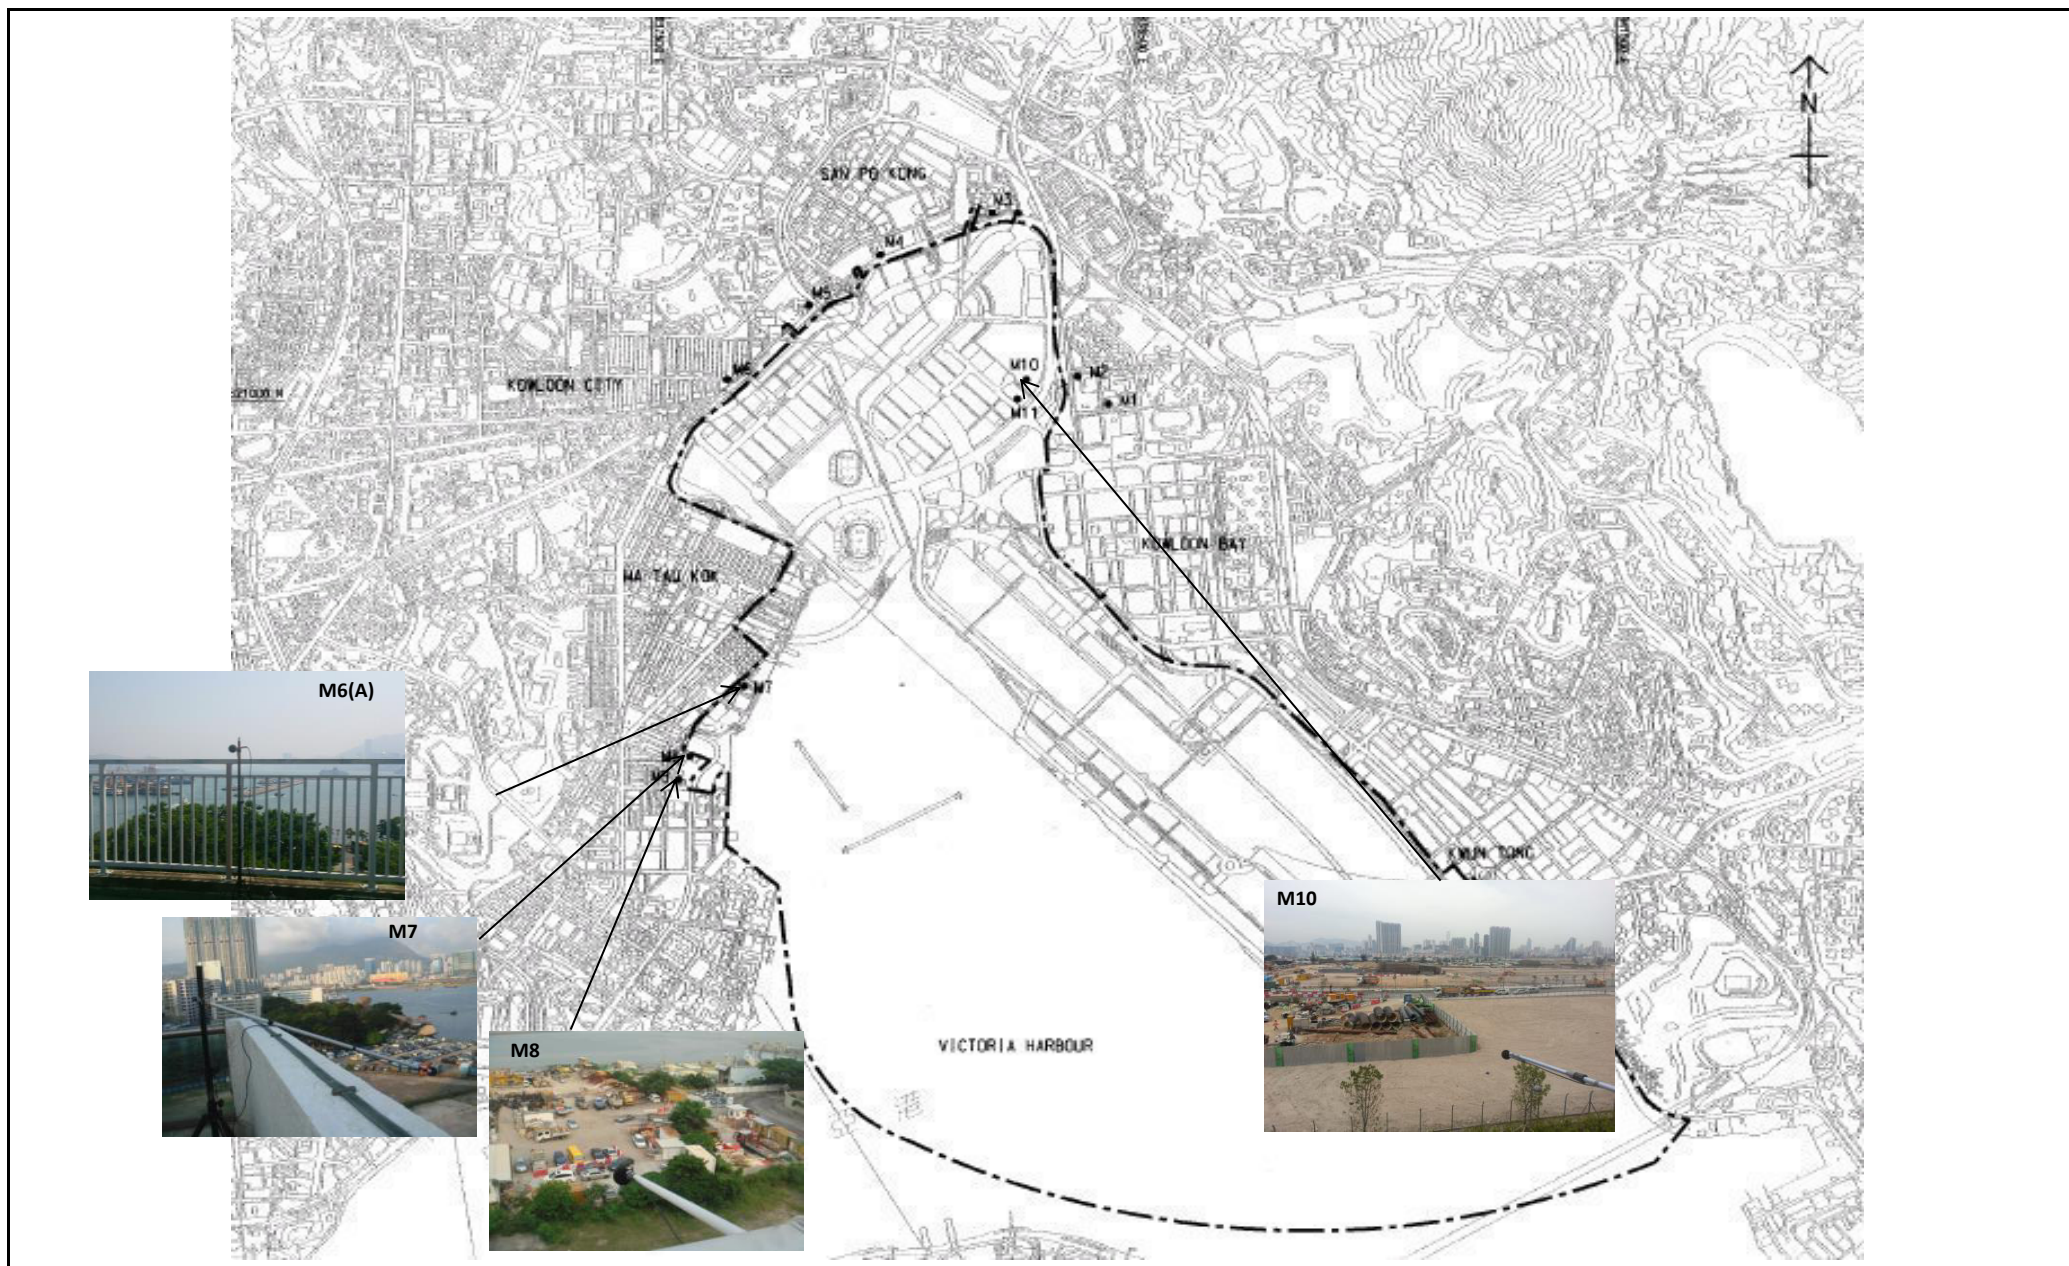
| | Noise Monitoring Stations under this Project | | Date | Figure | |

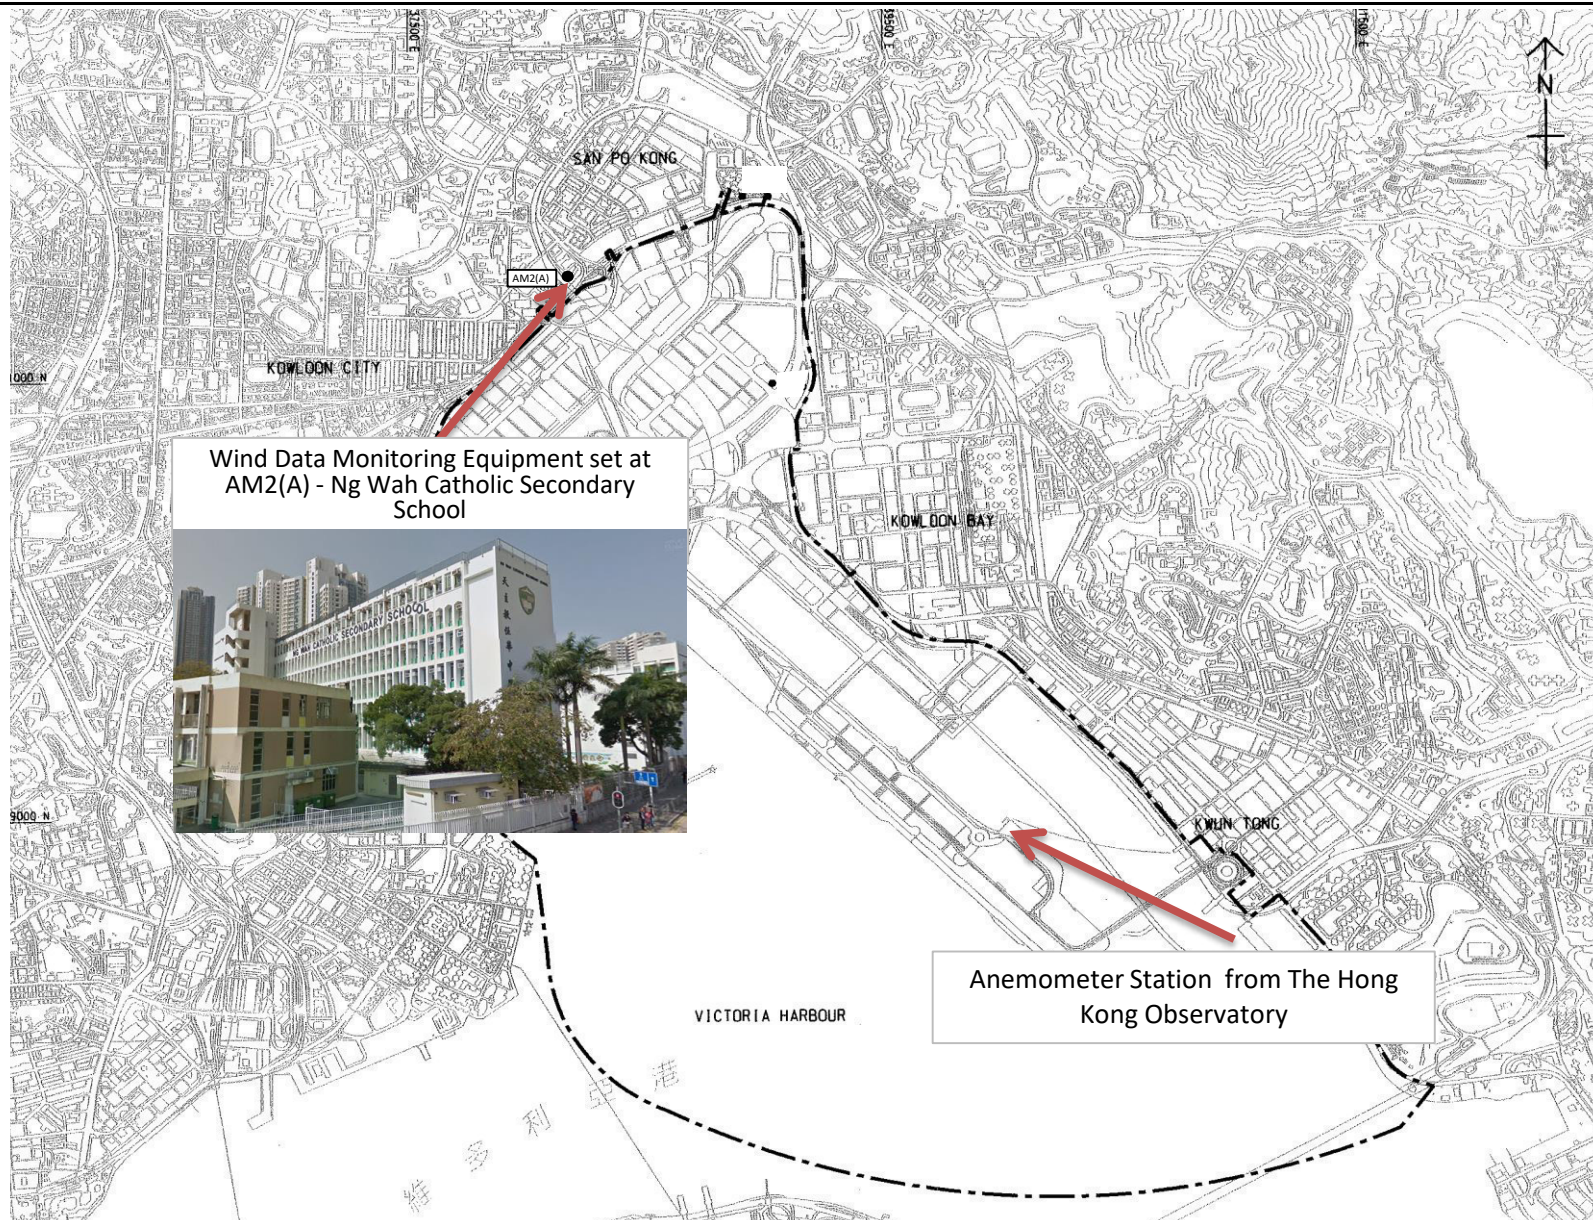
| | Location of Wind Data Monitoring Equipment | | Date | Figure | |

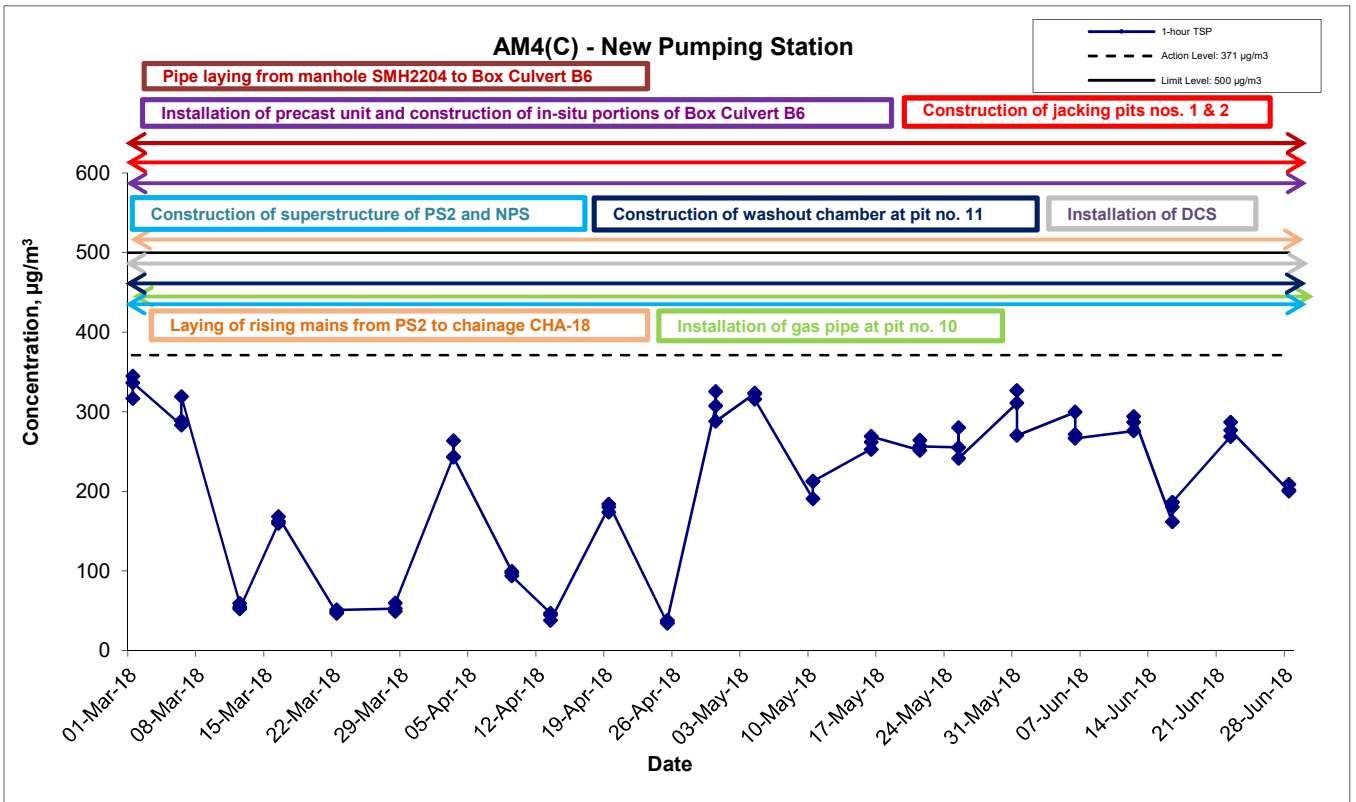
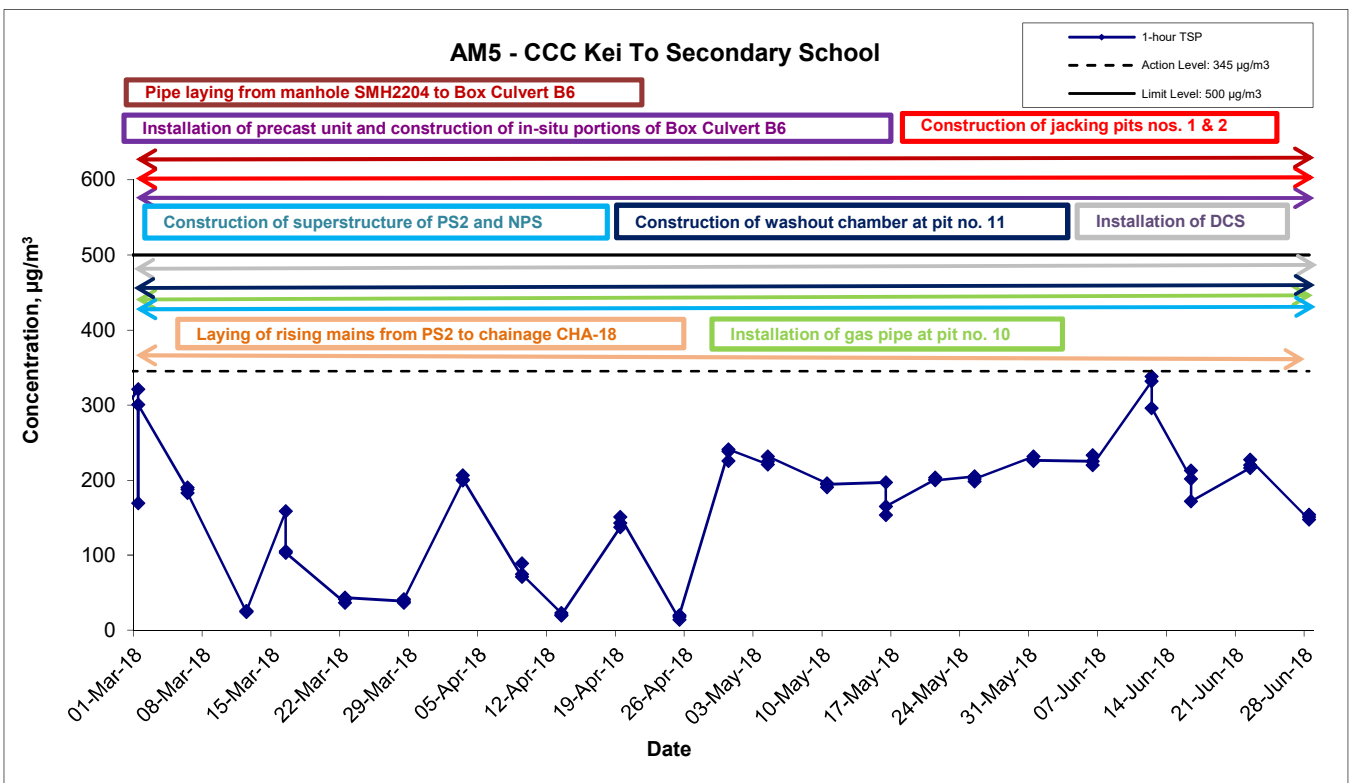
## 1-hr TSP Concentration Levels

| <b>Title</b><br>Contract No. KL/2012/03<br>Kai Tak Development –Stage 4 Infrastructure at Former North Apron Area<br><br>Graphical Presentation of 1-hour TSP Monitoring Results | <b>Scale</b><br>N.T.S | <b>Project No.</b><br>MA13056 | <b>CINOTECH</b> |

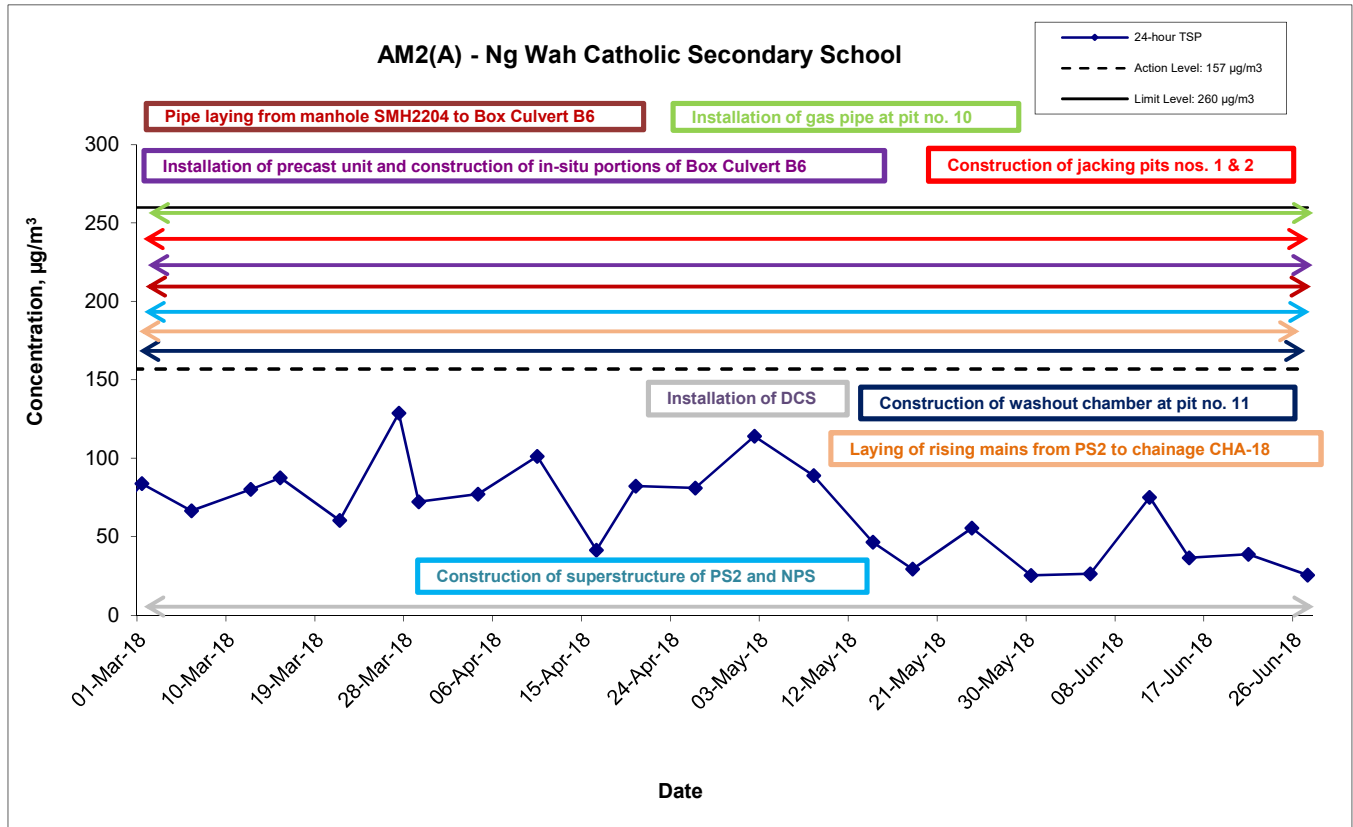
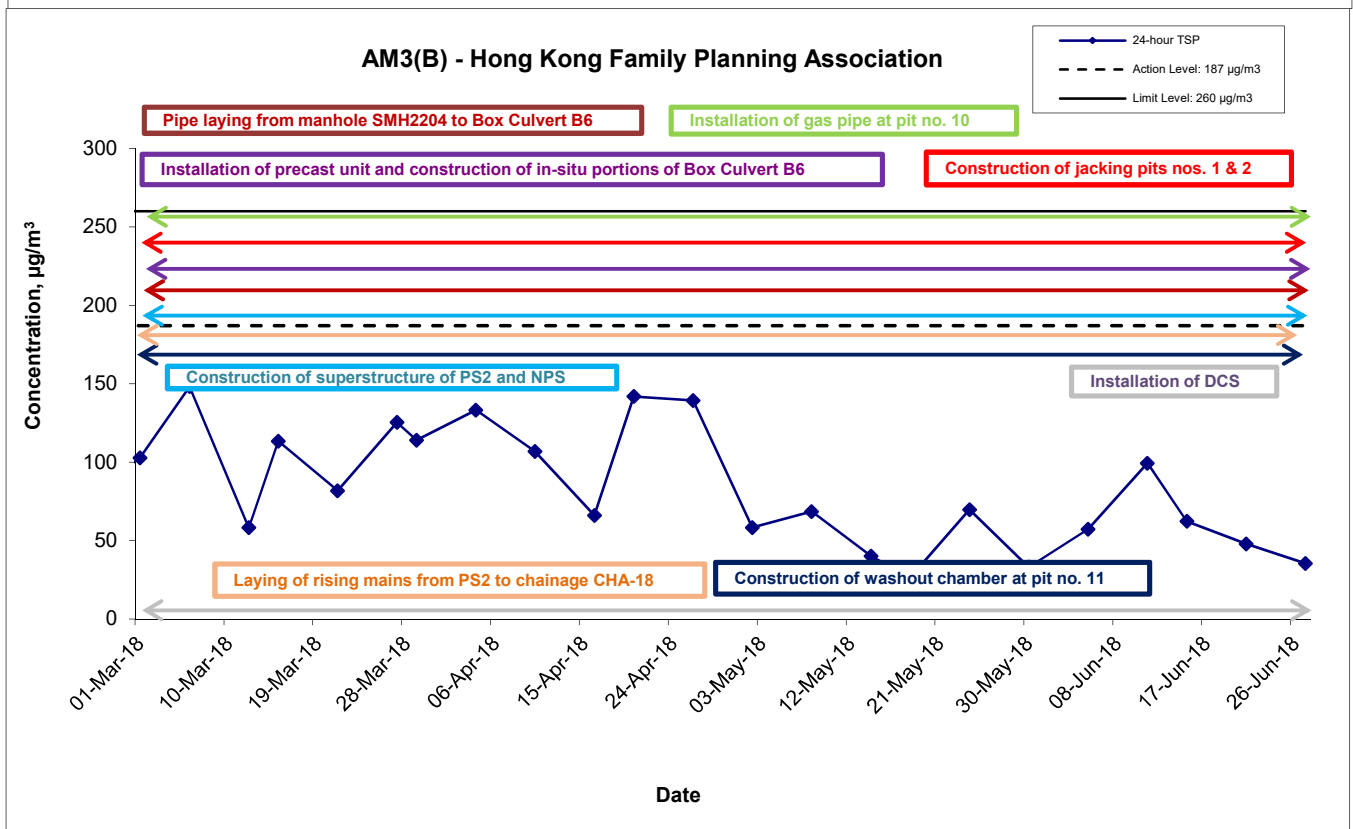
## 24-hr TSP Concentration Levels

| <b>Title</b><br>Contract No. KL/2012/03<br>Kai Tak Development –Stage 4 Infrastructure at Former North Apron Area<br><br>Graphical Presentation of 24-hour TSP Monitoring Results | <b>Scale</b><br>N.T.S | <b>Project</b><br>No. MA13056 | <b>CINOTECH</b> |

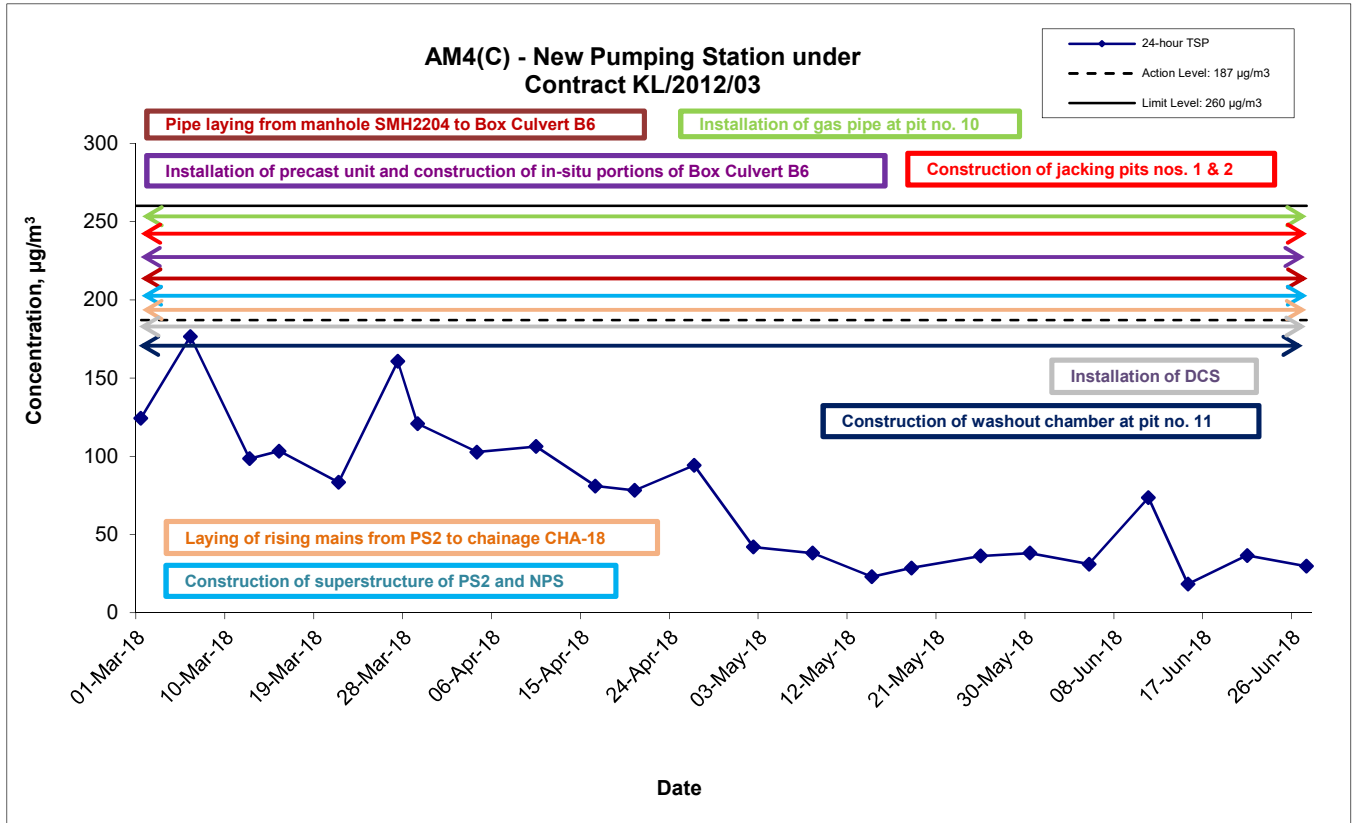
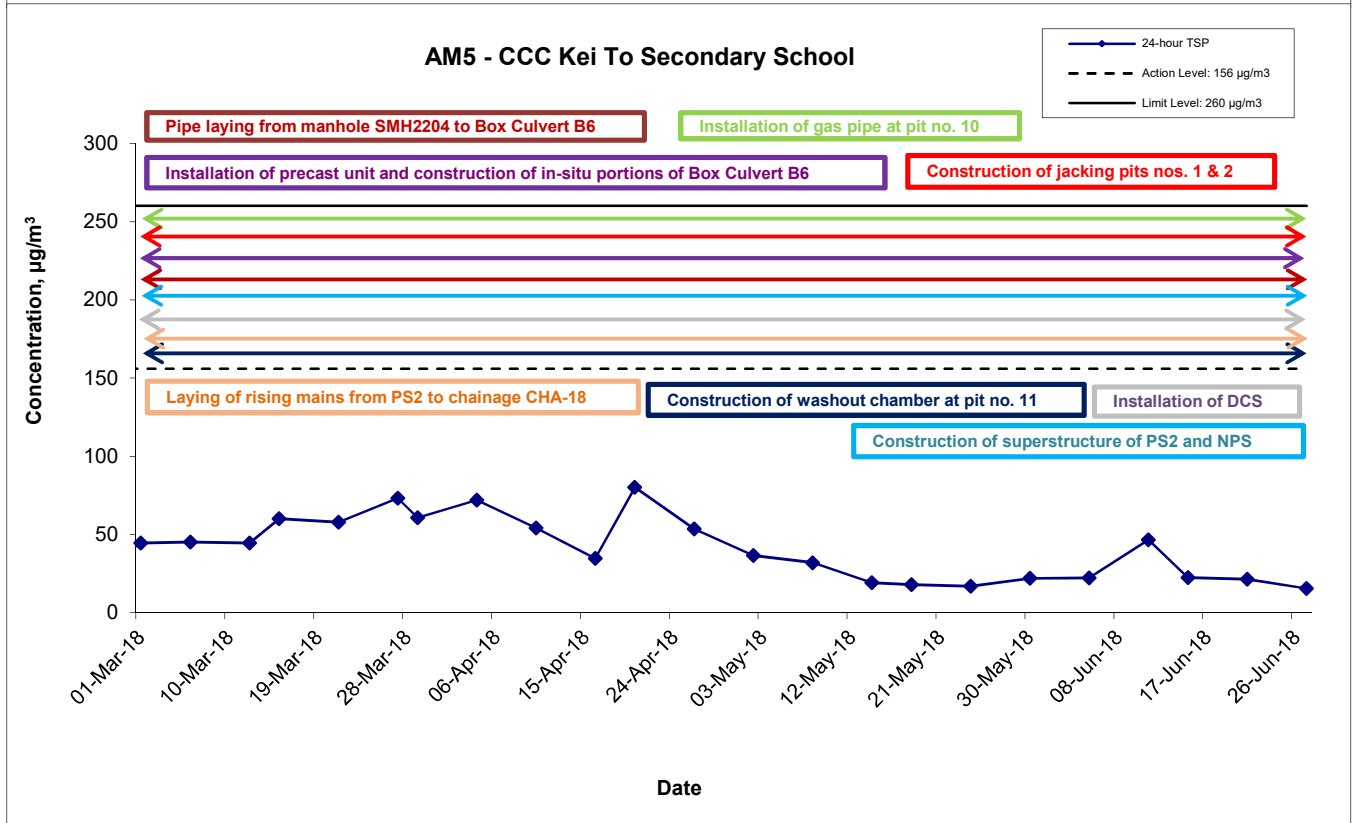
## 24-hr TSP Concentration Levels

| <b>Title</b><br>Contract No. KL/2012/03<br>Kai Tak Development –Stage 4 Infrastructure at Former North Apron Area<br><br>Graphical Presentation of 24-hour TSP Monitoring Results | <b>Scale</b> | <b>Project</b> | <b>CINOTECH</b> |

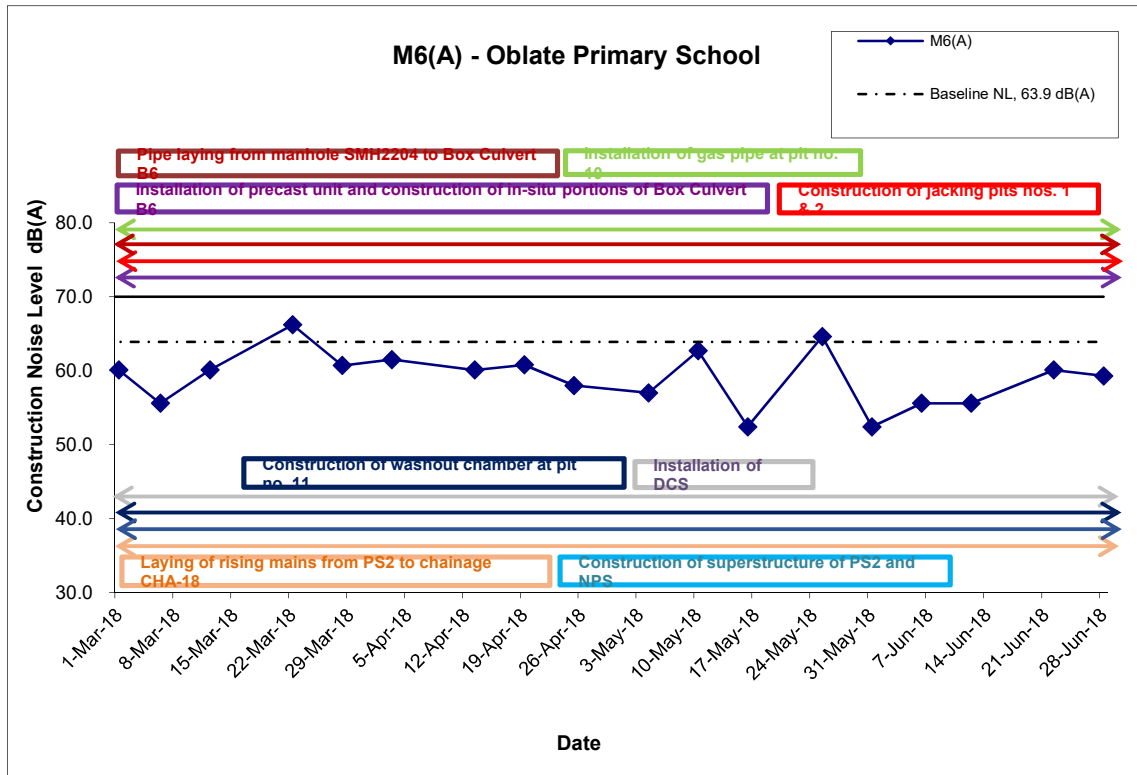
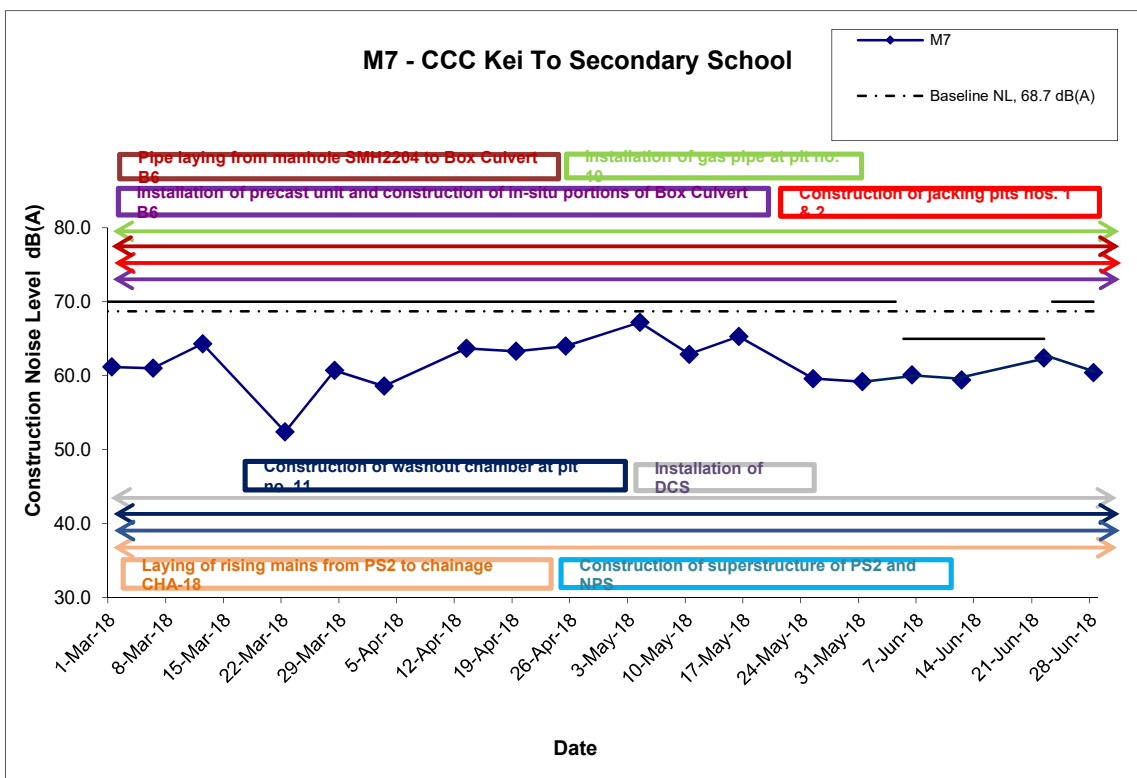
## Noise Levels

Remarks: The construction noise levels in the Tables in Appendix G were adopted for plotting the graphs

| <b>Title</b><br>Contract No. KL/2012/03<br>Kai Tak Development –Stage 4 Infrastructure at Former North Apron Area<br>Graphical Presentation of Construction Noise Monitoring Results | <b>Scale</b><br>N.T.S | <b>Project No.</b><br>VA13056 | <b>CINOTECH</b> |

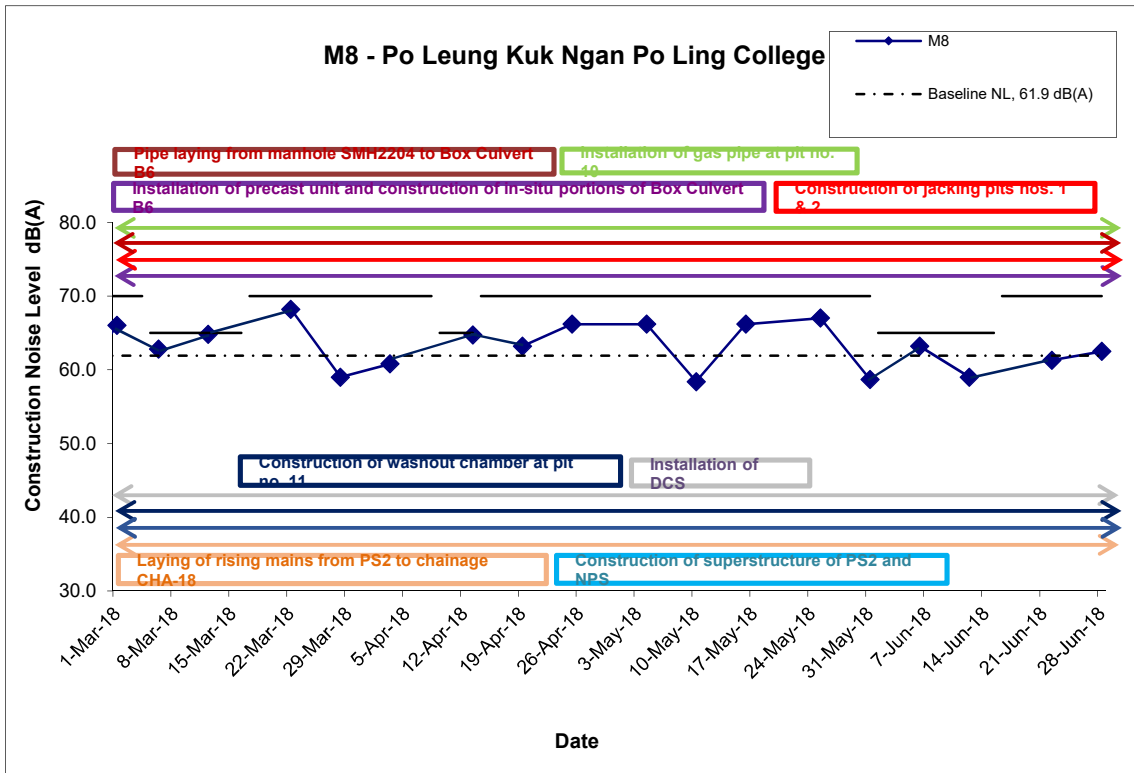
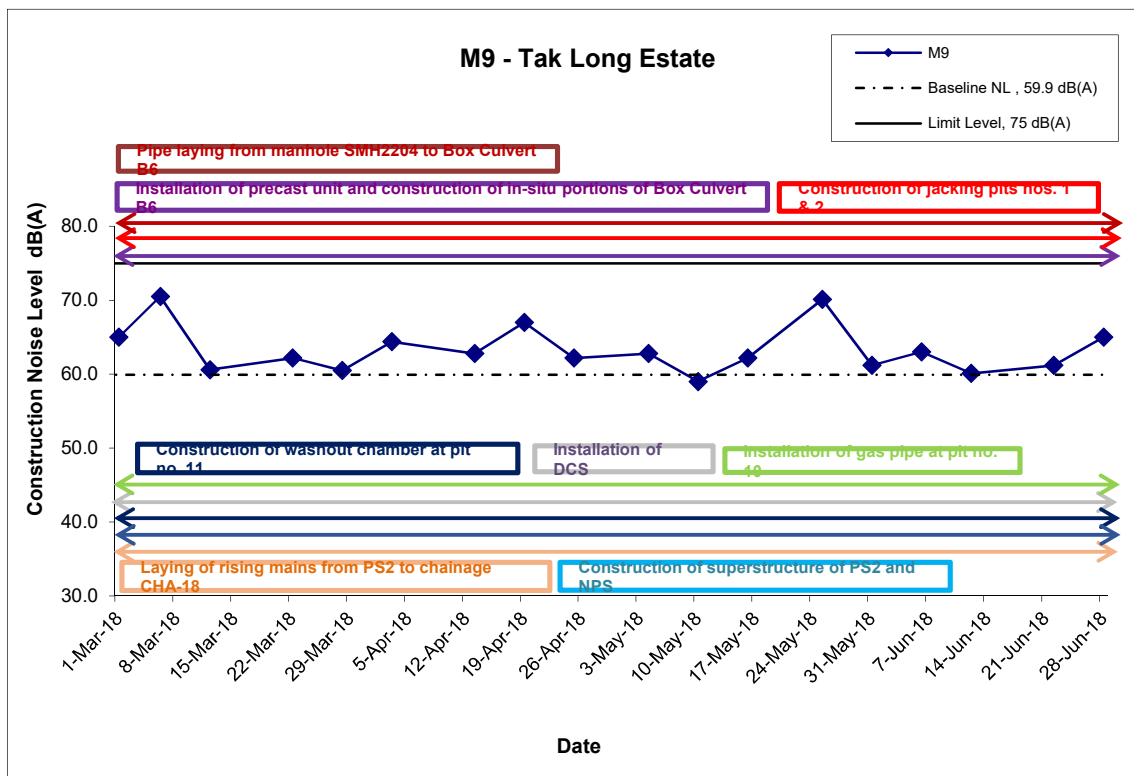
## Noise Levels

Remarks: The construction noise levels in the Tables in Appendix G were adopted for plotting the graphs

| <b>Title</b><br>Contract No. KL/2012/03<br>Kai Tak Development –Stage 4 Infrastructure at Former North Apron Area<br>Graphical Presentation of Construction Noise Monitoring Results | <b>Scale</b><br>N.T.S | <b>Project No.</b><br>VA13056 | <b>CINOTECH</b> |
