**EP-344/2009 – New Sewage Pumping Stations  
Serving KTD  
EP-337/2009 – New Distributor Roads Serving the  
Planned KTD**

**Contract No. KL/2012/03  
Kai Tak Development –Stage 4 Infrastructure at  
Former North Apron Area**

Monthly EM&A Report

August 2018

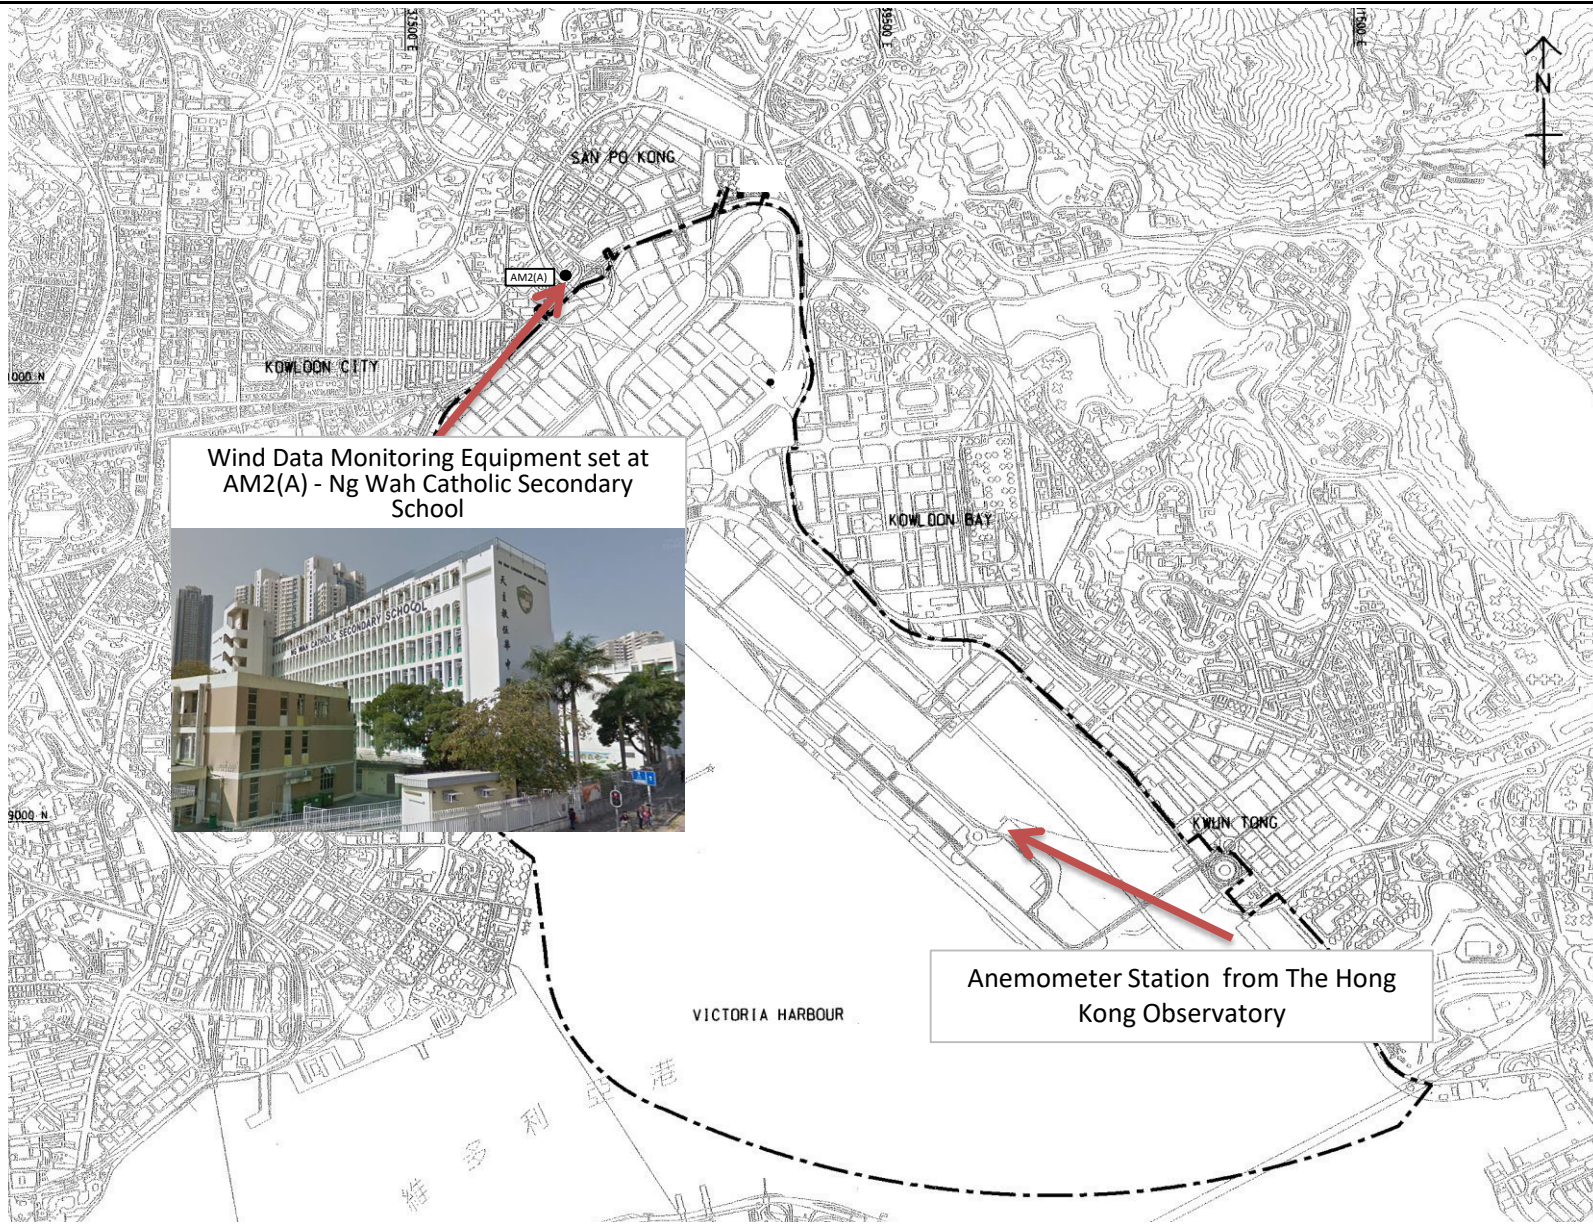
Scale	N.T.S	Project No.	MA13056
Date	Aug-17	Figure	4

Location of Wind Data Monitoring Equipment

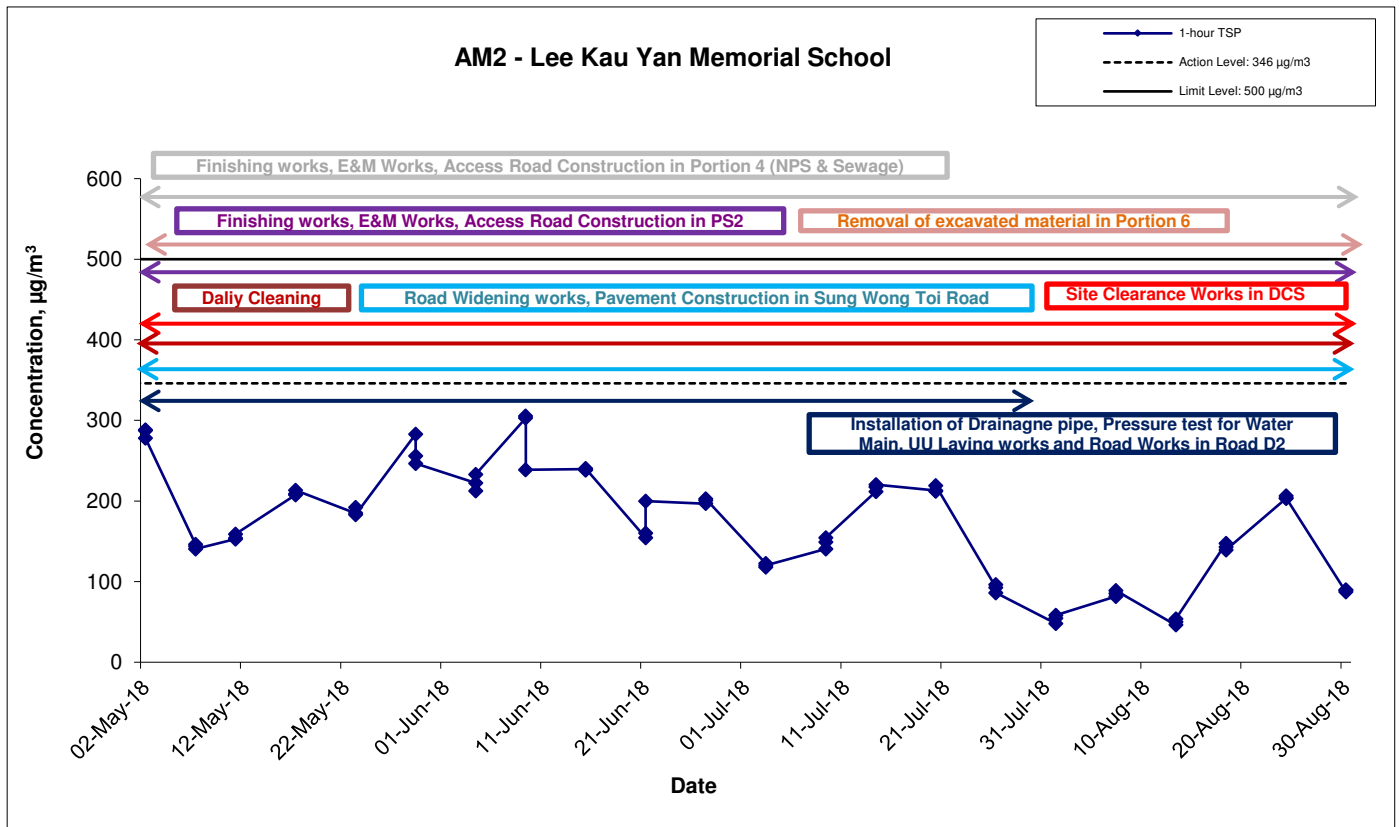
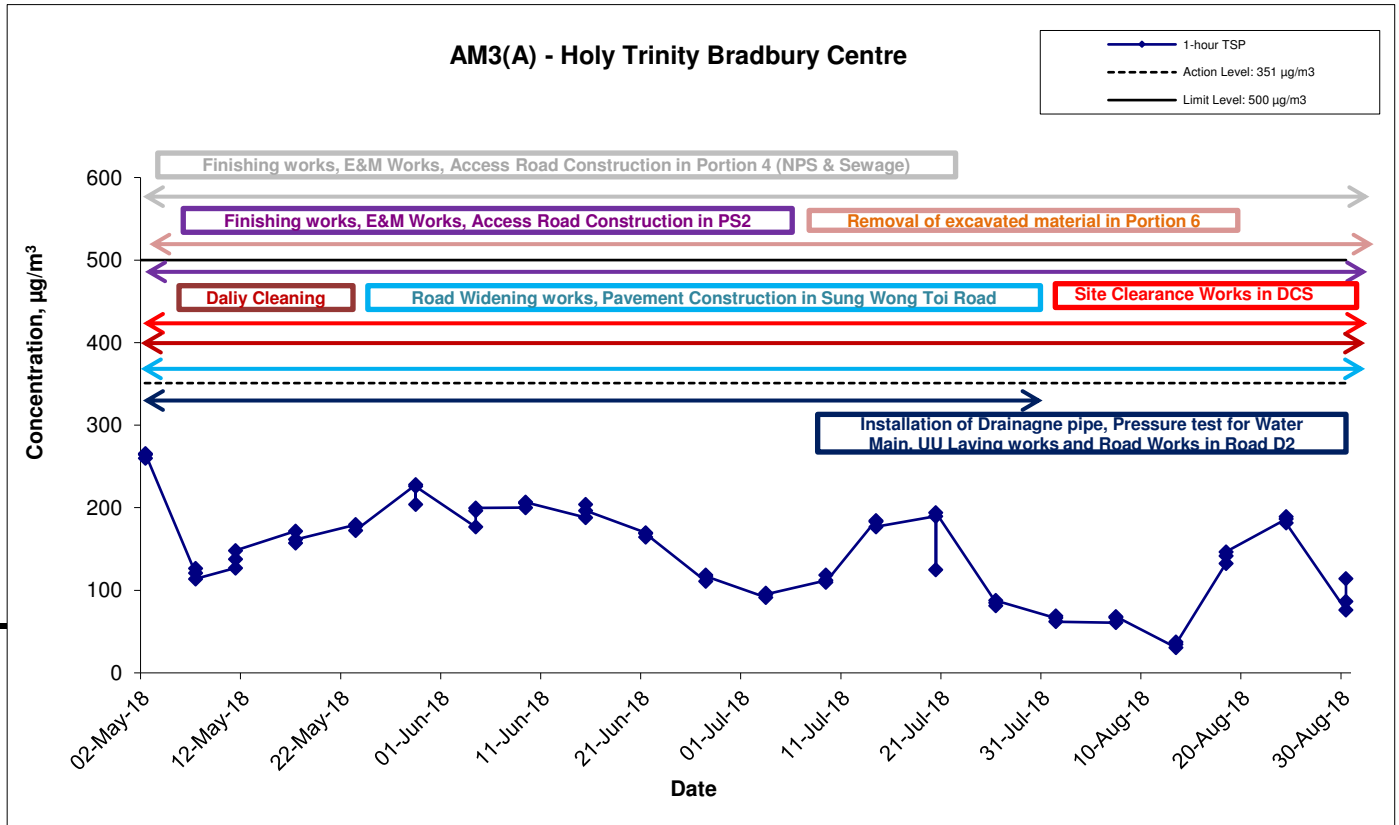
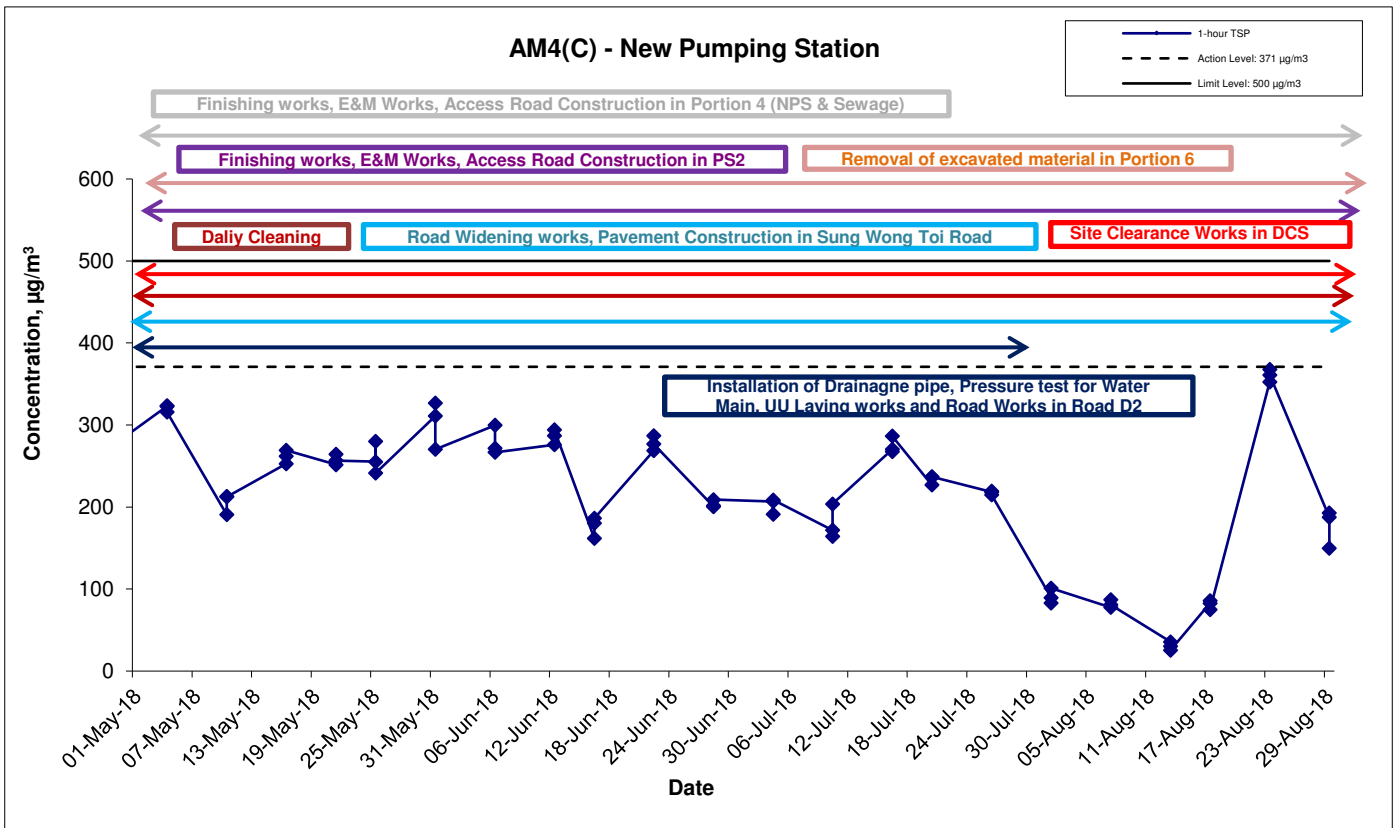
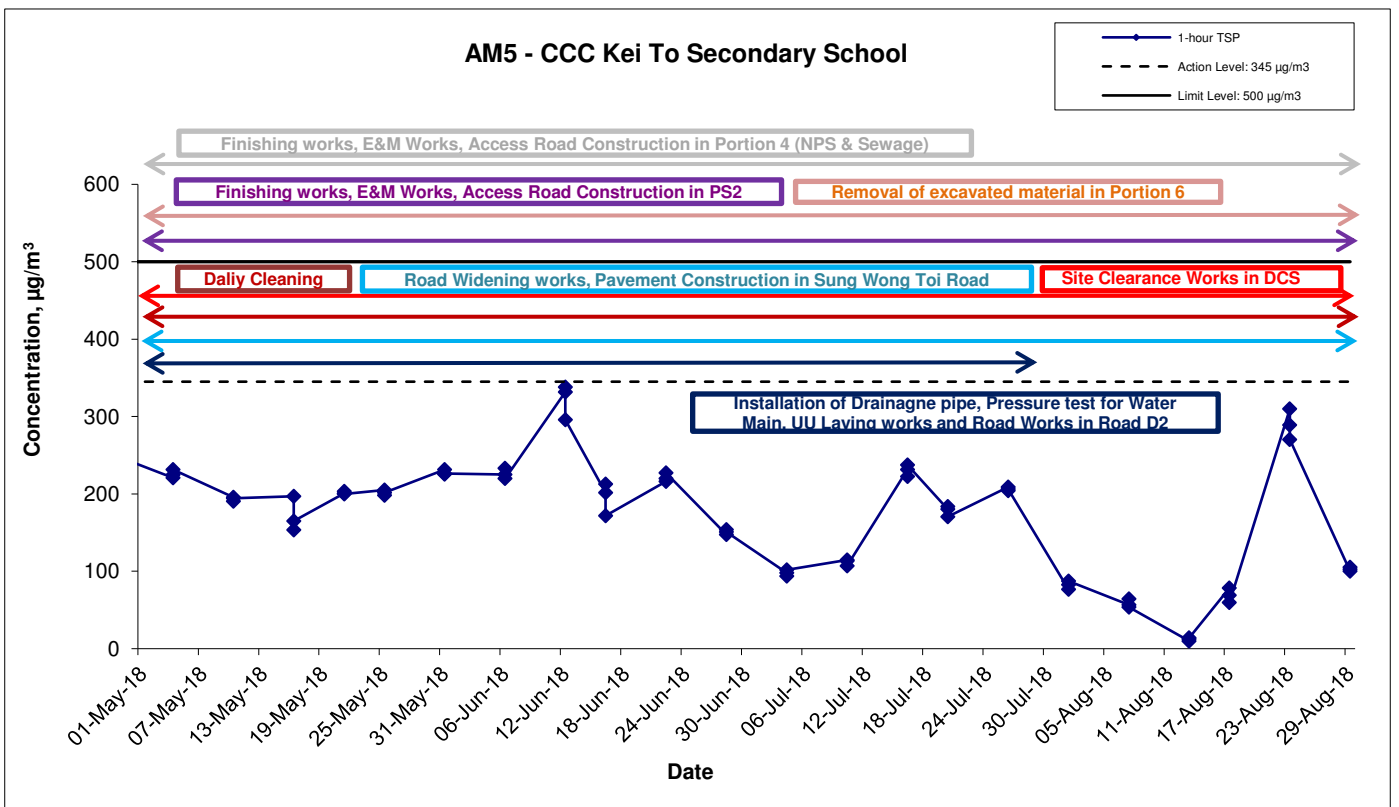
Title Kai Tak Development –Stage 4 Infrastructure at Former North Apron Area Graphical Presentation of 1-hour TSP Monitoring Results	Contract No. KL/2012/03	Scale N.T.S	Project No. MA13056	<b>CINOTECH</b>
		Date Aug 18	Appendix E

# 1-hr TSP Concentration Levels

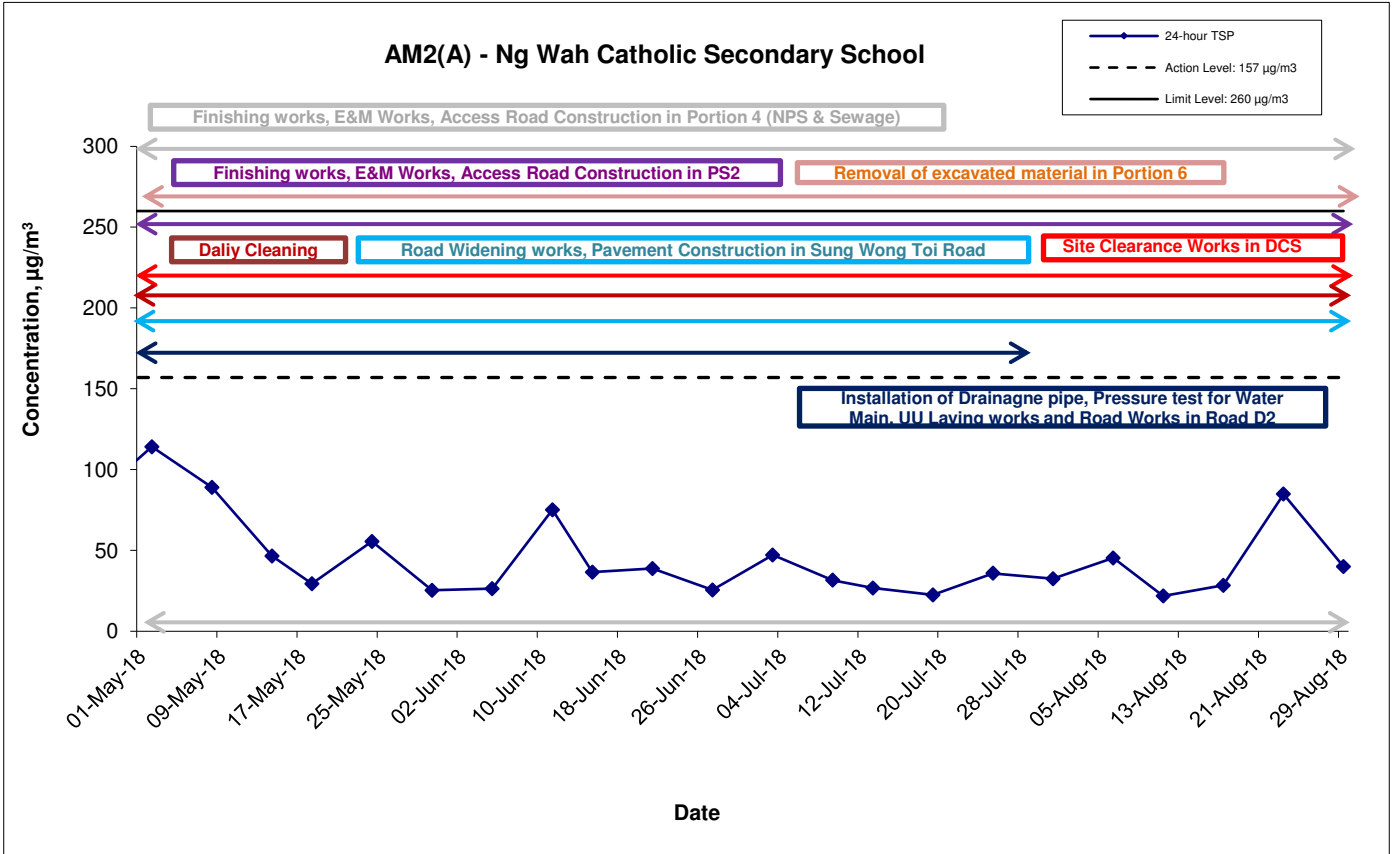
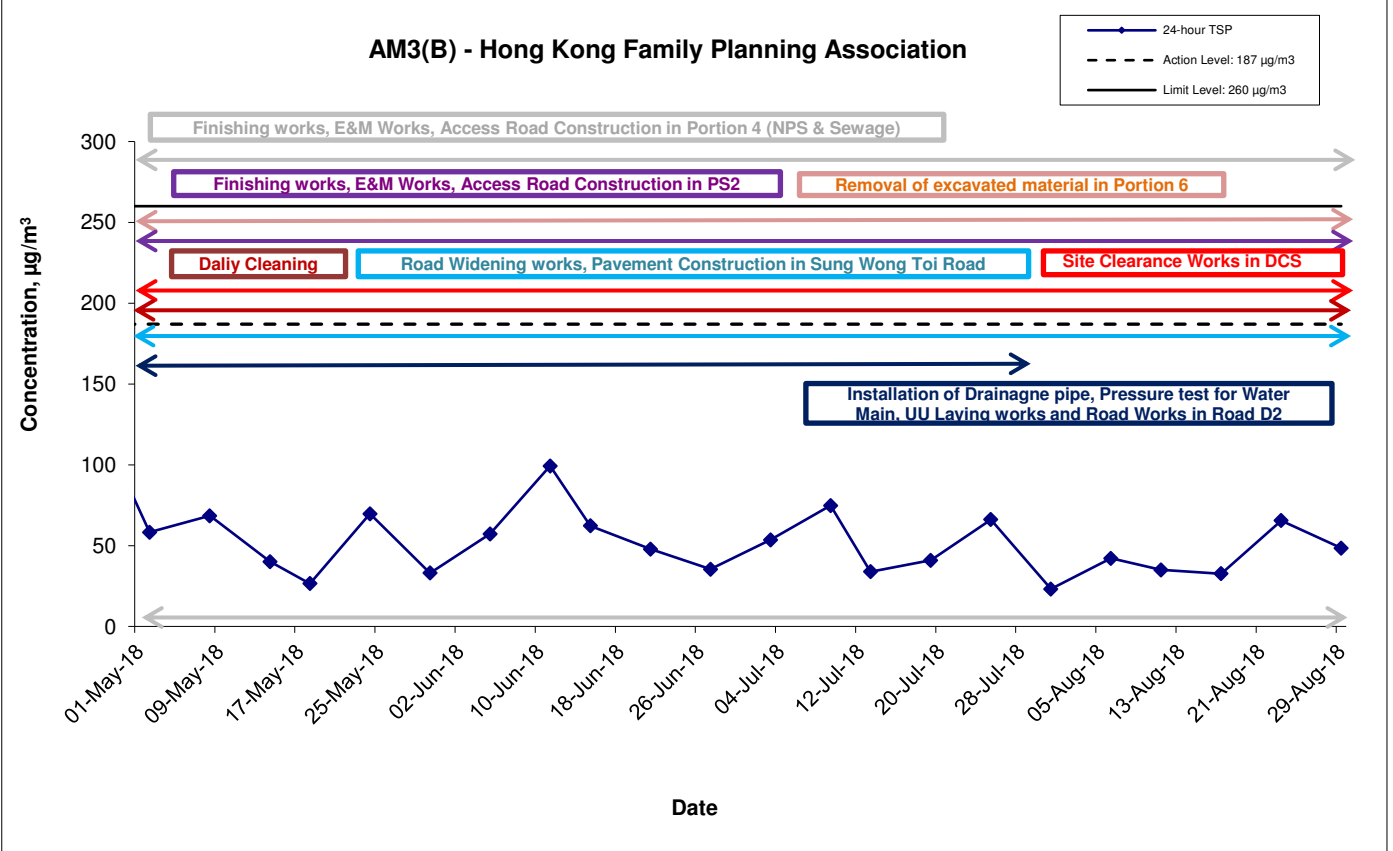
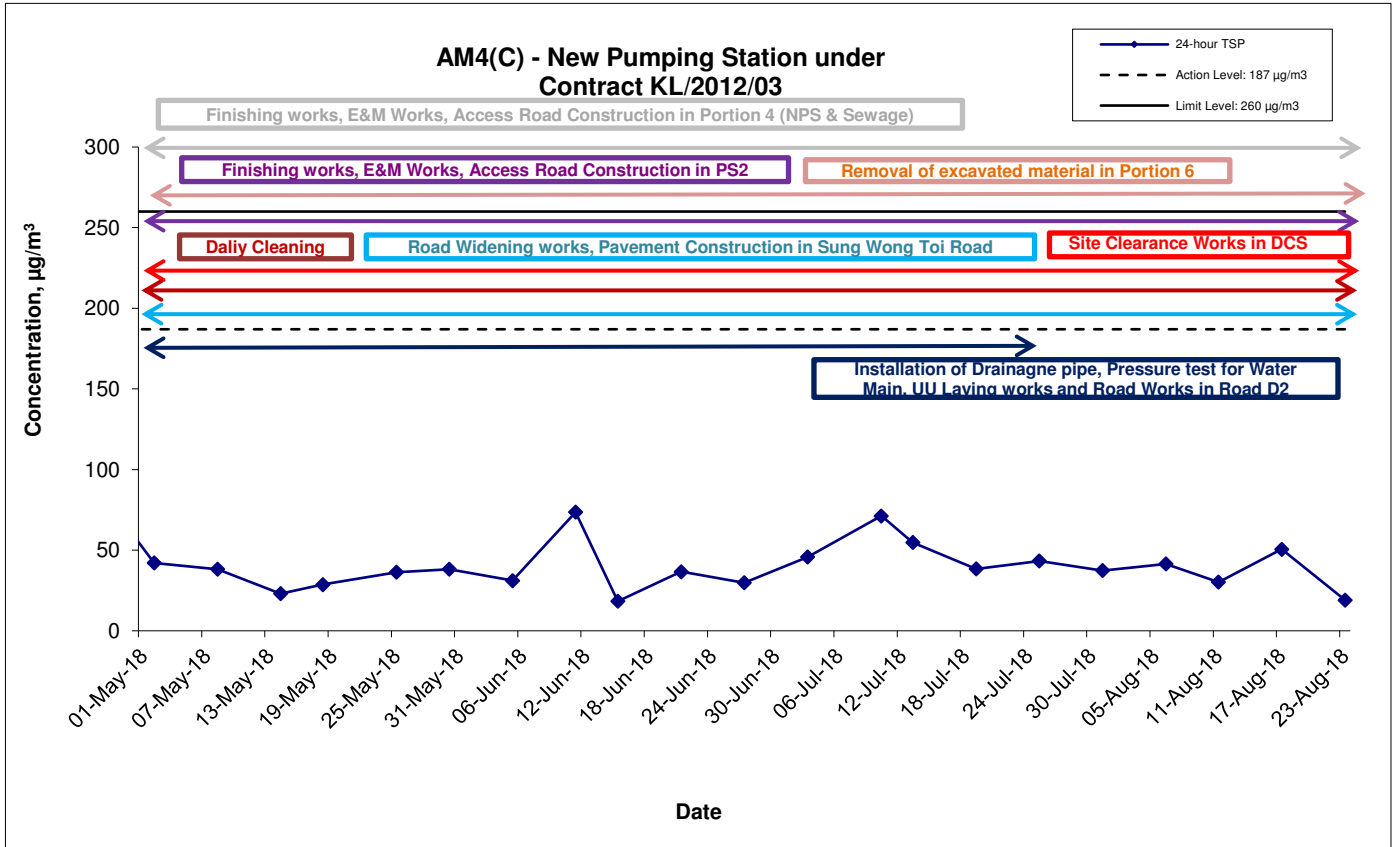
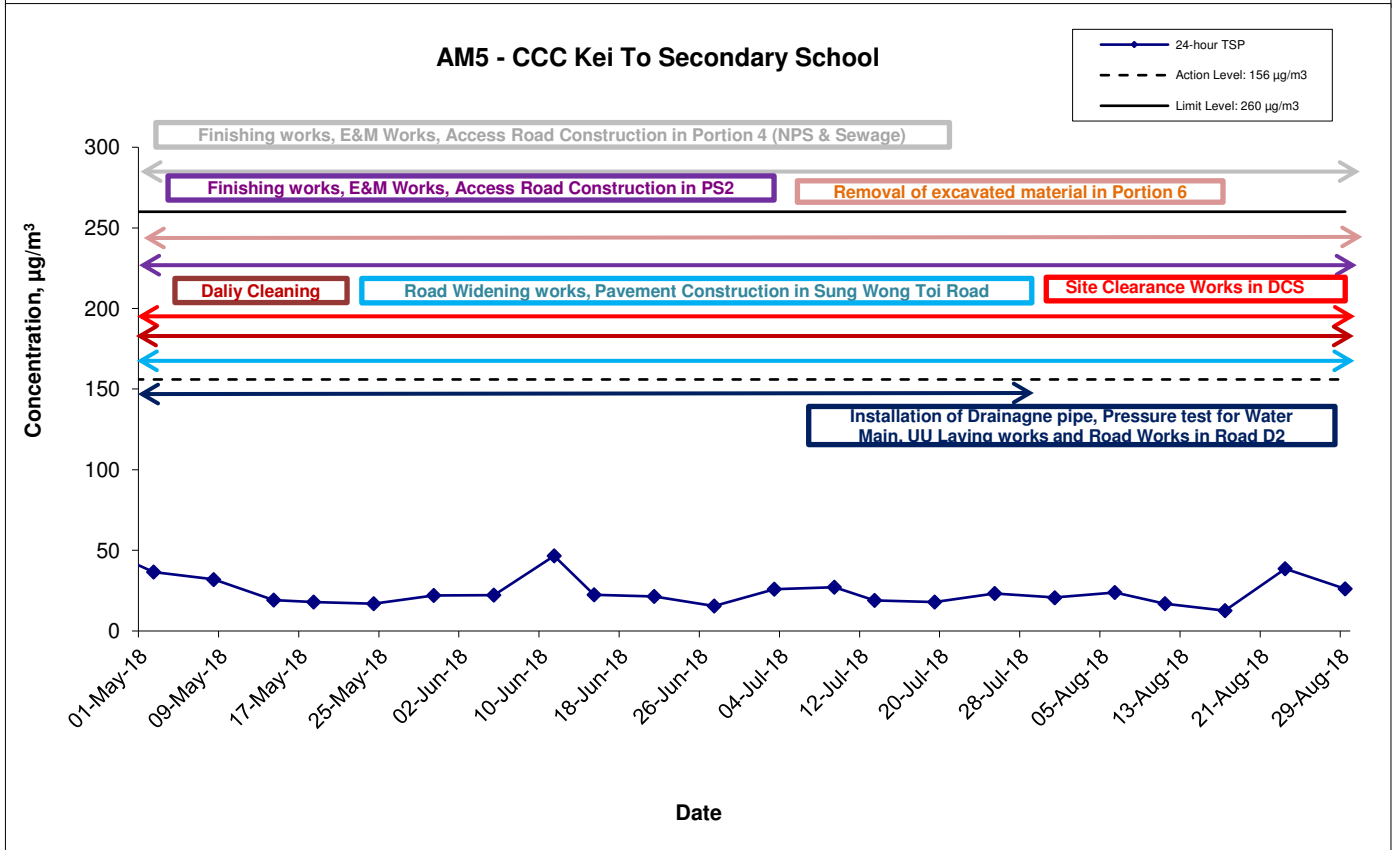
Title Contract No. KL/2012/03 Kai Tak Development –Stage 4 Infrastructure at Former North Apron Area Graphical Presentation of 24-hour TSP Monitoring Results	Scale N.T.S	Project No. MA13056	<b>CINOTECH</b>
	Date Aug 18	Appendix F

### 24-hr TSP Concentration Levels

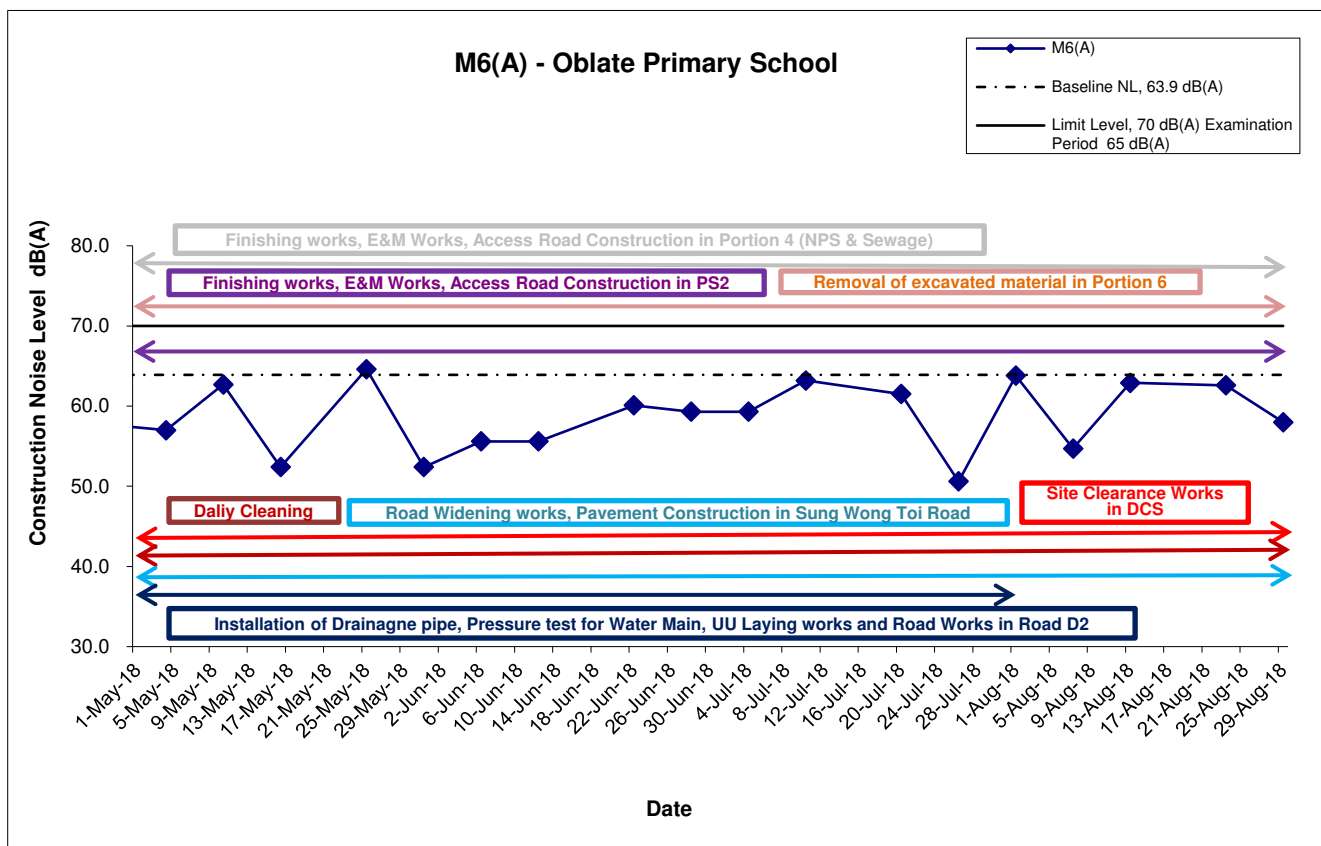
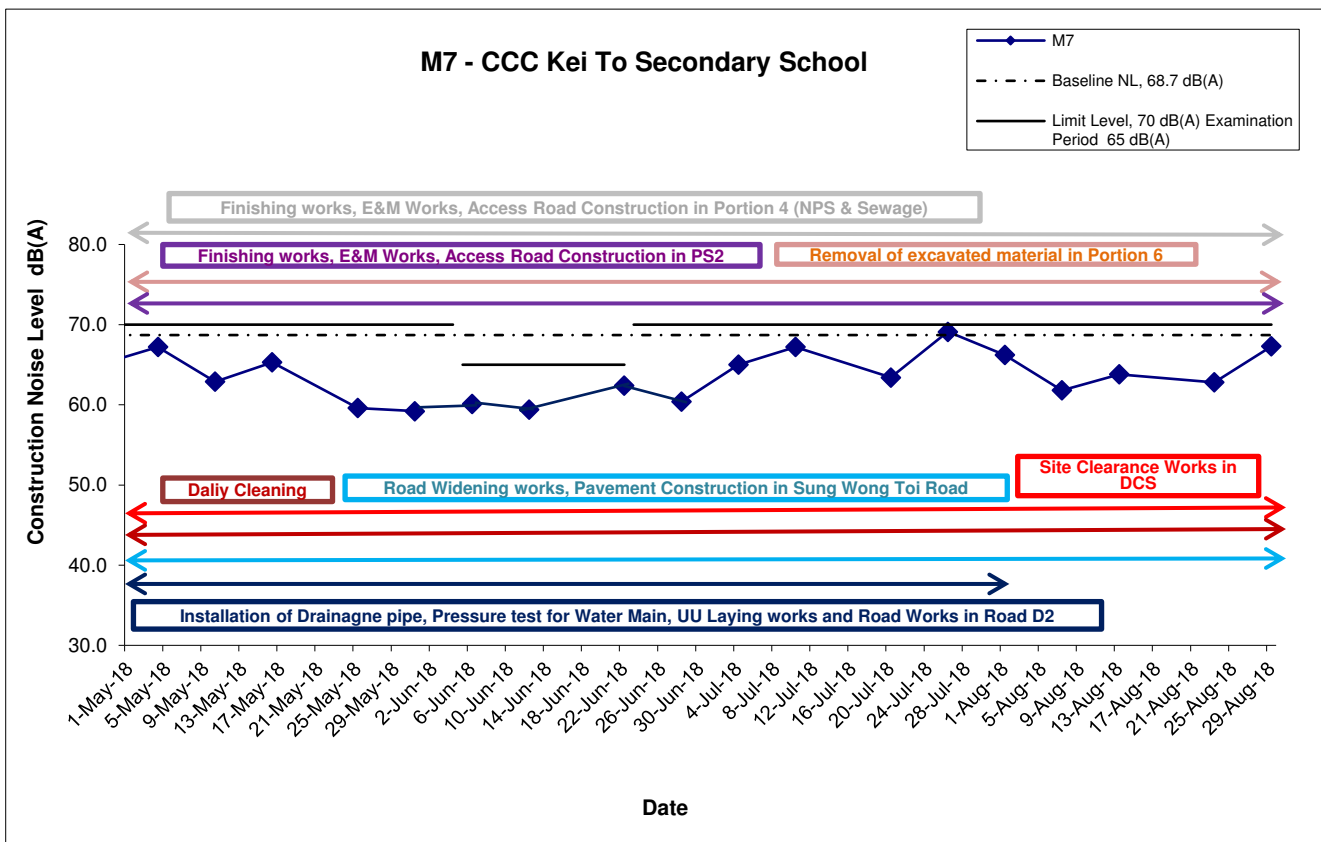
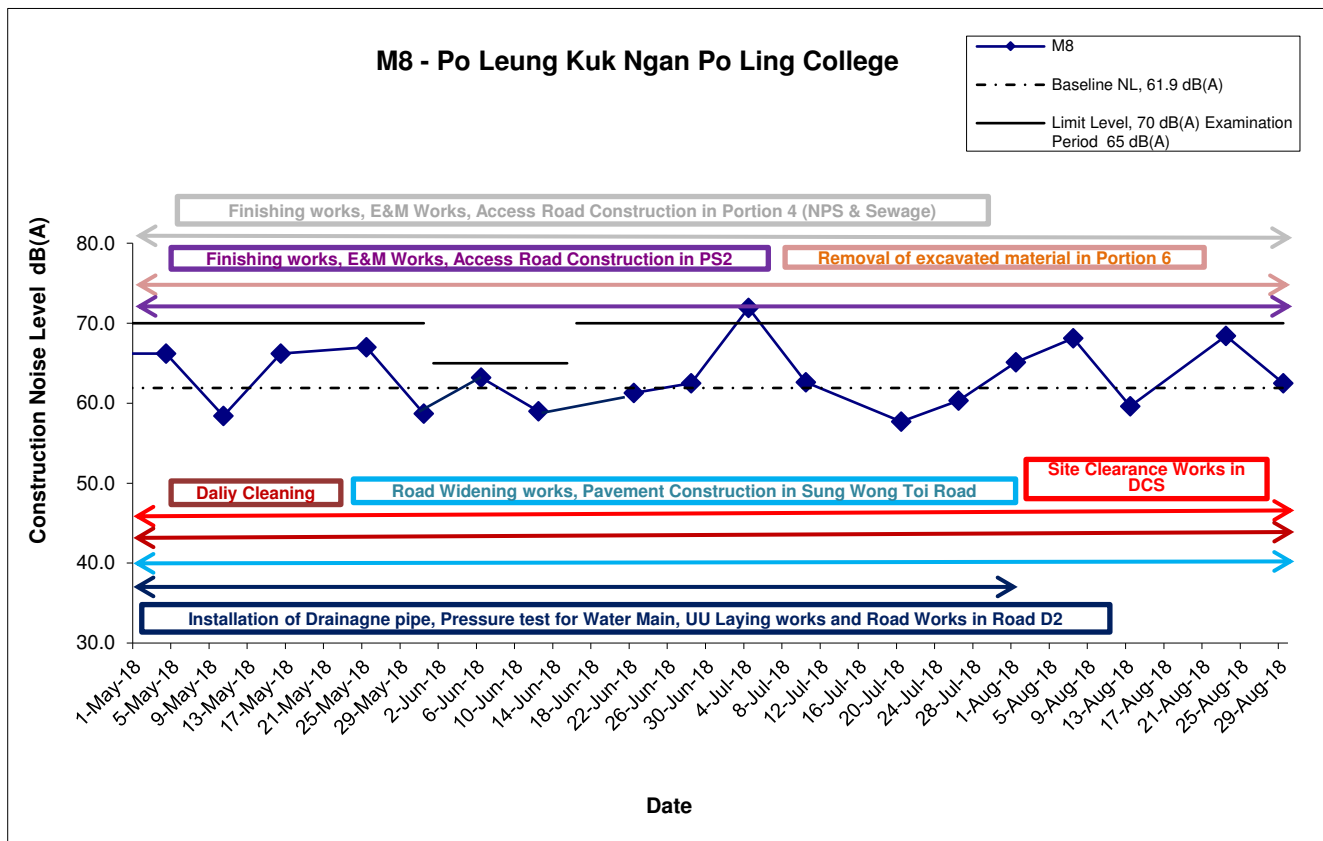
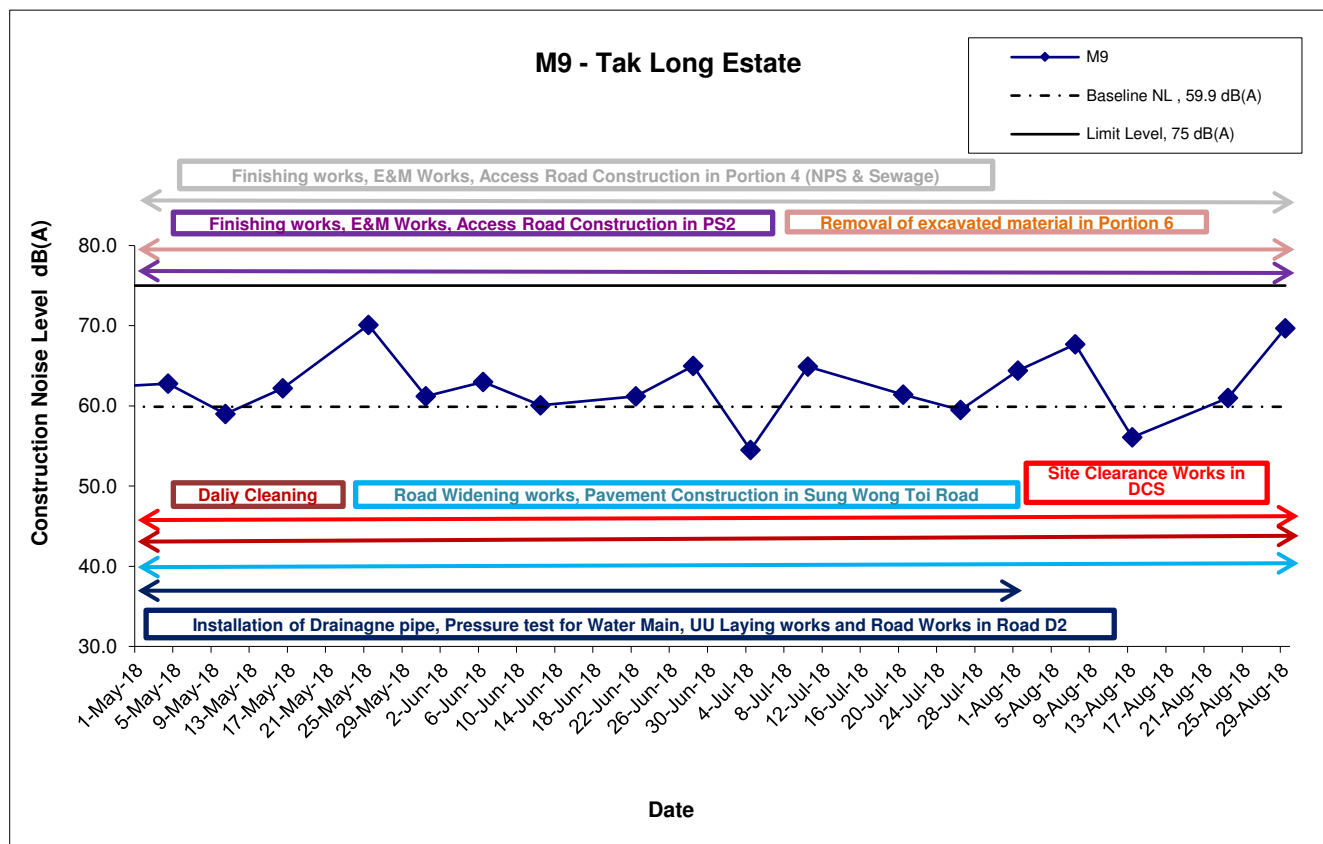
Title Contract No. KL/2012/03 Kai Tak Development –Stage 4 Infrastructure at Former North Apron Area Graphical Presentation of Construction Noise Monitoring Results	Scale N.T.S Date Aug 18	Project No. MA13056 Appendix G	
---	----------------------------------	---	--

Remarks: The construction noise levels in the Tables in Appendix G were adopted for plotting the graphs
