**EP-344/2009 – New Sewage Pumping Stations
Serving KTD
EP-337/2009 – New Distributor Roads Serving the
Planned KTD**

**Contract No. KL/2012/03
Kai Tak Development –Stage 4 Infrastructure at
Former North Apron Area**

Monthly EM&A Report

December 2018

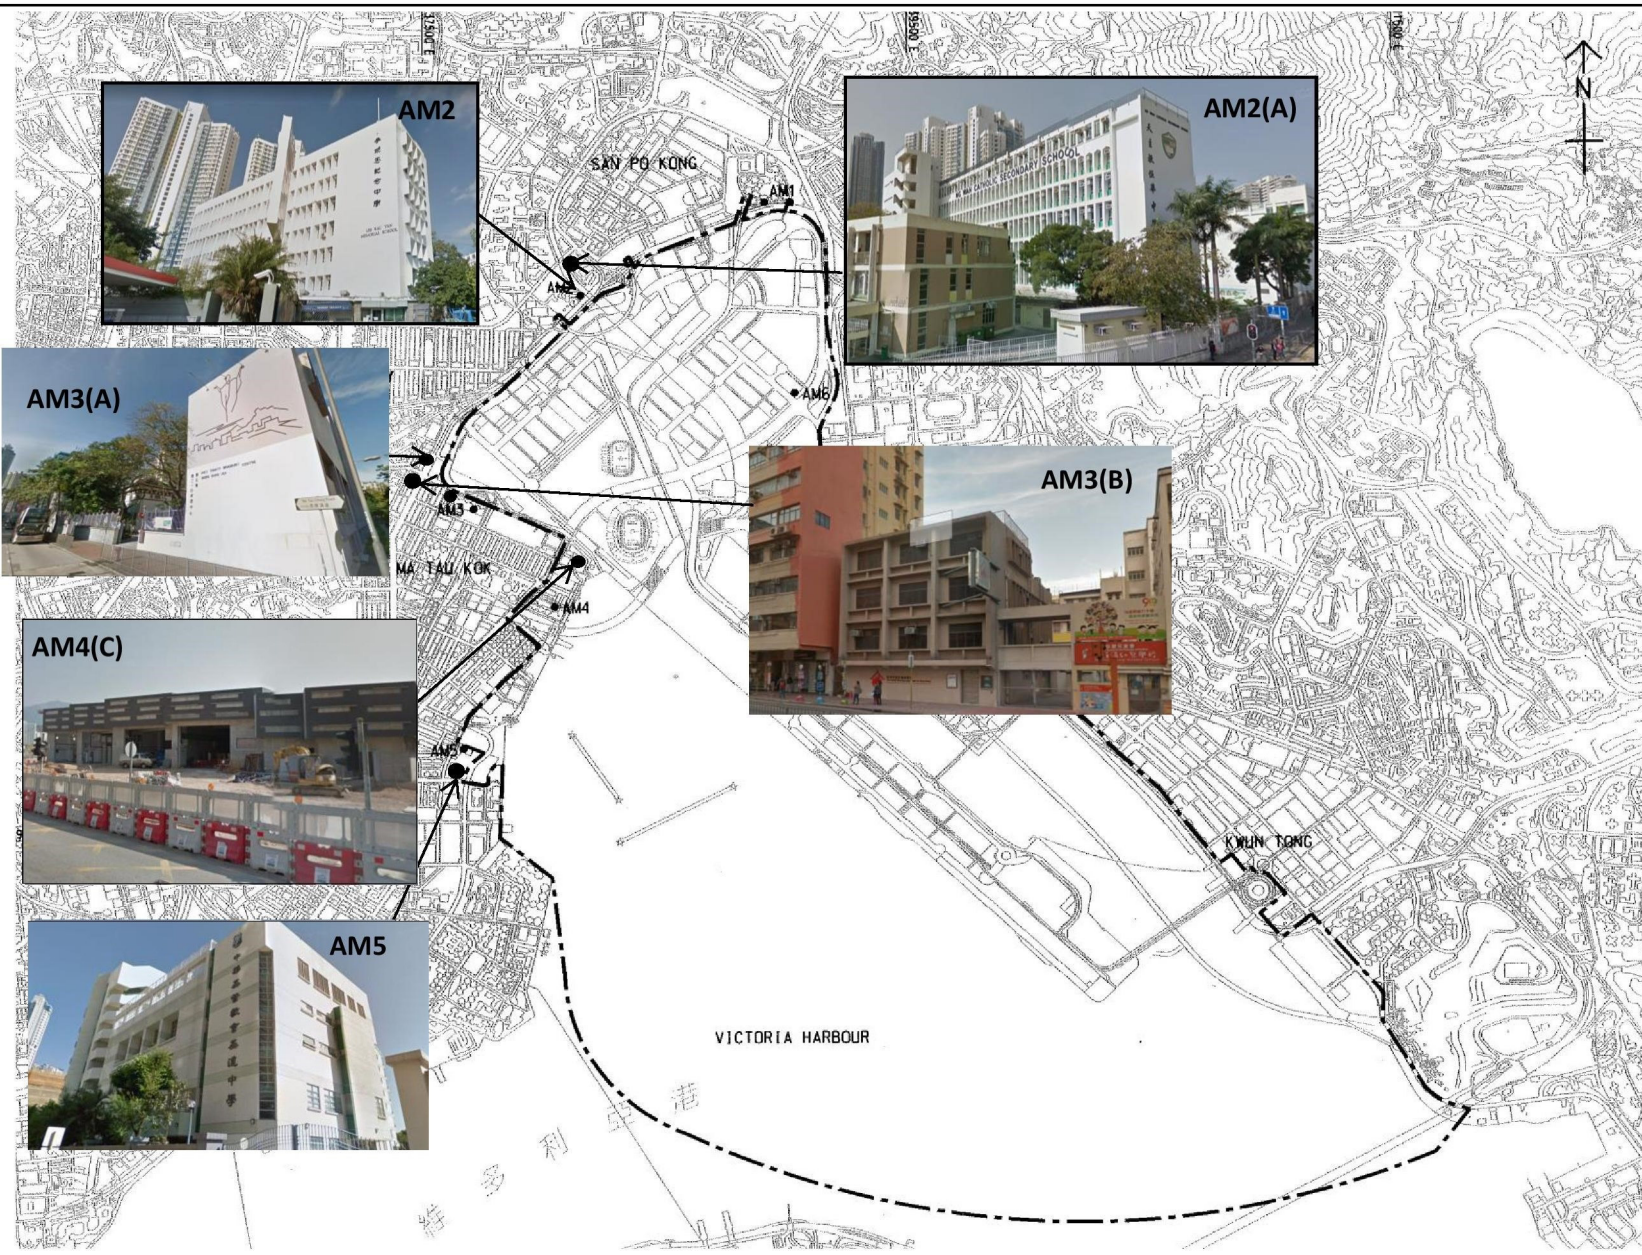
Title	Contract No. KL/2012/03		Scale	Project	CINOTECH
	Kai Tak Development –Stage 4 Infrastructure at Former North Apron Area		N.T.S	No. MA13056	
	Air Quality Monitoring Stations under this Project		Date	Figure	
			Dec-17	2

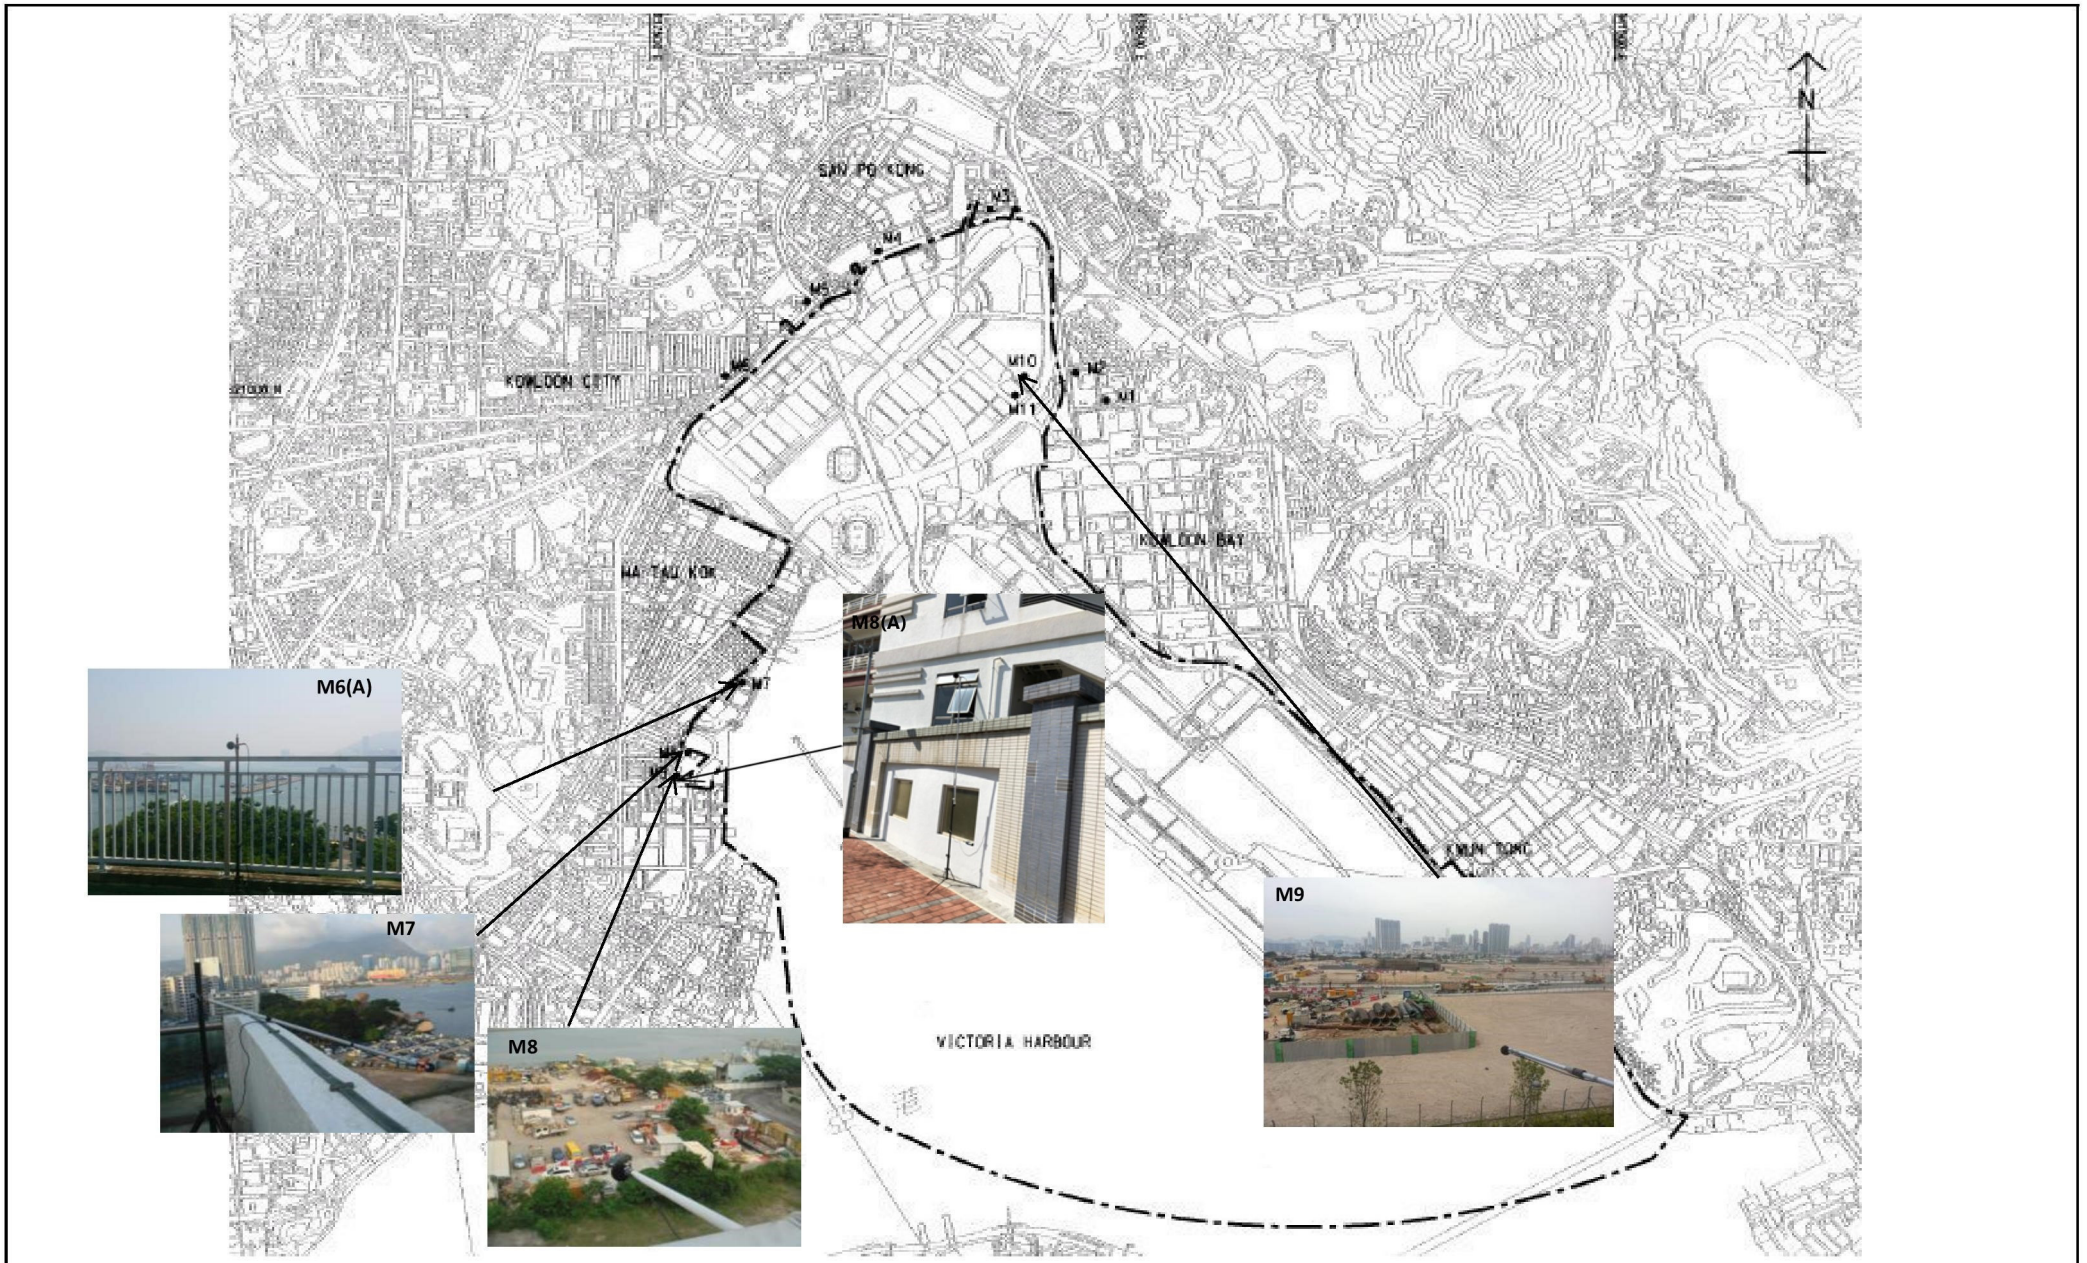
Title	Contract No. KL/2012/03		Scale	Project	CINOTECH
	Kai Tak Development –Stage 4 Infrastructure at Former North Apron Area		N.T.S	No. MA13056	
	Noise Monitoring Stations under this Project		Date	Figure	
			Dec-16	3

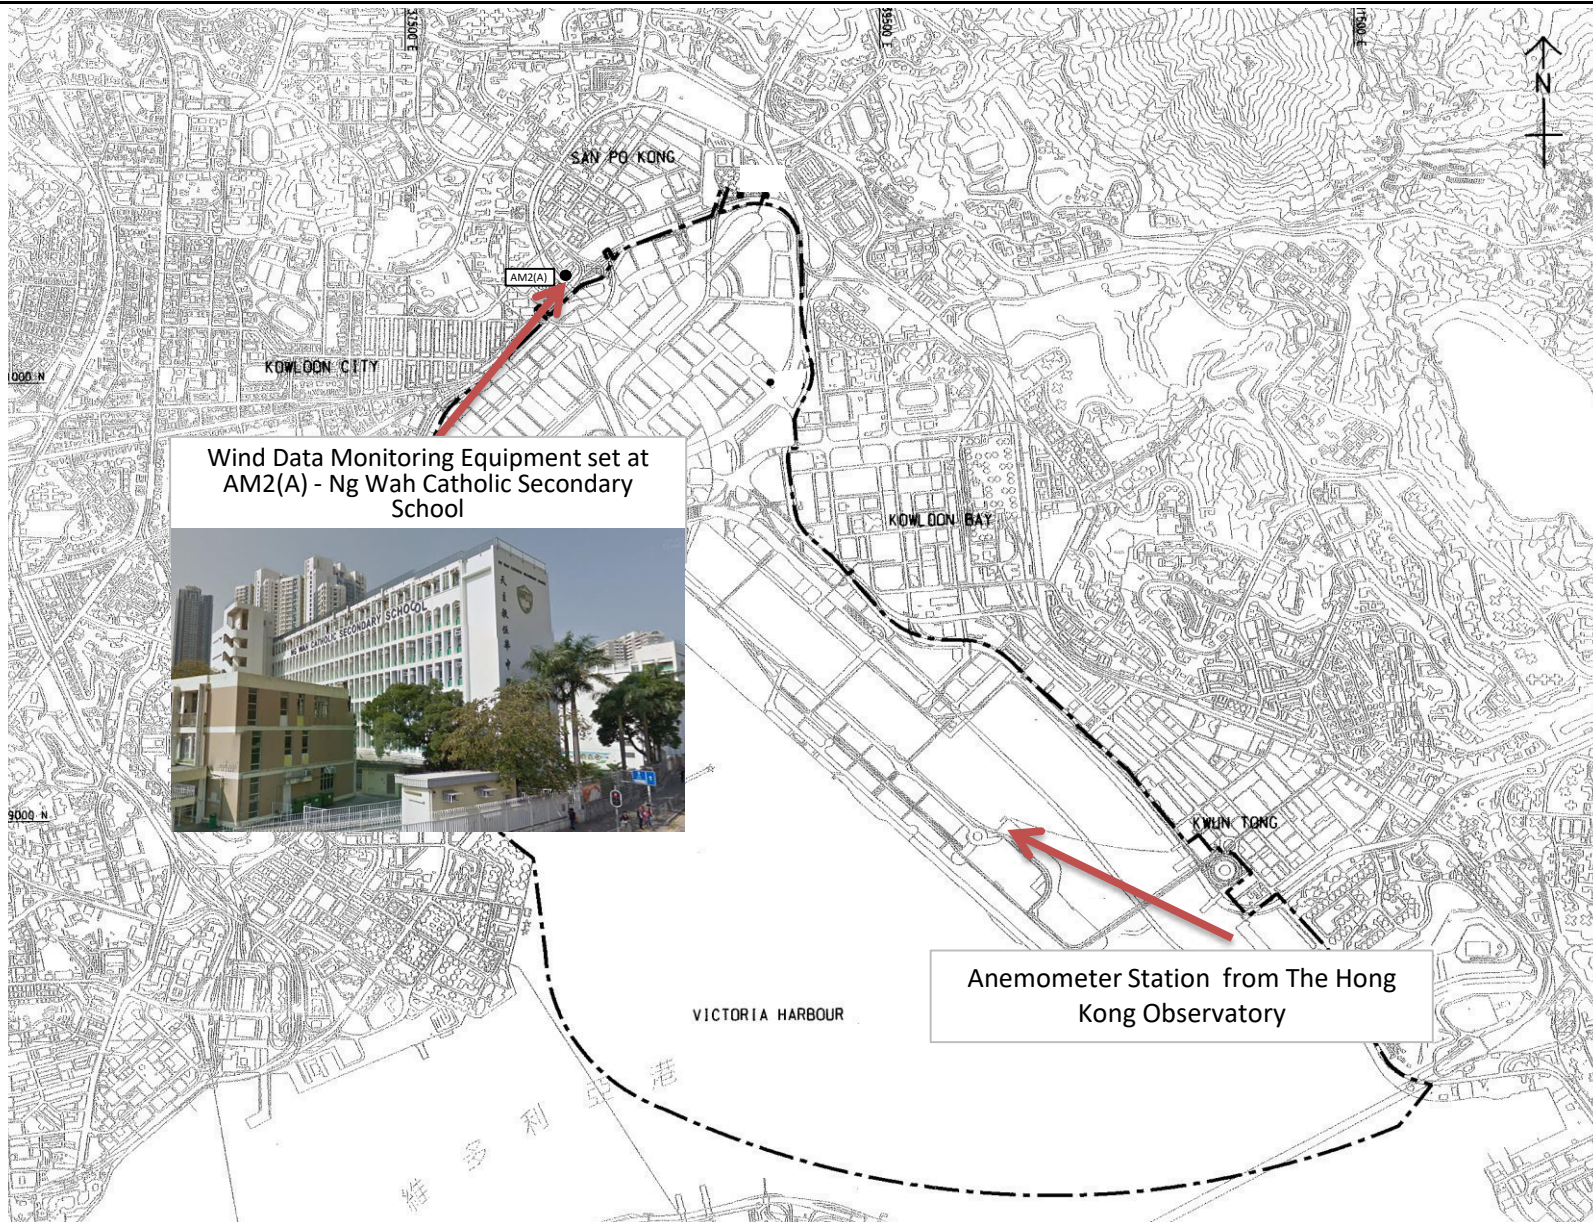
Wind Data Monitoring Equipment set at AM2(A) - Ng Wah Catholic Secondary School

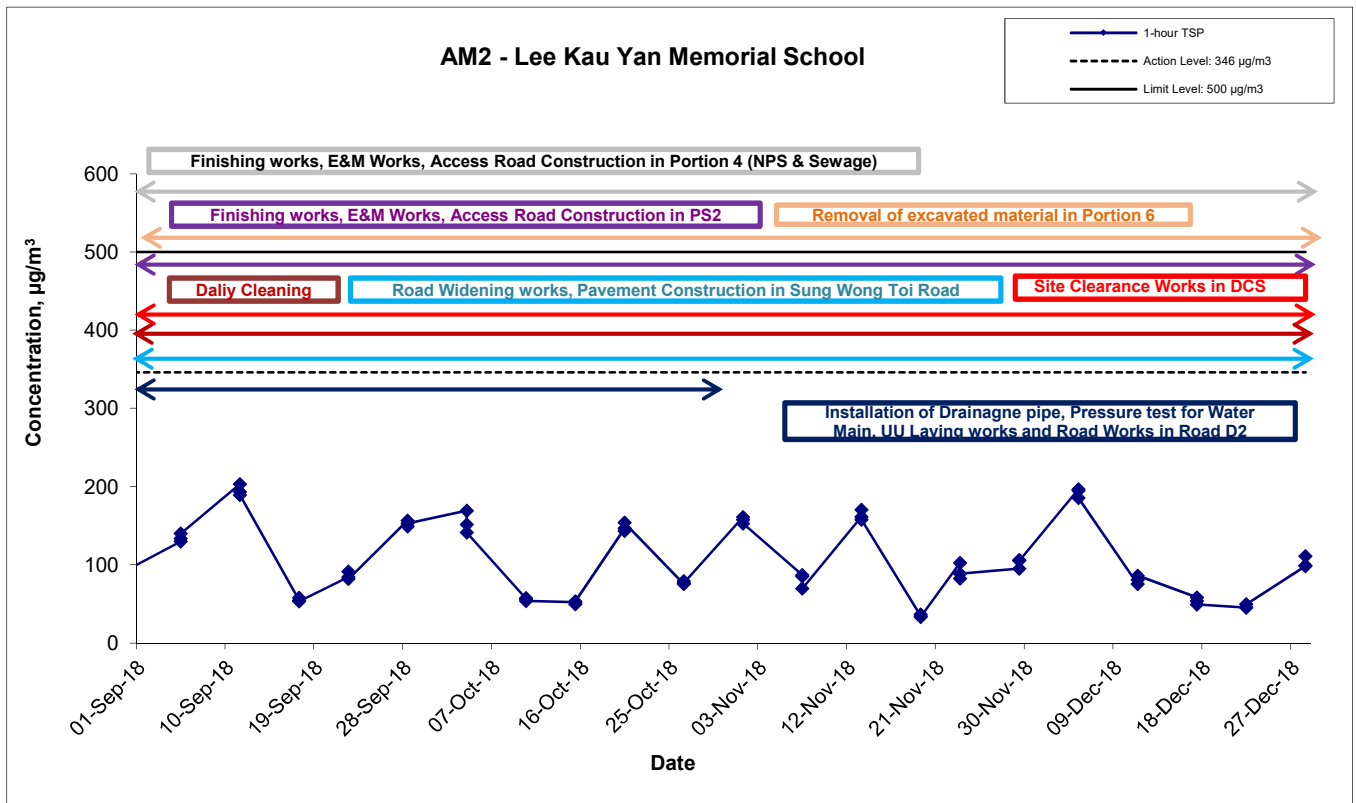
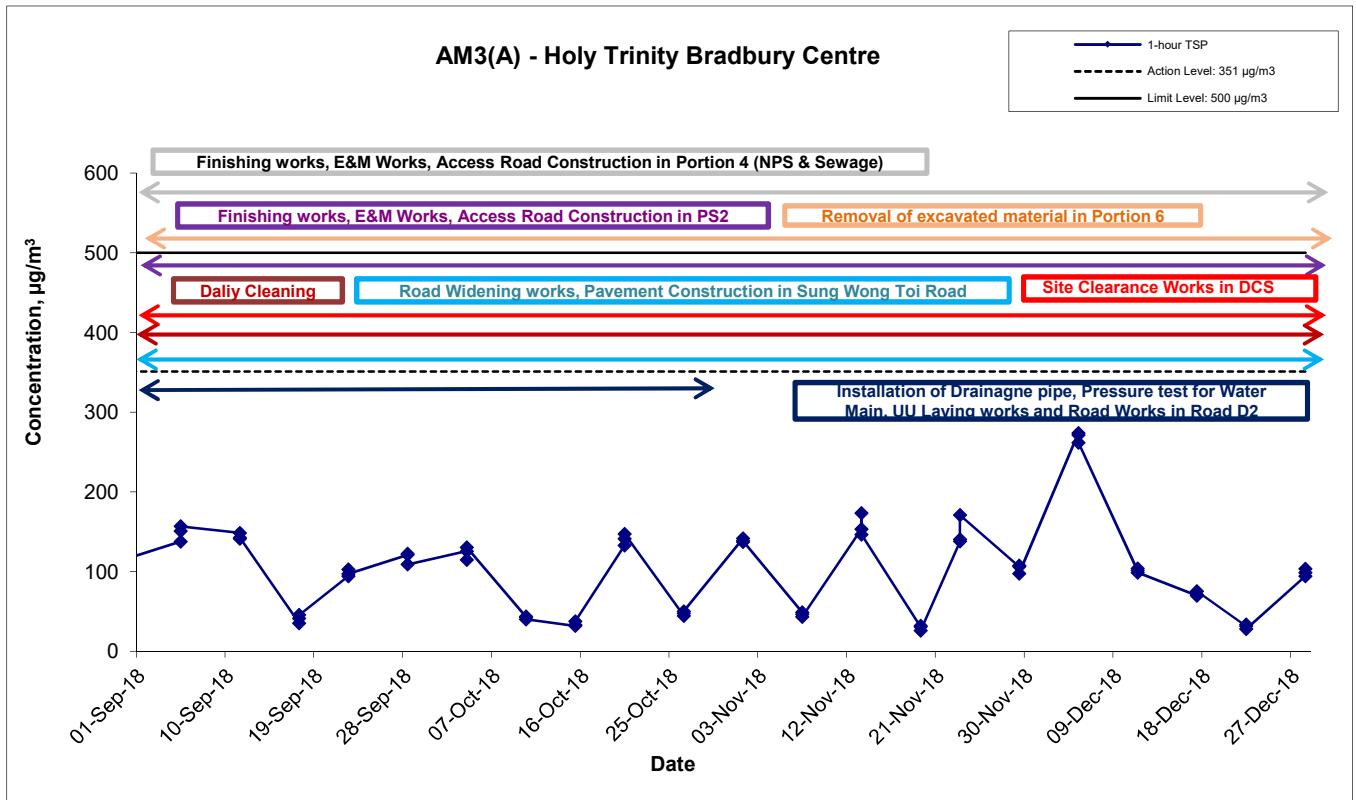
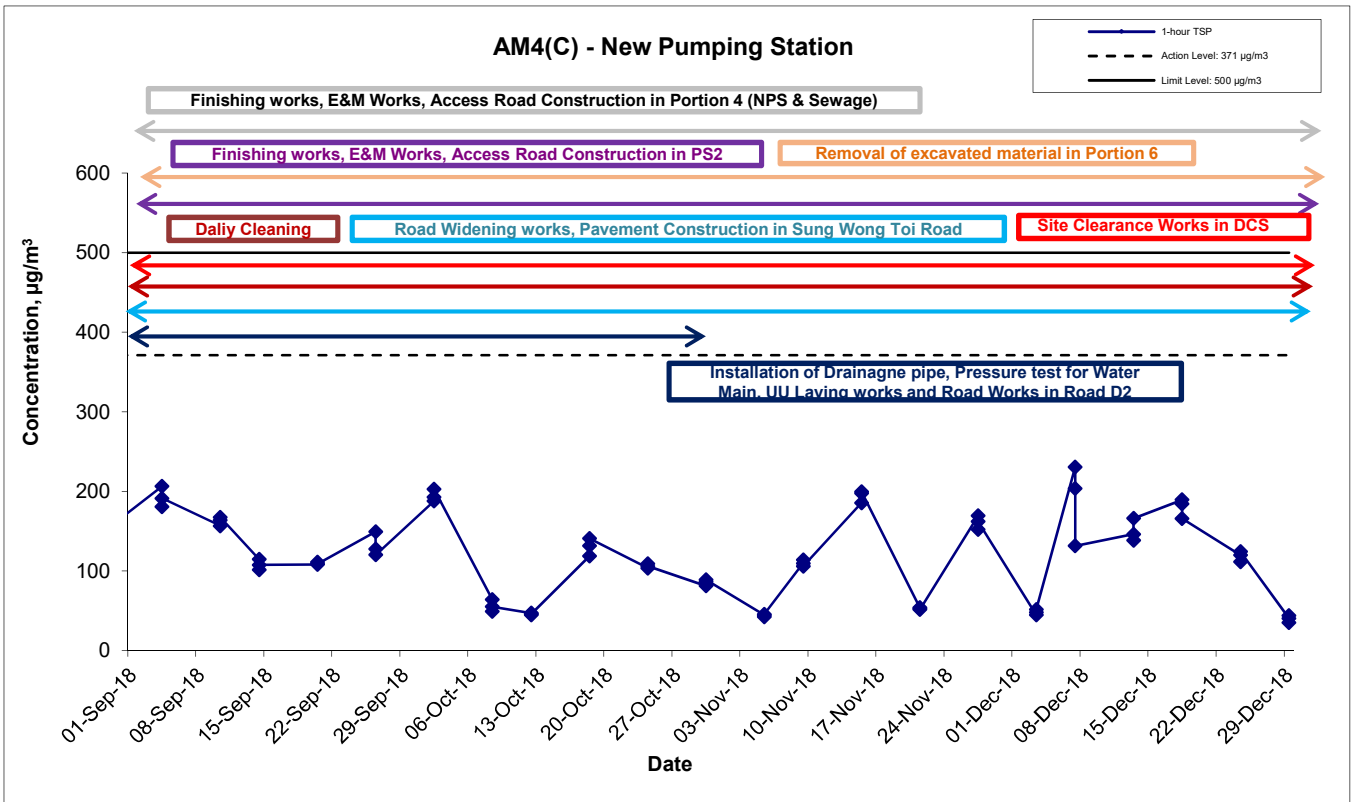
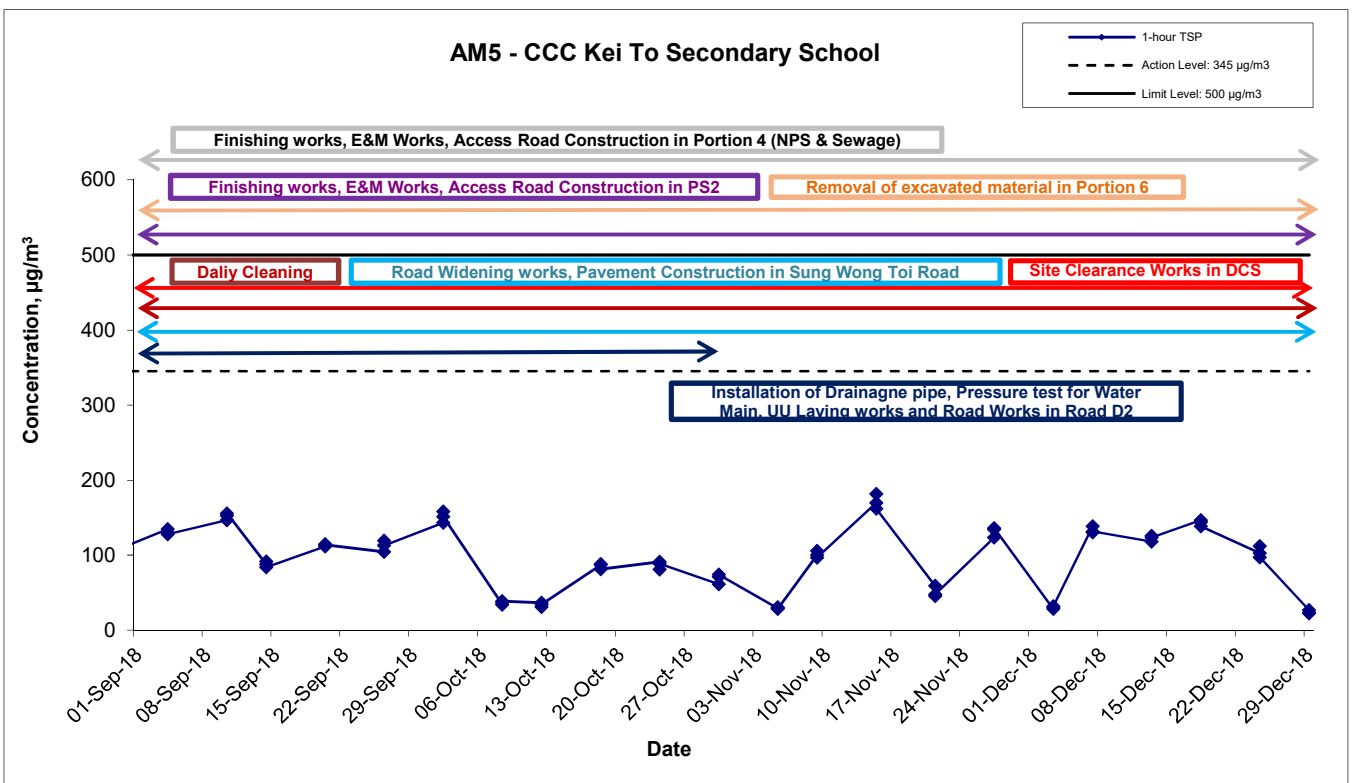
1-hr TSP Concentration Levels

Title	Contract No. KL/2012/03	Scale	Project	CINOTECH
	Kai Tak Development –Stage 4 Infrastructure at Former North Apron Area	N.T.S	No. MA13056	
Graphical Presentation of 1-hour TSP Monitoring Results		Date	Appendix	
		Dec 18	E

Title Kai Tak Development –Stage 4 Infrastructure at Former North Apron Area Graphical Presentation of 1-hour TSP Monitoring Results	Contract No. KL/2012/03	Scale N.T.S	Project No. MA13056	CINOTECH
		Date Dec 18	Appendix E

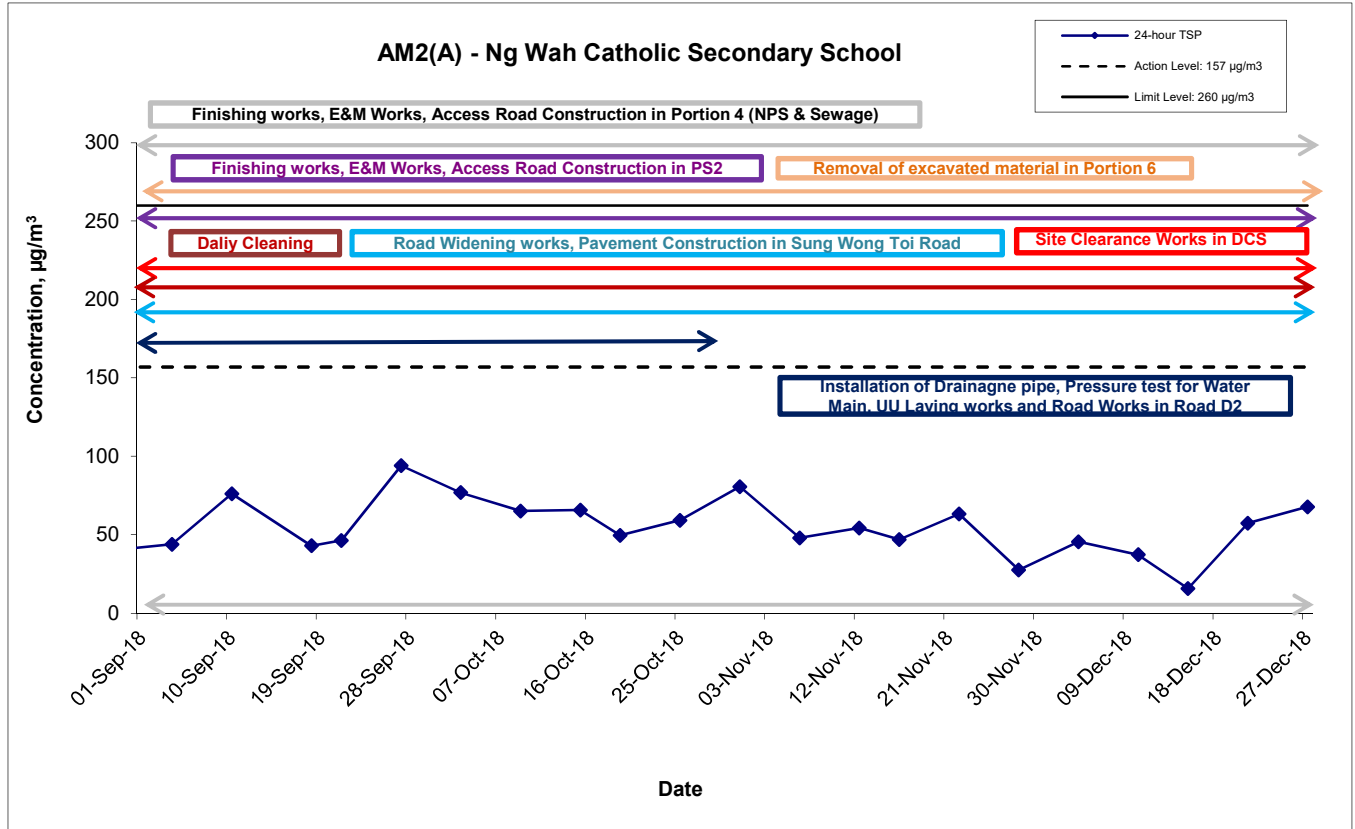
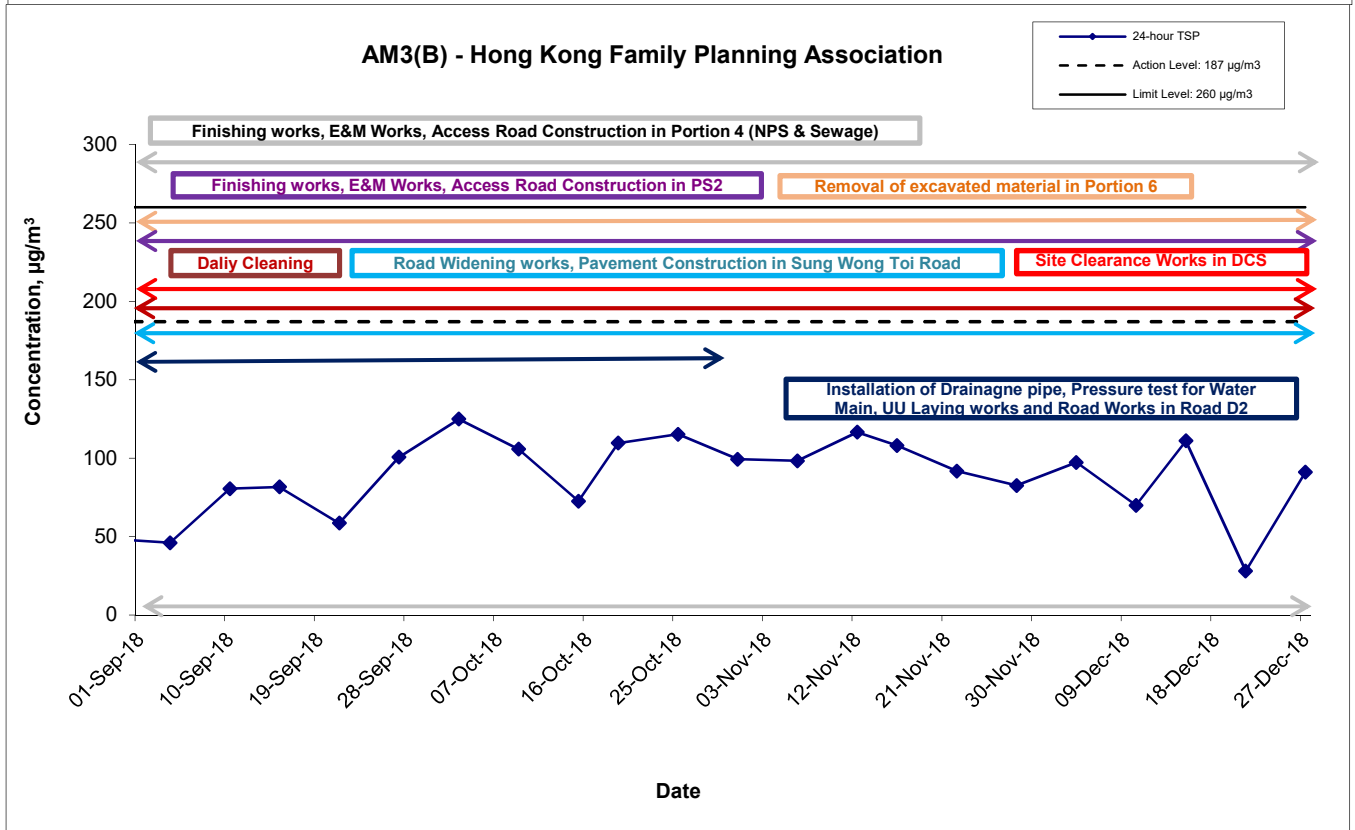
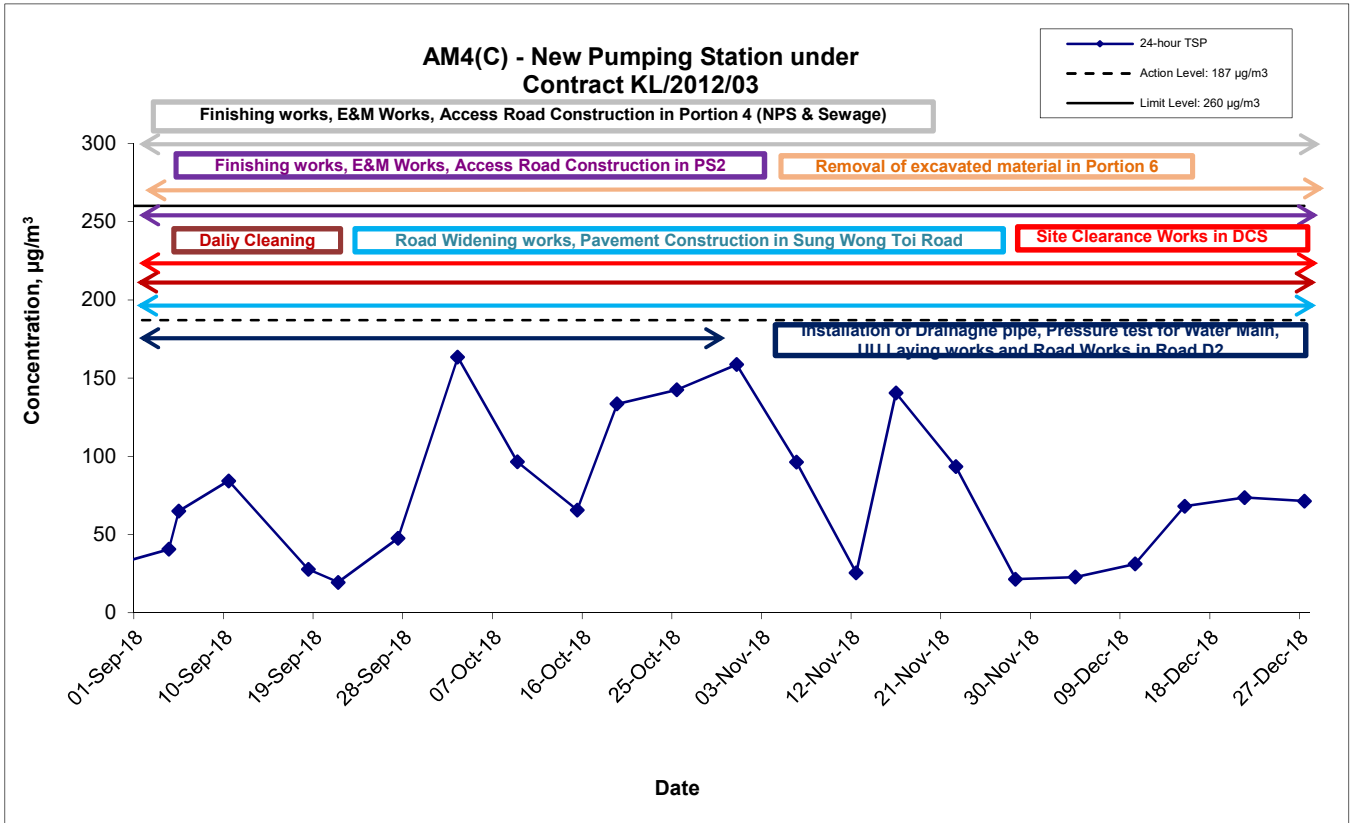
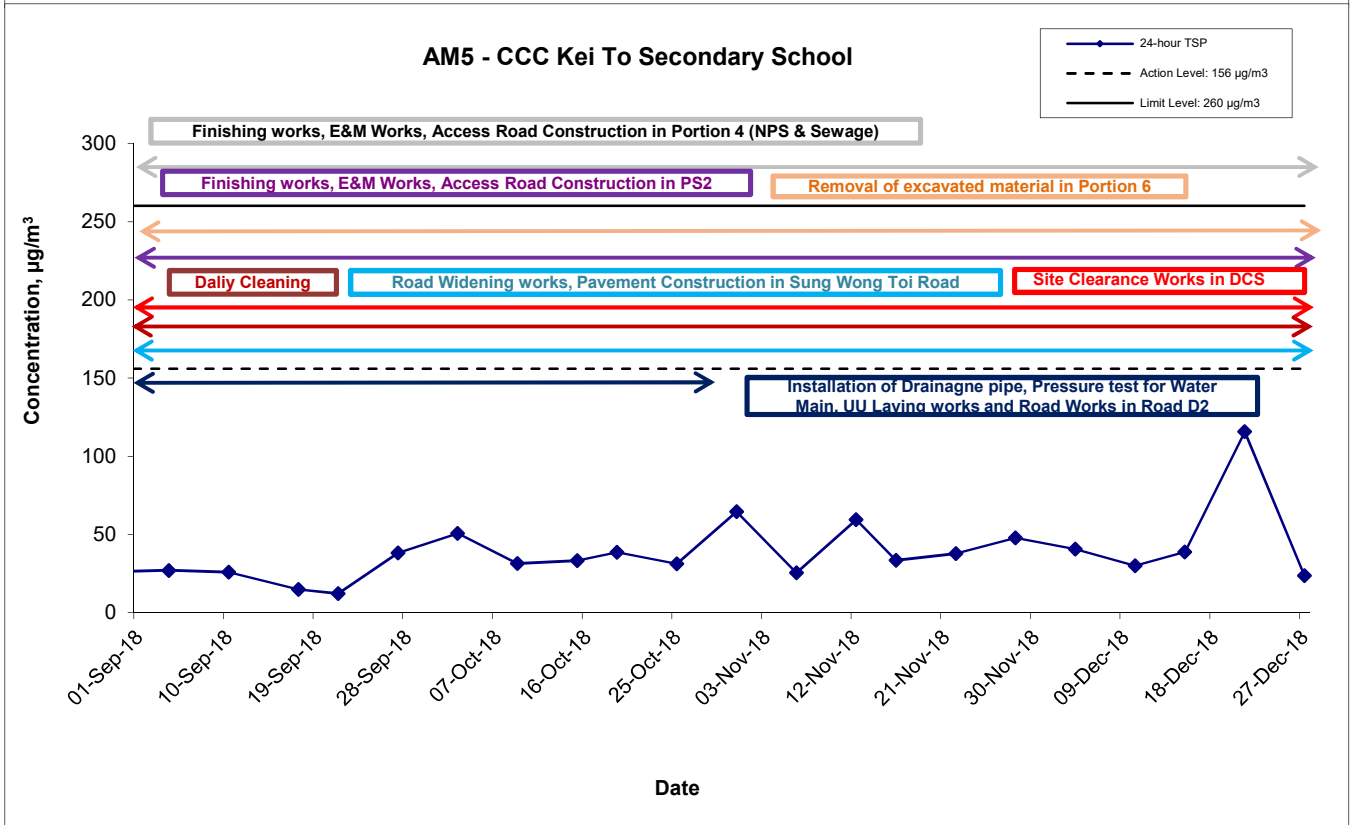
24-hr TSP Concentration Levels

Title Contract No. KL/2012/03 Kai Tak Development –Stage 4 Infrastructure at Former North Apron Area Graphical Presentation of 24-hour TSP Monitoring Results	Scale	Project		
		N.T.S		No. MA13056
	Date	Dec 18		Appendix F

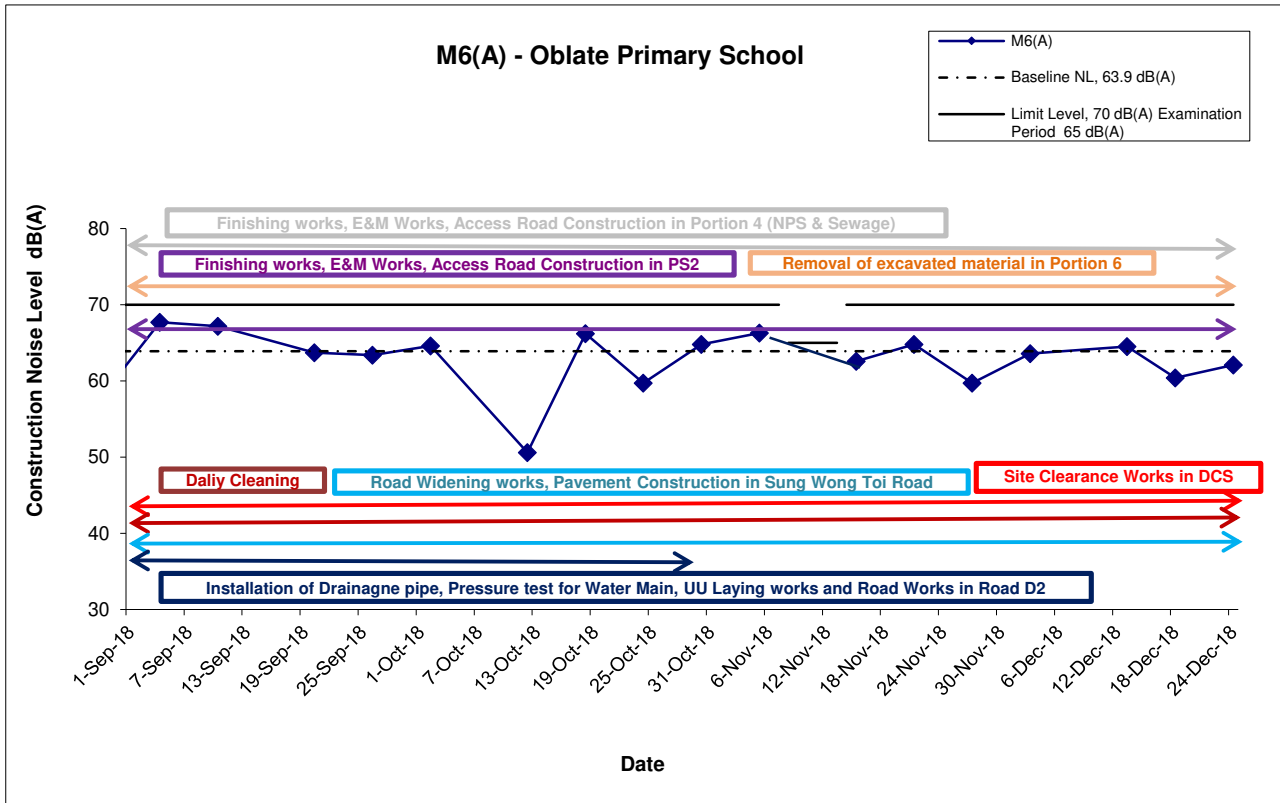
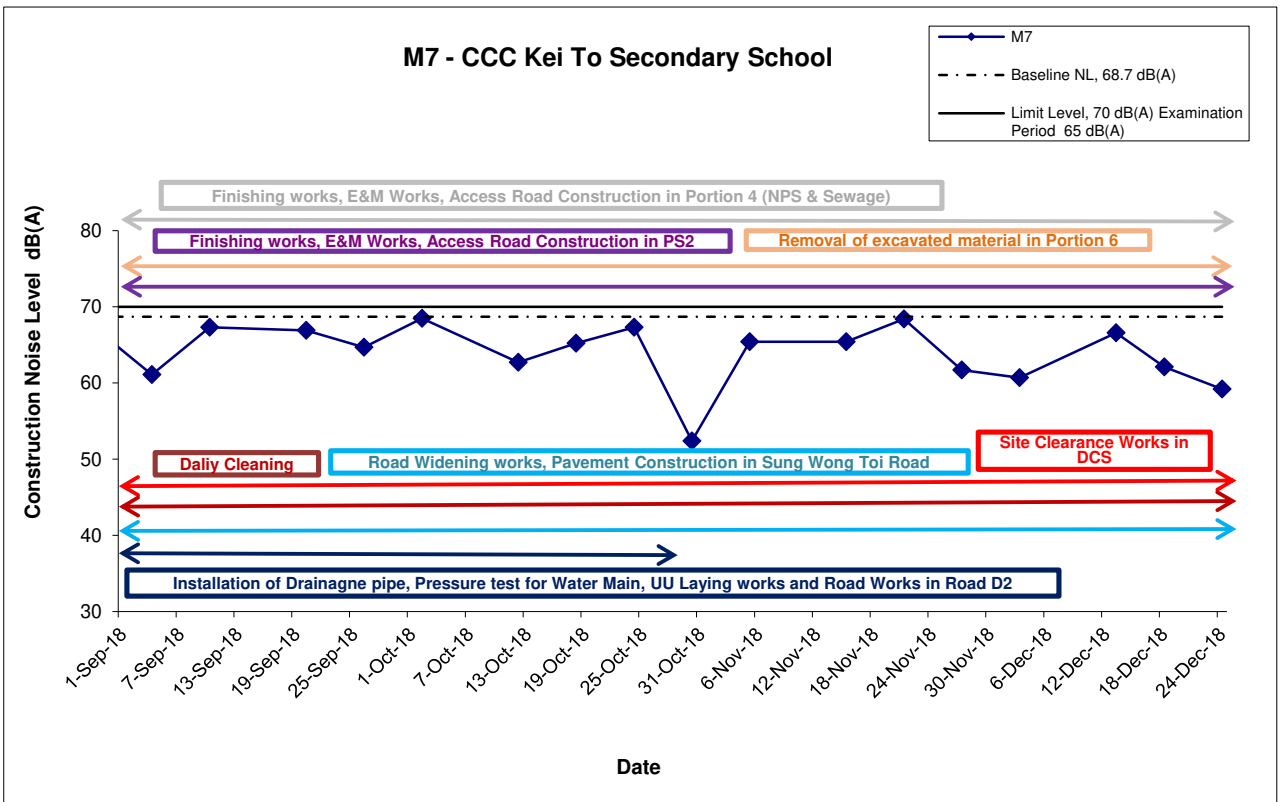
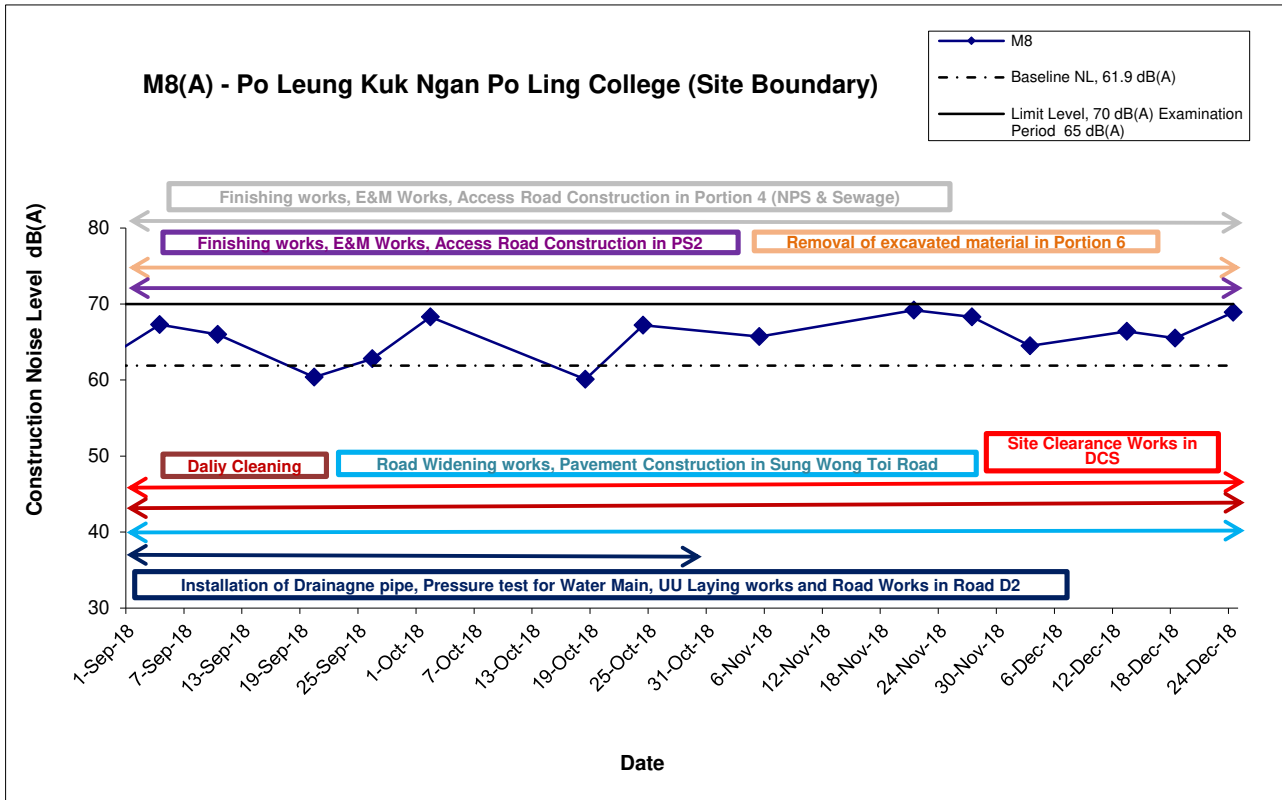
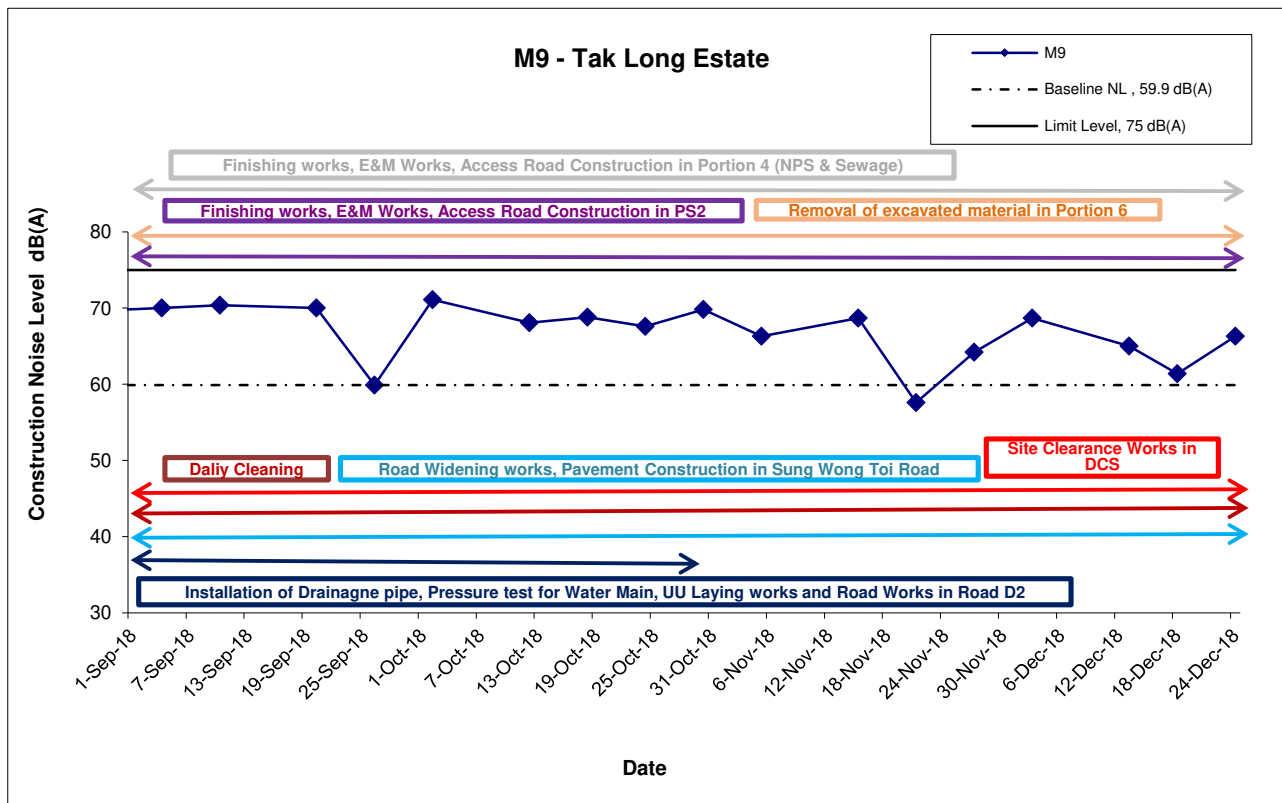
Noise Levels

Remarks: The construction noise levels in the Tables in Appendix G were adopted for plotting the graphs

Title Contract No. KL/2012/03 Kai Tak Development –Stage 4 Infrastructure at Former North Apron Area Graphical Presentation of Construction Noise Monitoring Results	Scale N.T.S	Project No. MA13056	CINOTECH
	Date Dec 18	Appendix G
