CONTRACT NO: HK/2011/07

WANCHAI DEVELOPMENT PHASE II AND CENTRAL  
WANCHAI BYPASS  
SAMPLING, FIELD MEASUREMENT AND TESTING WORKS  
(STAGE 2)

MONTHLY ENVIRONMENTAL MONITORING & AUDIT REPORT

- AUGUST 2015 -

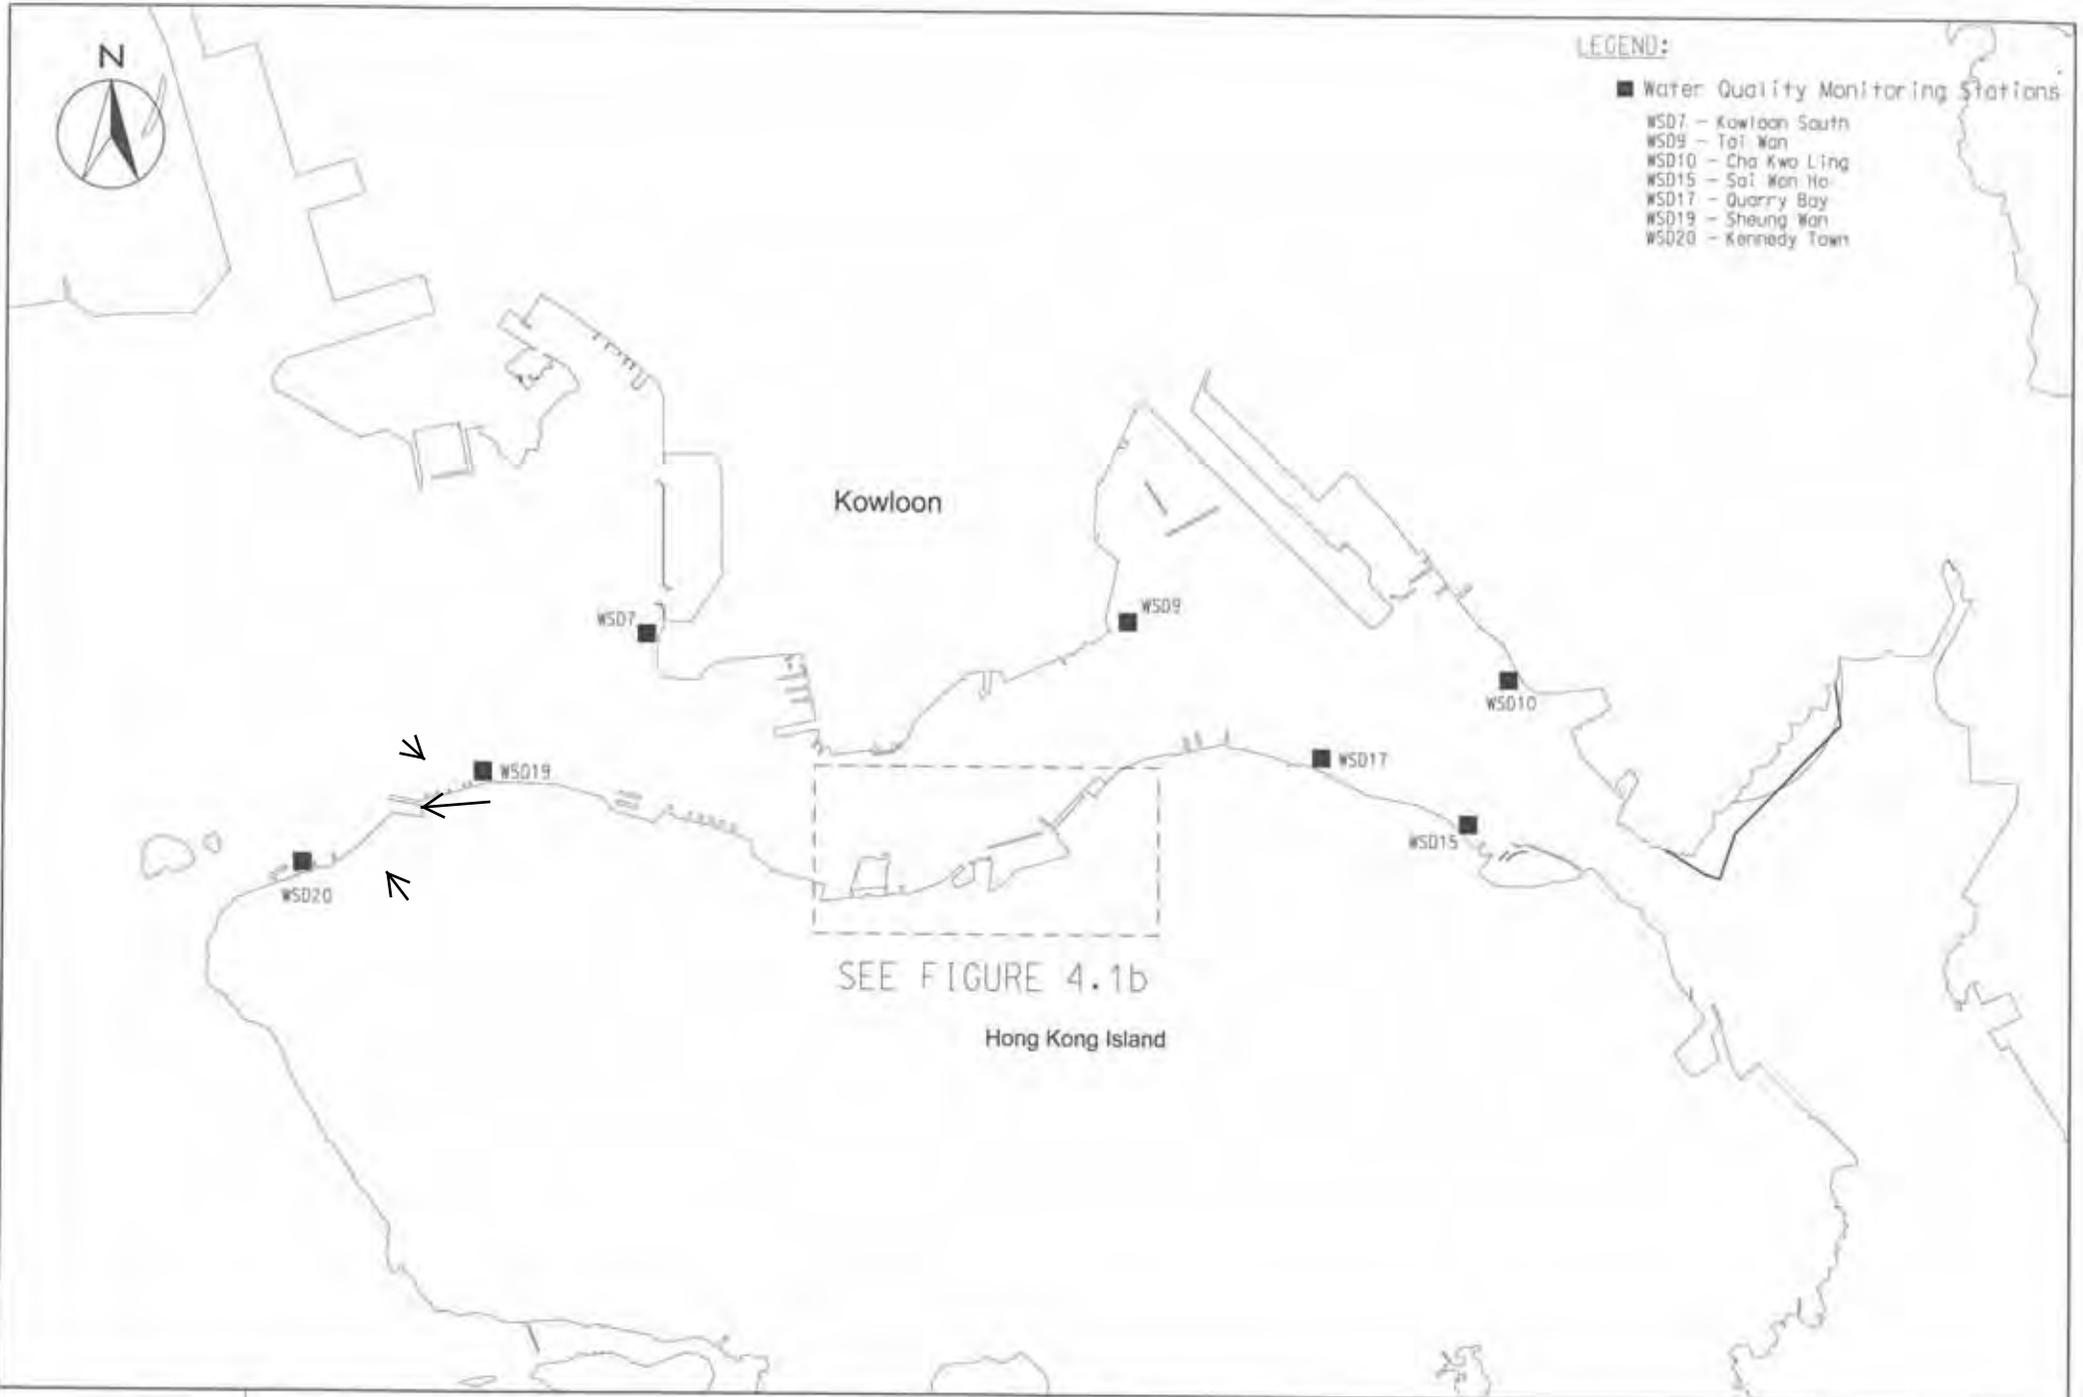
***Figure 4.1***

***Locations of Monitoring Stations***

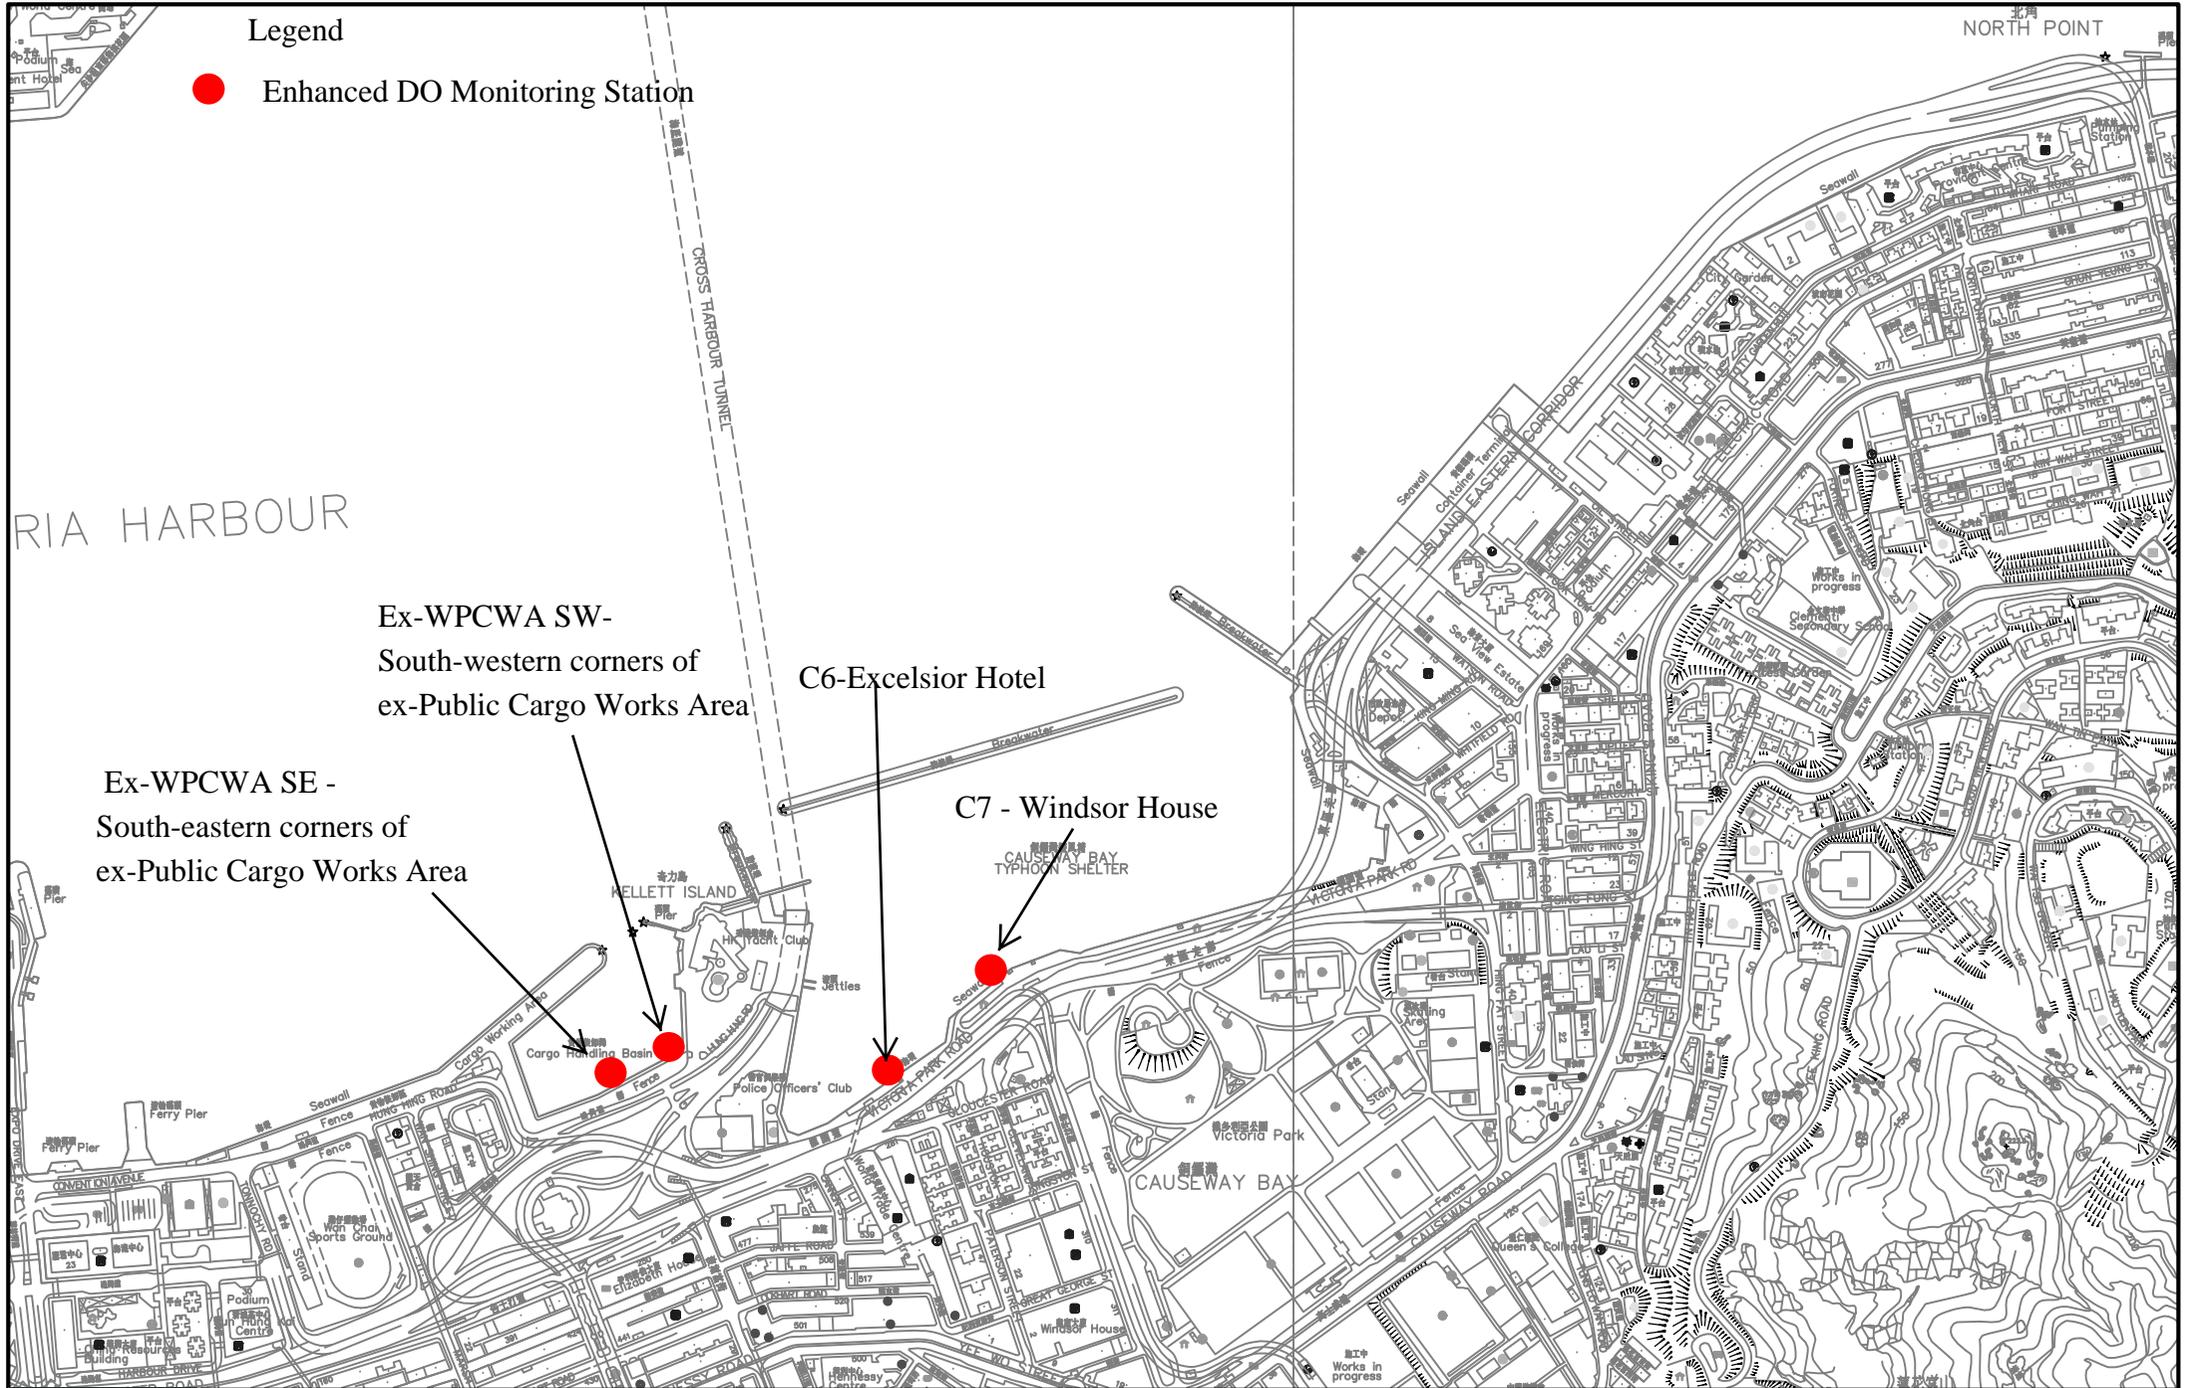
Locations of Enhance DO Monitoring Station

- xxii. With respect to the construction stage and access condition at Ex-PCWAW and the potential DO concern within the area, the suspended Enhance DO monitoring within Ex-PCWAW area at the Enhance DO monitoring station Ex-PCWA-SE was resumed on 10 August 2015 at the finely adjusted monitoring location.

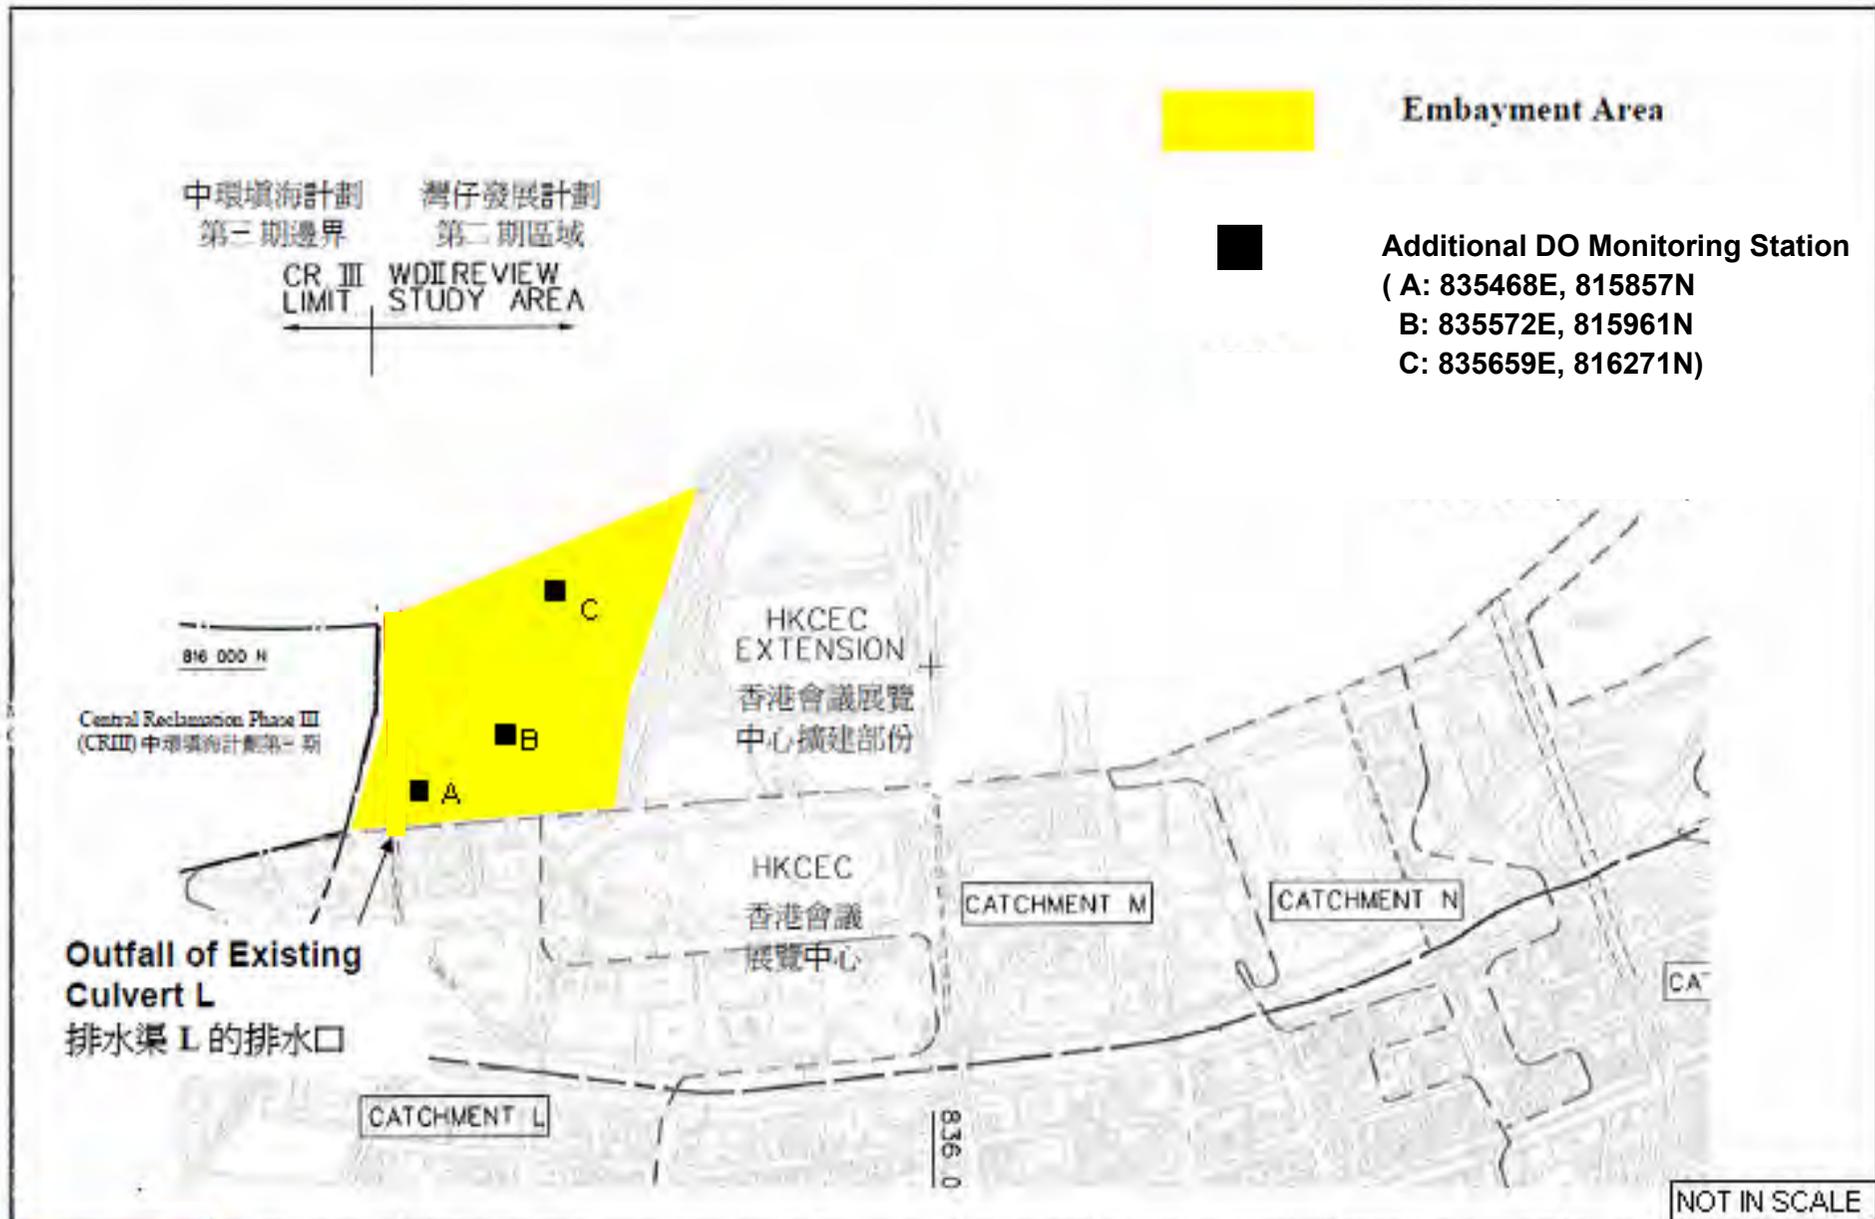
Location Plan of Additional Dissolved Oxygen Monitoring Stations for Culvert L Water Discharge Flow

- i. In response to the Condition 2.18 of the Environmental Permit no. EP-356/2009 requiring that a silt curtain / impermeable barrier system be installed to channel water discharge flow from Culvert L to locations outside the embayment area, a proposed replacement of the requirement with additional dissolved oxygen monitoring has been conducted at three monitoring stations, namely A, B and C between the eastern seawall of Central Reclamation Phase III and the HKCEC Extension since November 2011 under EP-356/2009 so that DO level between the eastern seawall of Central Reclamation Phase II and the HKCEC extension could be continuously monitored.

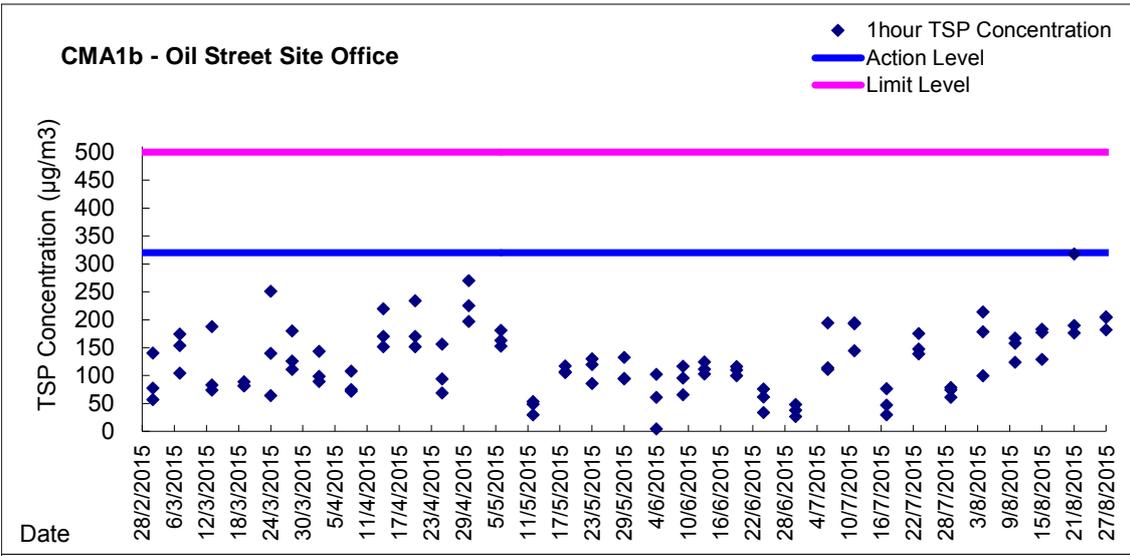
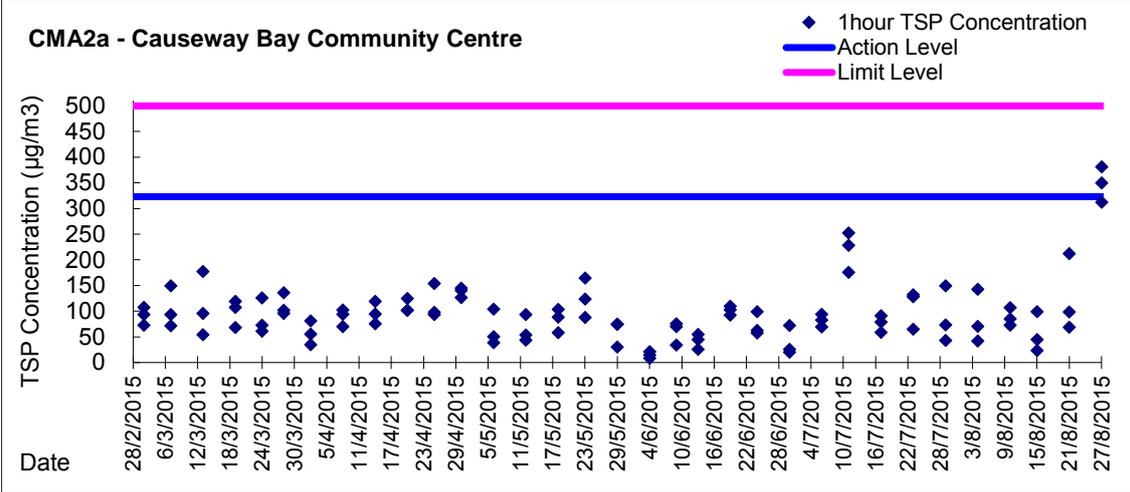
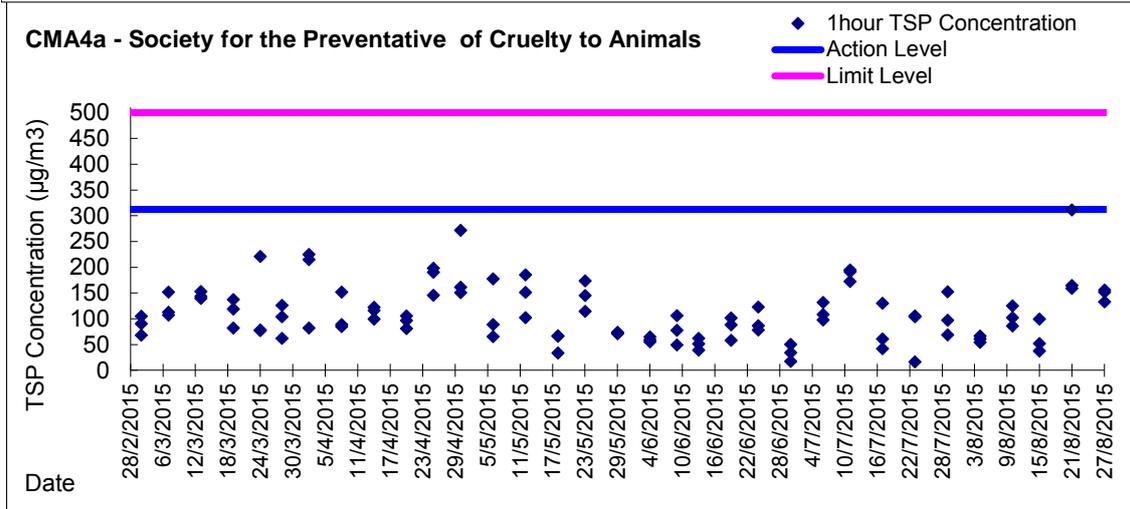
Remarks: Due to interruption of electricity, the 1hr TSP was rescheduled from 27 August 2015 to 28 August 2015.

Graphic Presentation of 1 hour TSP Result

- xv. Two action level exceedances during 1hr TSP monitoring was recorded at monitoring station CMA2a – Causeway Bay Community Centre on 27 August 2015 in the reporting month. Investigation found that the exceedance recorded was not related to the Project.

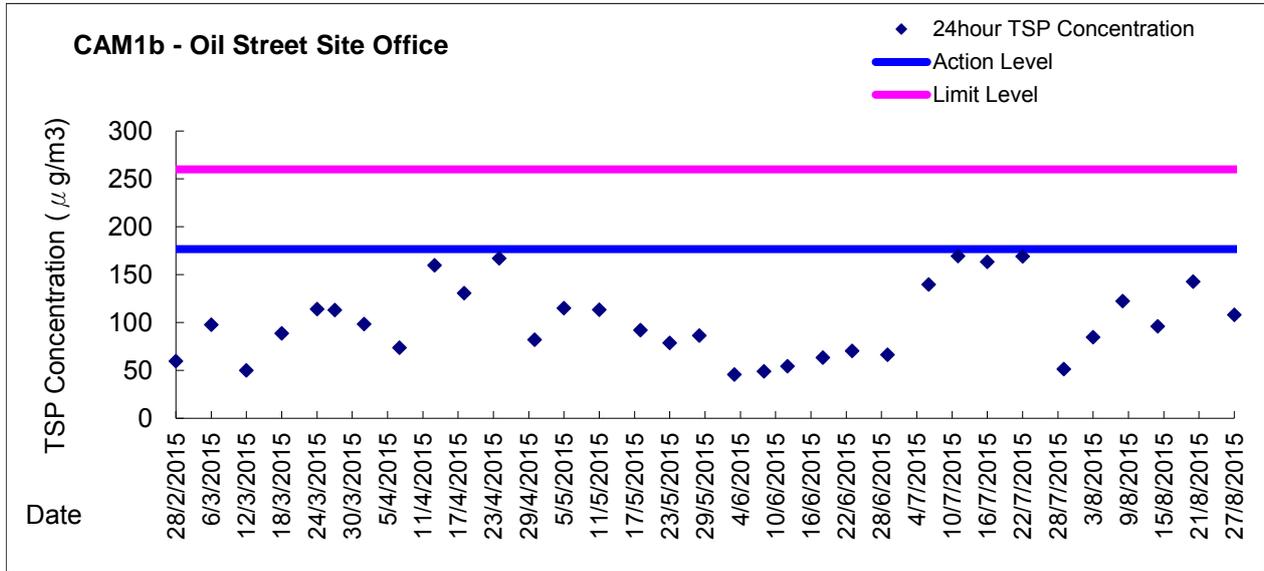
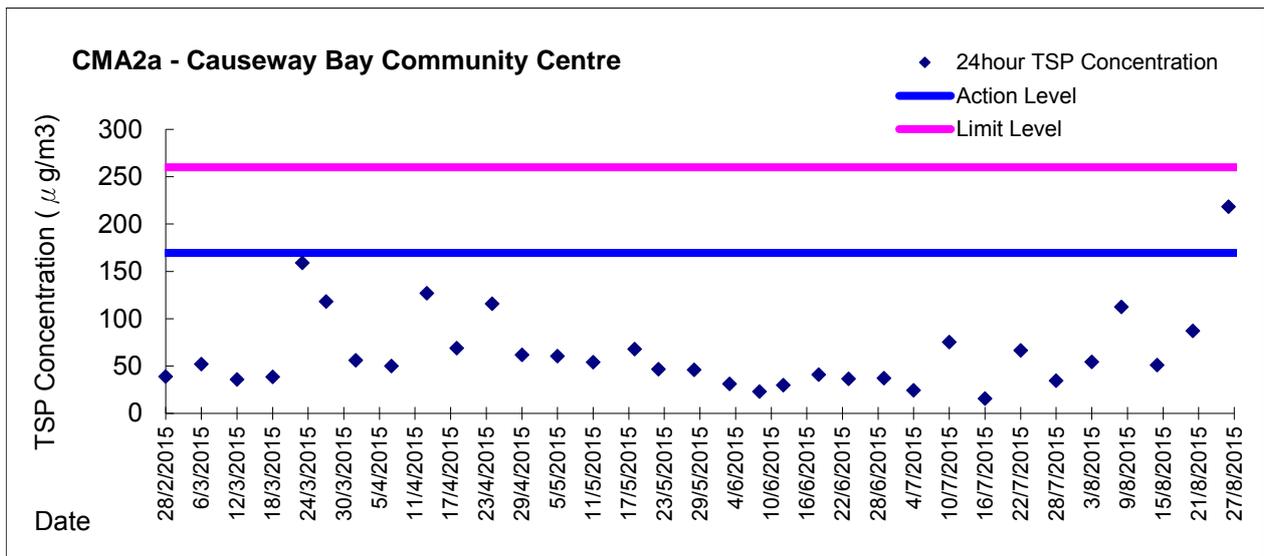
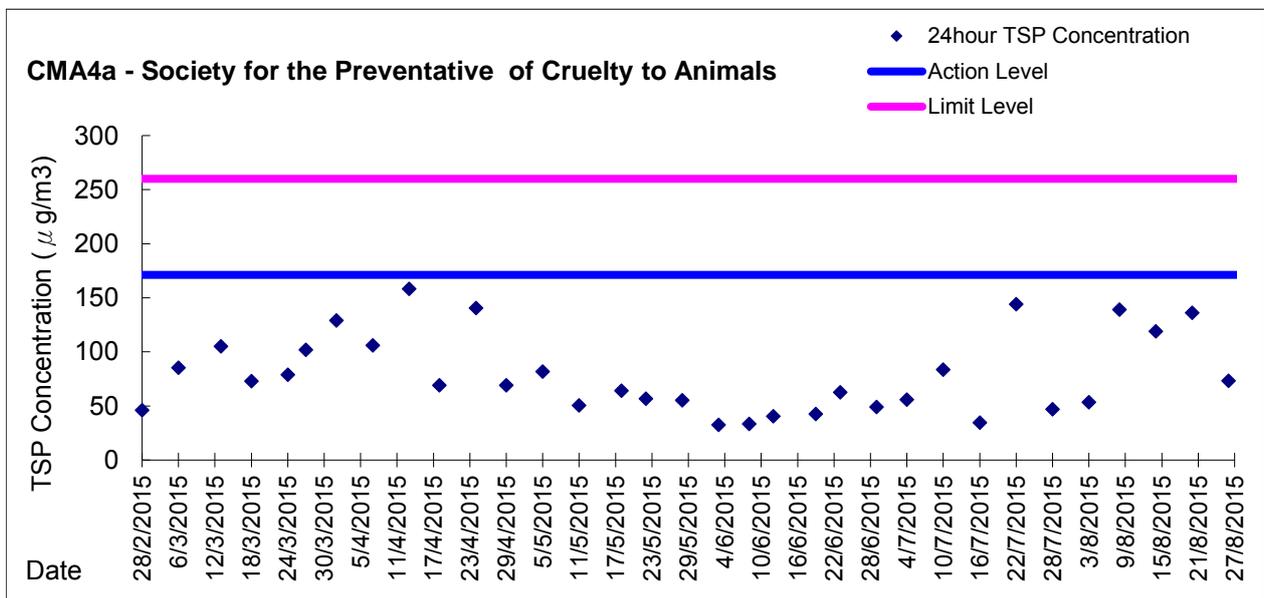
Graphic Presentation of 24 hour TSP Result

- xiv. One action level exceedance during 24hr TSP monitoring was recorded at monitoring station CMA2a – Causeway Bay Community Centre on 26 August 2015 in the reporting month. Investigation found that the exceedance recorded was not related to the Project.

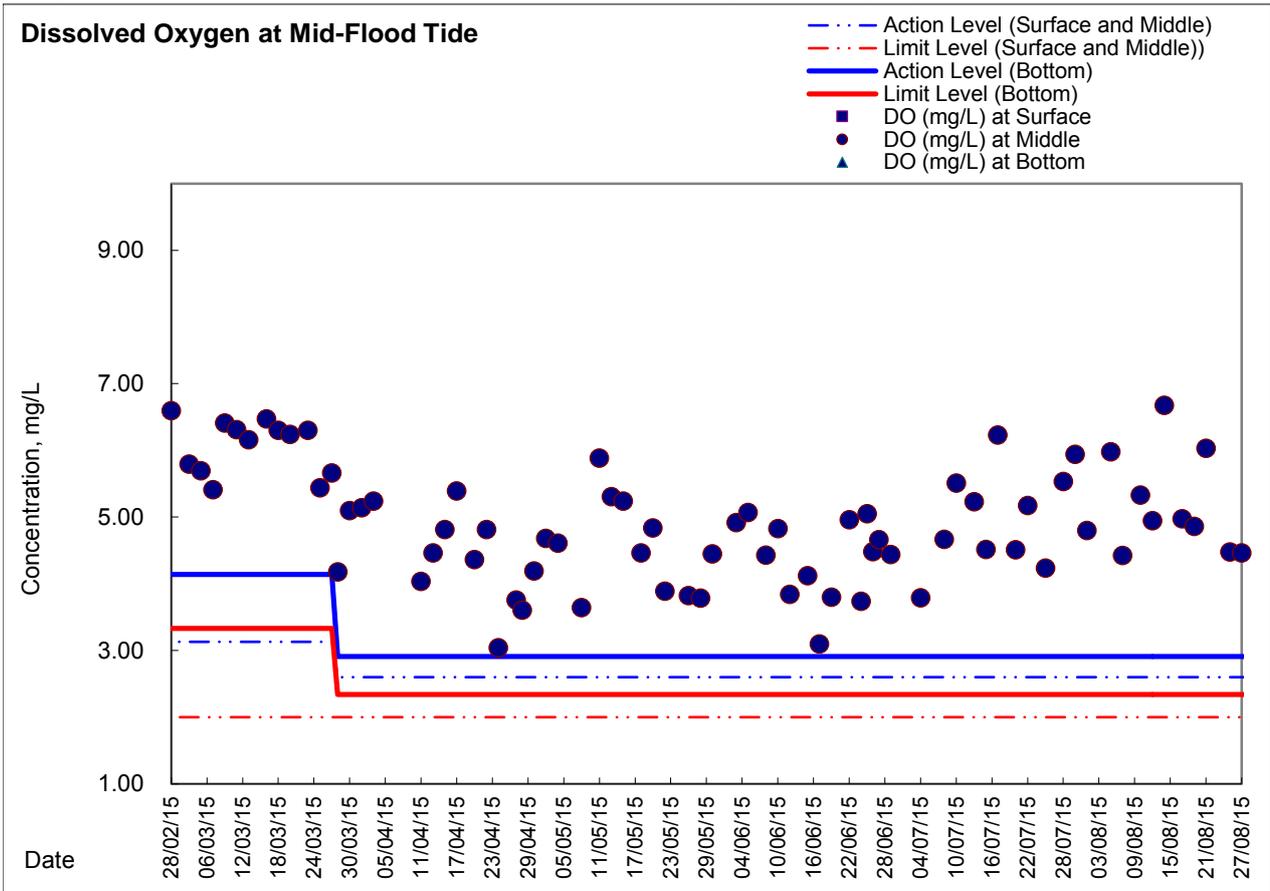
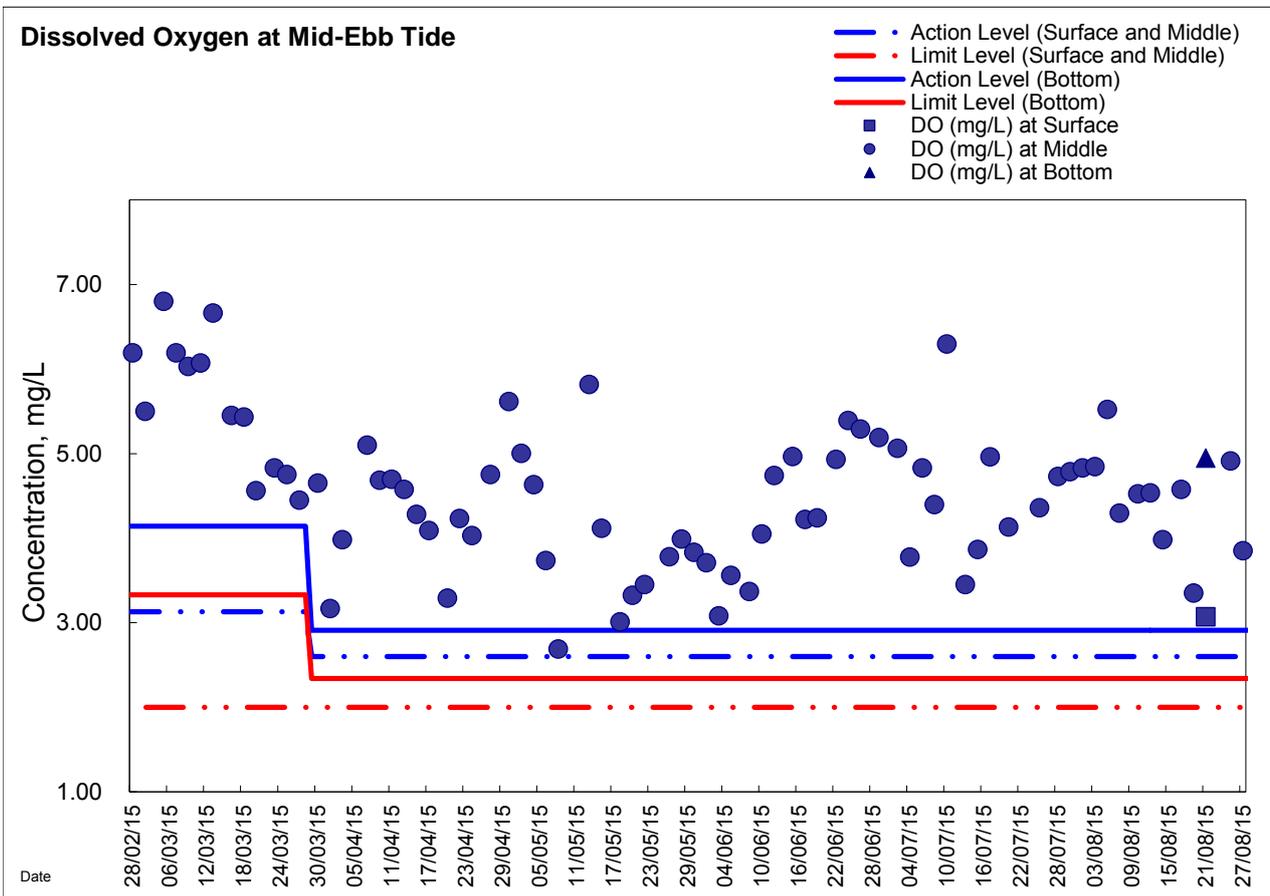
### Graphic Presentation of Enhanced Water Monitoring Results (DO) at C6 - Excelsior Hotel

- xlix. There were 4 action level and 7 limit level exceedances of enhanced dissolved oxygen recorded in this reporting month. Investigation found that the exceedances were not related to Project works. The details of the recorded exceedances can be referred to the **Section 6.4**.

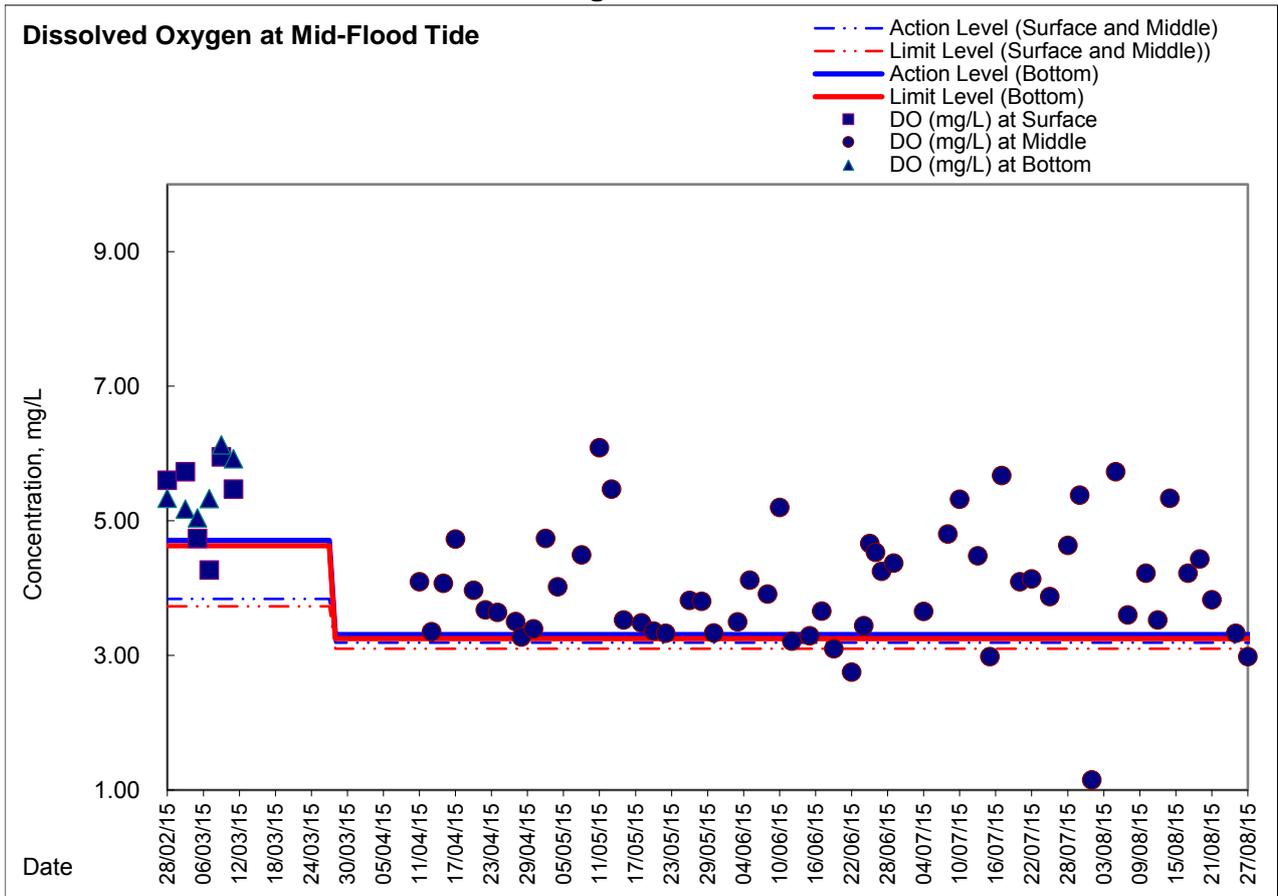
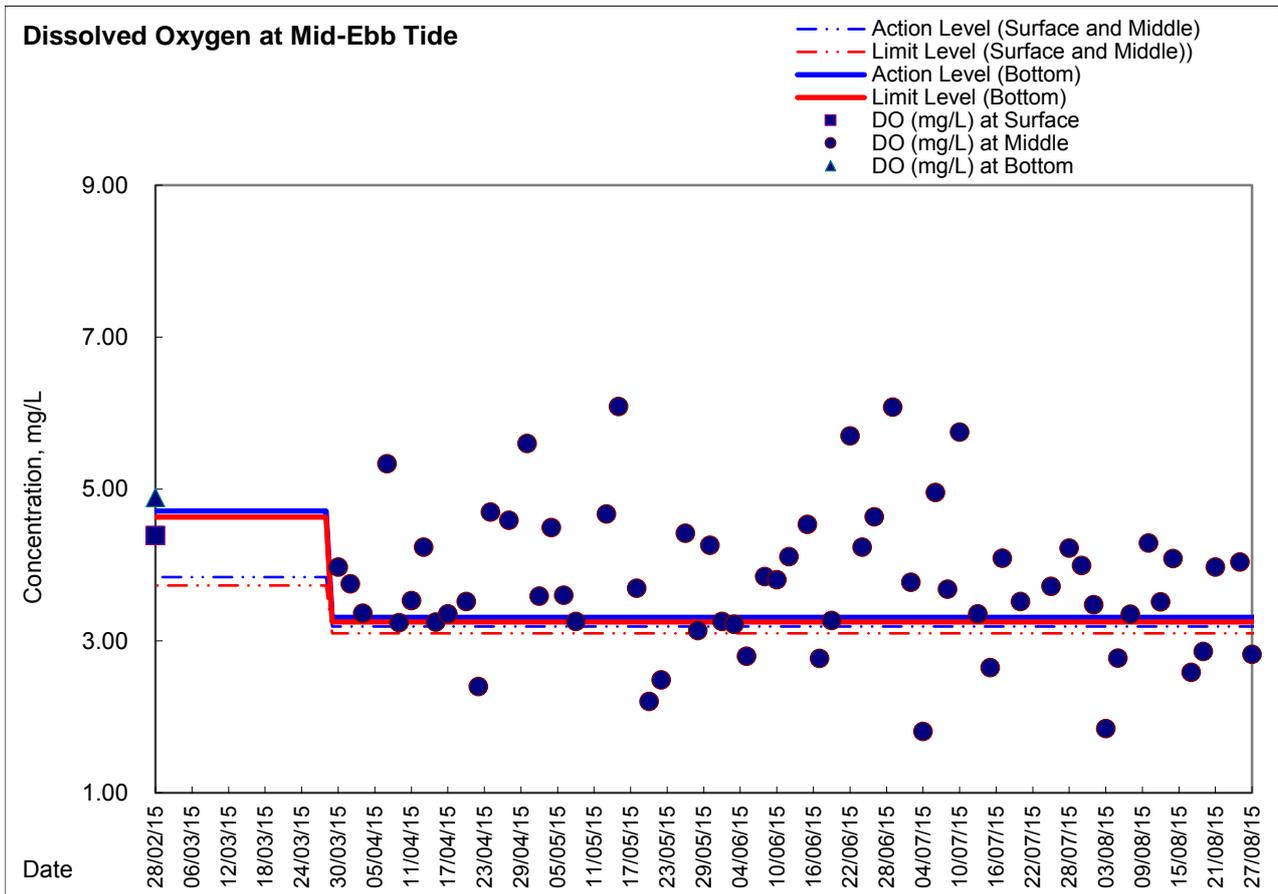
### Graphic Presentation of Enhanced Water Monitoring Results (DO) at Ex-WPCWA SW - South-western corners of ex-Public Cargo Works Area

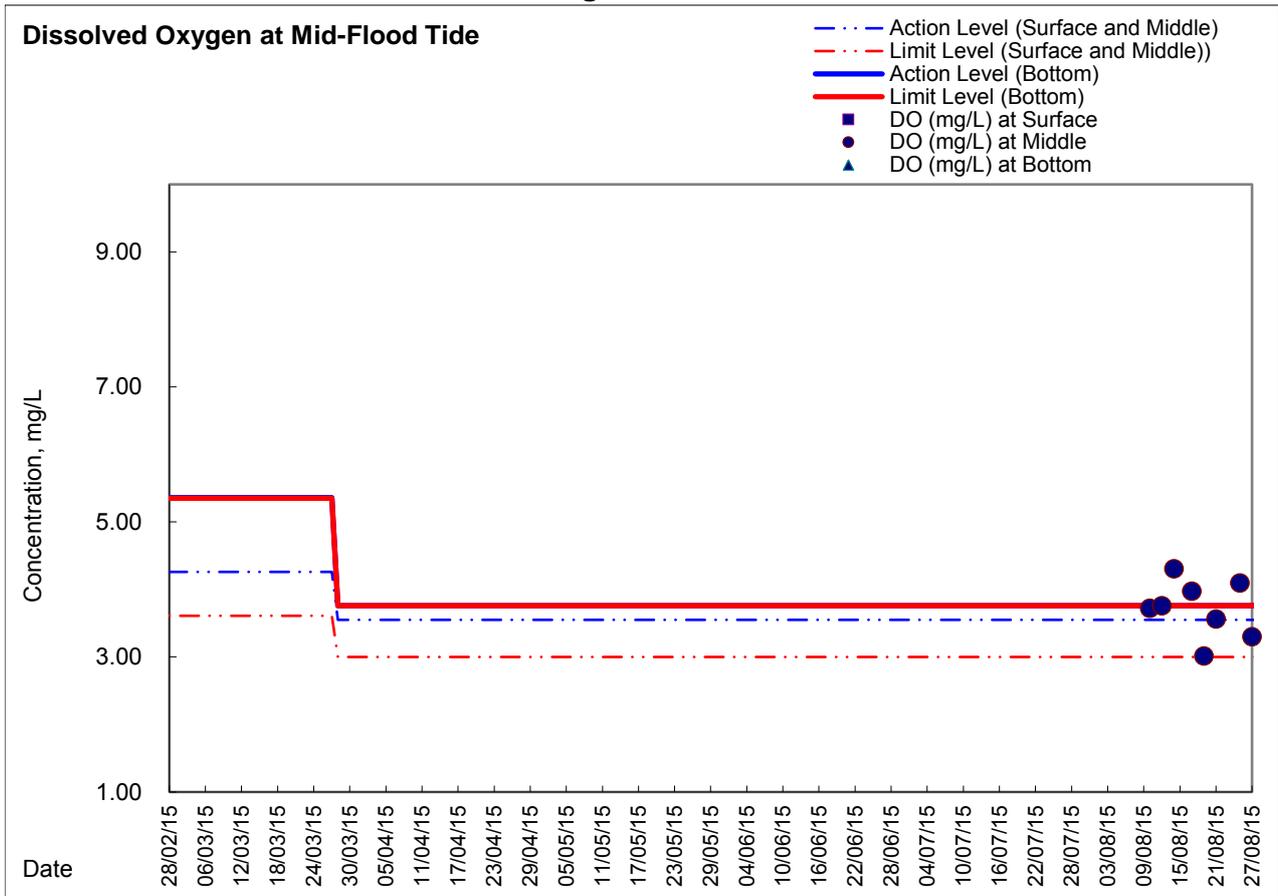
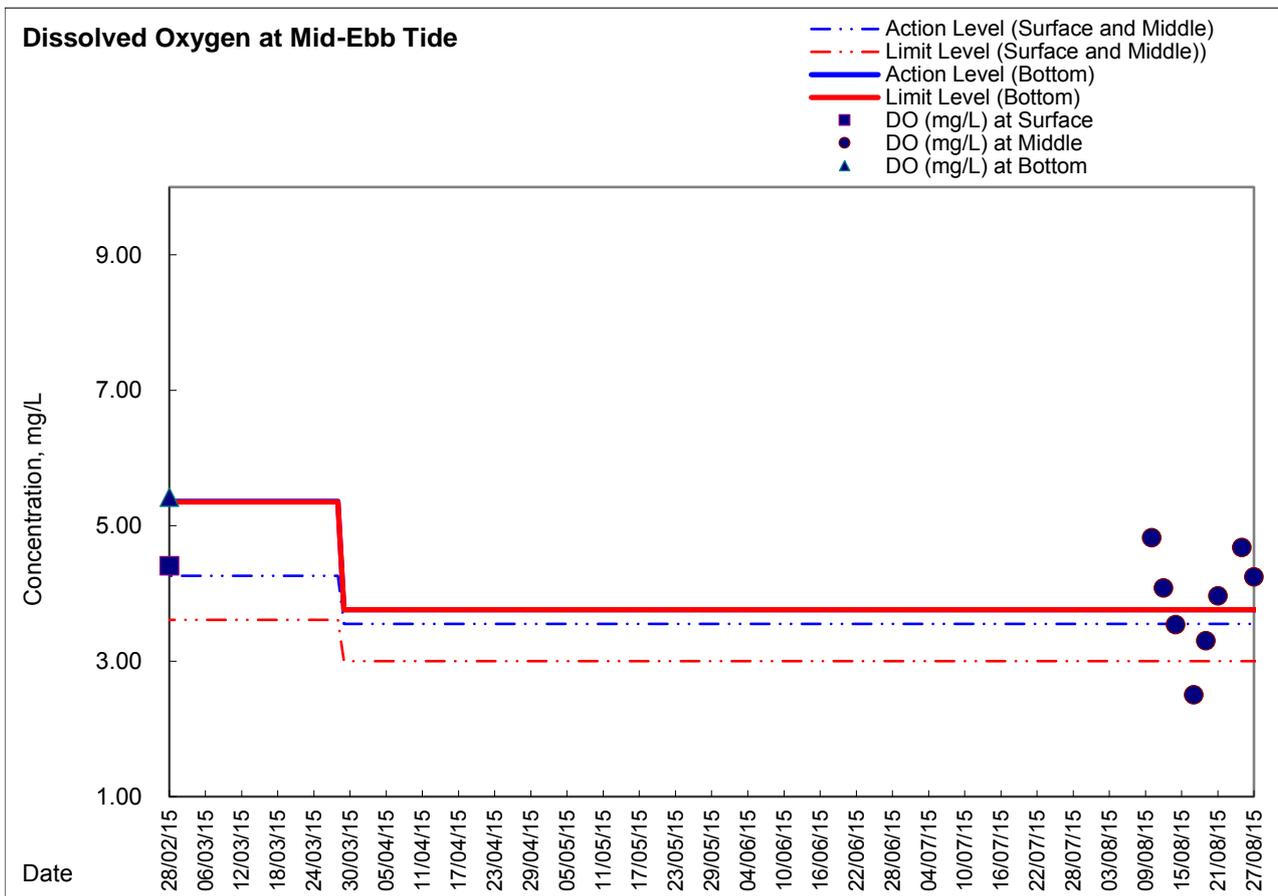
### Graphic Presentation of Enhanced Water Monitoring Results (DO) at Ex-WPCWA SE - South-eastern corners of ex-Public Cargo Works Area
