**Contract SCL1123 –  
Exhibition Station & Western Approach  
Tunnel**

**Shatin to Central Link -  
Hung Hom to Admiralty Section**

**Works Contract 1123 -  
CEDD Entrusted Work for Road P2 & other roads and Slip Road 3**

**Quarterly Environmental Monitoring  
and Audit Report for**

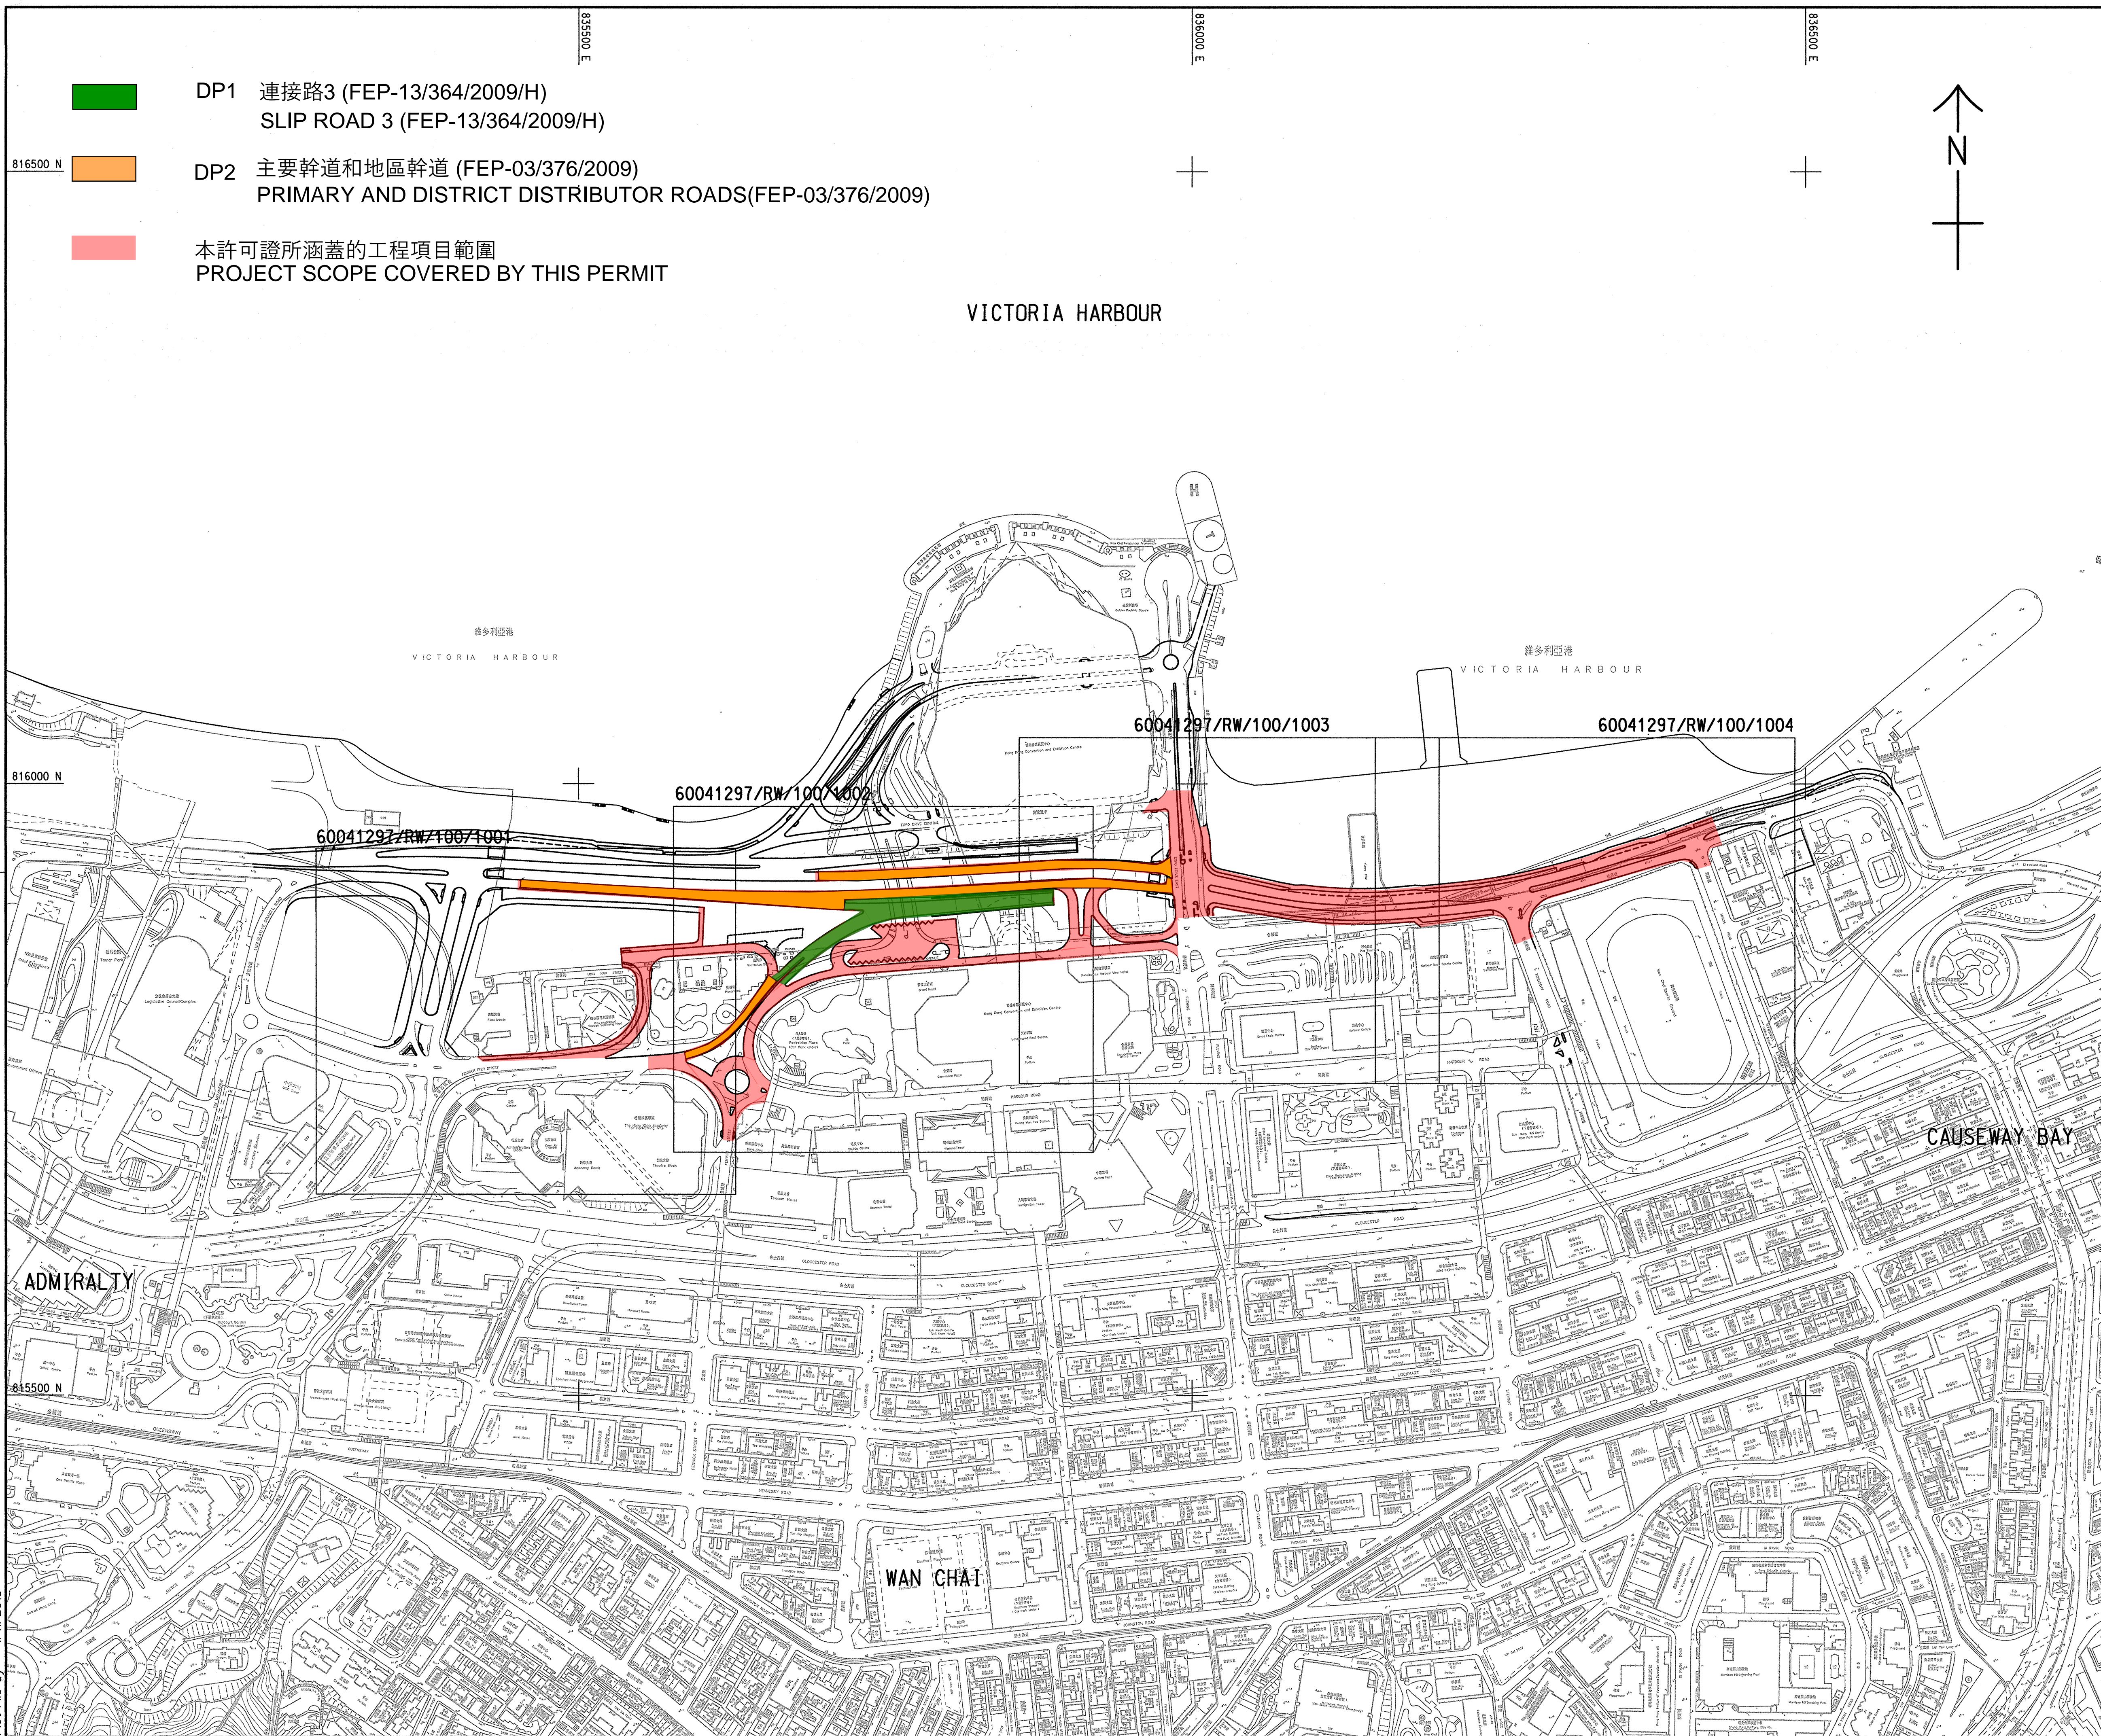
DRG.NO. Figure 1.1 圖紙編號		
DESIGNED BY 設計	CONTRACT NO. 合約編號	P. DIR. APPROVED 授權人
ST		TKH
DRAWN BY 繪圖	STATUS 狀態	
TS		
SCALE 比例	DIMENSIONS ARE IN 尺寸單位	
A1 1:2500	METRES	
© COPYRIGHT RESERVED 版權所有

- 2.1.4 The site layout plan of the Project is shown in **Figure 1.1**.

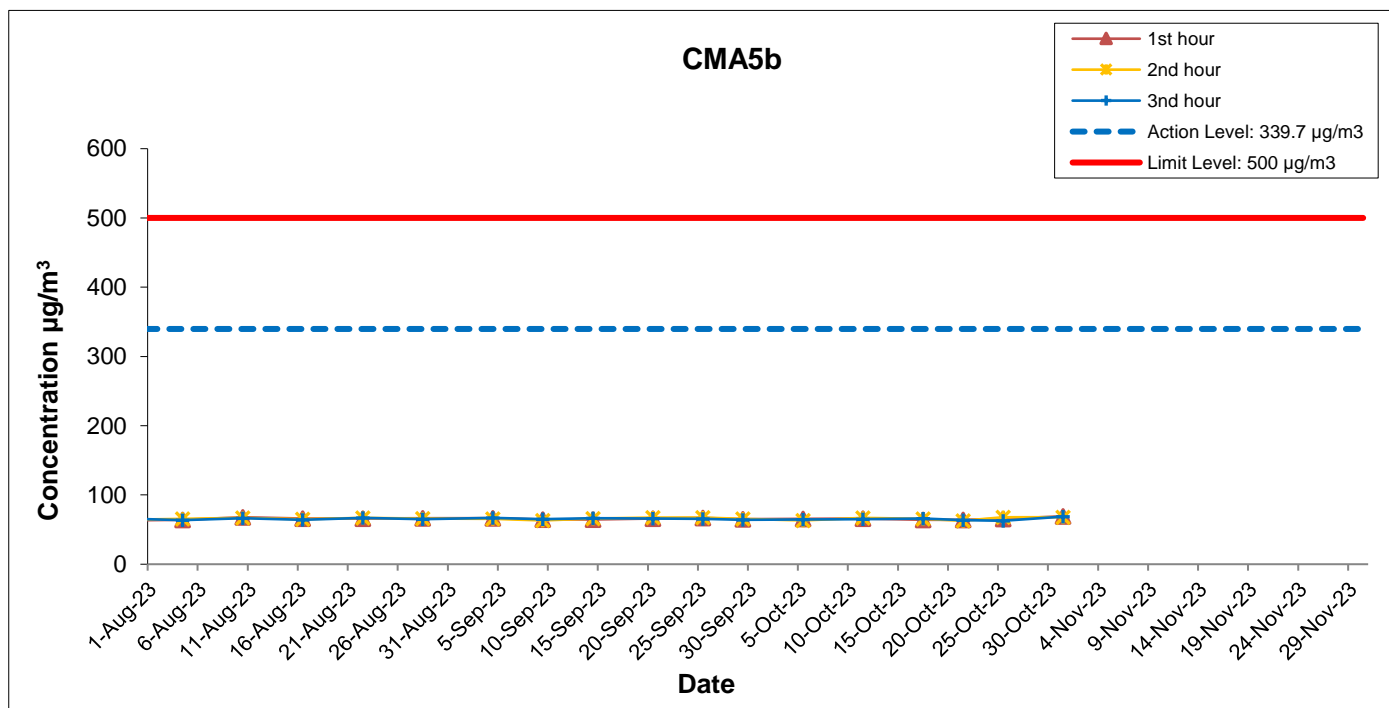
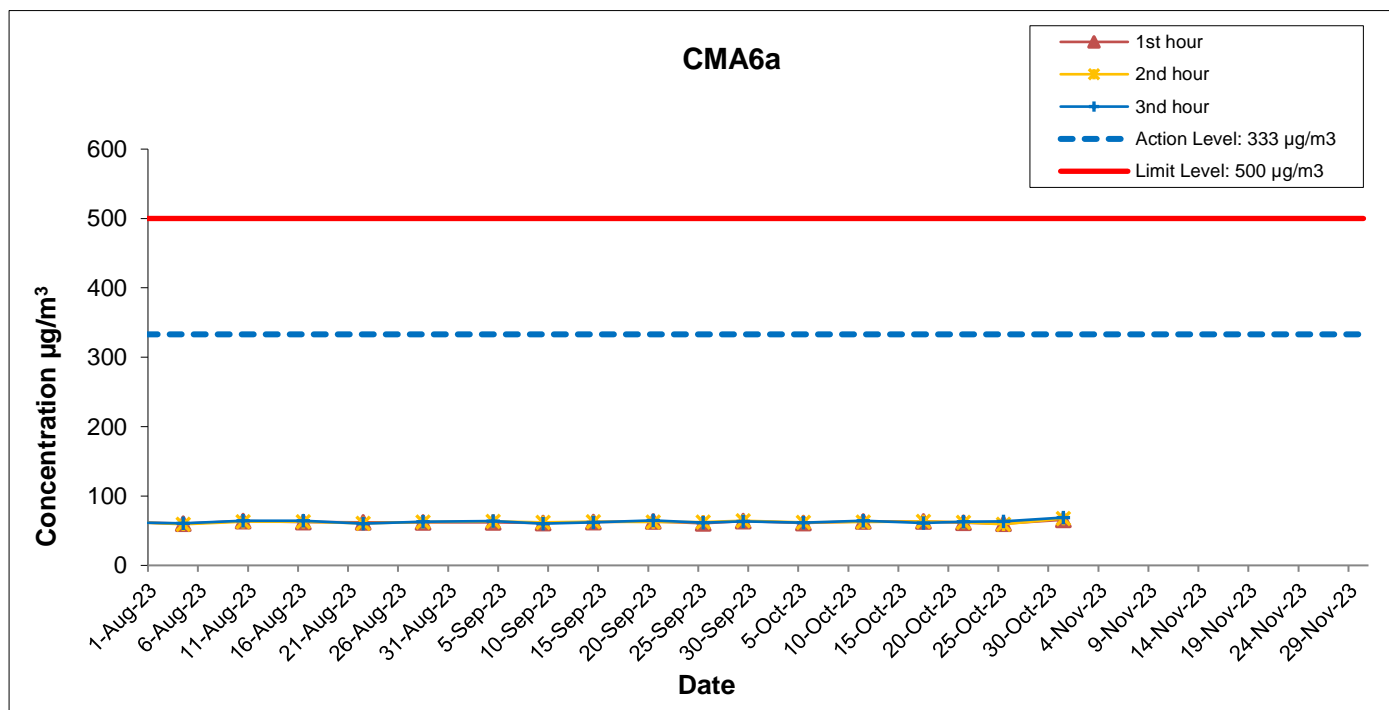
**1-hour TSP Monitoring Results at Station CMA6a (WDII PRE Site Office)**

Date	Start Time (hh:mm)	Weather Condition	1st Hour Conc. ( $\mu\text{g}/\text{m}^3$ )	2nd Hour Conc. ( $\mu\text{g}/\text{m}^3$ )	3rd Hour Conc. ( $\mu\text{g}/\text{m}^3$ )
04-Aug-23	13:45	Sunny	60.0	59.4	60.8
10-Aug-23	13:50	Sunny	63.9	62.8	64.2
16-Aug-23	14:00	Sunny	62.5	62.8	64.2
22-Aug-23	13:50	Sunny	62.2	60.7	60.1
28-Aug-23	13:50	Sunny	61.9	62.3	62.8
04-Sep-23	10:00	Sunny	62.2	63.6	64.0
09-Sep-23	10:45	Cloudy	60.9	62.2	60.1
14-Sep-23	10:45	Sunny	62.6	63.1	62.0
20-Sep-23	13:05	Sunny	63.3	62.4	64.6
25-Sep-23	13:05	Sunny	60.6	62.6	61.4
29-Sep-23	13:10	Sunny	64.0	64.4	63.6
05-Oct-23	13:05	Sunny	60.9	62.1	61.7
11-Oct-23	13:10	Sunny	63.2	62.3	64.4
17-Oct-23	13:00	Sunny	63.3	63.6	60.9
21-Oct-23	13:33	Fine	61.8	62.2	62.8
25-Oct-23	13:00	Sunny	60.0	59.1	63.2
31-Oct-23	13:05	Sunny	65.7	67.8	68.8
				Average	62.6
				Min	59.1
				Max	68.8

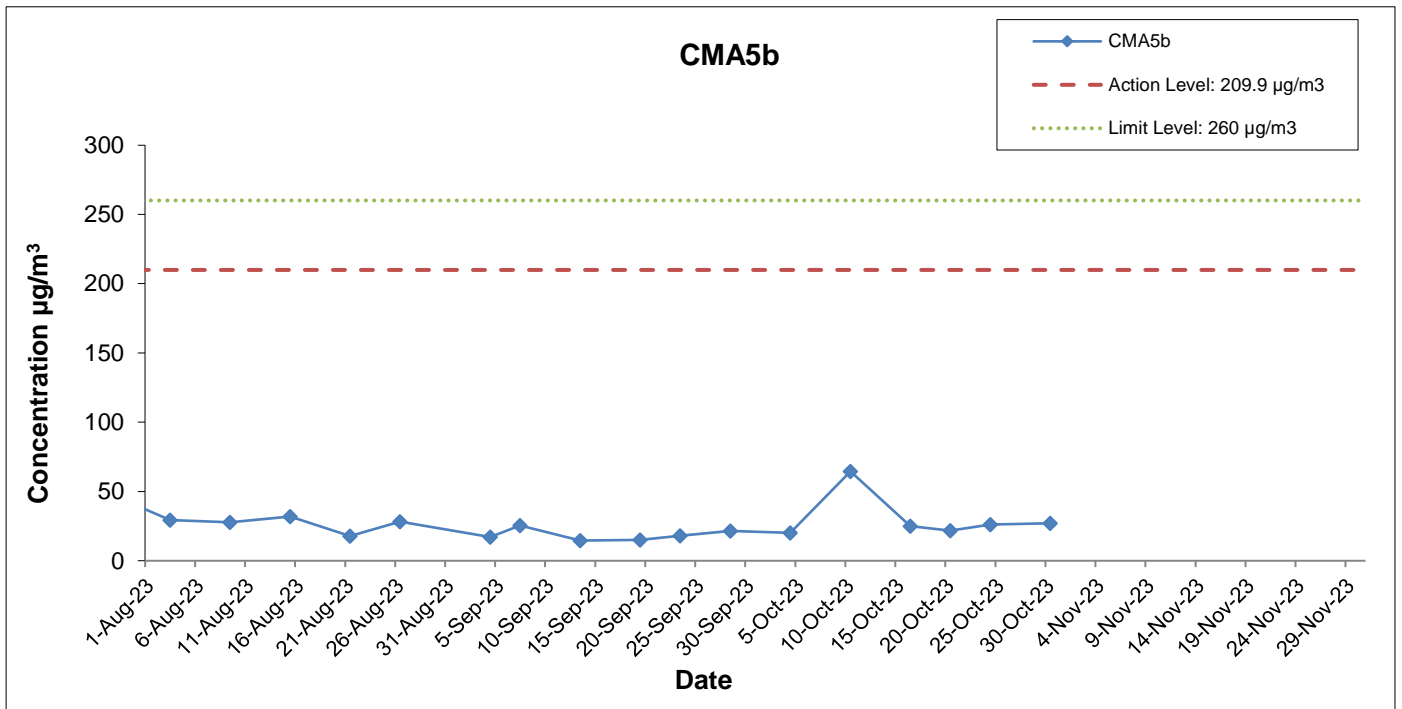
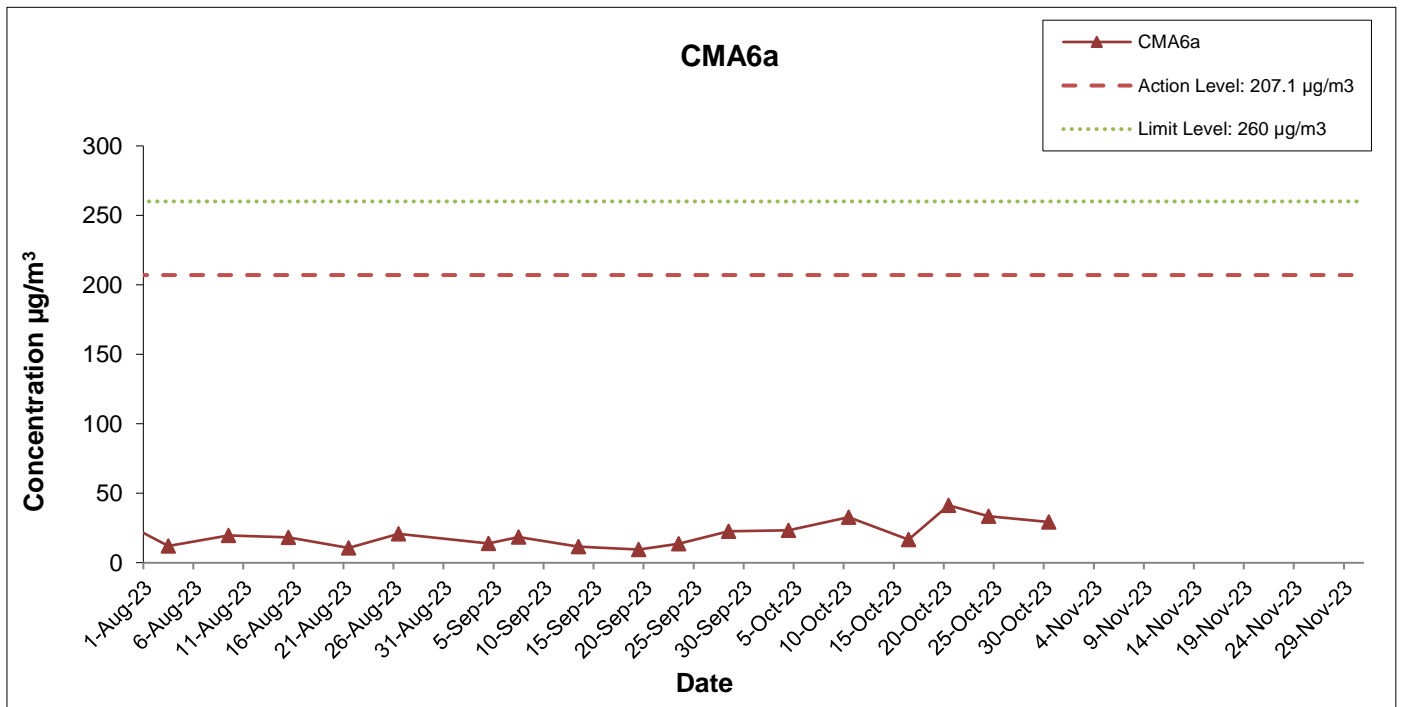
20-Oct-23	0:00	21-Oct-23	0:00	Sunny	25.9	1015.2	1.33	1.33	1.33	1916.6	2.7473	2.8265	0.0792	13440.37	13464.37	24.00	41.3
24-Oct-23	0:00	25-Oct-23	0:00	Sunny	26.8	1016.3	1.33	1.33	1.33	1916.6	2.7384	2.8028	0.0644	13464.37	13488.37	24.00	33.6
30-Oct-23	0:00	31-Oct-23	0:00	Sunny	26.1	1017.1	1.33	1.33	1.33	1916.6	2.7490	2.8055	0.0565	13488.37	13512.37	24.00	29.5
																Average	20.5
																Minimum	9.4
																Maximum	41.3
